Pavement Condition Report

Blue Earth Municipal Airport (SBU)

January 2016

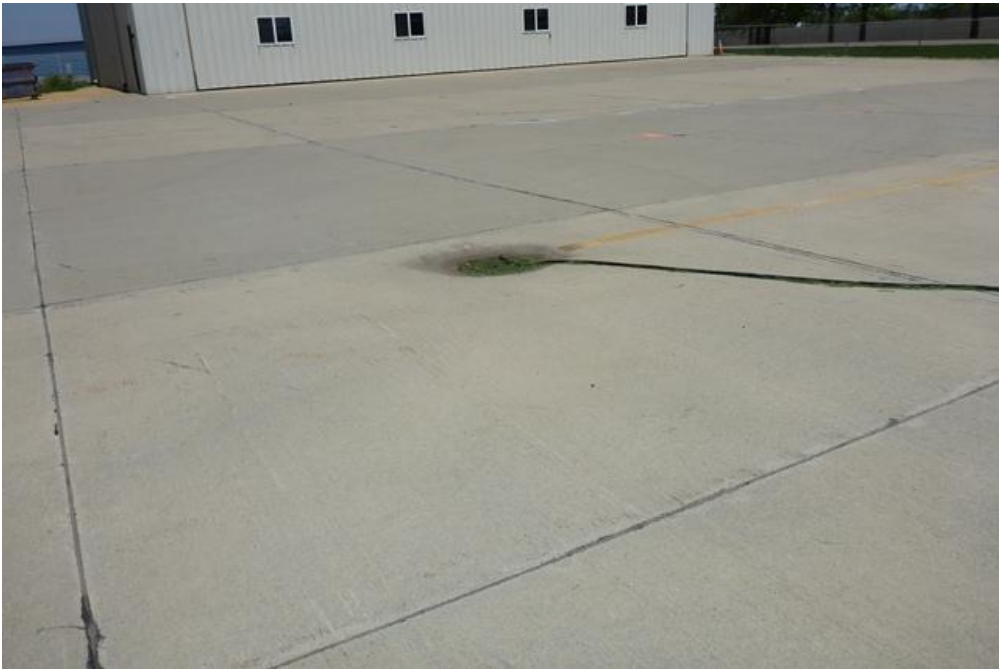
SBU APA 002 (PCI = 86)

74 JOINT SPALL L 1.00 Slabs Comments:
