Pavement Condition Report

Buffalo Municipal Airport (CFE)

December 2016

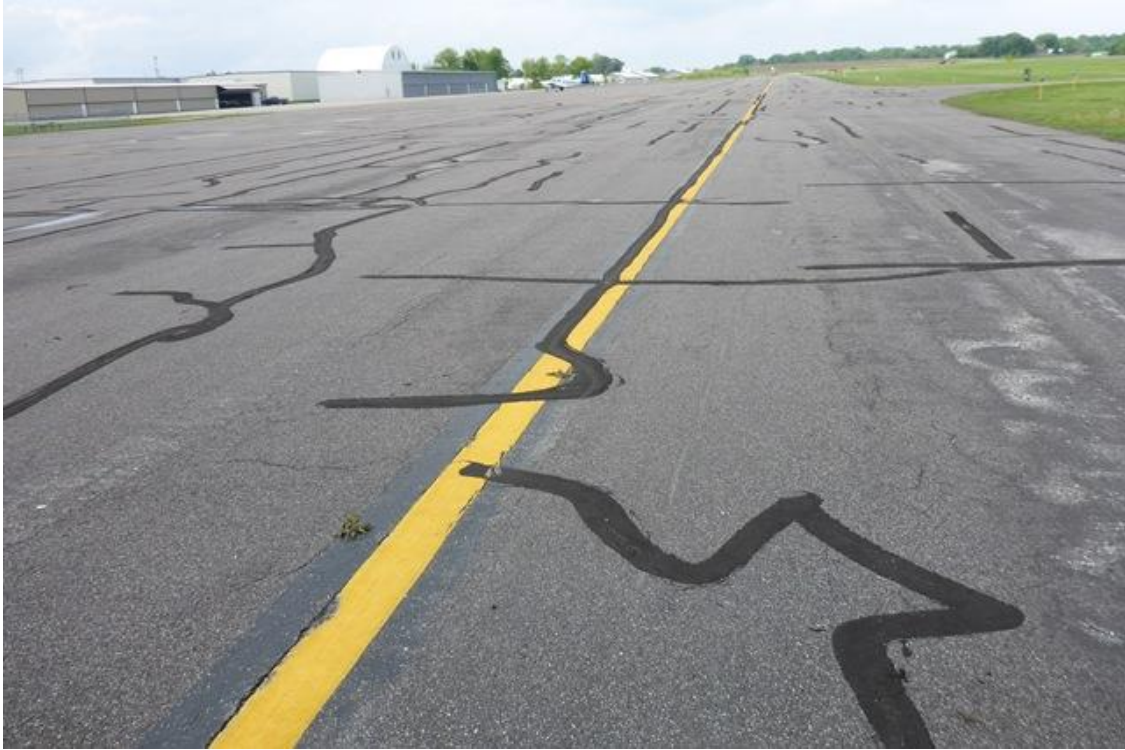
CFE APA 001 (PCI = 70)

Branch ID	Section ID	Surface type ¹	Section area (SF)	LCD ²	2013 PCI	2016 PCI	Drop in PCI/Yr ³	% Deduct due to		Distress types
								Load ⁴	Climate ⁵	
APA	001	AC	51,275	2005	77	70	3	14	86	Alligator Cracking, Block Cracking, L&T Cracking
APA	002	AC	32,725	2005	79	79	2	28	72	L&T Cracking, Rutting
APA	003	AC	10,650	2010	88	80	3	-	100	L&T Cracking, Weathering
APB	001	AC	28,800	2010	100	94	1	-	100	L&T Cracking, Weathering
CTA1	001	AC	9,200	2010	100	96	1	-	100	L&T Cracking, Weathering
CTA2	001	AC	9,750	2005	81	70	3	-	100	L&T Cracking, Weathering
CTA3	001	AAC	5,555	2005	78	69	3	-	100	L&T Cracking, Weathering
PTA	001	AC	22,700	2010	98	94	1	-	100	L&T Cracking, Weathering
PTA	002	AC	27,600	2005	81	72	3	-	100	Block Cracking, L&T Cracking, Weathering
PTA	003	AC	64,750	2010	100	95	1	-	100	L&T Cracking, Weathering
RY1836	001	AC	16,500	2010	100	91	2	-	100	L&T Cracking
RY1836	002	AC	156,000	2005	79	73	2	-	100	L&T Cracking, Weathering

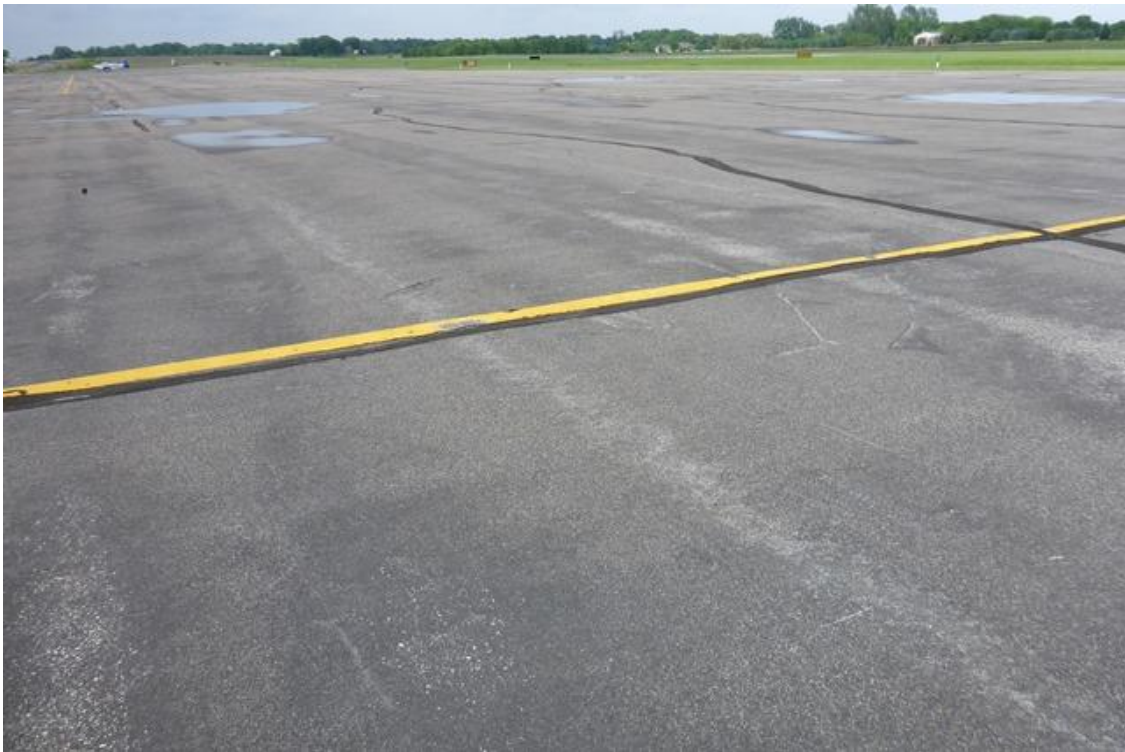
CFE APA 002 (PCI = 79)

Last Insp. Date: 5/25/2016 **TotalSamples:** 8 **Surveyed:** 2
Conditions: PCI: 79
Inspection Comments: New Crack Seal

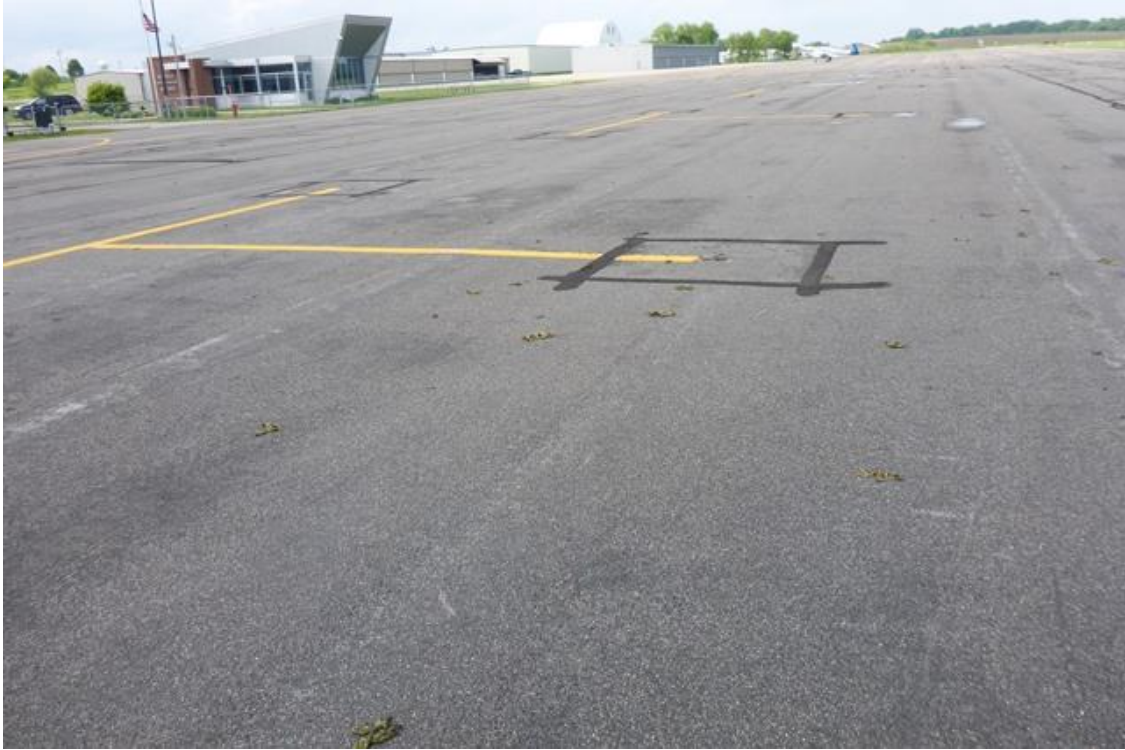
CFE APA 003 (PCI = 80)

Network:	CFE	Name:	BUFFALO						
Branch:	APA	Name:	APRON A	Use:	APRON	Area:	94,650 SqFt		
Section:	003	of 3	From:	210	To:	211	Last Const.:	9/1/2010	
Surface:	AC	Family:	MN2013 Asphalt Aprons	Zone:	E	Category:	3	Rank:	S
Area:	10,650 SqFt	Length:	213 Ft	Width:	50 Ft				
Slabs:	Slab Length:	Ft	Slab Width:	Ft	Joint Length:	Ft			
Shoulder:	Street Type:	Grade:	0	Lanes:	0				
Section Comments:									
Last Insp. Date:	5/25/2016	TotalSamples:	2	Surveyed:	1				
Conditions:	PCI: 80								
Inspection Comments: New Crack Seal Good Slurry Seal									
Sample Number:	214	Type:	R	Area:	5000.00 SqFt	PCI:	80		
Sample Comments:									
48	L & T CR	L	254.00	Ft					
57	WEATHERING	L	75.00	SqFt					
48	L & T CR	M	4.00	Ft

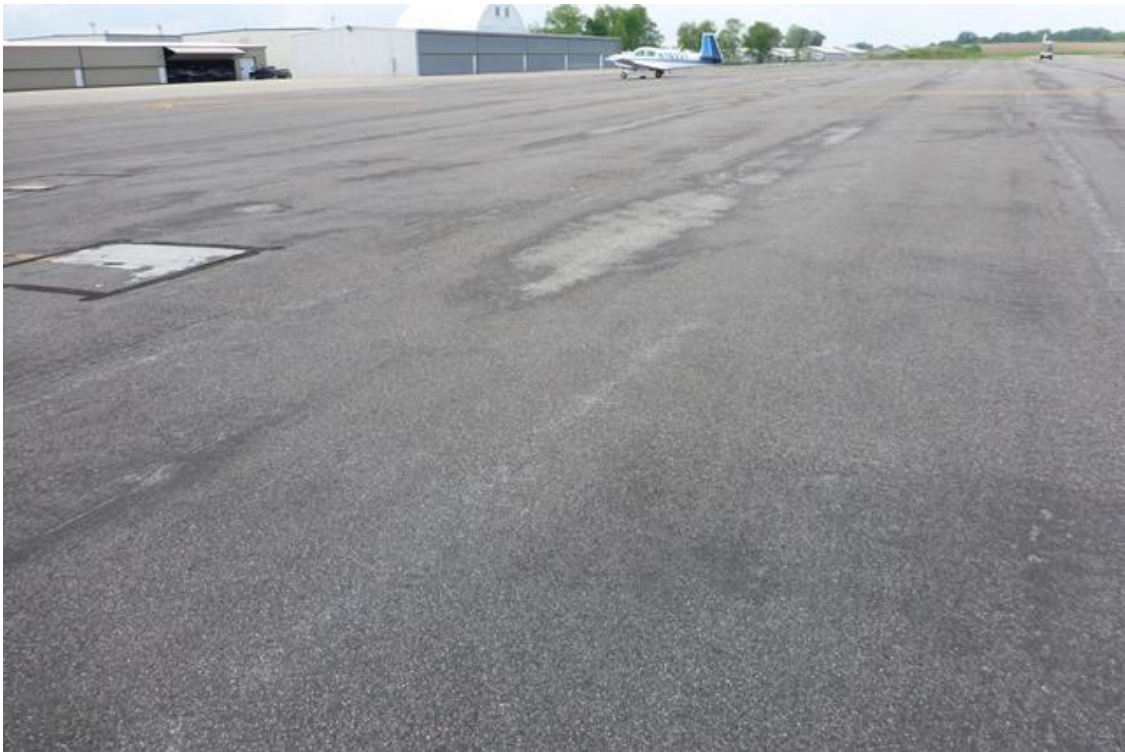
CFE APB 001 (PCI = 94)

Network:	CFE	Name:	BUFFALO						
Branch:	APB	Name:	Apron B	Use:	APRON	Area:	28,800 SqFt		
Section:	001	of 1	From:	400	To:	502	Last Const.: 7/1/2010		
Surface:	AC	Family:	MN2013 Asphalt Aprons	Zone:	E	Category:	3	Rank:	S
Area:	28,800 SqFt	Length:	320 Ft	Width:	90 Ft				
Slabs:	Slab Length:	Ft	Slab Width:	Ft	Joint Length:	Ft			
Shoulder:	Street Type:	Grade:	0	Lanes:	0				
Section Comments:									
Last Insp. Date:	5/25/2016	TotalSamples:	6	Surveyed:	2				
Conditions:	PCI: 94								
Inspection Comments:									
Sample Number:	400	Type:	R	Area:	4000.00 SqFt	PCI:	90		
Sample Comments:									
57	WEATHERING	L	150.00	SqFt					
48	L & T CR	L	100.00	Ft					
Sample Number:	501	Type:	R	Area:	5000.00 SqFt	PCI:	96		
Sample Comments:									
48	L & T CR	L	11.00	Ft					
57	WEATHERING	L	50.00	SqFt

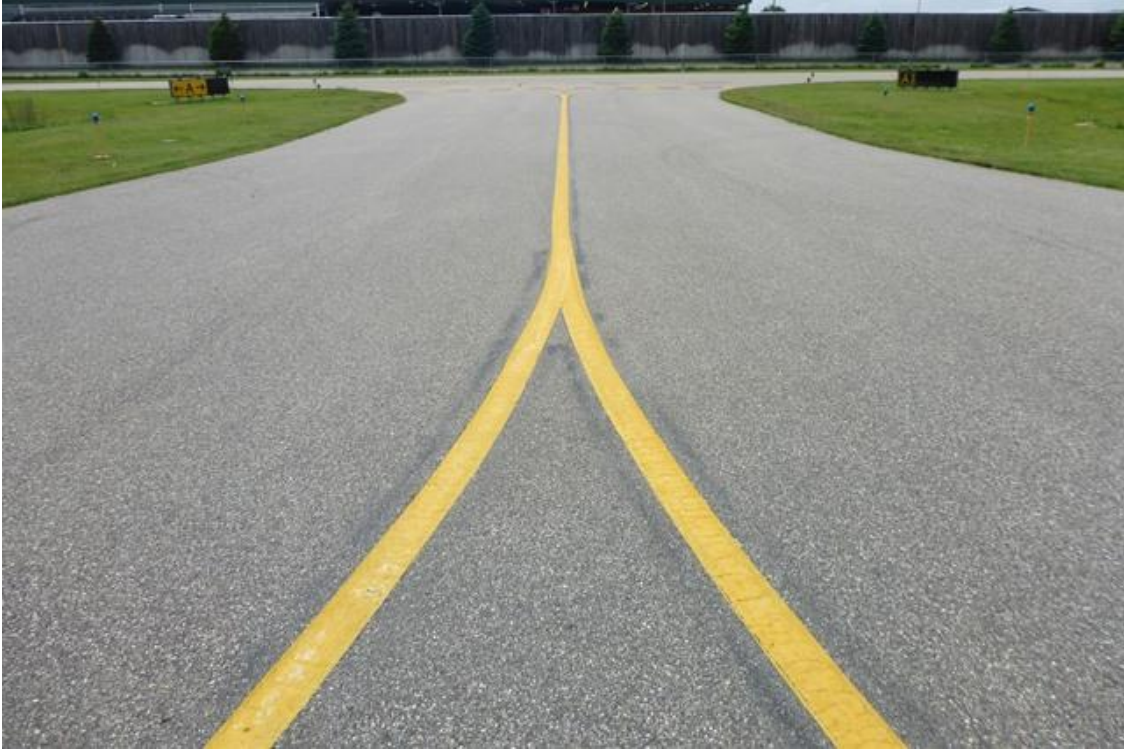
CFE CTA1 001 (PCI = 96)

Network:	CFE	Name:	BUFFALO						
Branch:	CTA1	Name:	Connecting Taxiway A1	Use:	TAXIWAY	Area:	9,200 SqFt		
Section:	001	of 1	From:	100	To:	101	Last Const.: 9/1/2010		
Surface:	AC	Family:	MN2013 Asphalt Taxiways	Zone:	E	Category:	3	Rank:	S
Area:	9,200 SqFt	Length:	180 Ft	Width:	35 Ft				
Slabs:		Slab Length:	Ft	Slab Width:	Ft	Joint Length:	Ft		
Shoulder:		Street Type:		Grade:	0	Lanes:	0		
Section Comments:									
Last Insp. Date:	5/25/2016	TotalSamples:	2	Surveyed:	1				
Conditions:	PCI: 96								
Inspection Comments:									
Sample Number:	100	Type:	R	Area:	4015.00 SqFt	PCI:	96		
Sample Comments:									
48	L & T CR	L	14.00 Ft						
57	WEATHERING	L	50.00 SqFt

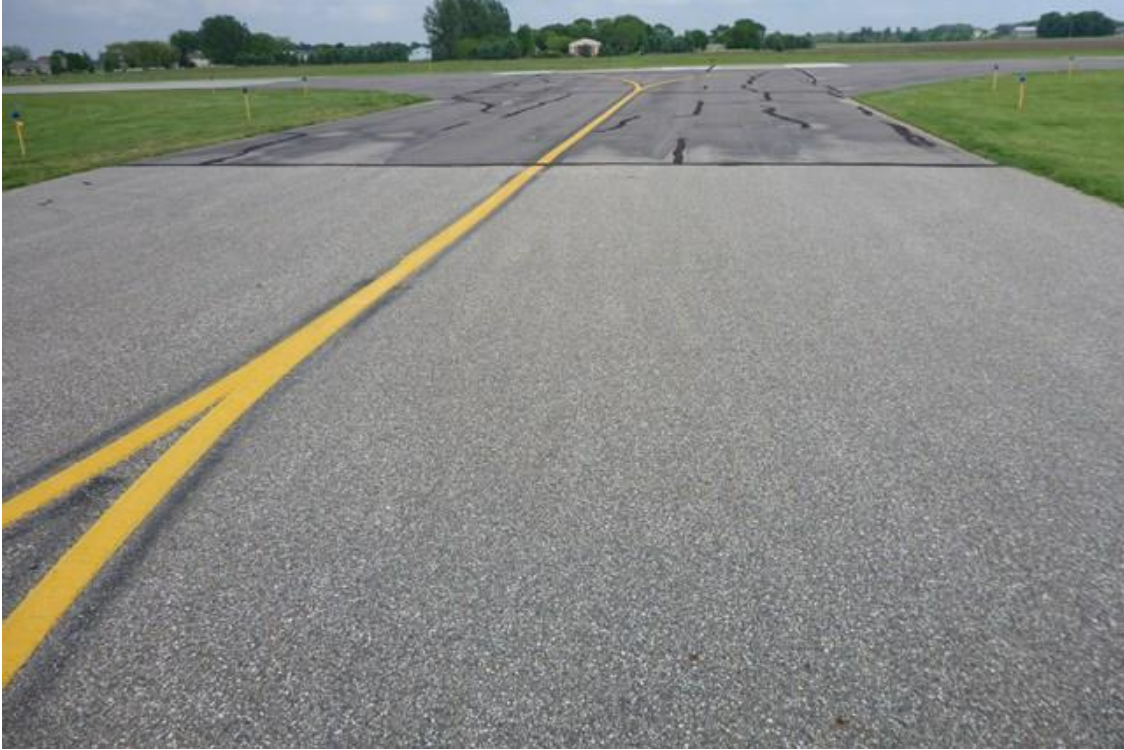
CFE CTA3 001 (PCI = 69)

Inspection Comments: New Crack Seal Good Slurry Seal

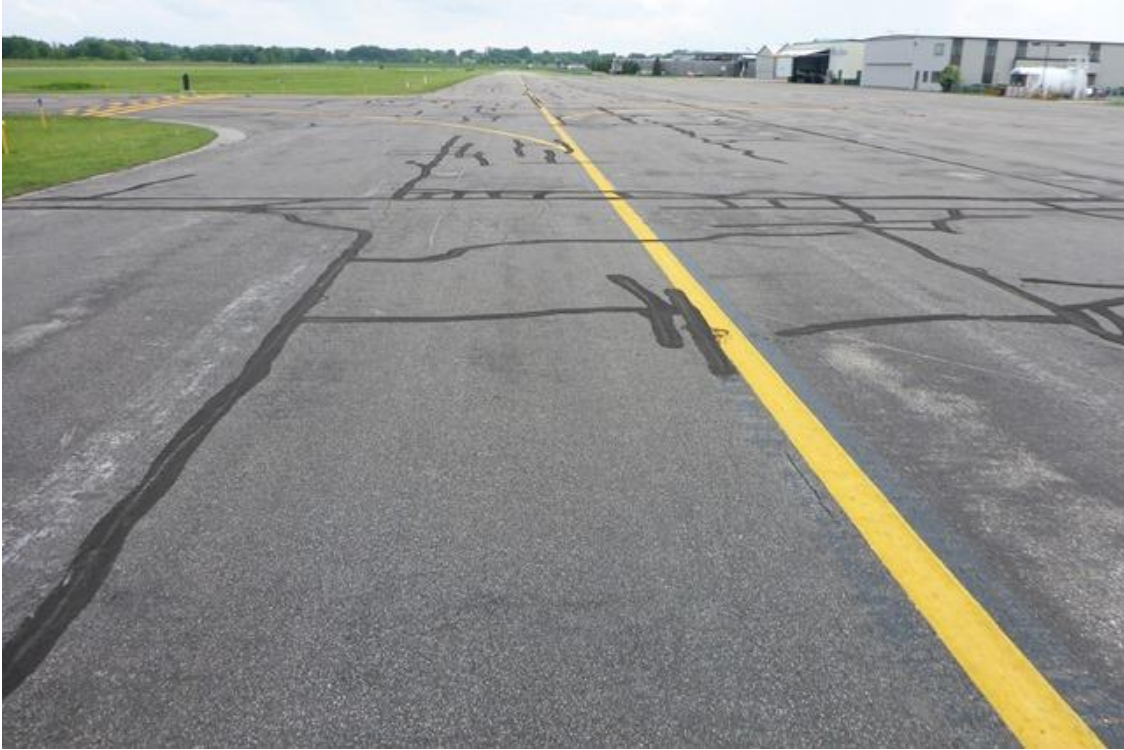
CFE PTA 002 (PCI = 72)

Inspection Comments: New Crack Seal Good Slurry Seal

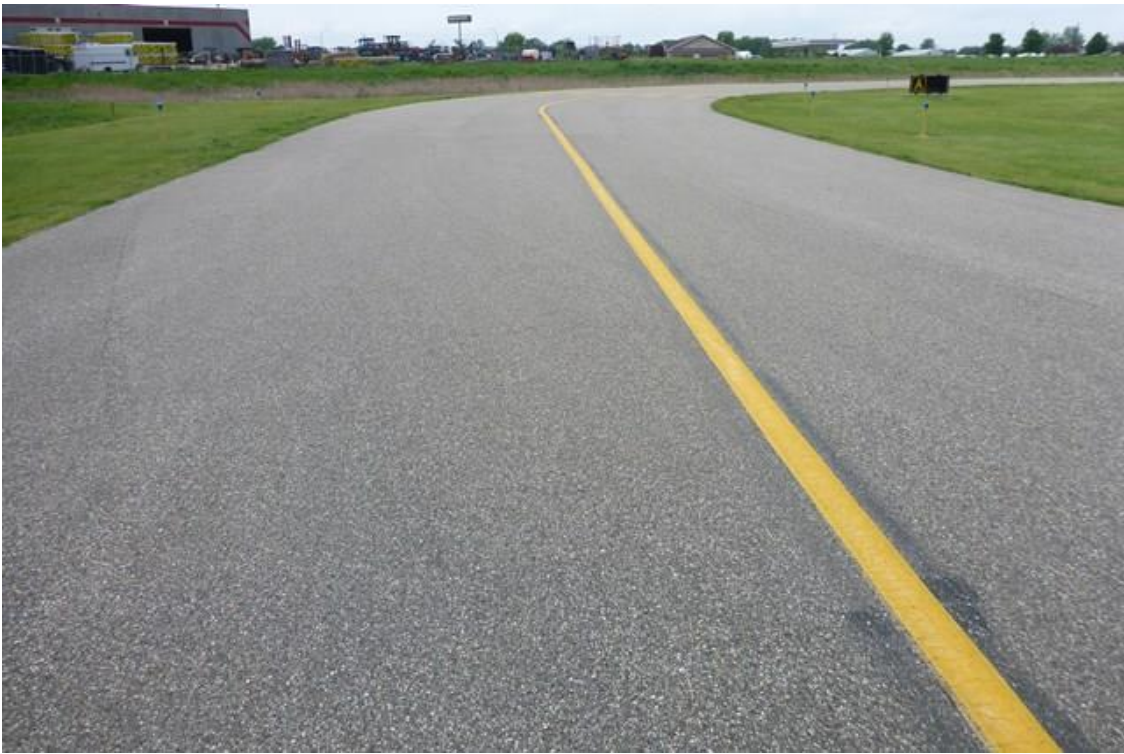
CFE PTA 003 (PCI = 95)

Network:	CFE	Name:	BUFFALO						
Branch:	PTA	Name:	PARALLEL TAXIWAY A	Use:	TAXIWAY	Area:	115,050 SqFt		
Section:	003	of 3	From:	200	To:	217	Last Const.:	9/1/2010	
Surface:	AC	Family:	MN2013 Asphalt Taxiways	Zone:	E	Category:	3	Rank:	P
Area:	64,750 SqFt	Length:	1,830 Ft	Width:	35 Ft				
Slabs:		Slab Length:	Ft	Slab Width:	Ft	Joint Length:	Ft		
Shoulder:		Street Type:		Grade:	0	Lanes:	0		
Section Comments:									
Last Insp. Date:	5/25/2016	TotalSamples:	18	Surveyed:	4				
Conditions:	PCI: 95								
Inspection Comments:									
Sample Number:	202	Type:	R	Area:	3500.00 SqFt	PCI:	94		
Sample Comments:									
48	L & T CR	L	3.00 Ft						
57	WEATHERING	M	150.00 SqFt						
Sample Number:	206	Type:	R	Area:	3500.00 SqFt	PCI:	96		
Sample Comments:									
57	WEATHERING	M	200.00 SqFt						
Sample Number:	210	Type:	R	Area:	3500.00 SqFt	PCI:	96		
Sample Comments:									
57	WEATHERING	M	200.00 SqFt						
Sample Number:	214	Type:	R	Area:	3500.00 SqFt	PCI:	92

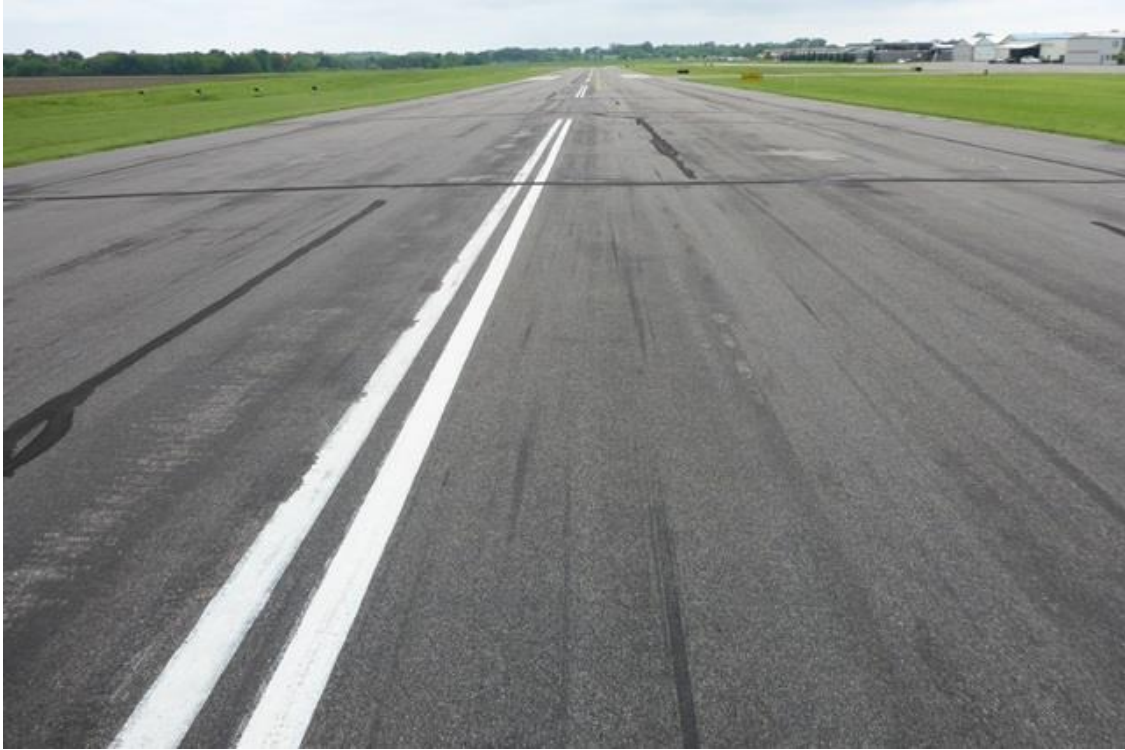
CFE RY1836 001 (PCI = 91)

Network:	CFE		Name:	BUFFALO					
Branch:	RY1836	Name:	RUNWAY 18-36	Use:	RUNWAY	Area:	240,000 SqFt		
Section:	001	of 4	From:	96	To:	99	Last Const.:	9/1/2010	
Surface:	AC	Family:	MN2013 Asphalt Runways	Zone:	E	Category:	3	Rank:	P
Area:	16,500 SqFt	Length:	220 Ft	Width:	75 Ft				
Slabs:	Slab Length:	Ft	Slab Width:	Ft	Joint Length:	Ft			
Shoulder:	Street Type:		Grade:	0	Lanes:	0			
Section Comments:									
Last Insp. Date:	5/25/2016	TotalSamples:	4	Surveyed:	2				
Conditions:	PCI: 91								
Inspection Comments:									
Sample Number:	97	Type:	R	Area:	3750.00 SqFt	PCI:	88		
Sample Comments:									
48	L & T CR	L	36.00	Ft					
48	L & T CR	M	12.00	Ft					
Sample Number:	98	Type:	R	Area:	3750.00 SqFt	PCI:	94		
Sample Comments:									
48	L & T CR	L	9.00	Ft					
48	L & T CR	M	2.00	Ft

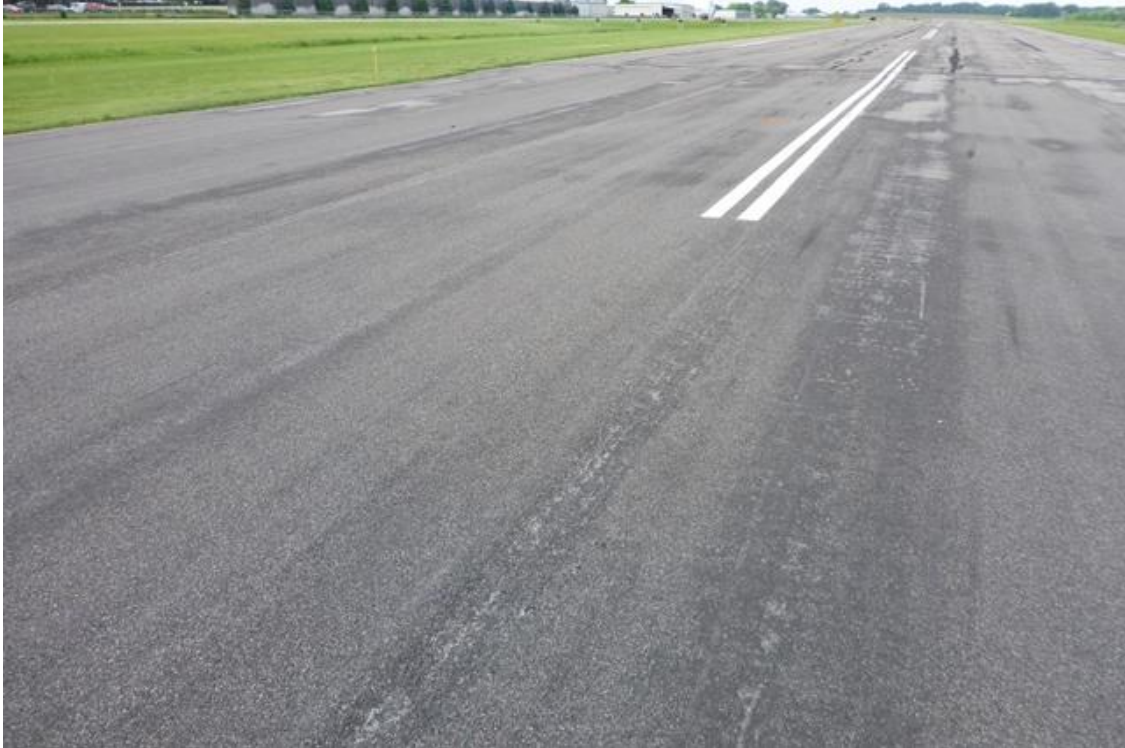
CFE RY1836 004 (PCI = 94)

RY1836	003	AC	39,000	2010	95	85	3	-	100	L&T Cracking, Weathering
RY1836	004	AC	28,500	2010	97	94	1	-	100	L&T Cracking, Ravelling, Weathering
TLA	001	AAC	24,500	2005	28	19	7	80	20	Alligator Cracking, L&T Cracking
TLA	002	AC	8,360	2005	24	17	8	78	22	Alligator Cracking, L&T Cracking, Rutting, Weathering
TLA	003	AC	31,160	2005	67	67	3	38	62	L&T Cracking, Patching, Ravelling, Rutting
TLA	004	AC	20,480	2005	89	80	2	-	100	L&T Cracking, Patching, Ravelling, Weathering
TLA	005	AC	35,925	2010	100	97	1	-	56	L&T Cracking, Oil Spill
TLA	006	AC	7,000	2010	100	92	1	-	100	L&T Cracking, Weathering
TLA	007	AAC	11,555	2005	81	77	2	-	100	L&T Cracking

Inspection Comments: Good Slurry Seal no Crack Seal

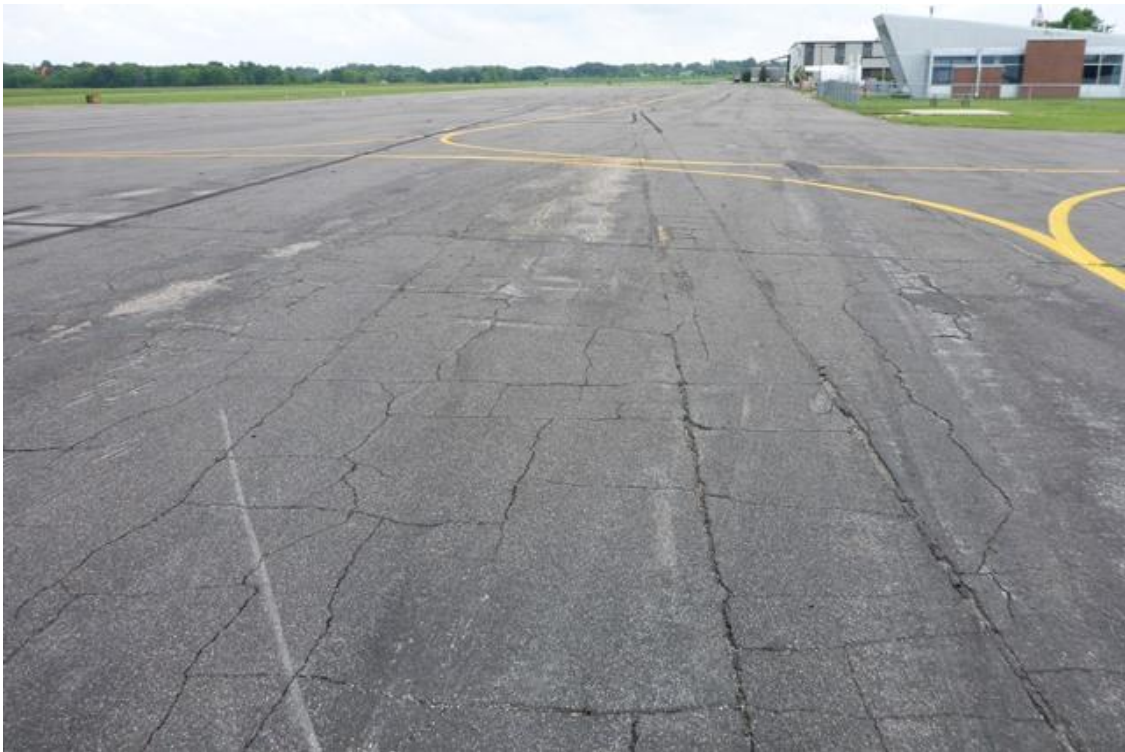
CFE TLA 001 (PCI = 19)

Note: Significant load related distress in taxilane sections with high deterioration rates.

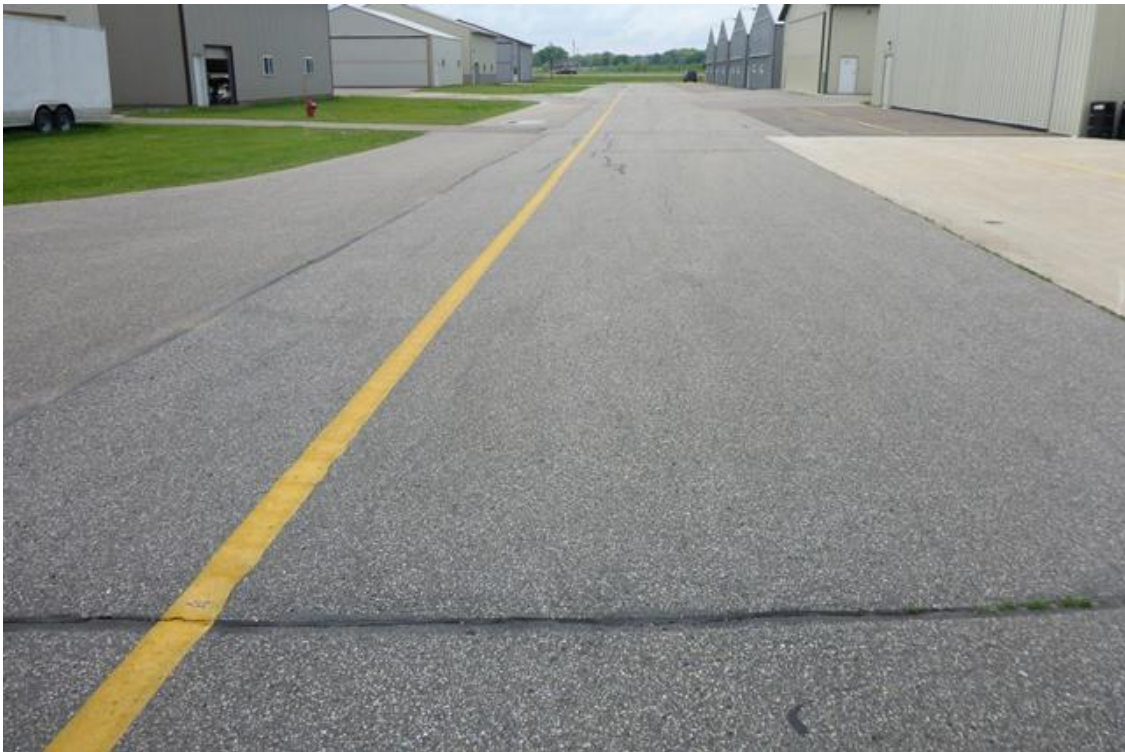
CFE TLB 001 (PCI = 58)

Branch ID	Section ID	Surface type ¹	Section area (SF)	LCD ²	2013 PCI	2016 PCI	Drop in PCI/Yr ³	% Deduct due to		Distress types
								Load ⁴	Climate ⁵	
TLB	001	AC	32,250	2005	74	58	4	16	84	Alligator Cracking, L&T Cracking, Patching, Weathering
TLB	002	AC	6,000	2007	64	39	7	80	20	Alligator Cracking, L&T Cracking, Rutting, Weathering
