Pavement Condition Report

Slayton Municipal Airport (DVP)

December 2017

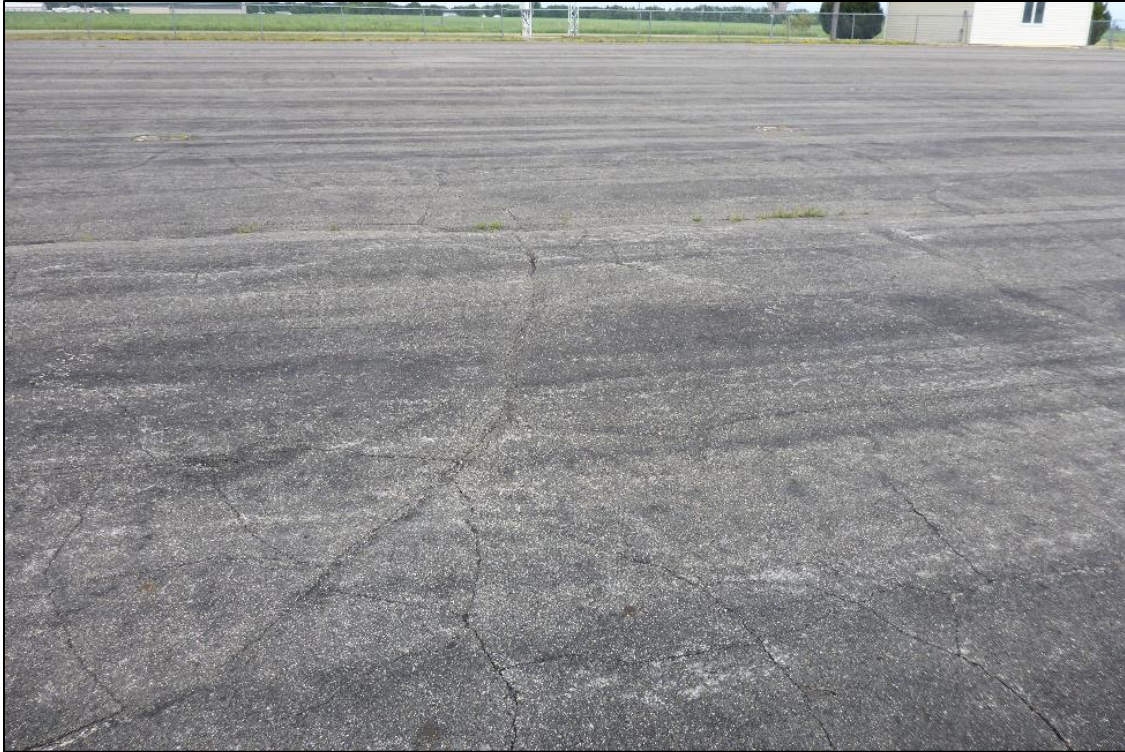
DVP APA 001 (PCI = 18)

Network: DVP			Name: SLAYTON			
Branch: APA	Name: APRON A	Use: APRON	Area: 45,000 SqFt			
Section: 001	of 1	From: 100	To: 302	Last Const.: 9/30/1980		
Surface: AC	Family: MN2013 Asphalt Aprons	Zone: S	Category: 1	Rank: S		
Area: 45,000 SqFt	Length: 300 Ft	Width: 150 Ft				
Slabs:	Slab Length: Ft	Slab Width: Ft	Joint Length: Ft			
Shoulder:	Street Type:	Grade: 0	Lanes: 0			
Section Comments:						
Last Insp. Date: 6/17/2017	Total Samples: 9	Surveyed: 3				
Conditions: PCI: 18						
Inspection Comments:						
Sample Number: 100	Type: R	Area: 5000.00 SqFt	PCI: 22			
Sample Comments:						
43	BLOCK CR	L	1500.00 SqFt			
52	RAVELING	L	5000.00 SqFt			
53	RUTTING	L	40.00 SqFt			
43	BLOCK CR	H	1000.00 SqFt			
43	BLOCK CR	M	2500.00 SqFt			
Sample Number: 201	Type: R	Area: 5000.00 SqFt	PCI: 15			
Sample Comments:						
43	BLOCK CR	M	2500.00 SqFt			
53	RUTTING	M	68.00 SqFt			
53	RUTTING	L	432.00 SqFt			
52	RAVELING	L	5000.00 SqFt

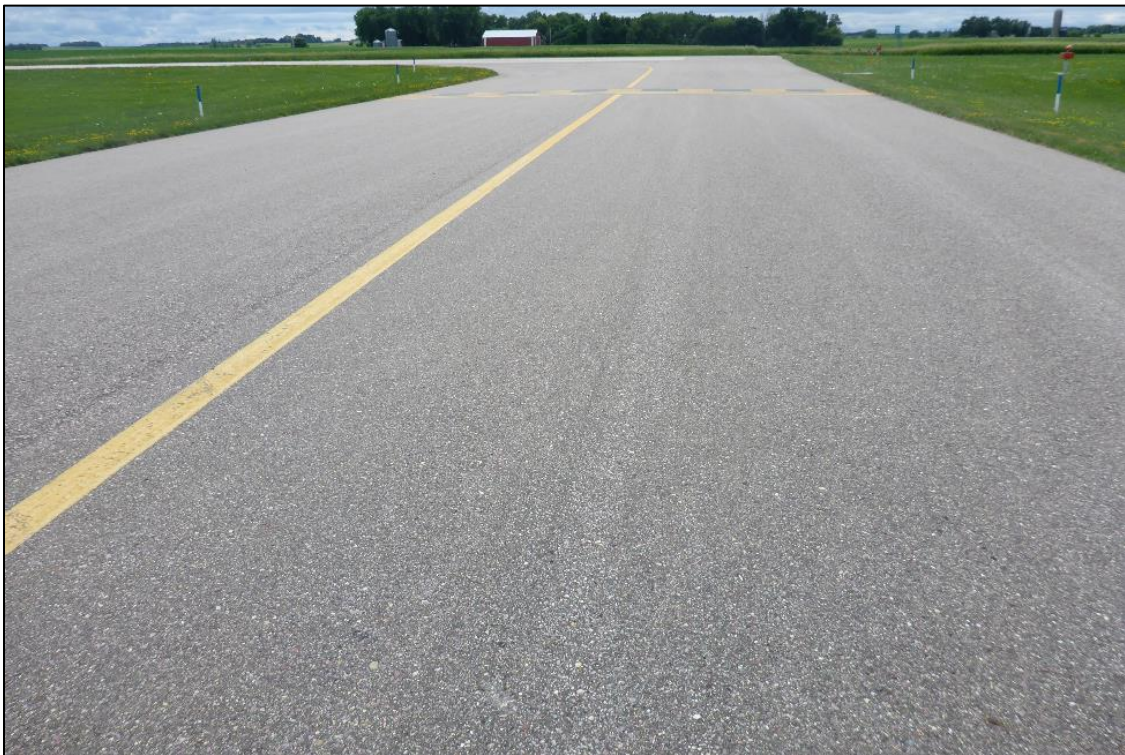
DVP CTA 001 (PCI = 97)

Network:	DVP	Name:	SLAYTON						
Branch:	CTA	Name:	CONNECTING TAXIWAY A	Use:	TAXIWAY	Area:	8,900 SqFt		
Section:	001	of 1	From:	100	To:	101	Last Const.:	10/11/2011	
Surface:	AC	Family:	MN2013 Asphalt Taxiways	Zone:	S	Category:	1	Rank:	P
Area:	8,900 SqFt	Length:	210 Ft	Width:	40 Ft				
Slabs:		Slab Length:	Ft	Slab Width:	Ft	Joint Length:	Ft		
Shoulder:		Street Type:		Grade:	0	Lanes:	0		
Section Comments:									
Last Insp. Date:	6/17/2017	TotalSamples:	2	Surveyed:	1				
Conditions:	PCI: 97								
Inspection Comments:									
Sample Number:	100	Type:	R	Area:	4255.00 SqFt	PCI:	97		
Sample Comments:									
57	WEATHERING	L	800.00	SqFt

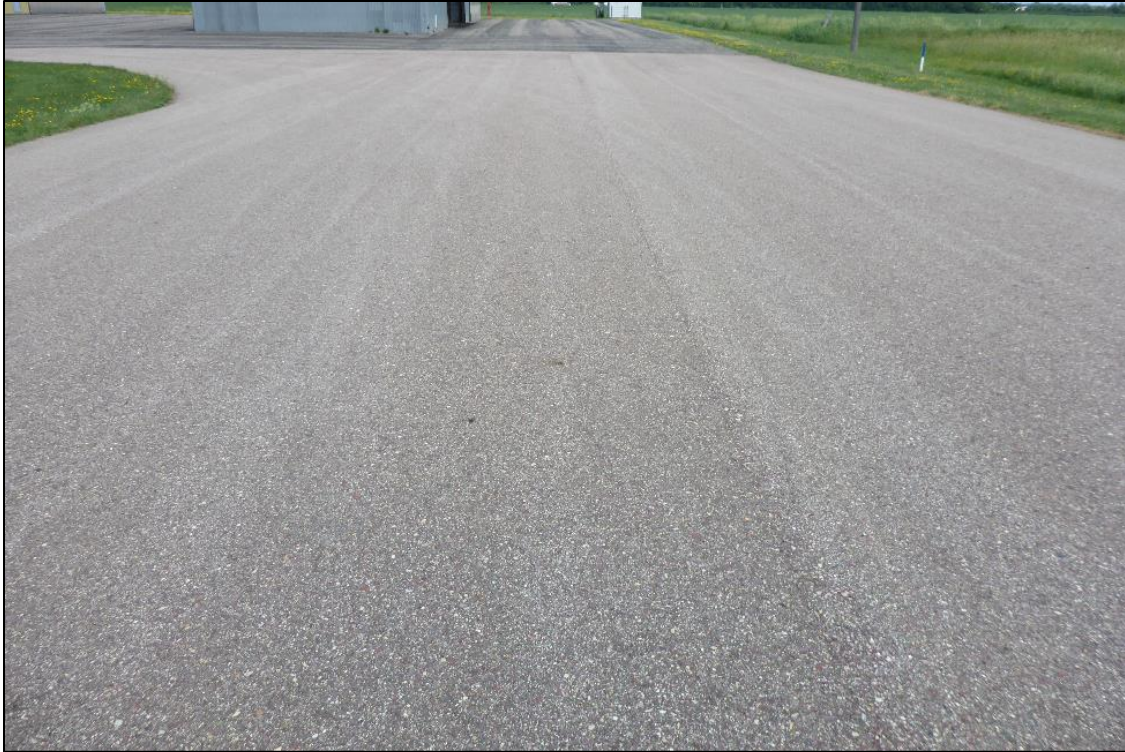
DVP CTB 001 (PCI = 97)

Network:	DVP	Name:	SLAYTON						
Branch:	CTB	Name:	CONNECTING TAXIWAY B	Use:	TAXIWAY	Area:	10,200 SqFt		
Section:	001	of 1	From:	200	To:	201	Last Const.:	10/11/2011	
Surface:	AC	Family:	MN2013 Asphalt Taxiways	Zone:	S	Category:	1	Rank:	P
Area:	10,200 SqFt	Length:	210 Ft	Width:	40 Ft				
Slabs:	Slab Length:	Ft	Slab Width:	Ft	Joint Length:	Ft			
Shoulder:	Street Type:		Grade:	0	Lanes:	0			
Section Comments:									
Last Insp. Date:	6/17/2017	TotalSamples:	2	Surveyed:	1				
Conditions:	PCI: 97								
Inspection Comments:									
Sample Number:	201	Type:	R	Area:	4425.00 SqFt	PCI:	97		
Sample Comments:									
57	WEATHERING	L	800.00	SqFt

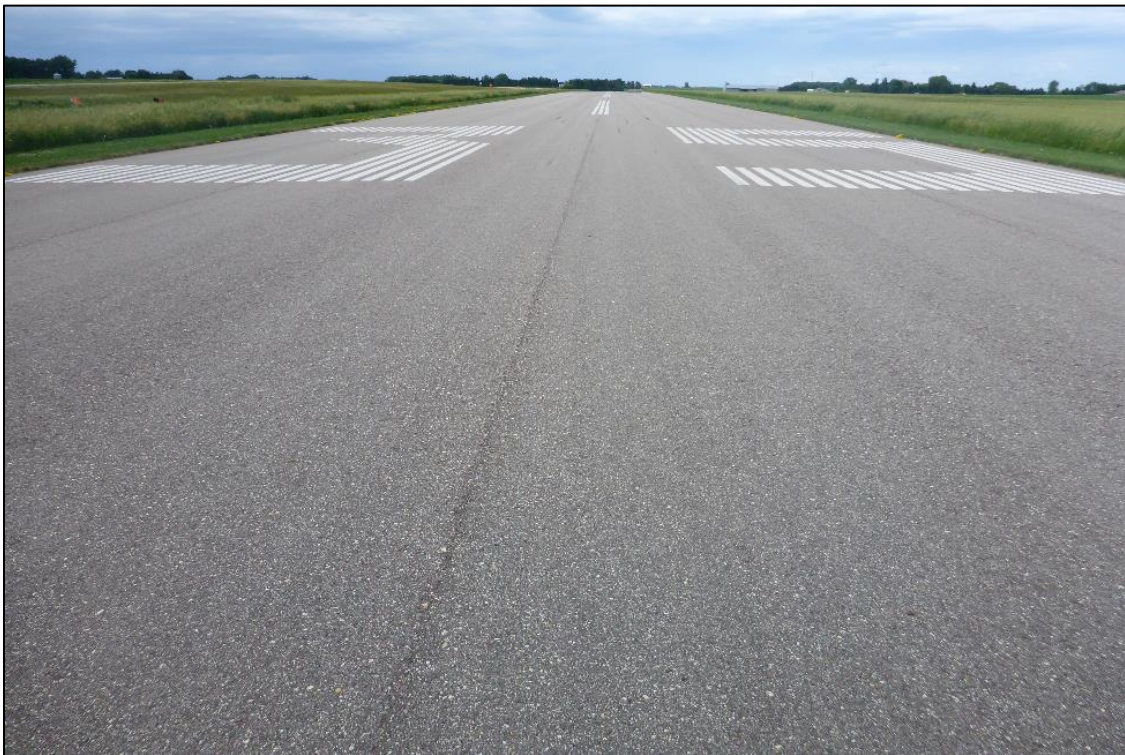
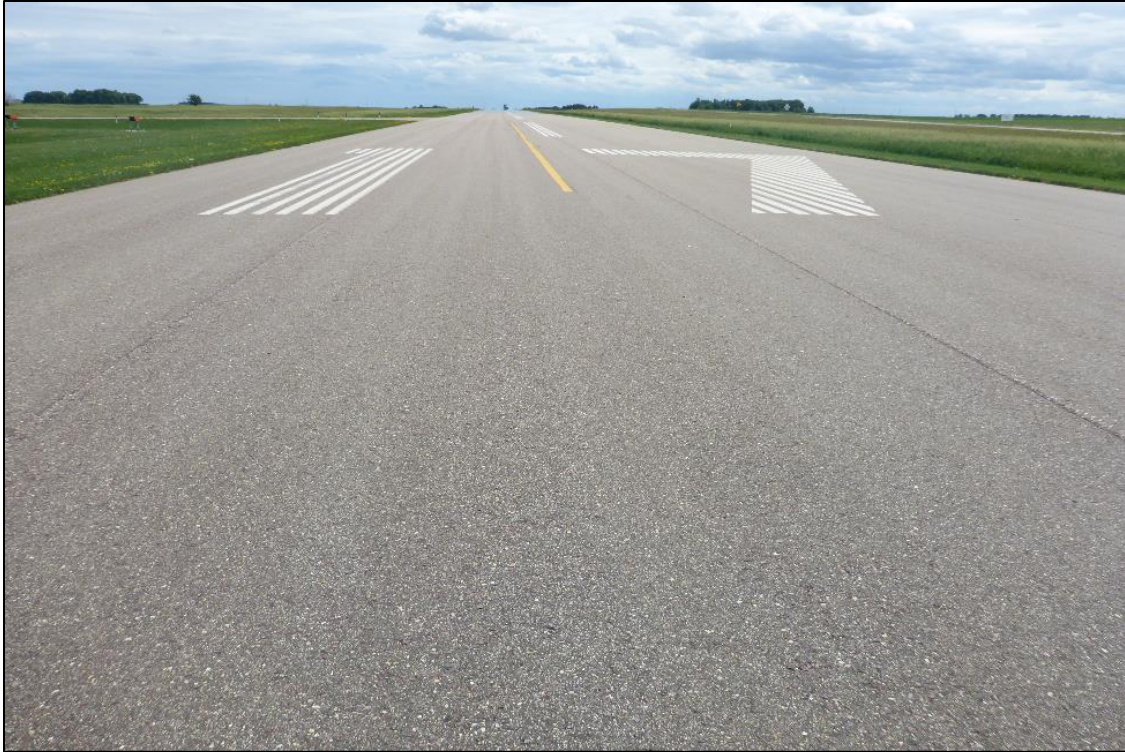
DVP RY1735 001 (PCI = 97)

Network:	DVP		Name:	SLAYTON					
Branch:	RY1735	Name:	RUNWAY 17-35	Use:	RUNWAY	Area:	187,050 SqFt		
Section:	001	of 1	From:	100	To:	159	Last Const.:	10/11/2011	
Surface:	AC	Family:	MN2013 Asphalt Runways	Zone:	S	Category:	1	Rank:	P
Area:	187,050 SqFt	Length:	3,005 Ft	Width:	60 Ft				
Slabs:		Slab Length:	Ft	Slab Width:	Ft	Joint Length:	Ft		
Shoulder:		Street Type:		Grade:	0	Lanes:	0		
Section Comments:									
Last Insp. Date:	6/17/2017		TotalSamples:	62	Surveyed:	6			
Conditions:	PCI:	97							
Inspection Comments:									
Sample Number:	109	Type:	R	Area:	3000.00 SqFt	PCI:	97		
Sample Comments:									
57	WEATHERING	L		800.00 SqFt					
Sample Number:	118	Type:	R	Area:	3000.00 SqFt	PCI:	97		
Sample Comments:									
57	WEATHERING	L		800.00 SqFt					
Sample Number:	127	Type:	R	Area:	3000.00 SqFt	PCI:	97		
Sample Comments:									
57	WEATHERING	L		800.00 SqFt					
Sample Number:	136	Type:	R	Area:	3000.00 SqFt	PCI:	97

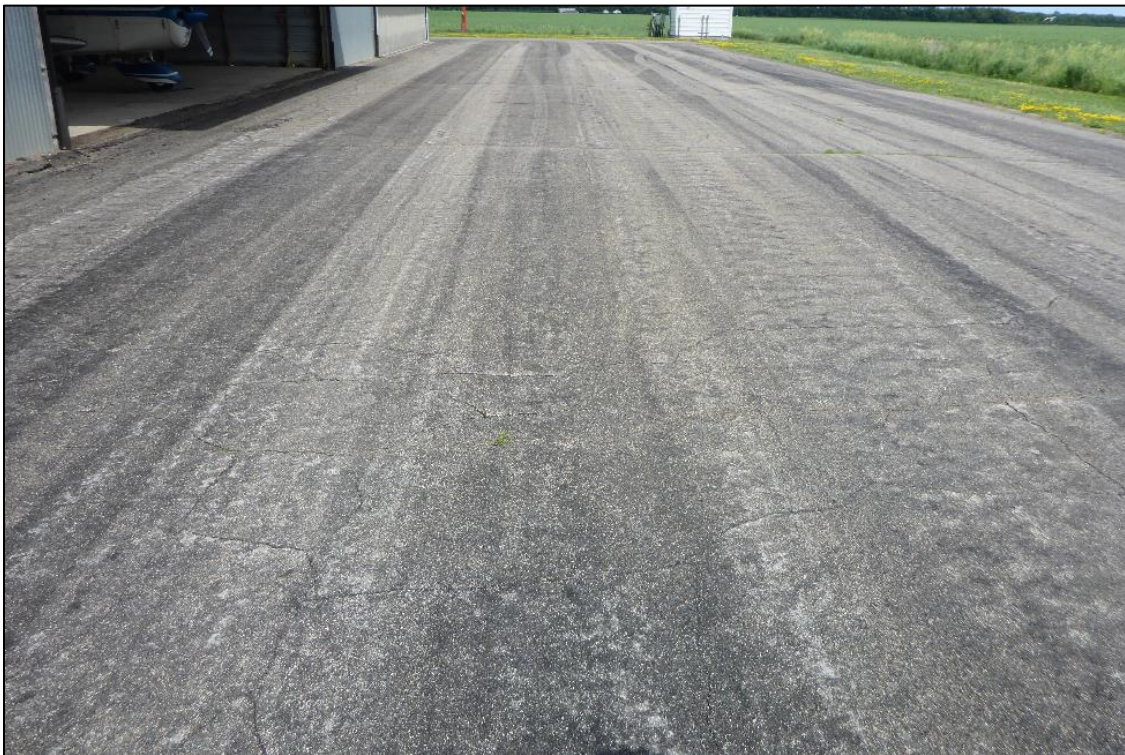
DVP TLA 001 (PCI = 23)

Network:	DVP	Name:	SLAYTON						
Branch:	TLA	Name:	Taxilane A	Use:	TAXILANE	Area:	36,500 SqFt		
Section:	001	of 1	From:	100	To:	108	Last Const.:	9/30/1980	
Surface:	AC	Family:	MN2013 Asphalt Taxilanes	Zone:	S	Category:	1	Rank:	T
Area:	36,500 SqFt	Length:	210 Ft	Width:	210 Ft				
Slabs:		Slab Length:	Ft	Slab Width:	Ft	Joint Length:	Ft		
Shoulder:		Street Type:		Grade:	0	Lanes:	0		
Section Comments:									
Last Insp. Date:	6/17/2017	TotalSamples:	9	Surveyed:	3				
Conditions:	PCI: 23								
Inspection Comments:									
Sample Number:	101	Type:	R	Area:	4200.00 SqFt	PCI:	13		
Sample Comments:									
43	BLOCK CR	M	600.00	SqFt					
45	DEPRESSION	L	120.00	SqFt					
52	RAVELING	L	4200.00	SqFt					
43	BLOCK CR	L	600.00	SqFt					
43	BLOCK CR	H	3000.00	SqFt					
Sample Number:	105	Type:	R	Area:	3750.00 SqFt	PCI:	22		
Sample Comments:									
43	BLOCK CR	H	600.00	SqFt					
45	DEPRESSION	L	130.00	SqFt					
43	BLOCK CR	L	1800.00	SqFt
