# Pavement Condition Report

## Mahnomen County Airport (3N8)

**December 2019**

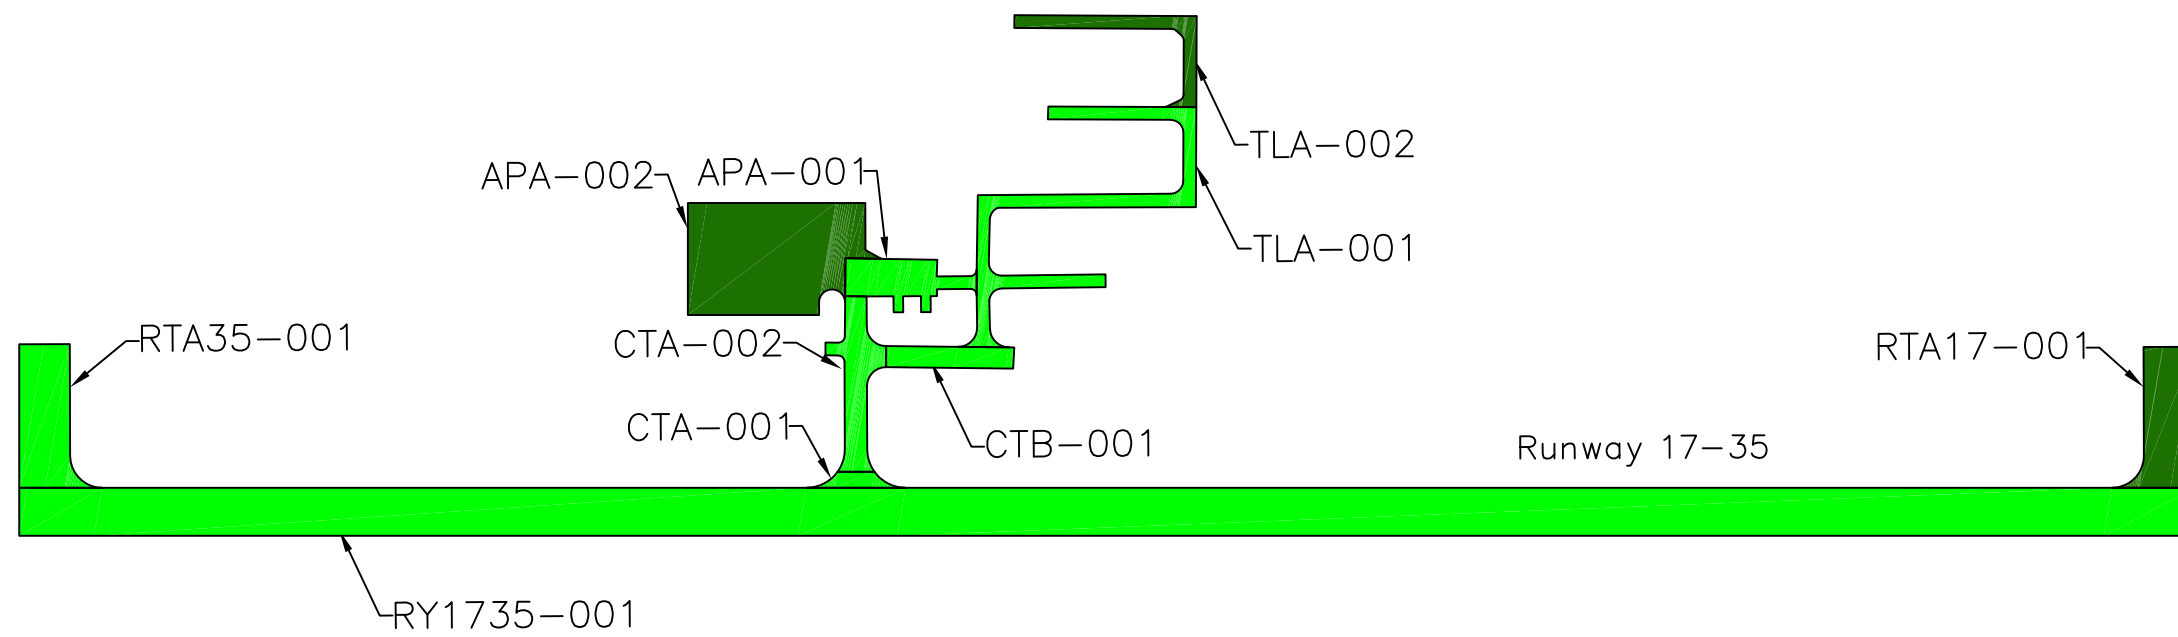
Figure 4. 2019 Pavement Condition Index Rating at Mahanomen County Airport (3N8).

<sup>6</sup>Higher than expected deterioration rate of 5.0 PCI/year due to the development of low and medium-severity L&T cracking in significant quantities
