# Culvert Inspection and Repair

Bonnie Peterson, HydInfra Coordinator  
Minnesota Department of Transportation  
APWX Mpls 2016

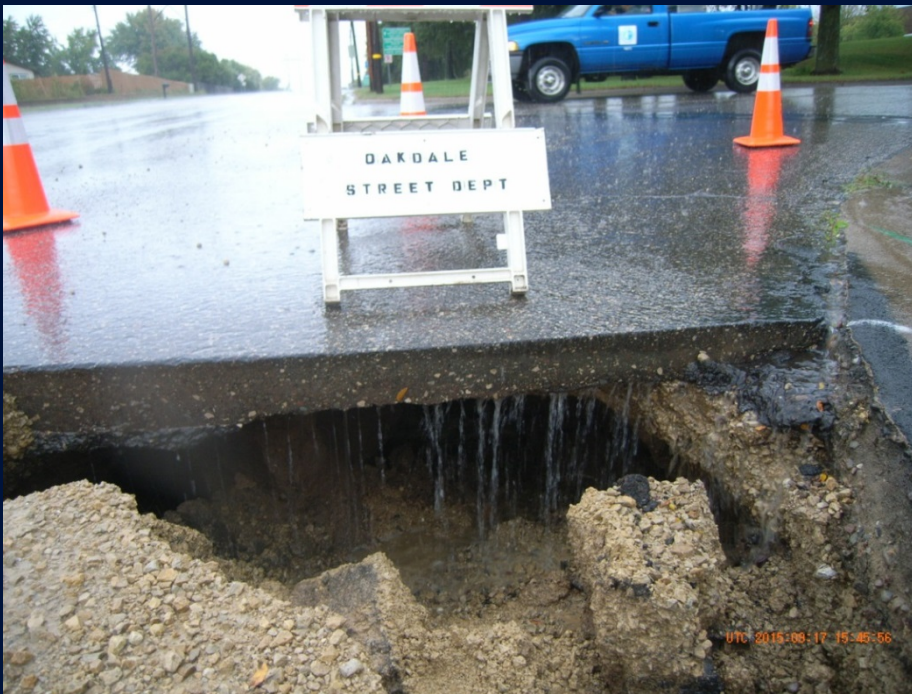
# Pipe with Holes causes Piping and Road Void

Road fill washes away  
at each burst of rain

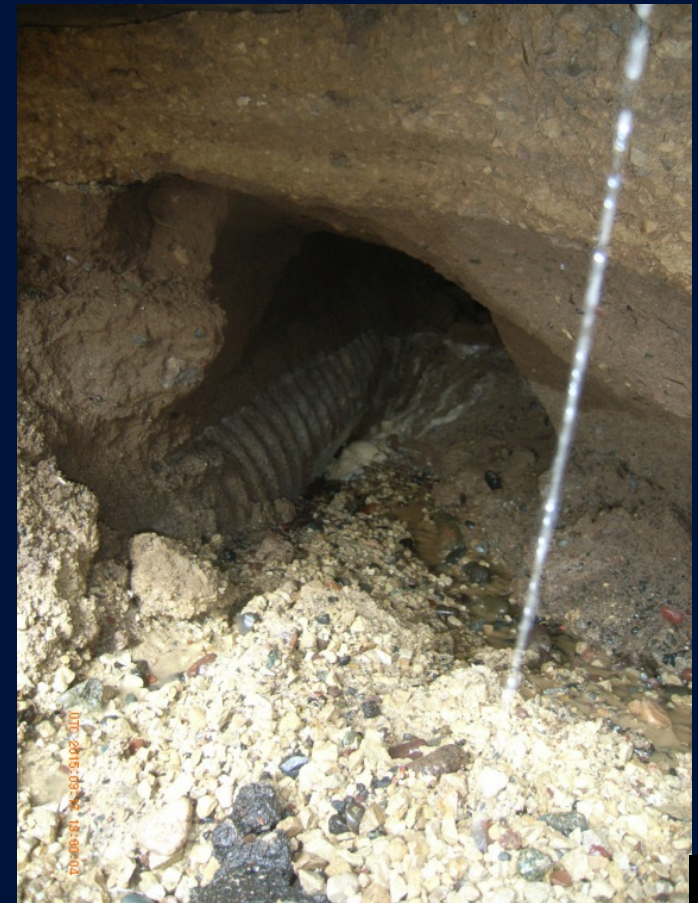
CMP Storm Drain on Hadley Avenue at  
MnDOT Oakdale Office in 2015

This is what **pipng** looks like –  
water leaves the pipe at holes or joint separations  
and **flows along the outside**

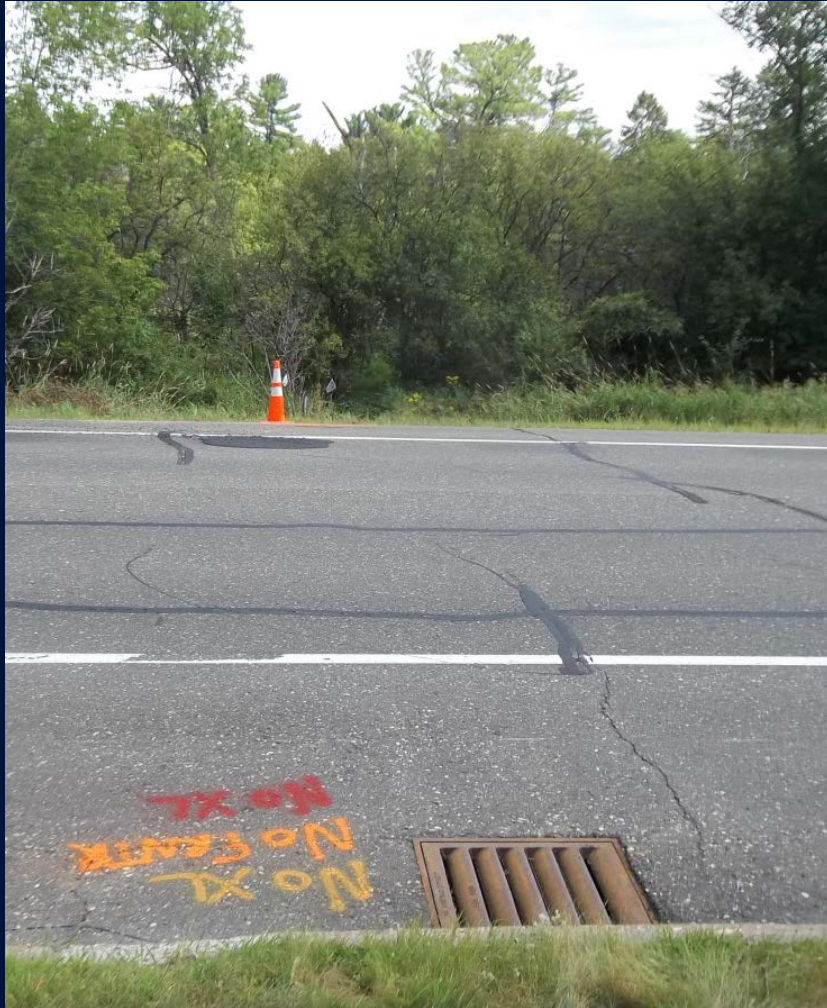
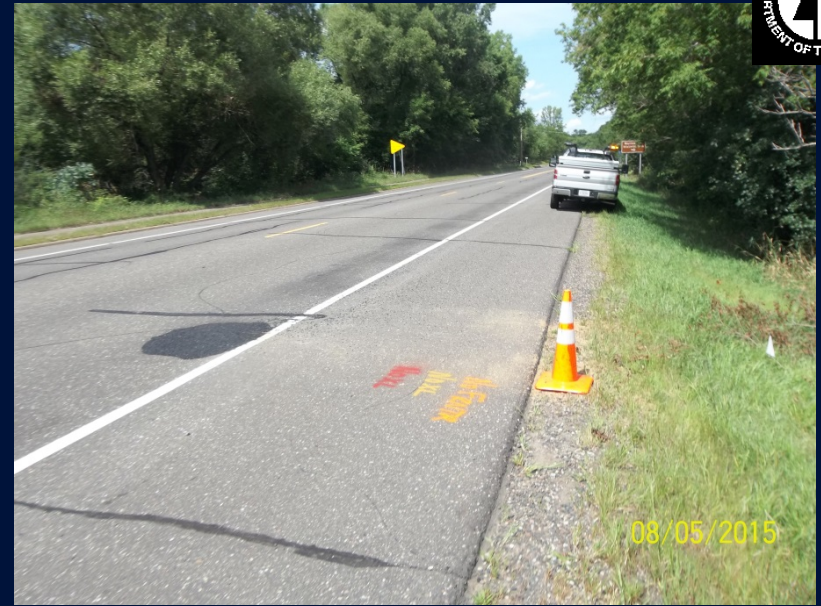
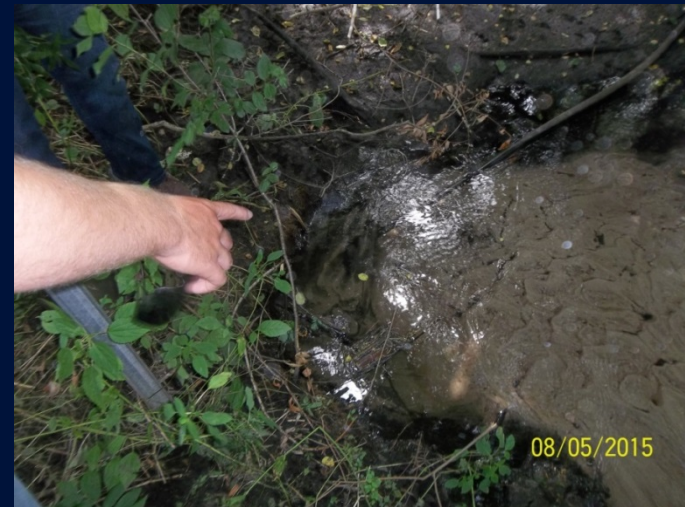
MN 95 2015 Eric Brenna

# Typical Culvert Failure has a pavement patch

Water flows along the outside  
of pipe carrying road fill away.

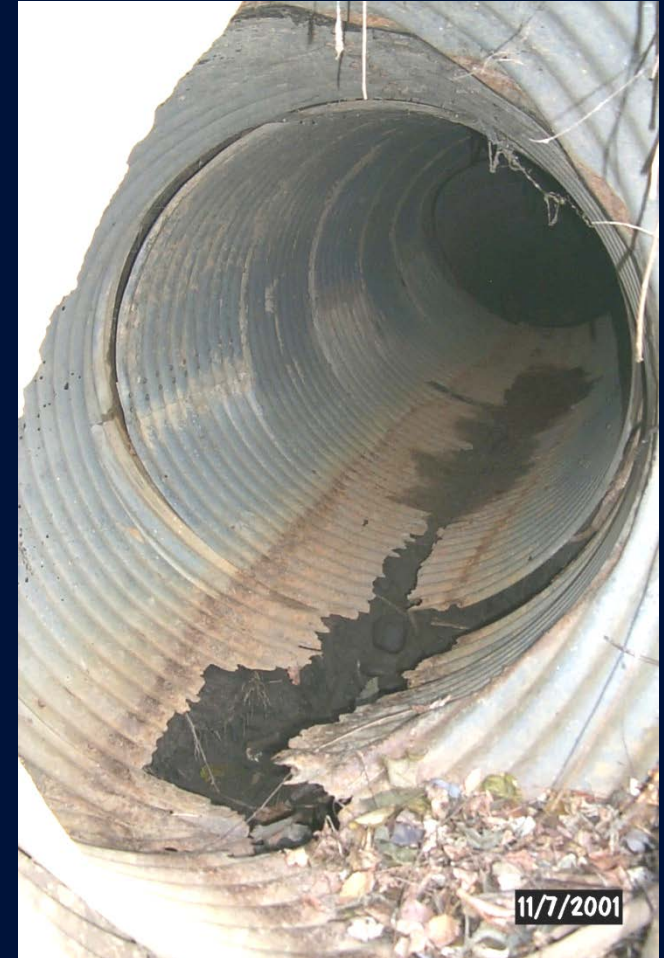
MN 95 near MP 89, near Marine on the St. Croix

**Pipe Repair is too late**  
when the road surface  
reflects condition of pipe

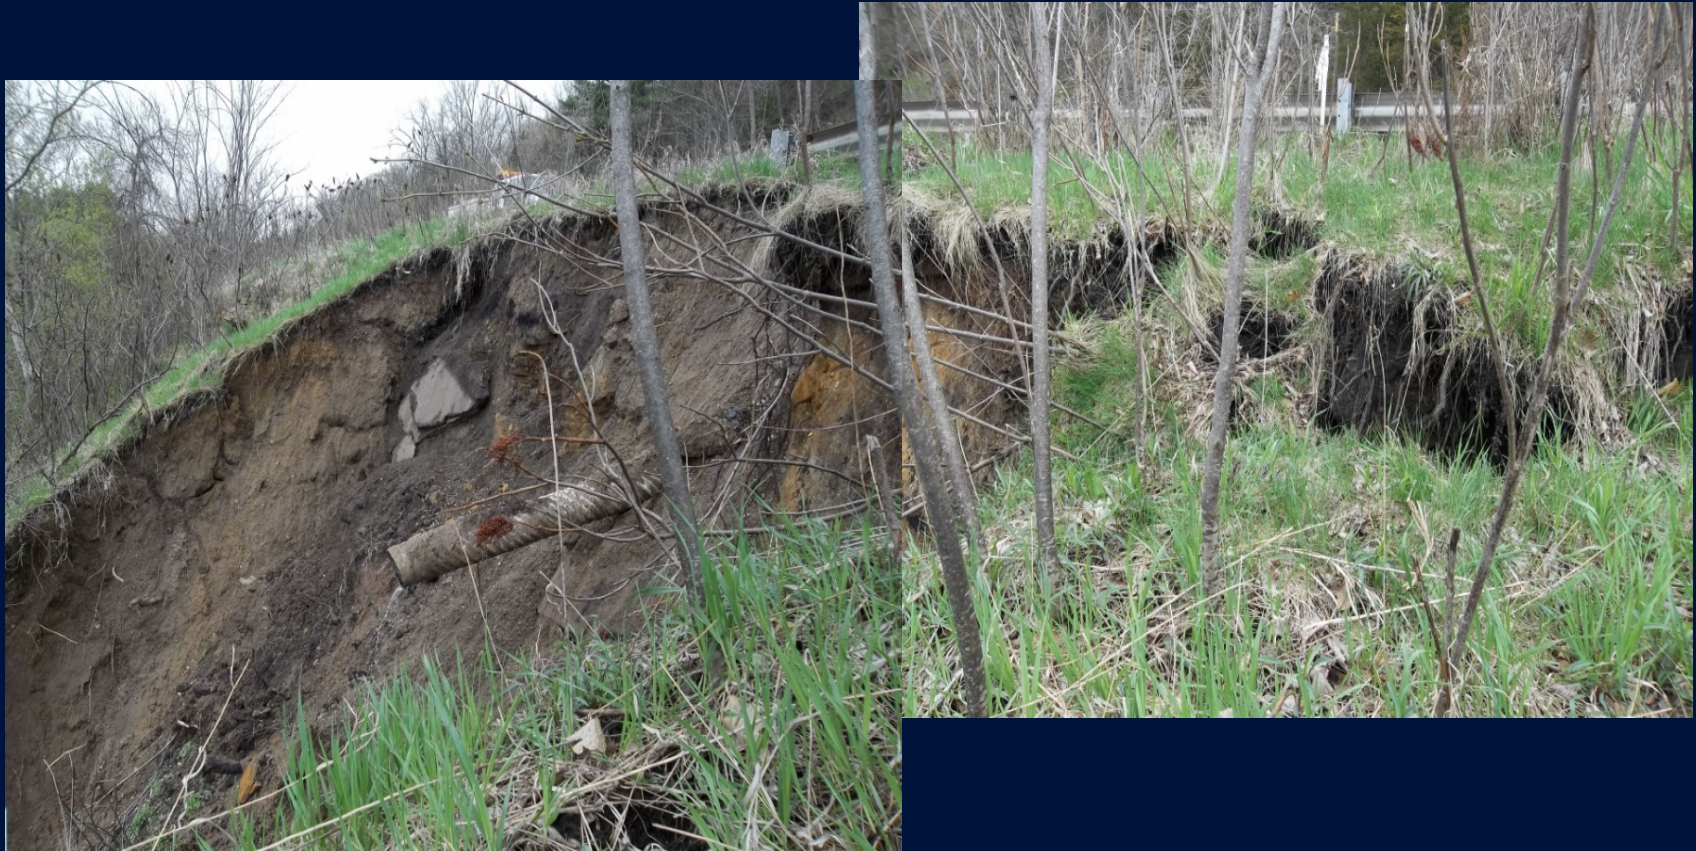
While some steep slopes are prone to failure **leaking pipes lubricate the slide**

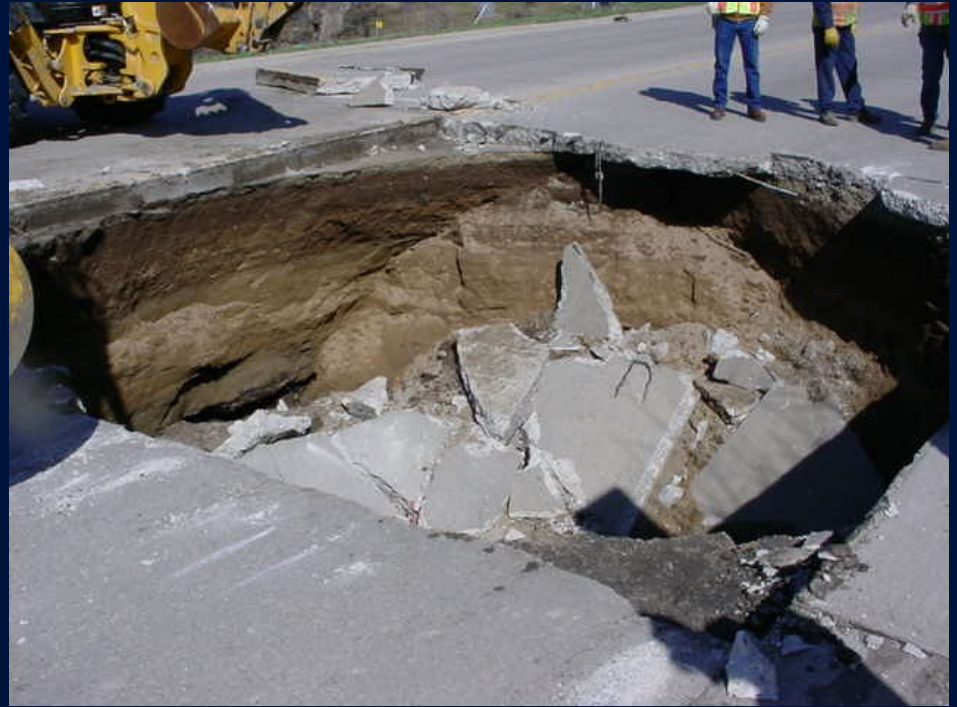
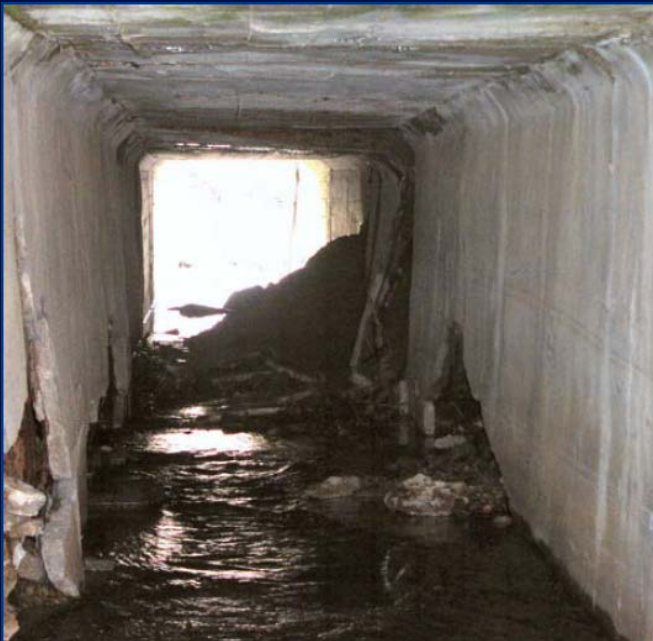
Pavement may span the void for awhile

until it doesn't.

Holes in 6' x6' box culvert allowed road fill to wash out but pipe did not collapse

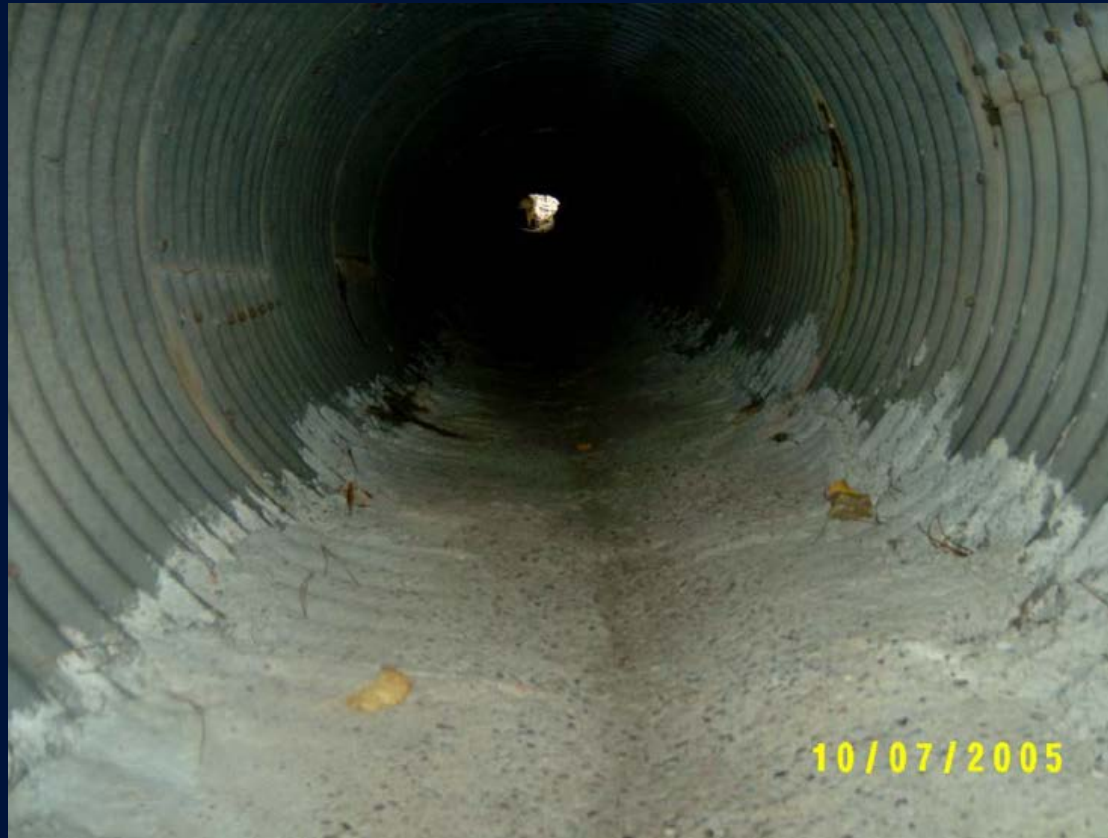
1971 Paved Invert repair still looks good in 2015

# Paved Invert Repair

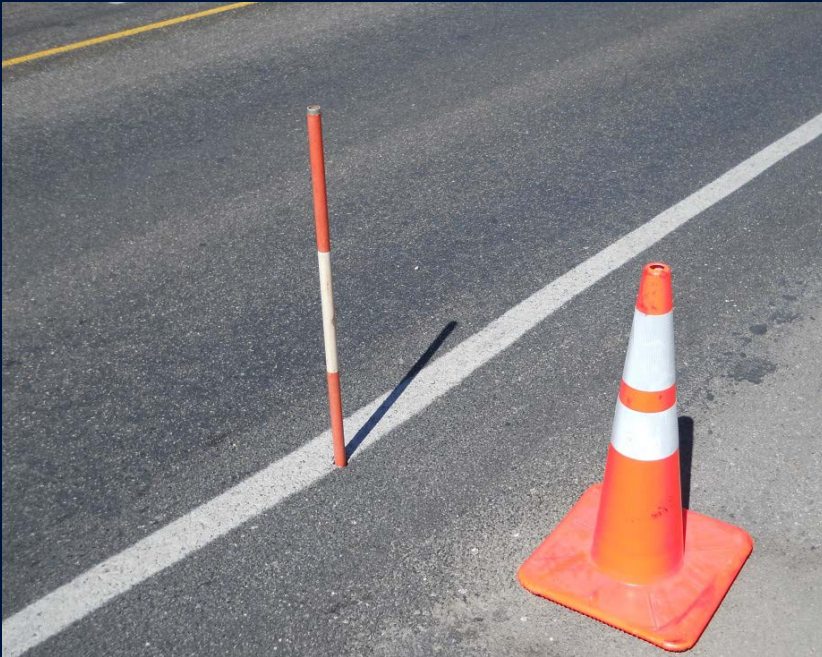
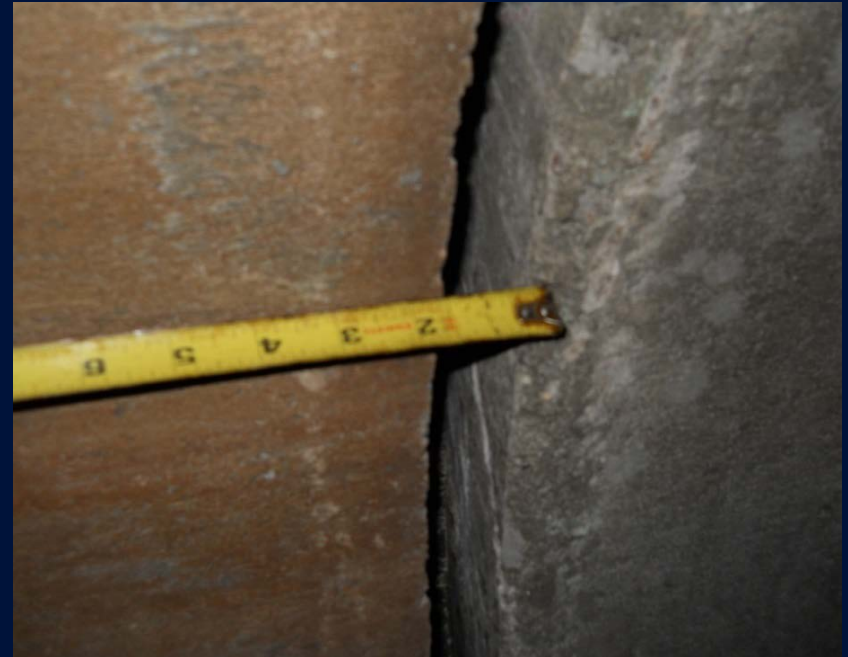
# Void in Road may occur through Joint Separation 1 inch or greater

Concrete jacked pipe with 1 ½ in joint separation creates road void, shown by survey range pole in hole in the pavement. 27SEP2011 – Rob Coughlin

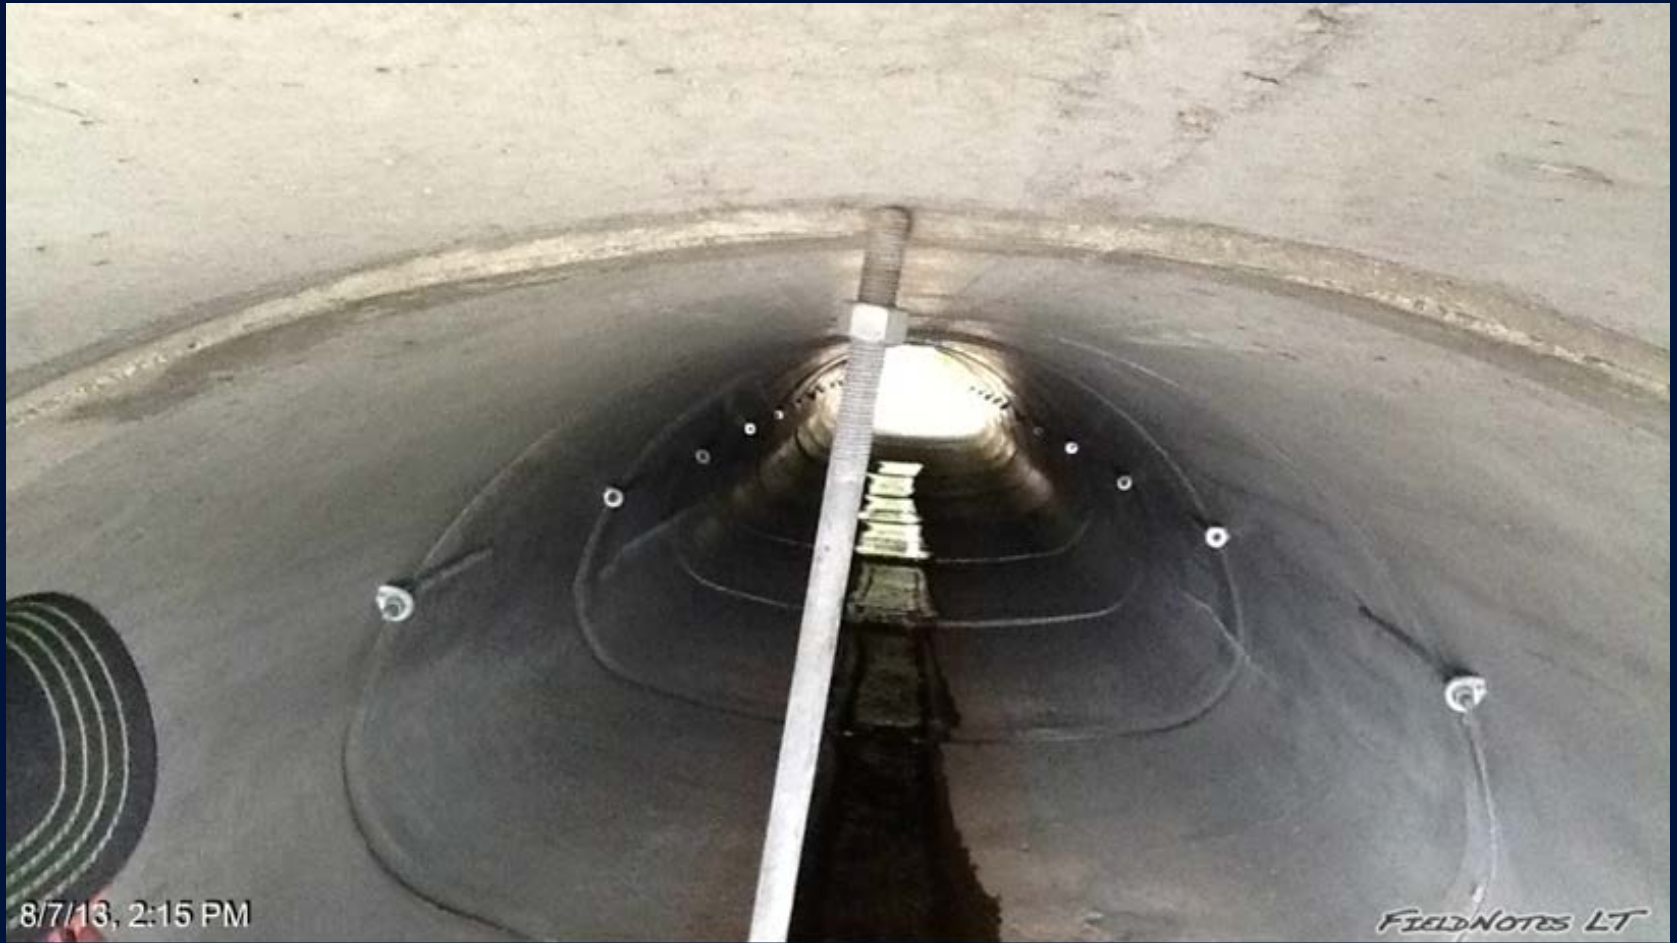
District 1 photo shows broken pipe tie pointing to joint separation in Concrete arch pipe

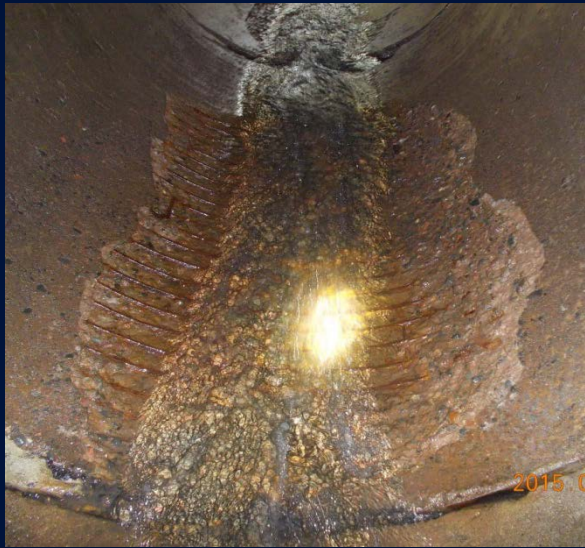
Abrasion from rocks  
District 1 Duluth

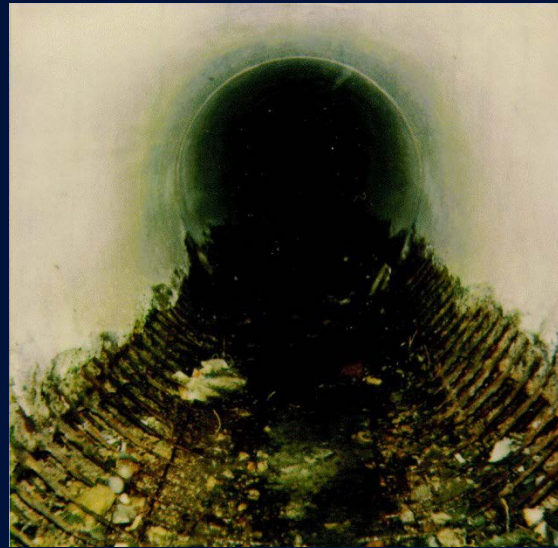
Acidic factory  
discharge,  
I-94 St. Paul  
Metro District

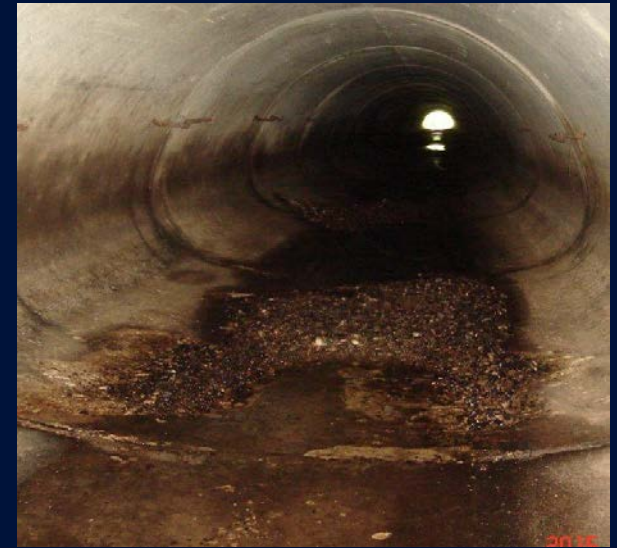
Bad concrete mix  
in alternating pipe  
sections, District 3  
Baxter

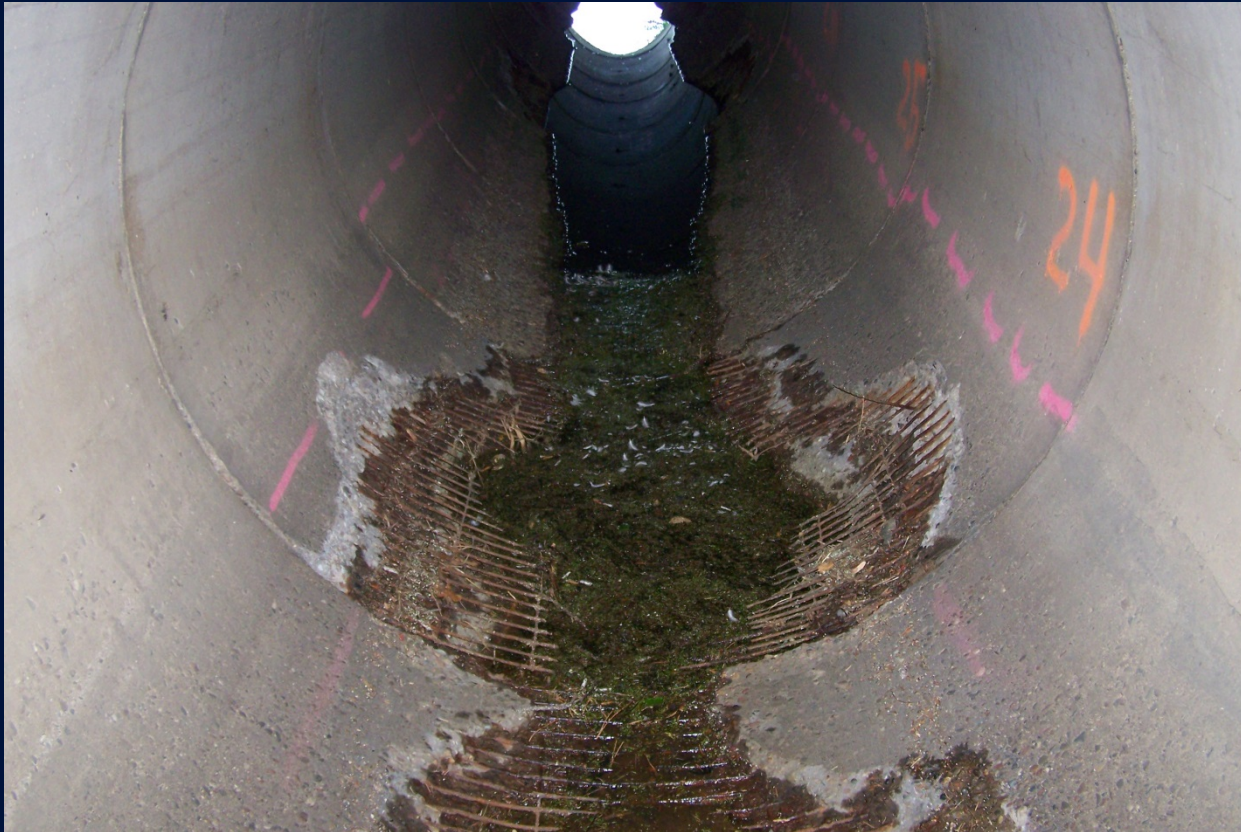
Acid attack looks similar to bad concrete mix  
but **alternating** good - bad pipe sections  
suggest bad material

MN Highway 36 culvert in Roseville alternated  
many good and a few bad pipe sections

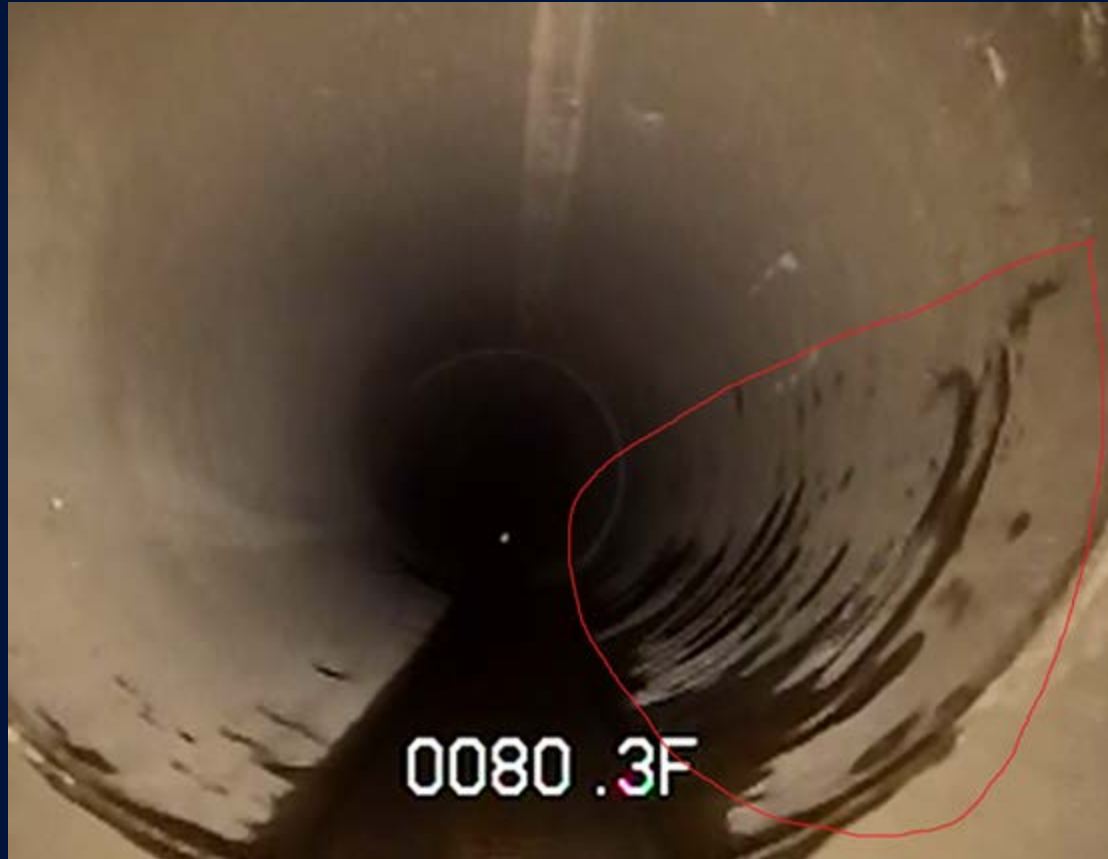
D7 MN Highway 22, 2014

# Porous weeping patches indicate bad concrete material

The pipe photo shows water trickling down the inside wall through perforations or honeycombing.

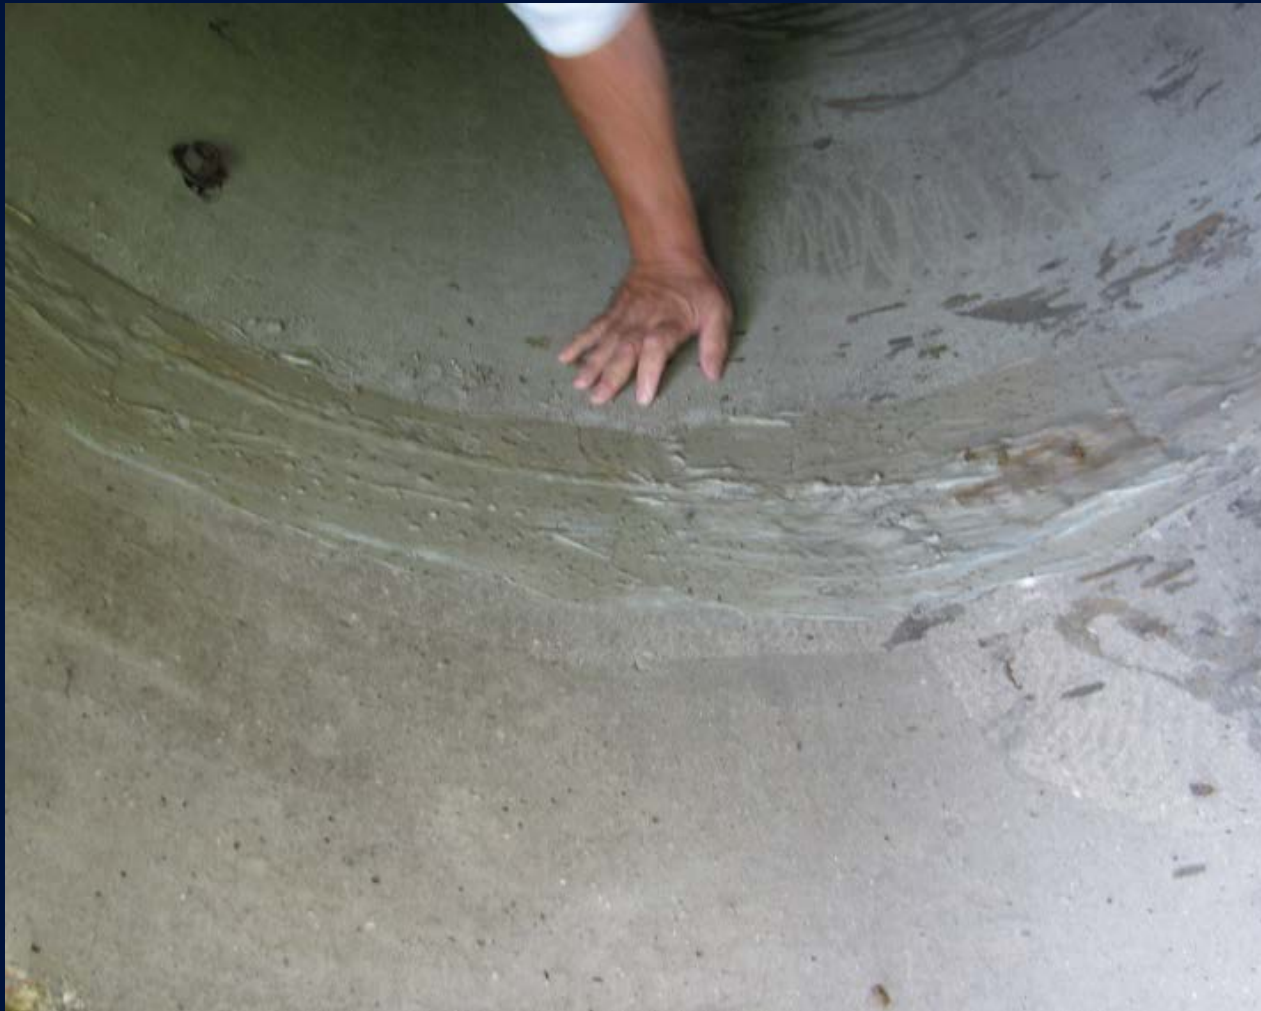
# Joint Repair in large Concrete culvert

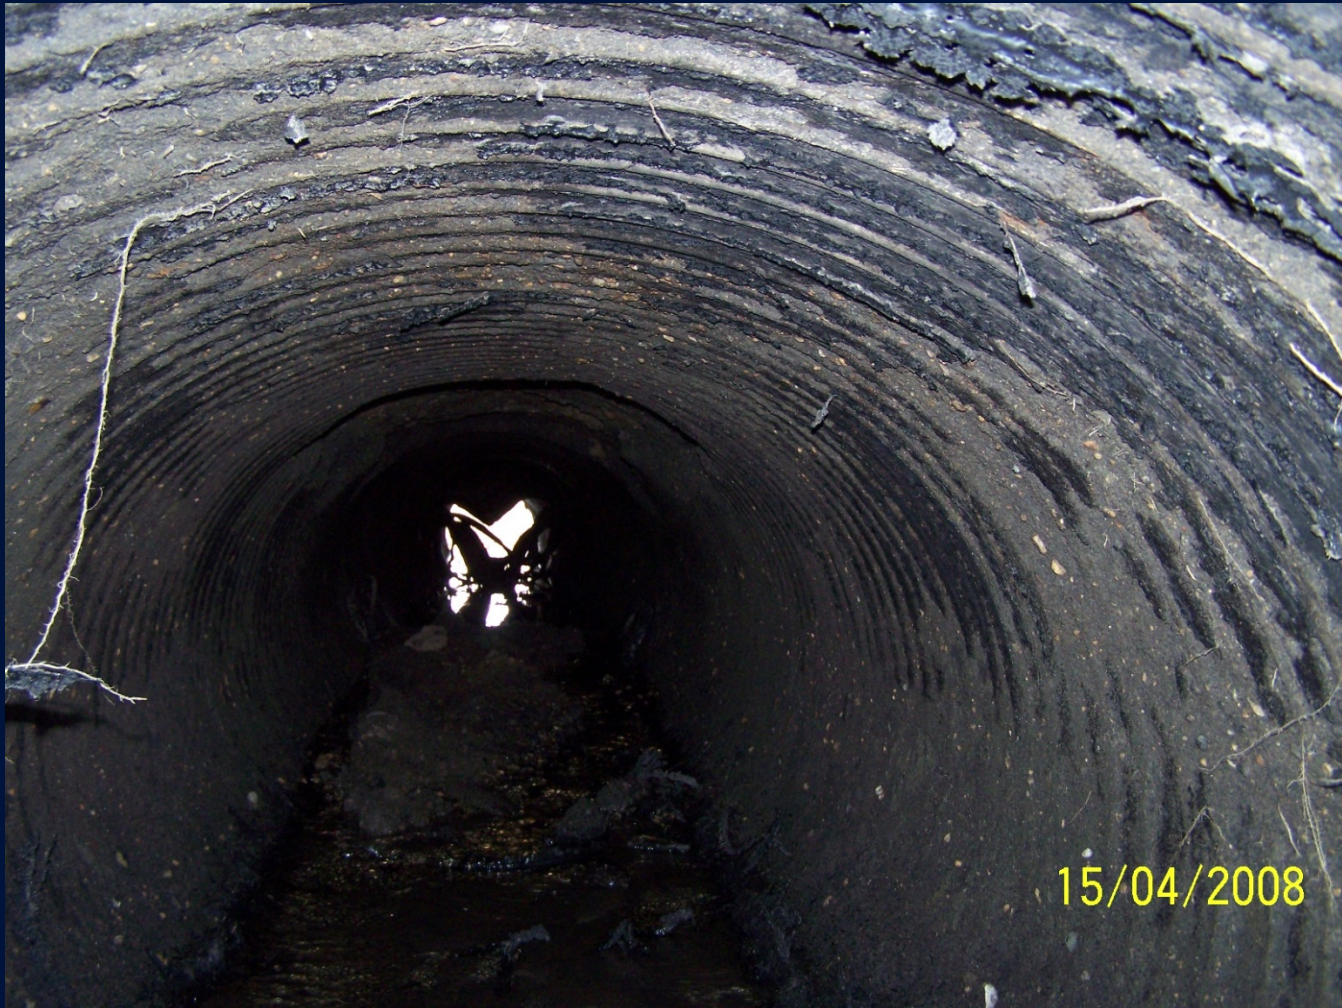
# Random grass **fire** burned this HDPE It has Flaking, Holes and Deformation

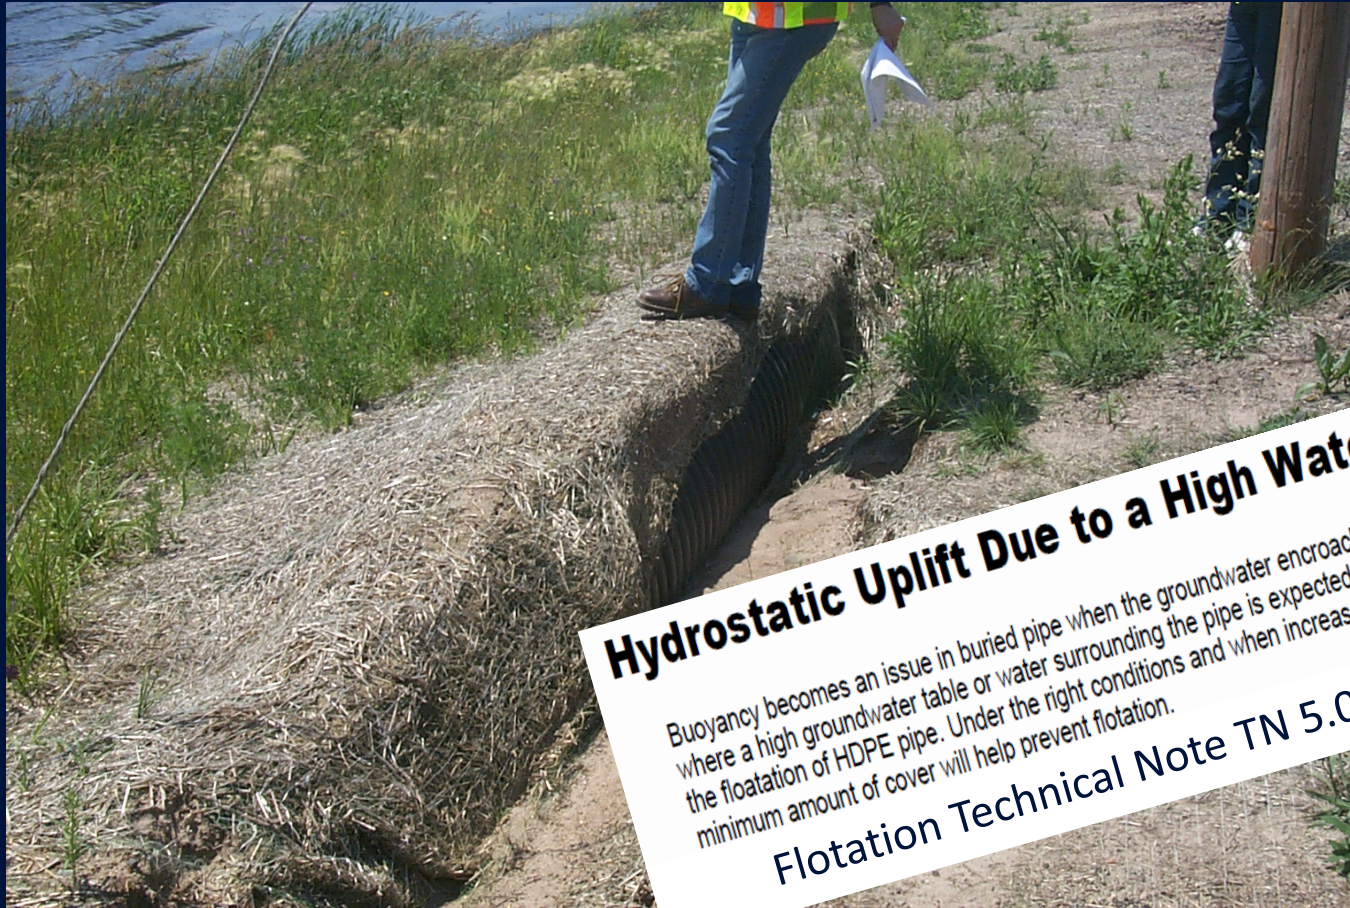
# Too little cover – Construction change caused **Floated** HDPE

Pipe was re-routed across road inslope with too little cover (about 6 inches). High water or frost heave can cause the pipe to “float”.

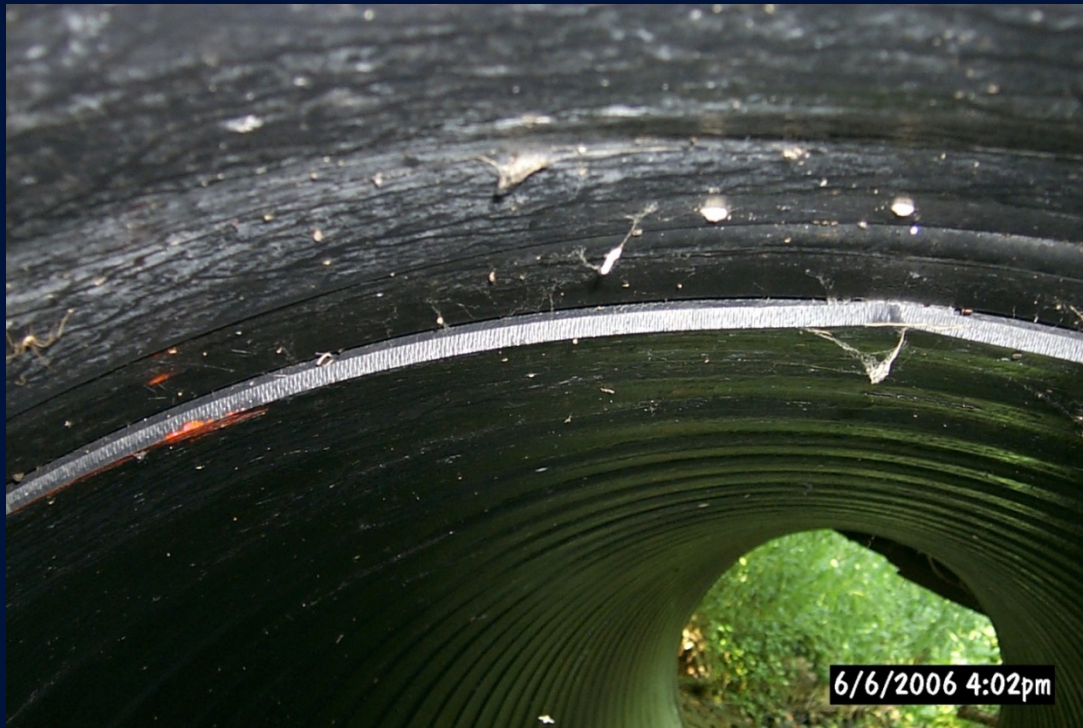
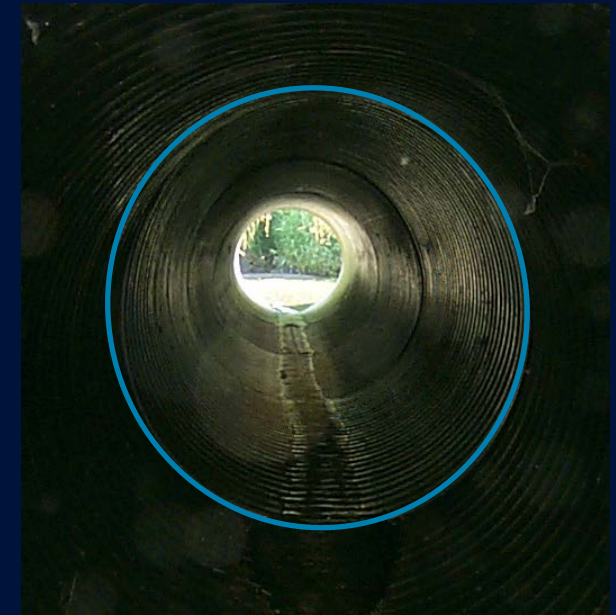
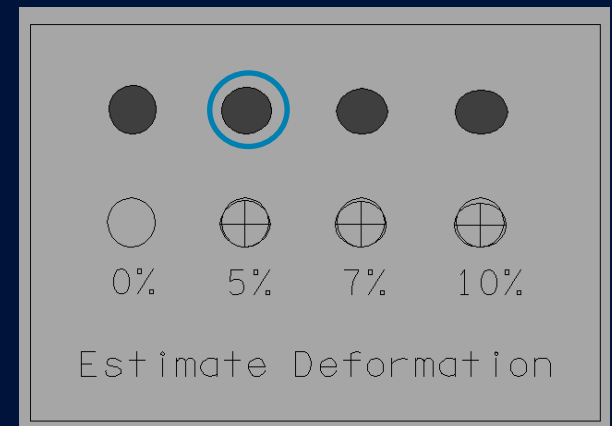
# Bad Resin 1996 HDPE pipe shows Deformation and Misaligned and Separated Joints

Photo above shows 5% Deformation (rotated)

HydInfra ID 36918 has **manufacturing defect** in pipe material

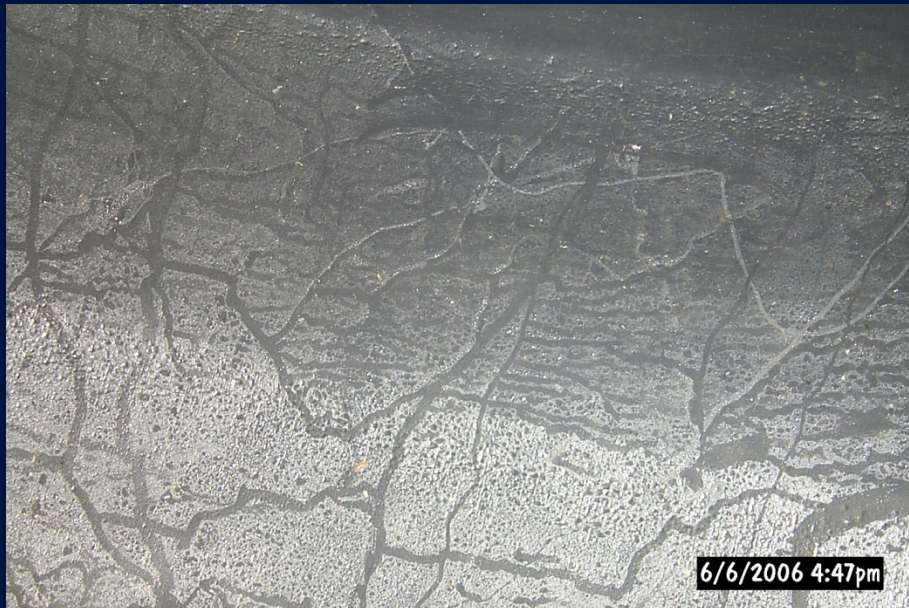
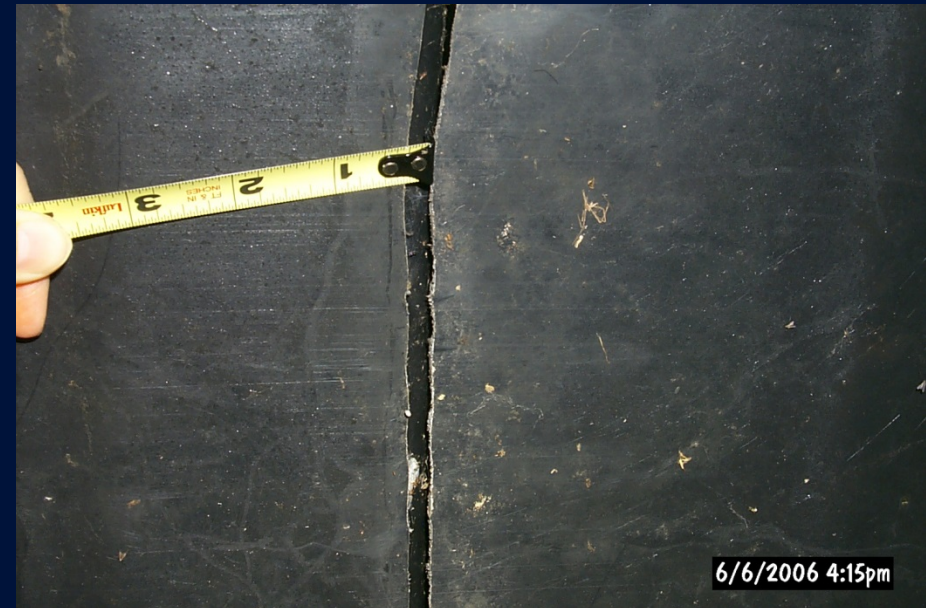
# 1996 **bad resin** HDPE has patterned surface and cracks in 2006

Resin Specs have been changed since this pipe was manufactured

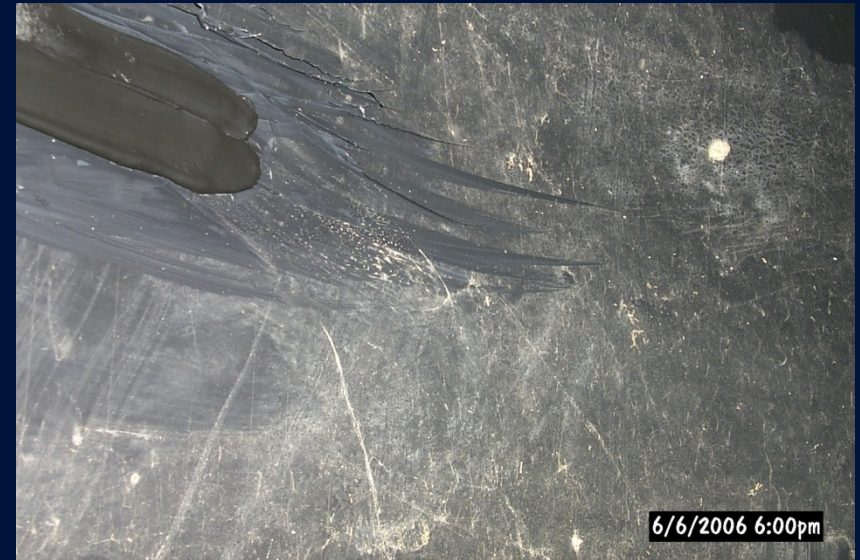
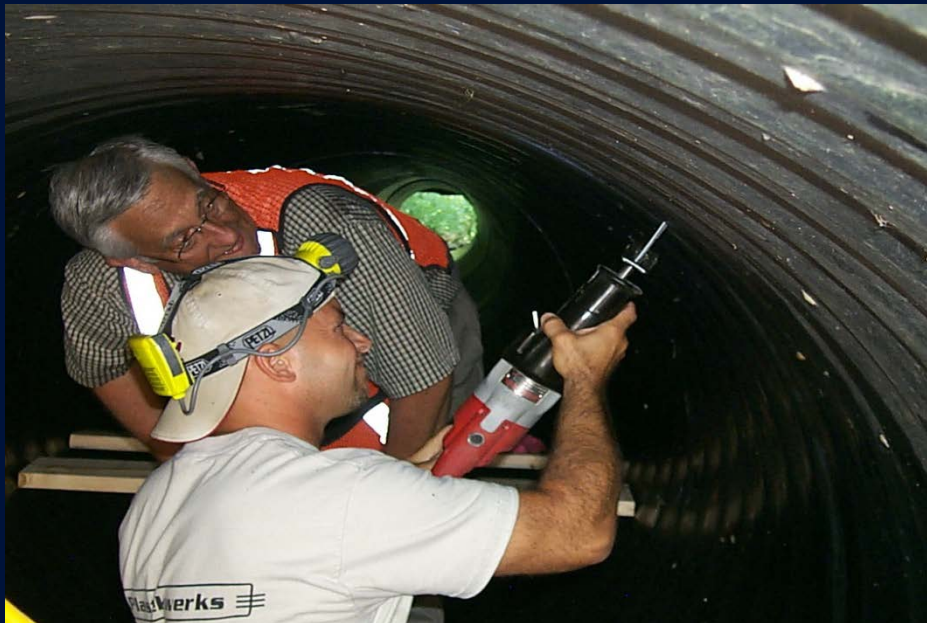
# HDPE cracks were repaired by manufacturer

- 2006 repair on 1996 HDPE
- Drill hole to stop cracking
- Patched by manufacturer's crew with their material
