# Culvert Inspection and Repair

Bonnie Peterson, HydInfra Coordinator  
Minnesota Department of Transportation  
APWX Mpls 2016

2 Decades of  
Culvert Inspection

Culvert and Storm Drainage System  
Inventory and Inspection Program

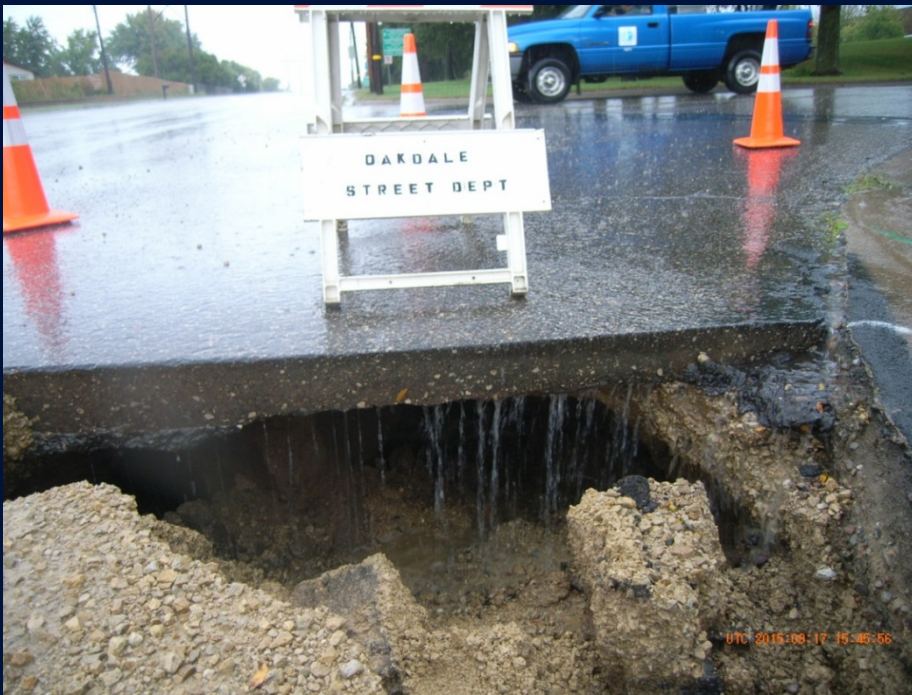
Road fill washes away  
at each burst of rain

CMP Storm Drain on Hadley Avenue at  
MnDOT Oakdale Office in 2015

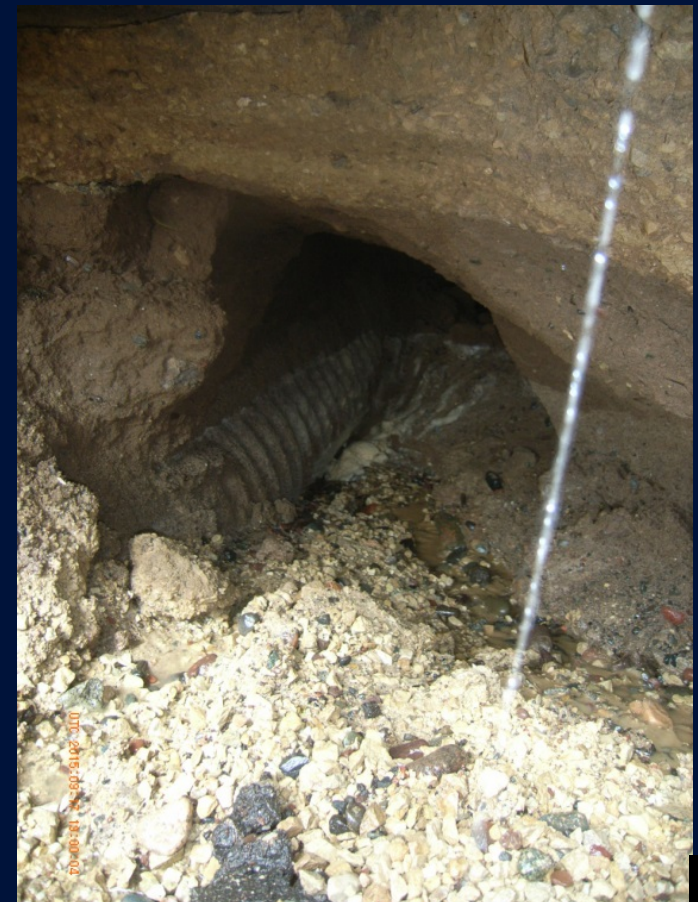
This is what **pipng** looks like –  
water leaves the pipe at holes or joint separations  
and **flows along the outside**

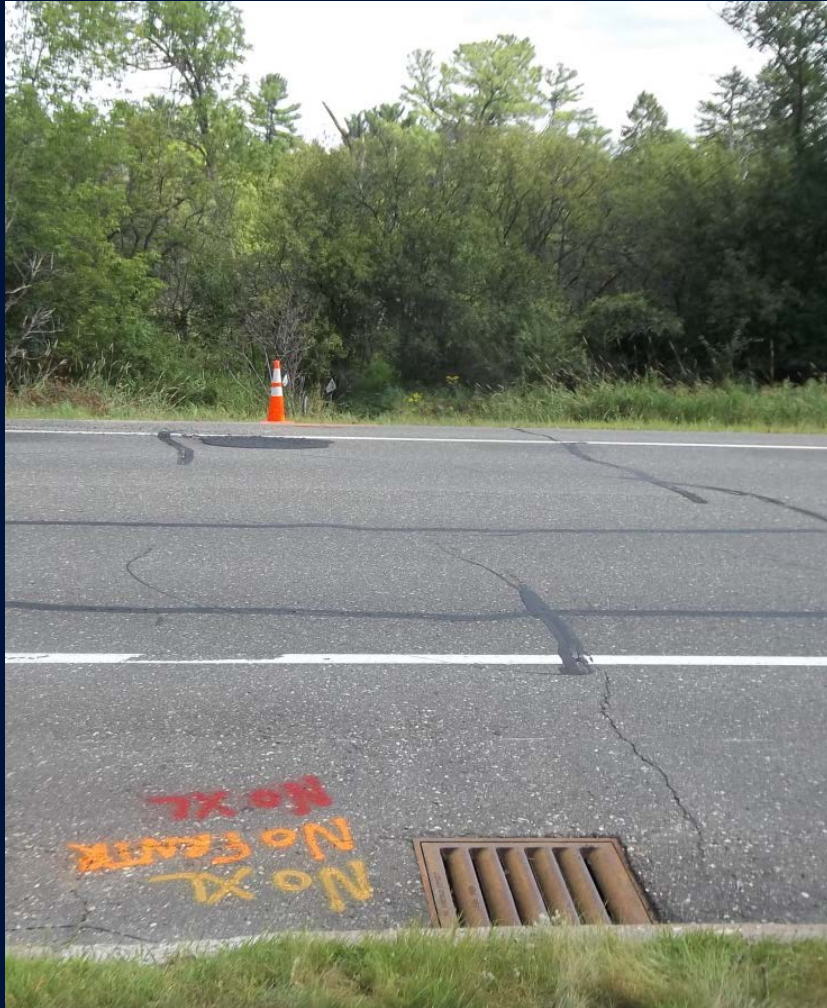
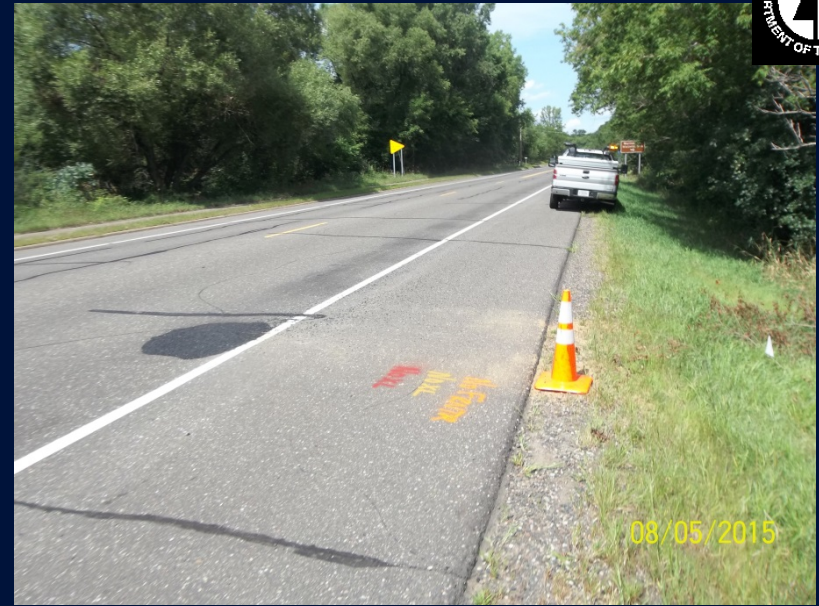
MN 95 2015 Eric Brenna

Water flows along the outside of pipe carrying road fill away.

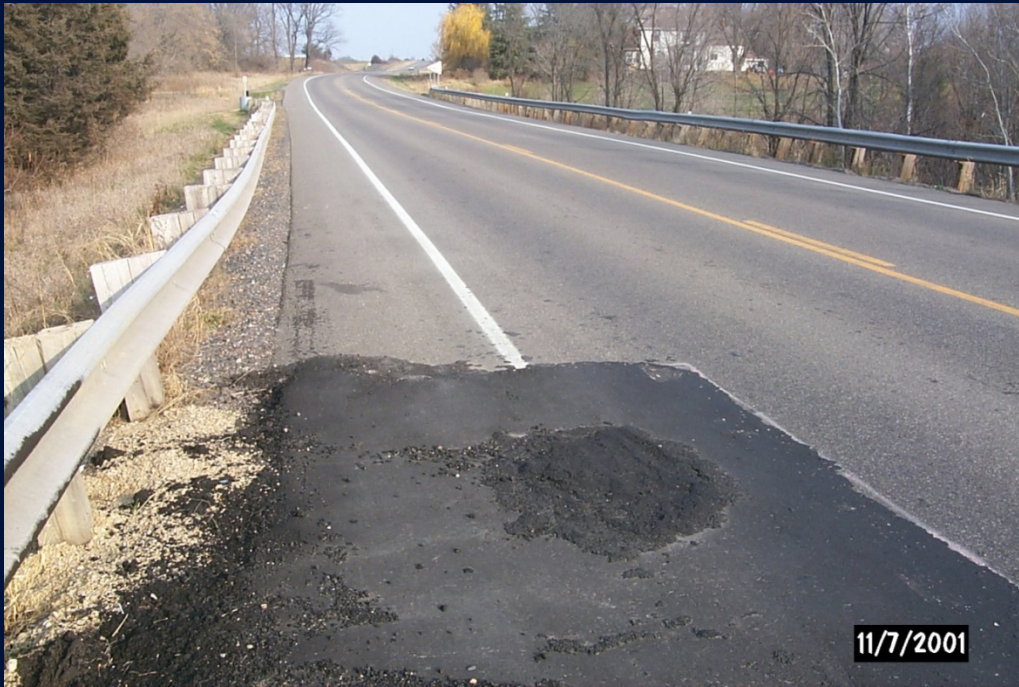
MN 95 near MP 89, near Marine on the St. Croix

**Pipe Repair is too late**  
when the road surface  
reflects condition of pipe

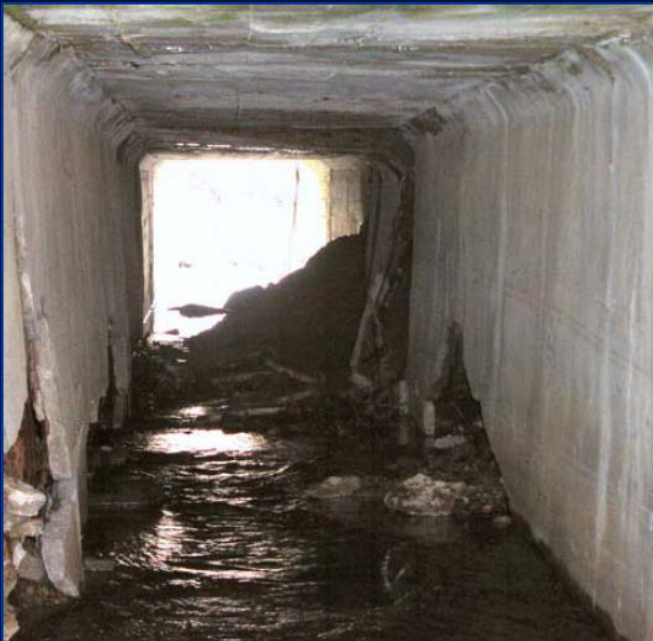
Holes in 6' x6' box culvert allowed road fill to wash out but pipe did not collapse

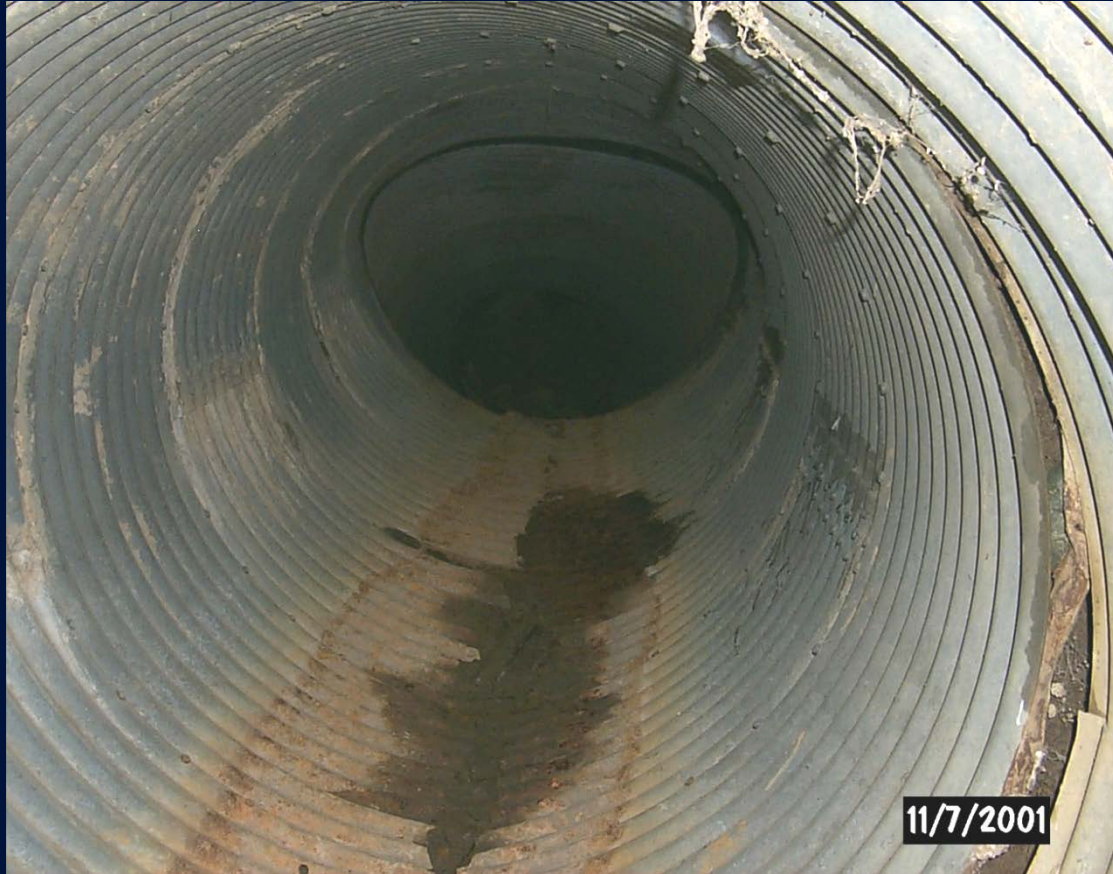
Most Steel pipe **gradually** deteriorates through a **series of defects** shown by inspection flags:

1. Pitting/Rusting
2. Spalling/Flaking
3. Holes
4. Piping
5. Road Void
6. Deformation

HydInfra data shows that about 10% of MnDOT's steel pipe has holes

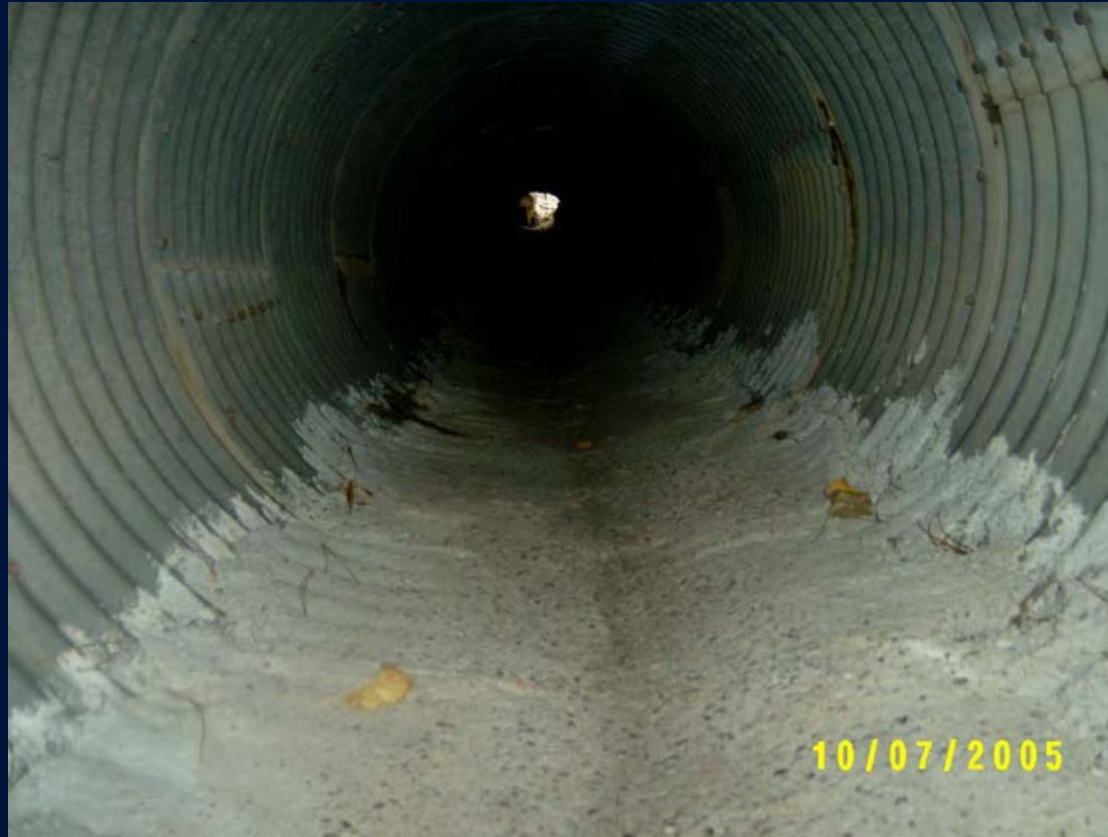
1971 Paved Invert repair still looks good in 2015

for steel pipes 3 foot height or larger

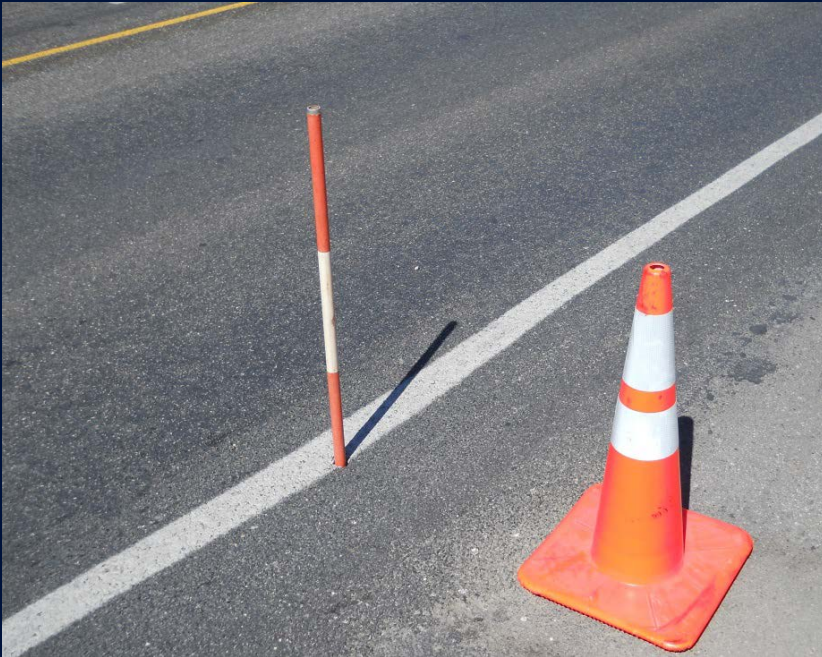
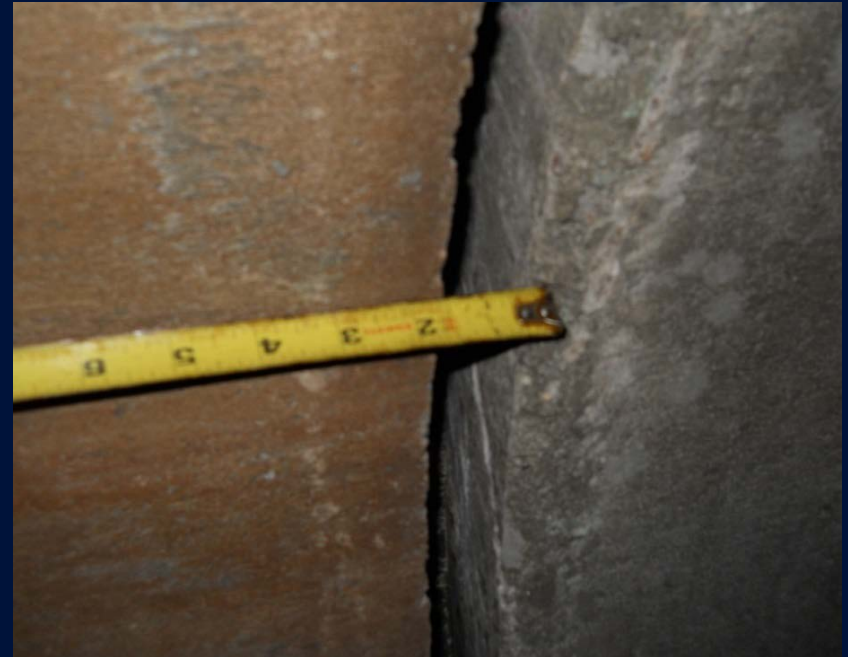
Concrete jacked pipe with 1 ½ in joint separation creates road void, shown by survey range pole in hole in the pavement. 27SEP2011 – Rob Coughlin

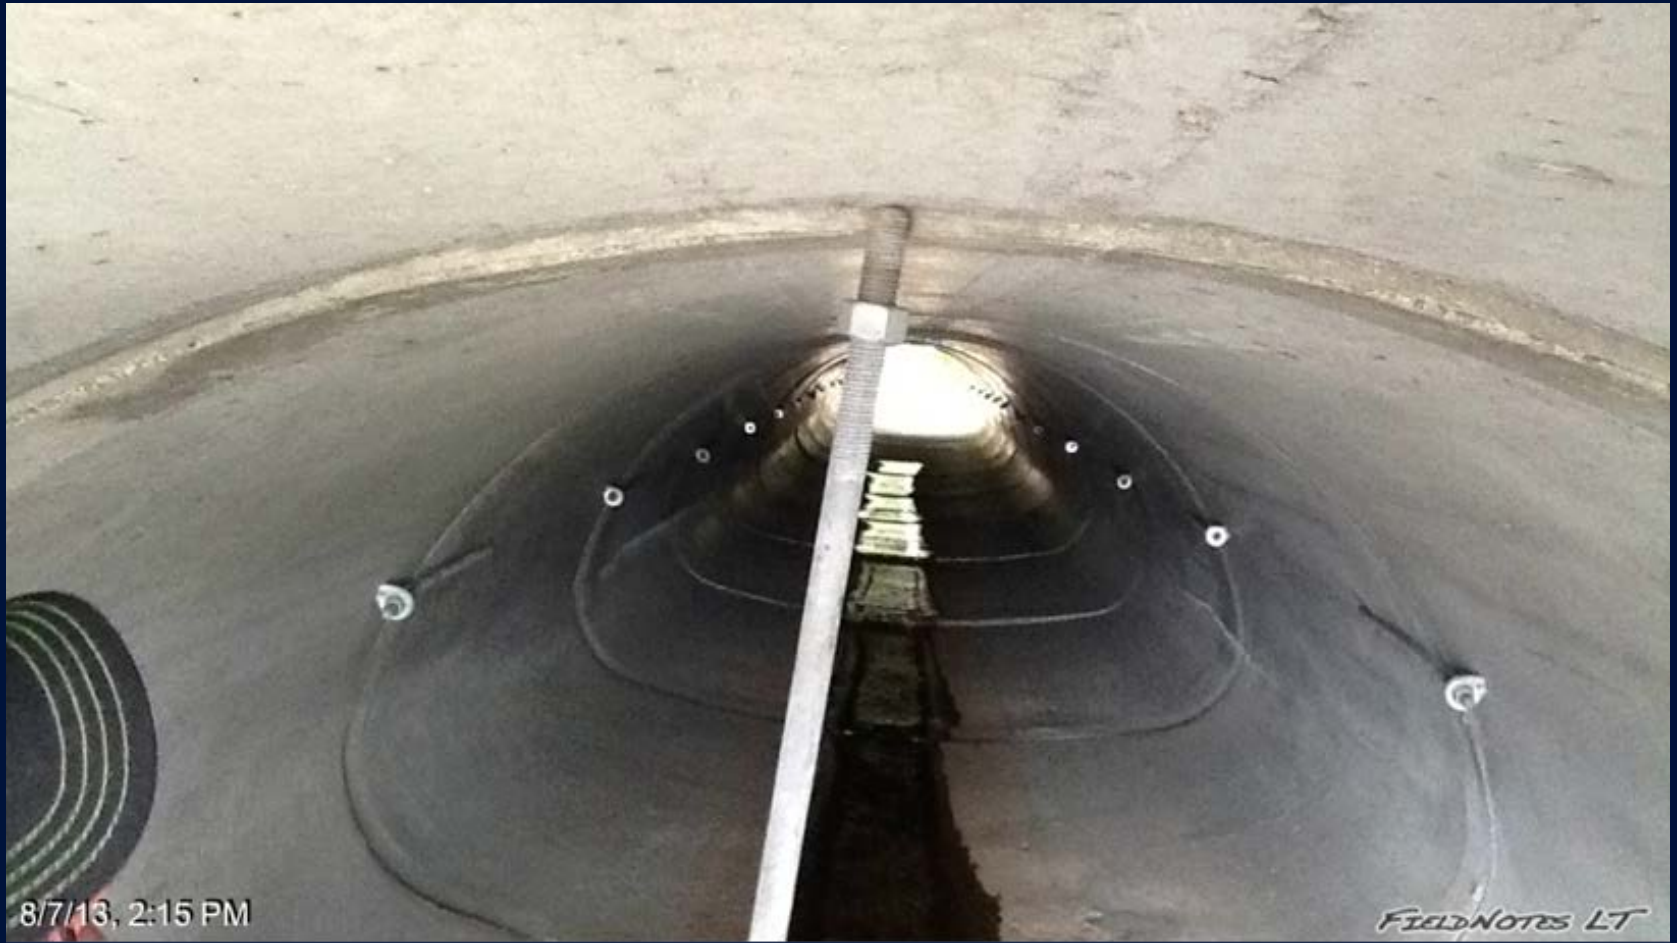
District 1 photo shows broken pipe tie pointing to joint separation in Concrete arch pipe

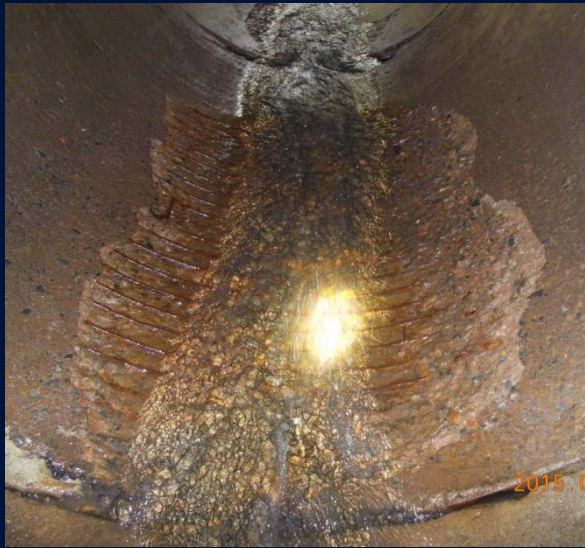
Abrasion from rocks  
District 1 Duluth

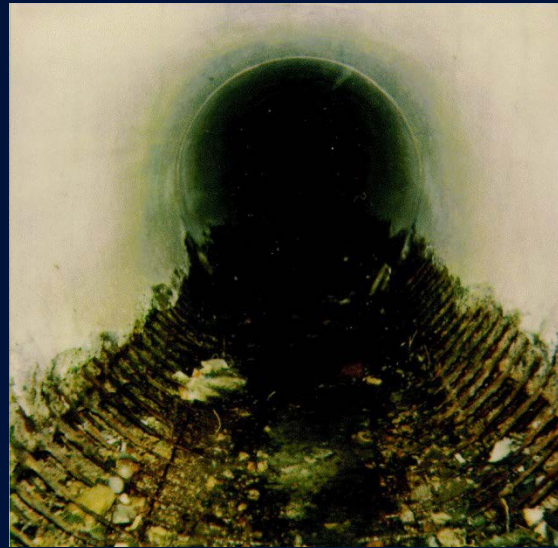
Acidic factory  
discharge,  
I-94 St. Paul  
Metro District

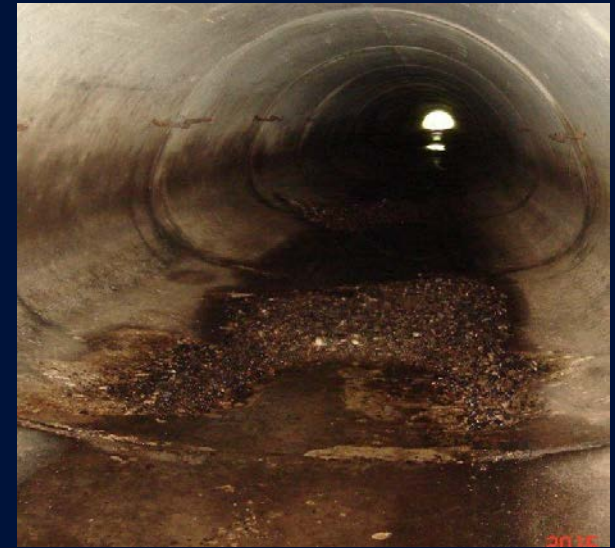
Bad concrete mix  
in alternating pipe  
sections, District 3  
Baxter

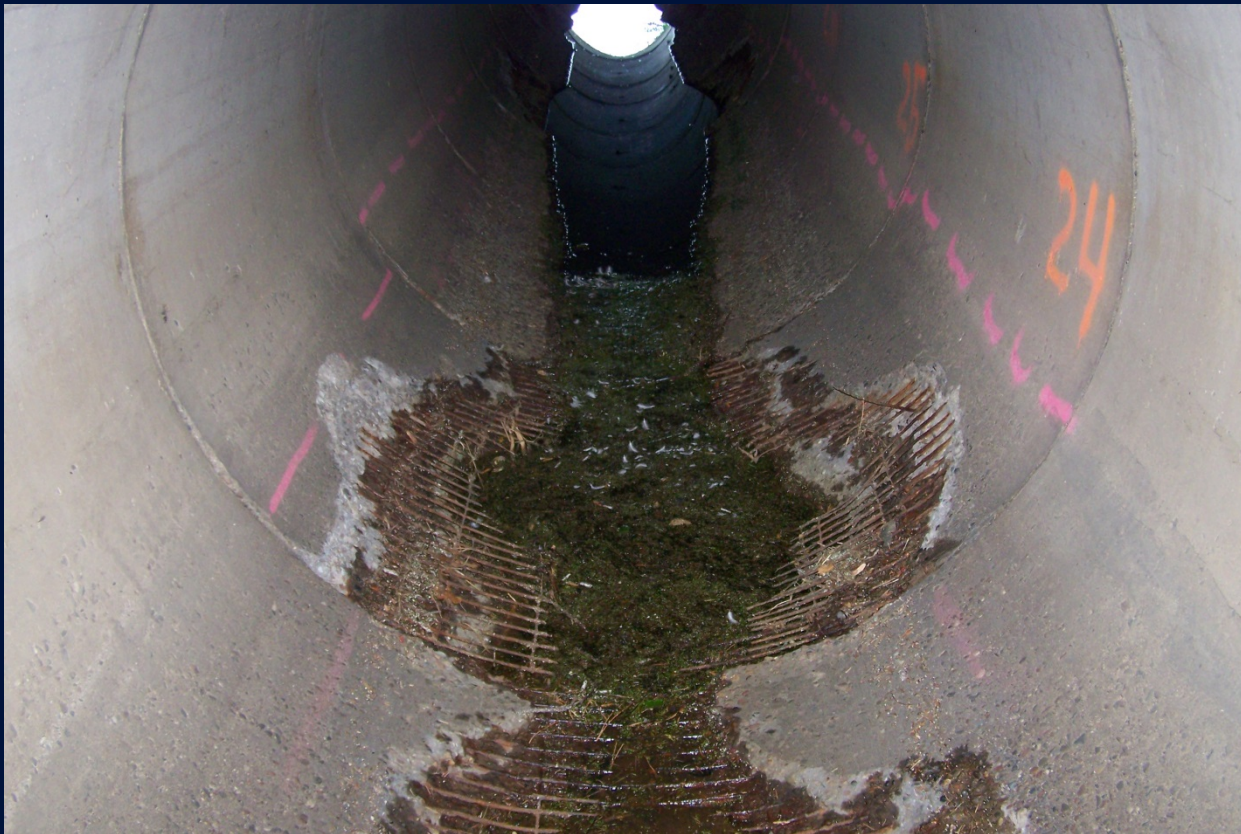
Acid attack looks similar to bad concrete mix  
but **alternating** good - bad pipe sections  
suggest bad material

MN Highway 36 culvert in Roseville alternated  
many good and a few bad pipe sections

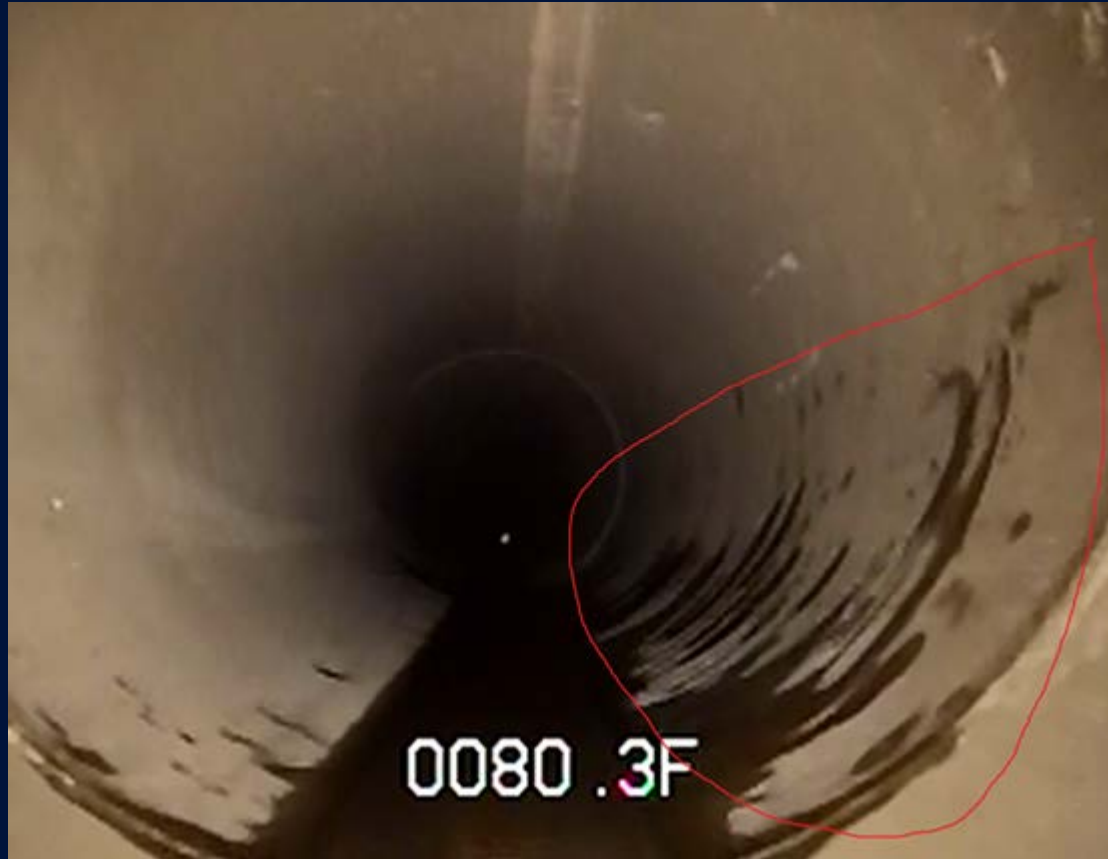
D7 MN Highway 22, 2014

# Porous weeping patches indicate bad concrete material

The pipe photo shows water trickling down the inside wall through perforations or honeycombing.

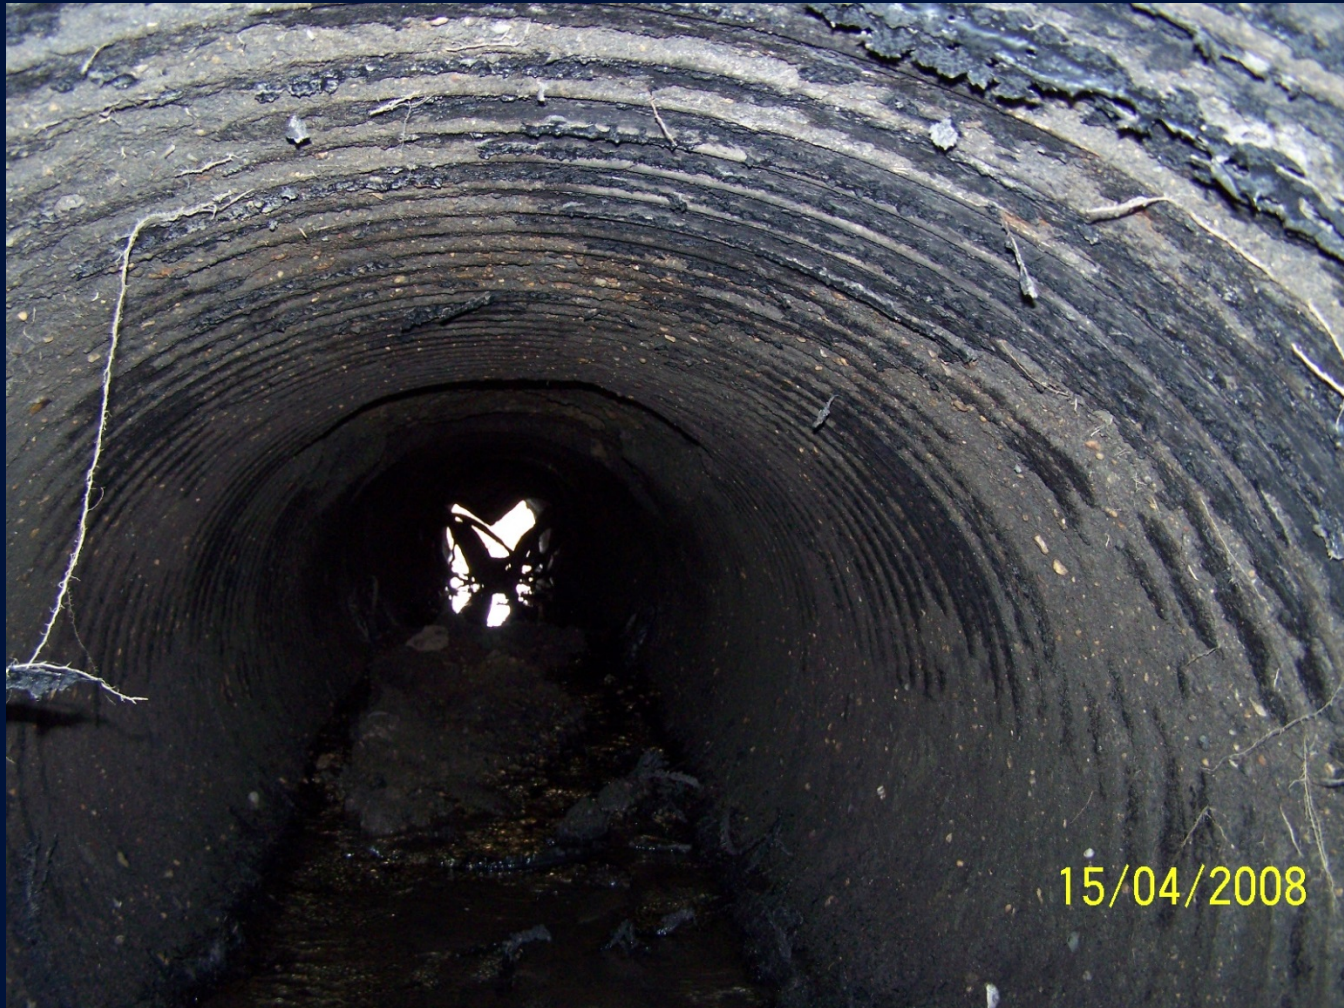
# Random grass **fire** burned this HDPE It has Flaking, Holes and Deformation

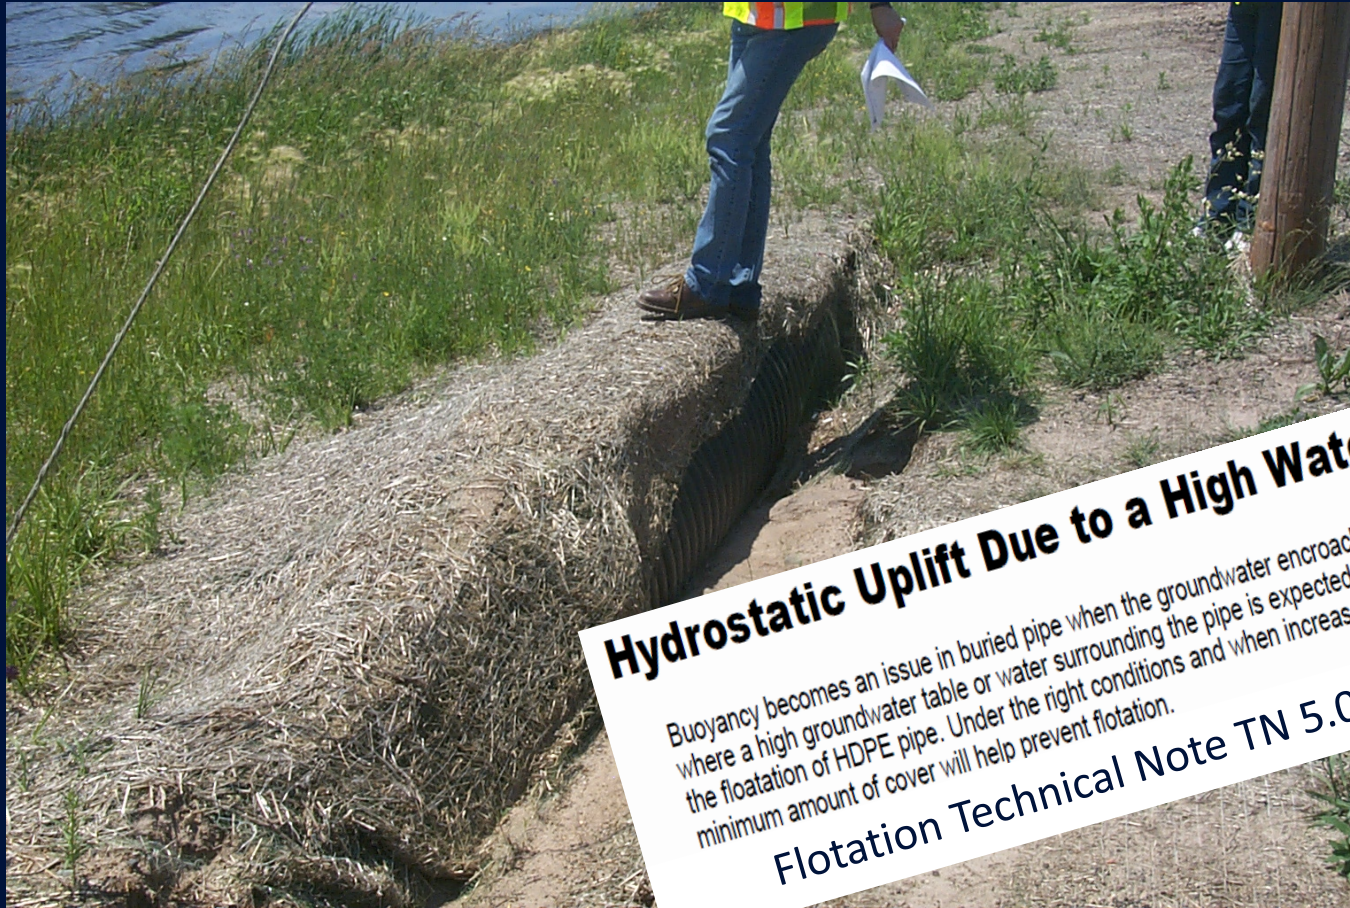
# Too little cover – Construction change caused **Floated** HDPE

Pipe was re-routed across road inslope with too little cover (about 6 inches). High water or frost heave can cause the pipe to “float”.

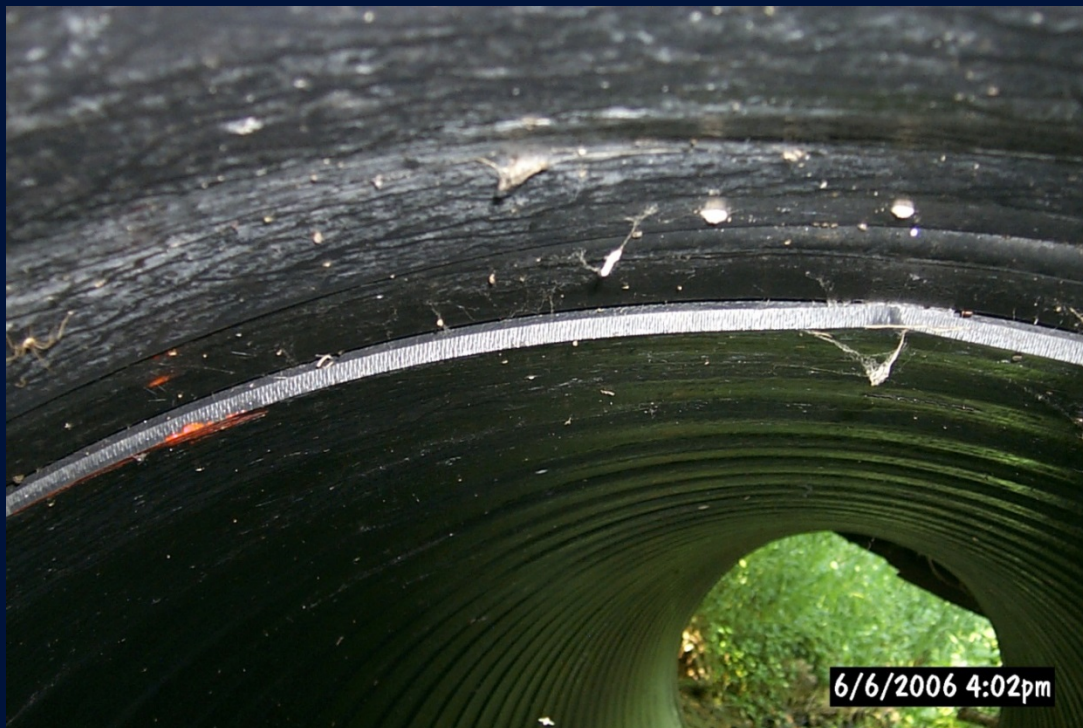
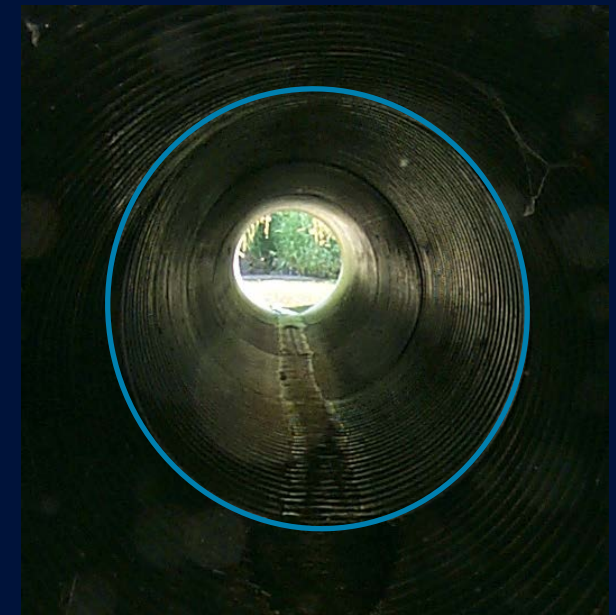
# Bad Resin 1996 HDPE pipe shows Deformation and Misaligned and Separated Joints

Photo above shows 5% Deformation (rotated)

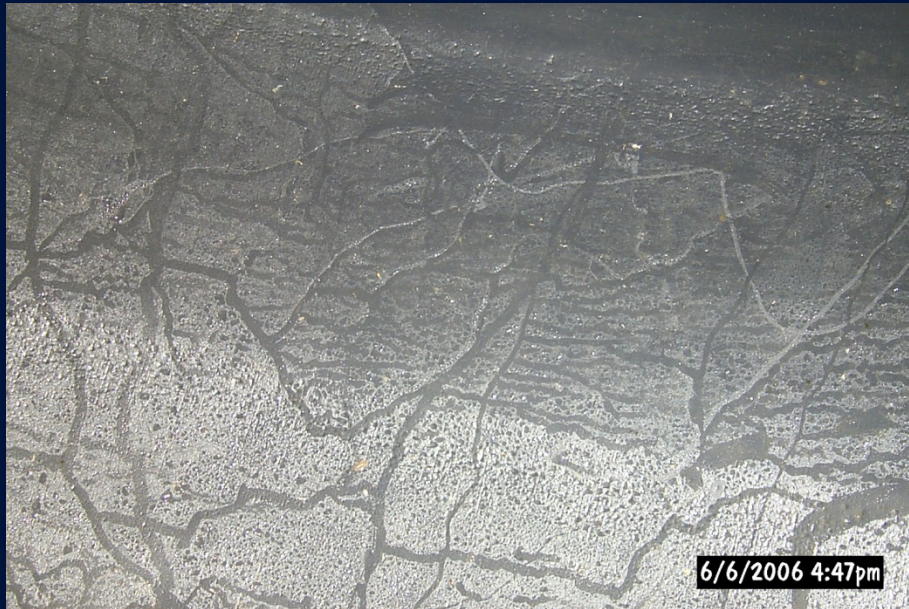
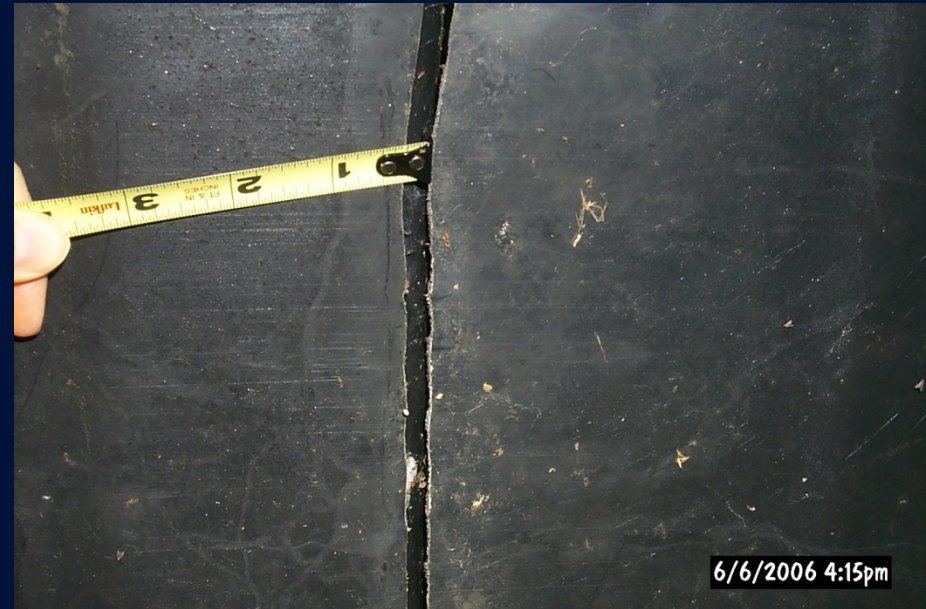
# 1996 **bad resin** HDPE has patterned surface and cracks in 2006

Resin Specs have been changed since this pipe was manufactured

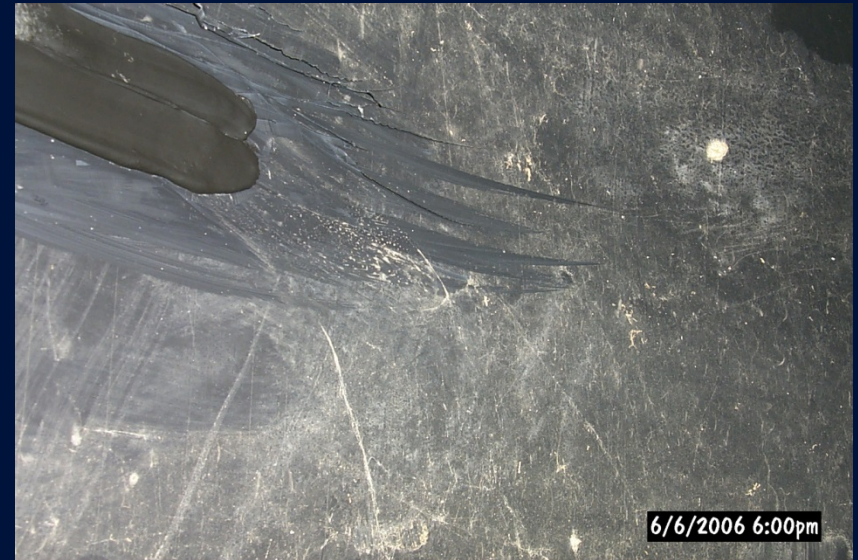
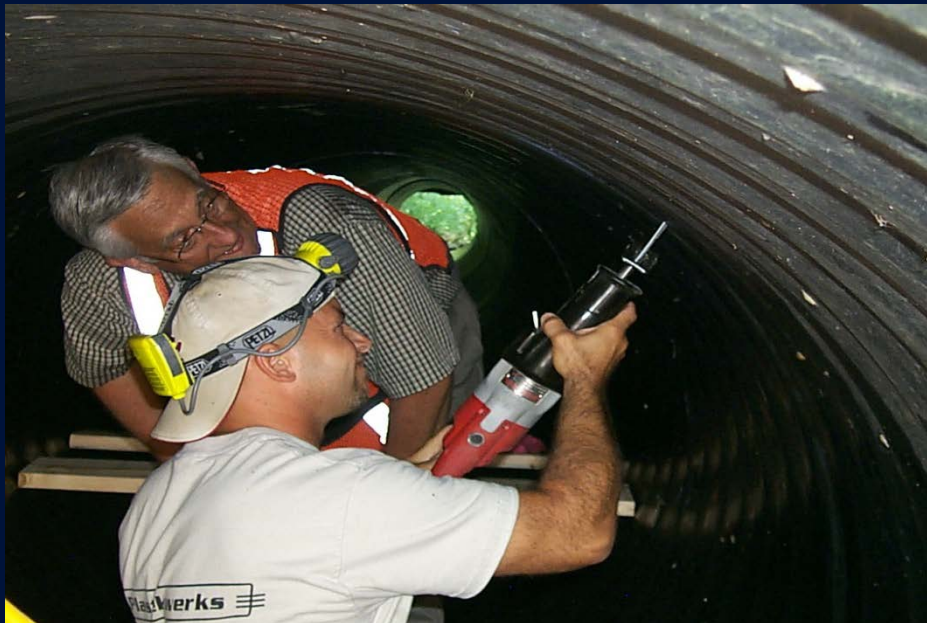
# HDPE cracks were repaired by manufacturer

- 2006 repair on 1996 HDPE
- Drill hole to stop cracking
- Patched by manufacturer's crew with their material
