Penn Avenue over TH 62	Xerxes Avenue over TH 62
Contract Start	Monday July 22, 2013	Monday, April 15, 2014
Contract Completion	Saturday, October 12 th , 2013	Friday, June 27, 2014
Duration	83	74
Actual Start	7/23/2013	4/7/2014
Actual Finish	10/19/2013	6/27/2014
Duration	89	82

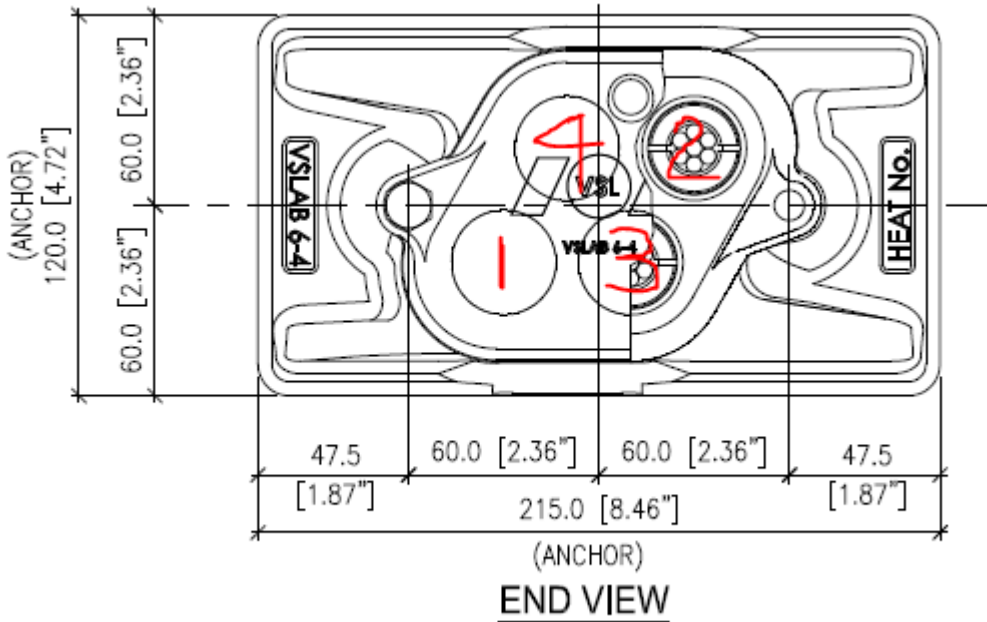
Show how the individual strands will be numbered within each anchor – they are stacked strands and I want everyone to be on the same page. I assume the numbering for tensioning sequence the first tendon would be as follows:

Assuming you are at tendon E9: E9-1, E9-2, E9-3, E9-4. The sequence of strand tensioning is also for even distribution of anchor forces:
