## **BRIDGE MAINTENANCE, REHABILITATION, AND REPLACEMENT: CASE HISTORIES**

## CASE HISTORY 15.1- IN-PLACE PRESERVATIVE TREATMENT OF DETERIORATING TIMBER BRIDGES

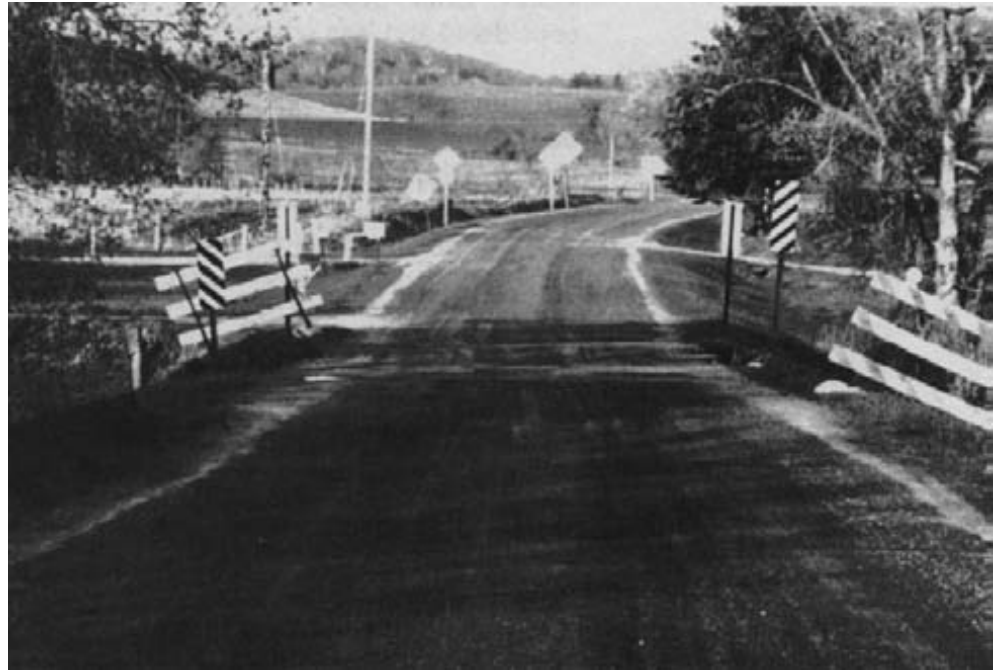
*Figure 15-18. - Typical concrete bridge on Pepin County Trunk Highway Z before rehabilitation. The bridges were adequate hydraulically and structurally, but did not meet minimum standards for roadway width.*

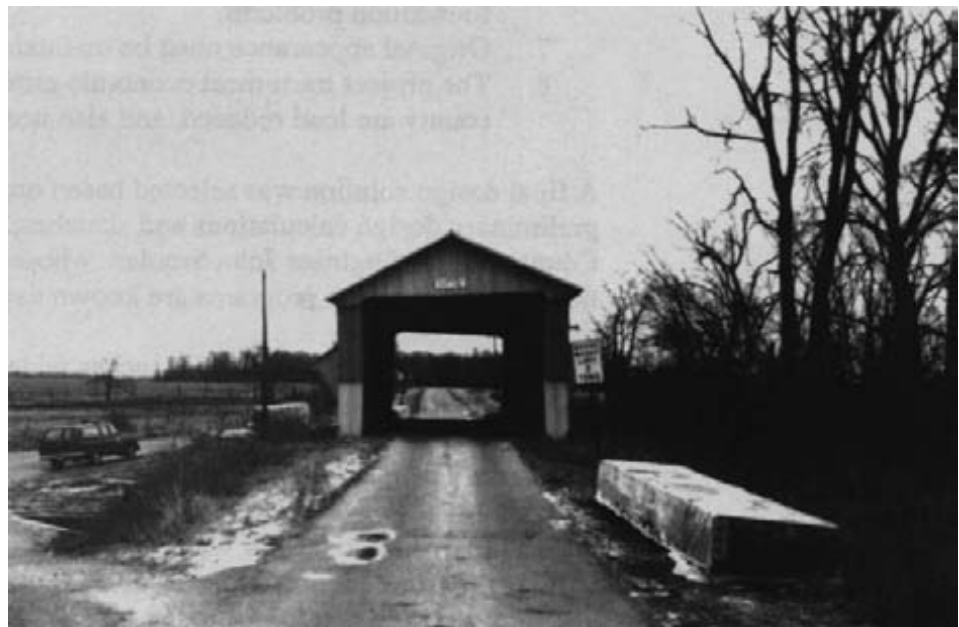
The first candidate was chosen based on its low traffic volume (dead-end road) and generally poor condition throughout the bridge. This truss, spanning 95 feet, had a noticeable twist caused primarily by nearly broken

lower chords at opposite corners. The ends of some diagonals and lower chords were decayed and crushed from years of termite attack and general deterioration. Two steel piers were placed under the bridge in the 1950's, along with other various supports added in attempts to keep the bridge standing. An accurate analysis of the bridge was nearly impossible because of the unique design, the poor condition of the truss, and all the supports installed over the years. The bridge had a posted load limit of only 3 tons.

*Figure 15-27. - Covered bridge on Winget Road before rehabilitation work began. Note the excessive rack and twist of the truss.*

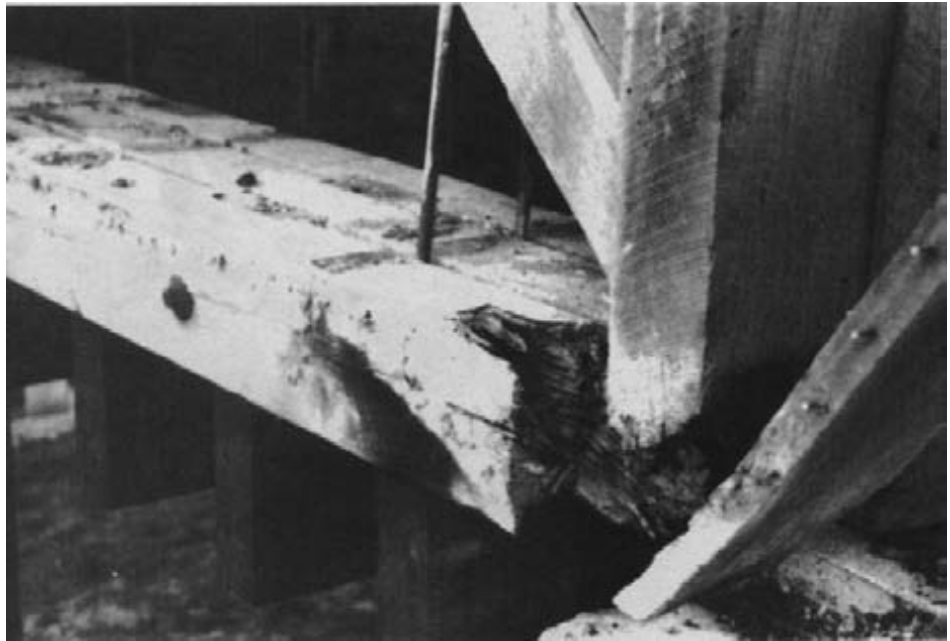
*Figure 15-32. - Severe deterioration at each corner of the bridge was one cause of the poor truss alignment. New floorbeams were extended beyond the girders to help support each truss.*

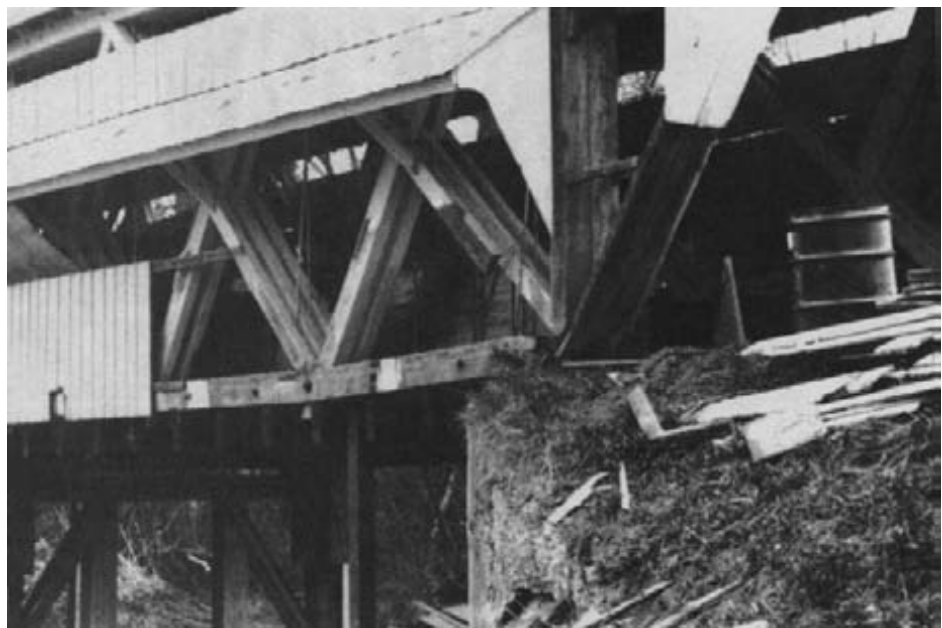
*Figure 15-33. - Broken lower chords at two of the four corners prompted the replacement of some existing truss members.*

Eventually, the decision was made to repair all four truss corners, especially the lower chords, with new poplar timbers. Once this was done the truss squared up nicely.

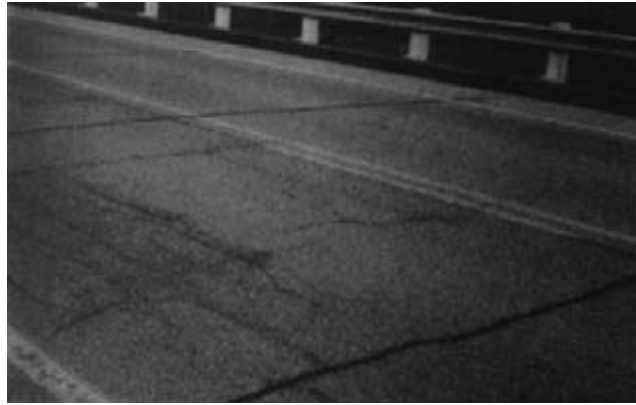
Figure 15-38. - Breakup of asphalt pavement because of delamination of the nail-laminated timber deck.

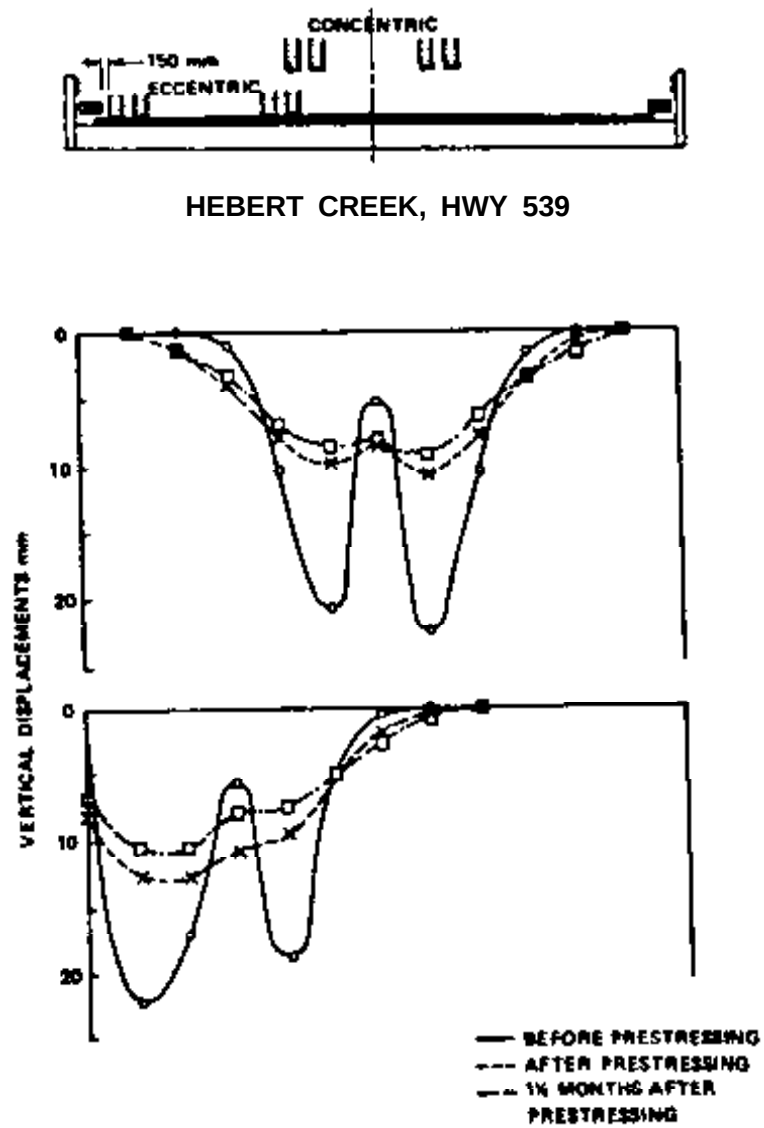
Figure 15-46. - Load test results at the Hebert Creek Bridge, before and after transverse prestressing was applied.

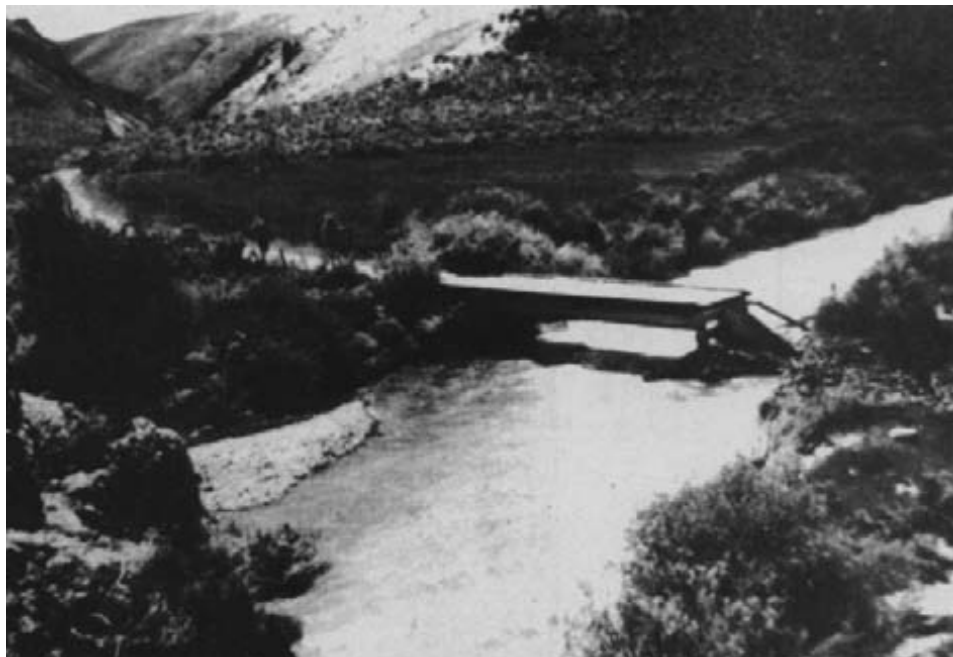
*Figure 15-56. - Collapsed span and breached approaches of the existing bridge.*

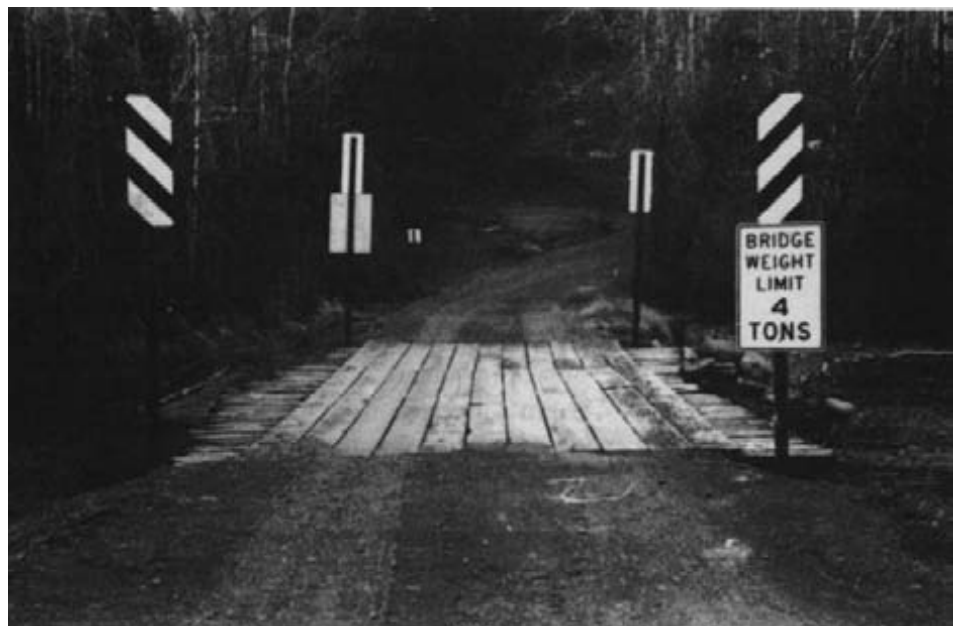
*Figure 15-77. - The existing bridge was structurally deficient and load-posted. In addition, it was too narrow and lacked curbs and railing (photo courtesy of Wheeler Consolidated, Inc.).*
