Development and Integration of Advanced Timber Bridge Inspection Techniques for NBIS

January 2015

Research Project
Final Report 2015-01

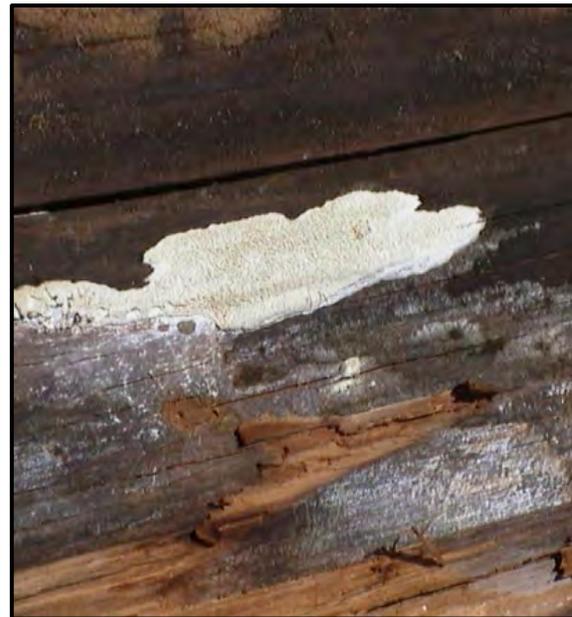
Figure 3.2. Douglas fir bridge member showing visual evidence of a fruiting body on the surface in addition to visual evidence of decayed timber.

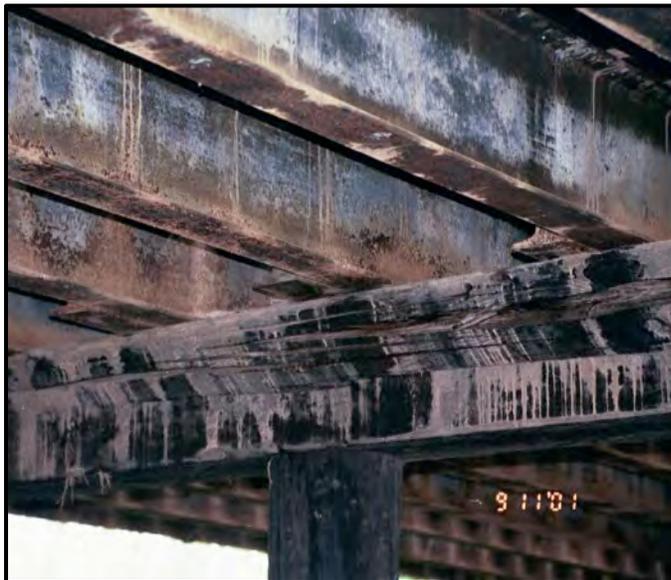
Figure 3.4. Timber abutment cap showing visual evidence of localized failure demonstrated by longitudinal cracking. Photo courtesy of MnDOT.

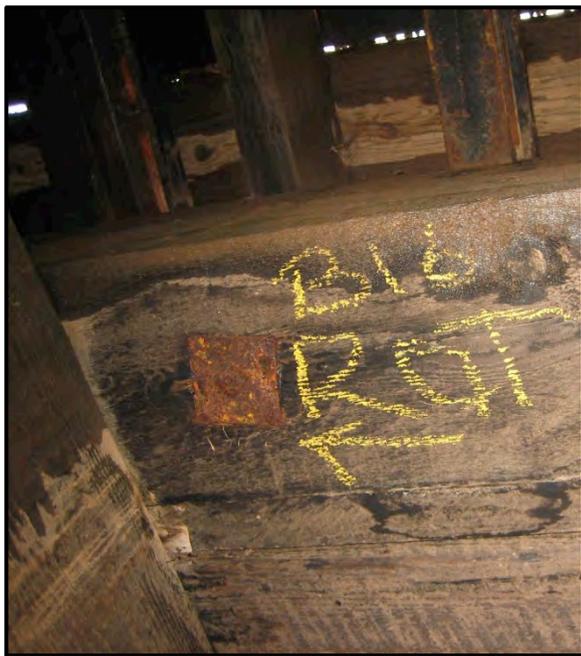
Figure 3.6. The timber members were stained and discolored due to high levels of water. The hardware shows significant corrosion.

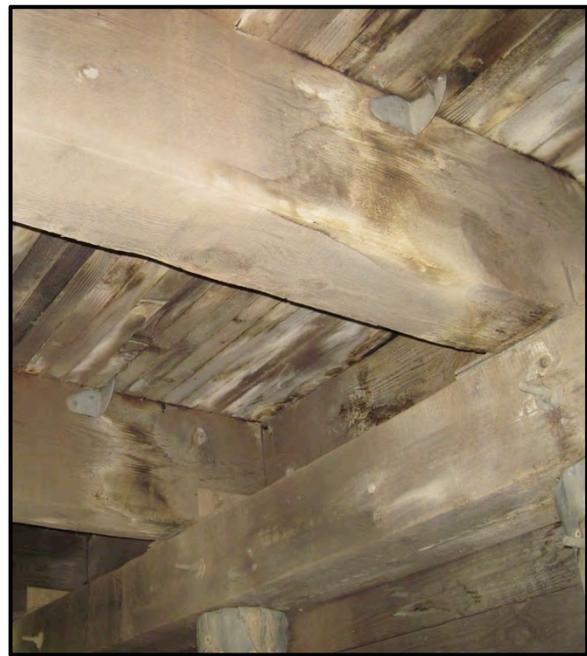
Figure 3.7. Water staining and discoloration caused by water that infiltrated through the bituminous wear layer and nail-laminated deck.

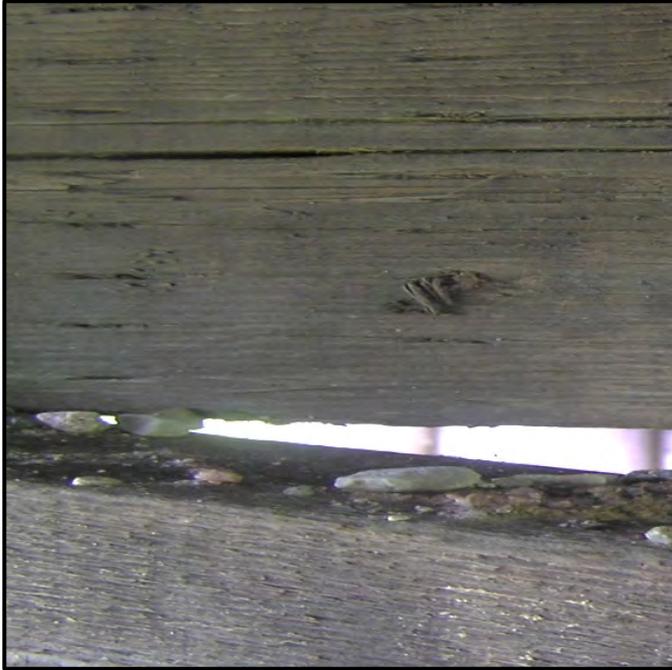
Figure 3.8. A timber abutment cap that has been initially deteriorated by decay. Carpenter ants are nesting in the cap, with frass being deposited onto the cross bracing member.

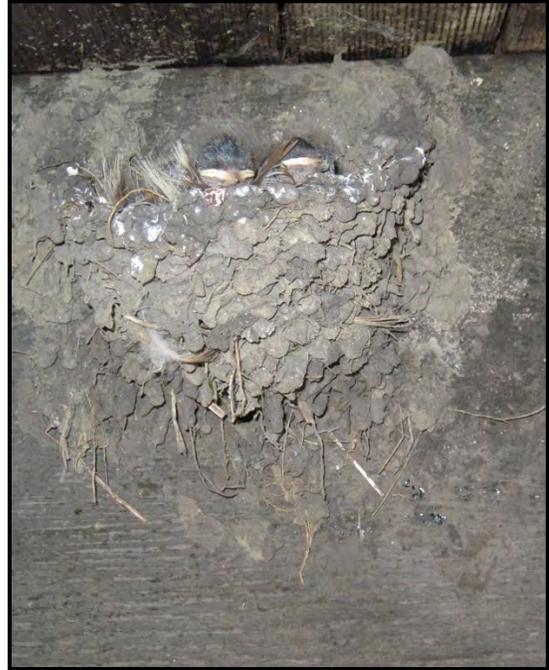
Figure 3.9. Nesting birds are often found under timber bridges and their nests can trap and hold moisture against timber beams and bracing.

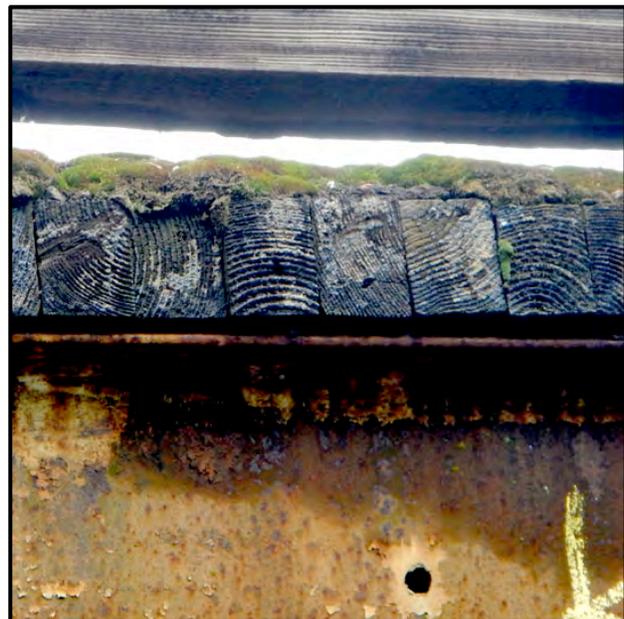
Figure 3.10. Moss growing on the surface of a nail laminated timber deck supported by steel beams along the curb/scupper zone.

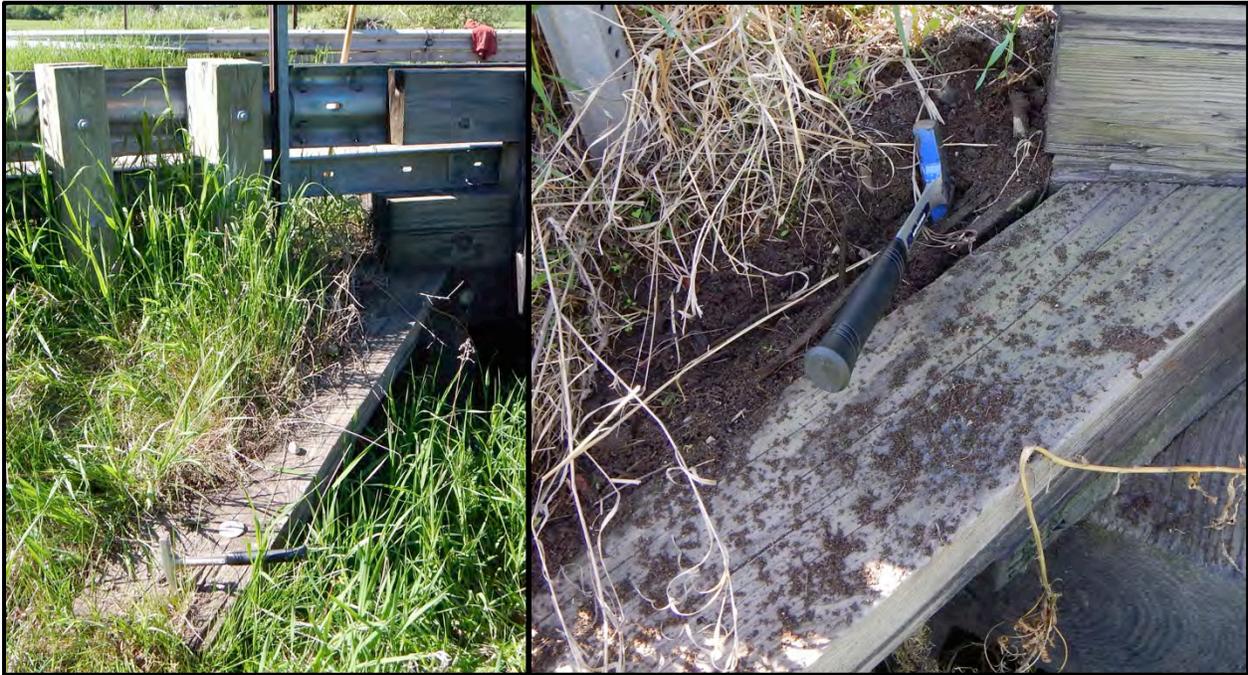
Figure 3.11. A wing wall timber abutment has substantial plant growth on the cap surface. Once removed, visual and probing inspection showed that 75% of the cap cross-section had been severely decayed. This will eventually result in damage to the wing wall pile elements.

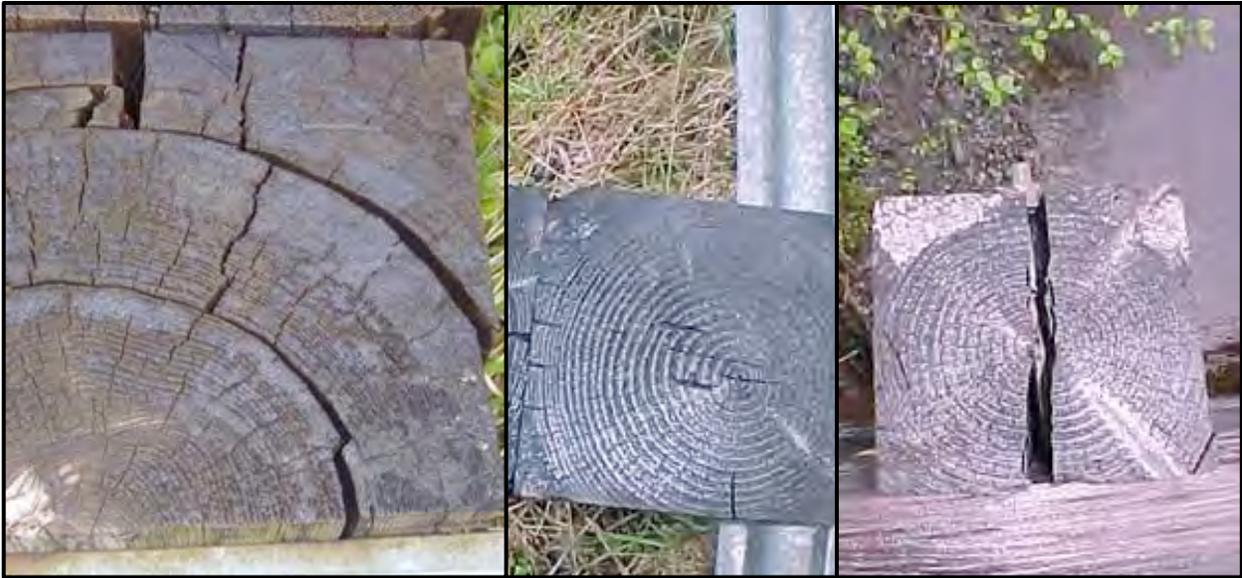
Figure 3.12. Timber railing posts showing various types of deterioration. From left to right, the posts show ring shake, small end checks, and severe through splits.

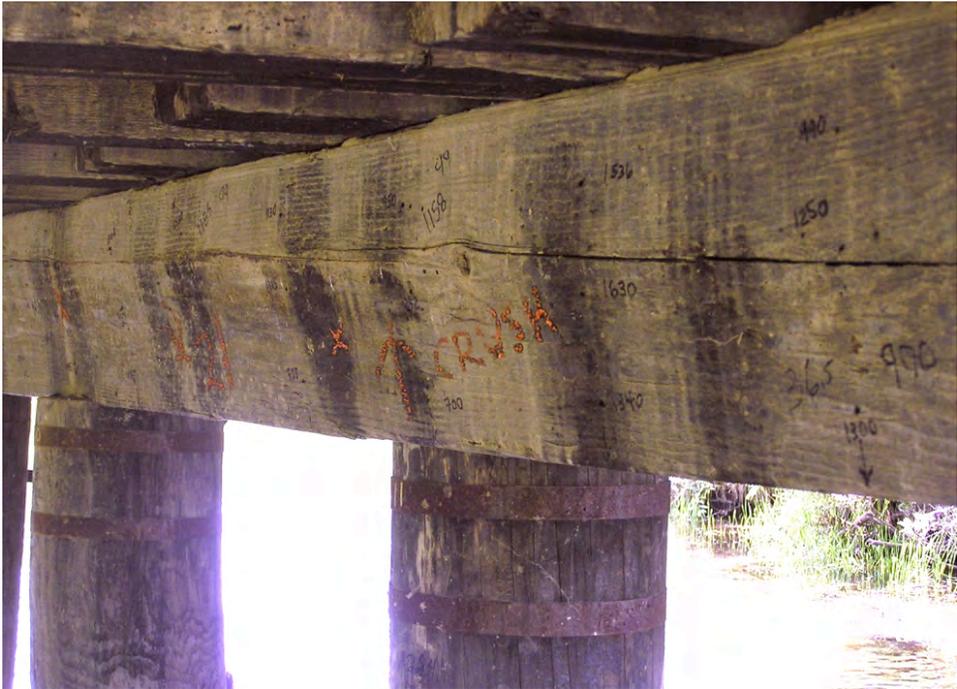
Figure 3.13. A long horizontal split provides an opportunity for moisture passing through the timber deck to enter the abutment cap, leading to substantial decay.

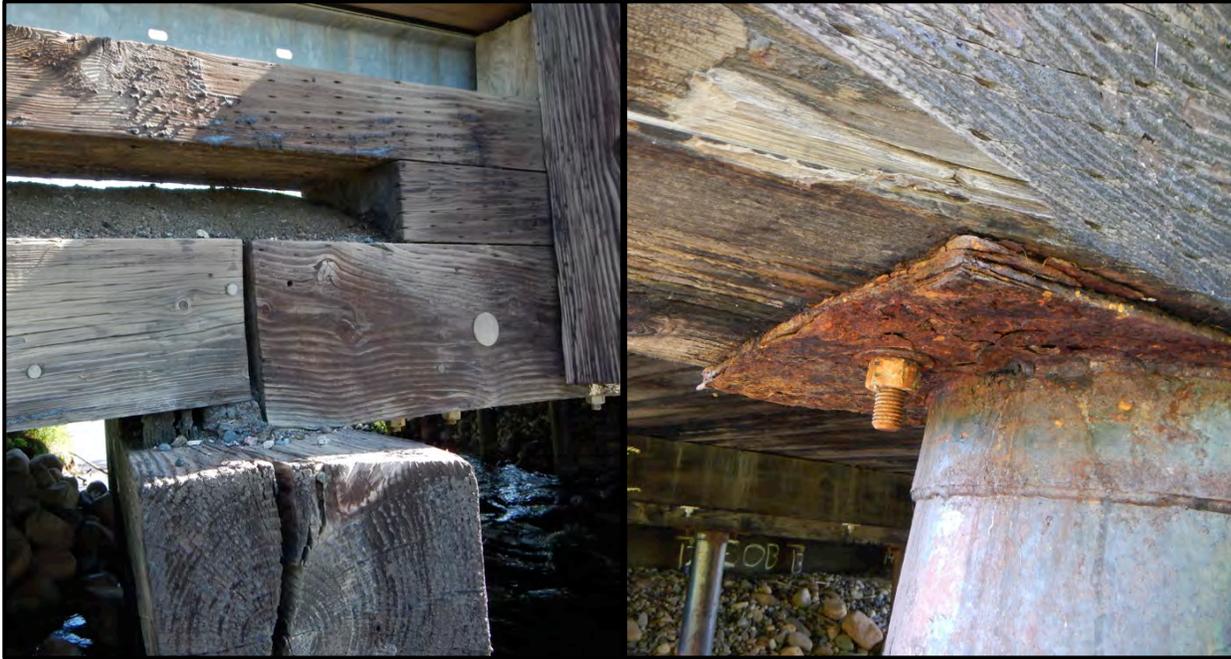
In **Figure 3.14**, a severe through split in an abutment cap provides an opportunity for moisture to absorb into the element, resulting in conditions that allow for potential decay as well as deterioration of the surrounding steel elements such as the CIP bearing plate.

Figure 3.14. Visual assessment of a pier cap split. The split allows moisture from the deck to enter the member beyond the protective layer of preservative treated wood, resulting in increased likelihood of future decay and allows for deterioration of hardware such as the CIP bearing plate that supports this element.

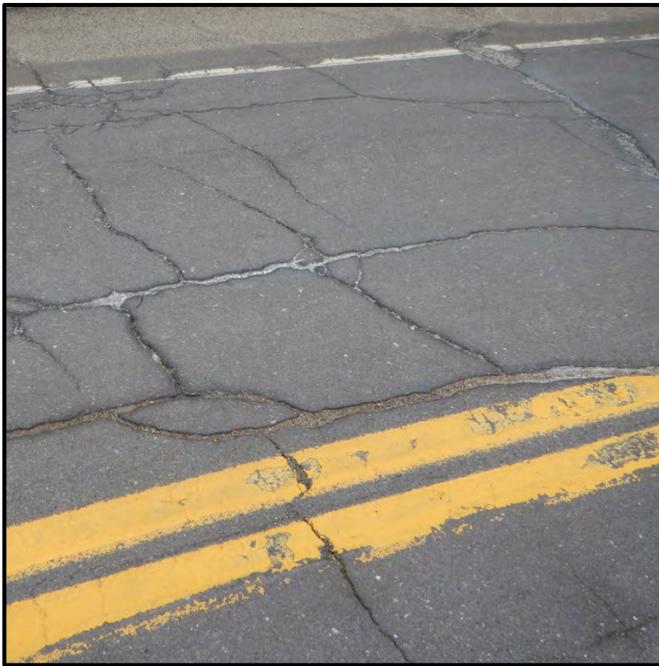
Figure 3.16. Cracking and deterioration of bituminous wear layers create opportunities for water to pond on the deck and seep into the superstructure elements creating decay potential.

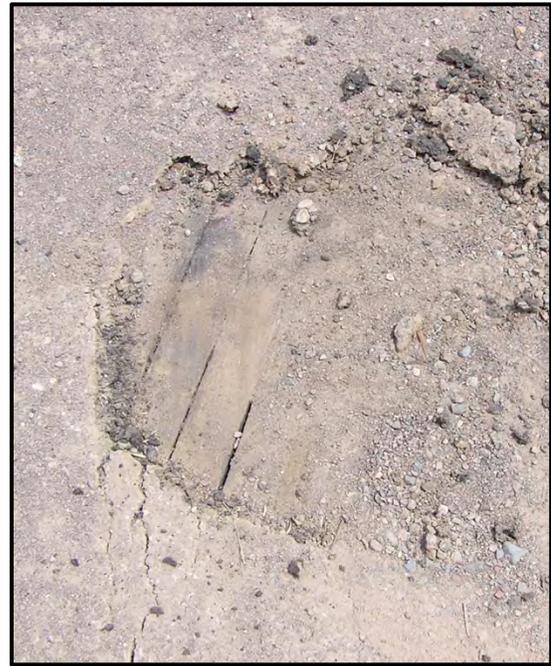
Figure 3.17 shows an exposed timber deck on the surface of a bridge where the wear layer has been completely removed. This creates an entry point for moisture infiltration into the timber decking, beams, abutments and piers.

Figure 3.17. The bituminous wear layer has deteriorated exposing structural timber decking to moisture and potential deterioration.

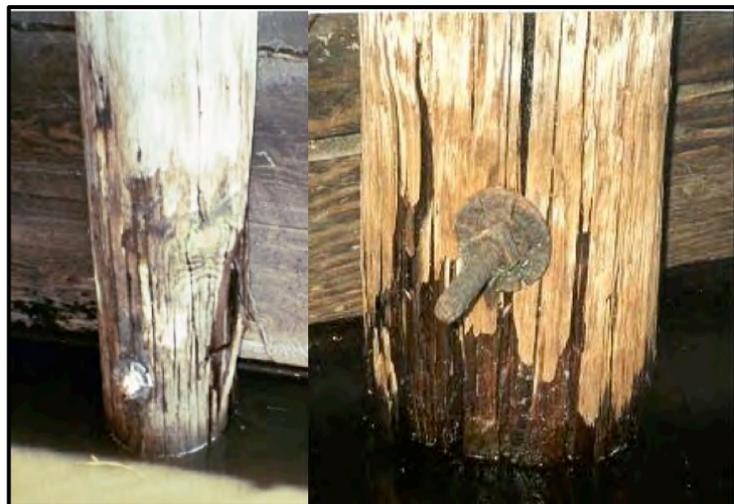
Figure 3.18. Shell damage to timber piling at or near the water line, often caused by freeze thaw cycles, ice damage or flotsam floating down the river.

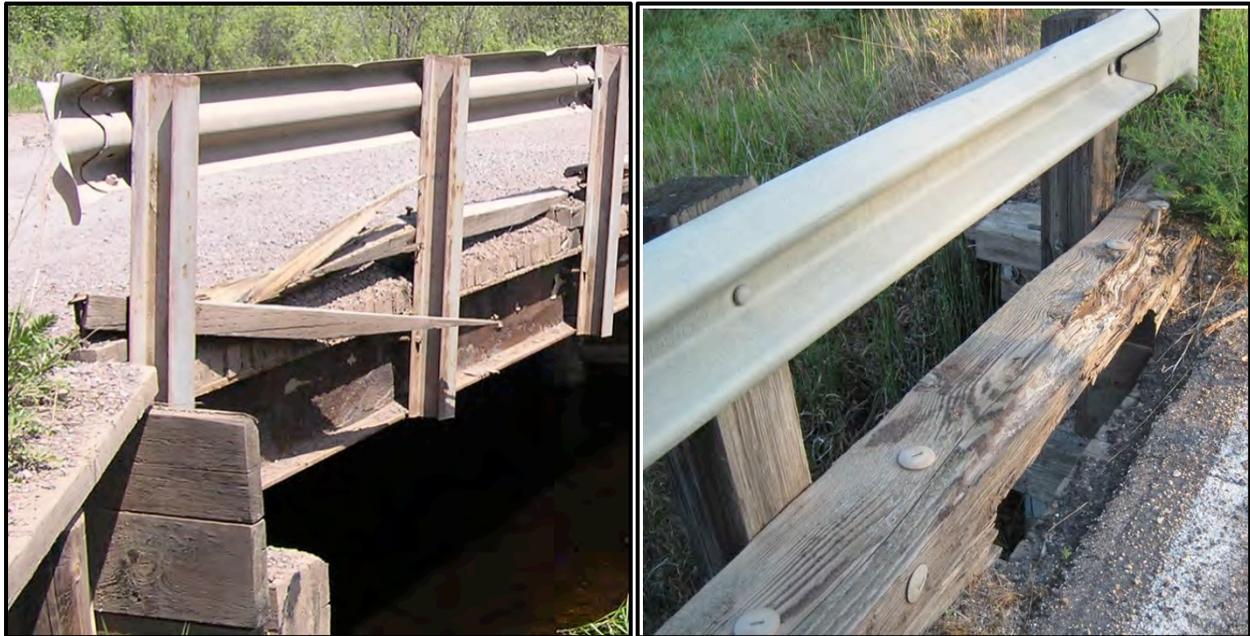
Figure 3.19. The timber curbs shown have significant damage from a snowplow or other vehicle exposing untreated wood to high levels of moisture.

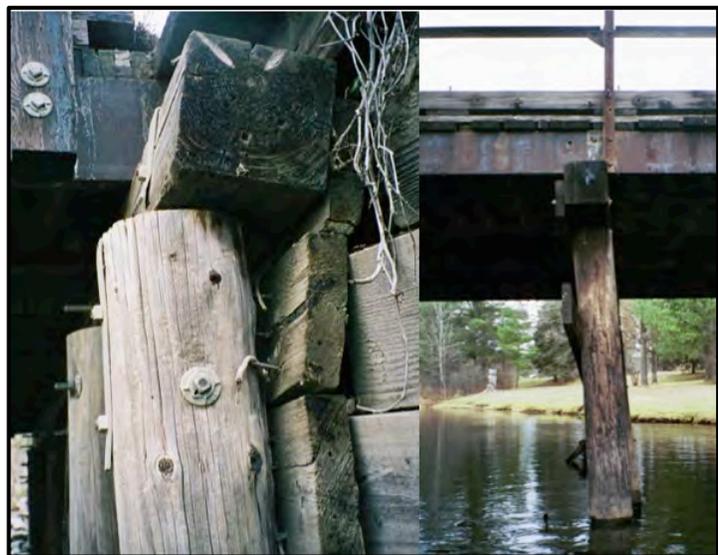
Figure 3.20. Rotation of timber pilings and pile caps in an abutment (left) and timber pier (right).

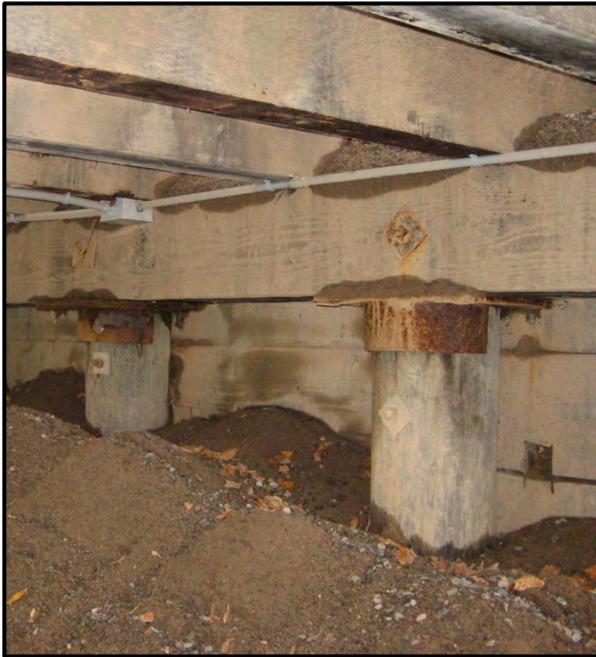
Figure 3.21. Sand and gravel are shown on top of the timber abutment cap as deposited through vehicle traffic or road maintenance through a timber deck.

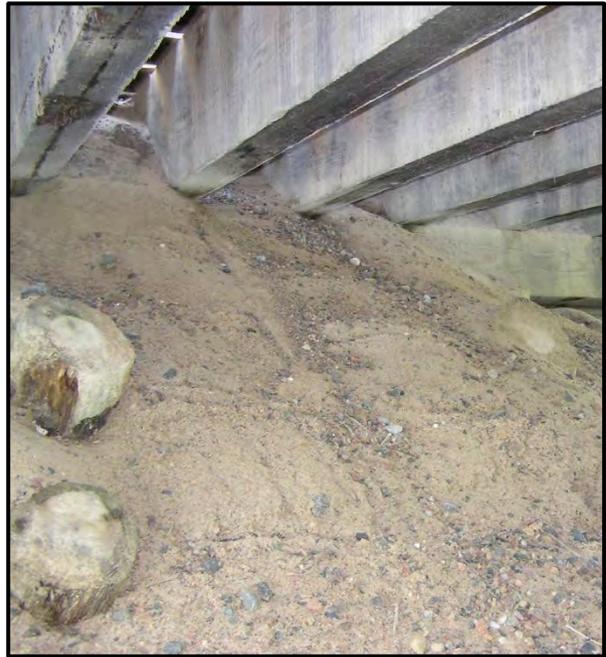
Figure 3.22. Sand and gravel are covering the timber abutment cap and the longitudinal timber beams, holding moisture against these elements.

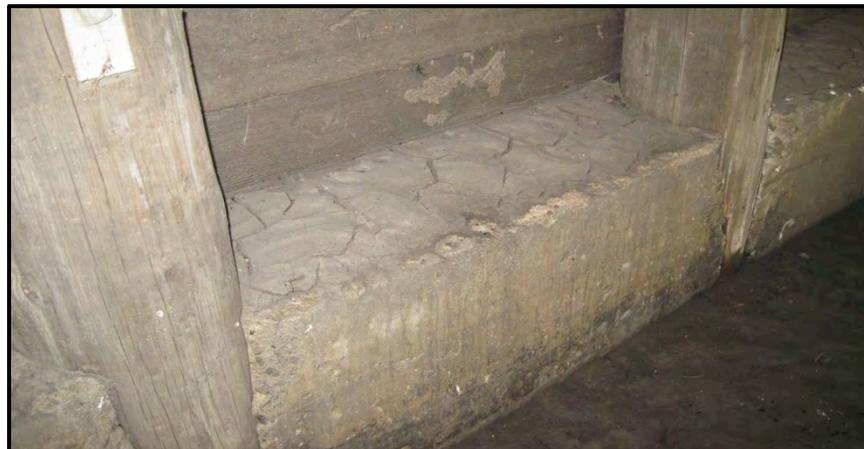
Figure 3.23. Timber piling in direct contact with concrete footing, creating high moisture content conditions.

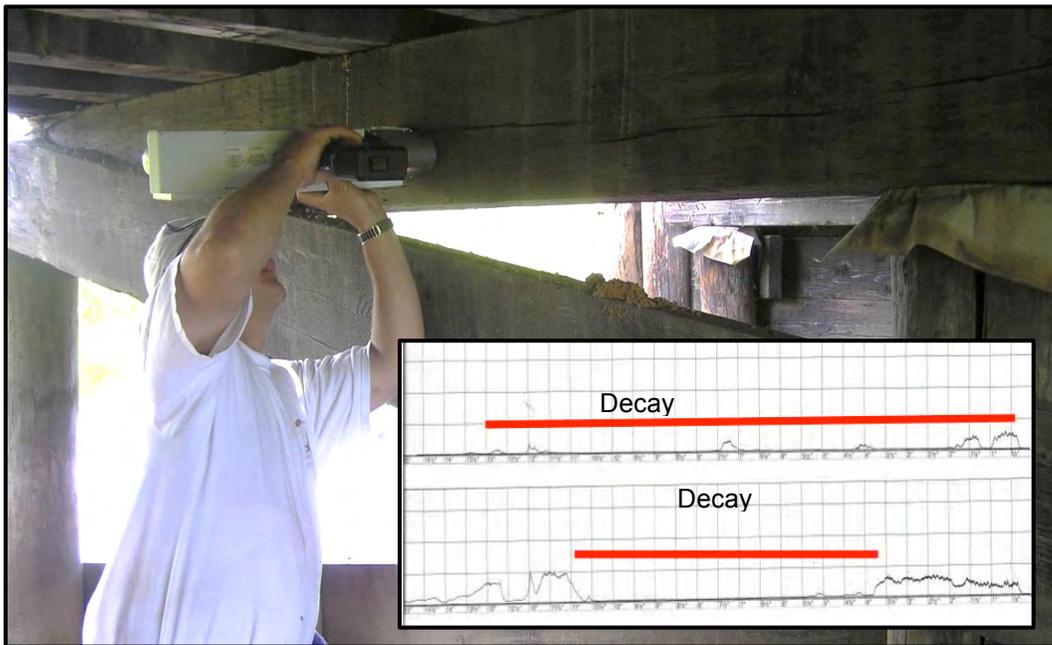
Figure 6.5. Resistance microdrilling showing significant decay in the bridge pile cap. The inlay shows the paper chart readout from a commercial drilling unit.

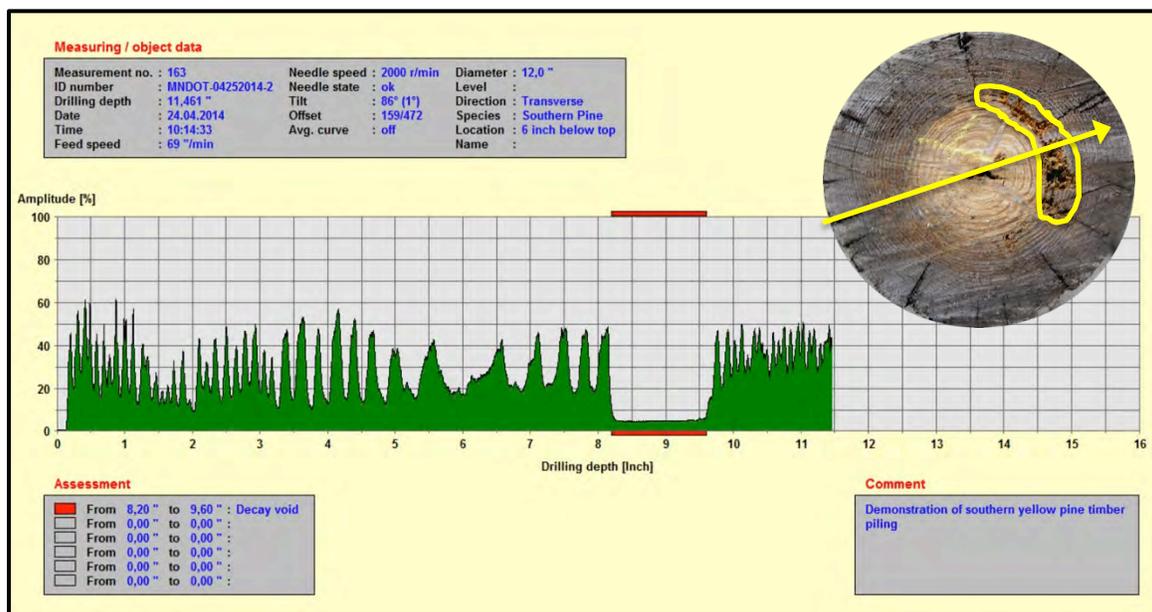
Figure 6.8. Electronic view of a southern yellow pine timber piling showing a decay pocket between 8 and 10 in. of the drilling profile.

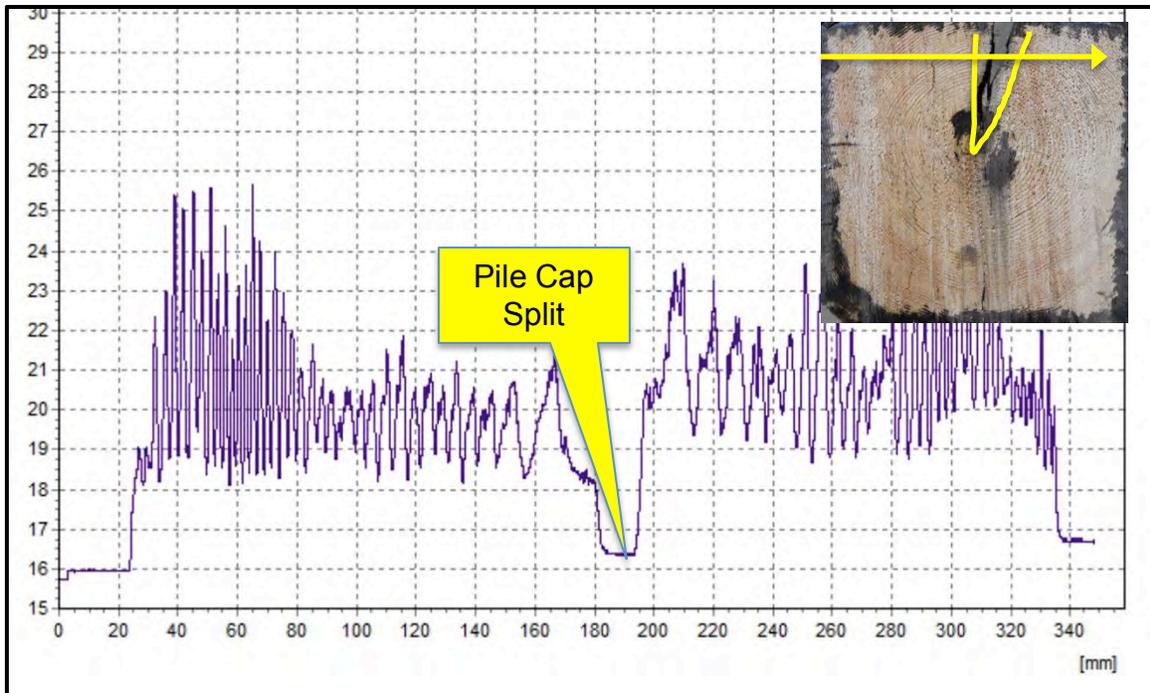
Figure 6.9. Electronic resistance chart of a Douglas fir pile cap showing a large crack between 180 and 200 mm (7.0 and 7.9 in) along the drilling path.

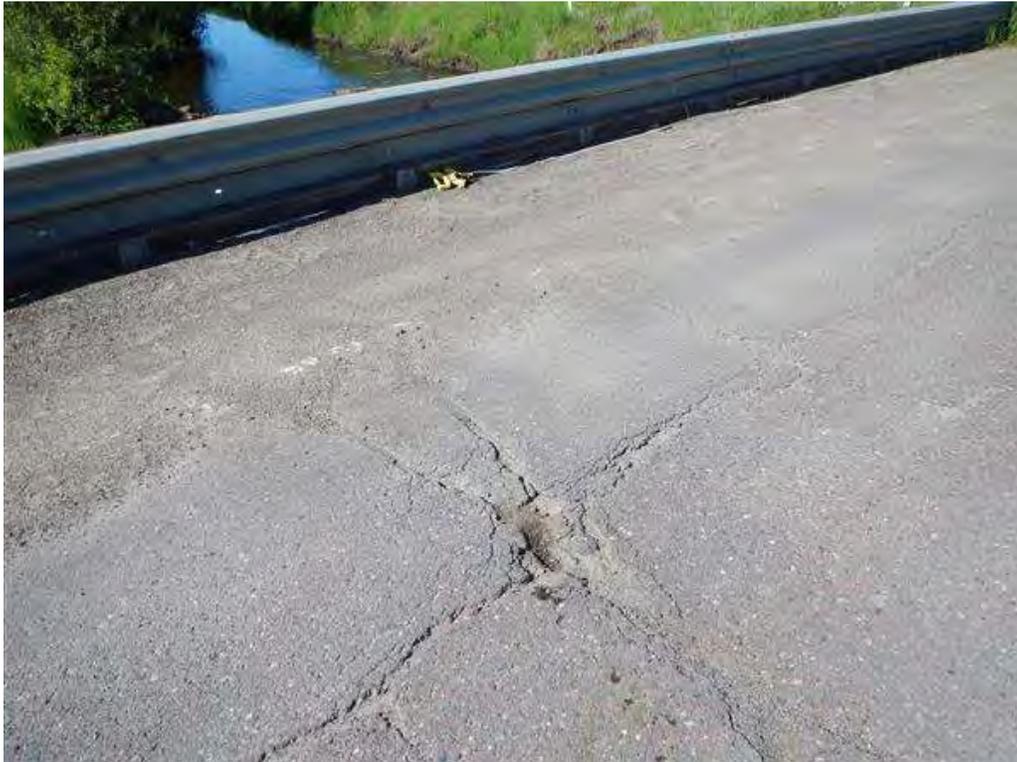
Photo 2 - Deck - Pot hole above Pier 2 with longitudinal cracking

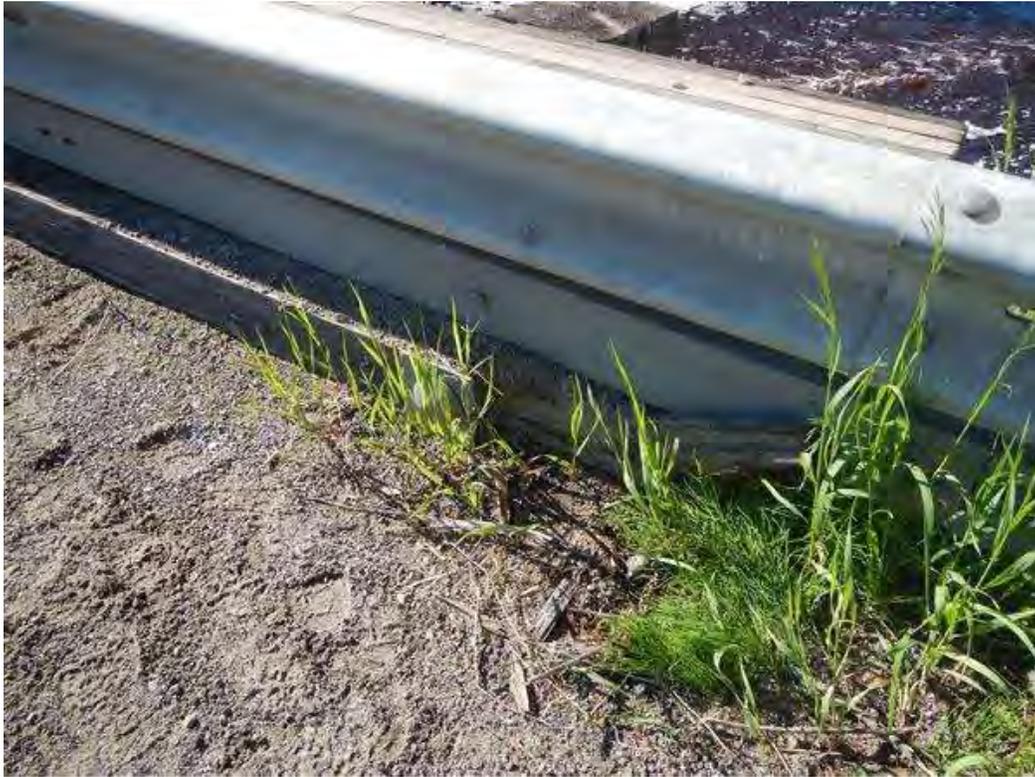
Photo 5 - SW corner of bridge showing vegetation and gravel/sand near curb. Deterioration noted.

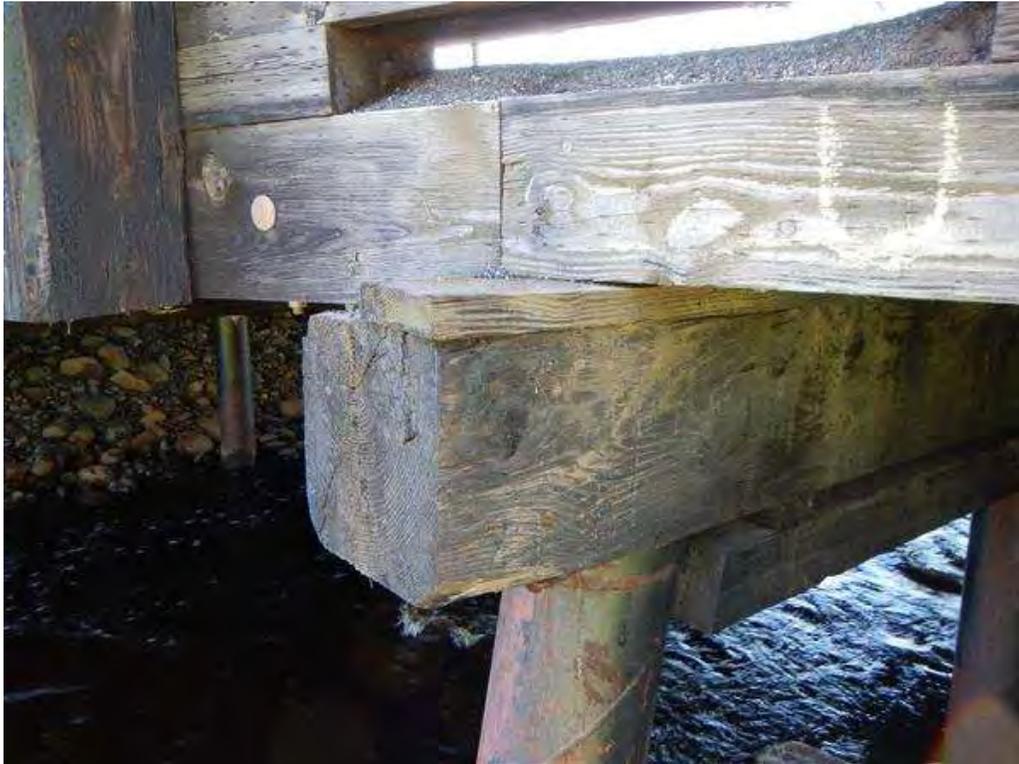
Photo 6 - Pier 1 - North End - Through split extending 80% of full length of cap. SWT over 500 but R drill showed only crack with no decay

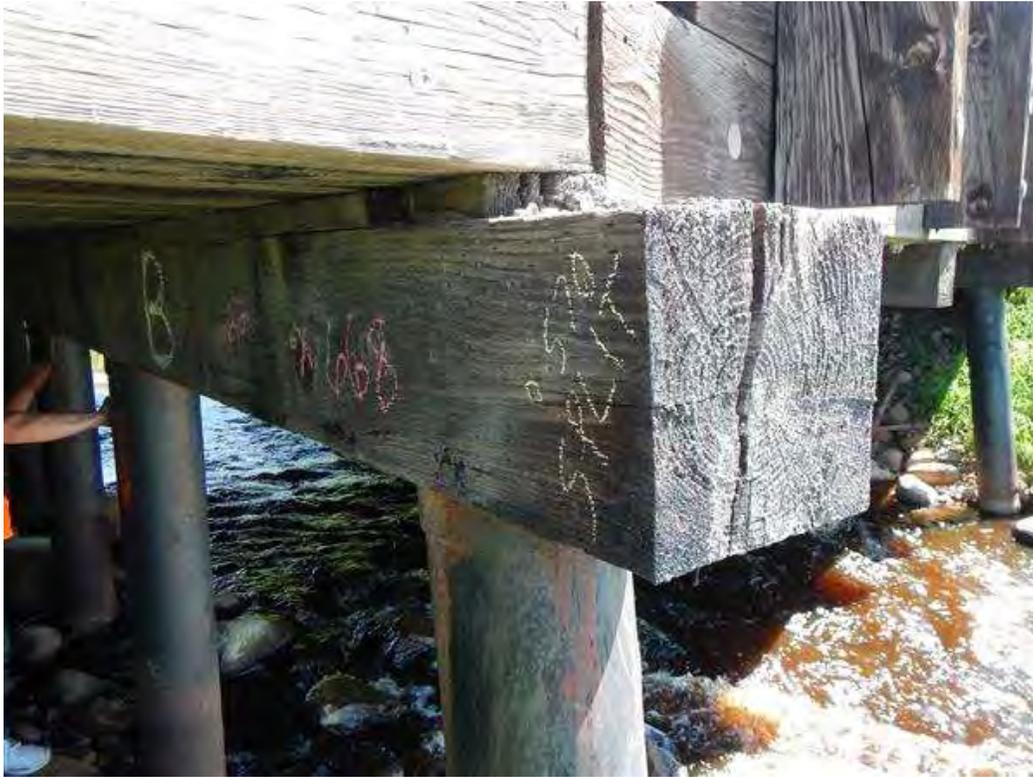
Photo 7 - Pier 1 - South End - Through split extending 36"

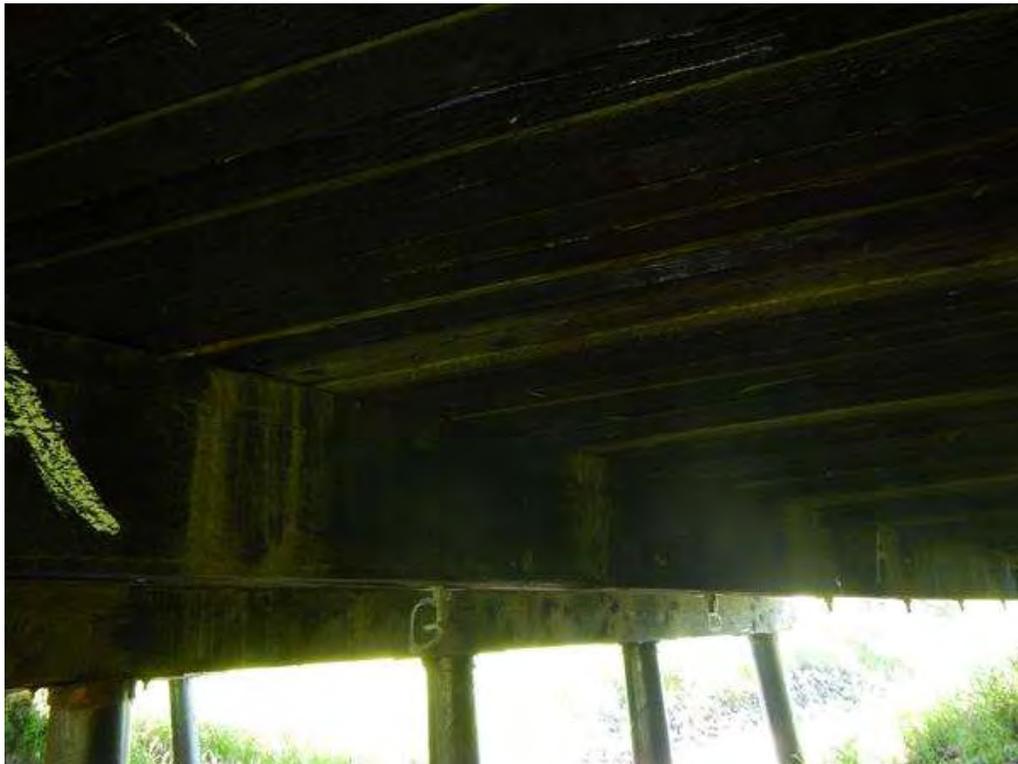
Photo 8 - Span 1 - Moisture pen. through deck.

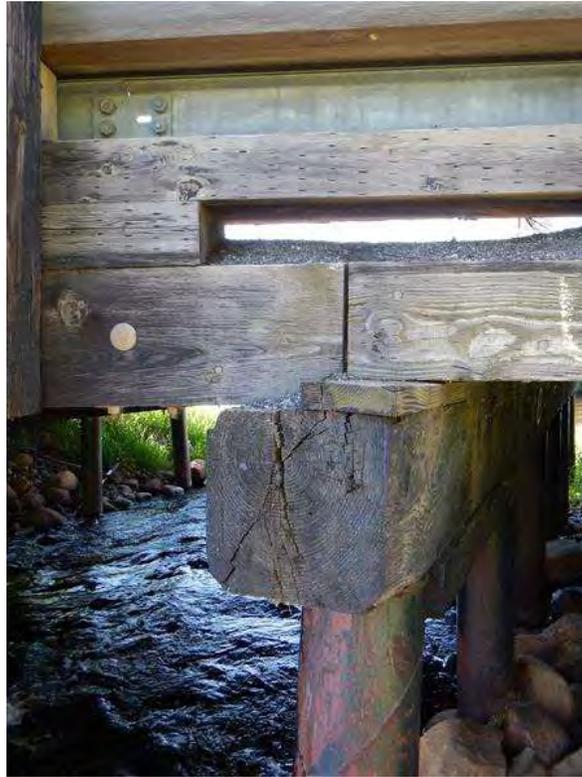
Photo 9 - Pier 2 - South end - Through split continuing 24 inches into cap.

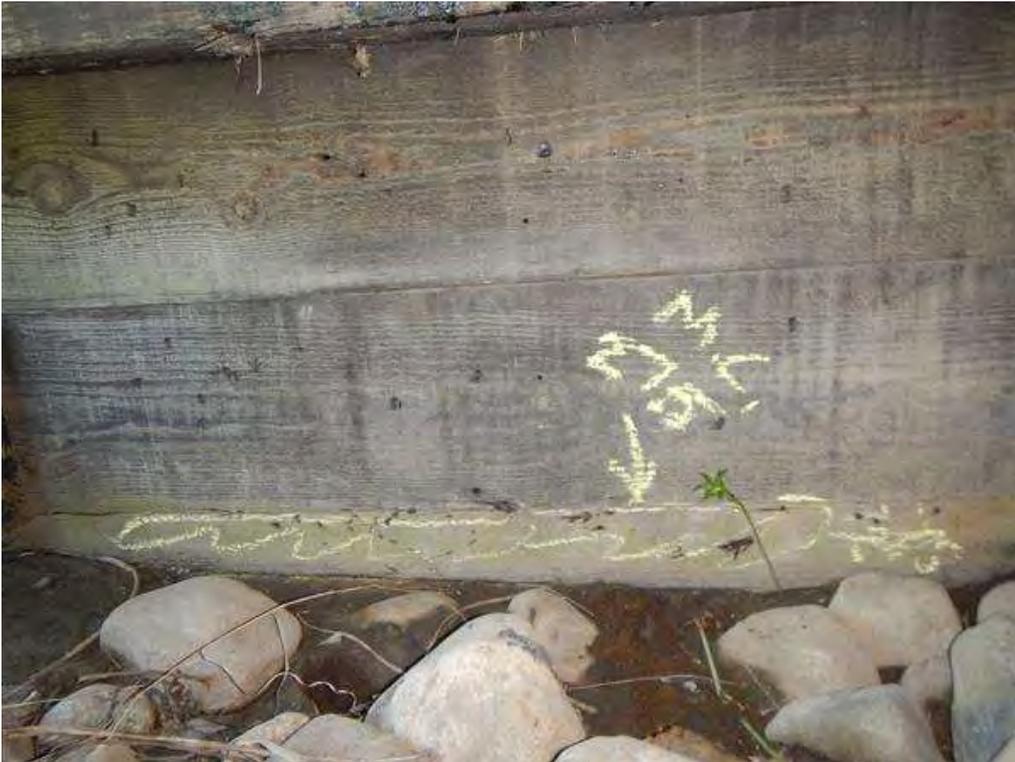
Photo 12 - High moisture abutment wall between piles 8 and 9. Moisture content over >25% but no decay present.

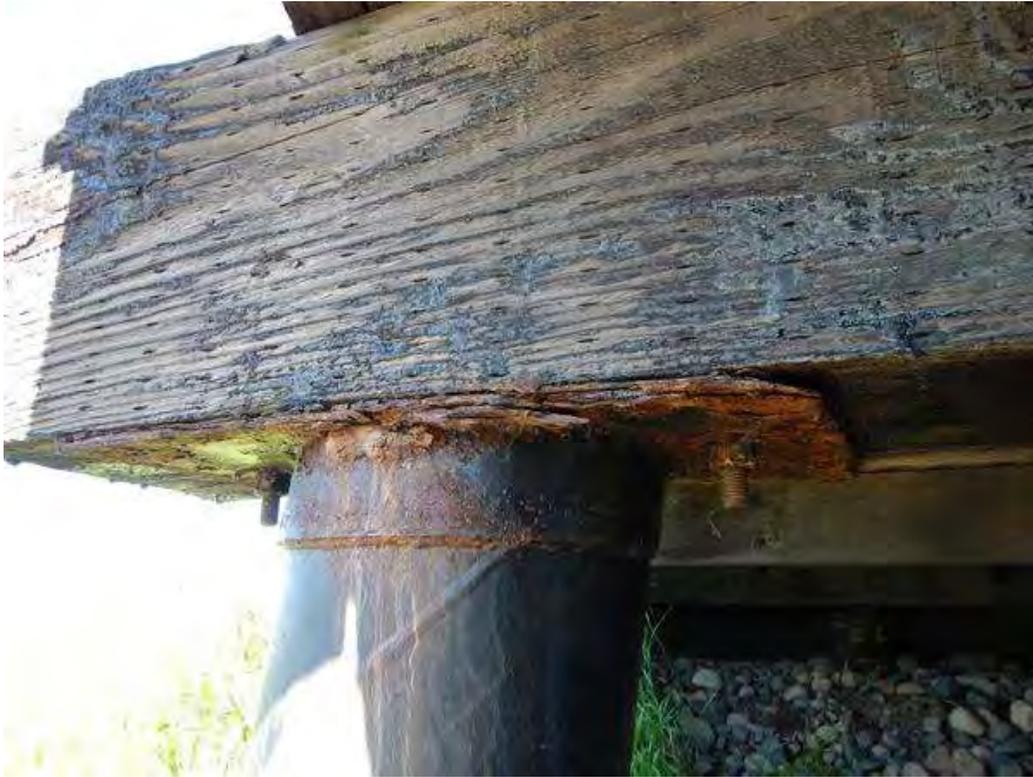
Photo 13 - Pier 1 -CIP cap plate rusting with section loss.

* Significant rust and deterioration of steel CIP plate. See photos.

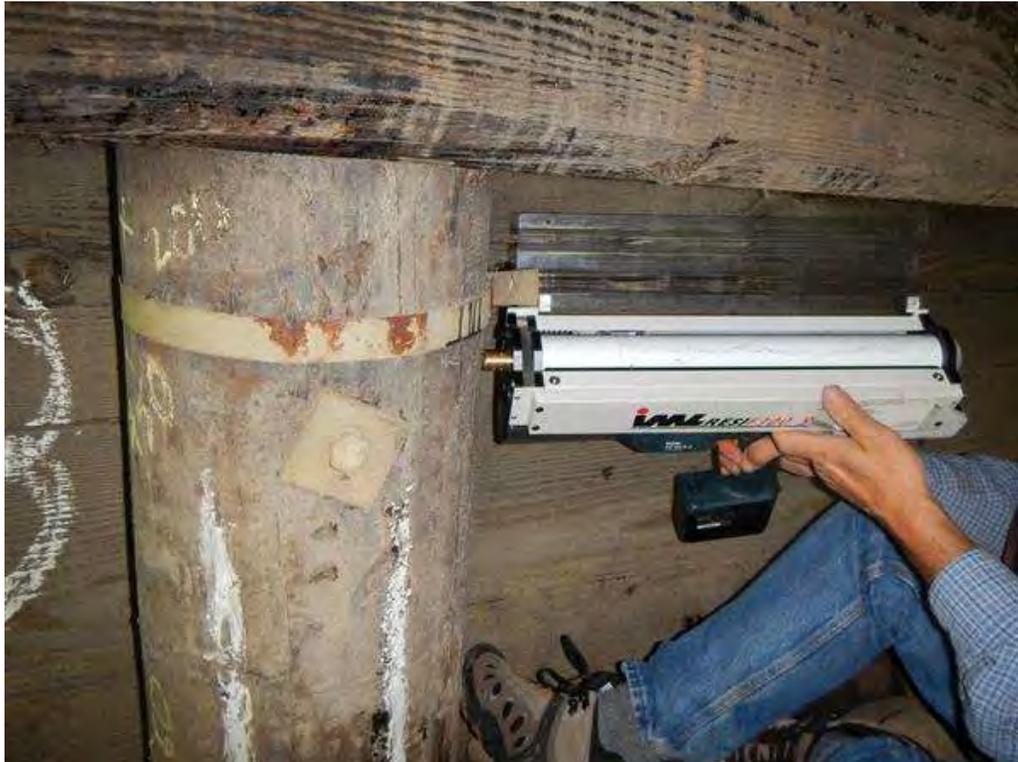
Photo 14 - E abut - Pile 11 - Sound condition

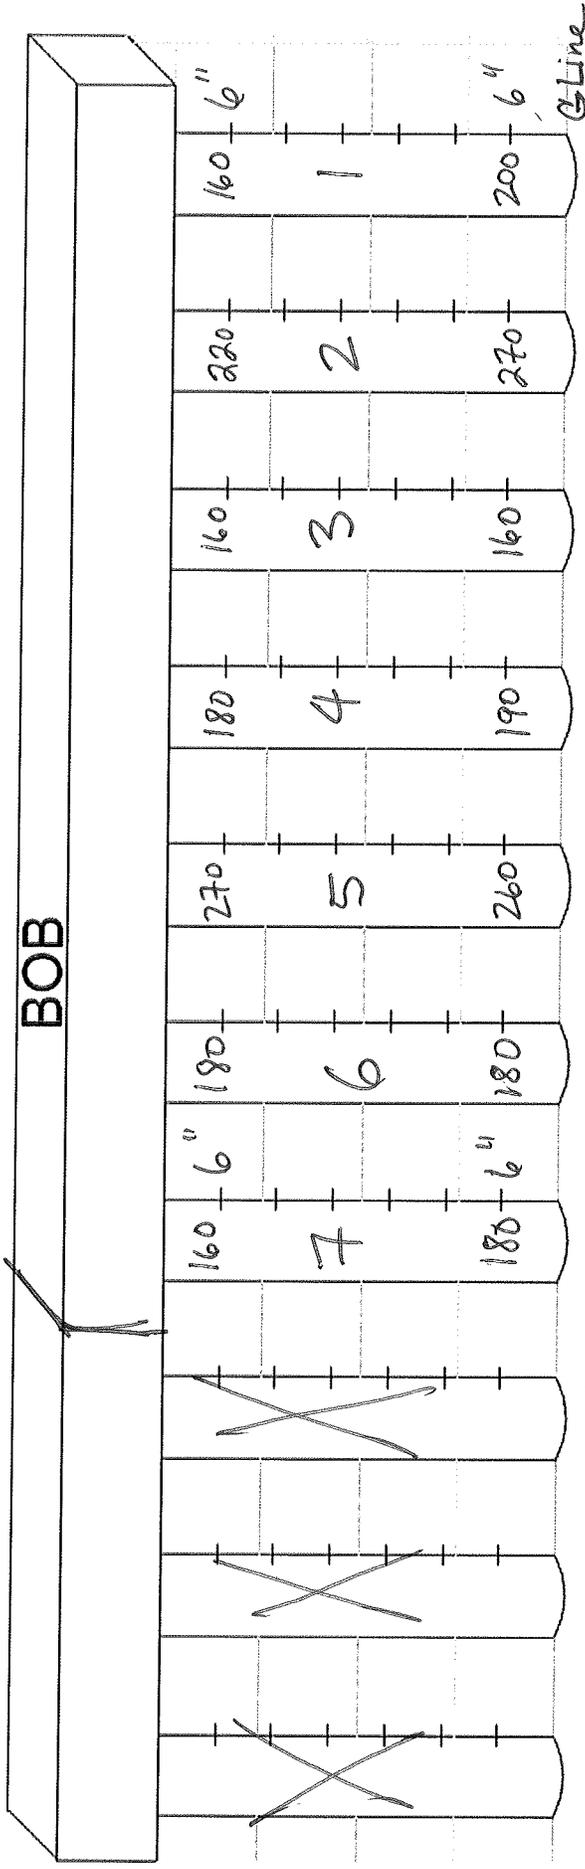
Notes: Timber pilings. Minimal surface checking. Stress wave timer shows good condition on all pilings. Full cross-section sound.

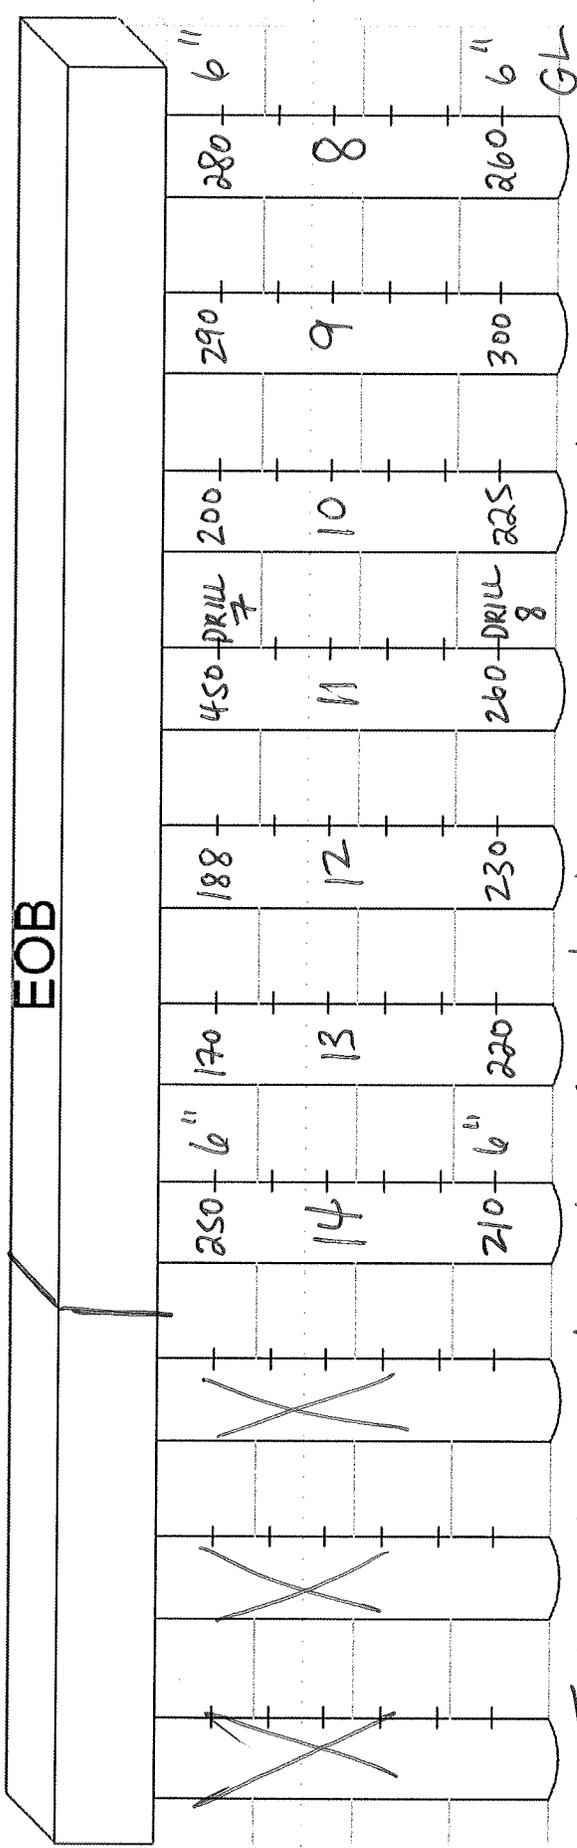
Notes: Timber pilings. Minimal surface checking. Stress wave timer on pile 11 affected by vertical crack/split. Resistance drill @ 460ms on pile 11 showed good condition.

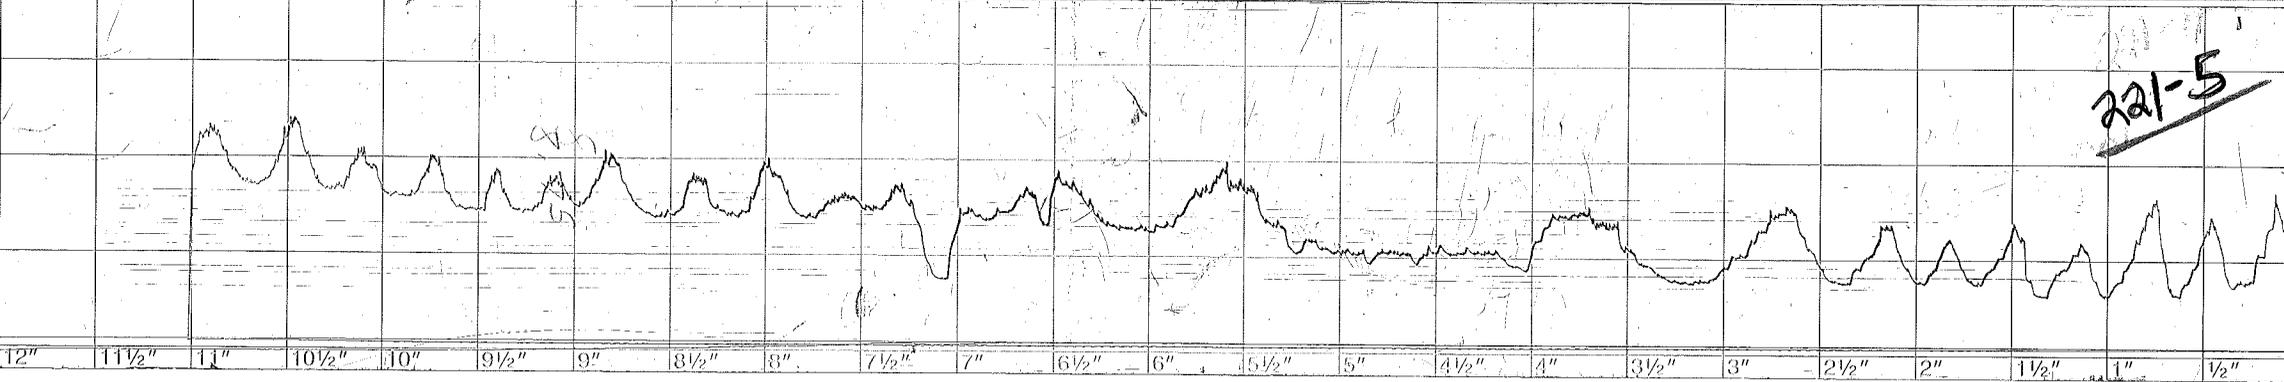
Name/Name: 830 us Pile Cap "B"
 Datum/Date: 16 8 from UP
 Nr./No.: Visual crack underside
 Bemerkung/Comment:
