Development and Integration of Advanced Timber Bridge Inspection Techniques for NBIS

January 2015

Research Project
Final Report 2015-01

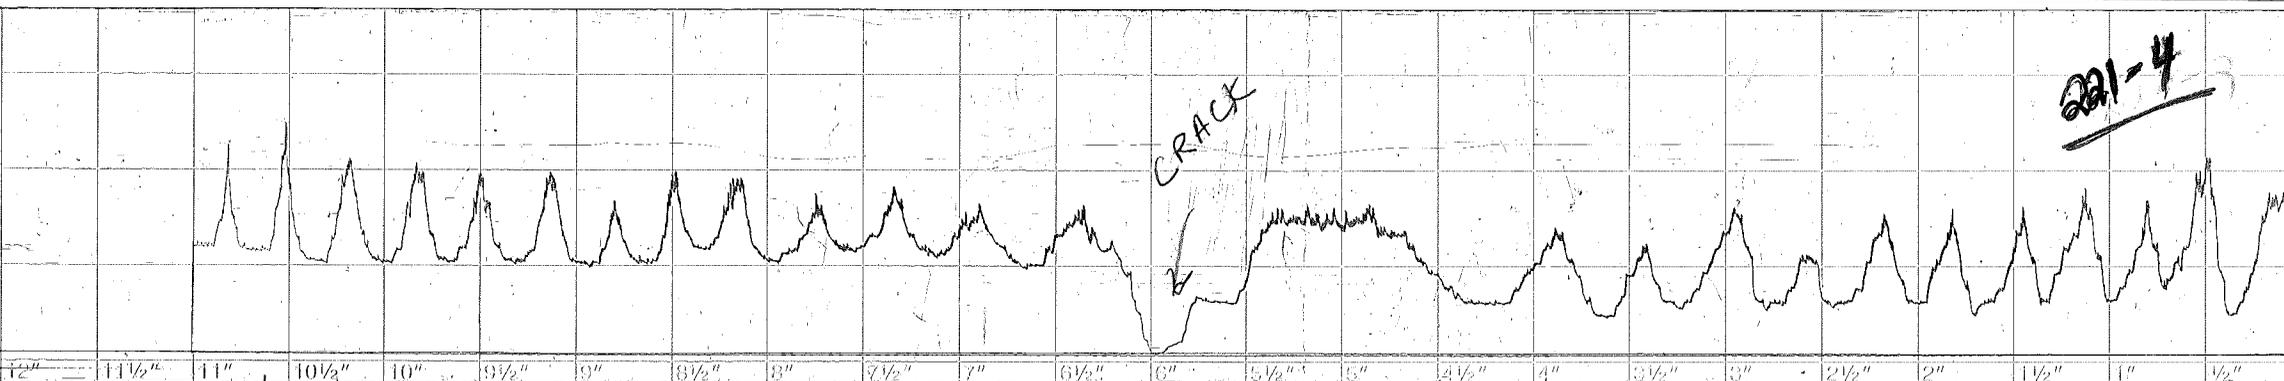
Name/Name: Bob Pile Cap "B"
 Datum/Date: Drilled at 7'3" from UP
 Nr./No.: Seems OK
 Bemerkung/Comment:

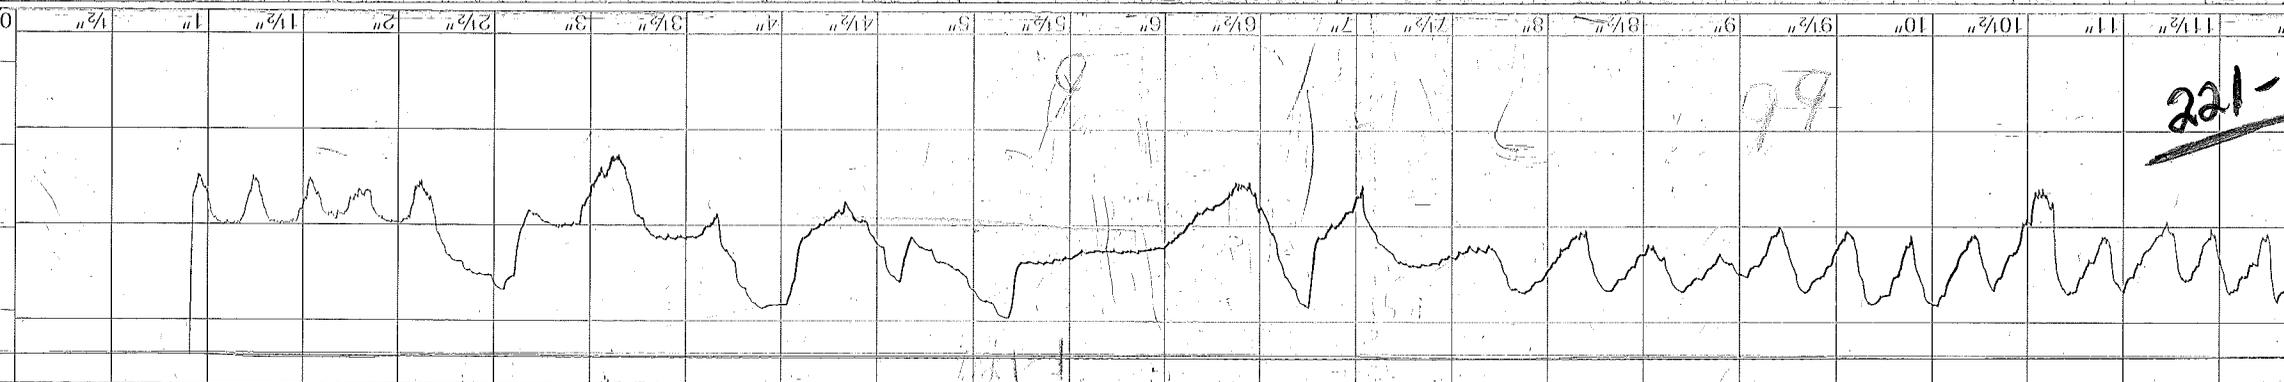
Name/Name: Beam B (Pile Cap)
 Datum/Date: 811 us
 Nr./No.: 811 us, seems to be large split caused more than decay
 Bemerkung/Comment: 1' 5" from UP
