Historic Features Report
for
Bridge 2440 Rehabilitation Design
(3rd Avenue Bridge), over the Mississippi River
Minneapolis, Hennepin County, Minnesota
S.P. 2710-47 (TH 65)

July 27, 2017

EXECUTIVE SUMMARY

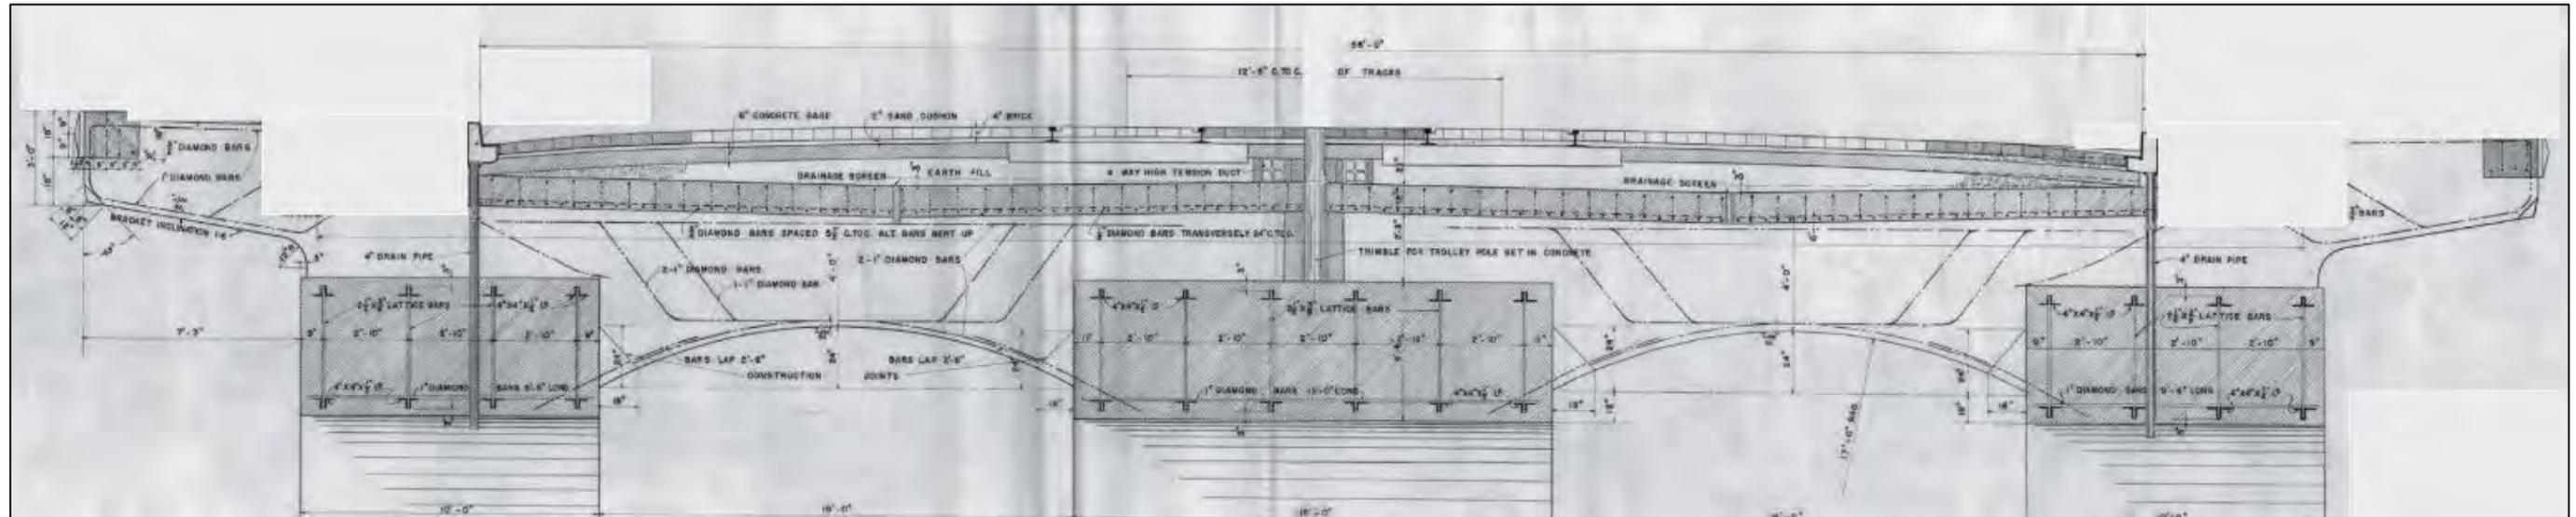
Figure 49. Removals during 1939 Rehabilitation

Removed concrete balustrade railing, curbing, and sidewalk.

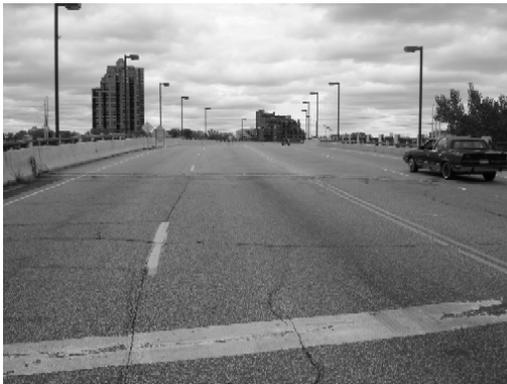
Figure 1. Looking north at the bridge from the south approach. The vehicle barriers are not symmetrical on the south end. A low profile barrier is provided on the east and a taller barrier is provided on the west. The approach roadway pavement is deteriorated and has extensive cracking.

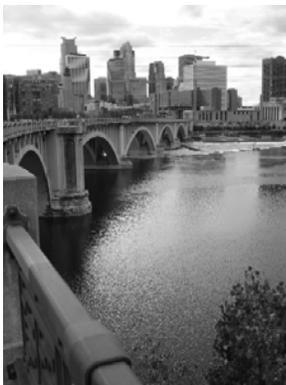
Figure 2. Looking south along the west side of the bridge from the west sidewalk. Stained, deteriorated concrete on the pier below the overlook is visible.

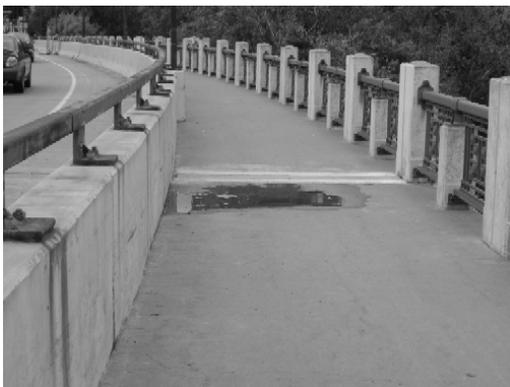
Figure 3. Looking north at the north end of the east sidewalk. Localized ponding adjacent to a reconstructed sidewalk expansion joint is visible. Staining on the vehicle barrier from the metal railing components and anchorages is typical.

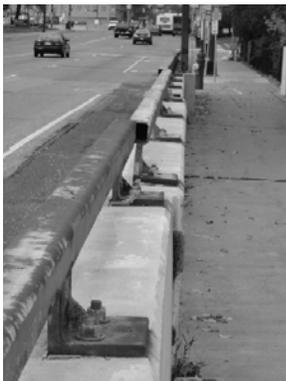
Figure 4. Looking north at the east vehicular railing on the north approach. Settlement has led to shifting of the barrier both vertically and laterally.

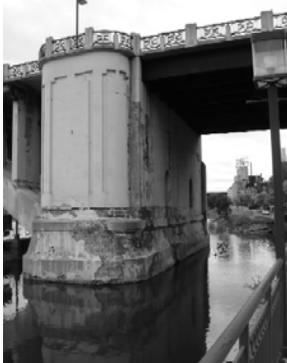
Figure 5. Looking east at the southernmost river pier. Deteriorated concrete is visible in many locations, primarily near the water line. The weathering steel beams supporting the south approach spans are also visible.

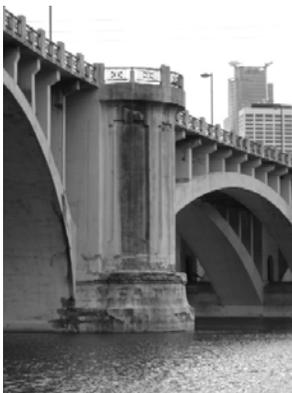
Figure 7. Staining and concrete spalls are visible on the north face of the west end of the pier between the barrel and rib arches.

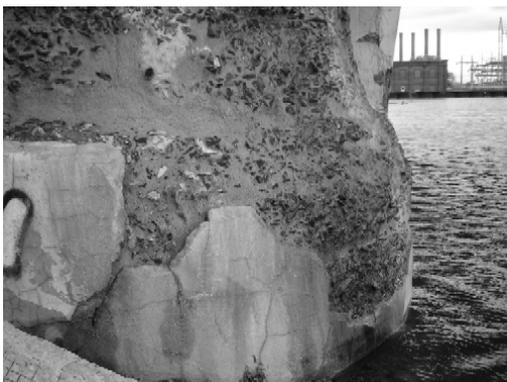
Figure 8. Looking east at the northernmost river pier. Shotcrete repairs to the pier have failed. Large spalled regions, with water draining out of the deteriorated area, were visible during the site visit.
