Bridge 2440

Third Avenue Bridge

Summary Engineering Report

March 5, 2015

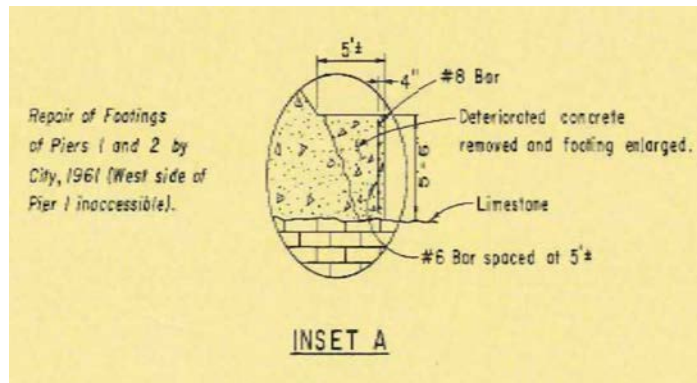
A repair detail from a 1961 maintenance operation responding to deteriorated concrete in the footings of Piers 1 and 2 was also included in the report (Figure 23). The suggested repairs indicate additional reinforced concrete may have been added to armor or protect the nose.

Figure 23: Pier 1 and 2 repair detail [2].

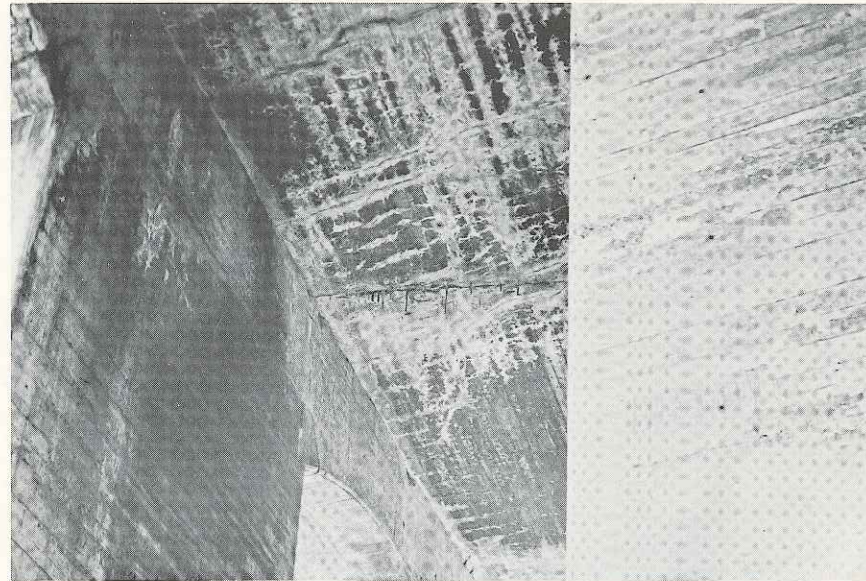
II-5. Patterned discoloration identifying scale on the underside of the deck.

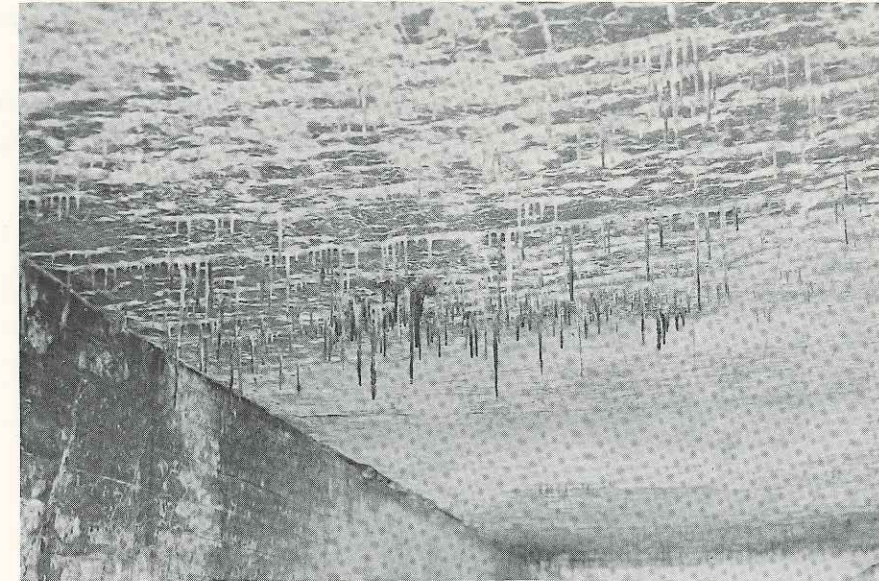
II-7. Stalactites on the underside of the deck.

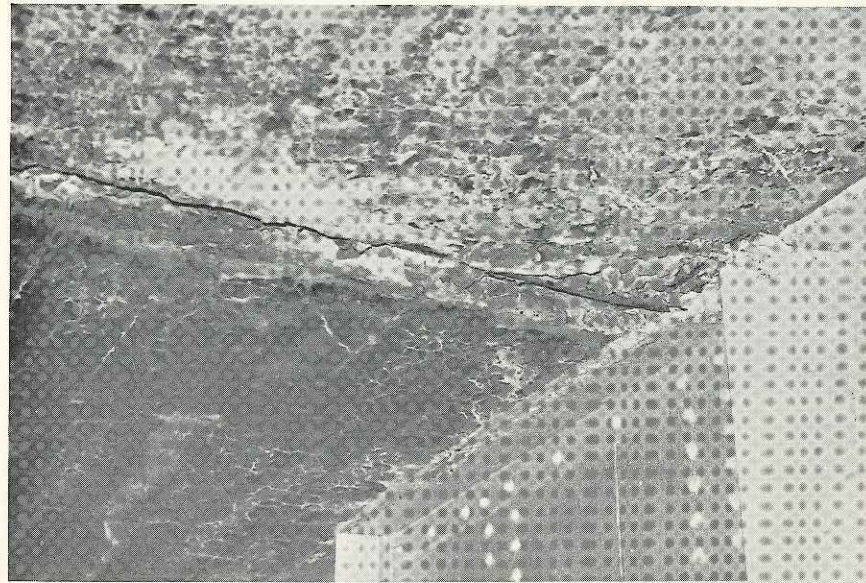
II-9. Deck expansion joint in Span 3.

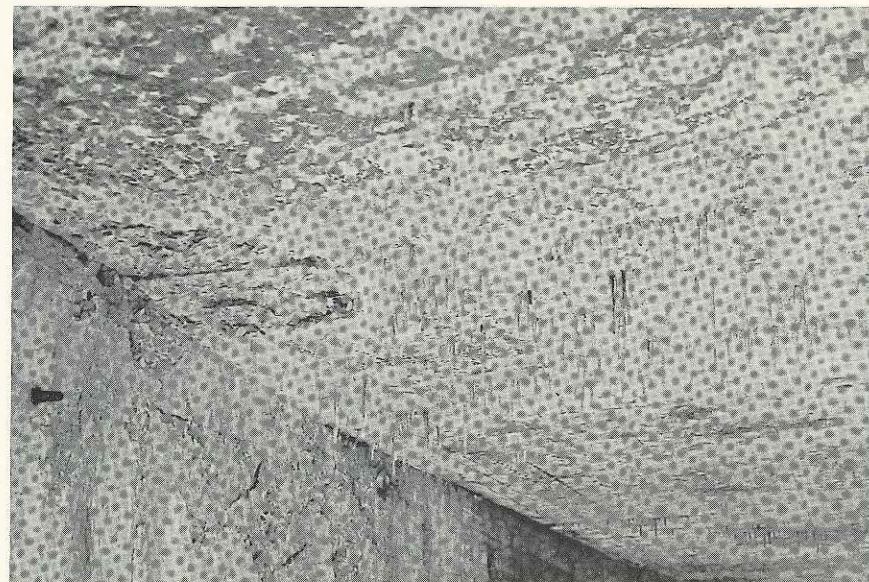
II-10. Well developed examples of scale, mineral deposits, and spall in Span 7.

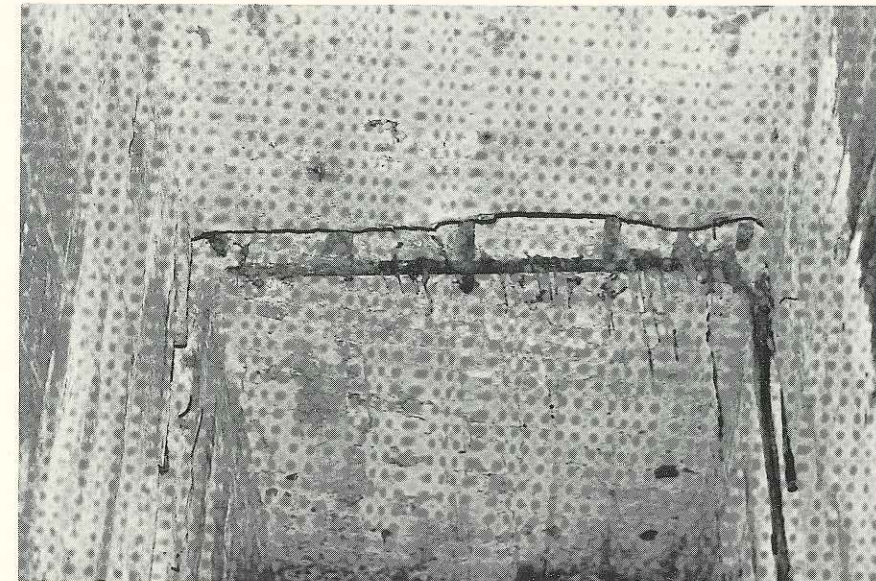
II-11. Spalled deck expansion joint and butt ends of T-beams at Bent 4.

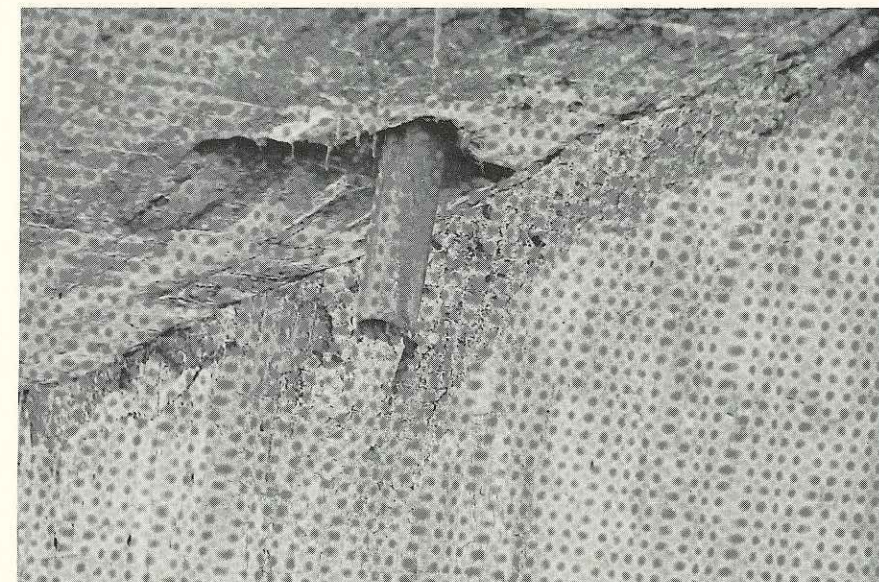
II-12. Spall at deck and spandrel column due to deteriorated floor drain.

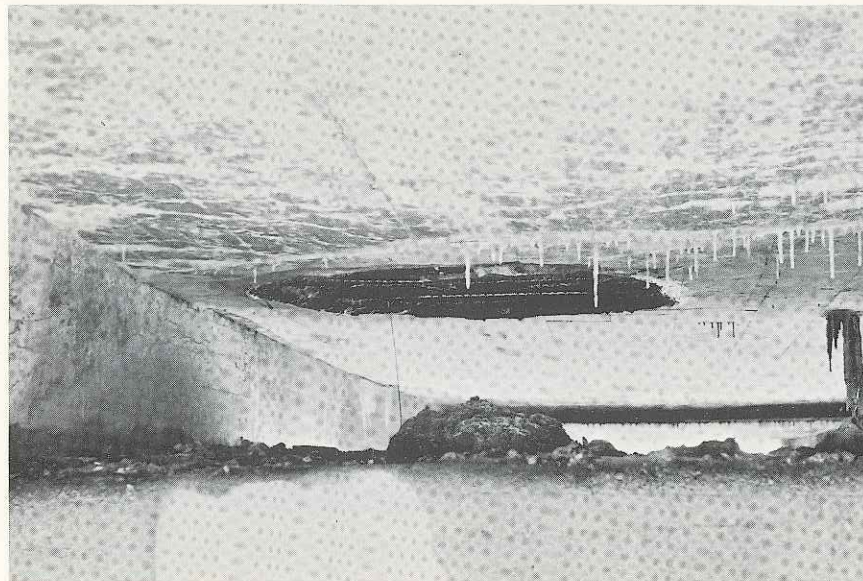
II-13. Spalled area of approximately 6 feet in diameter at floor drain.

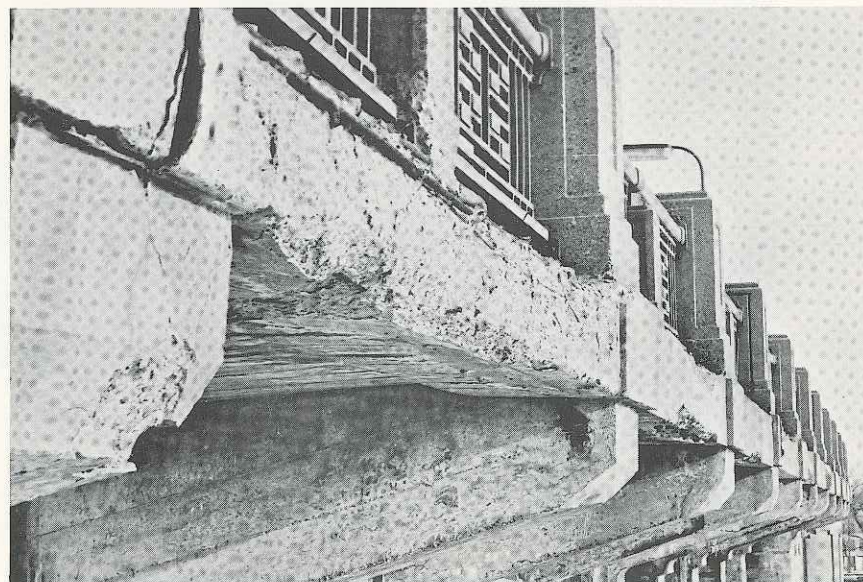
II-14. Areas of spall at the bridge railing posts, sidewalk deck, and spandrel cantilevers.

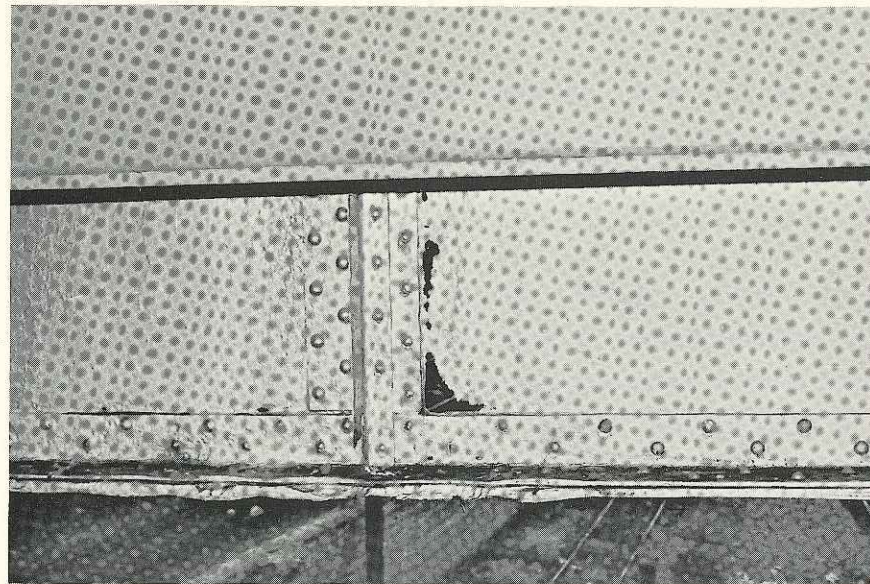
II-16. View of the rusted web and flange of Span 3 plate girder and the new 36WF230 adjacent to it.

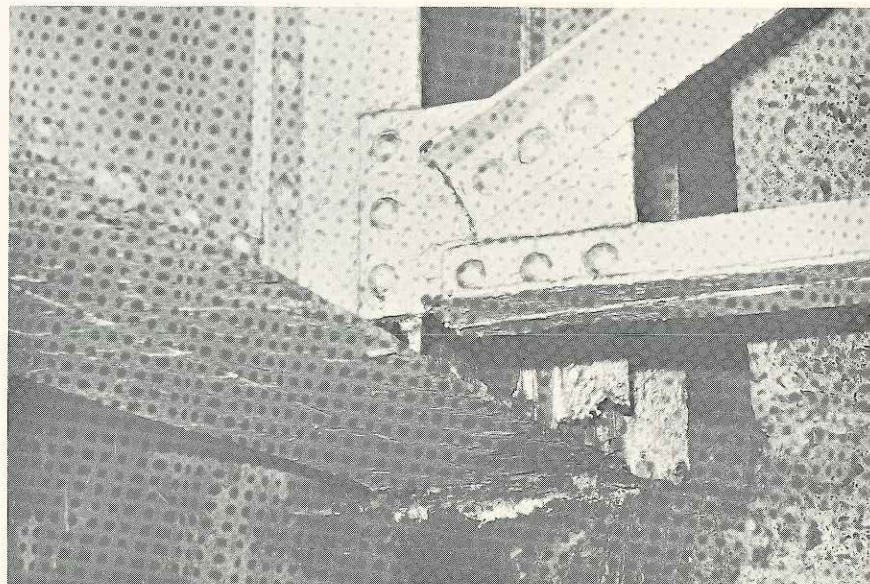
II-17. Rusted through bearing stiffener at Bent 2.

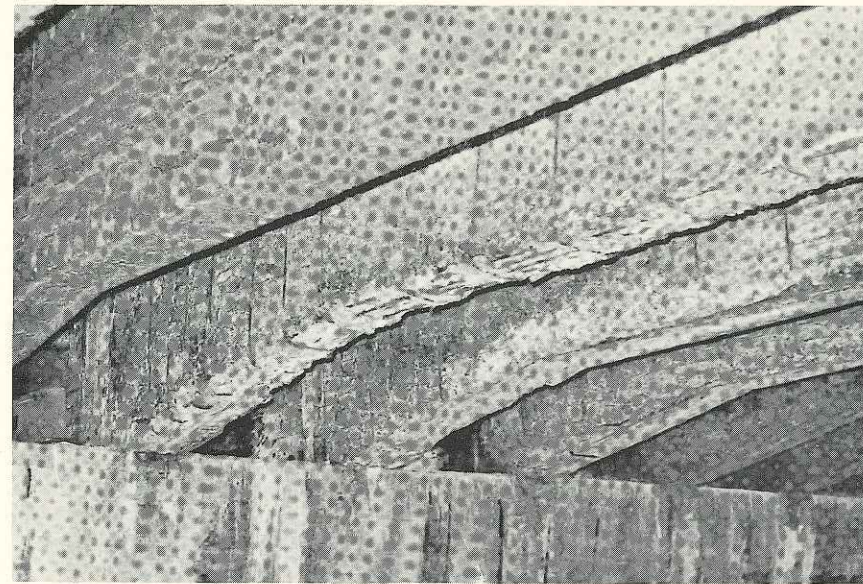
II-18. Bared stirrups and tensile reinforcement of the T-beams in Span 13.

A design analysis of the concrete girders indicates that nearly the entire tensile steel areas are necessary to carry the present loads. As the net steel section is reduced through deterioration to the state in which the bottom row of tensile steel is ineffective, the steel stress approaches twice the allowable stress.

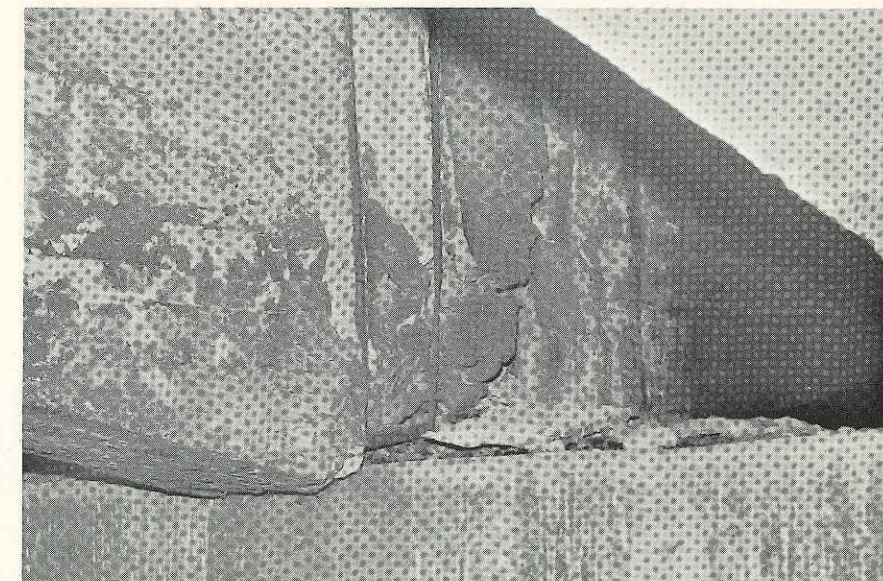
II-19. Crushed concrete at a beam haunch above Bent 5.

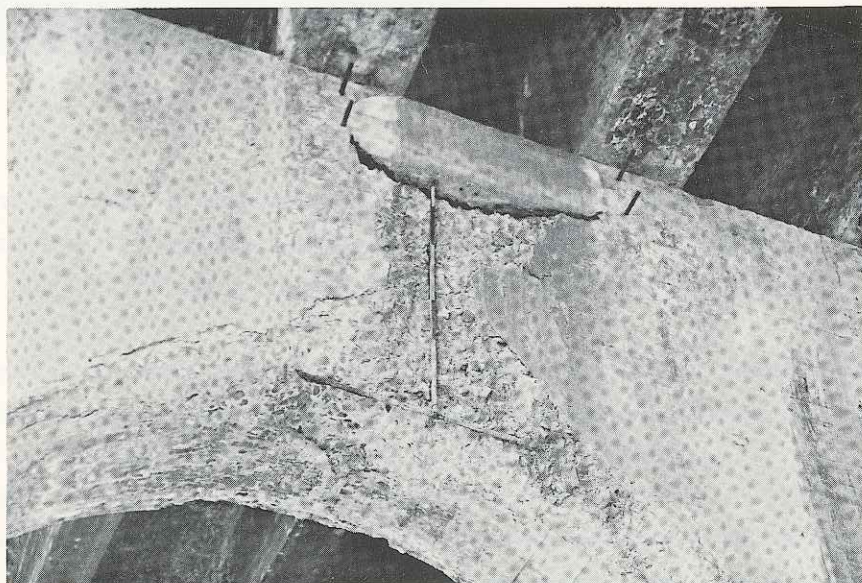
The surface deterioration of Bents 1, 2, 3, and 6 consists of areas of scale on the vertical surfaces and areas of severe spalling, exposing the reinforcement of the columns and cap beams. The cap beams of Bent 1, 2, 3, and 6 have diagonal cracks that are radial to the arches of the cap beams and have completely penetrated the beam. Examples of the above are shown in Photos II-20 and II-21.

II-20. Spalled area of Bent 6.

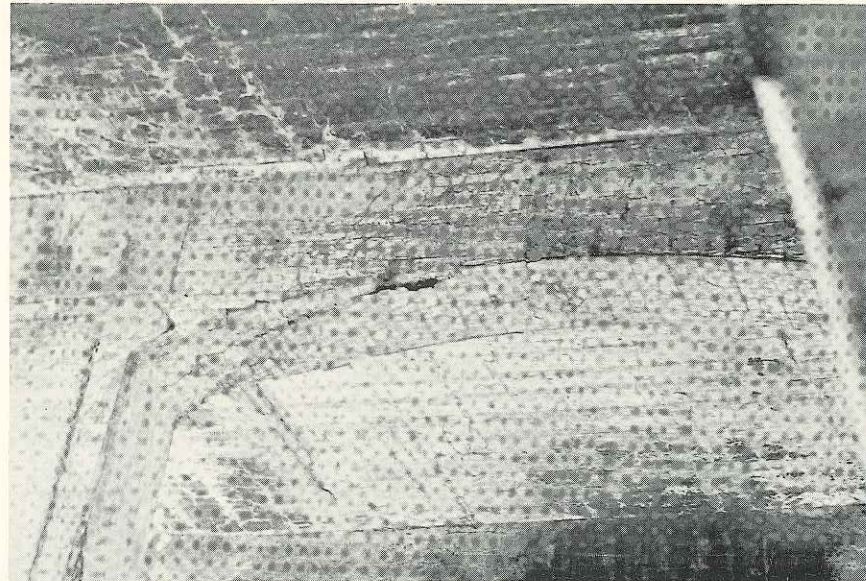
Water, seeping through the deck, the expansion joints and over the outer edge of the sidewalks, has caused considerable deterioration to the upper portion of many spandrel columns and walls. Approximately one-third of the columns above the ribbed arches have areas of mineral deposits and spall on the cap beams and the upper three feet of the columns. The lower portion of the columns have some areas of light spalling that do not impair the structural capacity of the column. See Photos II-22 and II-23, for typical examples. About one-third of the tall spandrel walls above the barrel arches have numerous vertical cracks, usually the length of the column and completely penetrating it. The short walls have well developed mineral deposits from the deck to the back of the barrel arch and the cantilevers have areas of spall under the deck; see Photo II-24.

II-22. Typical examples of deterioration to the cap-beam portion of spandrel columns.

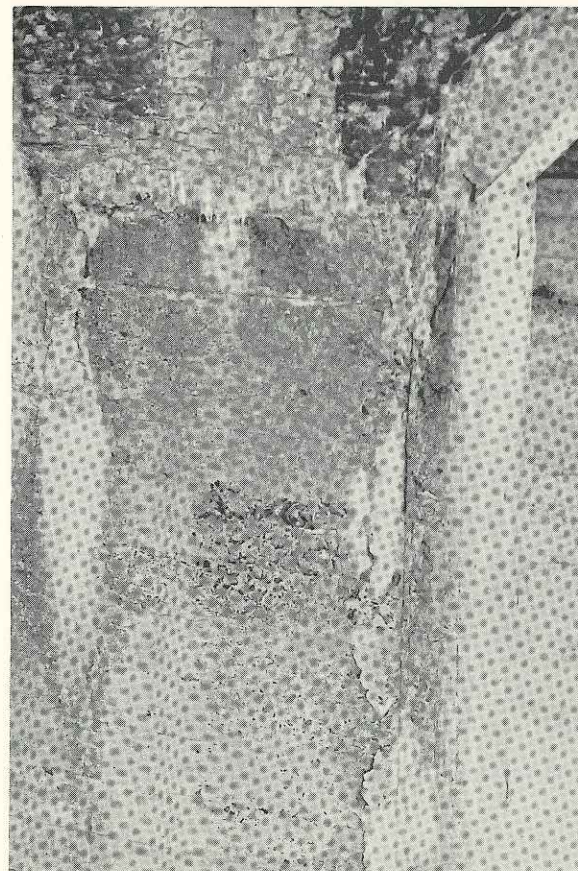
II-23. Mineral deposits and bared reinforcement at the column of a spandrel column in Span 9.

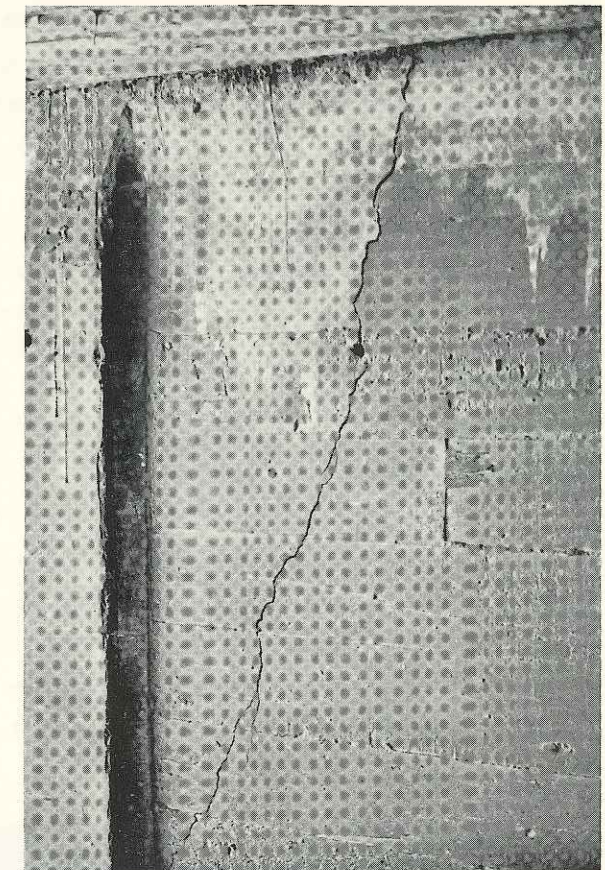
II-24. Nearly vertical crack in a spandrel wall of Span 11.

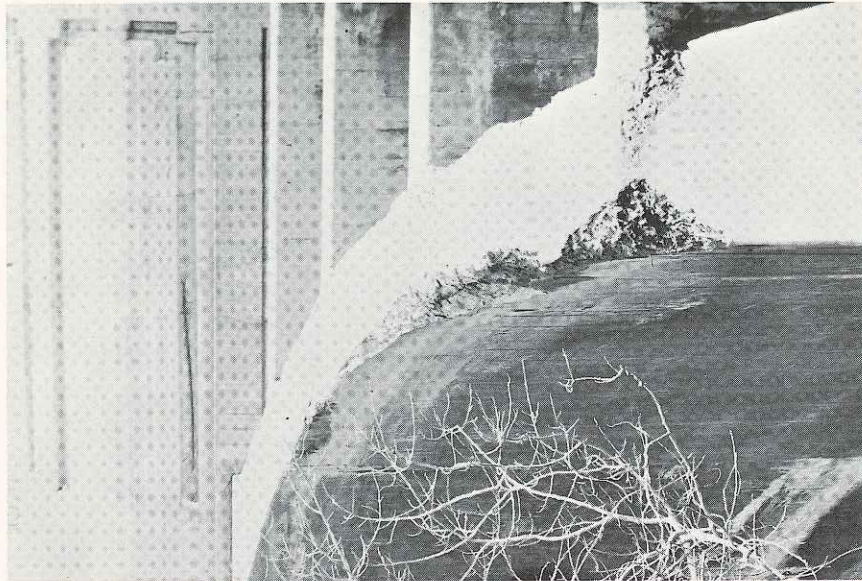
II-25. Surface spalling along the edge of the Span 10 barrel arch.

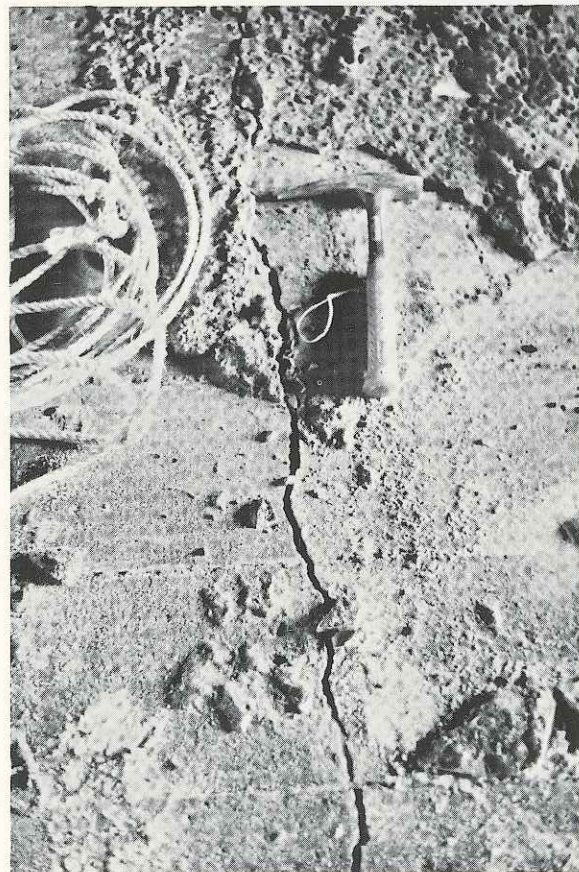
II-26. Longitudinal crack through the barrel arch of Span 10.

The hairline cracks in the arch ribs are commonly associated with shrinkage and/or creep and indicate no loss of structural integrity; test results of the corings bear this out. The longitudinal cracks in the barrel arches, which incidently often propagate into the spandrel walls, are believed to be caused by temperature. Since they are parallel to the principal stresses in the arch, they do not reduce the load carrying capacity of the arch. The two transverse cracks are believed to be the result of loss of bond between concrete pours; since their width is small compared to the width of the arch, they do not weaken the arch to any measurable degree.

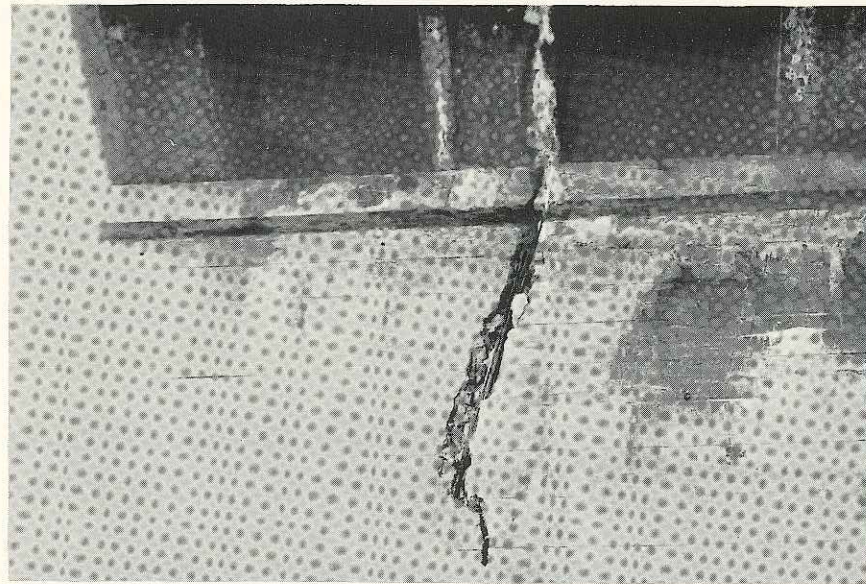
II-27. Wide vertical crack near the upstream edge of the north abutment.

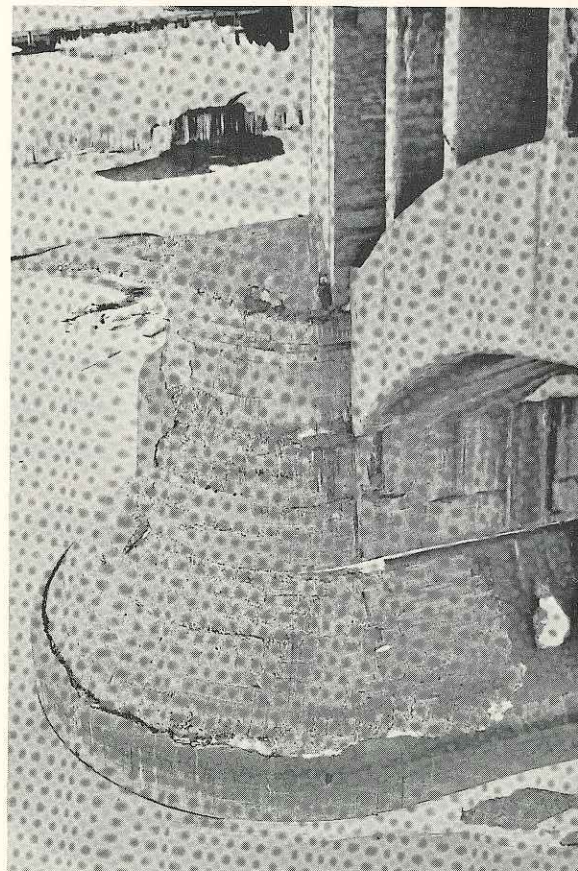
II-28. Surface spalling at the downstream face of Pier 3.

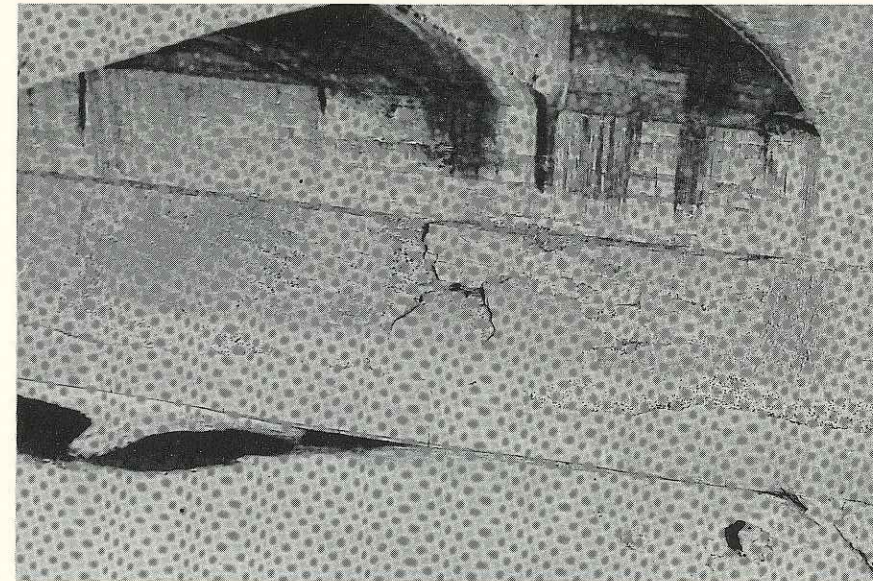
Pier 4, as seen in Photo II-29, has an area of more severe deterioration but the reinforcement is not bared and thus presents no repair problem.

II-29. Deterioration to the south wall of Pier 4.

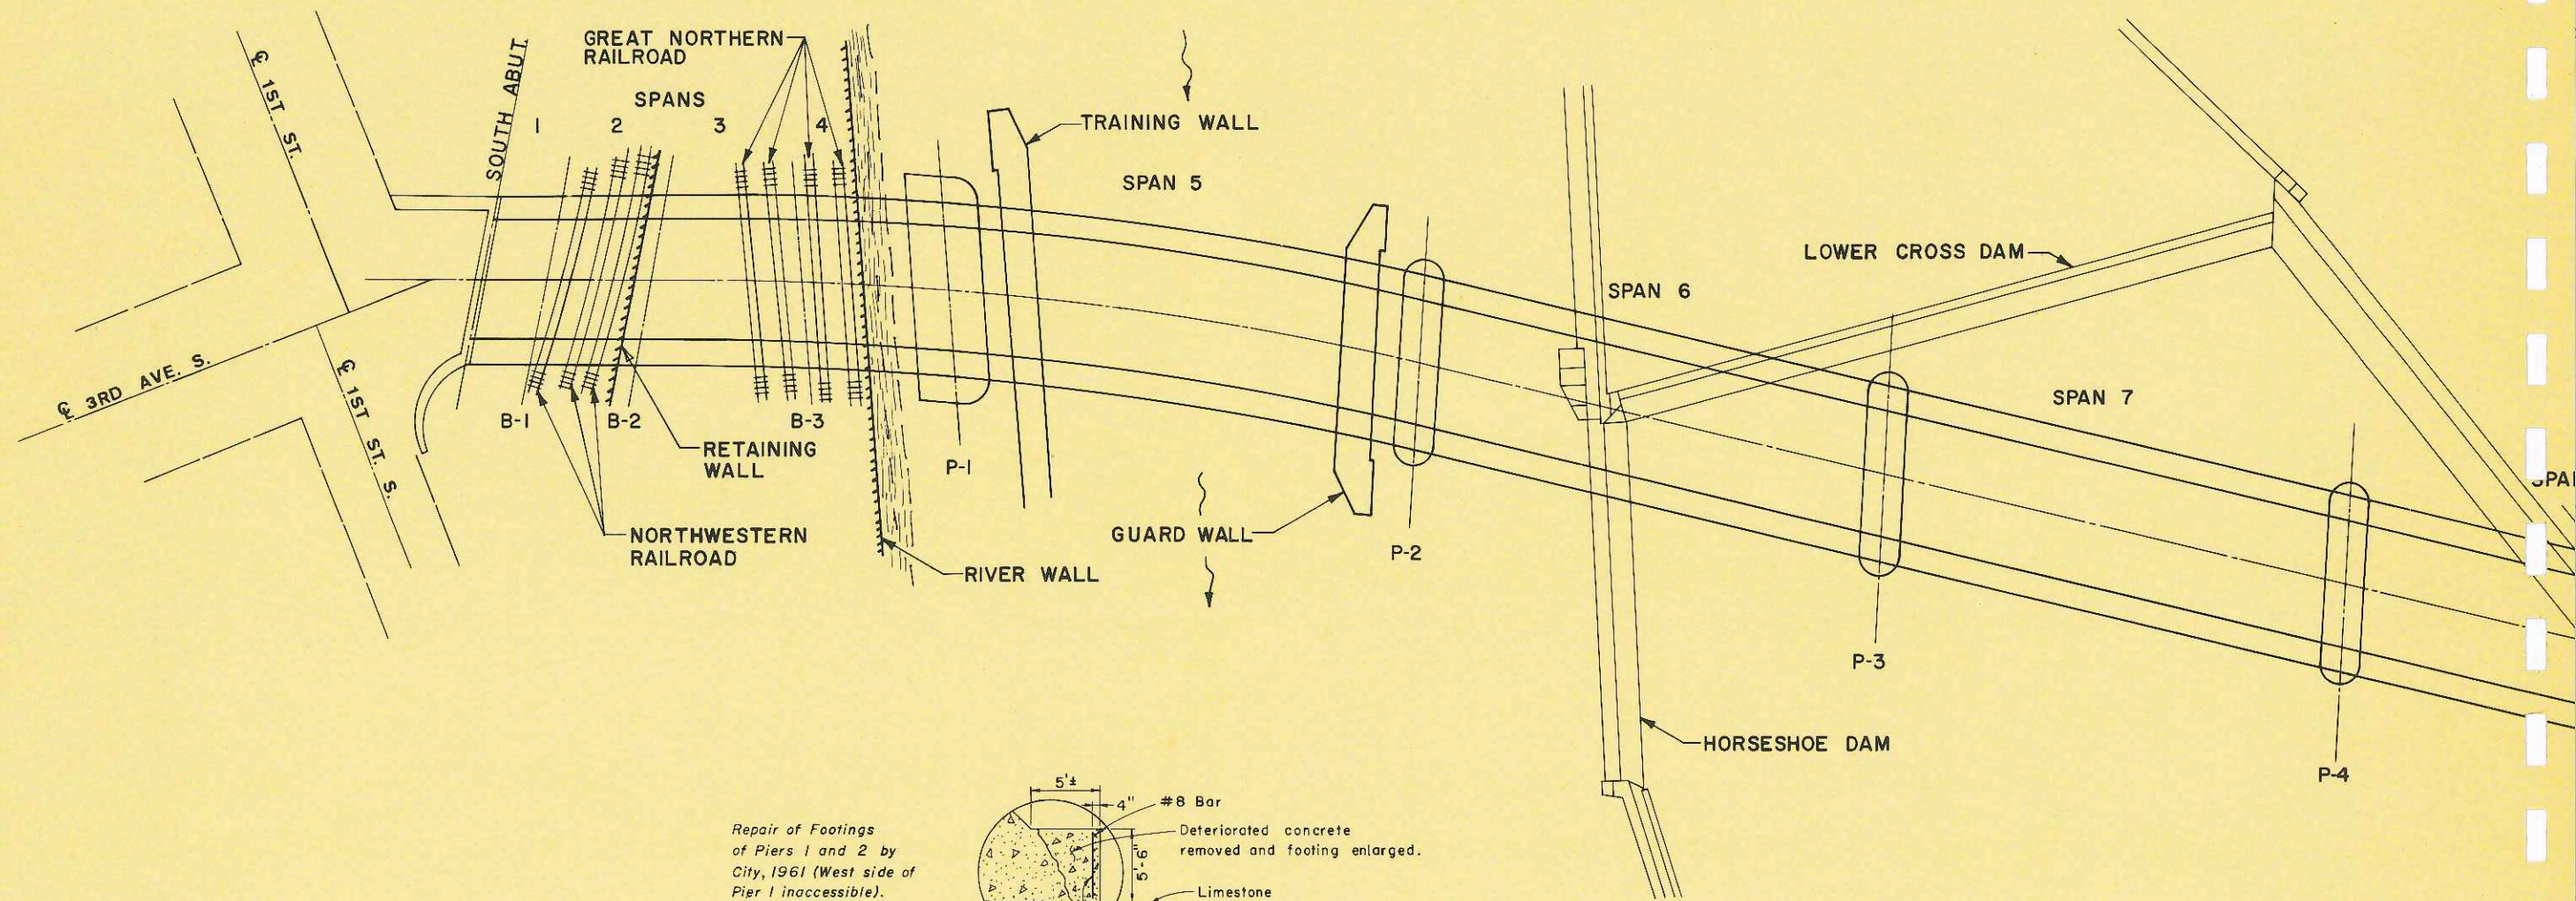
Repair of Footings of Piers 1 and 2 by City, 1961 (West side of Pier 1 inaccessible).

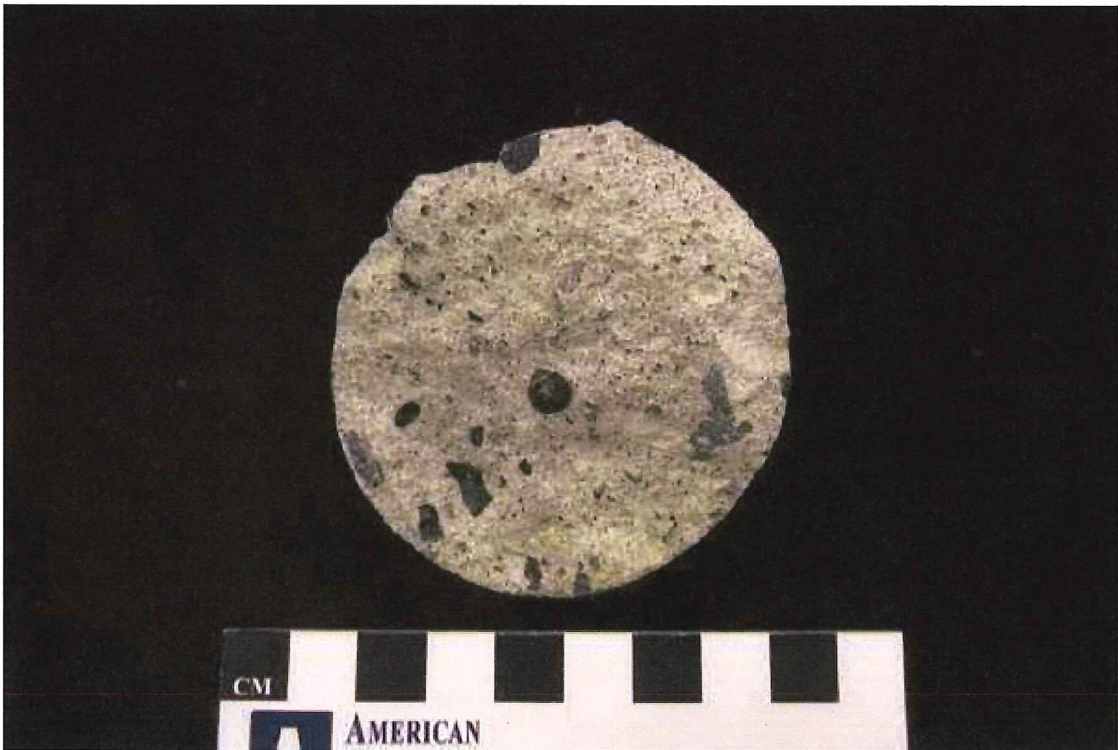
PHOTO: 2

SAMPLE ID: B1 DESCRIPTION: Fractured end surface of core sample.

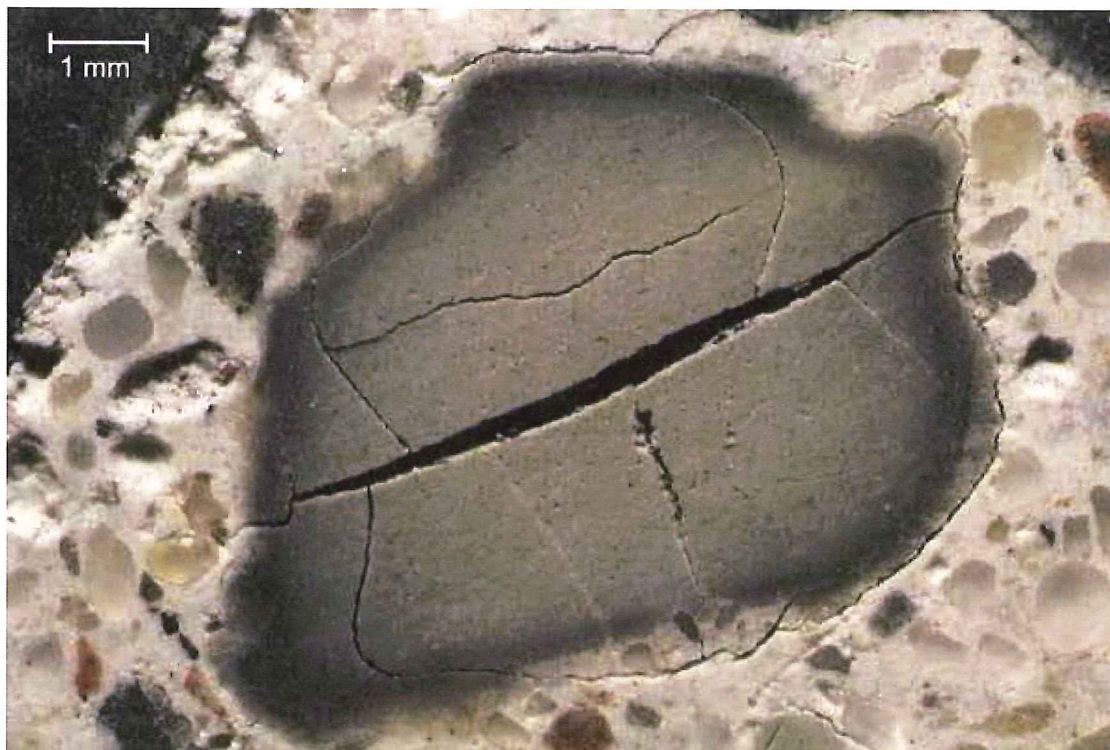
PHOTO: 8

SAMPLE ID: B1
MAG: 30x DESCRIPTION: A shale fine aggregate particle that exhibits internal cracking and cracking propagating into the paste.

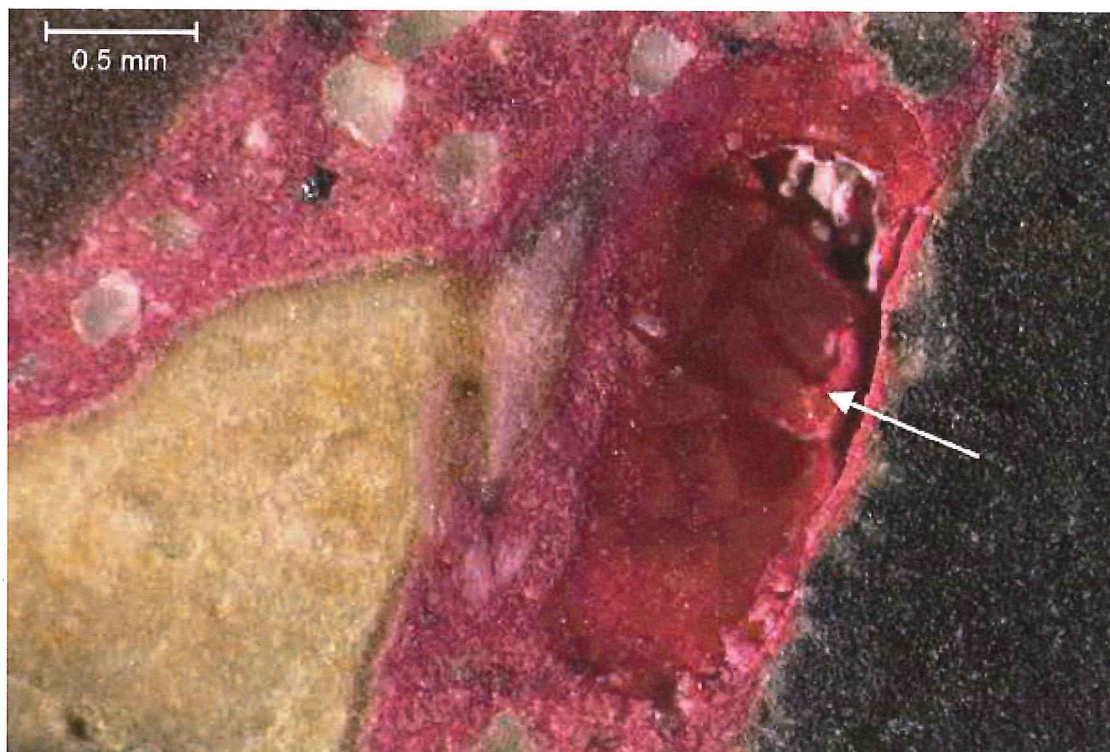
PHOTO: 9

The petrographic analysis of the concrete sample indicated good overall concrete however the concrete was not air entrained and the coarse aggregate was large. The concrete had some crystalline deposits suggesting water movement through the concrete and there were also a few alkali silica reactive quartzite particles, both of these conditions were considered minor and innocuous.

SAMPLE ID: B1
MAG: 75x DESCRIPTION: Alkali-silica gel partially filling an air void (white arrow) proximate to a reactive quartzite gravel particle.

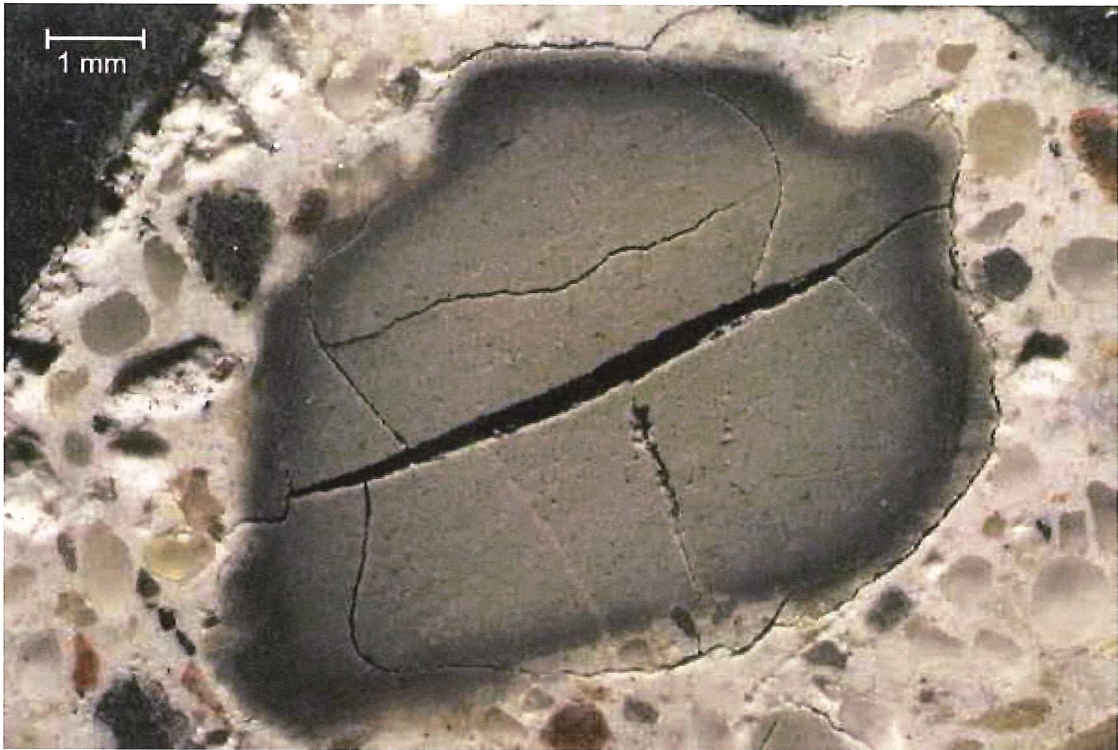
PHOTO: 8

SAMPLE ID: B1
MAG: 30x DESCRIPTION: A shale fine aggregate particle that exhibits internal cracking and cracking propagating into the paste.

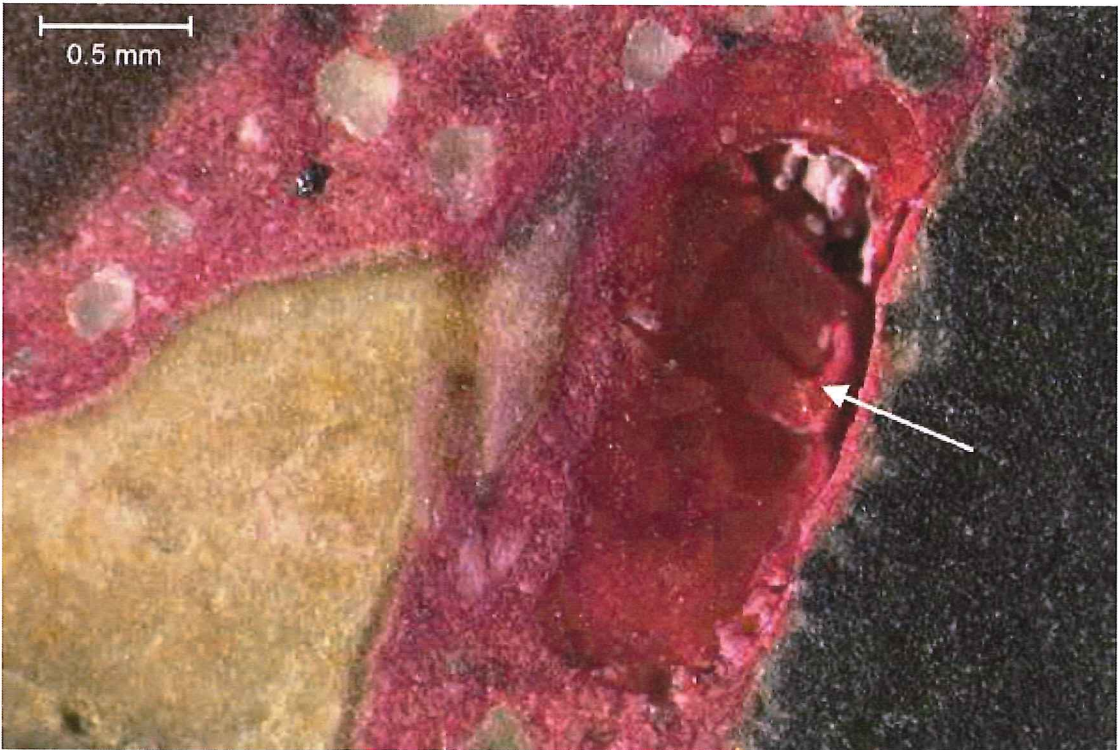
PHOTO: 9

SAMPLE ID: B1
MAG: 75x DESCRIPTION: Alkali-silica gel partially filling an air void (white arrow) proximate to a reactive quartzite gravel particle.

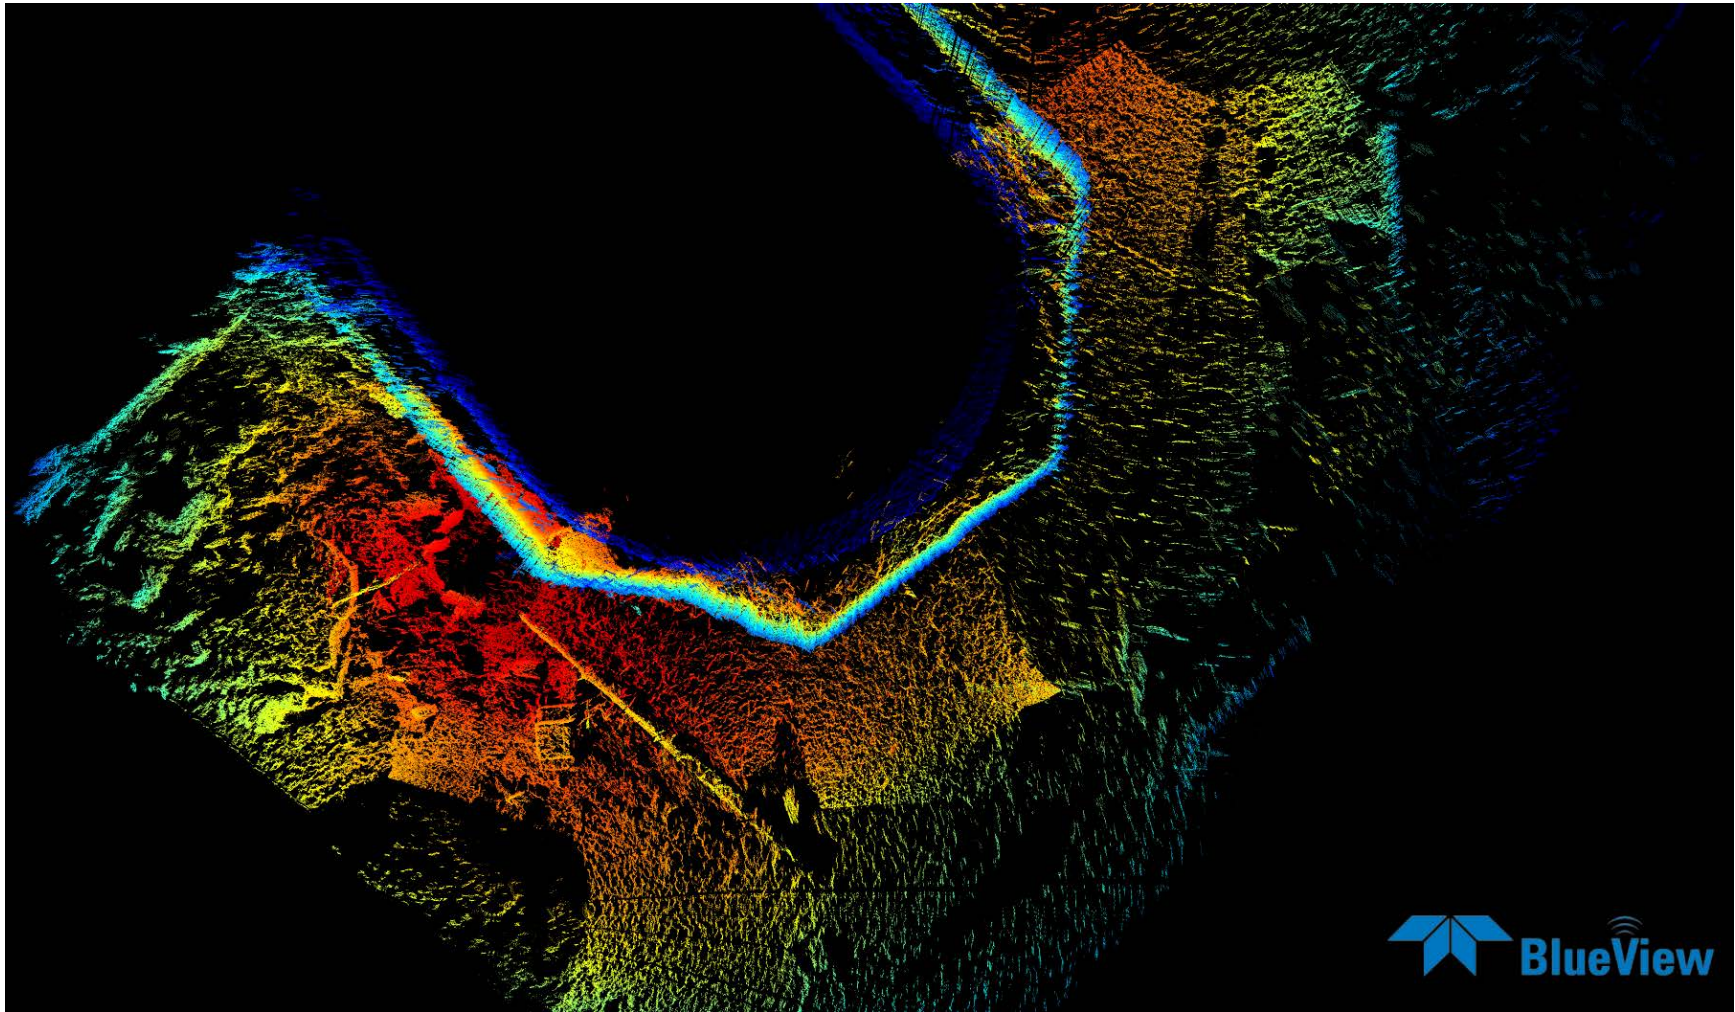
Based on the information available at the time of this report the deterioration in the footing of Pier 5 is most likely due to sediment at the bottom of the cofferdam that was not adequately removed prior to placement of the concrete footing seal. A layer or “ribbon” of sediment could have been left on the limestone bedrock. Timbers, used to support the cofferdam, may have also been left in place creating further potential for

future voids. A thin “shell” of concrete may have then encapsulated the defect which was gradually washed away over the years leaving a cavity. Available records indicate that Pier 5 was not completely dewatered when the concrete seal was cast [4]. It was also excavated primarily with an orange peel bucket and the rock in the cofferdam was cleaned by divers with water jets. This method would have removed large portions of sediment and debris but left considerable amounts behind.

Figure 25: Concrete void in Pier 5.

Based on the available information, it is the author's recommendation that the damaged area be encapsulated with reinforced concrete and that the void be cleaned and pressure grouted. The work could be performed with a cofferdam or underwater with divers. However, based on the difficulty, cost, and risks associated with installation of a cofferdam, performing the work underwater is recommended. This may require some special construction quality control procedures.
