**Re: Bridge No. 2440 Rehabilitation Dive Inspection Summary for 2015**

AMI Project # 141122

Minnesota Department of Transportation  
 Bridge No # 2440  
 Dive Inspection  
 Saint Paul, Minnesota

General Plan & Section Details

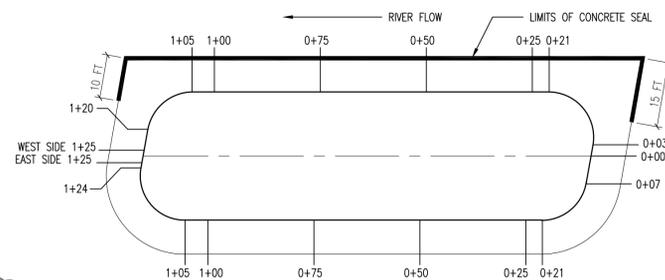
1 2 PIER 1 SECTION  
S1.0 SCALE: 1" = 20'-0"

The rehabilitation of the deteriorated concrete near the mudline was completed during the 2015 construction season. Before the start of construction, areas of soft concrete was documented at the base of the pier, so the limits of the concrete removal and the required number of horizontal dowels were changed depending on the void height and penetration. Originally, the plans had two horizontal dowels epoxied into the vertical face of the concrete pier at 4'-0" on-center. But if the height of the void exceeded 3'-0" and the penetration of the void exceeded 1'-0", an additional horizontal dowel was to be installed at 2'-0" on-center. The revised details also limited the removal of the soft concrete to 3'-0" horizontally. See revised sheet No 5 of the MnDot plan set in the attached documents for additional details. During AMI's inspection, the additional dowels at 2'-0" on-center were not installed yet. Also, the spacing of the typical dowels exceeded the 4'-0" max spacing by 2" at one location on the south side of the pier.

After the contractor installed the concrete seal at the base of the pier, AMI inspected the bottom seal for voids, areas of concrete washout, or areas of soft concrete. One area of soft concrete was documented at station 0+67 on the west side of the pier. The area of soft concrete was approximately 2'-0" in diameter with a maximum depth of  $\frac{3}{4}$ " to 1". The concrete in this area was slightly above the top of the permanent concrete forms and did not extend below the top of the forms.

During the 2014 construction season, AMI documented an area of concrete washout which exposed some of the newly installed rebar at station 0+35 on the west side of the pier. The contractor installed a small form around this area and placed additional concrete to fill the void. AMI re-inspected this area after the smaller form has been removed and found no deficiencies.

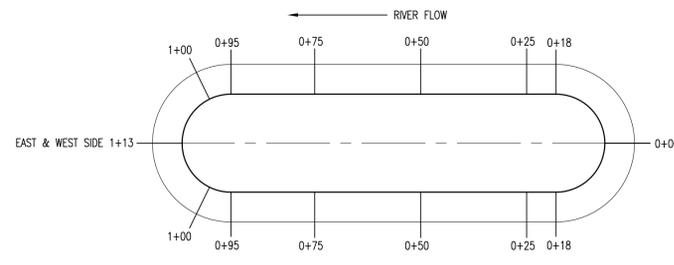
3 PIER 2 SECTION  
S1.0 SCALE: 1" = 20'-0"

Bridge pier #2 was located directly to the east of pier #1. The required concrete rehabilitation for pier #2 was similar to pier #1 but the construction documents only required that vertical concrete face near the waterline be rehabilitated. During AMI's last site visit in 2014, the concrete forms were still present on the downstream half of the pier, so AMI was unable to inspect the new concrete in these areas. With the concrete forms now removed, AMI inspected the remaining portions of the pier and no deficiencies were documented.

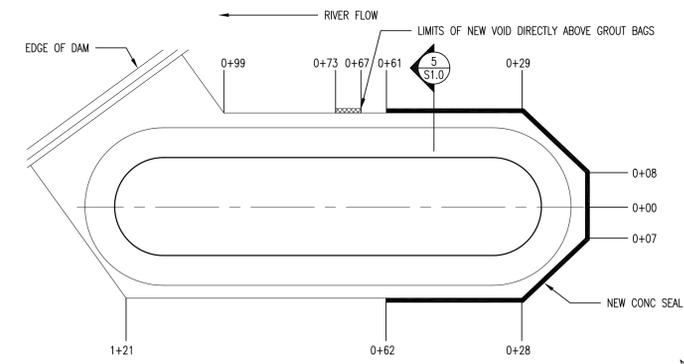
1 4 PIER 5 SECTION  
S1.0 SCALE: 1" = 20'-0"

The bottom seal on pier #5 was completed during the 2014 construction season. AMI inspected the bottom concrete seal in 2015 to document any voids, areas of concrete washout, or areas of soft concrete. Two areas of soft concrete were documented on the east side of the pier. The first area was located at station 0+38 and was approximately 2'-0" to 2'-6" in diameter with a maximum depth of 5" to 6". The concrete in this area was slightly built up above the top of the permanent forms, so the area of soft concrete only extends approximately 2" to 3" below the top of the forms.

The second area of soft concrete was located at station 0+28 and was approximately 3'-0" by 3'-0". The area of soft concrete was approximately 5" to 8" deep but the concrete was also built up above the top of the permanent forms in this area. Therefore, the area of soft concrete only extends approximately 3" to 5" below the forms.

During AMI's last inspection, a new void was documented on the east side of the pier. The void was approximately 5'-0" to 6'-0" long with a maximum height of 1'-1" and maximum penetration of 2'-0". The start of the void was located at station 0+67 on the vertical face of the pier directly above the new grout bags. The new void is located in an area of soft concrete and was likely scoured out due to the altered water flow around the pier from the new concrete seal located just upstream.
