**2014 ROUTINE  
BRIDGE INSPECTION REPORT**

**BRIDGE # 2440  
TH 65 (3rd Ave S) over Mississippi R & City St**

**Date(s) of Inspection: 10/13/2014**

**MnDOT Bridge Office  
3485 Hadley Avenue North  
Oakdale, MN 55128**

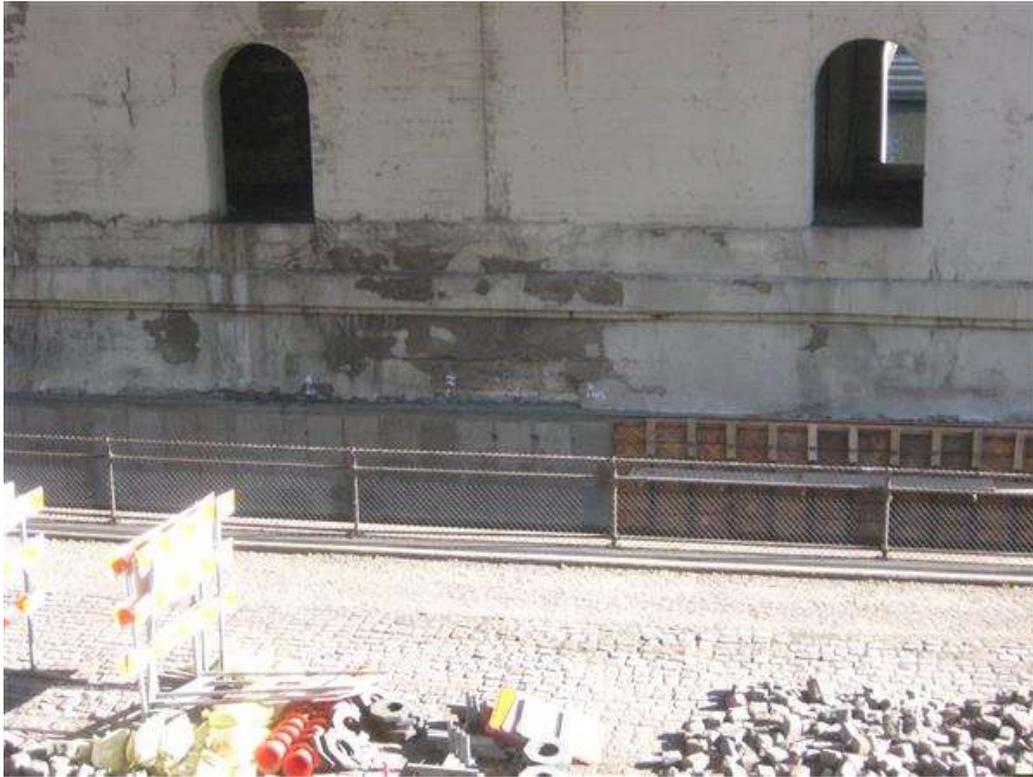
Notes: Element includes arch piers (both the footings & upper portions) with the exception of far upper sections, all are original 1917 construction. [1984] Arch pier footings have severe spalling (up to 8" deep) below deck drains. [1996] Underwater inspection found severe scale along waterline (all piers), with "voids" at upstream ends of piers 1 & 5. [1992/97] Pier 8: upper portion of pier wall (curved east end) has a severe diagonal crack (3/4" wide) severe spalling (4" deep). The curved west end has similar cracking, but not as severe. [2003] Good condition pier footings, inspected by construction inspector Tom Waks during low water. [2010] Quantity and condition ratings adjusted as suggested in the 2008 underwater inspection report. Timber debris lodged between pier 5 and spillway. [2012] Arch pier 8 has large vertical cracks extending from the ground surface all the way to the top of the pier, and significant section loss to exposed reinforcing steel exposed in the interior pier wall. There is a significant washout at the south end of arch pier 8 as well, which has been noted in previous "in-depth" type reports on the structure. [2014] All arch piers have moderate spall with exposed rebar. Bridge arch piers under contract for repair, contractor adding collar to base of arch piers 1 & 2, about 6", (see pictures 1-5)

Photo 1 - Adding 6" cover to base arch pier 1

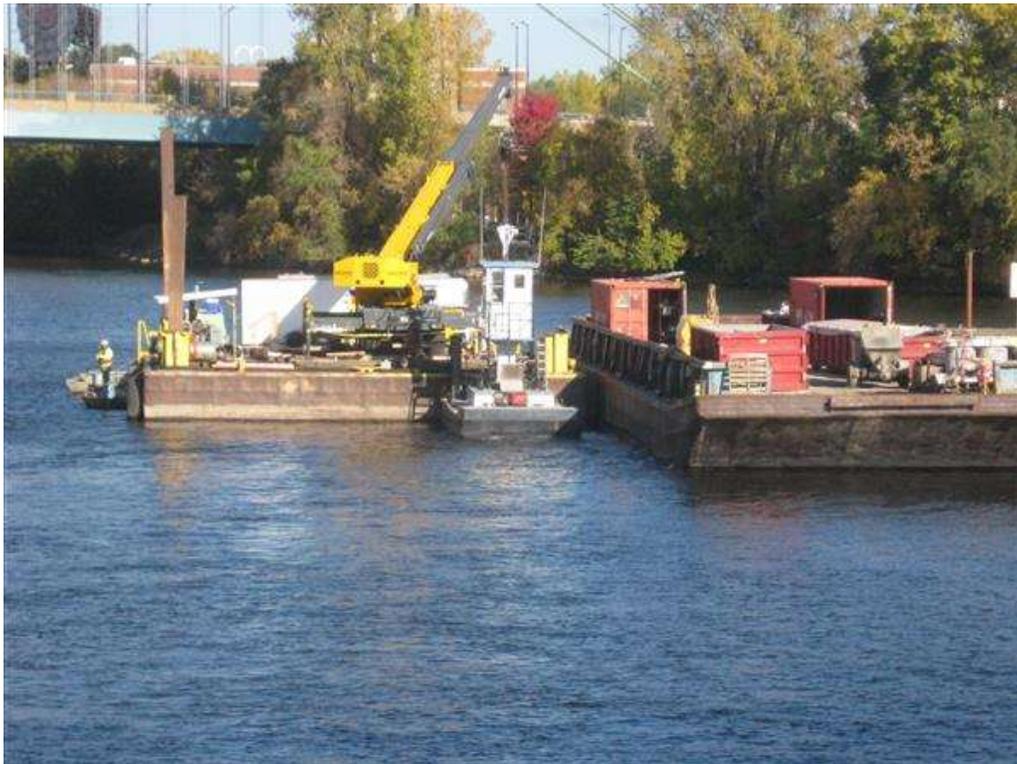
Photo 2 - Construction barges doing bridge repair

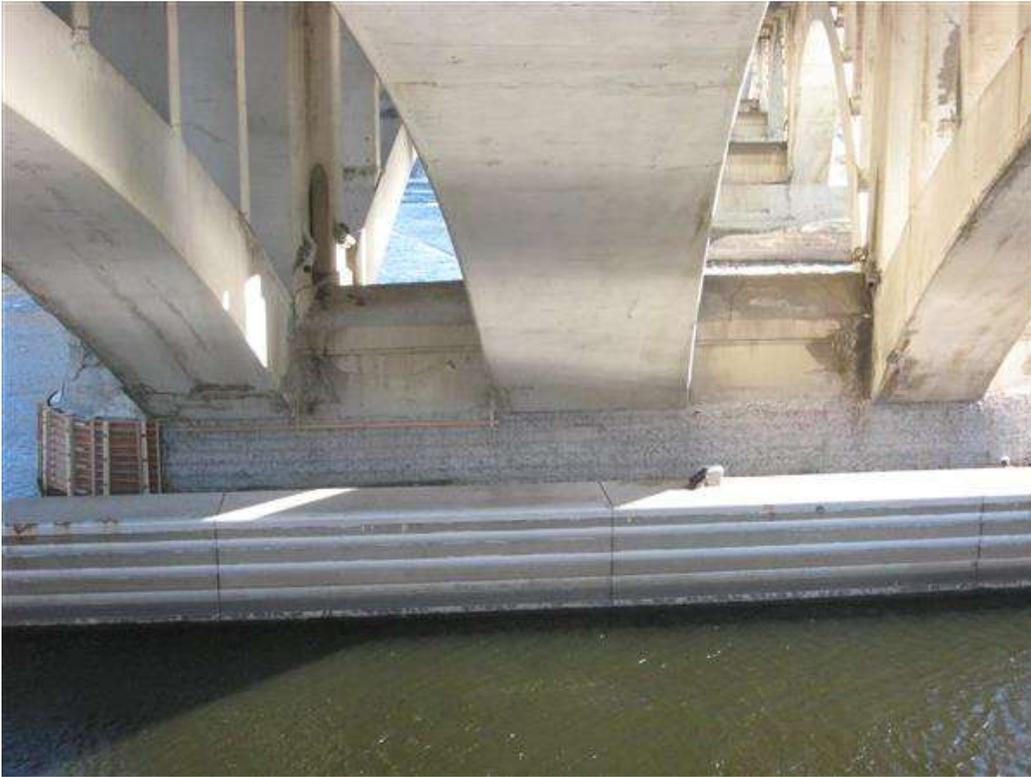
Photo 3 - Adding 6" cover to base arch pier 2. (3)

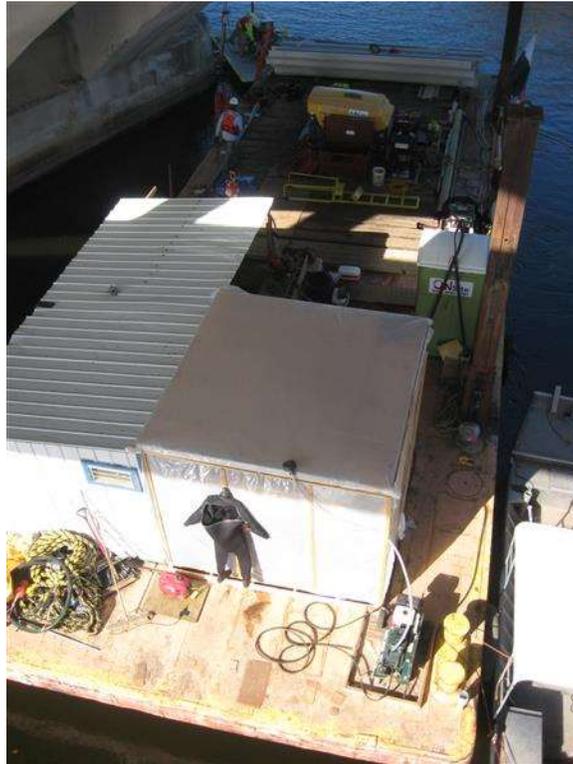
[2014] Continued investigation of foundation exposure and undermining (undercut) extent and limits at Pier 5, currently site investigation and repairs are underway. [2014] See Photos and attached 2008 & 2012 UW inspection reports.

Photo 4 - Construction barge working on arch pier 5. (4)

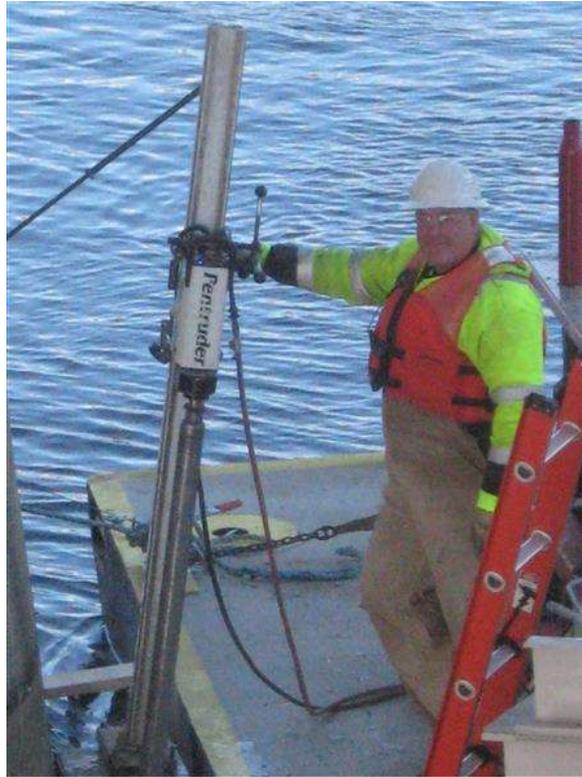
Photo 5 - Core drilling base footing arch pier 5. (5)

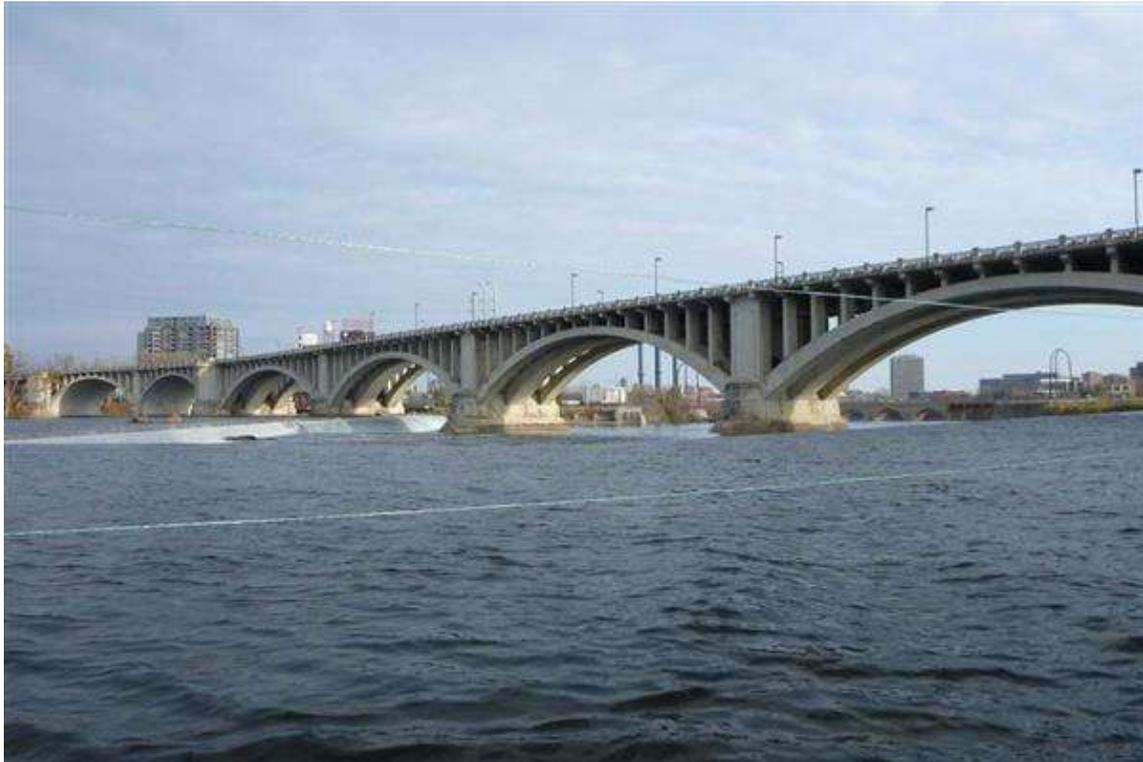
Photo 6 - Overall View of Structure, Looking Southeast.

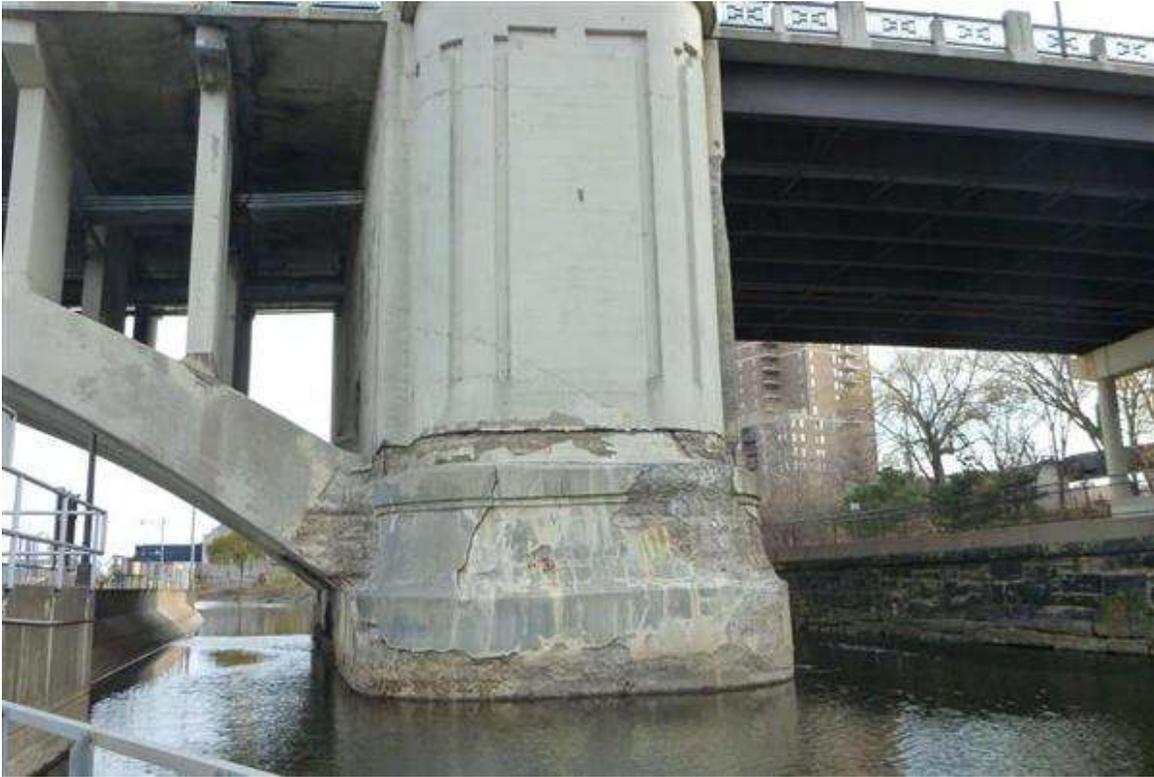
Photo 7 - View of Pier 1, Looking South

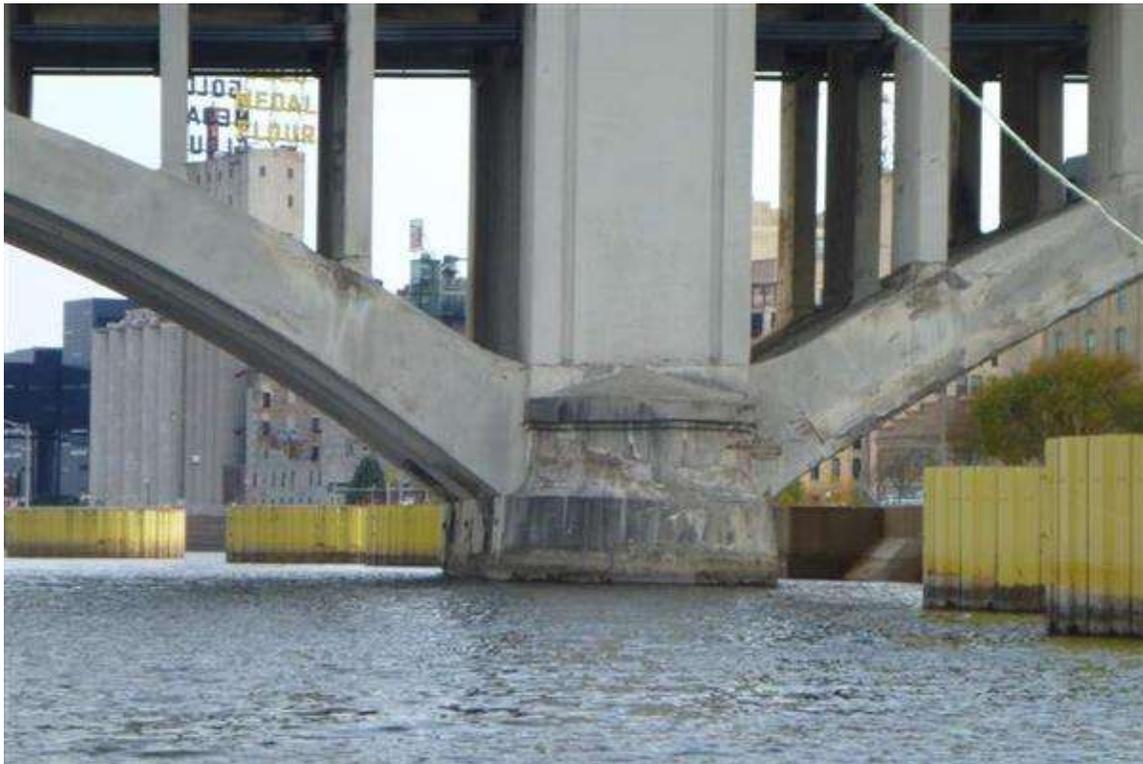
Photo 8 - View of Pier 2, Looking South.

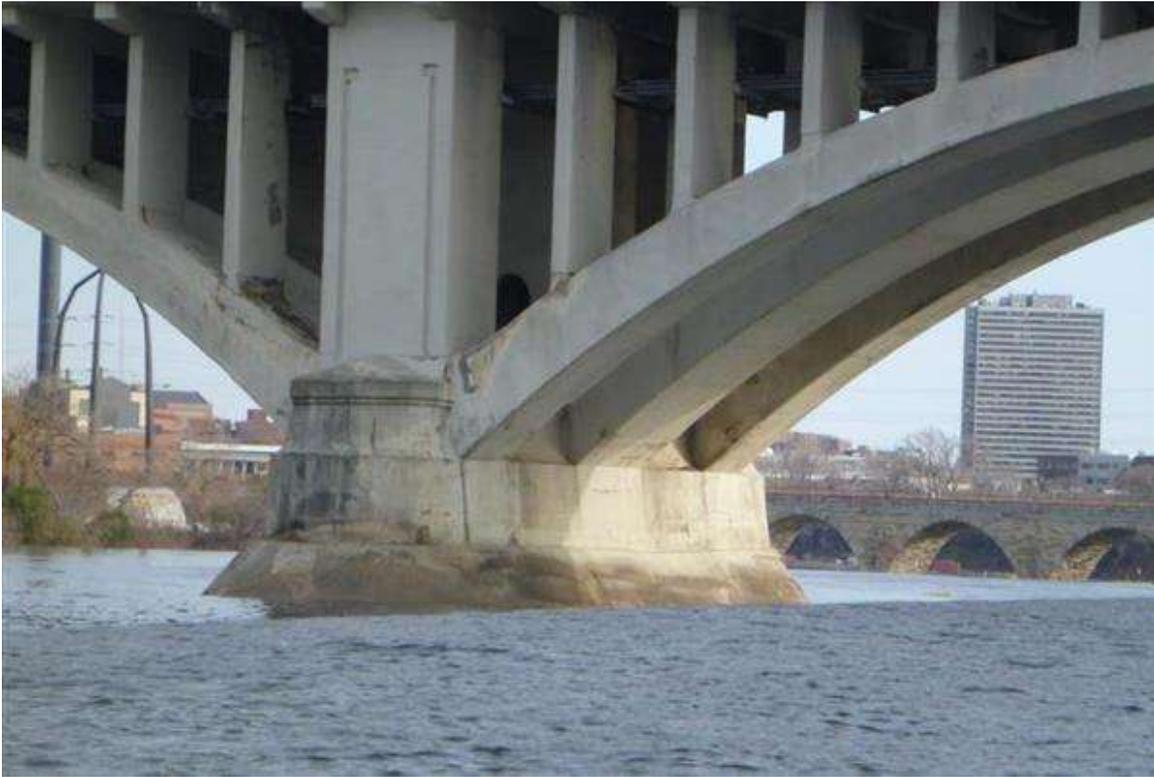
Photo 9 - View of Pier 3, Looking Southeast

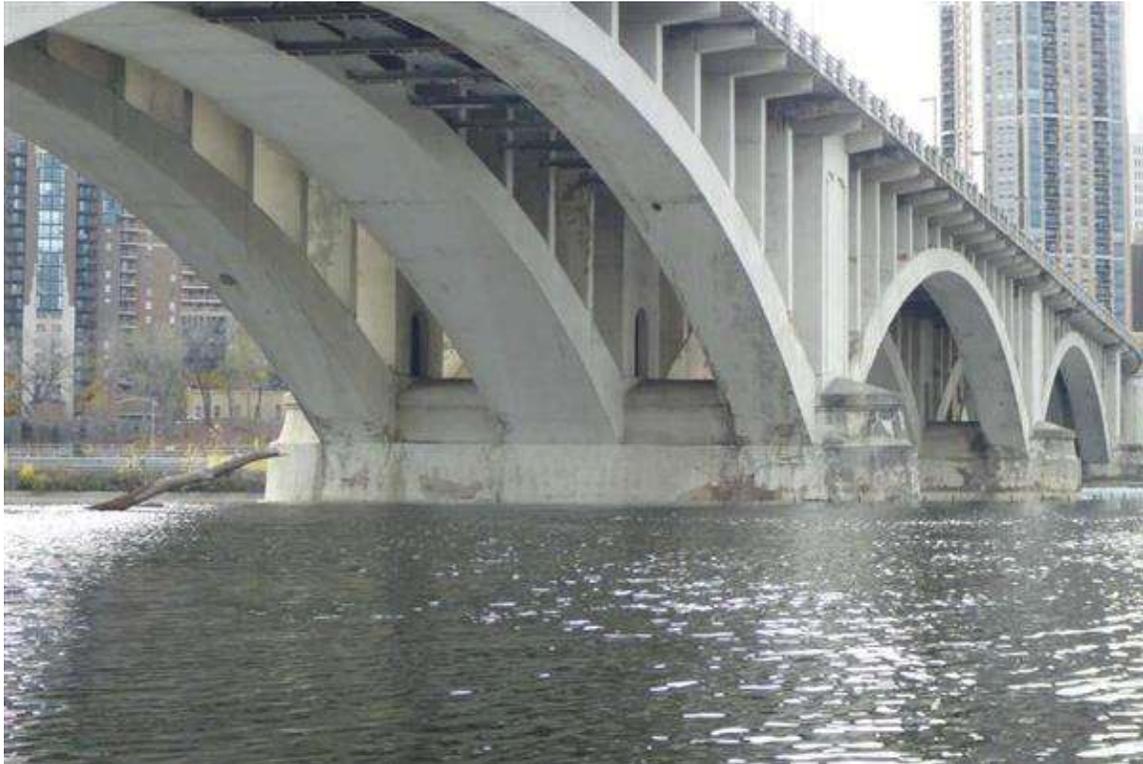
Photo 10 - View of Pier 4, Looking West

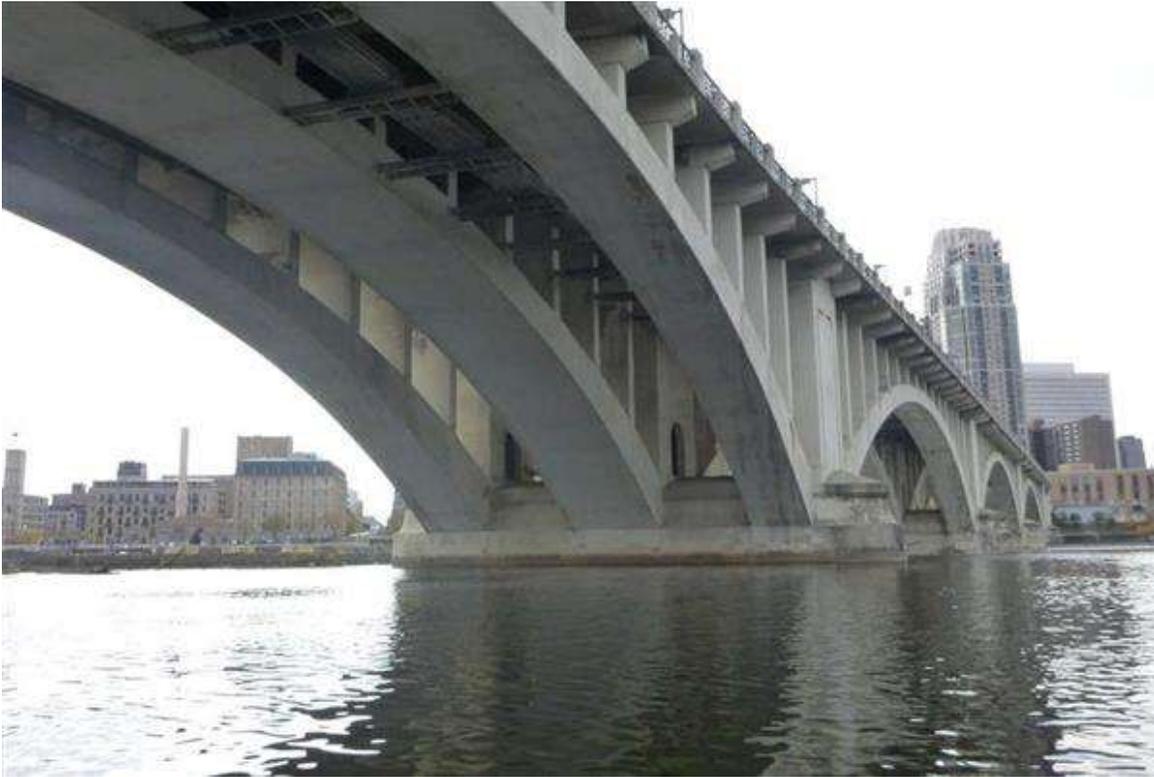
Photo 11 - View of Pier 5, Looking West

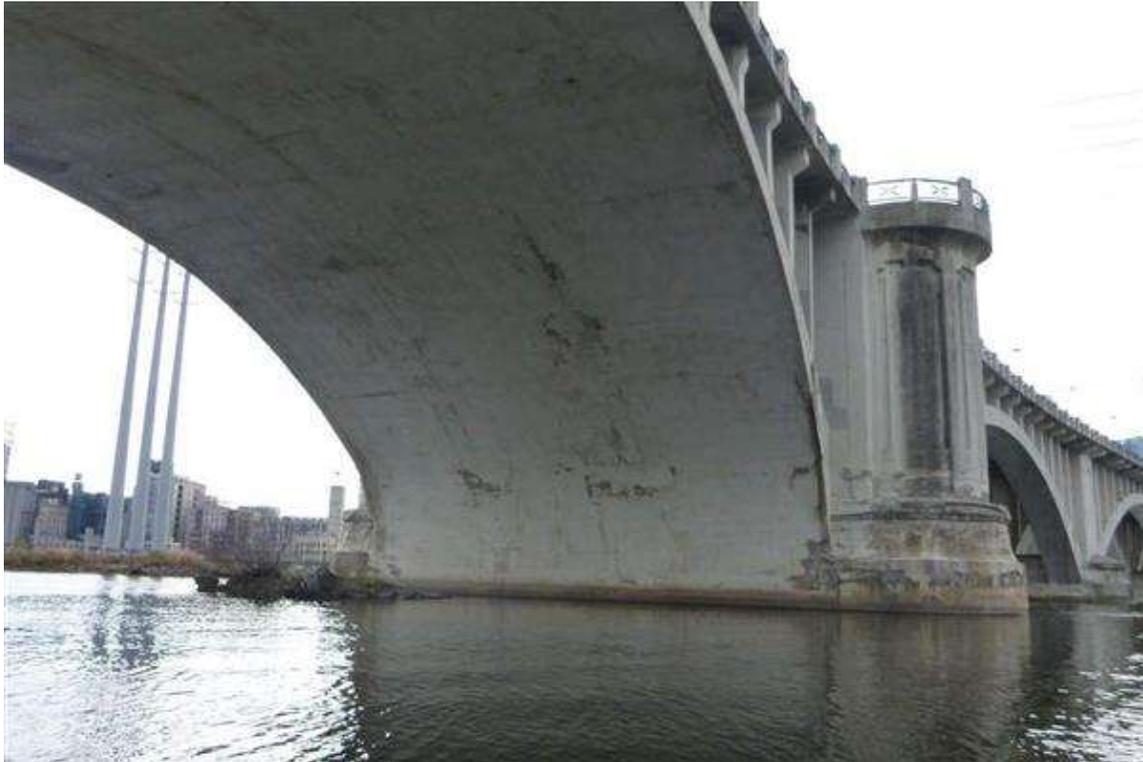
Photo 12 - View of Pier 6, Looking West

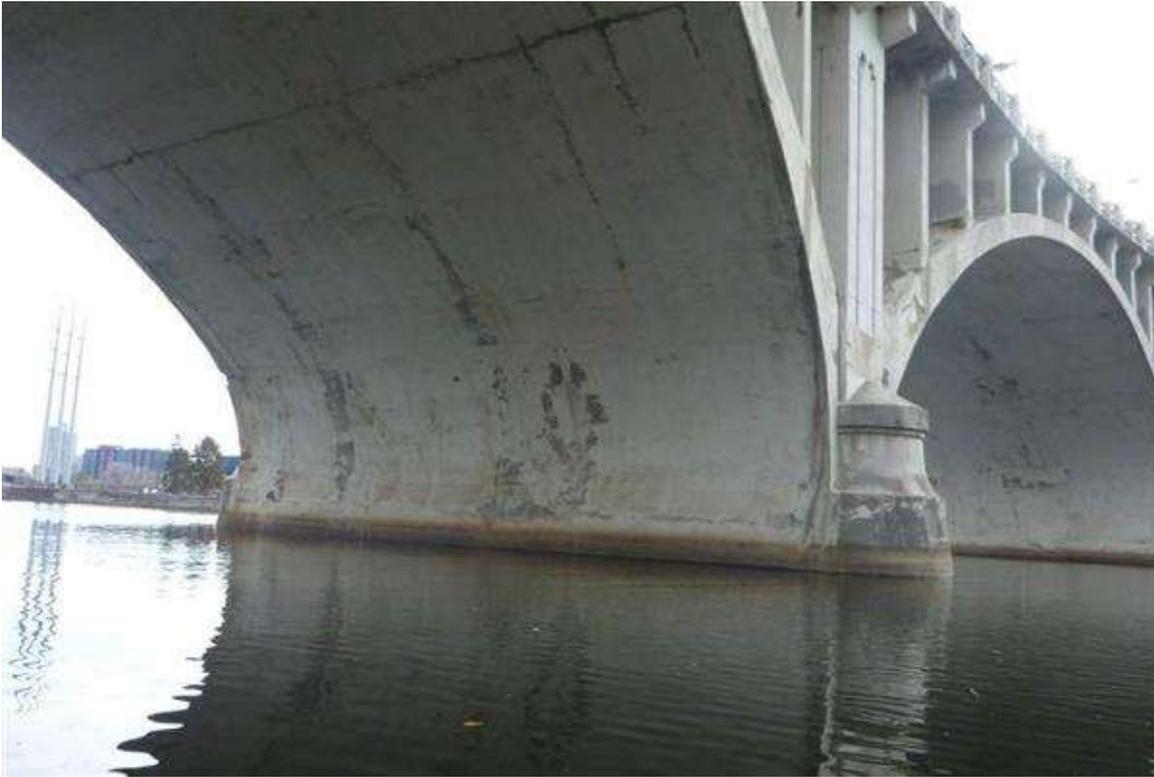
Photo 13 - View of Pier 7, Looking Southwest

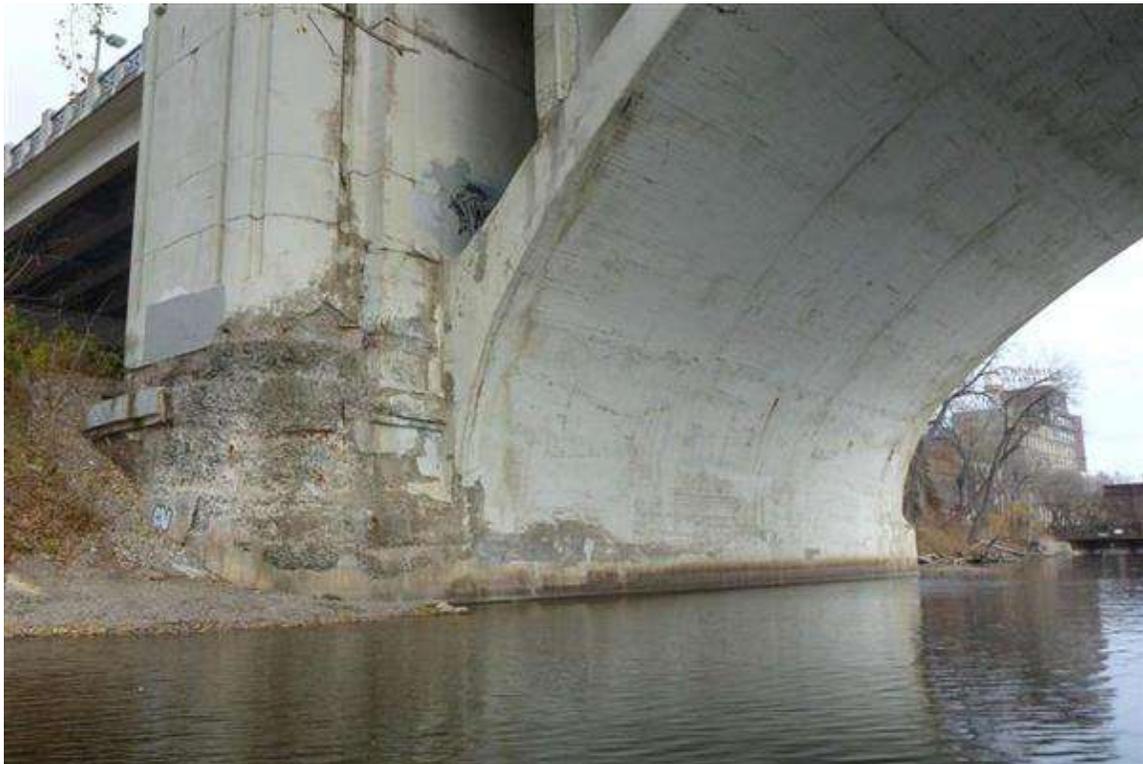
Photo 14 - View of Pier 8, Looking Southeast
