Minnesota Department of Transportation

2000 Bridge Inspection Report Bridge #2440: Hwy. 65 over the Mississippi River (3rd Ave. Bridge)

Inspection Date: June 16 & July 31, 2000

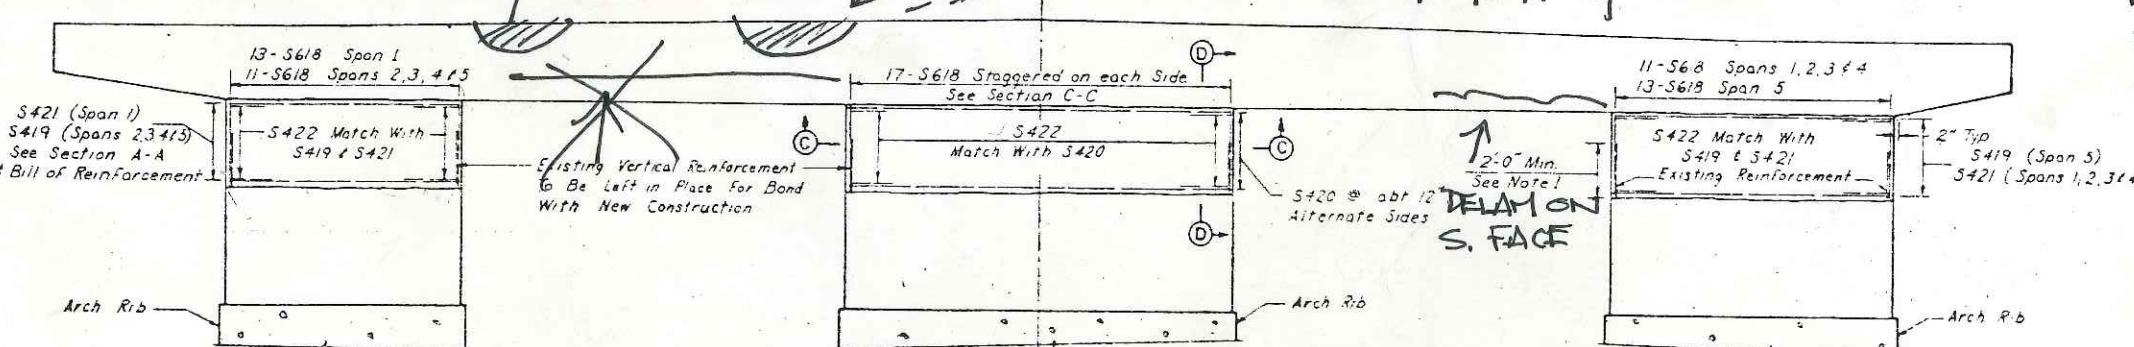
SPAN #1
CAP A

DECK HAS WATER SAT (SOME DELAM)
EXTENDING FROM 8" TO 16" OUT
FROM FACE OF CAP - ENTIRE LENGTH

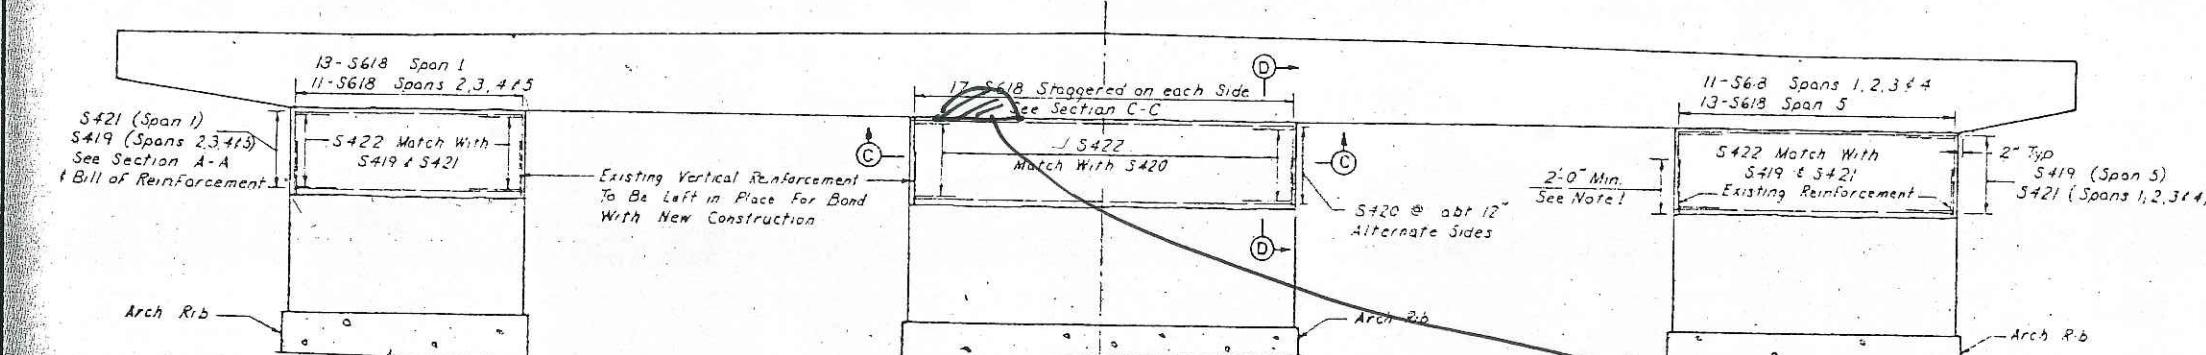
CAP H HAS AXA
SPALL ON N. FACE (EAST END)

SPAN # 1
CAP F
NO SPALLS
MINOR DECK DETERIORATION
CAP G HAS 5 LF SPALL SAME LOCATION ON BOTH N. FACE

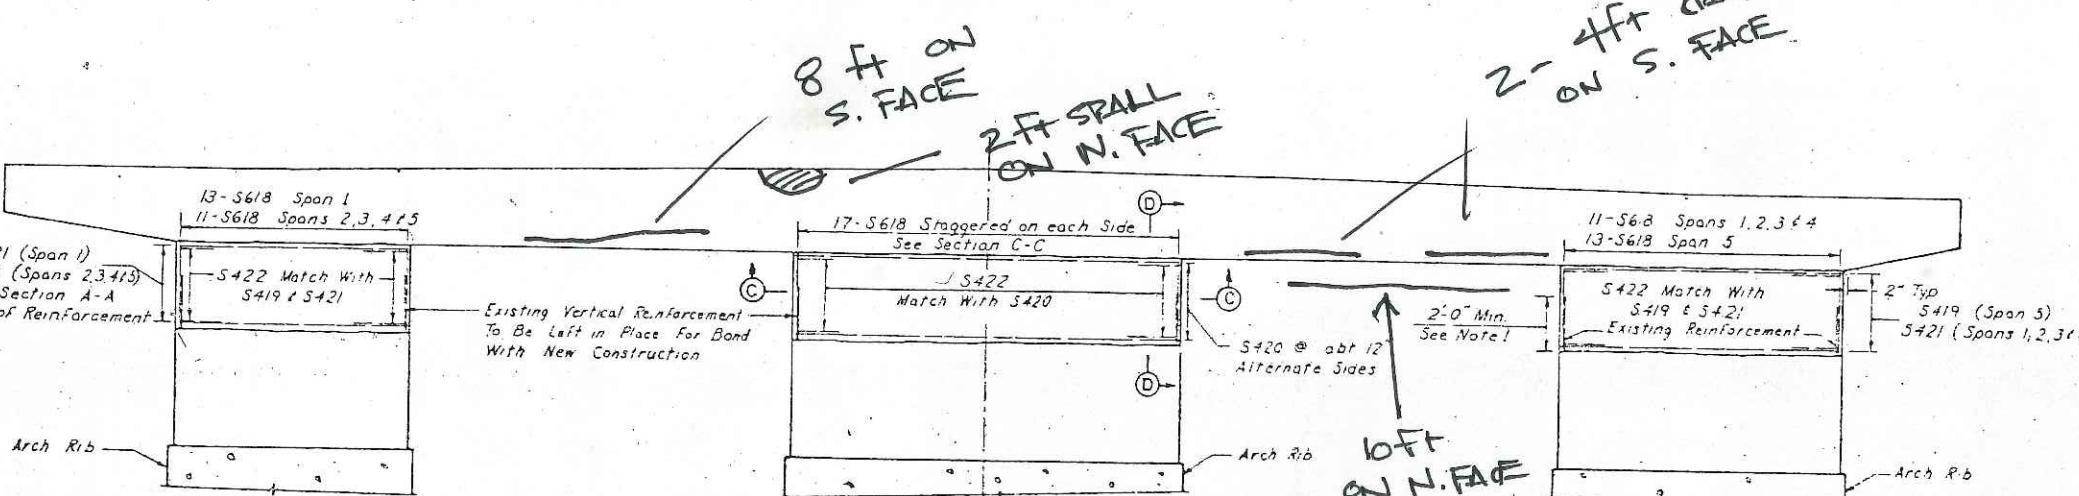
DECK HAS AREAS OF 6"- 36" DELAM (WATER SAT.)

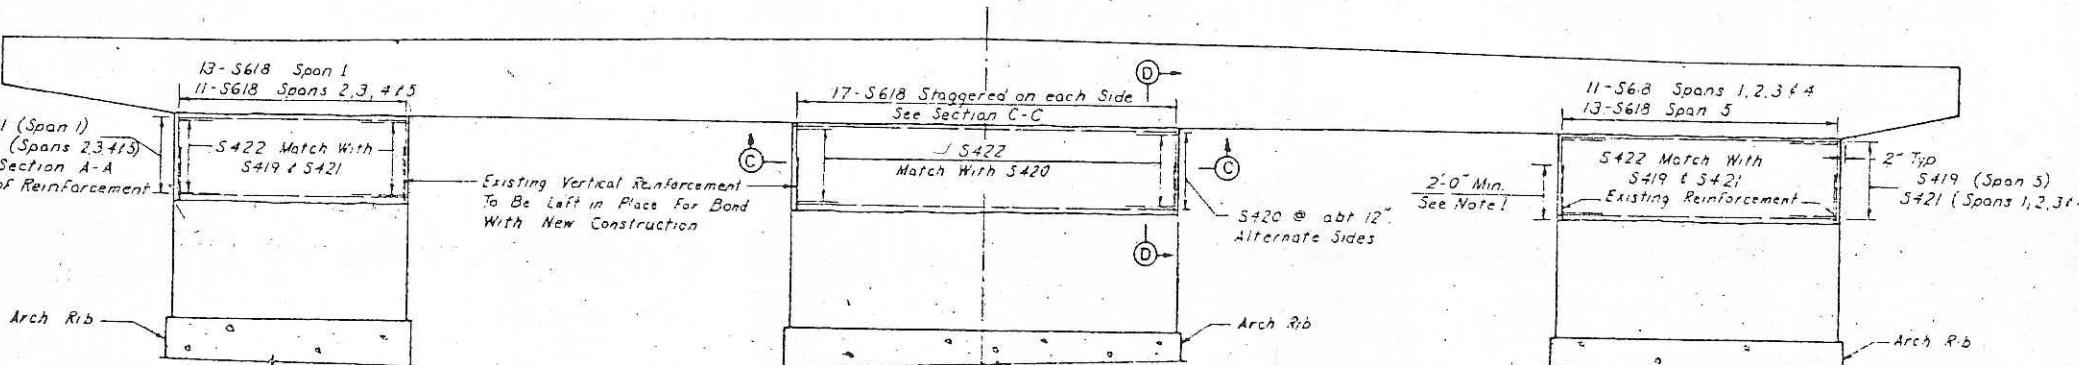
SPAN # 2
CAP I

MINOR DECK DET.

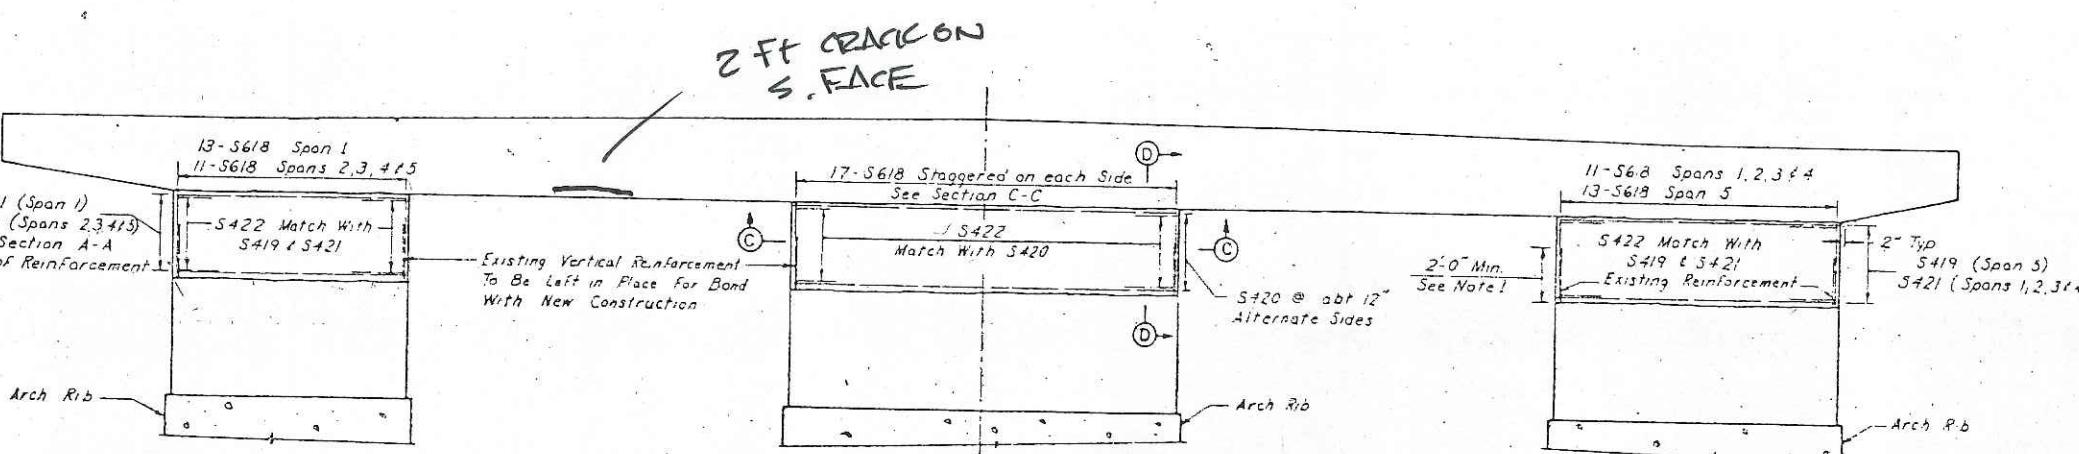
SPAN # 3
CAP A

DECK HAS WATER SAT
& DELAM 0"-18"
SMALL SPALC

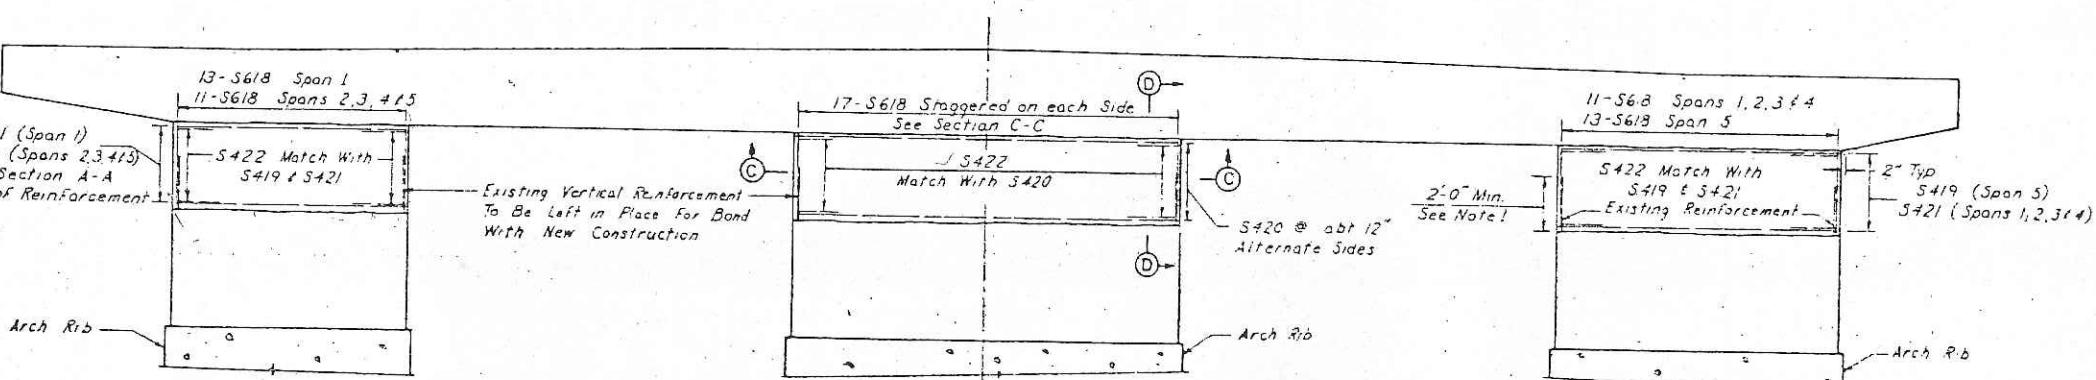
SPAN #3
GAP D
WATER SAT.
DECIC - 0"-6" 6"

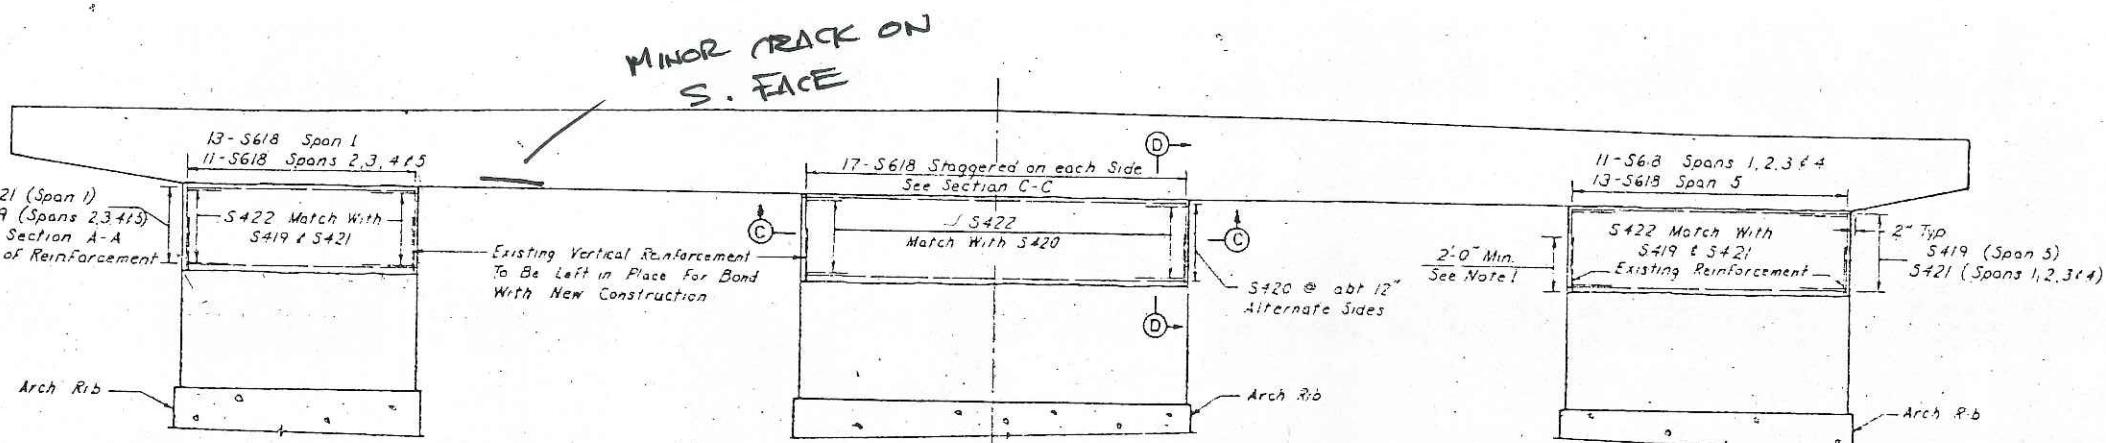
SPAN # 3
CAP # 1
MINOR DECK DET.

SPAN #3
CAP K
DECK HAS MINOR DET.
SOME DELAM.
ONE AREA

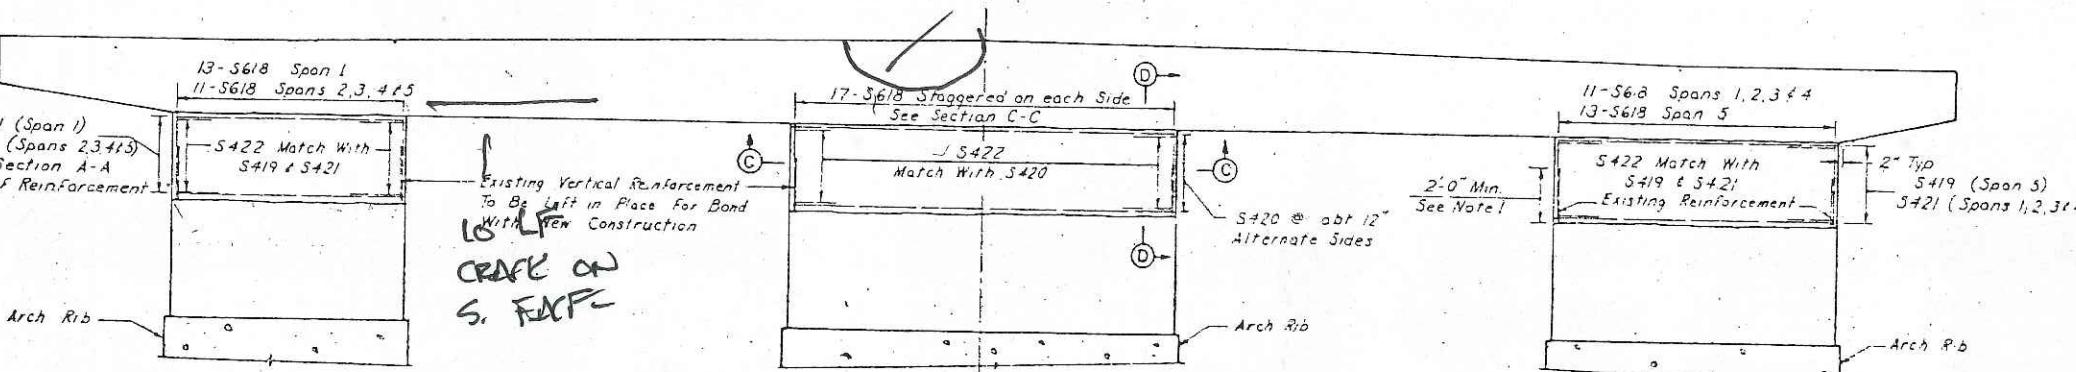
SPAN # 3
CAP 1
- 36" SECTION
DECK HAS 20" SECTION
WTH DELAM / WATER SAT
SPALL
TWO

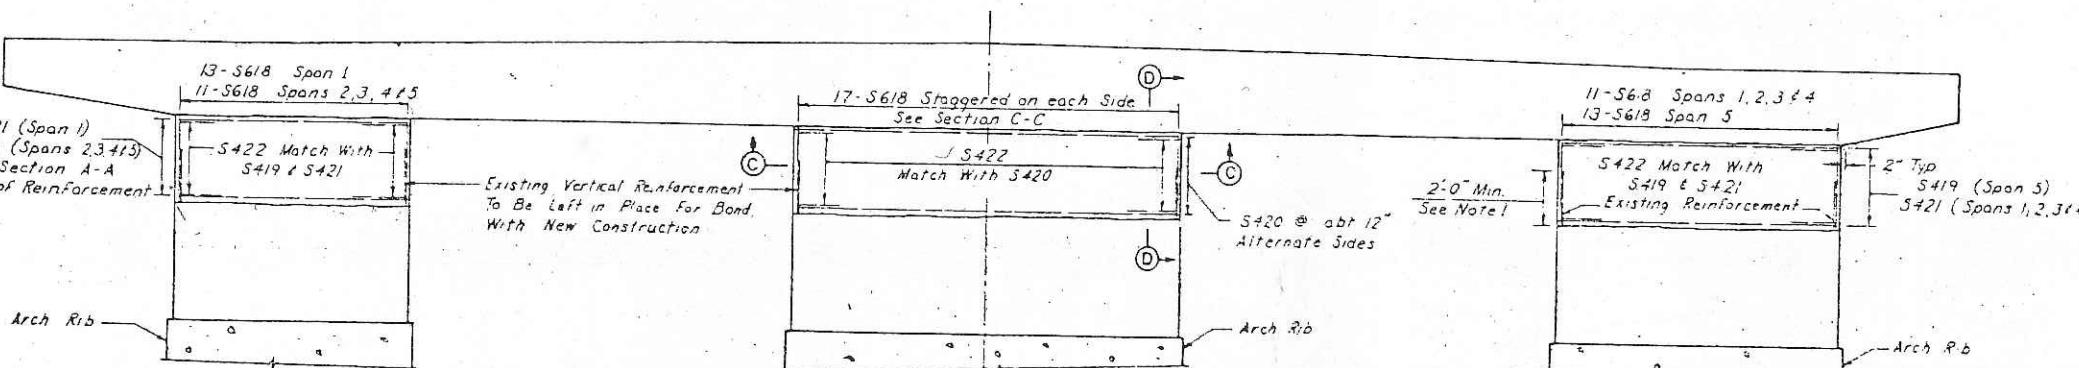
SPAN #4
CAP D

MINOR WATER SAT
8"

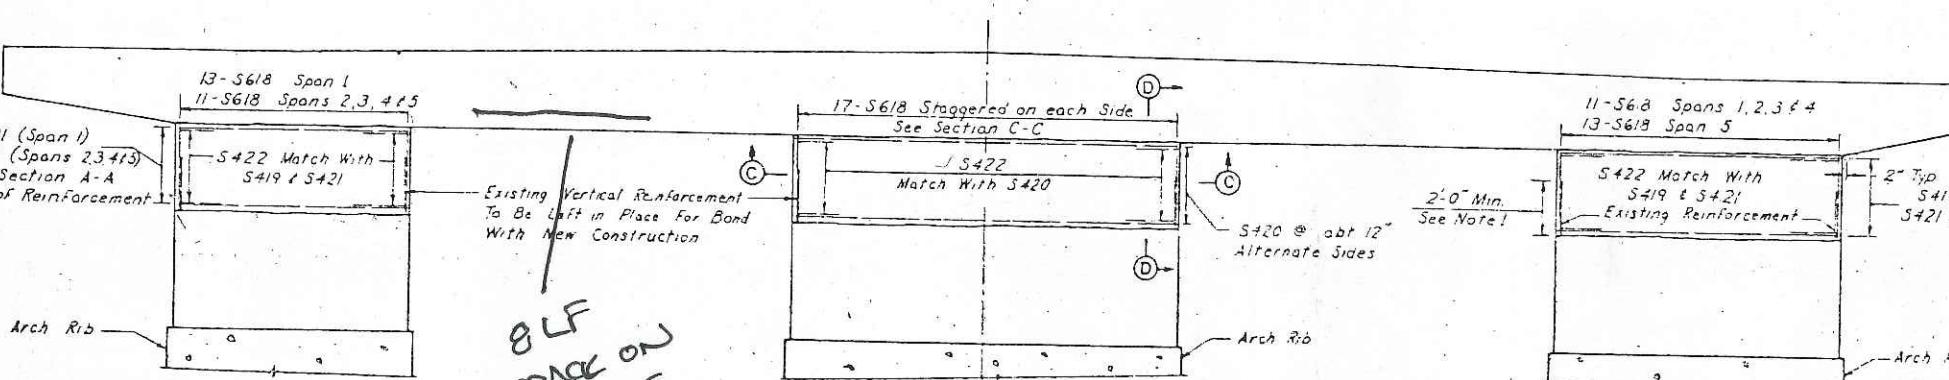
SPAN #4
CAP F

DECK MINOR - MODERATE
WATER SAT

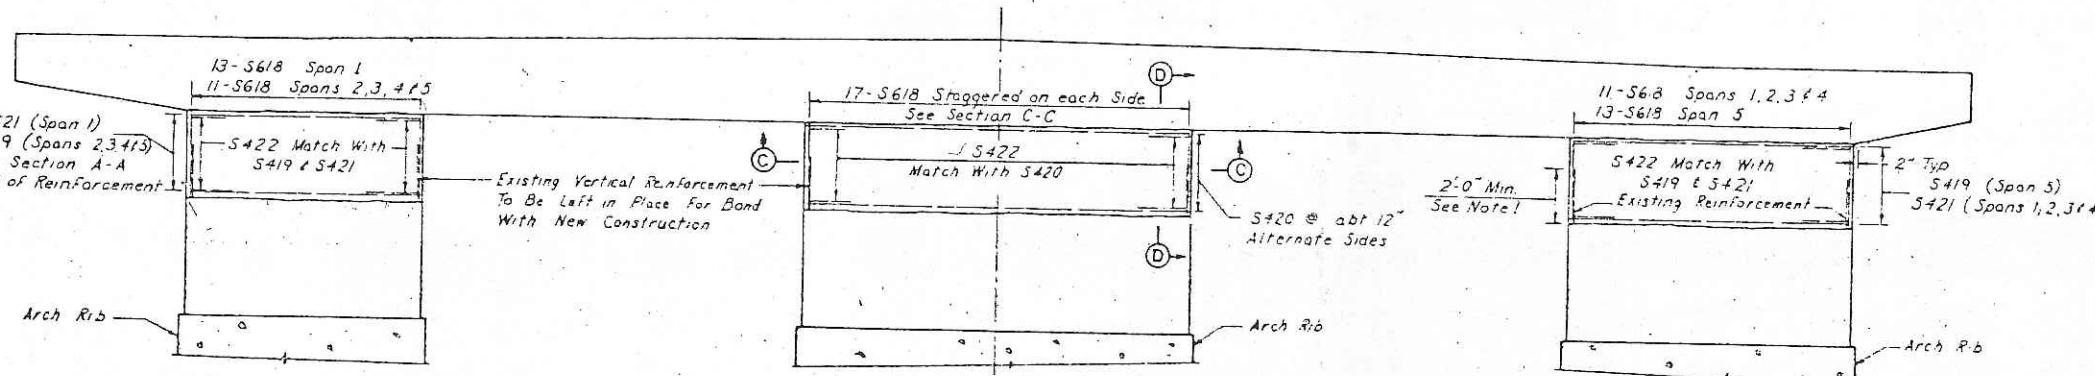
SPAN #4
CAP I
DECK HAS MINOR
WATER SAT
- SOME DELAM

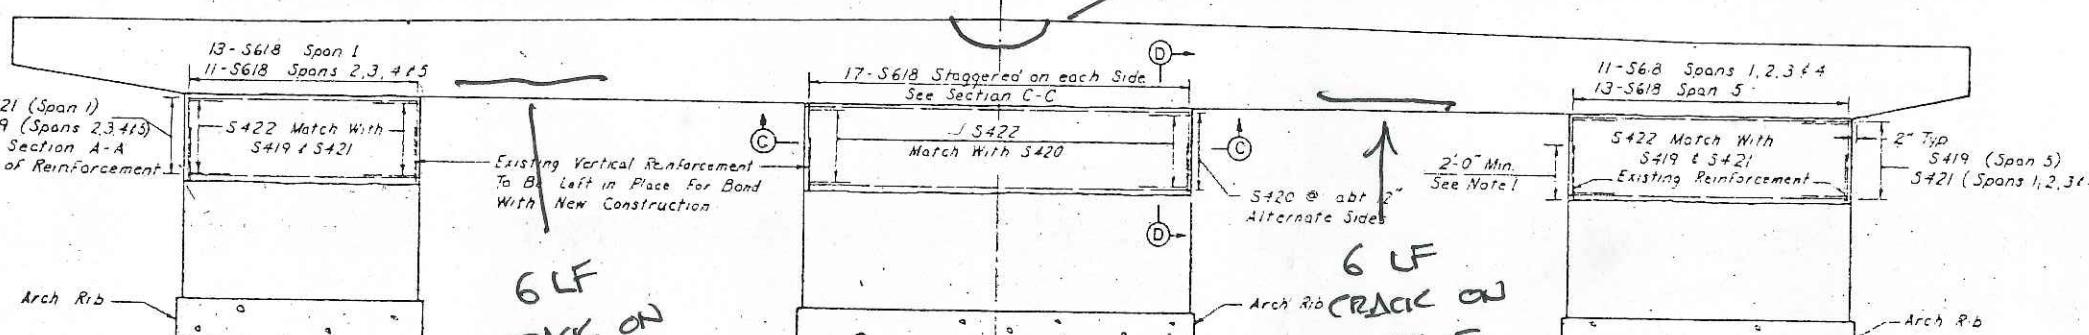
SPAN #4
CAP K
DECK 6- 24" WATER SAT.
ONE DELAM

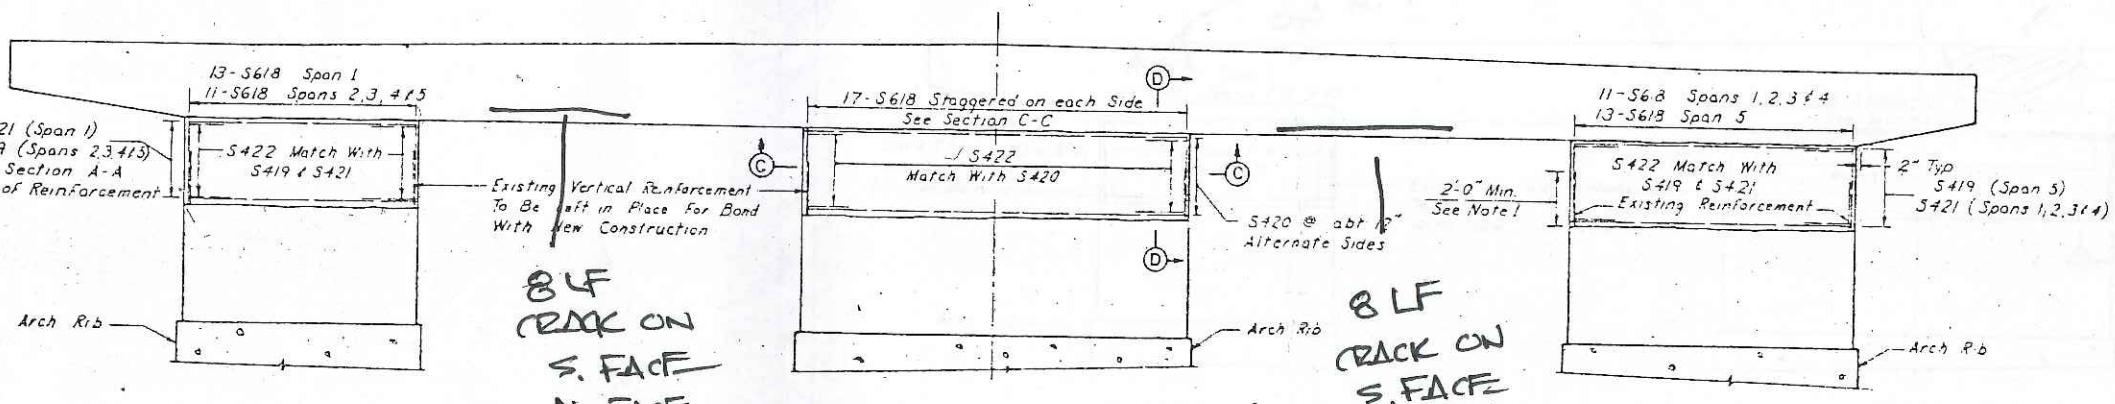
SPAN #4
CAP N
DECK HAS 10"-24" OF
WATER SAT
SEVERAL DELAM'S

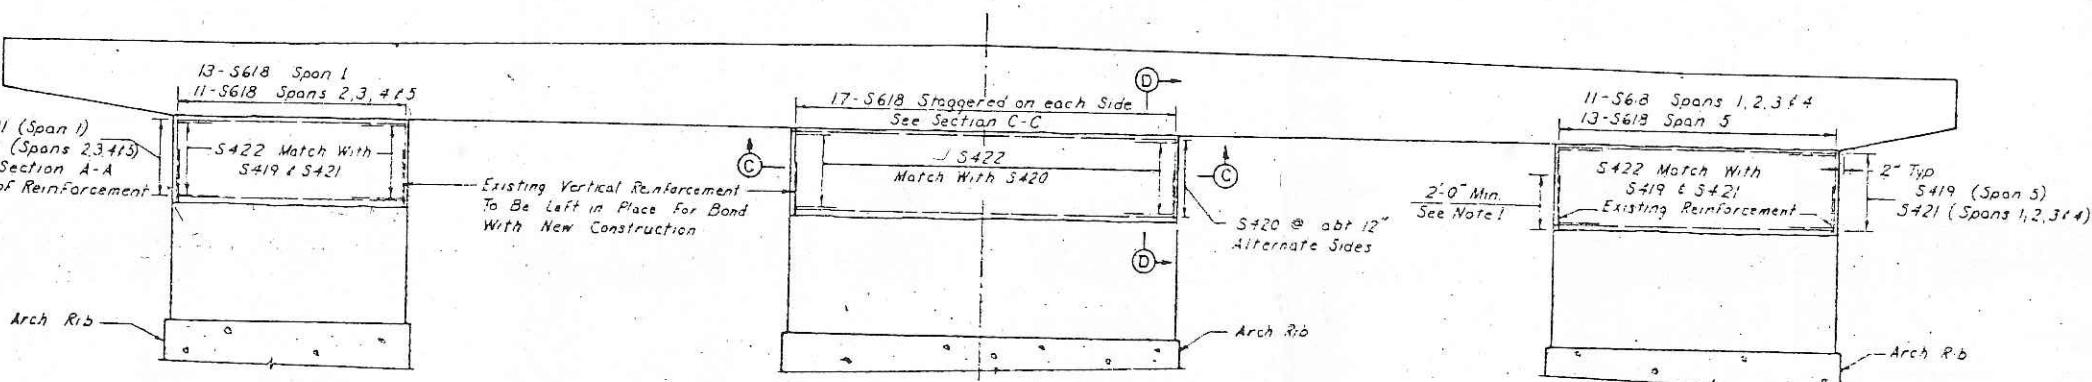
**SPAN #5
CAP T
MINOR DECK PET.**

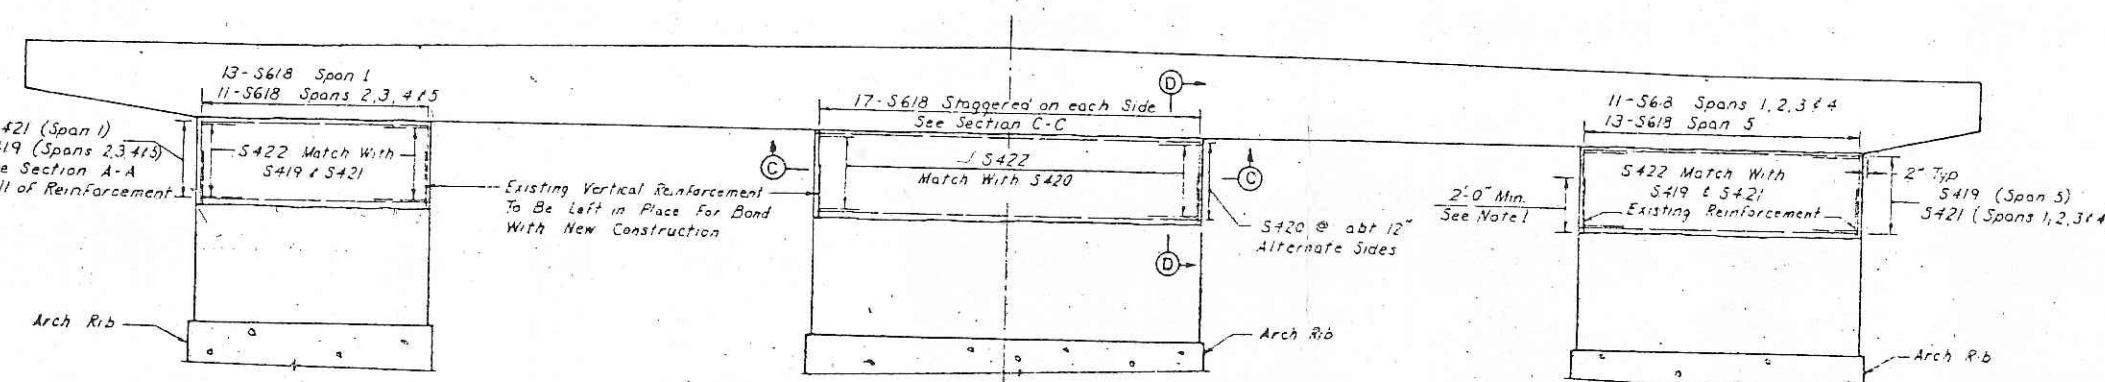
SPAN # 5
CAP I
DECK HAS 6" WATER SAT
SOME SMALL DELAMS

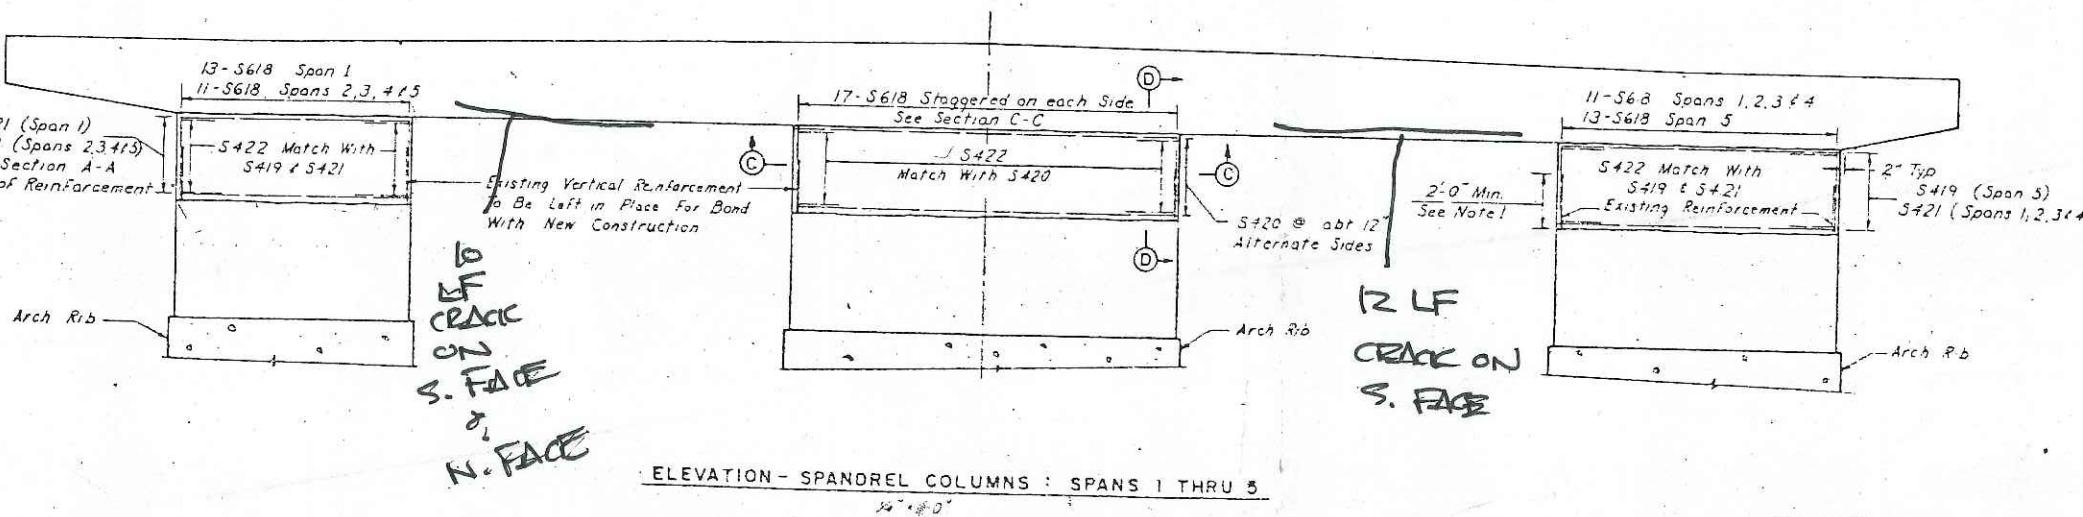
SPAN #5
CAP N
DECK HAS 12"-30" WATER SAT
EXTENSIVE DELAMINATIONS

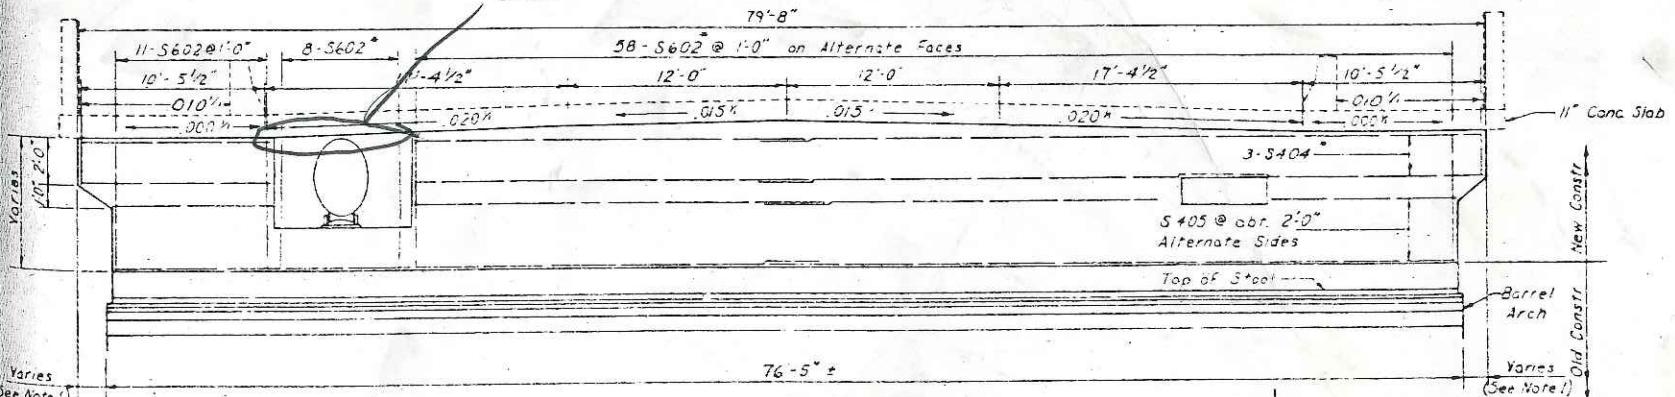
SPALL ON DECK

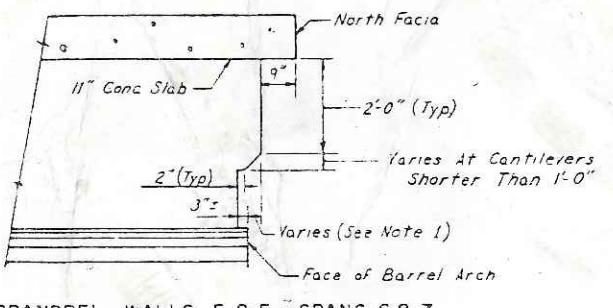
SPANDREL WALLS E & F - SPANS 6 & 7

UP TO 36° OF
WATER SAFE
SEVERAL DEAMS
