# Mn/DOT STRUCTURE INVENTORY SHEET

Bridge ID: 2440

TH 65 (3RD AVE S) OVER MISS R, BN RR&amp; CITY STS

STRUCTURE NO. 2440  
MINNESOTA STATE HIGHWAY NO. 65  
OVER  
THE MISSISSIPPI RIVER  
DISTRICT 5 - HENNEPIN COUNTY

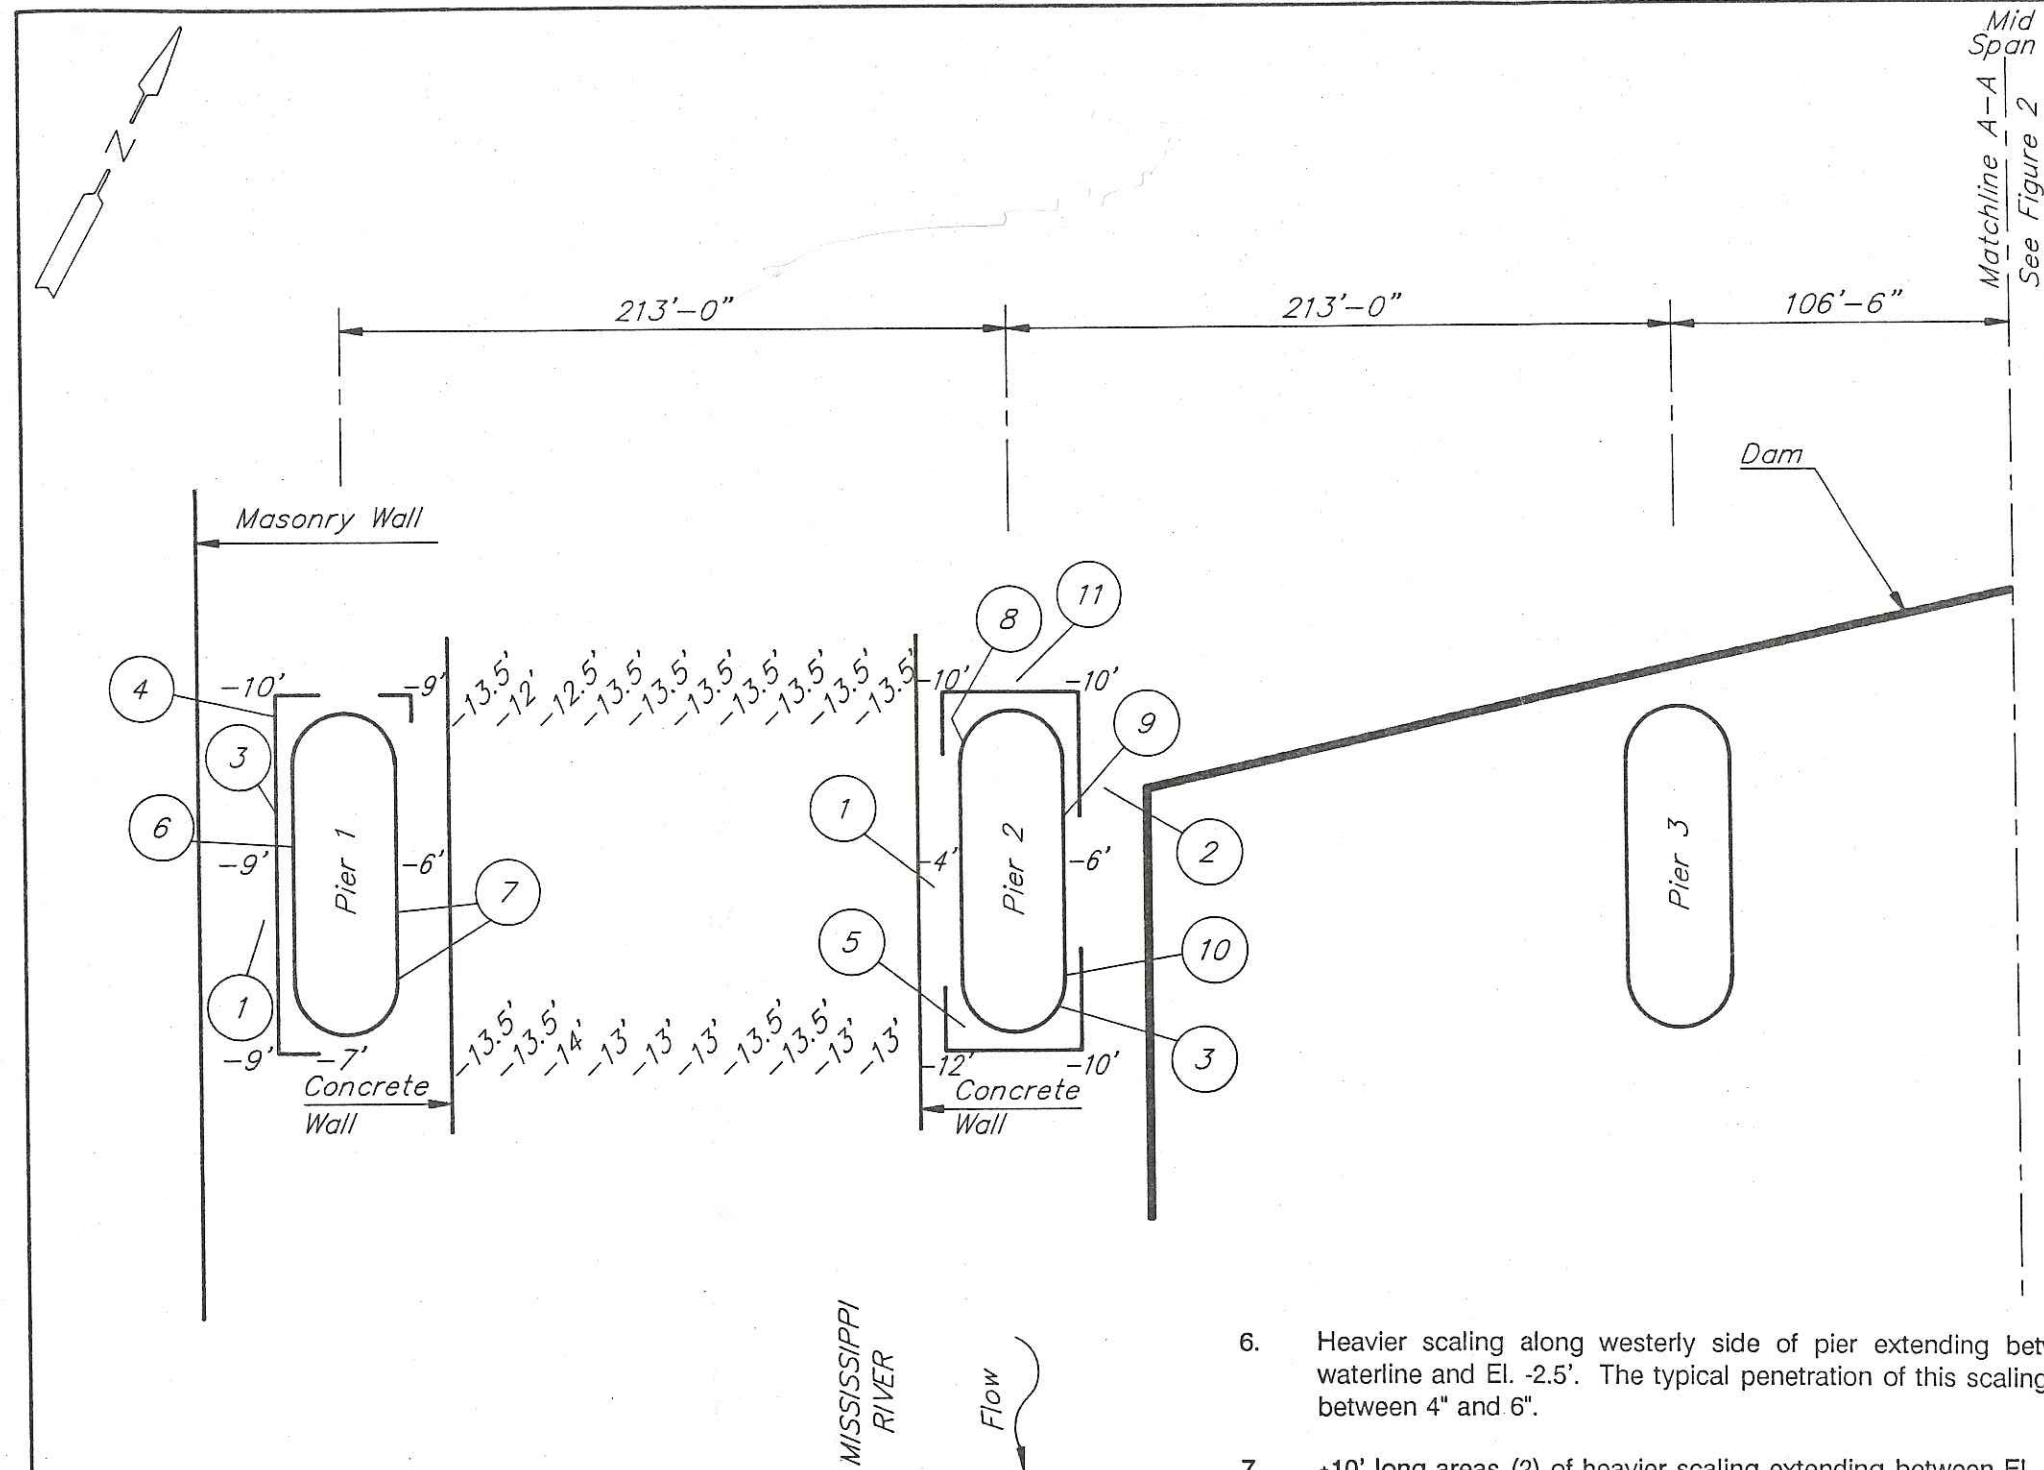
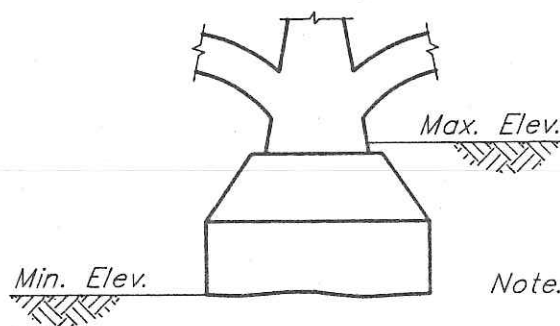
| | DATE: OCTOBER, 1991 | FIGURE 1 |

Note: Design plans indicate footing bells cast on rock channel bottom.

6. Heavier scaling along westerly side of pier extending between waterline and El. -2.5'. The typical penetration of this scaling was between 4" and 6".
7. ±10' long areas (2) of heavier scaling extending between El. +2.5' and El. -2.5'. The typical penetration of this scaling was between 3" and 4".
8. ±10' long spalled area extending between waterline to El. -2.5', with maximum penetration of ±3".
9. ±10' long spalled area extending between El. +6' to El. -2.5', with maximum penetration of ±6" and exposed reinforcing steel.
10. ±8' long spalled area extending between El. +5' to El. -2.5', with maximum penetration of ±6".
11. Light accumulation of timber debris on channel bottom.

3. All of the pier shafts were lightly to moderately scaled with exposed aggregate from the waterline to the top of the footing bell (El. -2.5'). The typical penetration of this scaling was between 1" and 2". Areas of heavier scaling and/or spalling are identified in the inspection notes.

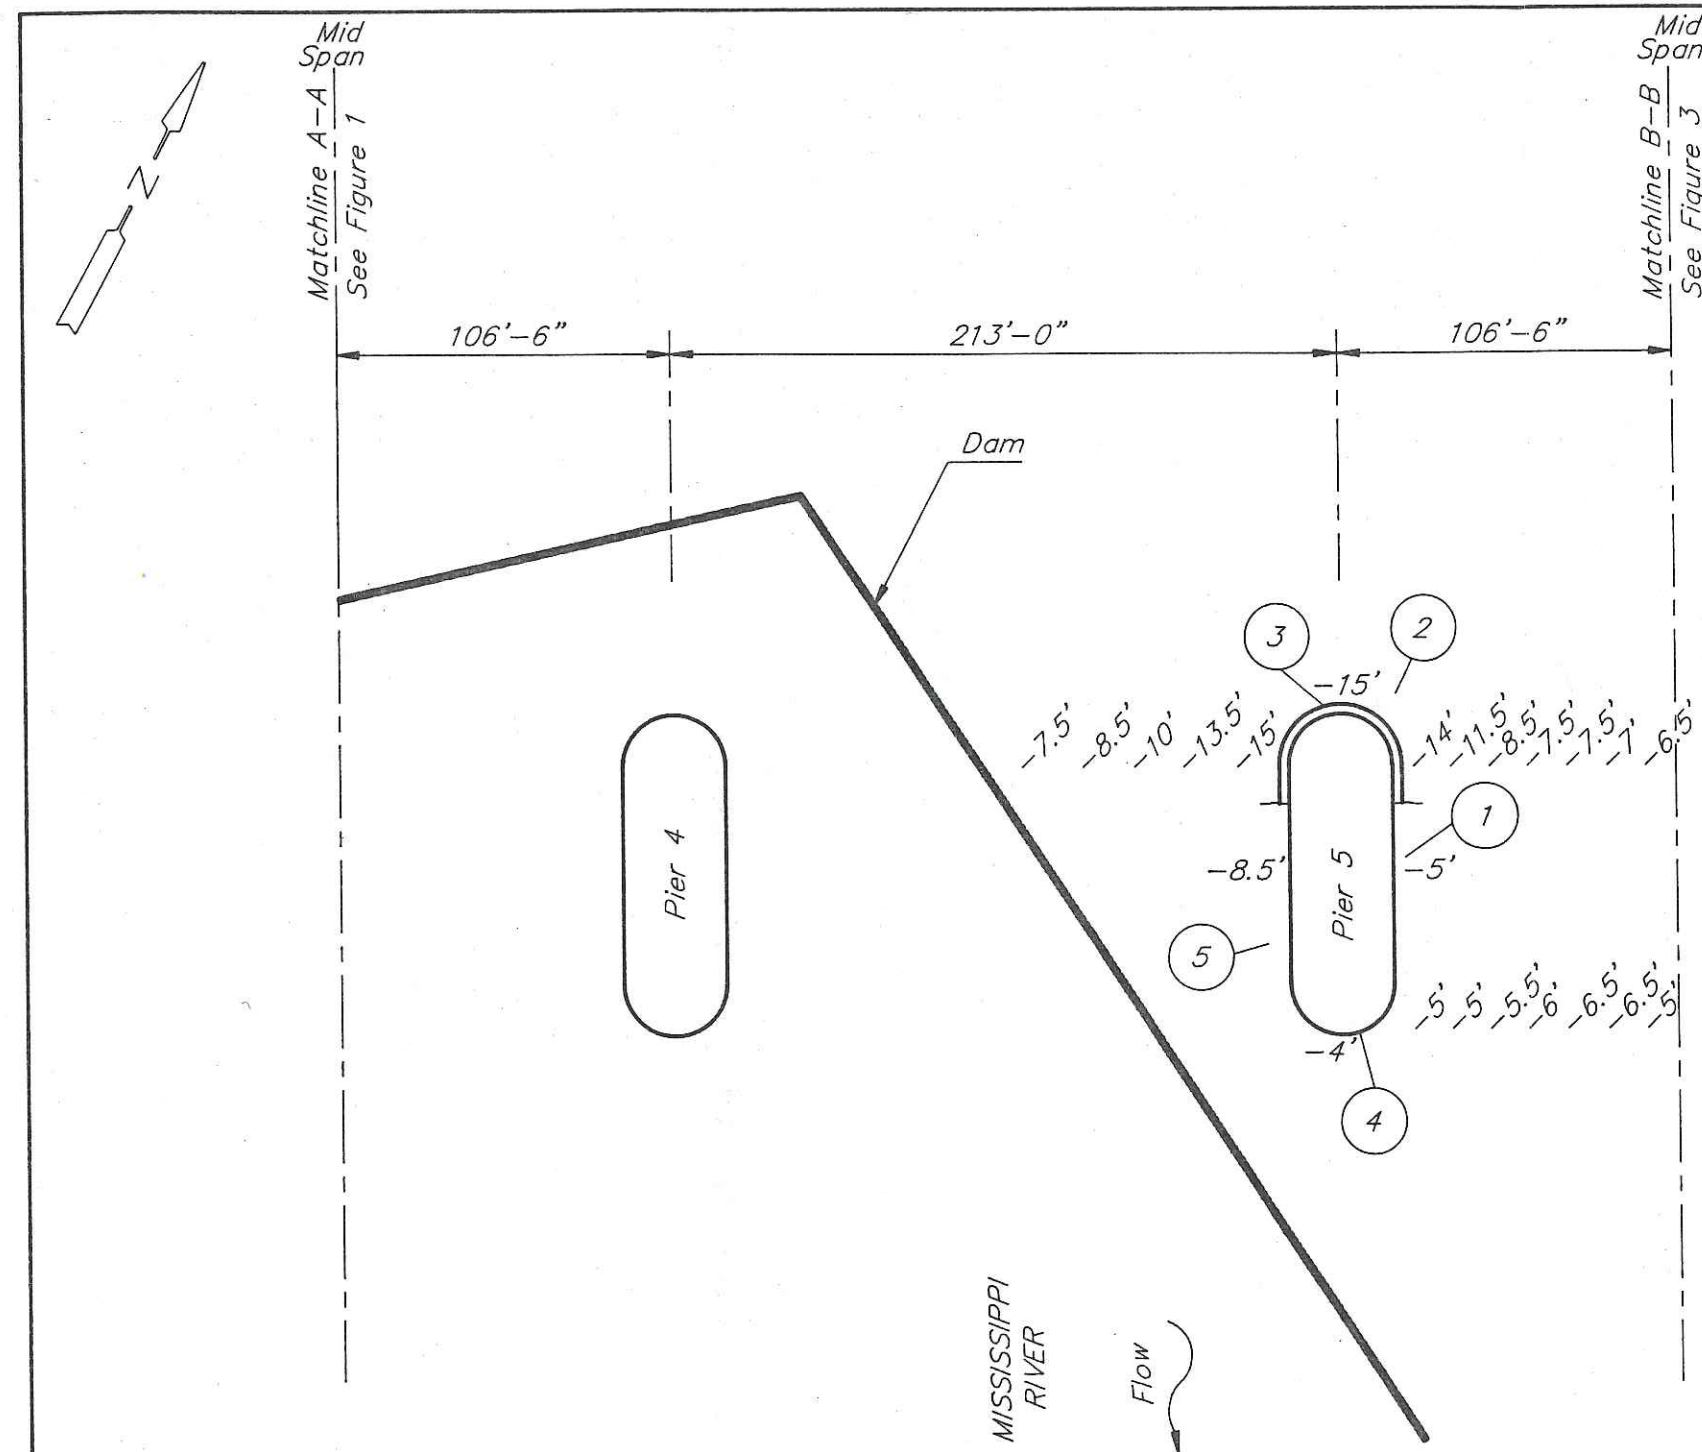
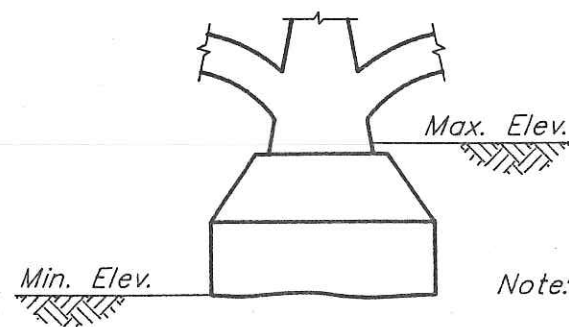
| | DATE: OCTOBER, 1991 | FIGURE 2 |

Note: Design plans indicate footing bells cast on rock channel bottom.

- All of the pier shafts were lightly to moderately scaled with exposed aggregate from the waterline to the top of the footing bell (El. -2.5'). The typical penetration of this scaling was between 1/2" and 1". Areas of heavier scaling and/or spalling are identified in the inspection notes.

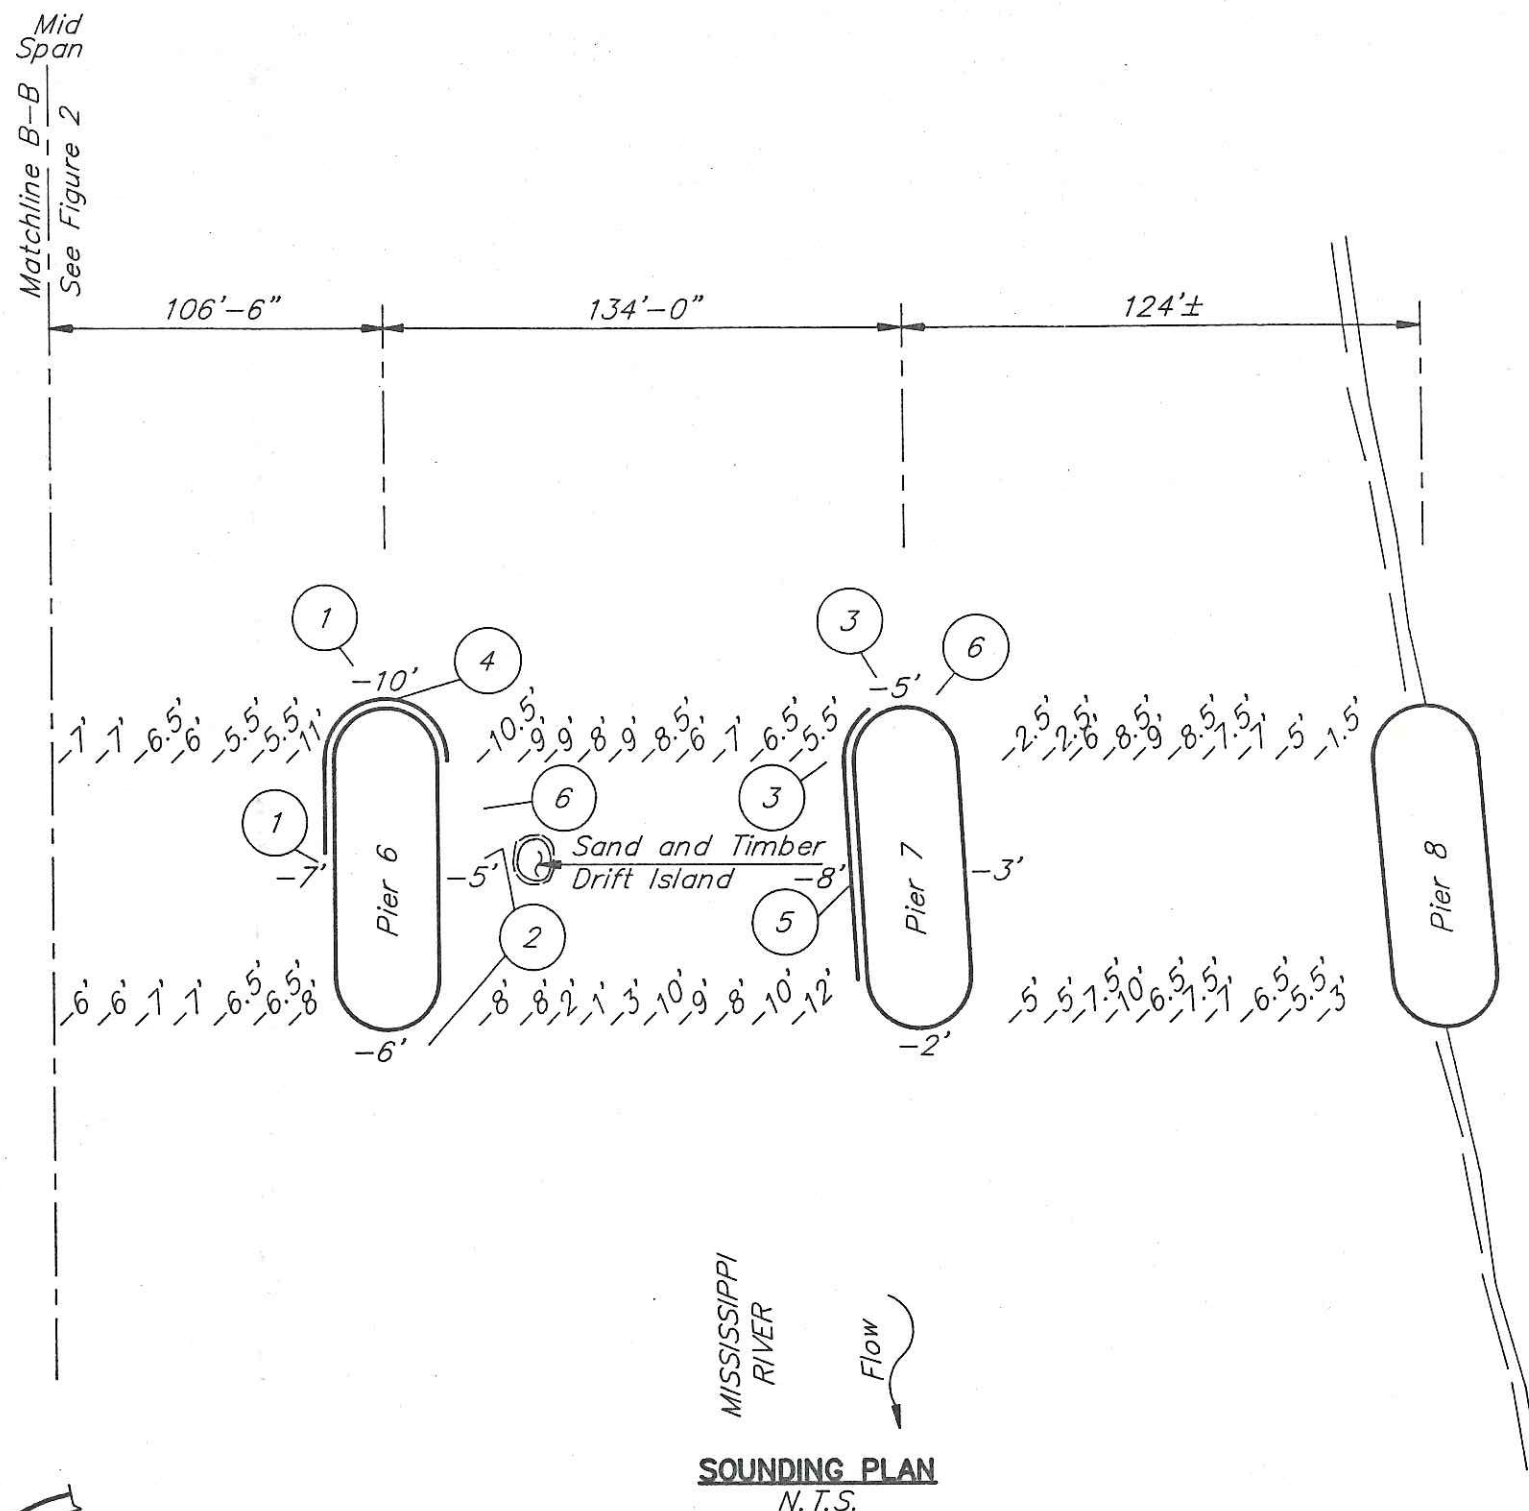
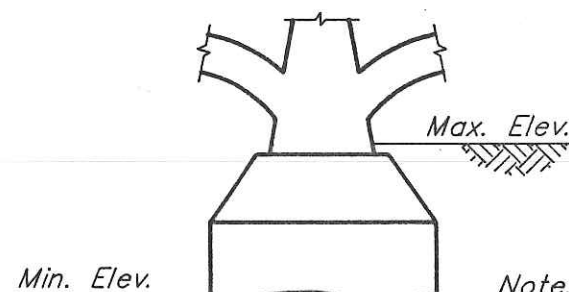
| | DATE: OCTOBER, 1991 | FIGURE 3 |

Note: Design plans indicate footing bells cast on rock channel bottom.

3. All of the pier shafts were lightly to moderately scaled with exposed aggregate from the waterline to the top of the footing bell (El. -2.5'). The typical penetration of this scaling was between 1/2" and 1". Areas of heavier scaling and/or spalling are identified in the inspection notes.
