UNDERWATER BRIDGE INSPECTION REPORT

STRUCTURE NO. 2440

MISSISSIPPI RIVER

MINNESOTA DEPARTMENT OF TRANSPORTATION
UNDERWATER BRIDGE INSPECTION

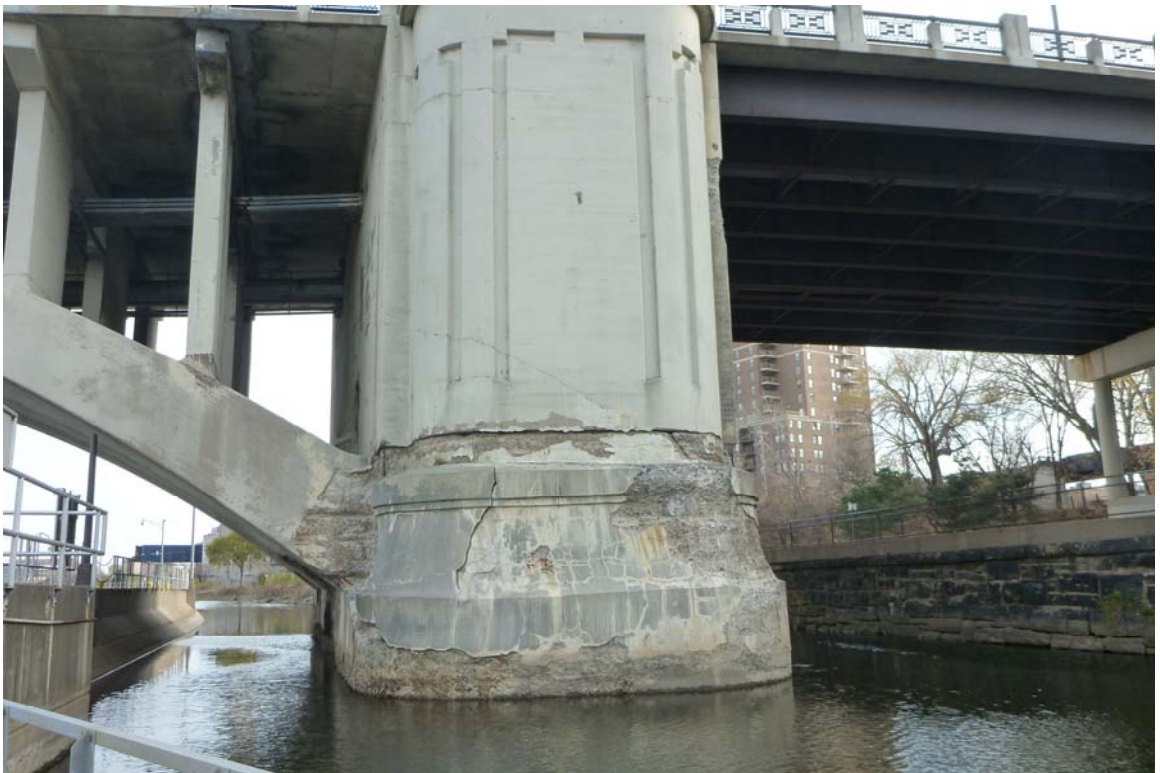
- (A) The concrete of Piers 1 and 2 exhibited widespread spalling and loss of section with typical penetrations of 6 inches to 1 foot and maximum penetrations of 2 feet. The deterioration was typically concentrated from 2 feet below to 4 feet above the waterline.
- (B) The footing at Pier 1 was exposed along the west face of the pier with 2 to 3 feet of vertical exposure. The concrete of the footing also exhibited moderate to heavy deterioration with 6 inch to 2 foot penetrations.
- (C) The footing at Pier 2 was exposed around the upstream and downstream nose with 3 to 4 feet of vertical exposure.
- (D) The concrete of Pier 5 exhibited random minor deterioration with 2 to 3 inch penetration.

Photograph 2. View of Pier 1, Looking South.

- (A) The extent of concrete deterioration at Piers 1 and 2 does not pose an immediate threat to the structural integrity of those piers at this time, given the overall size of the piers. However, consideration should be given to repairing the deteriorated areas by removing all unsound concrete and replacing with new concrete designed to provide high durability and low permeability.

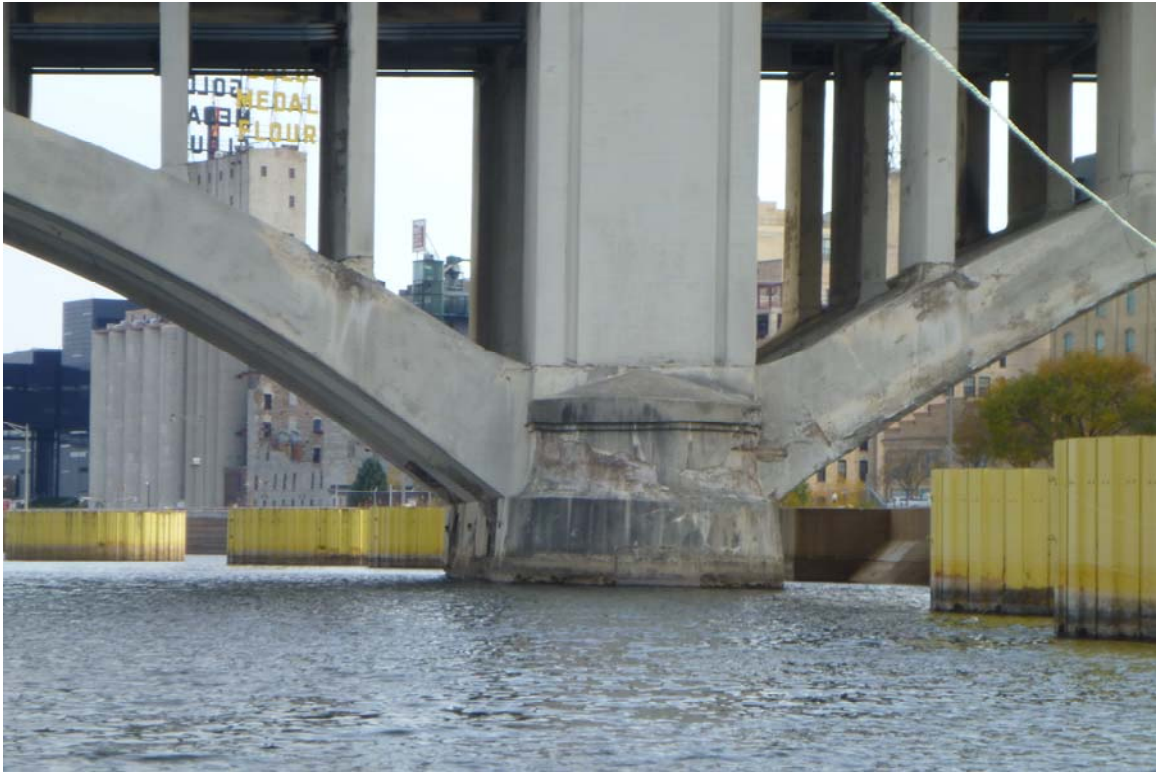
Photograph 3. View of Pier 2, Looking South.

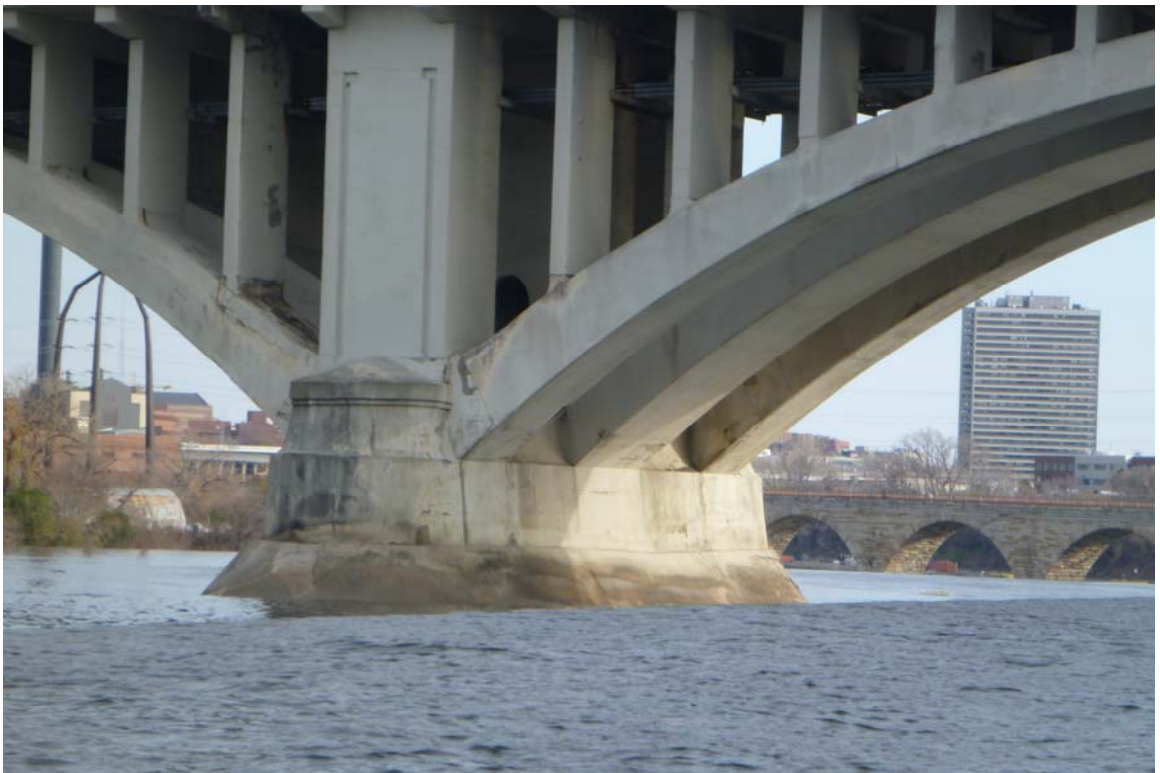
- (K) Pier 3 and 4 continue to be adequately founded in the concrete construction of the adjoining spillway.

Photograph 4. View of Pier 3, Looking Southeast.

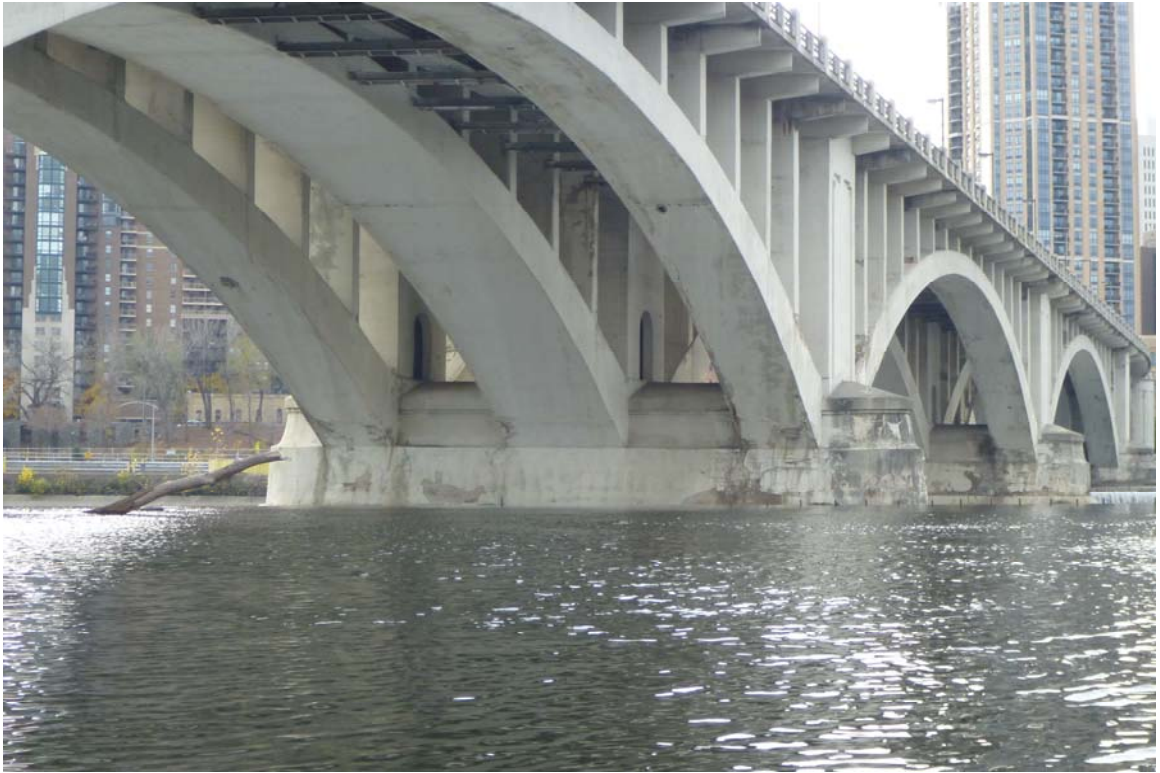
Photograph 5. View of Pier 4, Looking West.

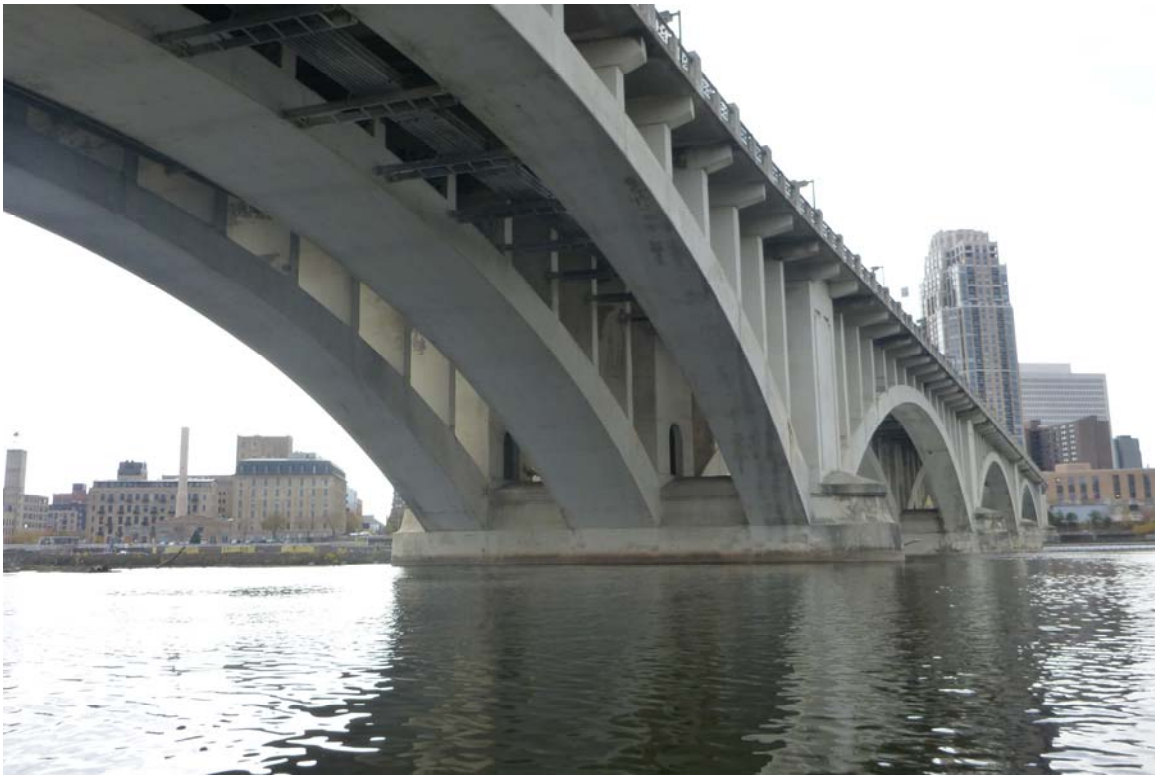
- (E) The concrete of Piers 7 and 8 exhibited a 1 to 1.5 foot high band of light to moderate scaling at the waterline with 1 to 3 inch penetrations.
- (F) An area of section loss, measuring 5 feet wide by 3 feet high with 2 to 3 foot penetration, was located on the east side of Pier 5 near the downstream 1/4 point at approximately 3 feet below the waterline.

- (J) Heavy accumulation of timber debris, consisting of up to 2 foot diameter drift pieces, was observed along the downstream half of the west face of Pier 5, extending from the channel bottom to 3 feet above the waterline.

Photograph 6. View of Pier 5, Looking West.

- (B) Monitor timber debris accumulation at Pier 5 during future inspections, and consider removal operations if debris is found to be increasing to an excessive extent.

- (C) Presently, given the overall massive size of Pier 5 (compared to the cavity in/under the footing) and the fact that there was no notable deflection/settlement of the structure at the time of inspection, Pier 5 appears to be stable. The cavity that was in/under the pier footing appears to be related to erosion of rather old concrete, and this condition has progressed significantly since the previous inspection. Consequently, it is recommended that serious consideration be given to addressing the conditions at Pier 5. The recommended corrective measures should include a structural analysis of the pier, and the analysis should consider the estimated loss of bearing under the footing. Based on the analysis, the above mentioned defects will most likely warrant countermeasures/repairs. The countermeasures could include the placement of riprap around the undermined/exposed footing and filling the cavity with pumped grout. The Pier 5 foundation should be closely monitored until a structural analysis and warranted repairs are implemented.

- (E) Until a structural analysis and necessary repairs are implemented at Pier 5 the structure should be closely monitored and placed on a reduced underwater inspection interval of twenty four (24) months.

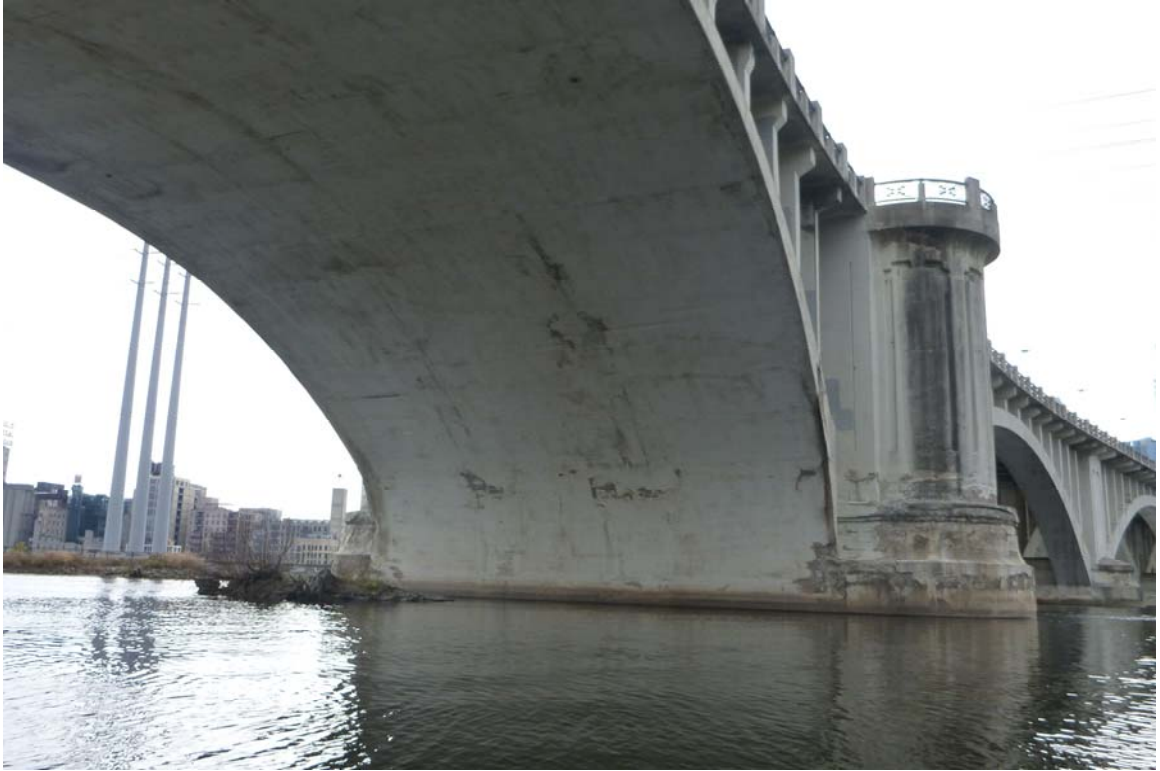
- (H) The footing at Pier 6 was exposed around the upstream nose with a maximum vertical exposure of 4 feet.
- (I) The footing step at Pier 8 was exposed along the west face of Pier 8 with up to 3.5 feet of vertical exposure.

Photograph 7. View of Pier 6, Looking West.

- (D) Monitor footing exposures at Piers 1, 2, and 6 during future inspections, and if exposure is found to be increasing to a detrimental extent, implementation of scour countermeasures may become warranted at that time.

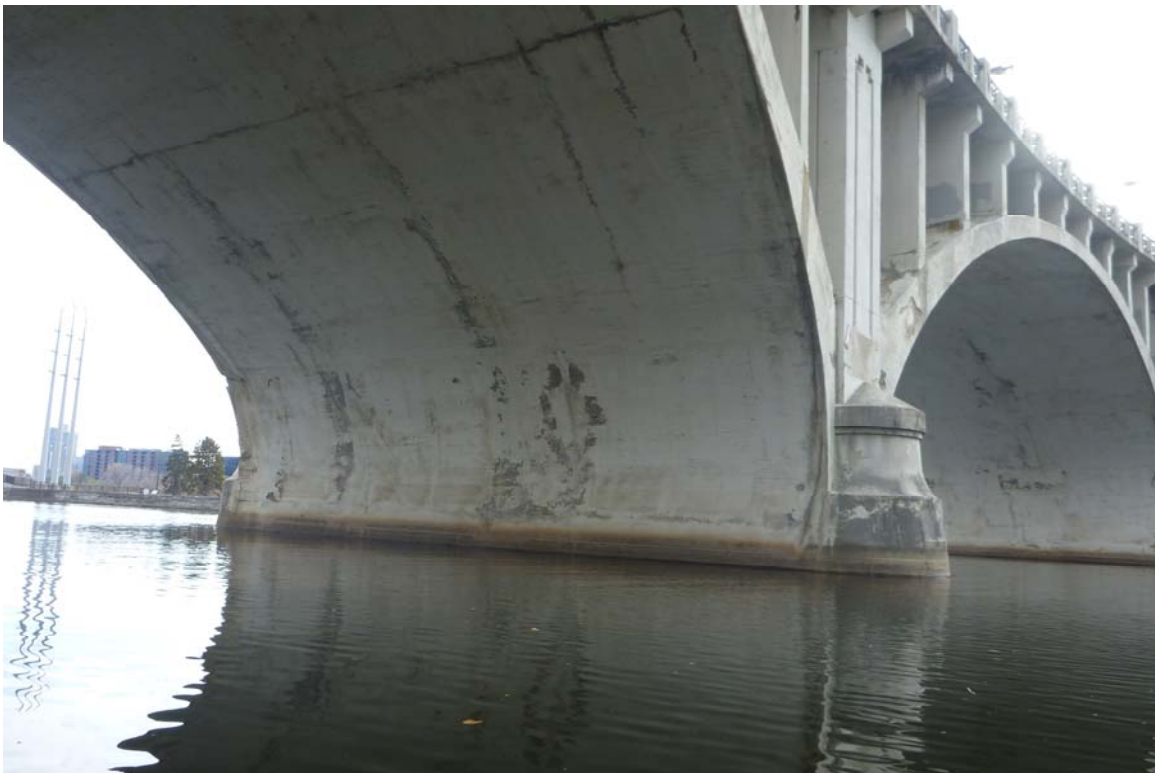
Photograph 8. View of Pier 7, Looking Southwest.

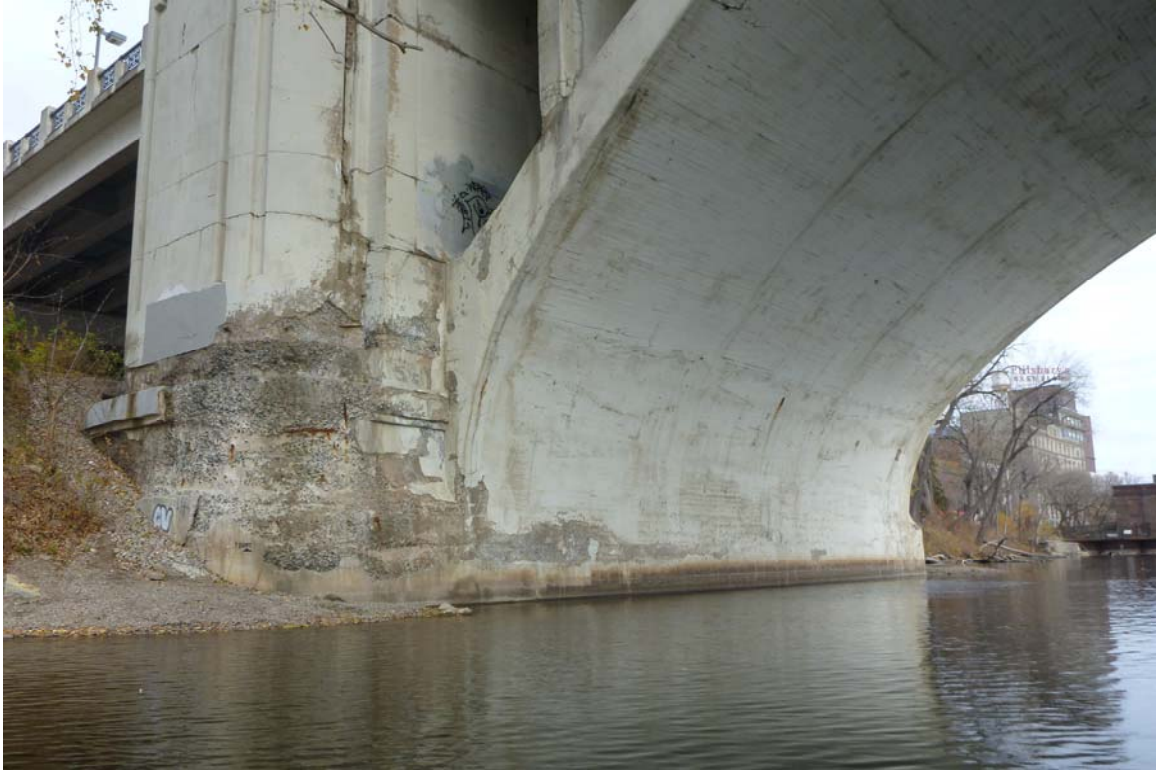
Photograph 9. View of Pier 8, Looking Southeast.

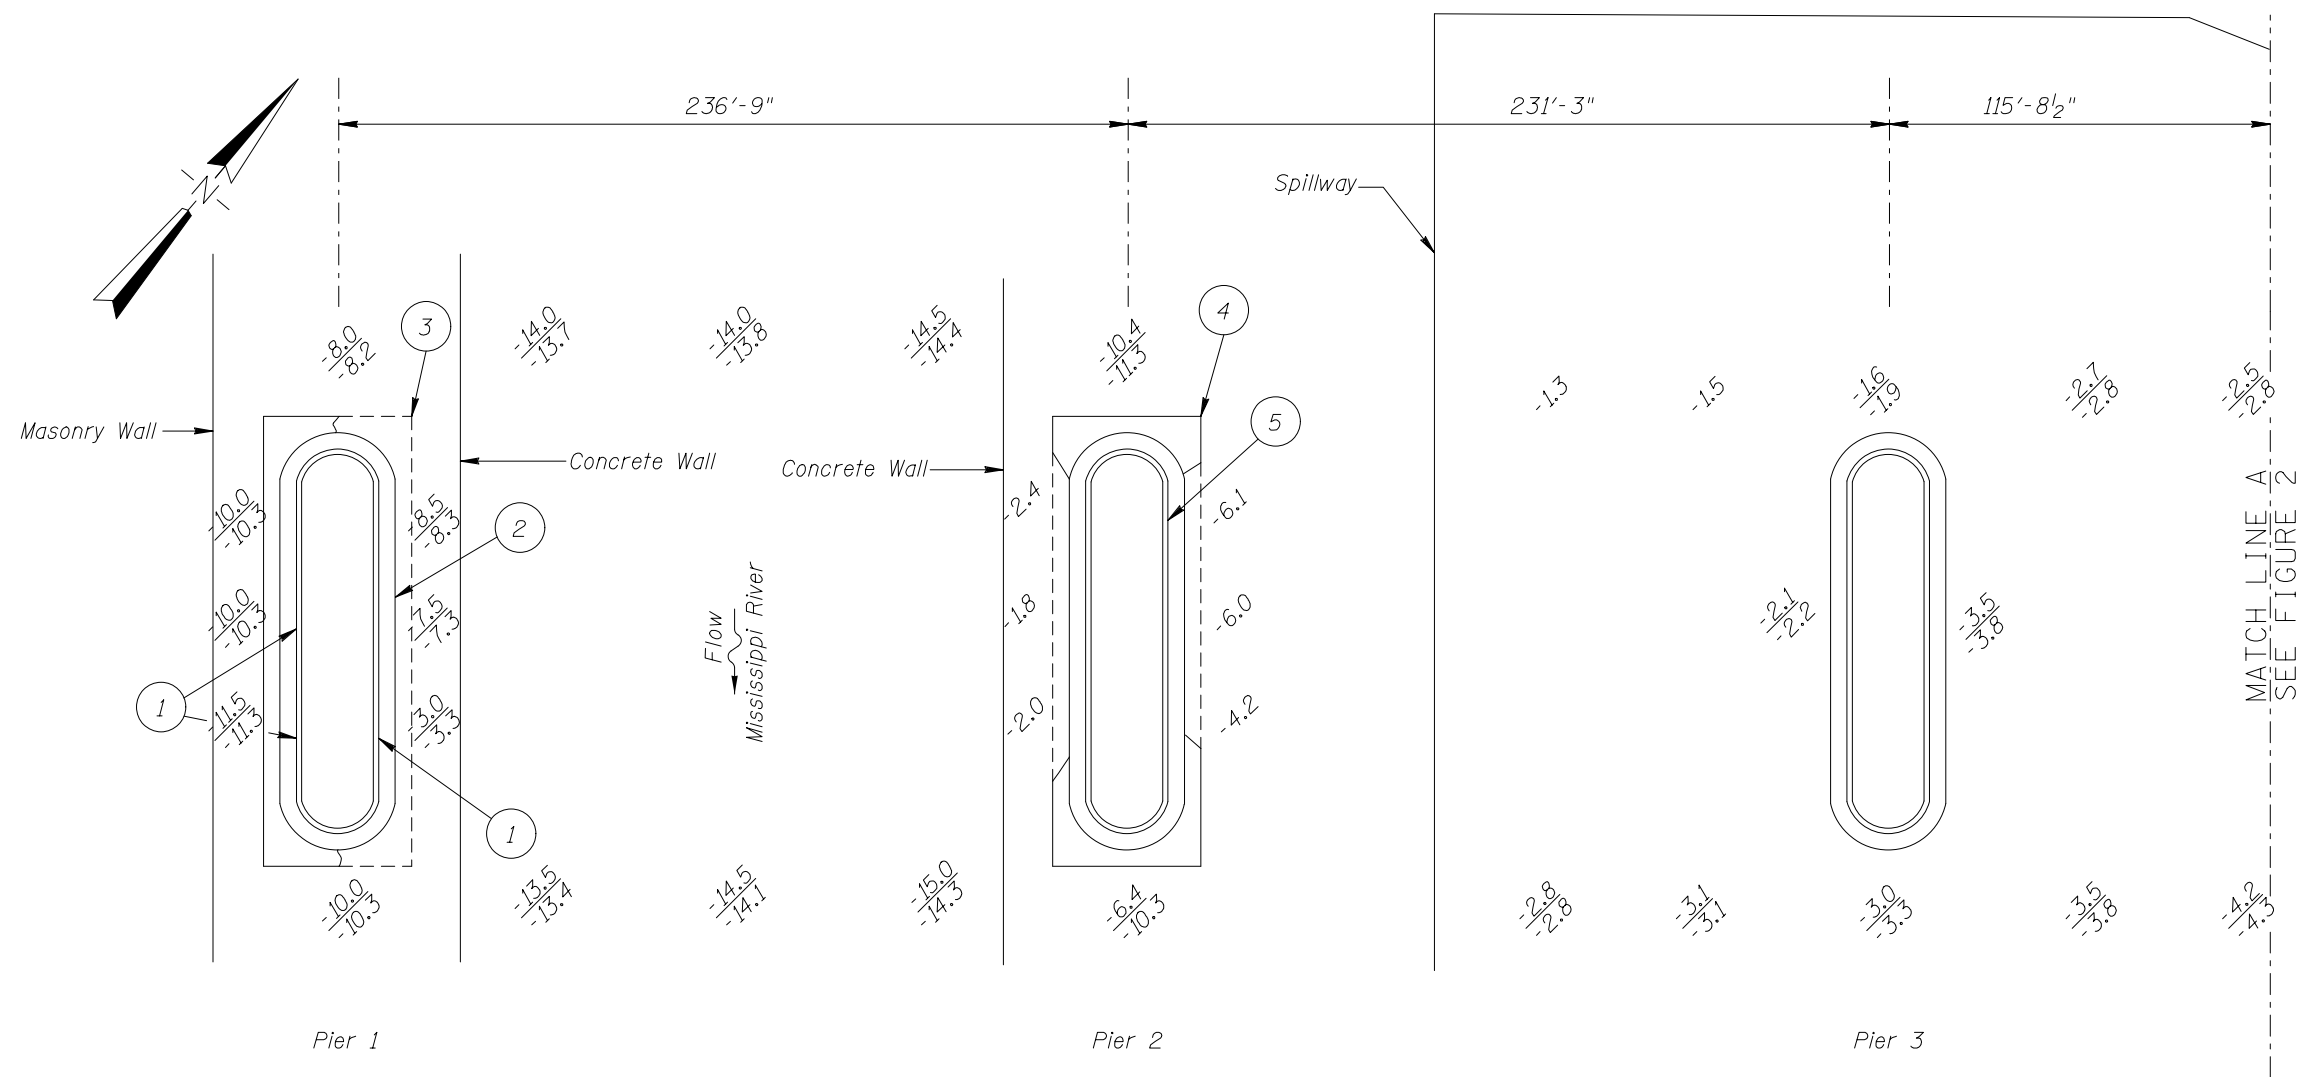
INSPECTION AND SOUNDING PLAN

- 1 Up to 1/4 inch wide vertical cracks were observed at the midpoint and the downstream 1/4 point on the west face and near the 1/4 point on the east face of Pier 1, typically extending from 5 to 10 feet above the waterline to the top of the footing.

- 2 The concrete of Pier 1 exhibited widespread spalling and loss of section with typical penetrations of 6 inches to 1 foot and maximum penetrations of 2 feet, typically extending from 2 feet below to 4 feet above the waterline.

- 3 At Pier 1, the footing was exposed from the middle of the upstream nose, along the entire west face to the middle of the downstream nose. The vertical footing exposure ranged from 2 feet at the upstream corner to 3 feet at the downstream corner. The concrete of the footing exhibited moderate to heavy spalling and deterioration with 6 inch typical and up to 2 feet maximum penetration.

- 4 At Pier 2, the footing was exposed around the upstream and the downstream end of the pier. The vertical footing exposure at both ends of the pier typically varied from 3 to 4 feet.

- 5 The concrete of Pier 2 exhibited widespread spalling and loss of section with 6 inches to 1 foot deep penetrations, typically extending from 2 feet below to 4 feet above the waterline.

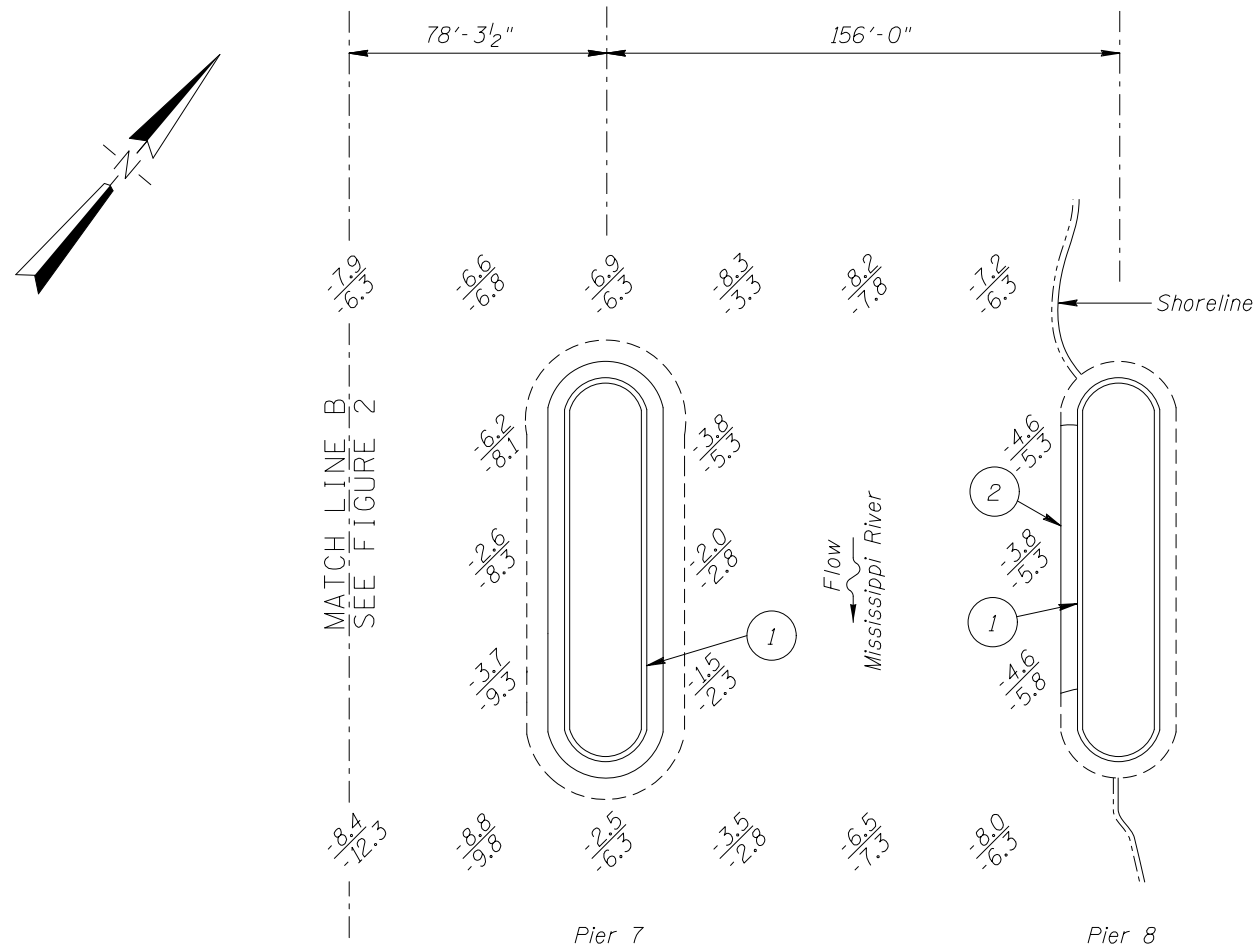
- 1 A band of moderate to heavy scaling, 1 to 1.5 foot high with 1 to 3 inch penetration, was present at the waterline around perimeter of Piers 7 and 8.
- 2 At Pier 8, the footing (shaft step) was exposed along the west face of the pier with 3 to 3.5 feet of vertical exposure.
