UNDERWATER BRIDGE INSPECTION REPORT

STRUCTURE NO. 2440

MISSISSIPPI RIVER

MINNESOTA DEPARTMENT OF TRANSPORTATION
UNDERWATER BRIDGE INSPECTION

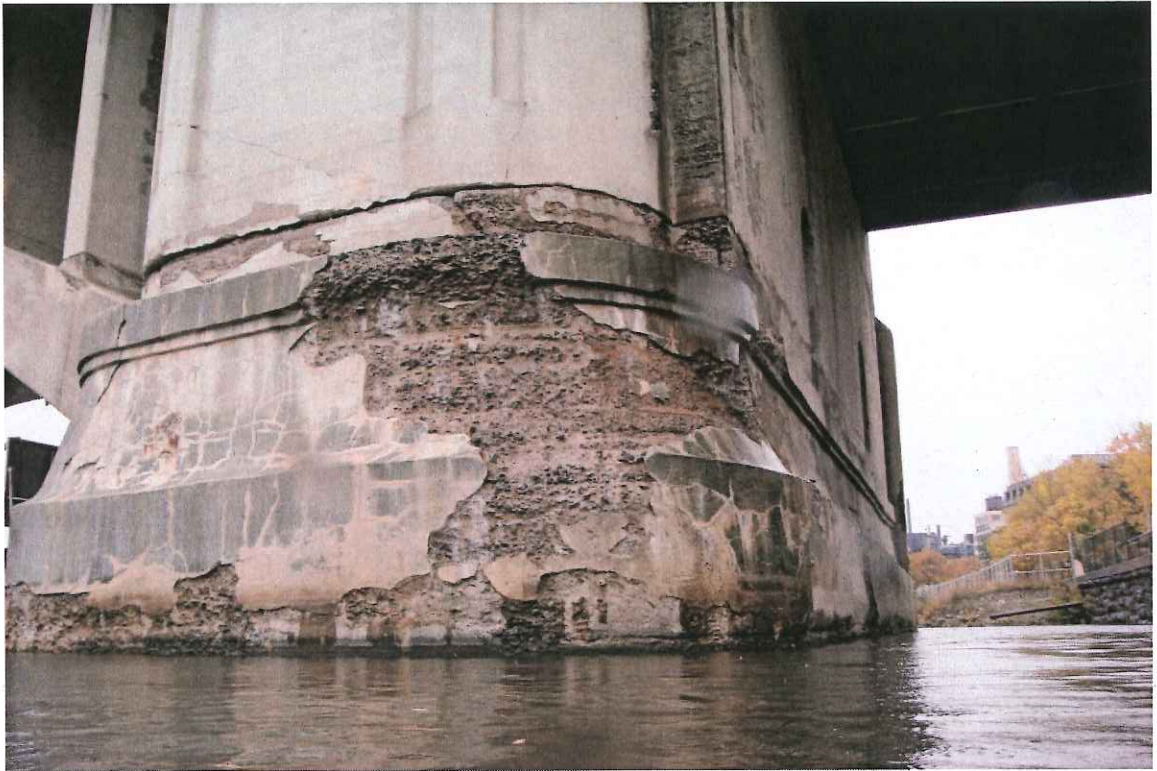
Photograph 3. View of Pier 1, Looking Southeast.

- 2 The concrete of Pier 1 exhibited widespread spalling and loss of section with typical penetrations of 6 inches to 1 foot and maximum penetrations of 2 feet, typically extending from 2 feet below to 4 feet above the waterline.

- 3 At Pier 1, the footing was exposed from the middle of the upstream nose, along the entire west face to the middle of the downstream nose. The vertical footing exposure ranged from 2 feet at the upstream corner to 3 feet at the downstream corner. The concrete of the footing exhibited moderate to heavy spalling and deterioration with 6 inch typical and up to 2 feet maximum penetration.

- (A) The extent of concrete deterioration at Piers 1 and 2 does not pose an immediate threat to the structural integrity of those piers at this time, given the overall size of the piers. However, consideration should be given to repairing the deteriorated areas by removing all unsound concrete and replacing with new concrete designed to provide high durability and low permeability.

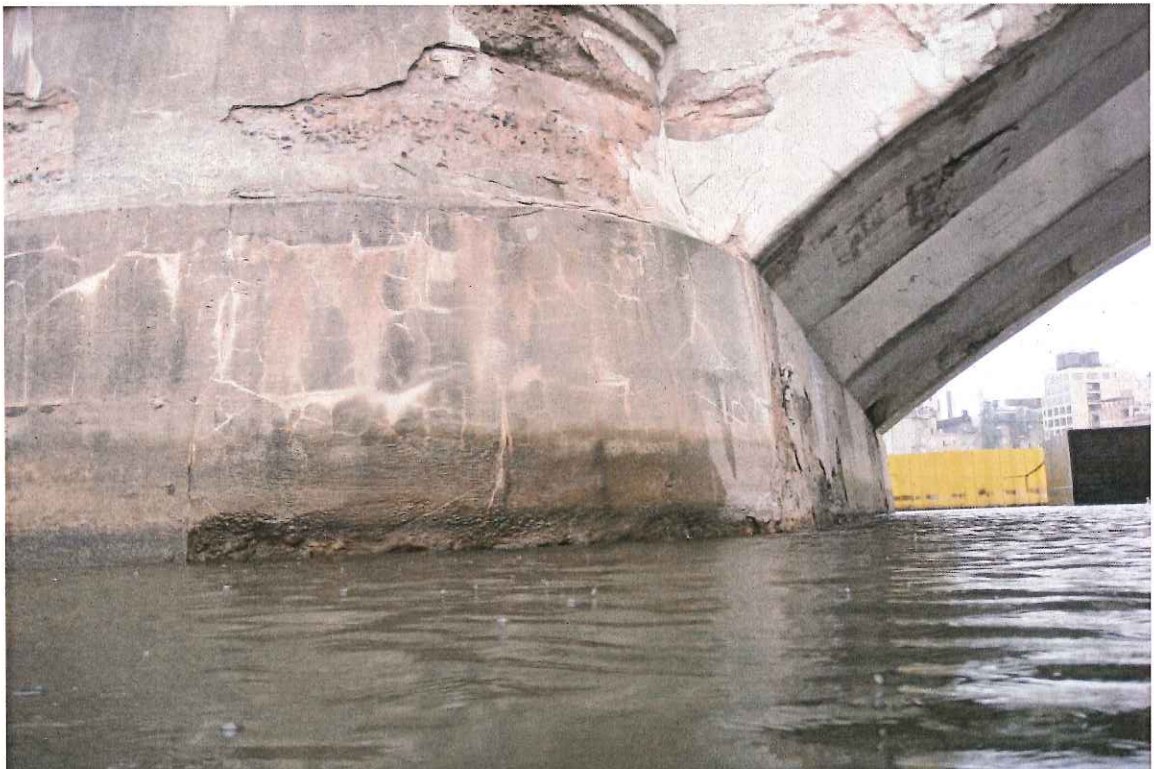
Photograph 4. View of Pier 2, Looking Southeast.

- 4 At Pier 2, the footing was exposed around the upstream 1/4 and the downstream 1/4 of the pier. The vertical footing exposure at both ends of the pier typically varied from 3 to 4 feet.

- 5 The concrete of Pier 2 exhibited widespread spalling and loss of section with 6 inches to 1 foot deep penetrations, typically extending from 2 feet below to 4 feet above the waterline.

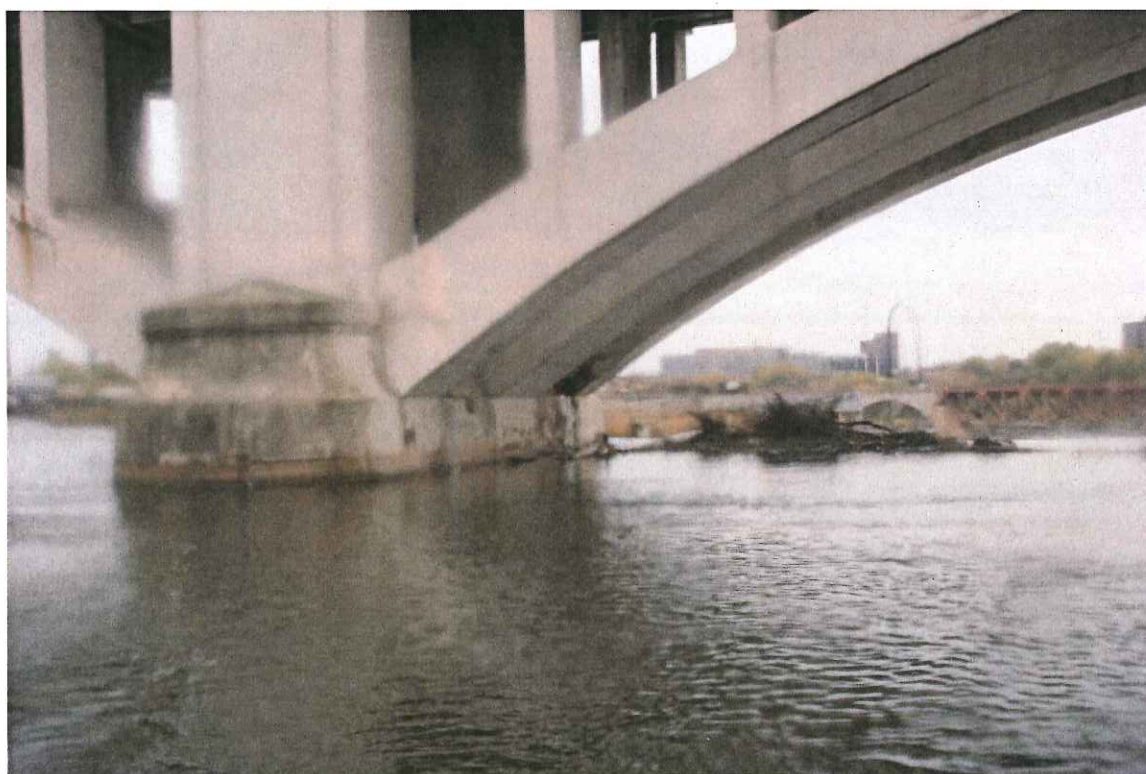
- (E) The concrete of Piers 7 and 8 exhibited a 1 to 1.5 foot high band of light to moderate scaling at the waterline with 1 to 3 inch penetrations.
- (F) An area of section loss, measuring 5 feet wide by 3 feet high with 2 to 3 foot penetration, was located on the east side of Pier 5 near the downstream 1/4 at approximately 3 feet below the waterline.

- (G) The footing at Pier 5 was exposed around the upstream 1/3 of the pier with 3 to 4 feet of typical vertical exposure. At the upstream nose of the pier, the footing was undermined (undercut from section loss) with a cavity measuring up to 2 feet in height with 2 to 3 foot penetration. The concrete of the footing also exhibited heavy deterioration with 2 to 3 foot penetration.

- (J) The footing step at Pier 8 was exposed along the west face of Pier 8 with up to 3.5 feet of vertical exposure.
- (K) Heavy accumulation of timber debris, consisting of up to 2 foot diameter drift pieces, was observed along the downstream half of the west face of Pier 5, extending from the channel bottom to 3 feet above the waterline.

Photograph 6. View of Pier 5, Looking East.

- (B) Monitor timber debris accumulation at Pier 5 during future inspections, and consider removal operations if debris is found to be increasing to an excessive extent.

- (C) Consideration should be given to implementation of scour countermeasures to address the undermined (undercut) foundation at Pier 5. The countermeasures could include the placement of riprap and/or pumped grout around the undermined/exposed footing.

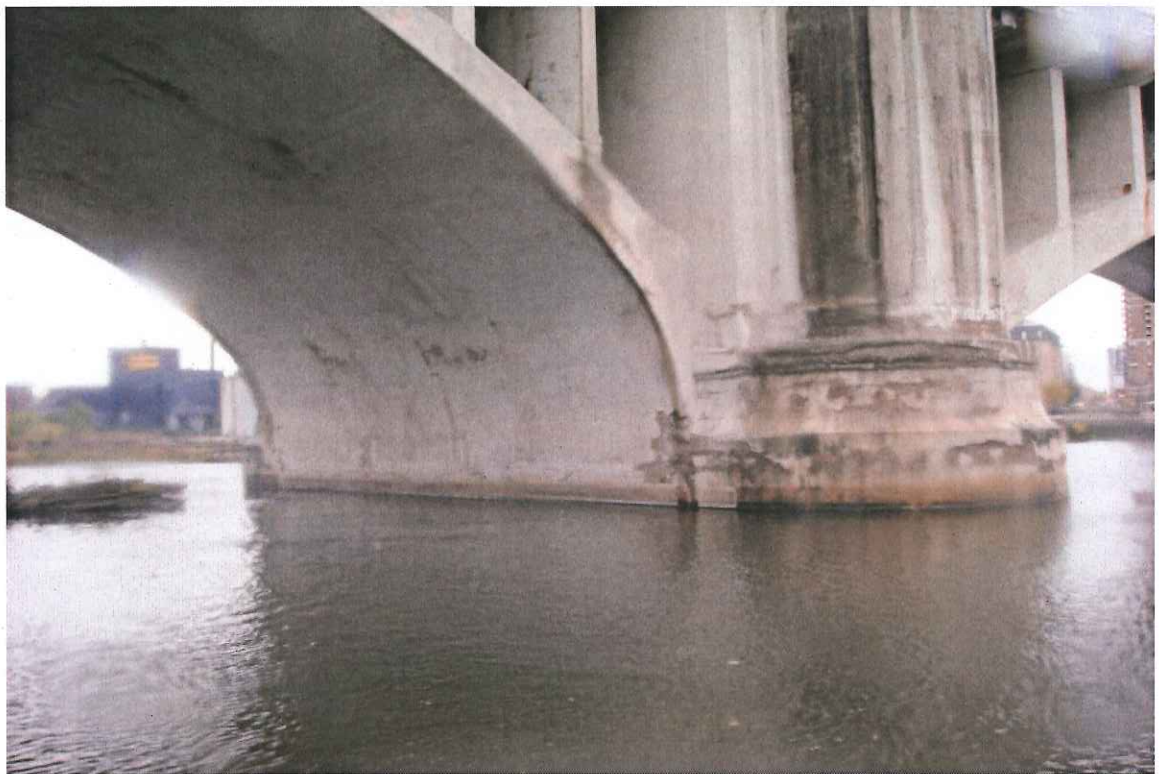
- (H) The footing at Pier 6 was exposed around the upstream nose with a maximum vertical exposure of 4 feet.
- (I) The footing at Pier 7 was exposed along the west side of the pier with 1 to 3 feet of vertical exposure. The footing exhibited a 20 foot wide area of section loss and undercutting with 6 inch to 1 foot penetrations.

Photograph 7. View of Pier 6, Looking Southwest.

- (D) Monitor footing exposures at Piers 1, 2, 6, and 7 during future inspections, and if exposure is found to be increasing to a detrimental extent, implementation of scour countermeasures may become warranted at that time.

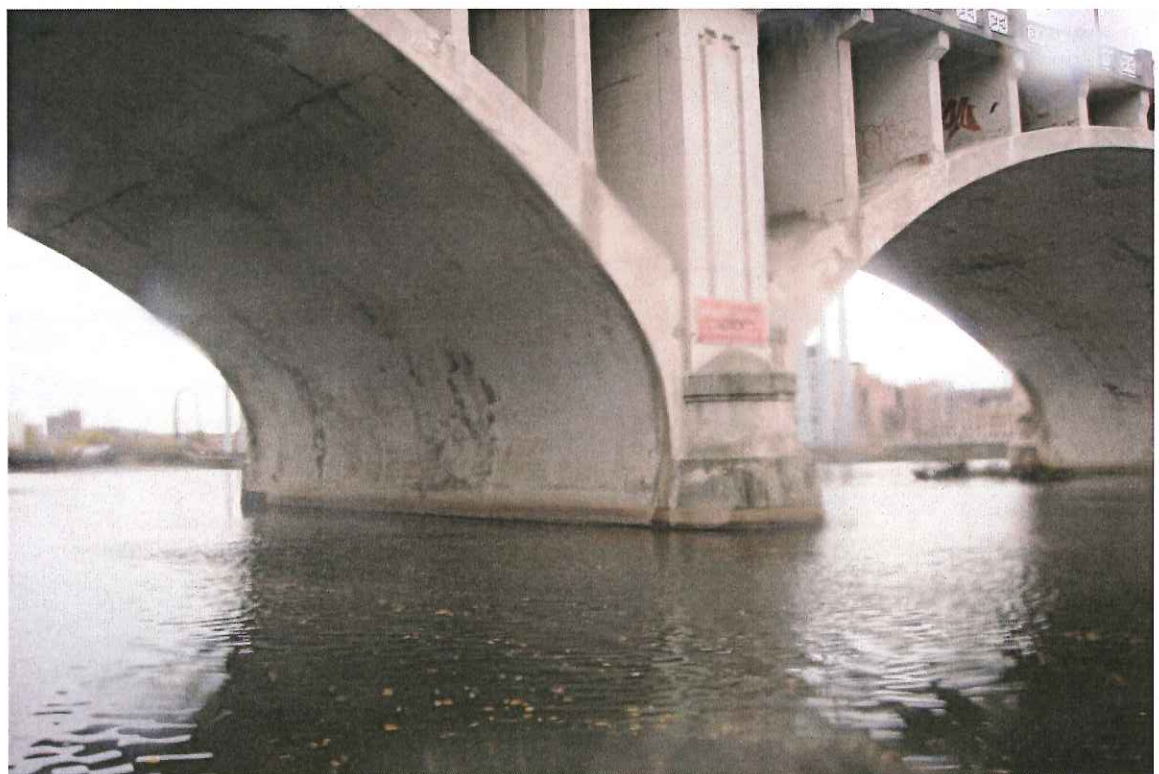
Photograph 8. View of Pier 7, Looking Southwest.

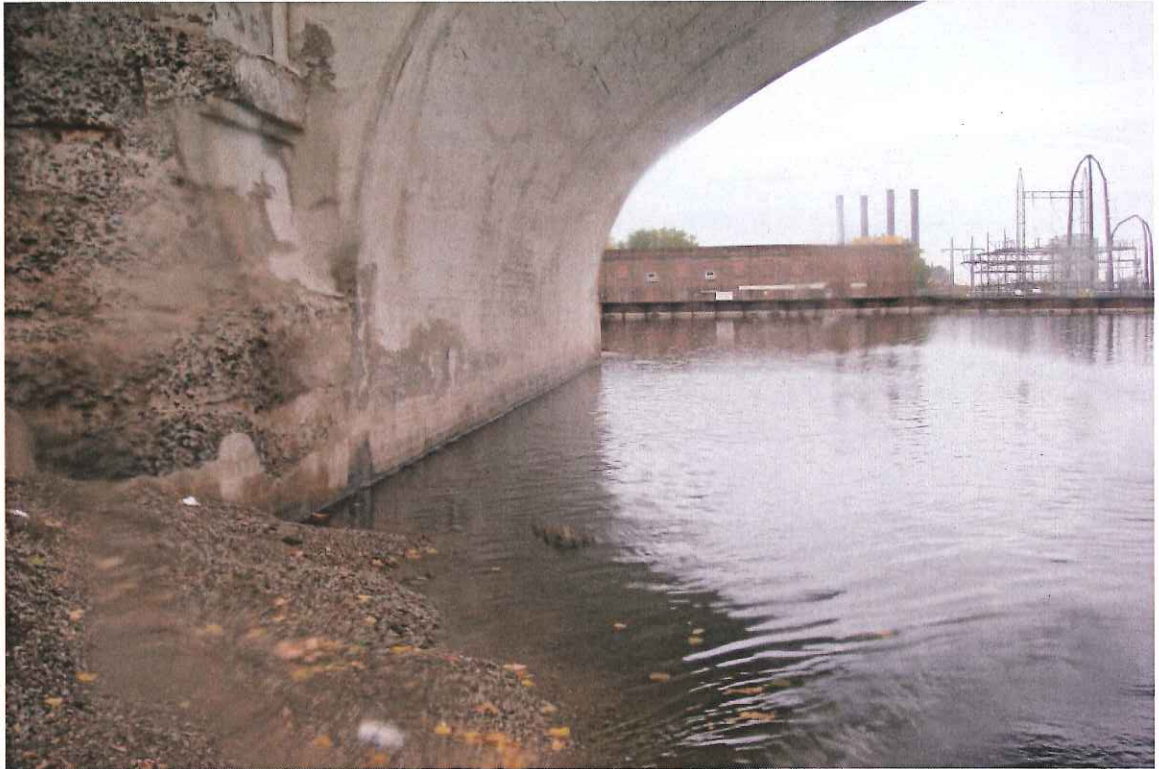
Photograph 9. View of Pier 8, Looking East.

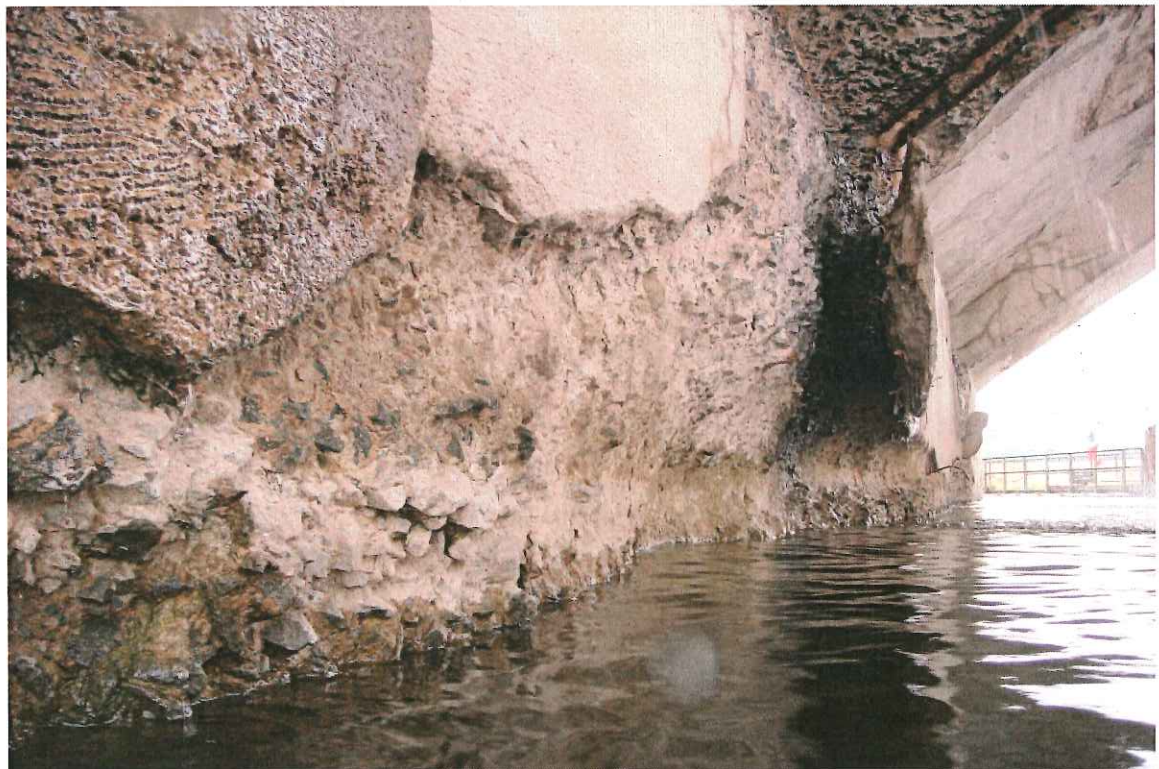
Photograph 10. View of typical concrete deterioration on the East face of Pier 1, Looking Northwest.

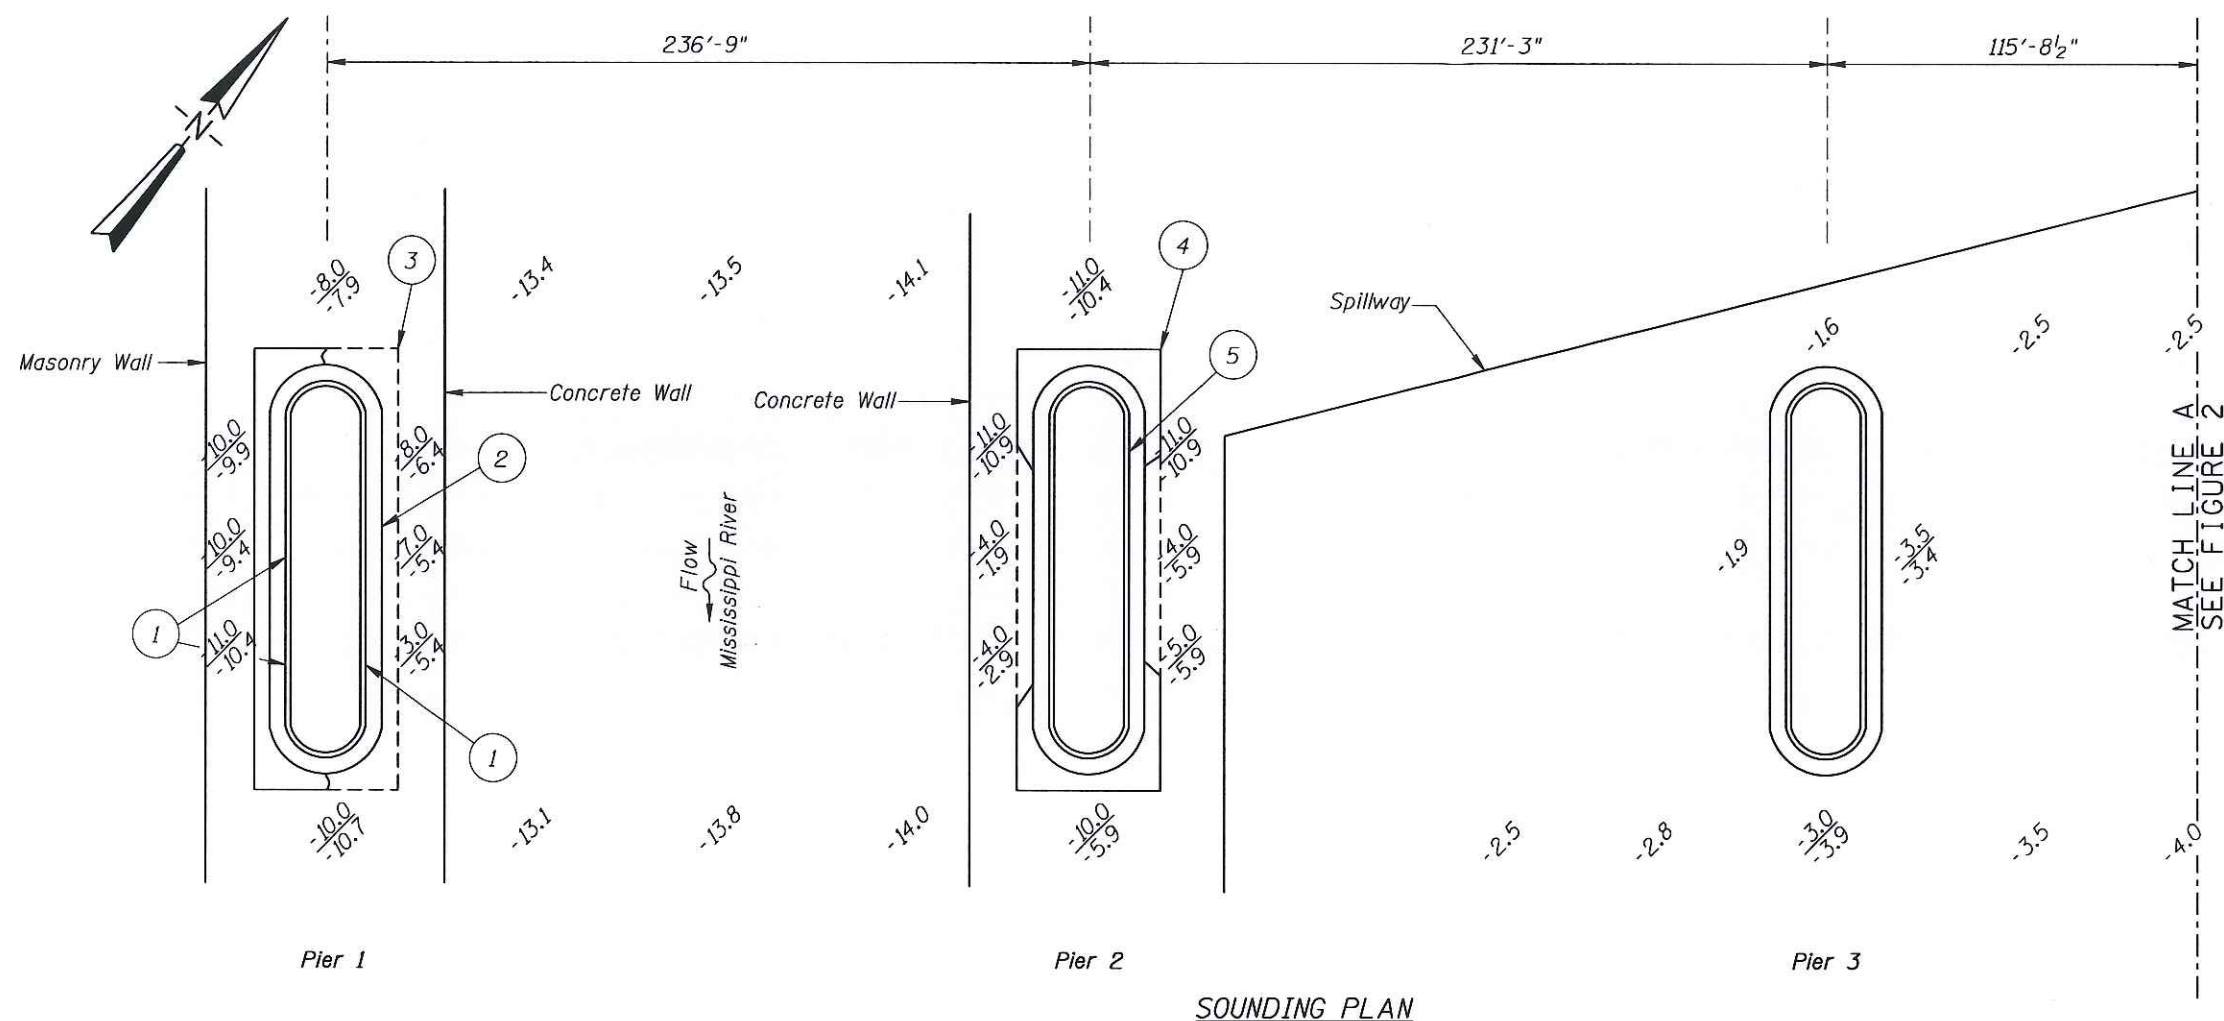
INSPECTION AND SOUNDING PLAN

- 1 Up to 1/4 inch wide vertical cracks were observed at the midpoint and the downstream 1/4 point on the west face and near the 1/4 point on the east face of Pier 1, typically extending from 5 to 10 feet above the waterline to the top of the footing.

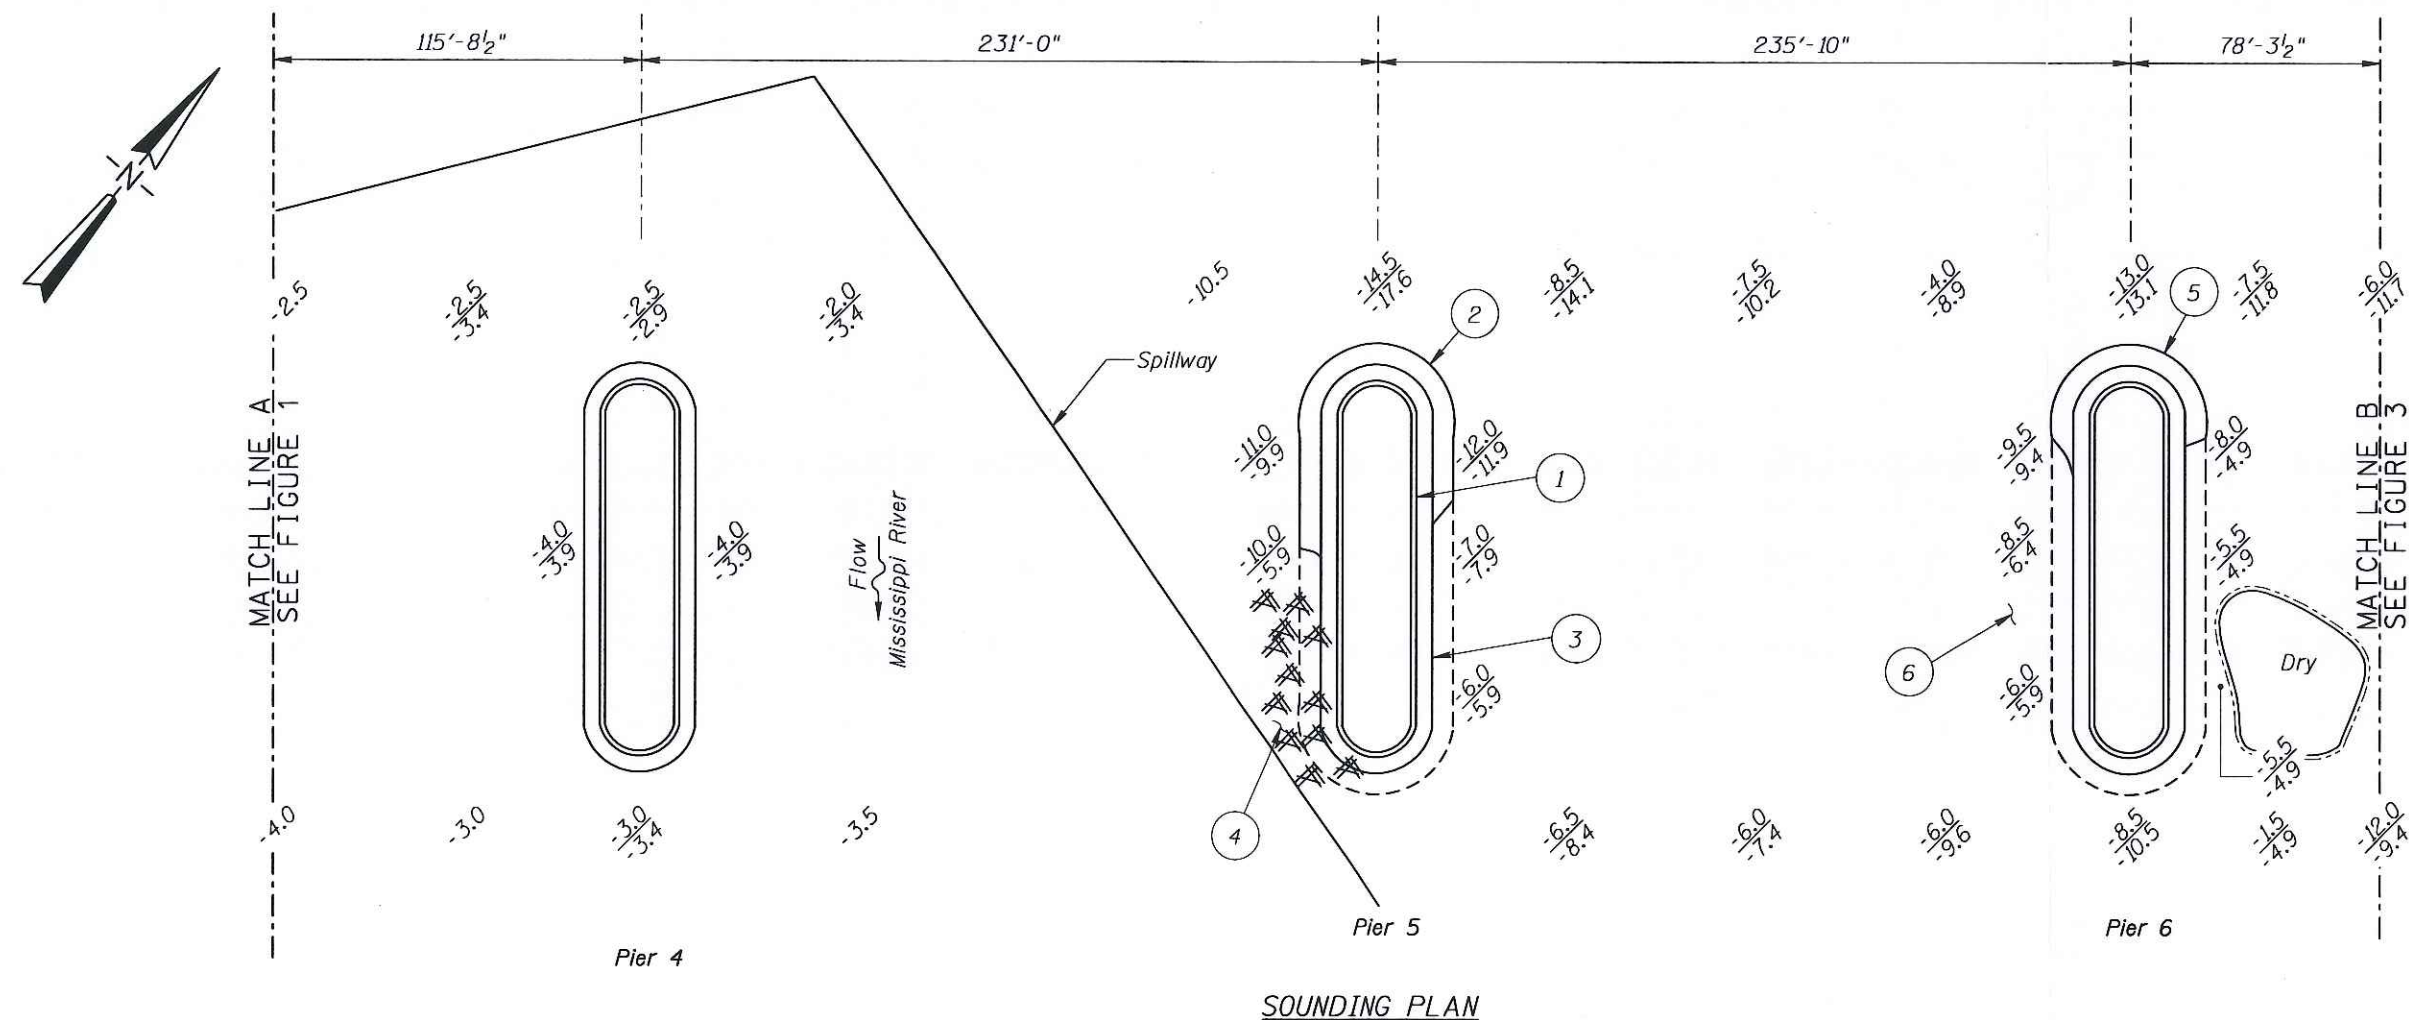
INSPECTION AND SOUNDING PLAN

- 1 The concrete of Pier 5 shaft exhibited random minor deterioration around the perimeter of the pier with 2 to 3 inch penetrations.
- 2 The footing at Pier 5 was exposed around the upstream 1/3 of the pier with typical vertical exposure of 3 to 4 feet. The footing was also undermined (undercut) at the upstream nose of the pier with vertical cavity height of 2 feet and typical penetration of 2 to 3 feet deep. The concrete of the footing at the upstream end exhibited deterioration with typical penetrations of 2 feet and maximum penetration of 3 feet.

- 3 A 5 feet wide by 3 feet high area of section loss was observed along the east side near the downstream 1/4 point of Pier 5, with penetration of 2 to 3 feet located approximately 3 feet below the waterline.

- 4 Heavy accumulation of timber debris, consisting of up to 2 foot diameter drift pieces, was observed at the downstream nose to the downstream 1/4 point along the west side of Pier 5, extending from the channel bottom to 3 feet above the waterline.

- 5 The footing at Pier 6 was exposed around the upstream nose of the pier with a maximum vertical exposure of 4 feet.
- 6 The channel bottom around the perimeter of Pier 6 was covered with concrete rubble.

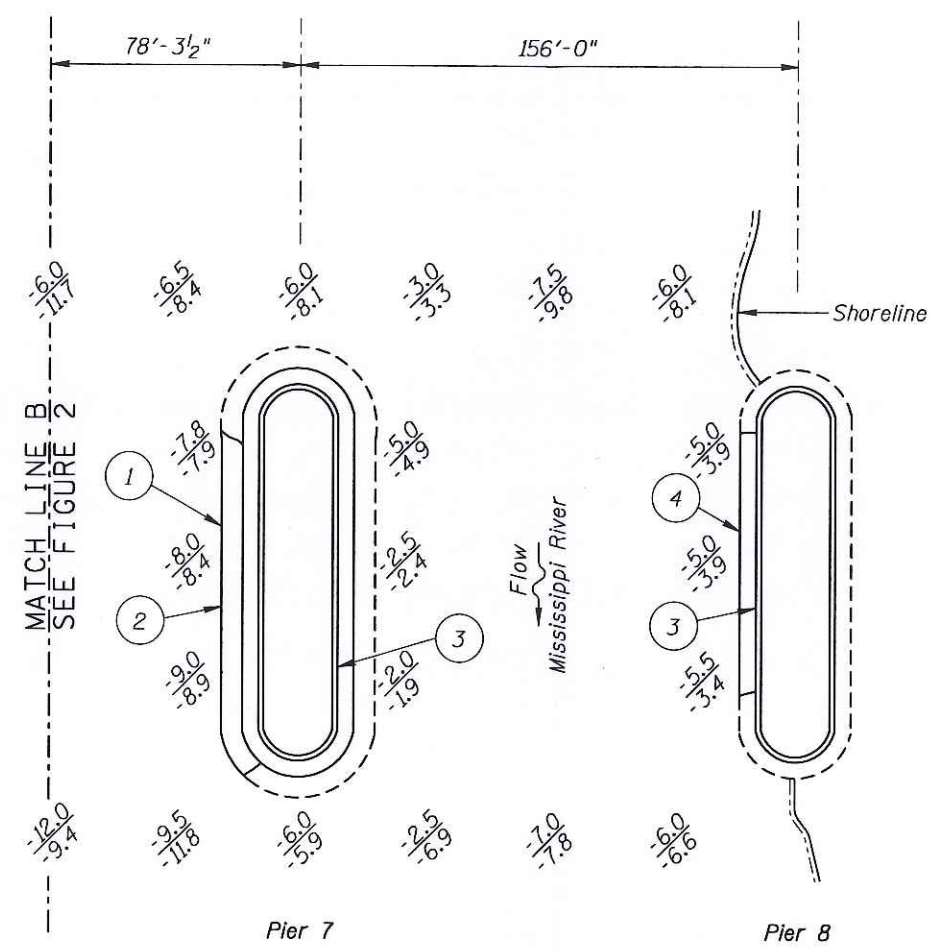
SOUNDING PLAN

- 1 The footing at Pier 7 was exposed along the west face of the pier, with vertical exposure ranging from 1 foot at the upstream end to 3 feet at the downstream end.
- 2 The exposed footing at Pier 7 exhibited an approximately 20 foot wide area of section loss with undercutting and 6 inch to 1 foot deep penetrations.
- 3 Band of light to moderate scaling, 1 to 1.5 foot high with 1 to 3 inch penetration, was present at the waterline around perimeter of Piers 7 and 8.
- 4 At Pier 8, the footing (shaft step) was exposed along the west face of the pier with 3 to 3.5 feet of vertical exposure.
