**UNDERWATER BRIDGE INSPECTION  
SUPPLEMENTAL REPORT  
for**

**Bridge 2440  
Minnesota Trunk Highway 65  
over  
Mississippi River**

PREPARED FOR:  
**Minnesota Department of Transportation**

PERFORMED BY:  
**Parsons Brinckerhoff Quade and Douglas, Inc.**

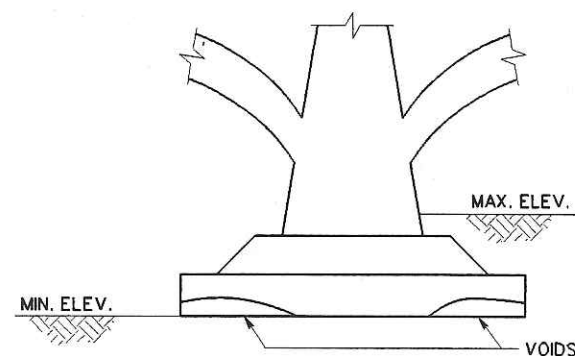
**END VIEW OF PIER 5**  
N.T.S.

upstream nose of the footing. The void in the south half of the footing nose measures 8' wide x 2.5' high x 6.5' deep. The void in the north half of the footing nose measured 8' wide x 2.5' high x 3' deep. The last inspection reported only one void located in the northwest corner and the reported depth was  $\pm 3'$ .

1. CHANNEL BOTTOM MATERIAL WITHIN 6' OF SUBSTRUCTURE UNIT WAS SAND WITH PROBE ROD PENETRATIONS OF  $\pm 6"$ .
2. MUCH CONCRETE AND STEEL REINFORCING DEBRIS ON CHANNEL BOTTOM AROUND UPSTREAM AND NORTH SIDE OF PIER.
3. VERTICAL FACE OF FOOTING BELL EXPOSED AS SHOWN WITH UNDERMINING POCKETS AT SOUTH AND NORTH SIDES OF UPSTREAM NOSE. SOUTH CAVITY WAS 8' WIDE  $\times$  2.5' HIGH  $\times$  6.5' DEEP. NORTH CAVITY WAS 8' WIDE  $\times$  2.5' HIGH  $\times$  3' DEEP. EXPOSED VERTICAL HEIGHT OF FOOTING WAS  $\pm 10'$ , INCLUDING THE FOOTING BEVEL.
4.  $\pm 15'$  LONG AREA OF HEAVIER SCALING EXTENDING BETWEEN WATERLINE AND EL. -1.5'. THE TYPICAL PENETRATION OF THIS SCALING WAS BETWEEN 2" AND 3".
5. HEAVY ACCUMULATION OF TIMBER DEBRIS EXTENDING FROM THE CHANNEL BOTTOM TO  $\pm 5'$  ABOVE THE WATERLINE.

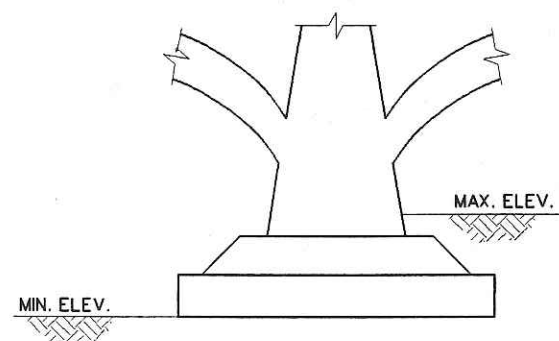
**END VIEW OF PIER 6**  
N.T.S.

- Pier 6 exhibited a maximum vertical exposure of the footing of 4.7' at the upstream nose. The exposed face of the footing shows 1-1/2" deep scaling over entire surface. The face of the pier exhibits moderate scaling around entire pier.
- Pier 7 exhibits moderate scaling around entire pier with heavier scaling along the west face. There was vertical footing exposure along the west face with a maximum 4.5 exposure at the center of the south face. The face of the footing exhibits heavy scaling with typical depths of 3" to 4" and localized areas up to 1' deep.
- Pier 8 exhibits heavy scaling along the west face from the mudline to 1.5' above the waterline with a maximum depth of 4".

3. MUCH CONCRETE AND STEEL REINFORCING DEBRIS ON CHANNEL BOTTOM.
4. VERTICAL FACE OF FOOTING BELL EXPOSED AS SHOWN WITH MAXIMUM HEIGHT, INCLUDING THE FOOTING BEVEL, OF 4.7' AROUND UPSTREAM NOSE. VERTICAL FACE EXHIBITS OVERALL SCALE APPROXIMATELY  $1\frac{1}{2}"$  DEEP.

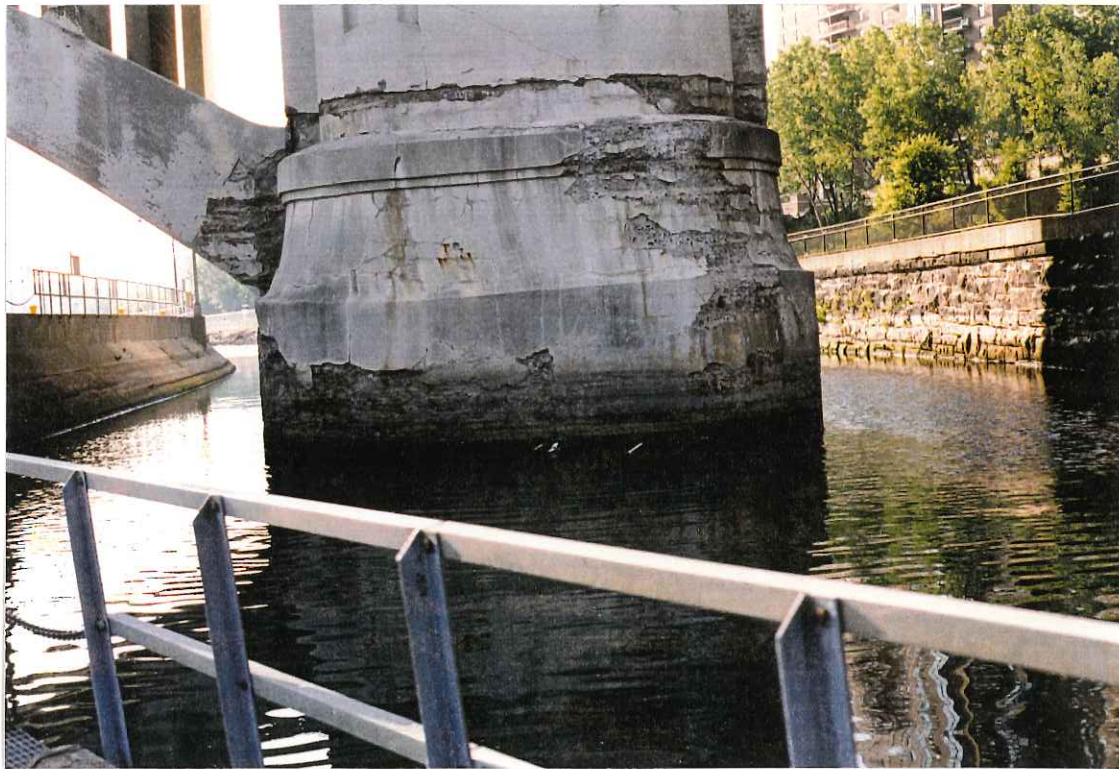
- Pier 1 exhibited heavy scaling around the entire pier with localized areas 2' to 3' high by 18' long by 1.0' to 1.5' deep. The aggregate is generally loose.

**Pier 1 - Upstream Nose (Scaling)**

- Remove the timber debris as part of routine maintenance.
- Repair void areas in footings at Piers 1 and 5.
- Repair severely spalled areas and exposed reinforcement.
- Inspect the bridge underwater at intervals not to exceed five years.

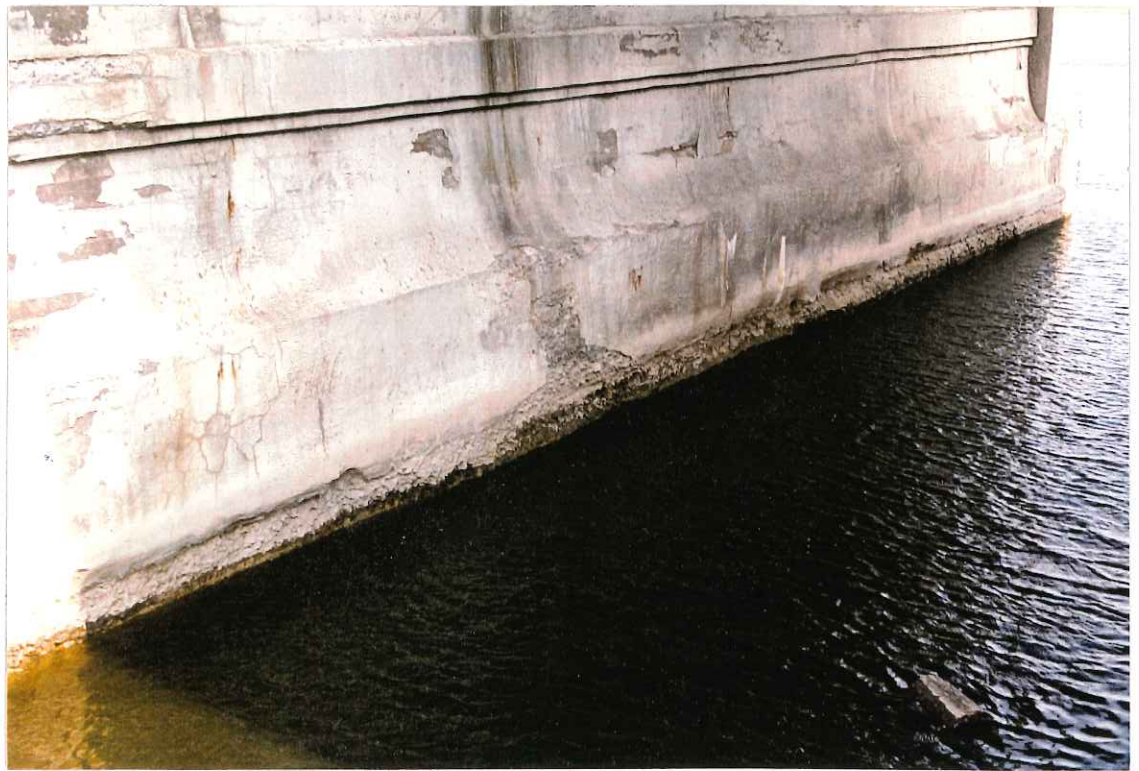
**Pier 1 - West Face (Scaling)**

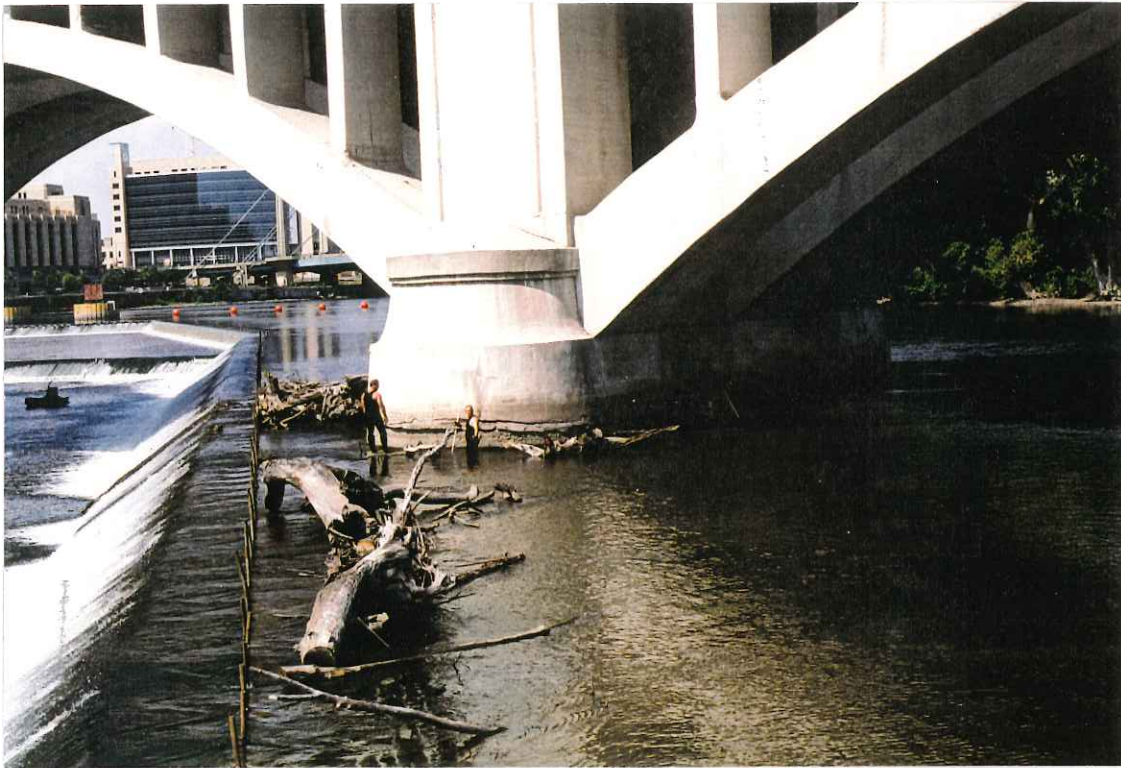
- At Pier 5 there was a large amount of timber debris, with large trees extending 5 feet above the waterline.

- Pier 4 exhibited moderate scaling around the entire pier.
- Pier 5 exhibited moderate scaling around the entire pier. A large accumulation of timber debris was located at the southwest corner of the pier. There were two void areas at the

**Pier 5 - Downstream End  
(Debris and Scaling)**

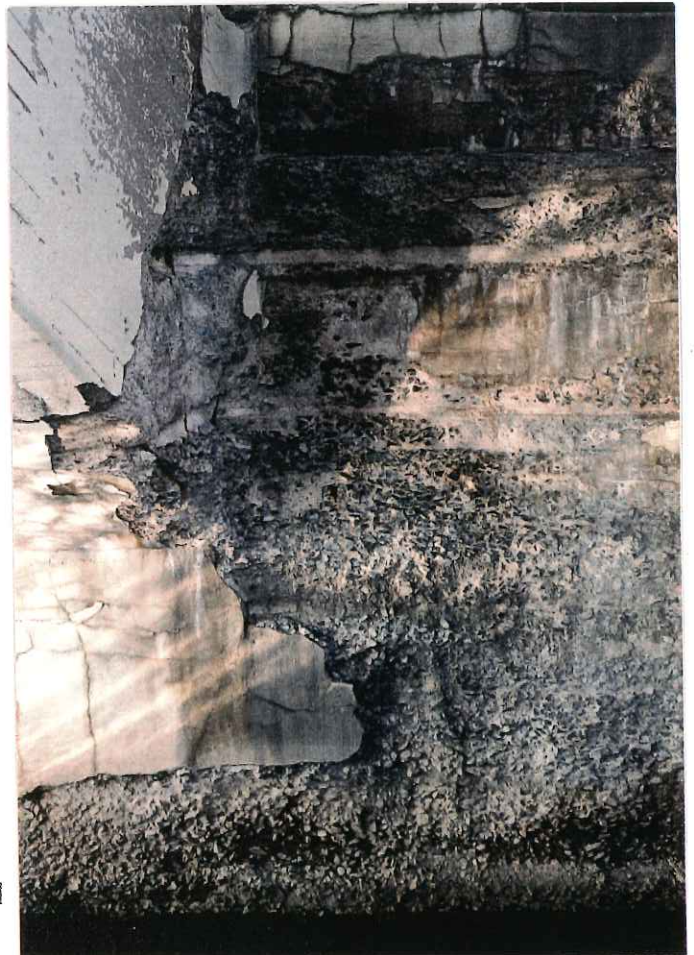
**Pier 1 - Between Center and  
North Arches (Scaling)**
