Minnesota Department of Transportation (Mn/DOT)

Historic Bridge Management Plan

Bridge Number: 2440

Executive Summary

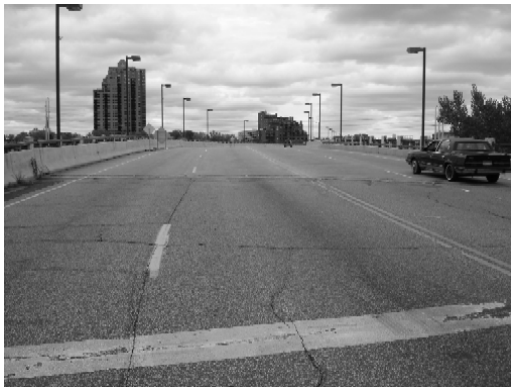
The bituminous approach for the south end of the bridge has also cracked extensively and appears heavily worn with minor rutting.

Figure 1. Looking north at the bridge from the south approach. The vehicle barriers are not symmetrical on the south end. A low profile barrier is provided on the east and a taller barrier is provided on the west. The approach roadway pavement is deteriorated and has extensive cracking.

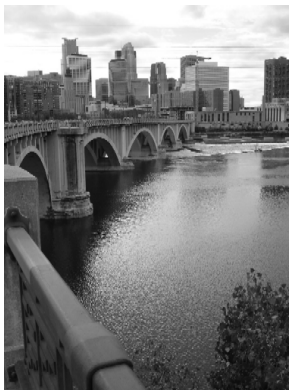
Figure 2. Looking south along the west side of the bridge from the west sidewalk. Stained, deteriorated concrete on the pier below the overlook is visible.

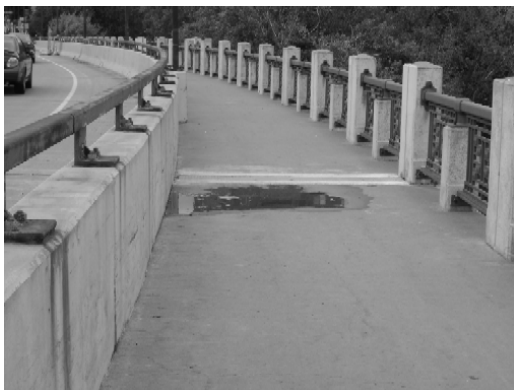
There is cracking in the deck on the west shoulder of the bridge. Localized ponding of water was visible in isolated locations on the east sidewalk during the site visit.

Metal railing components on the vehicular railing are rusting near "sharp" edges of components and staining the concrete below.

Figure 3. Looking north at the north end of the east sidewalk. Localized ponding adjacent to a reconstructed sidewalk expansion joint is visible. Staining on the vehicle barrier from the metal railing components and anchorages is typical.

4. Seal cracks in the deck and sidewalks utilizing standard Mn/DOT procedures.
5. Clean and paint the metal components of the vehicular railings. Utilize Mn/DOT standard procedures and match the existing paint color on the pedestrian railing.

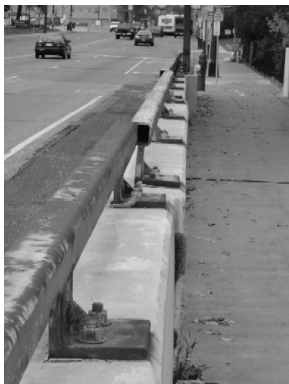
One segment of the east vehicular railing has rotated (top to the east) along the north approach. A horizontal offset of 1-2" is noted at the height of the metal railing.

Figure 4. Looking north at the east vehicular railing on the north approach. Settlement has led to shifting of the barrier both vertically and laterally.

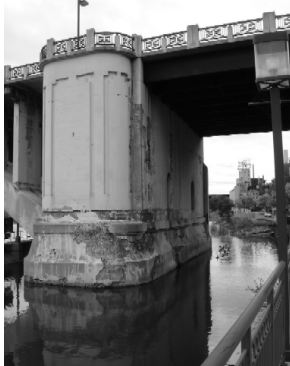
The weathering steel girders on the south approach spans are staining the substructure units, with the heaviest staining under the fascias.

The west and east faces of the south river pier have been repaired and appear to be in better condition than adjacent pier elements.

Figure 5. Looking east at the southernmost river pier. Deteriorated concrete is visible in many locations, primarily near the water line. The weathering steel beams supporting the south approach spans are also visible.

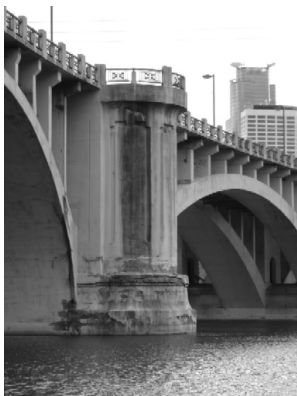
Figure 7. Staining and concrete spalls are visible on the north face of the west end of the pier between the barrel and rib arches.

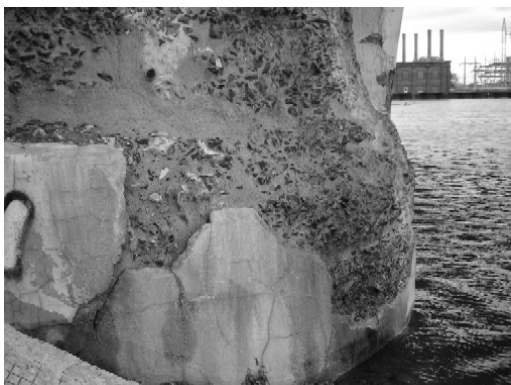
There is a substantial amount of graffiti on the inner walls of the pier on the north bank of the river. There are also several vertical cracks over the access openings. Shotcrete repairs on the west face of the pier have failed. During the site visit, water was visibly draining out of the pier in the spalled region.

Figure 8. Looking east at the northernmost river pier. Shotcrete repairs to the pier have failed. Large spalled regions, with water draining out of the deteriorated area, were visible during the site visit.

10. Based on the results of the concrete testing program, identify appropriate repairs for deteriorated regions. Repair deteriorated concrete components subsequent to any electrochemical chloride extraction rehabilitation. Conduct concrete repair using standard Mn/DOT repair methods and in compliance with National Park Service Preservation Bulletin 15 – Preservation of Historic Concrete. Consult with Mn/DOT's Office of Bridges and Structures before making final determination of the means and methods of concrete repairs. Apply Mn/DOT special surface finish to exposed concrete subsequent to the repairs. Apply anti-graffiti coating to the areas of the concrete susceptible to graffiti.
