## Asset Management Memorandum

**Re:** *Asset Management*  
*TH 11 Corridor Assessment*  
*WSB Project No. 03063-000*

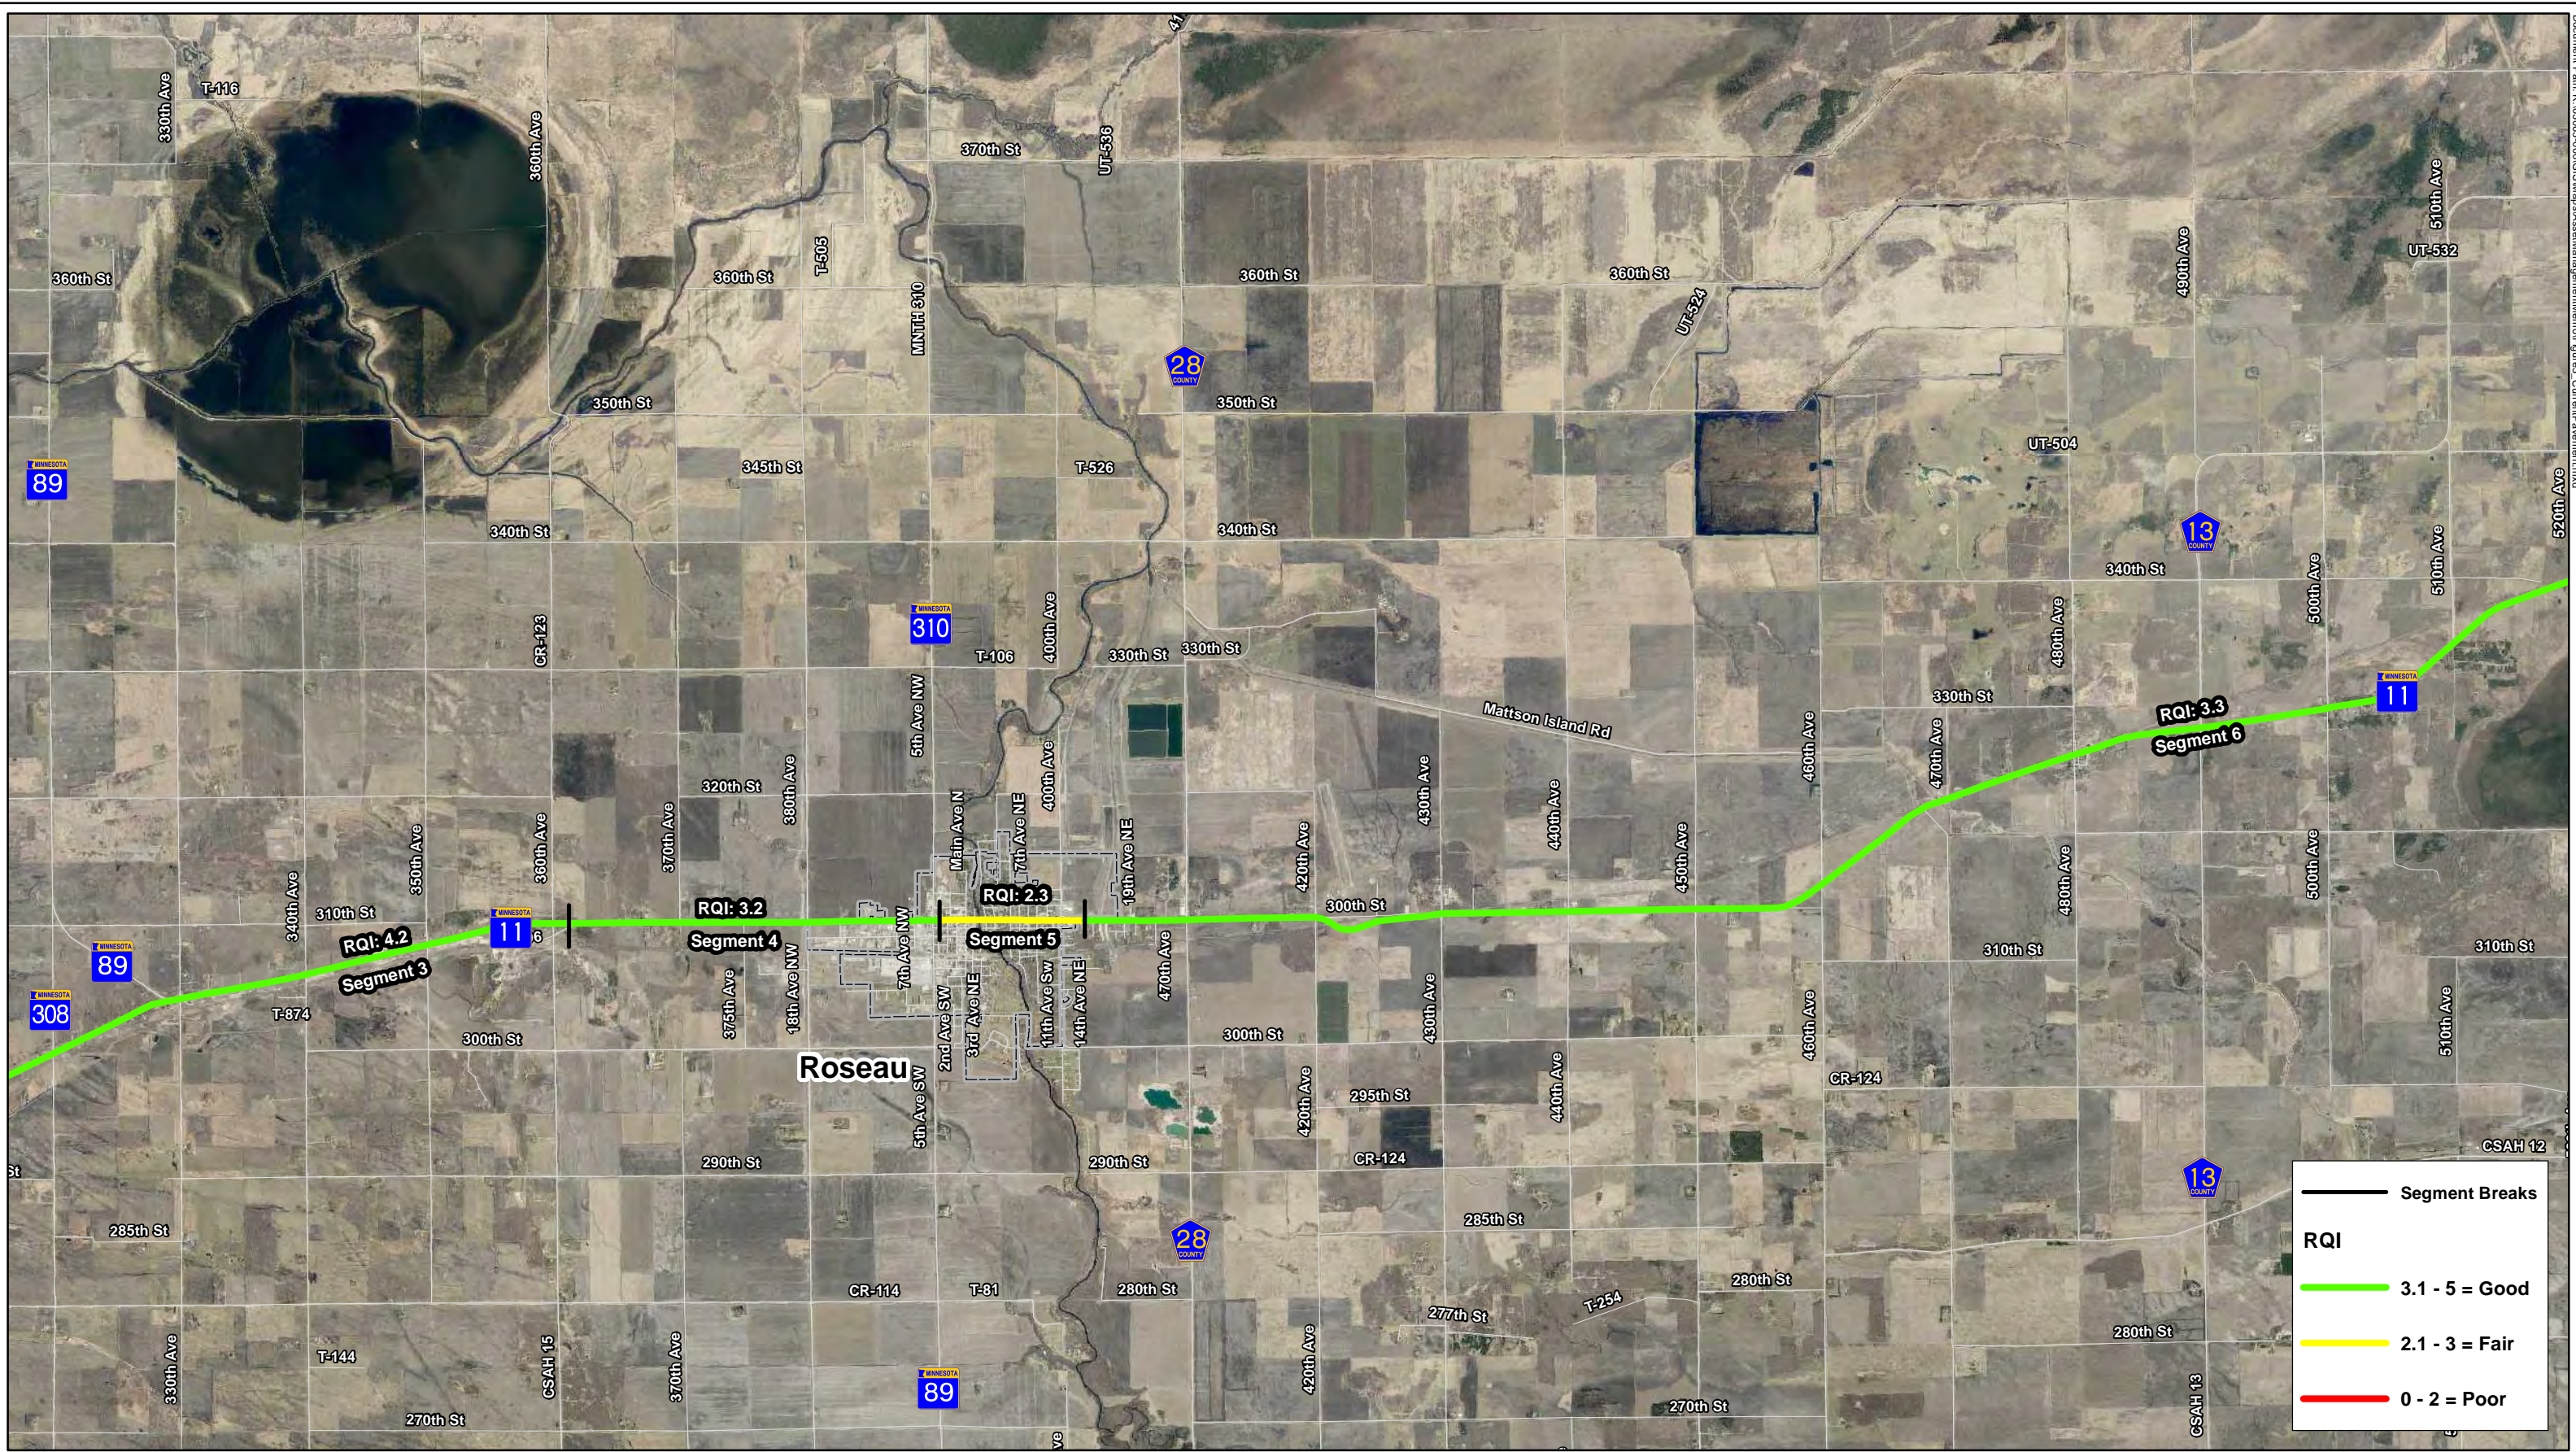
**Figure 3**  
**2014 Pavement Condition**  
**Roseau**

As of 2014, nearly the entire TH 11 corridor was considered to have good pavement condition. Only two segments had an RQI below 3.1. Segment 5 has an RQI of 2.3. This segment is a 1.2 mile segment of TH 11 in the center of Roseau, from TH 89/TH 310 to 14th Avenue NE. The RQI for this segment indicates an immediate need for reconditioning. No pavement reconditioning activities have occurred since 2006.

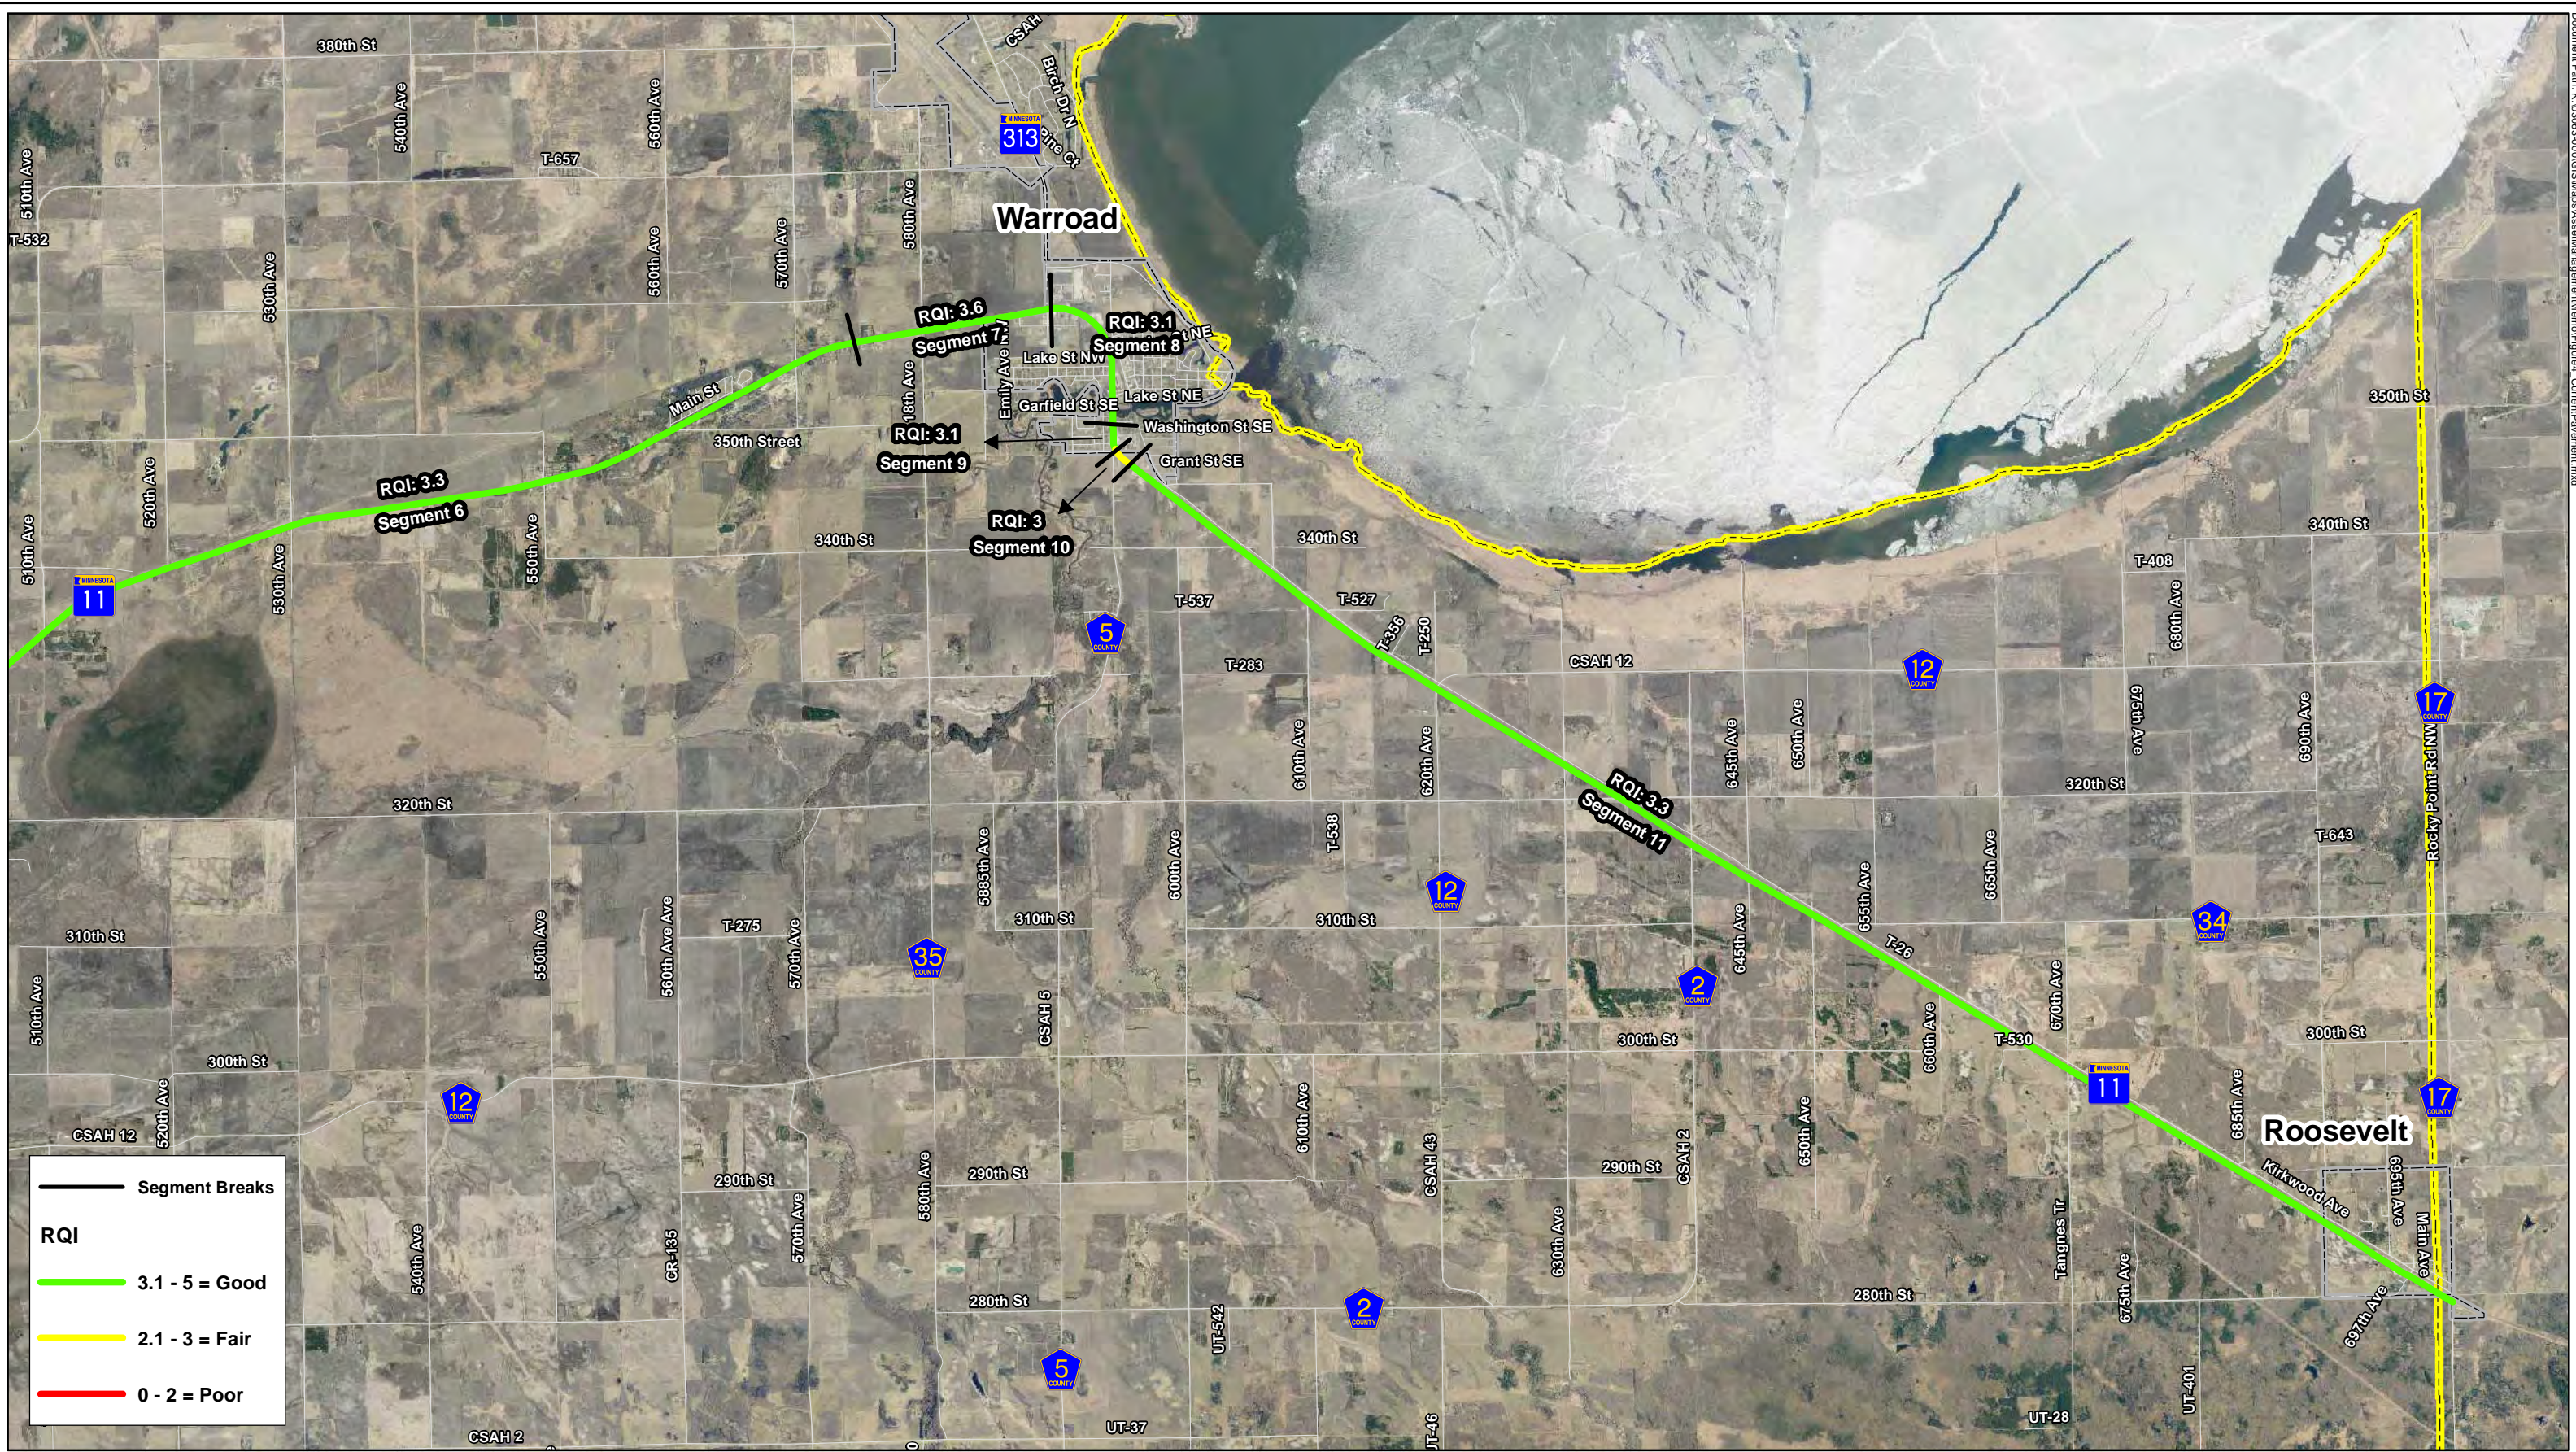
**Figure 4**  
**2014 Pavement Condition**  
**Warroad**

Segment 10 has an RQI of 3, at the upper limit of fair pavement condition. This is an 800-foot segment of TH 11 at the southern city limits of Warroad (300 feet north of CSAH 5 to 500 feet southeast of CSAH 5). The most recent maintenance on this segment was a thin mill and overlay in 2008. MnDOT is completing a 2 inch mill and overlay on segments 8-10 in 2015. Following the mill and overlay RQI is expected to be at 4.0 or above, which should extend the life of these segments until 2030. Pavement maintenance history on TH 11 indicates that the life of a mill and overlay is approximately 15 years. While **Table 1** shows that a thin mill and overlay was performed on segments 8-10 in 2008, the pavement seams near the wheel path have rapidly raveled between 2013 and 2014. As a result, MnDOT plans to accelerate the normal maintenance schedule for this segment.

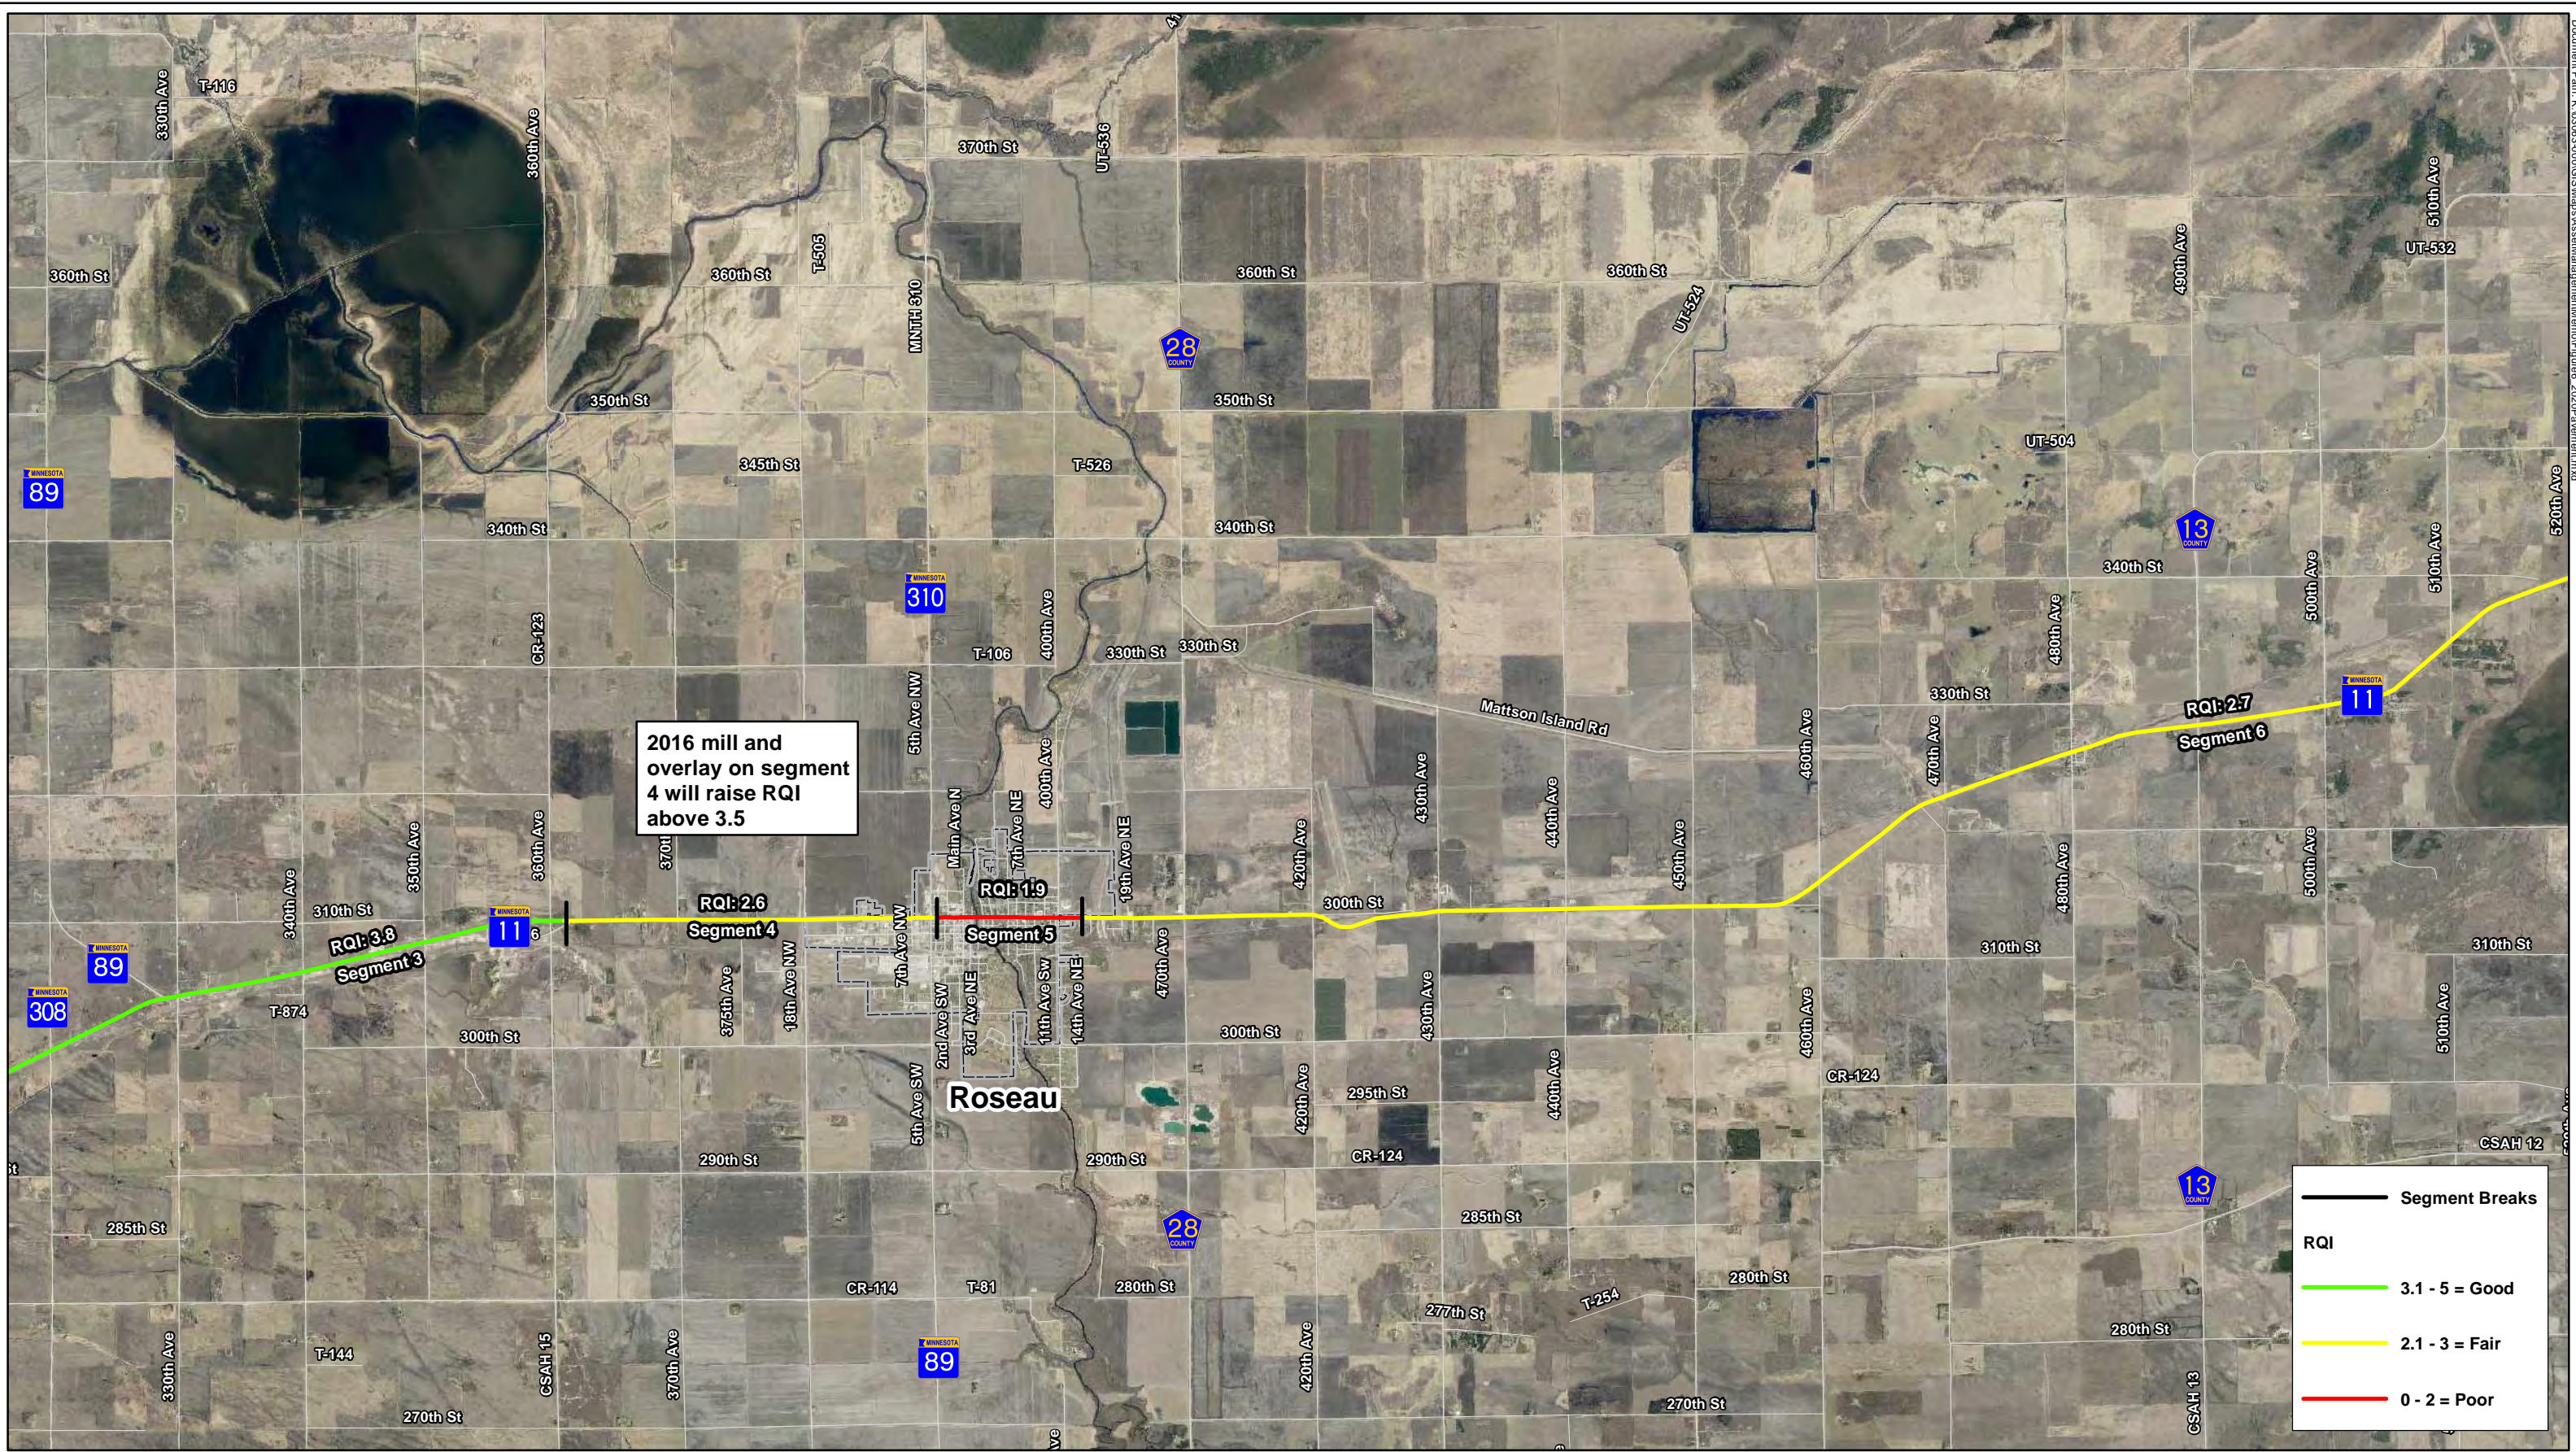
**Figure 6**  
**Predicted 2020 Pavement Condition**  
**Roseau**

As a result of planned maintenance activity before 2020, only one segment of TH 11 will remain below the 2.5 RQI threshold. Segment 5 in the center of Roseau (TH 89/TH 310 to 14th Avenue NE) is predicted to have an RQI of 1.9. No maintenance activities are planned for this segment prior to 2020; however, preventative maintenance is needed on this segment to extend the life of the roadway and reduce the need for roadway reconstruction. It should be noted that RQI measured in urban areas can be skewed because the measure is based on a 50 mph speed. In urban areas, there are also more manholes and utilities in the pavement that affect ride quality.

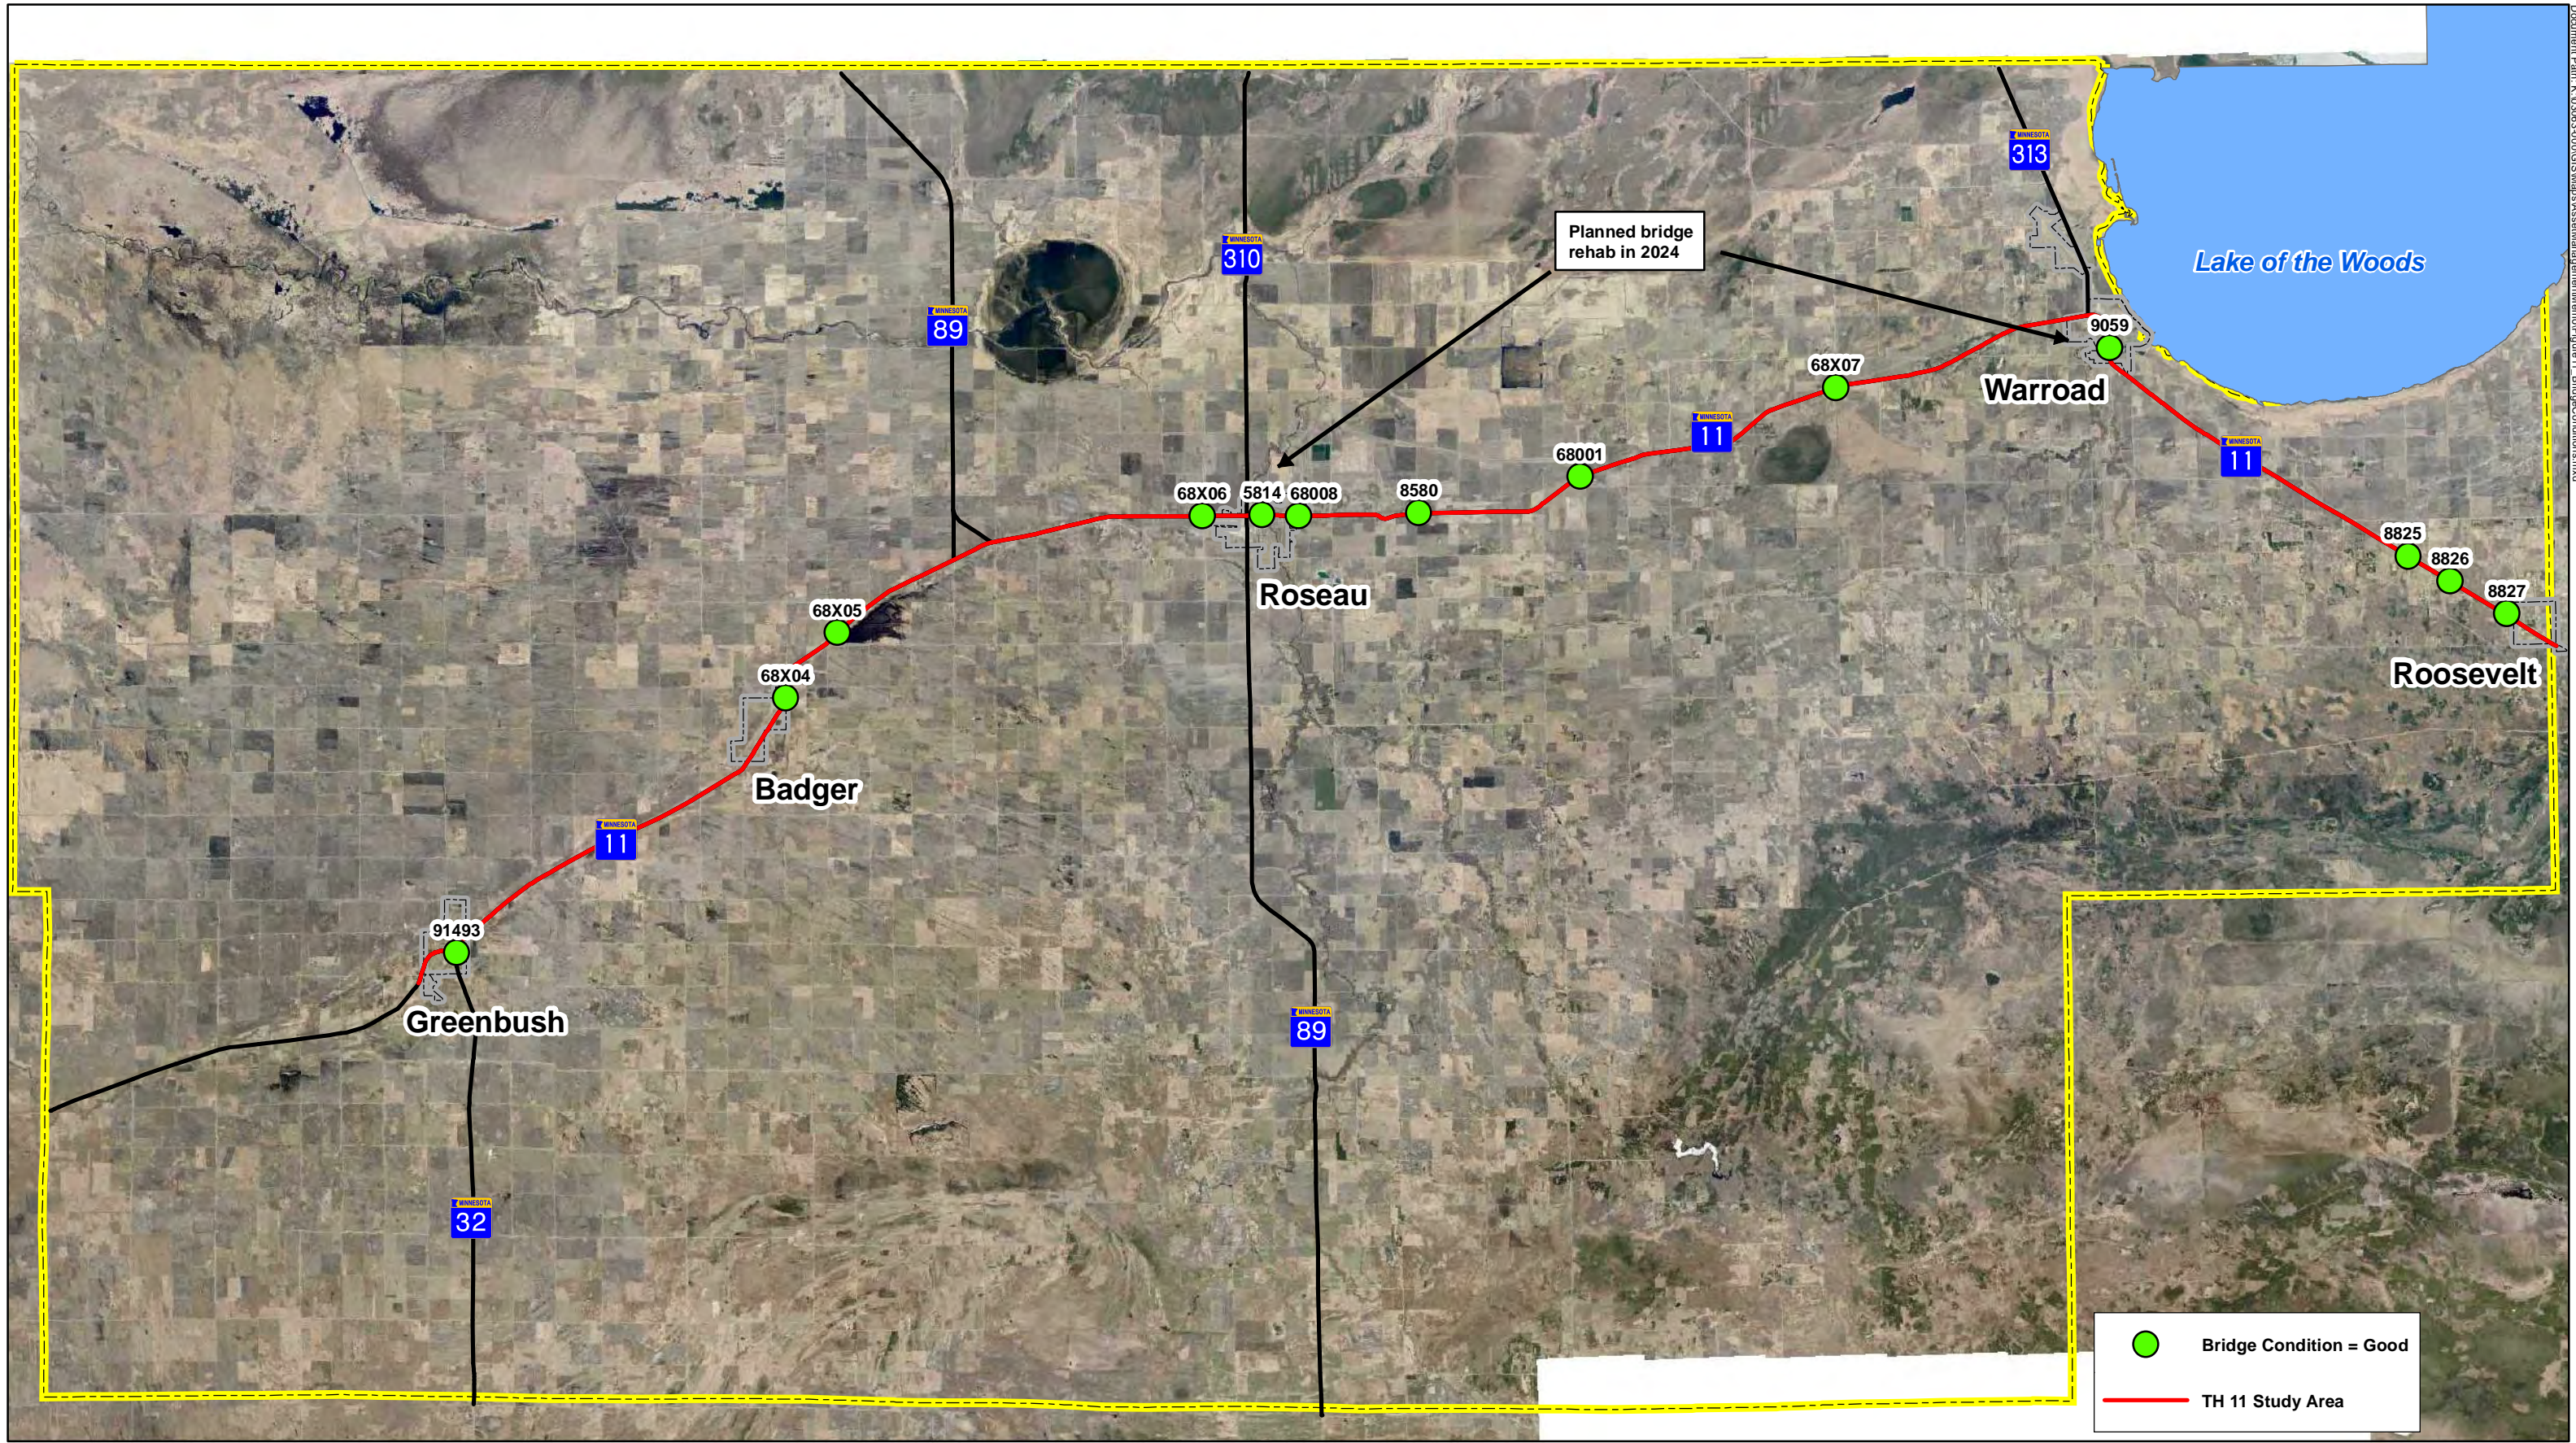
**Figure 11**  
**Current Bridge Conditions**

All bridges within the study area are in good condition based on inspections in 2012-2014. No bridges within the study area are considered functionally obsolete or fracture critical. All bridges but one have sufficiency ratings above 97.4. Bridge 8580, located 4 miles east of Roseau, has a sufficiency rating of 87.3. MnDOT considers bridges with sufficiency ratings of 80 or less to be candidates for bridge rehabilitation. Ratings of 50 or less indicate a potential need for bridge replacement.

Based on 2014 bridge inspections, there are no immediate needs for bridge rehabilitation or replacement within the study area. All bridges on the corridor are in good condition and will only need ongoing maintenance in the near-term. As part of its 10-year plan MnDOT is recommending two bridge rehabilitation projects for the TH 11 corridor in the study area. One project is scheduled for 2024 in Warroad (Bridge 9059). There is a 36-foot length of the bridge where the beams are in poor condition and need to be addressed. Re-decking may also be necessary. The second project is expected to occur in 2025 for Bridge 5814 in Roseau. There are no major concerns about this bridge at this time. This bridge is programmed for paint, low-slump overlay, and repair to approach panels. The deck and superstructure are in good condition and there are no strength issues. MnDOT may want to consider installing guardrails on the approaches to this bridge as none exist today.

Based upon the information contained in the bridge inspection reports and planned improvements, it is anticipated that two additional bridges will need rehabilitation or replacement prior to 2040. Bridge 8580 is a precast box culvert constructed in 1927 located four miles east of Roseau. Recent inspections found cracks on the inside of the culvert that will need to be addressed prior to 2040. This bridge is a W-type box culvert that should not be rehabilitated by installing a concrete liner. It is anticipated that this box culvert would be replaced rather than rehabilitated.

Based on the review of bridge inspection reports, rehabilitation is also recommended on bridge 68001 over Hay Creek, located 1.3 miles west of Salol. This bridge is a concrete slab span that was constructed

in 1969 and re-decked in 1998. Recent inspections indicate cracking on the bridge deck. An overlay of low-slump concrete is recommended to address cracks on the bridge deck.

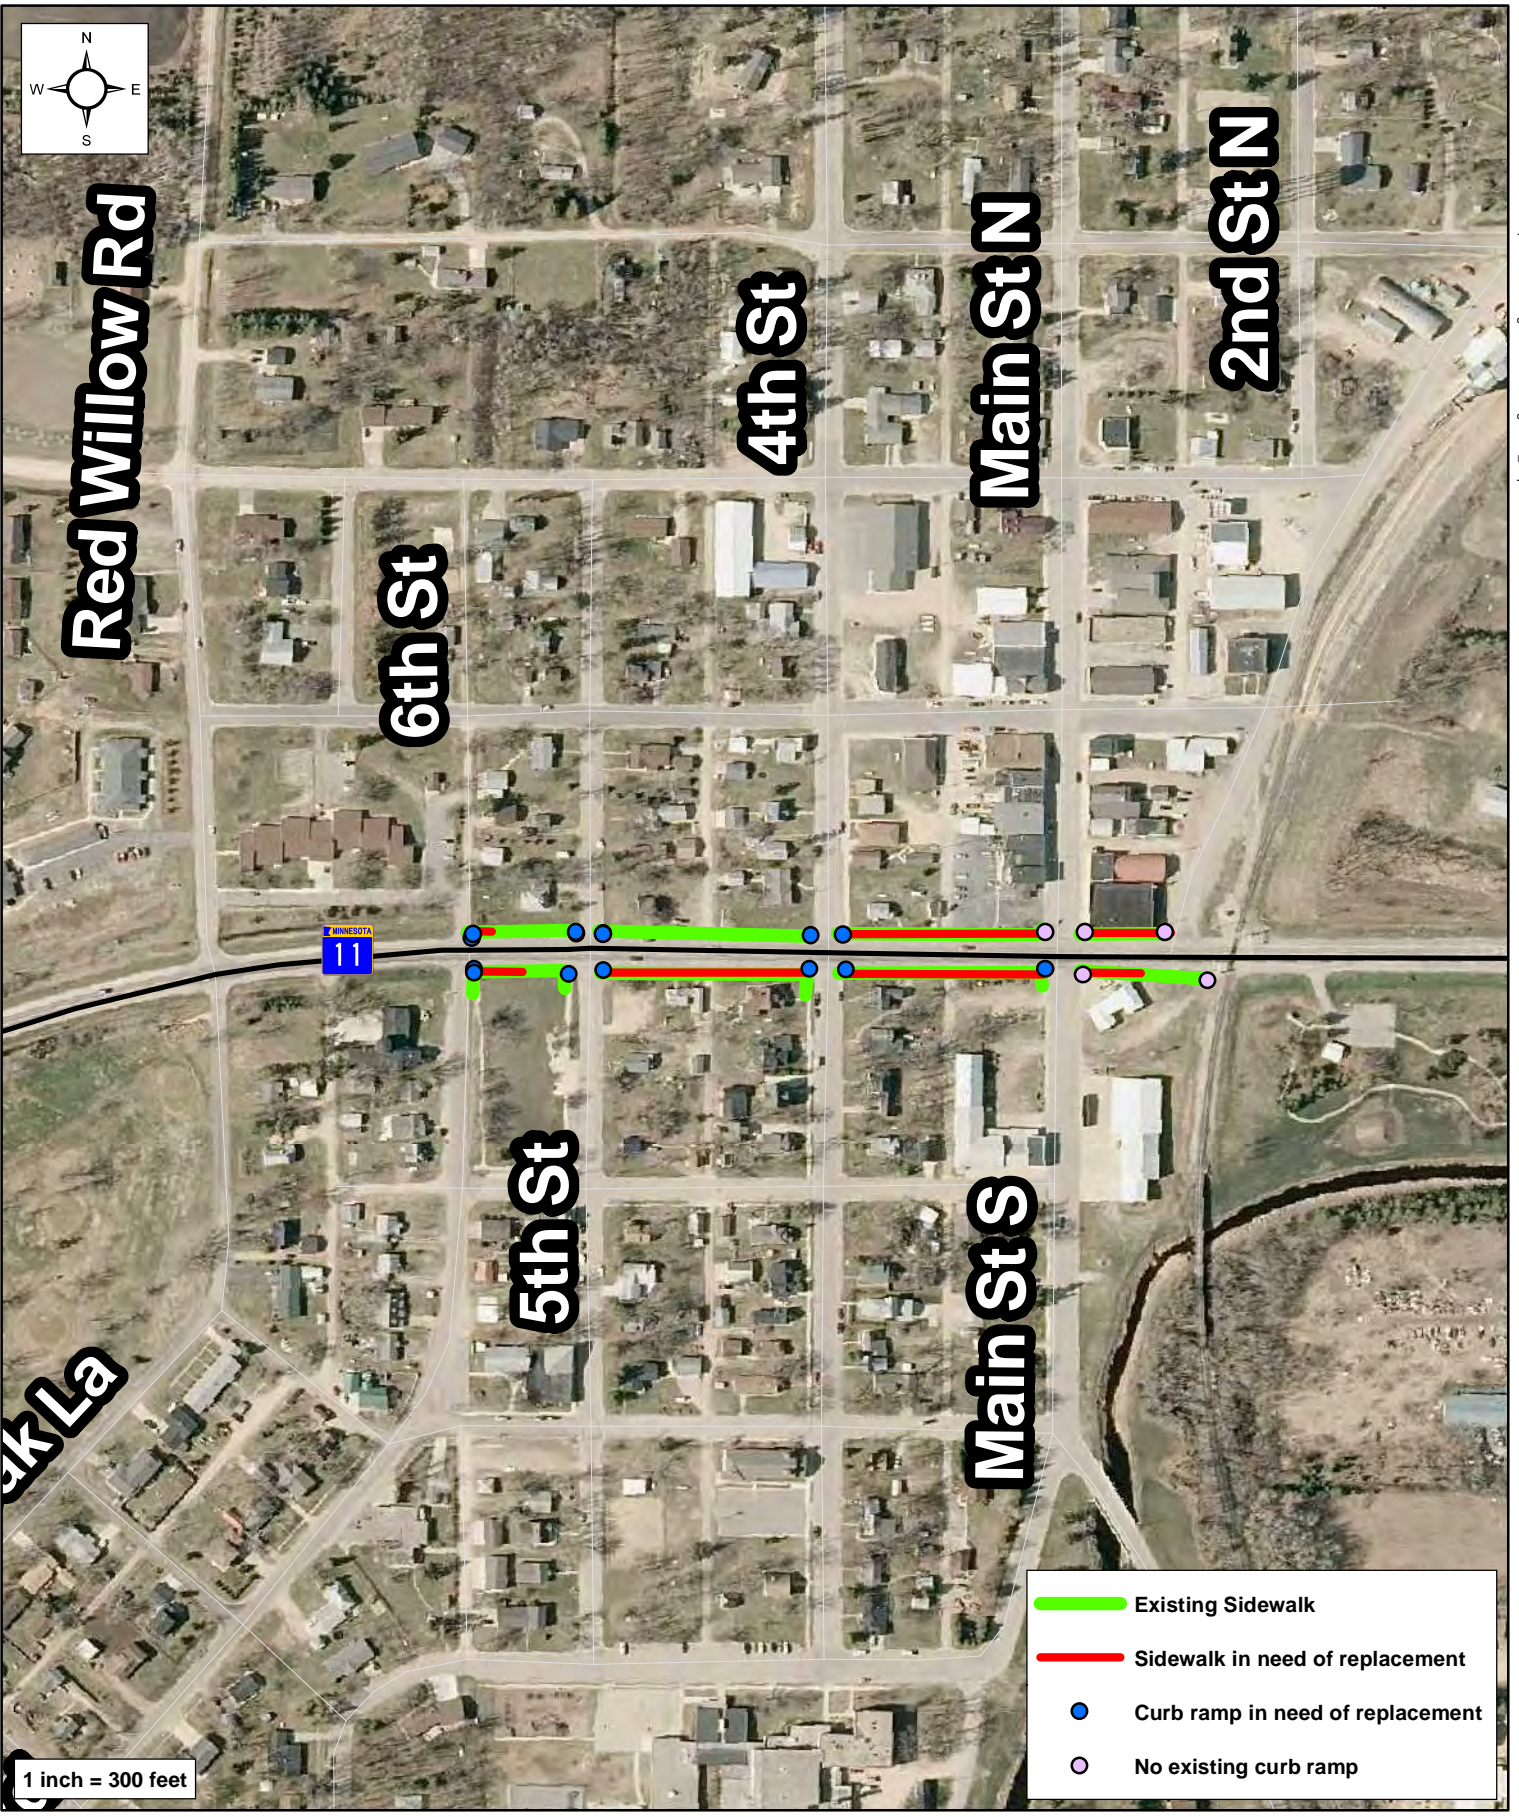
**Figure 12**  
**Existing Sidewalk and**  
**Sidewalk Replacement Needs**  
**Greenbush**

**Figure 12** shows sidewalk condition and recommendations for replacement within the City of Greenbush. Along both sides of TH 11, there is sidewalk from 6th Street to approximately 50 feet west of the Minnesota Northern Railroad. There is approximately 2,050 feet of existing sidewalk and 15 curb ramps in Greenbush. The majority of sidewalk within Greenbush has poor surface condition. Sidewalk cross-slope within Greenbush is generally below 3 percent, except for at the intersection with 6th Street and in some sections between 4th and Main Streets. None of the curb ramps meet current ADA standards. Additionally, there are five corners without curb ramps between Main Street and 1st Street N.

Based on existing sidewalk conditions and the criteria outlined above, 1,280 feet of sidewalk is recommended for replacement. All 15 curb ramps are recommended for replacement and 5 new curb ramps will need to be constructed to be provided at corners where there are no existing curb ramps. Sidewalks and curb ramps recommended for replacement are shown on **Figure 12**. **Table 7** shows the length of sidewalk segments recommended for replacement.

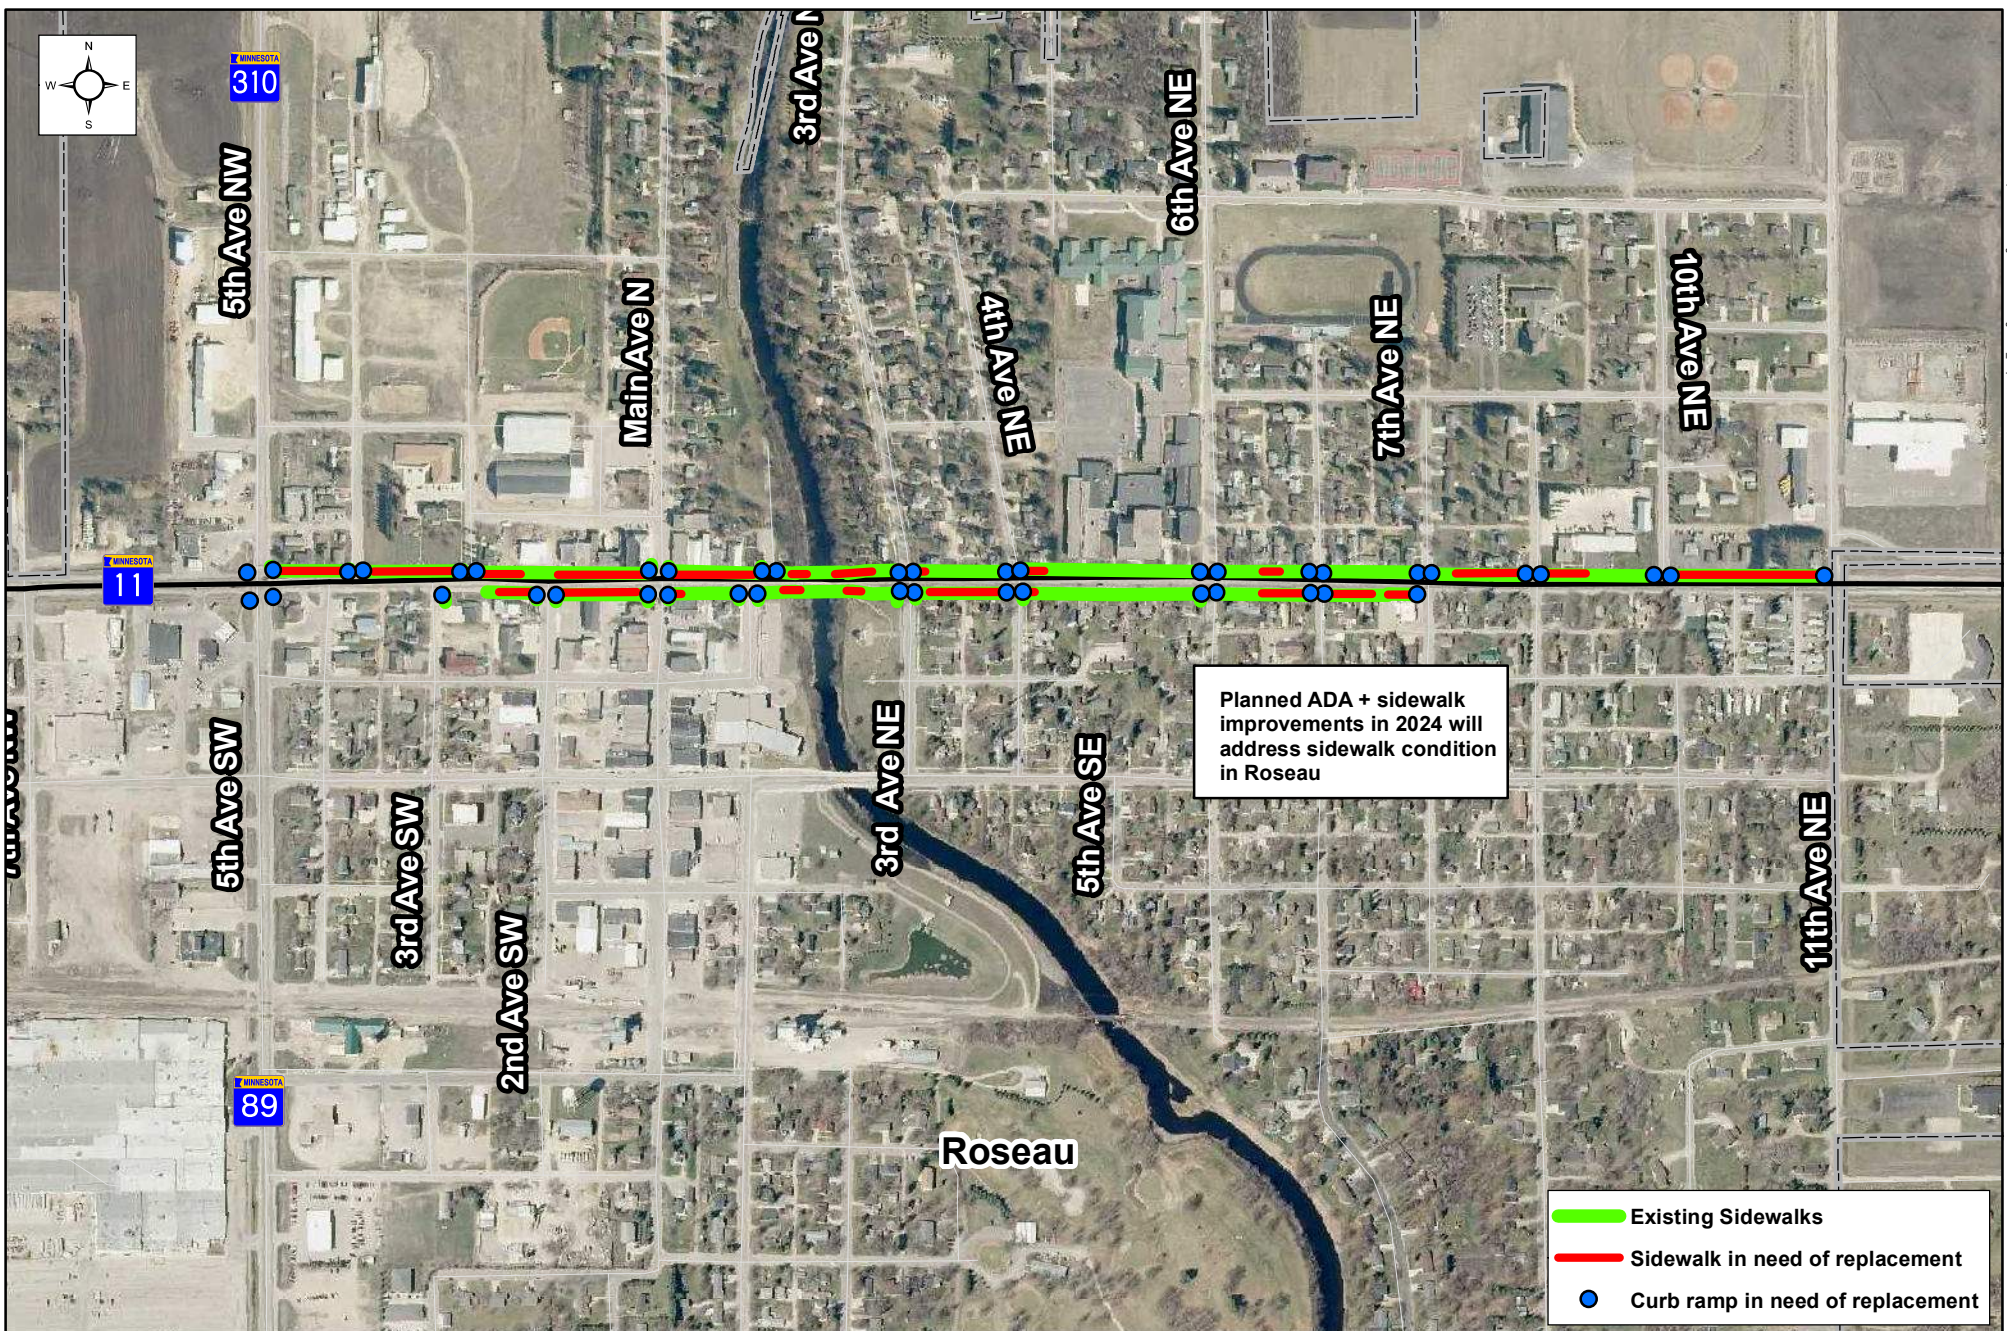
**Figure 13**  
**Existing Sidewalk and**  
**Sidewalk Replacement Needs**  
**Roseau**

Sidewalks along TH 11 within Roseau generally have fair to good surface condition. Most sidewalk segments west of 3rd Avenue NE have fair surface condition. Sidewalks east of 3rd Avenue NE vary between fair and good condition. While sidewalk surface condition is generally acceptable, the majority of sidewalk segments in Roseau have cross-slopes greater than 3 percent which is problematic for ADA requirements.

Based on existing sidewalk conditions, approximately 3,860 feet of sidewalk is recommended for replacement. All 43 curb ramps are recommended for replacement. The length of sidewalk segments recommended for replacement is shown in **Table 7**.
