## Asset Management Memorandum

**Re:** *Asset Management*  
*TH 11 Corridor Assessment*  
*WSB Project No. 03063-000*

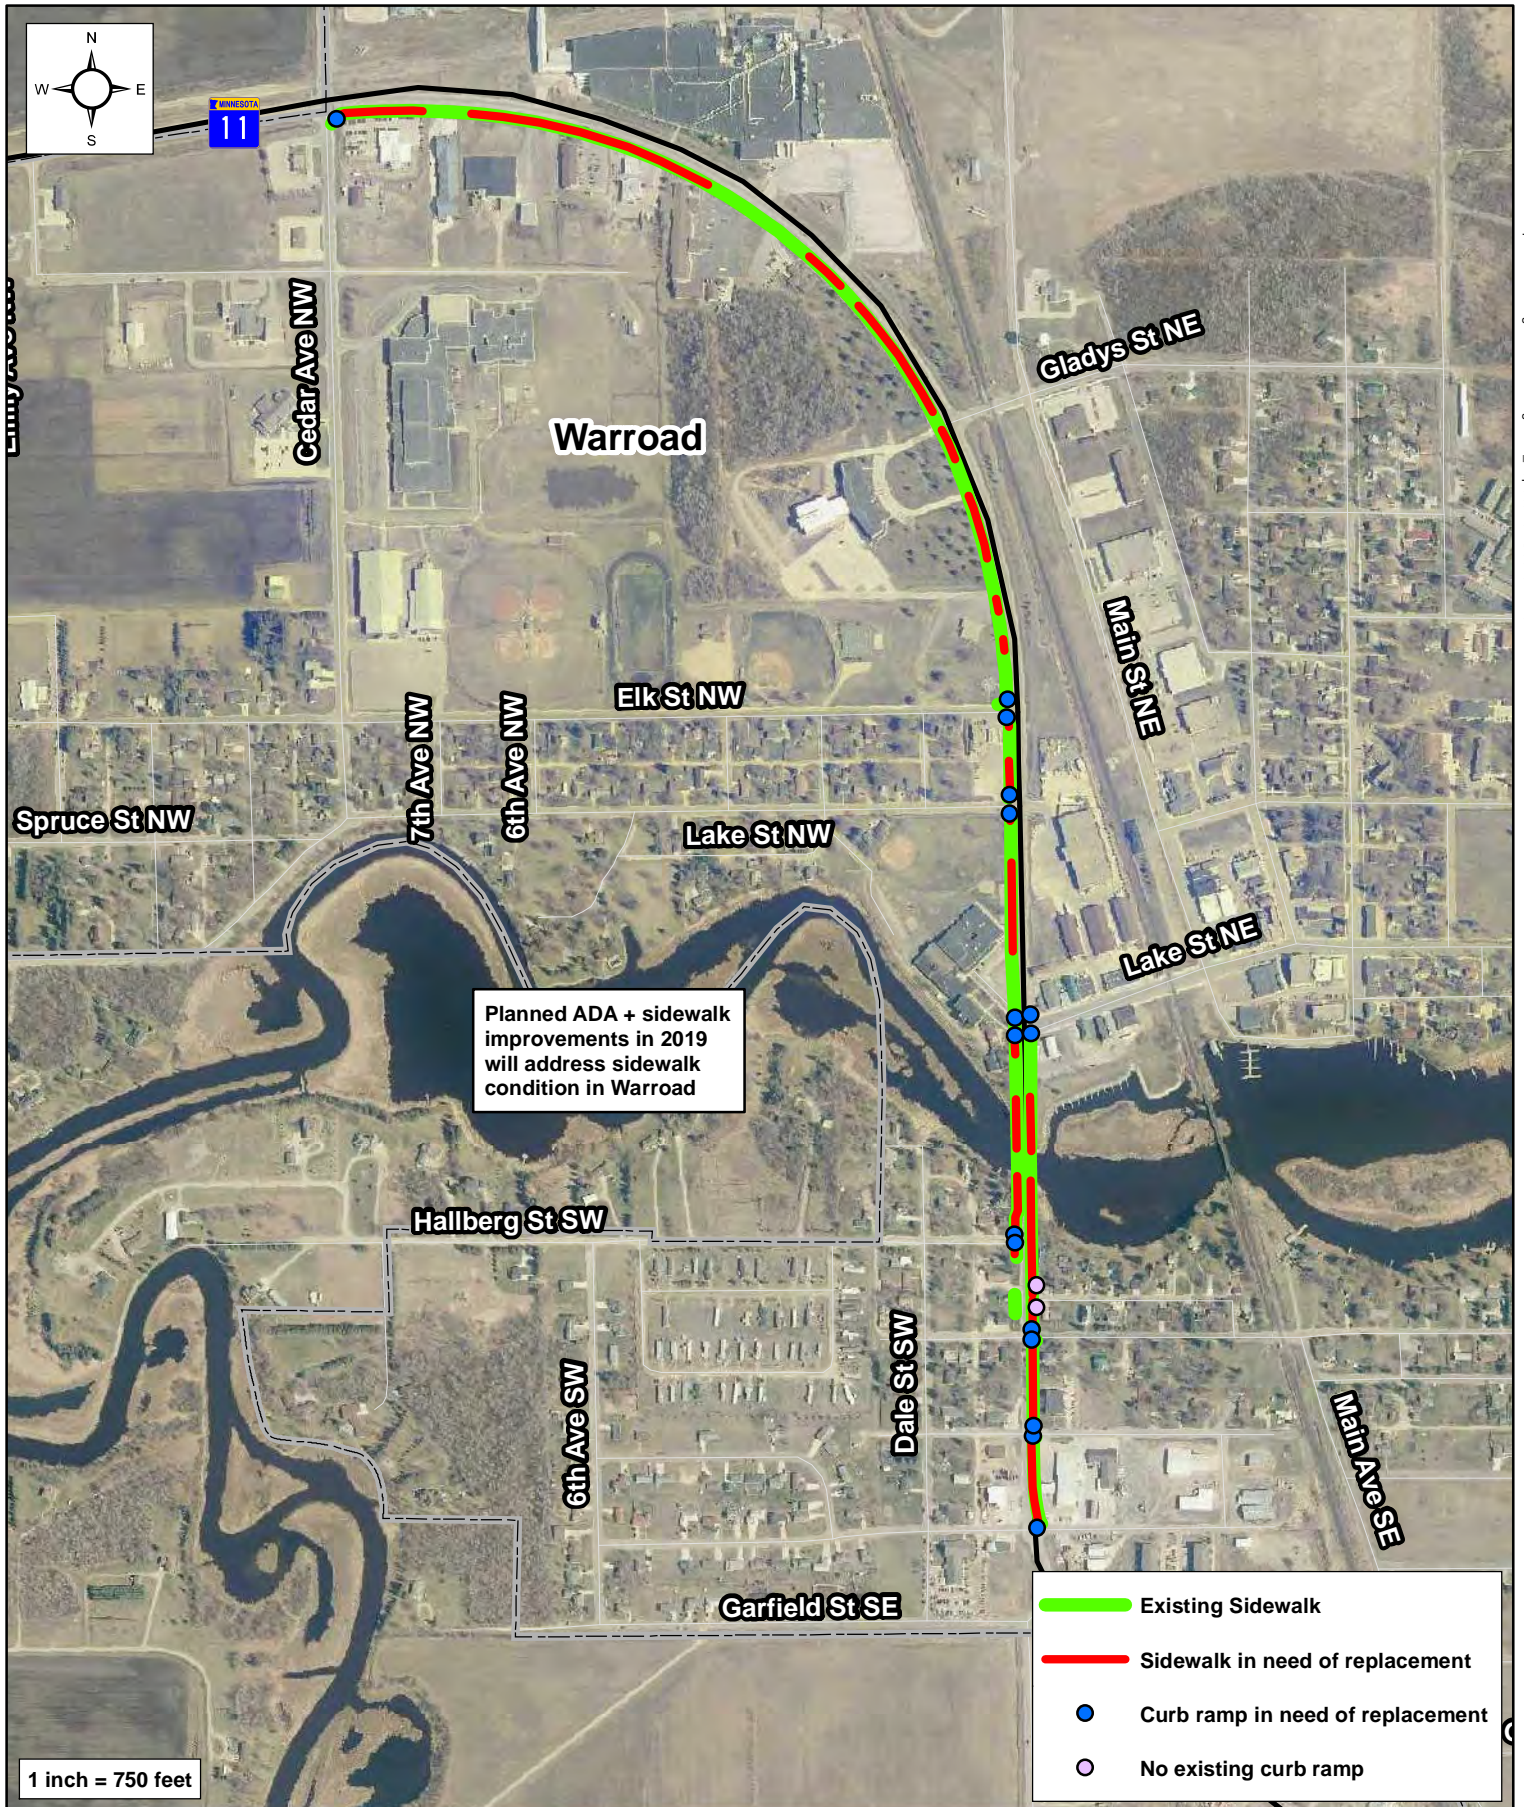
**Figure 14**  
**Existing Sidewalk and**  
**Sidewalk Replacement Needs**  
**Warroad**

Along TH 11 within the City of Warroad, sidewalk condition is generally fair. There are some short segments with sidewalk in good condition. On the east side of TH 11 south of the Warroad River, sidewalk condition is generally poor. Cross-slopes exceed 3 percent on the majority of sidewalk segments between Cedar Ave NW/TH 313 and Elk Street NW. Cross-slopes also exceed 3 percent on many segments south of Elk Street NW.

Approximately 4,960 feet of sidewalk are recommended for replacement due to condition and/or cross-slope. All 16 curb ramps in Warroad are recommended for replacement to comply with ADA standards. Additionally, two curb ramps will need to be constructed to be provided at corners where there are no existing curb ramps. **Figure 14** shows the location of sidewalks and curb ramps recommended for replacement. **Table 7** summarizes the sidewalk segments recommended for replacement.

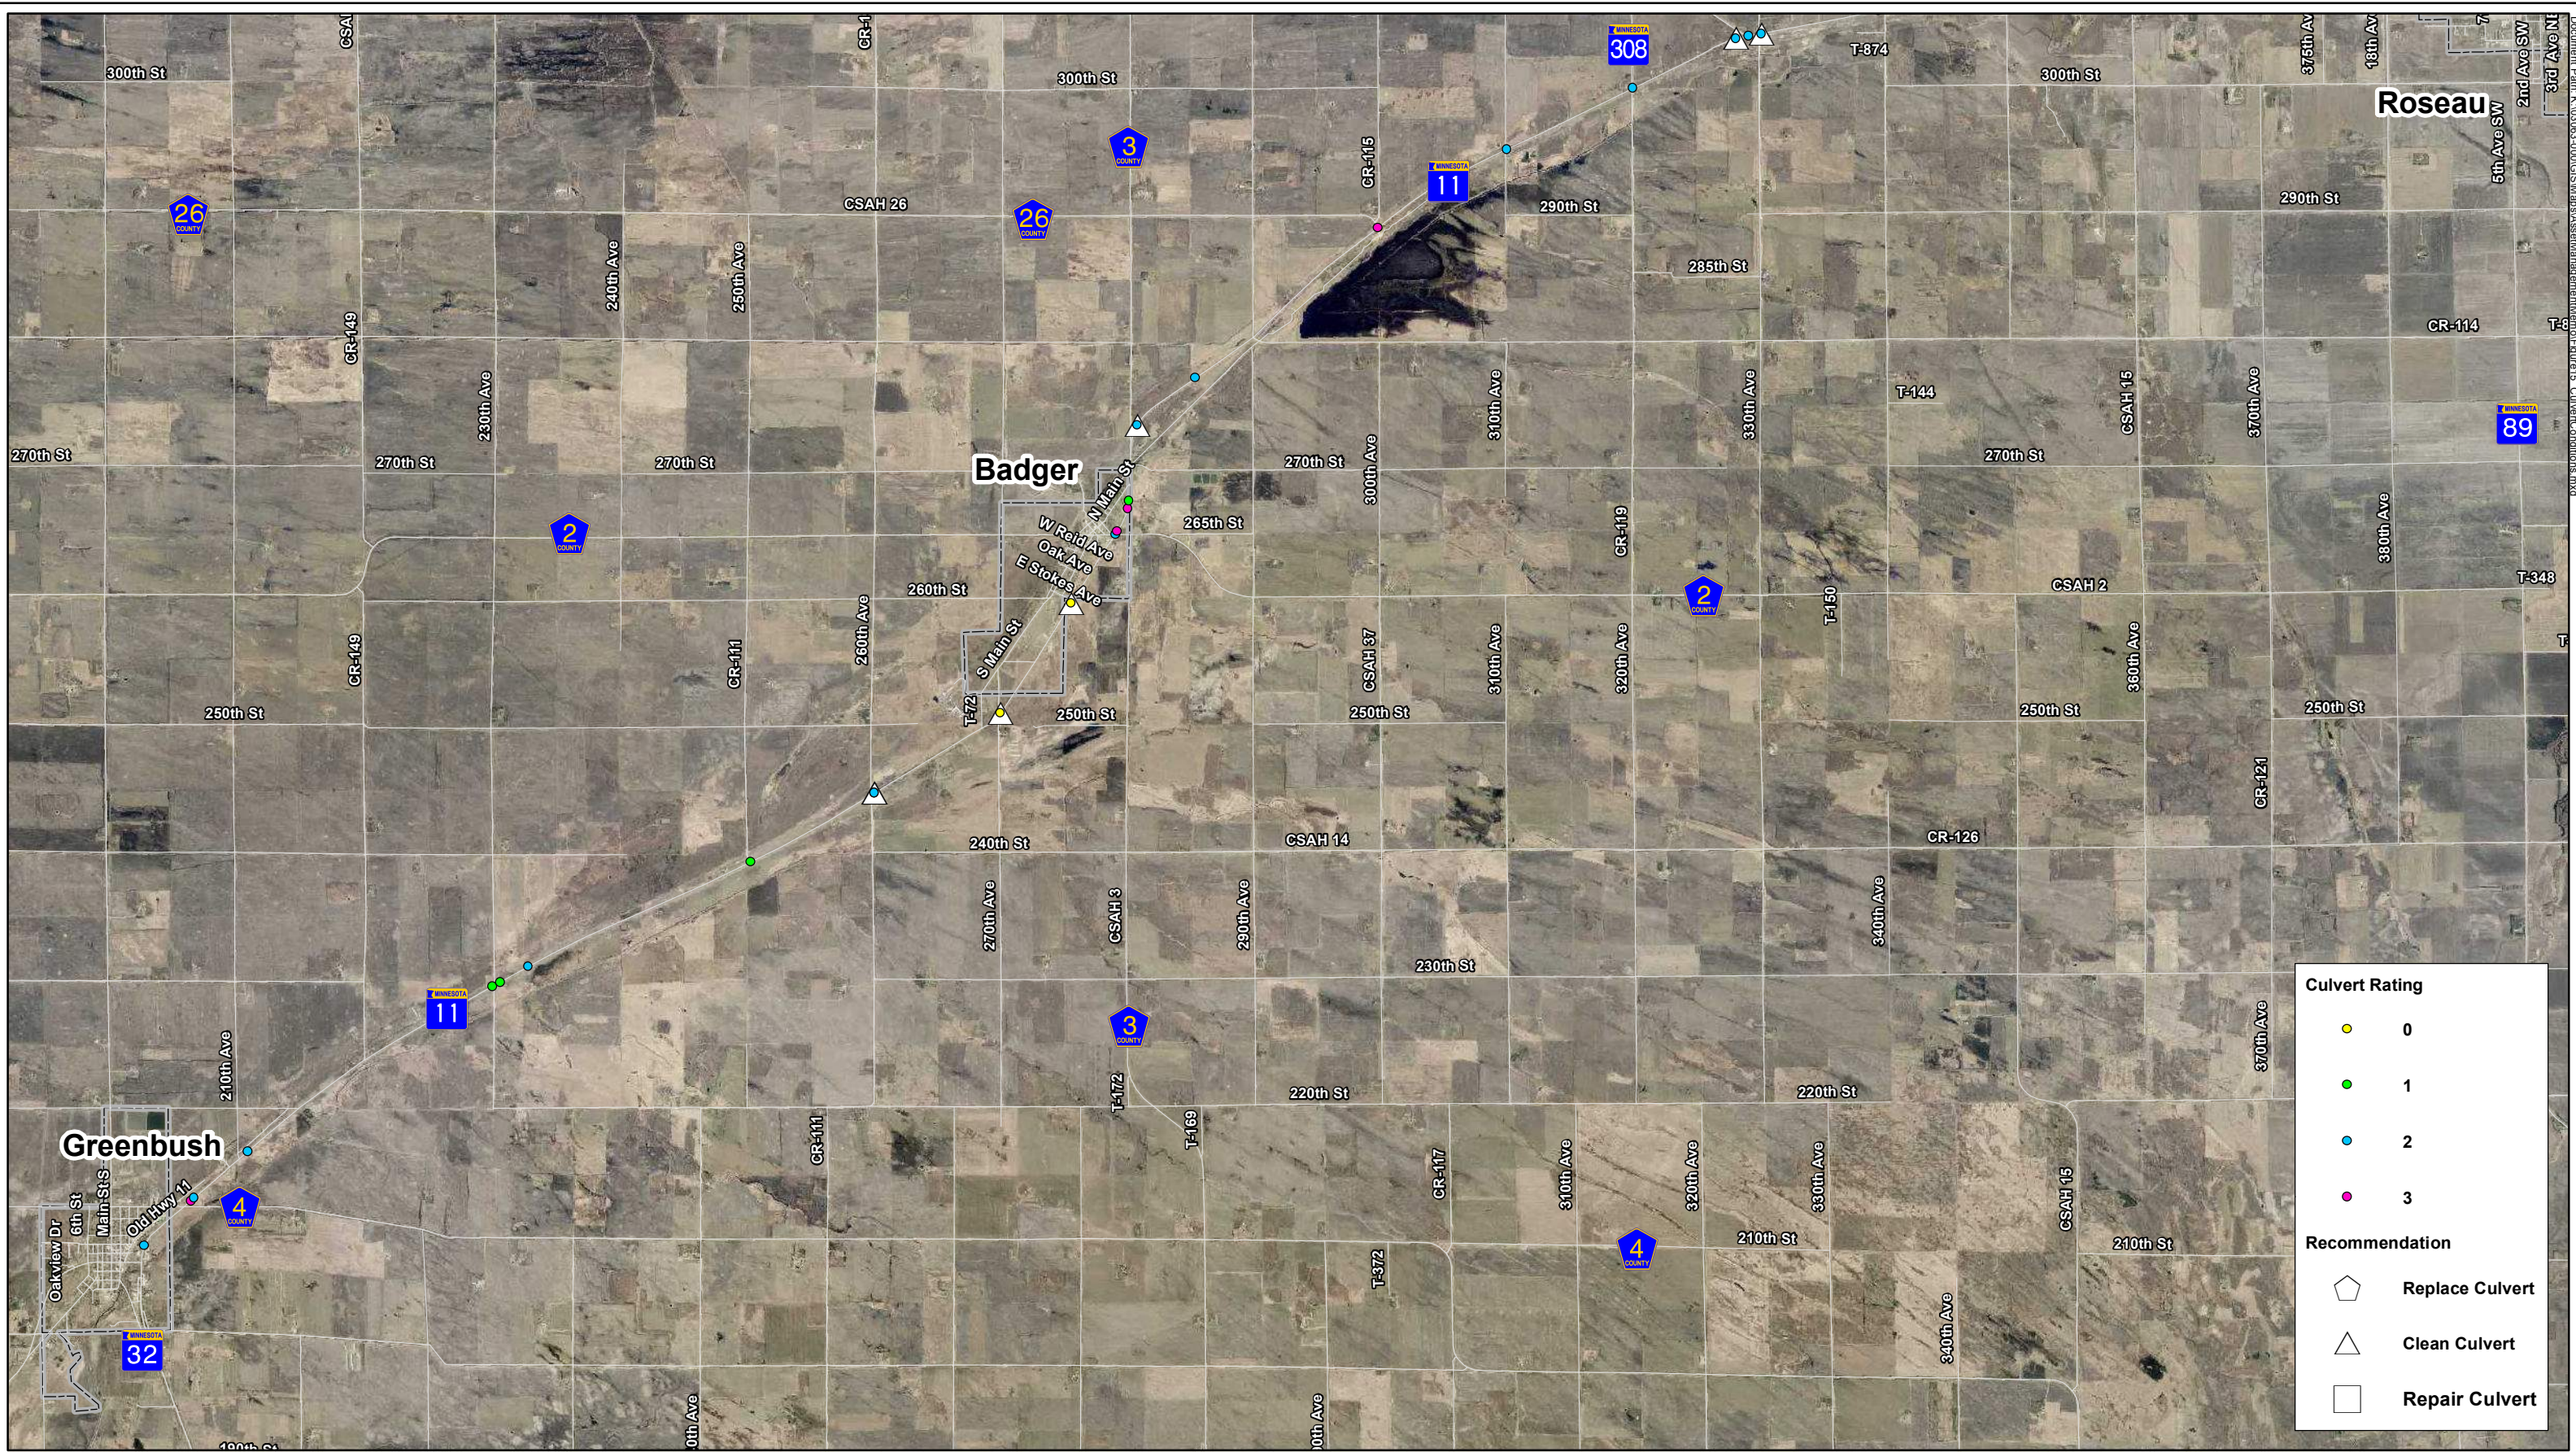
**Figure 15**  
**Current Culvert Conditions**  
**Greenbush & Badger**

Culvert condition varies throughout the corridor. 19 culverts are rated in excellent condition, including several that were replaced in 2015 as part of roadway reconstruction in Roseau. Most culverts in the study area (63) were given a rating of 2, indicating fair condition. 47 culverts were given a rating of 3, indicating a need for repair or replacement. Four culverts were not able to be rated due to soil, vegetation, or water that prevented a full inspection.

Based on the most recent inspection reports available, most culverts in the corridor should be inspected every six years, with the next inspections recommended in 2021. Based on 2015 inspections, 47 culverts should be inspected every 2-4 years, with the next inspections in the 2017-2019 timeframe.

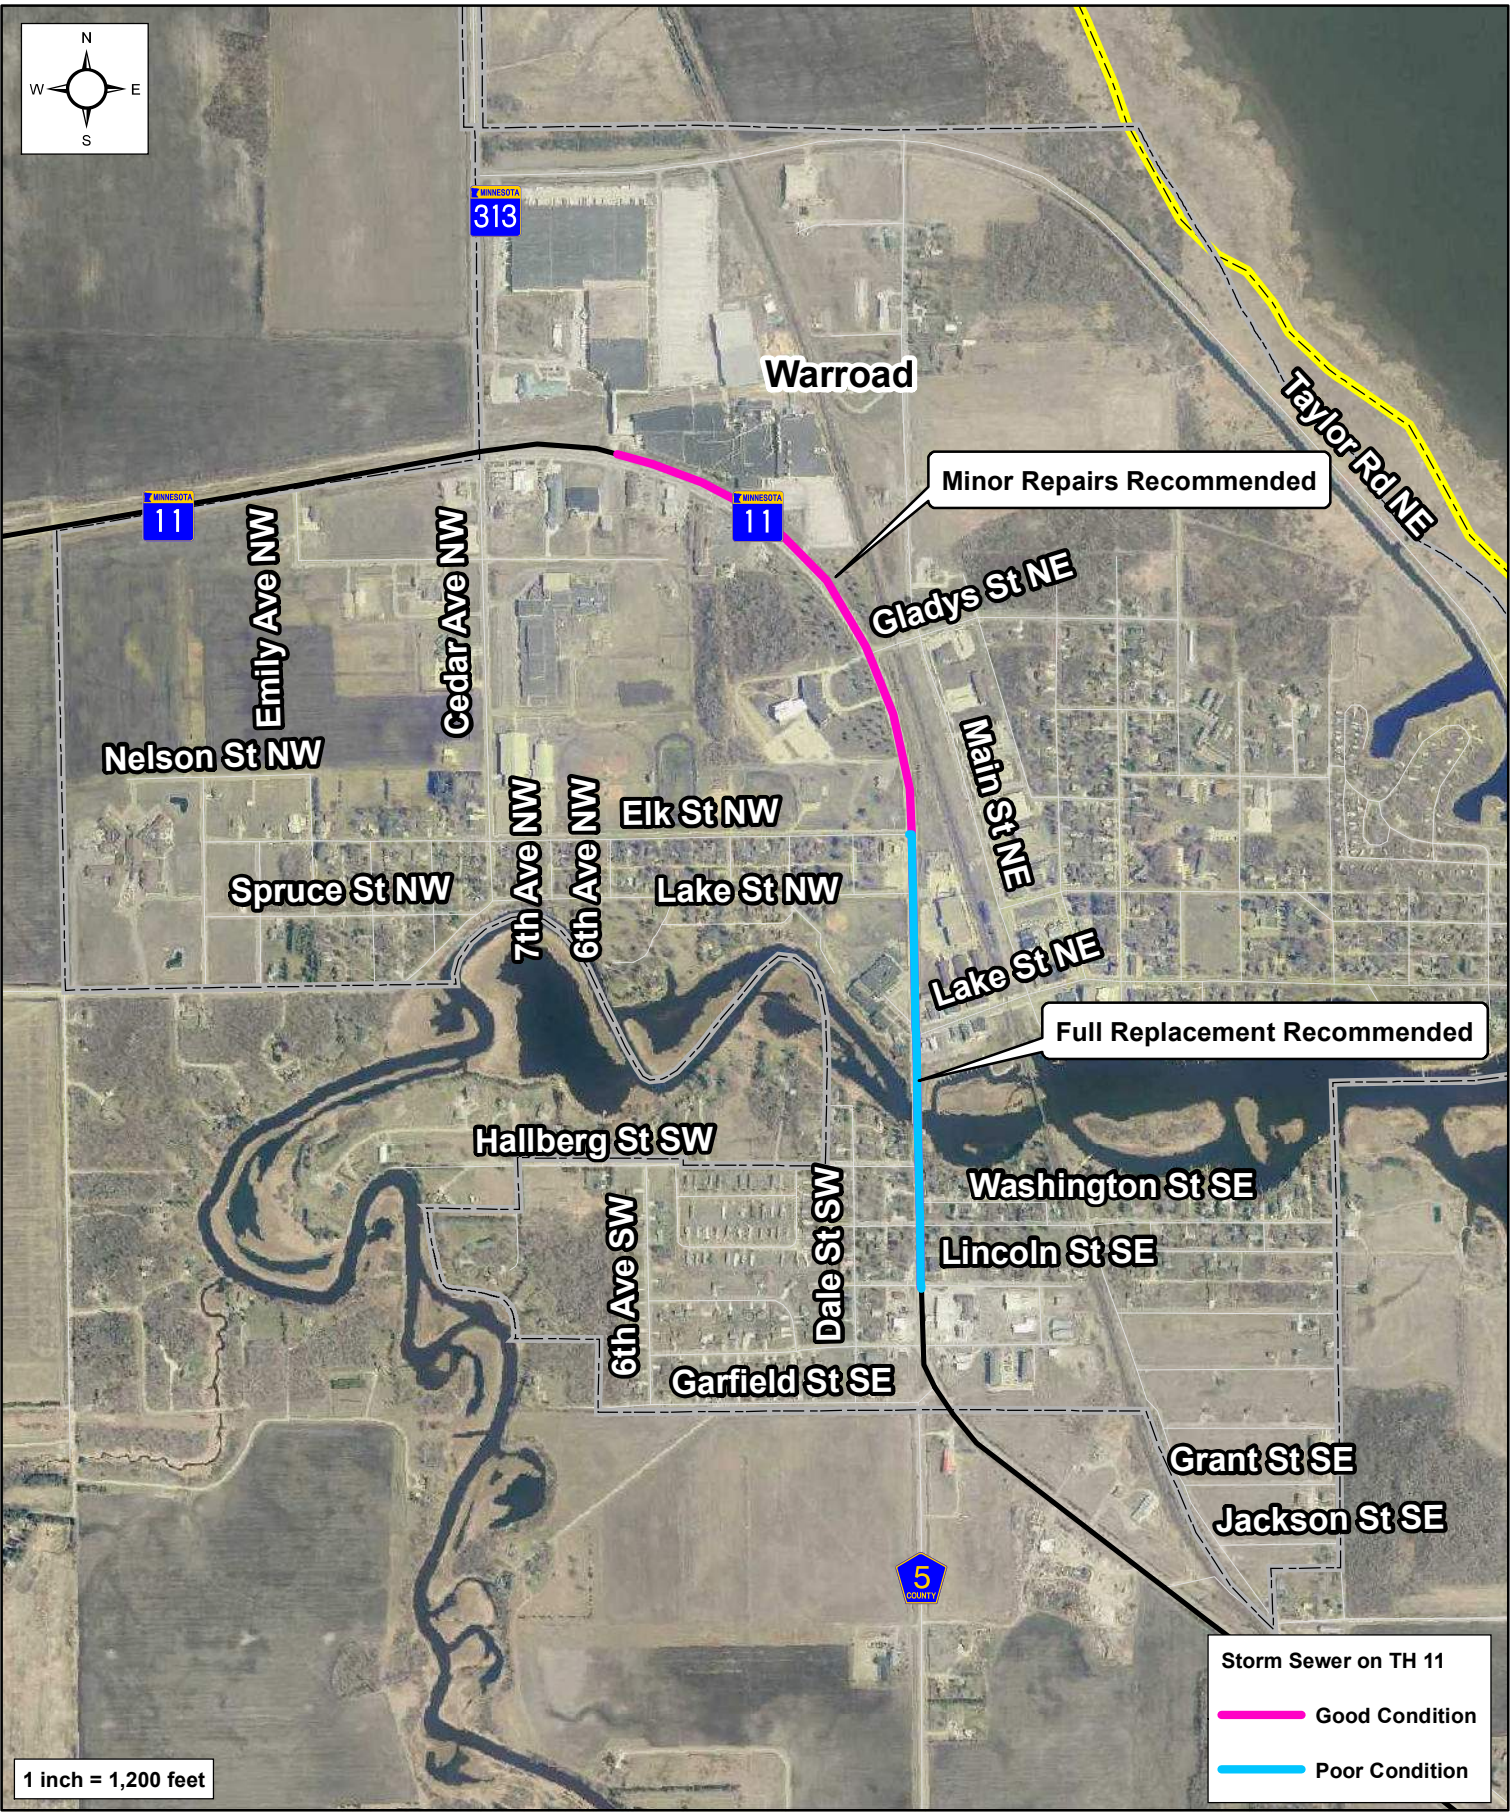
**Figure 19**  
**Existing Storm Sewer**  
**Warroad**

Storm sewer between Elk Street and Lincoln Street is in poor condition and is recommended to be replaced. The 2015 inspection report identifies approximately \$234,000 worth of storm sewer replacements in this area. The report recommends including storm sewer replacements with planned ADA, sidewalk, and signal improvements programmed for 2019. The new storm sewer will need to include sump catch basins or storm sewer treatment devices prior to out-letting into the Warroad River.

Storm sewer should generally be inspected every five years to comply with MS4 permit requirements, with the next inspection recommended in 2020. Subsequent inspections should follow in 2025 2030, 2035 and 2040. Inspections should identify needs to clean drains, clean sediment in storage ponds, and address erosion around open inlets or grates.
