**Mn/DOT Bridge #9616
Asbestos & Regulated
Waste Inspection Report,
Minneapolis, Minnesota**

Bridge #9616

East 42nd Street over I-35W in Minneapolis, Minnesota

January 2006

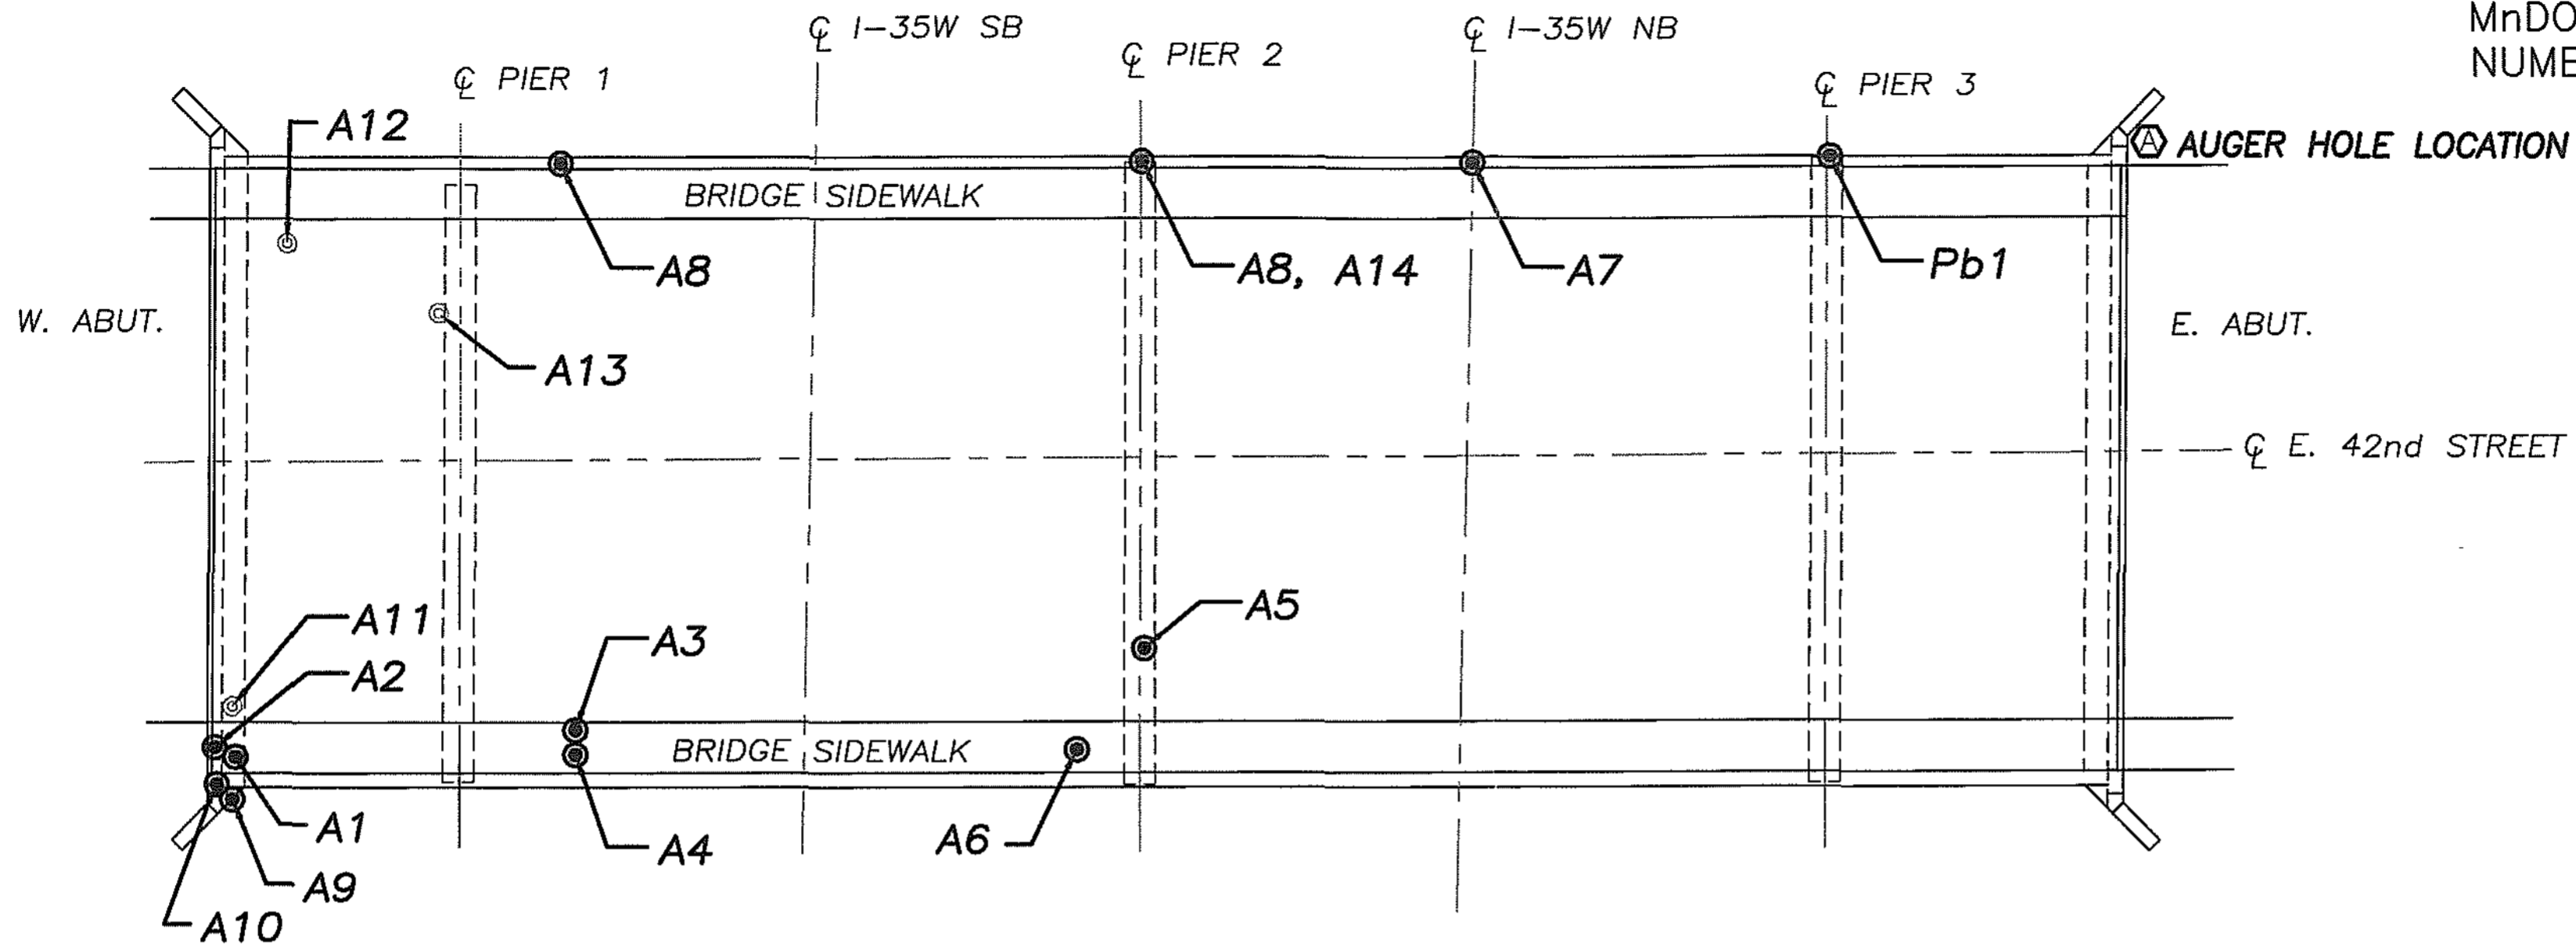
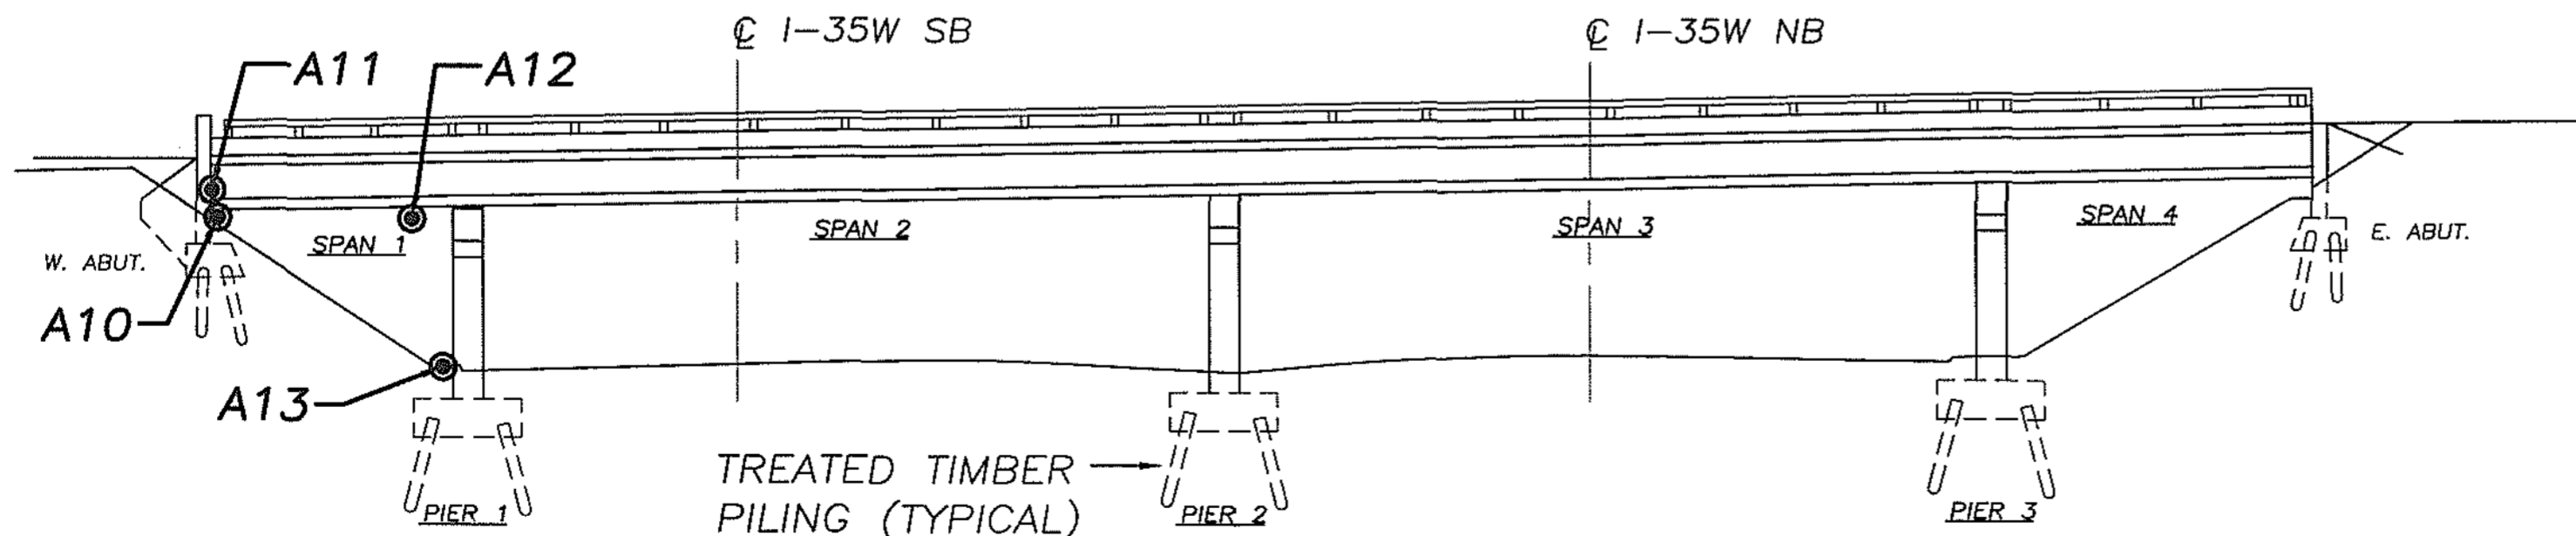
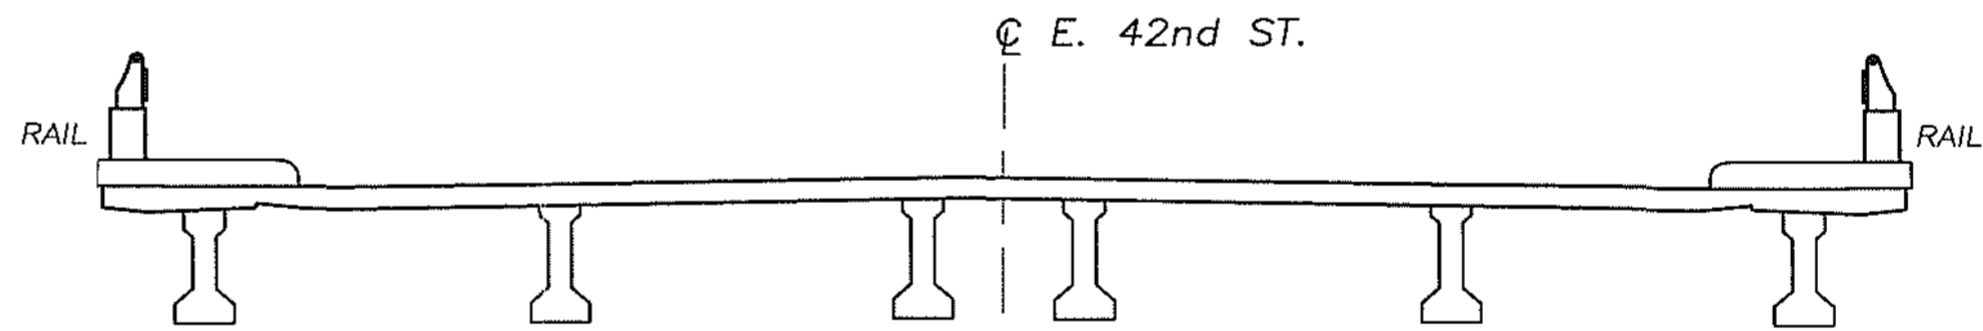
SAMPLING LOCATION DIAGRAM
MnDOT BRIDGE NUMBER 9616
E. 42nd STREET OVER I-35W
MINNEAPOLIS, MINNESOTA

Treated Wood: Green treated wood guard rail support posts were identified beneath the bridge deck during the inspection (see Photograph #21). In addition, creosote treated timber piles were identified beneath the piers and abutments during review of the detail drawings (see Figure 3).

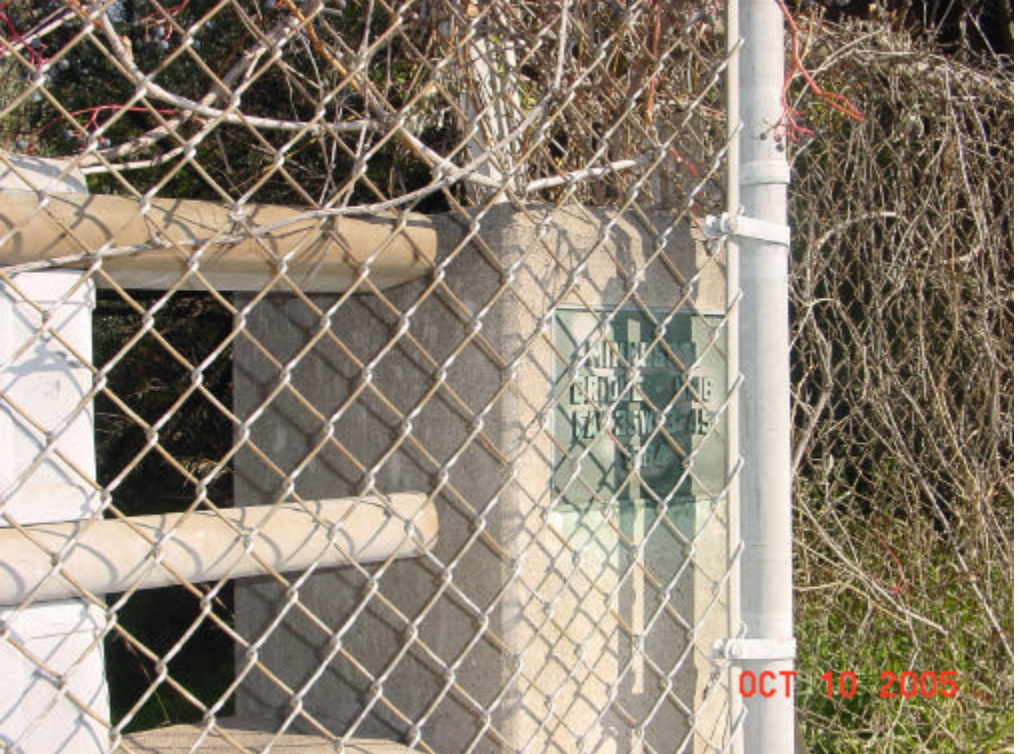
Client Name: Mn/DOT		Site Location: Bridge #9616	Project No.: 30070-XA
Photo No.: 1	Date: 10/10/05

Direction Photo Taken: N/A			
Description: Bridge identification plate for Bridge #9616. This bridge is located at East 42nd Street over I-35W in Minneapolis, Minnesota.

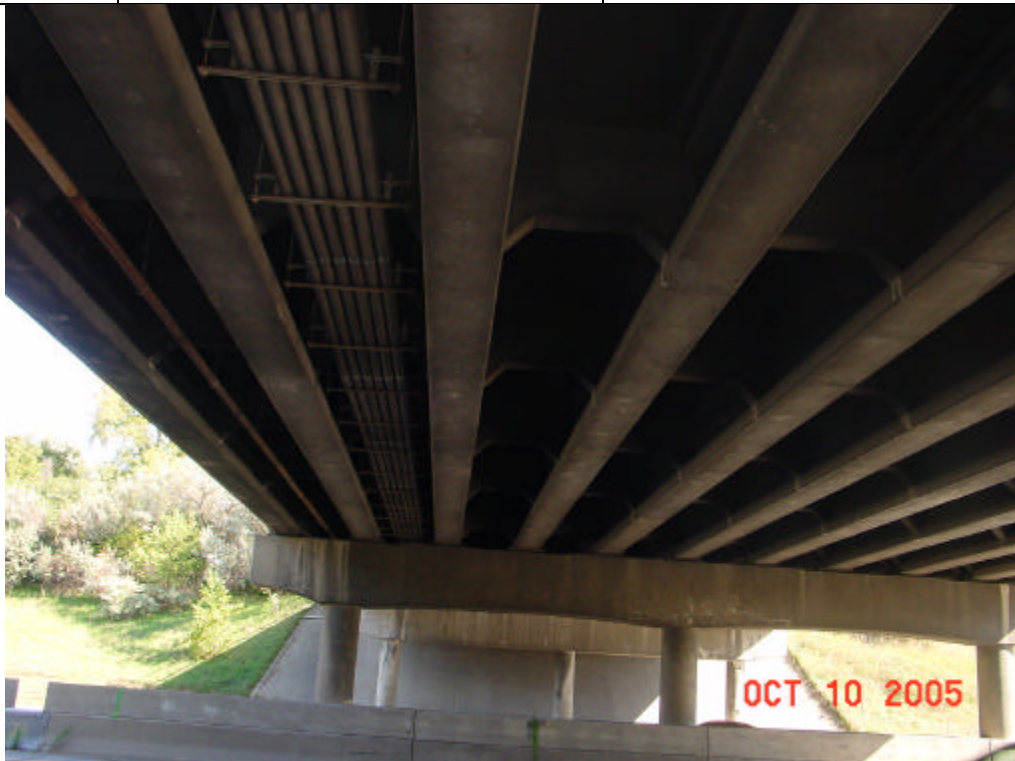
Photo No. 3	Date: 10/10/05
-----------------------	--------------------------

Description:
View of the underside of Bridge #9616.

Note transite piping along the steel girders spanning the length of the bridge.

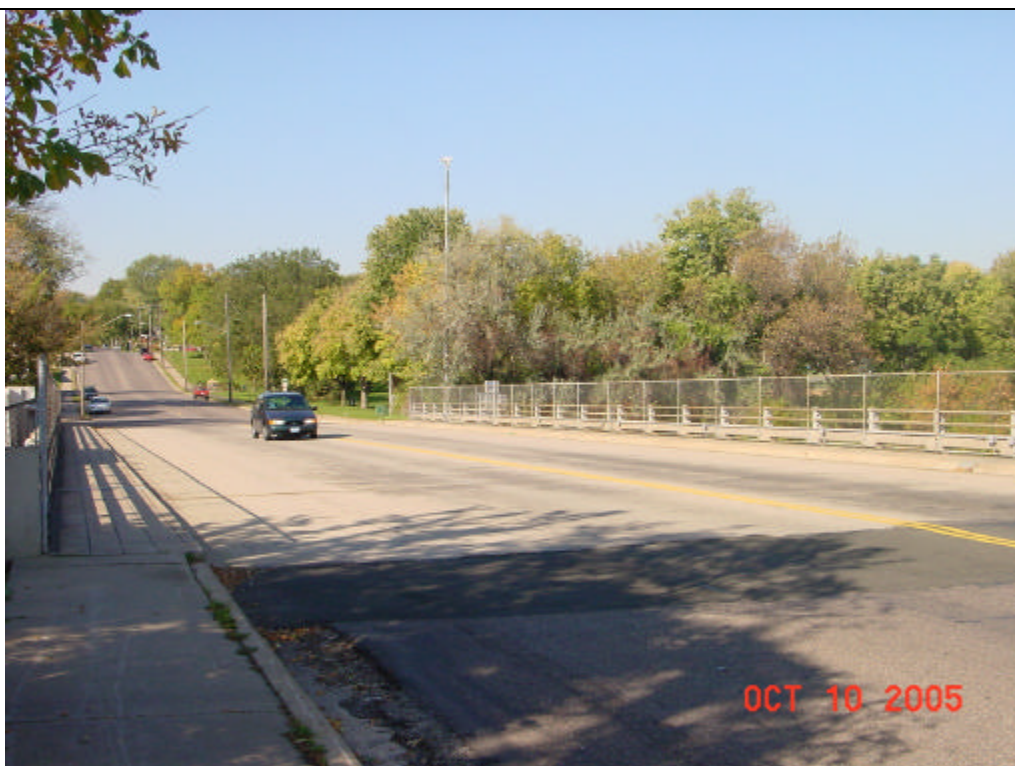
Photo No. 4	Date: 10/10/05
-----------------------	--------------------------

Description:
View of the top of Bridge #9616.

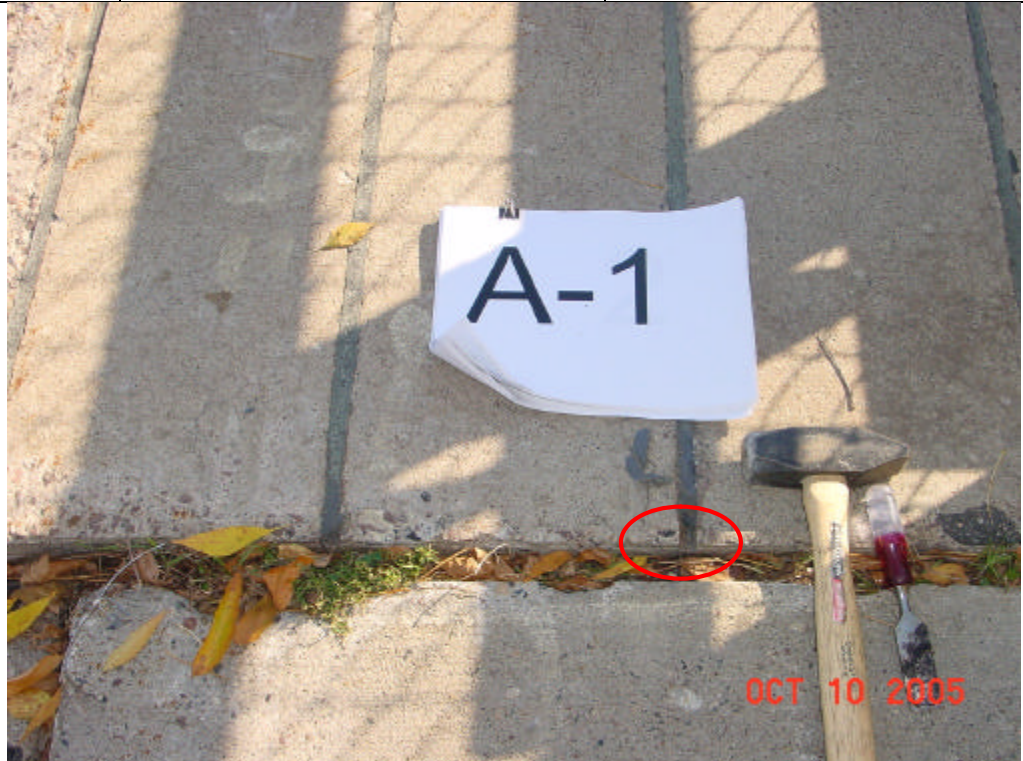
Photo No. 5	Date: 10/10/05
Direction Photo Taken: Looking down at sidewalk joint on the SW side of bridge	
Description: Asbestos sample A-1 Sidewalk joint compound.

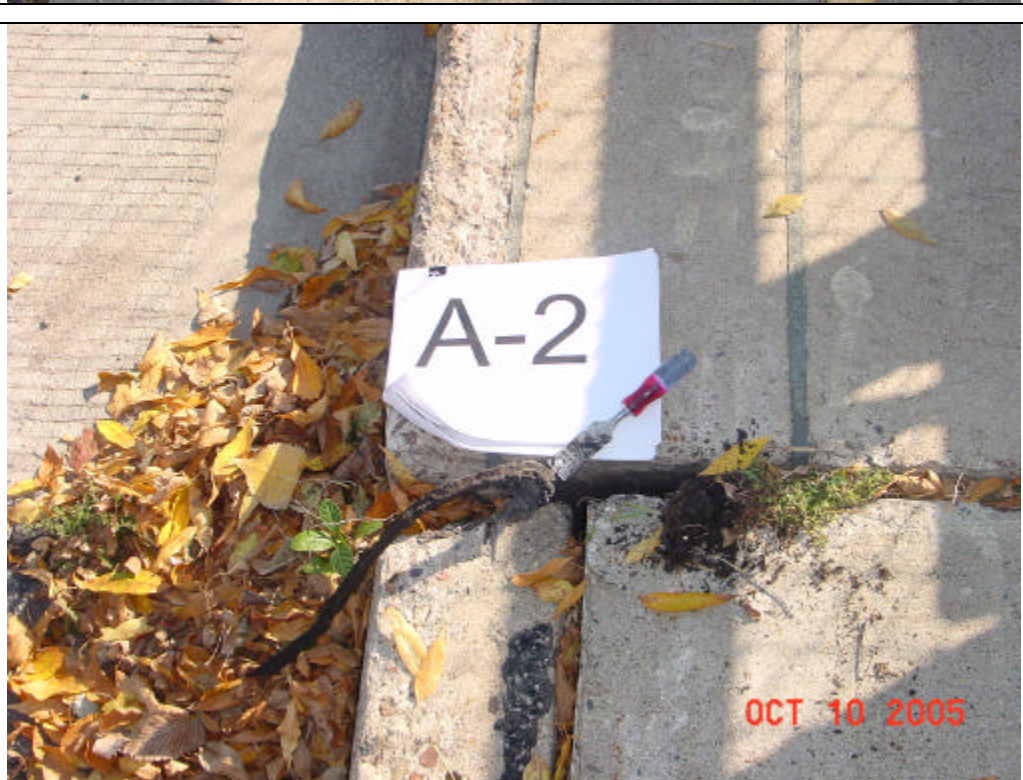
Photo No. 6	Date: 10/10/05
Direction Photo Taken: Looking down at sidewalk/bridge walk on the SW corner of bridge	
Description: Asbestos sample A-2 Sidewalk/bridge walk joint compound

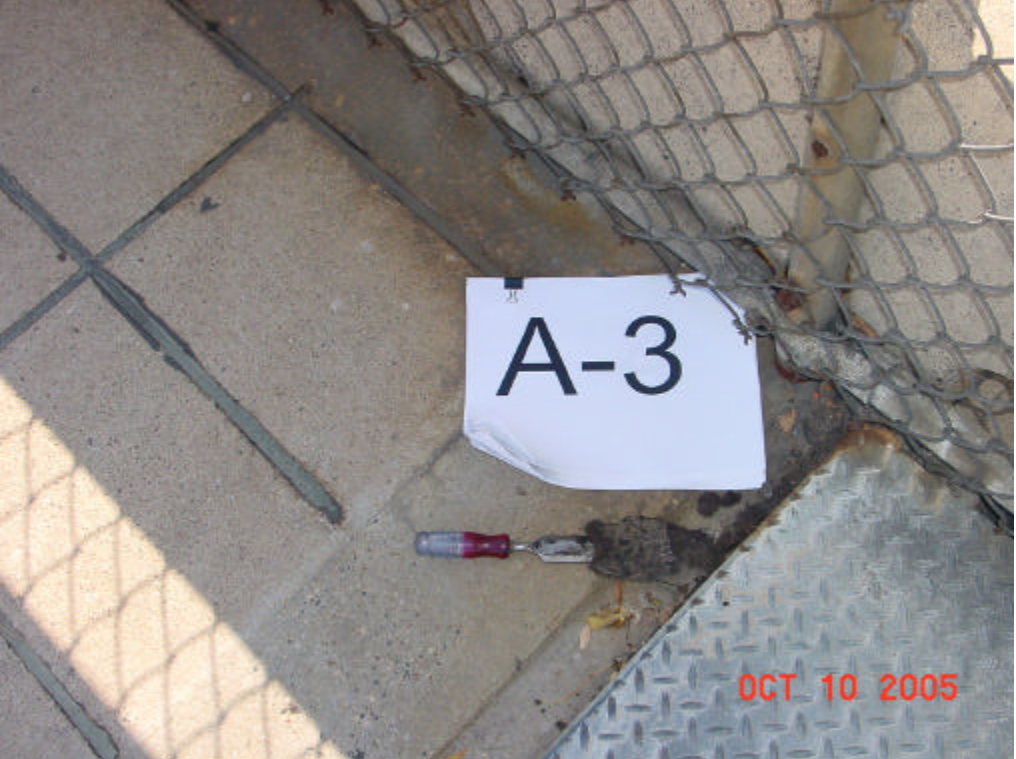
Client Name: Mn/DOT		Site Location: Bridge #9616	Project No. 30070-XA
Photo No. 7	Date: 10/10/05

Direction Photo Taken: Looking down at gasket expansion joint on the south side of bridge			
Description: Asbestos sample A-3 Gasket for the expansion joint plate

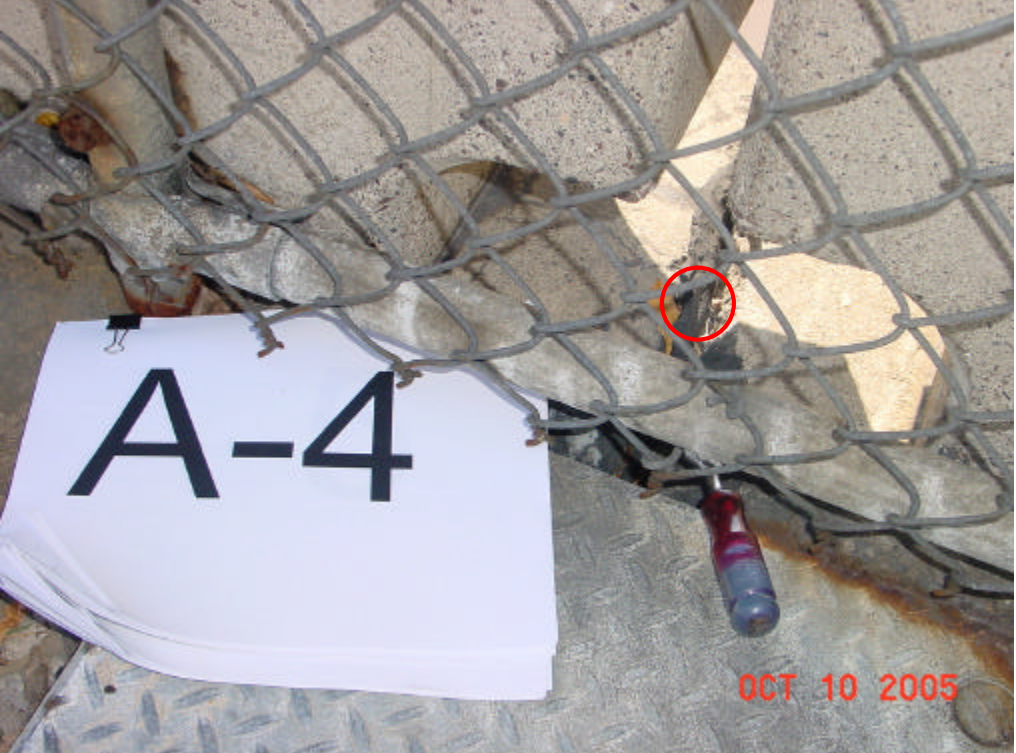
Photo No. 8	Date: 10/10/05

Direction Photo Taken: Looking down at bridge deck/railing joint on the south side of bridge			
Description: Asbestos sample A-4 Bridge deck/railing joint compound

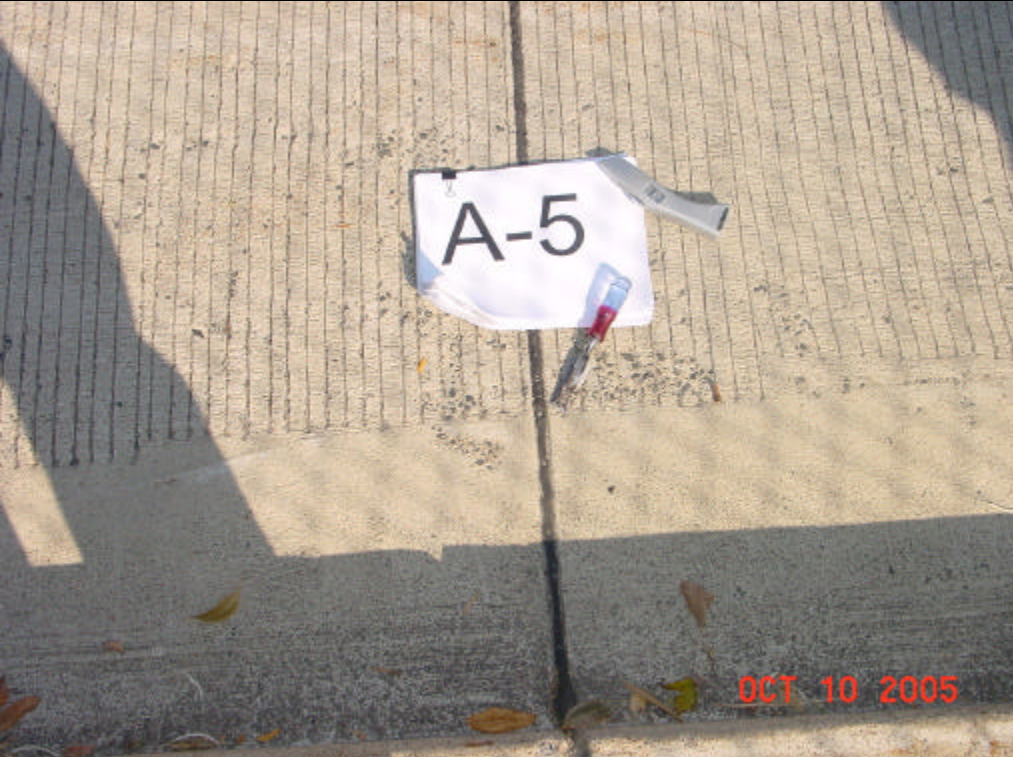
Client Name: Mn/DOT		Site Location: Bridge #9616	Project No. 30070-XA
Photo No. 9	Date: 10/10/05

Direction Photo Taken: Looking down at mid-span bridge deck			
Description: Asbestos sample A-5 Mid-span bridge deck joint sealant.

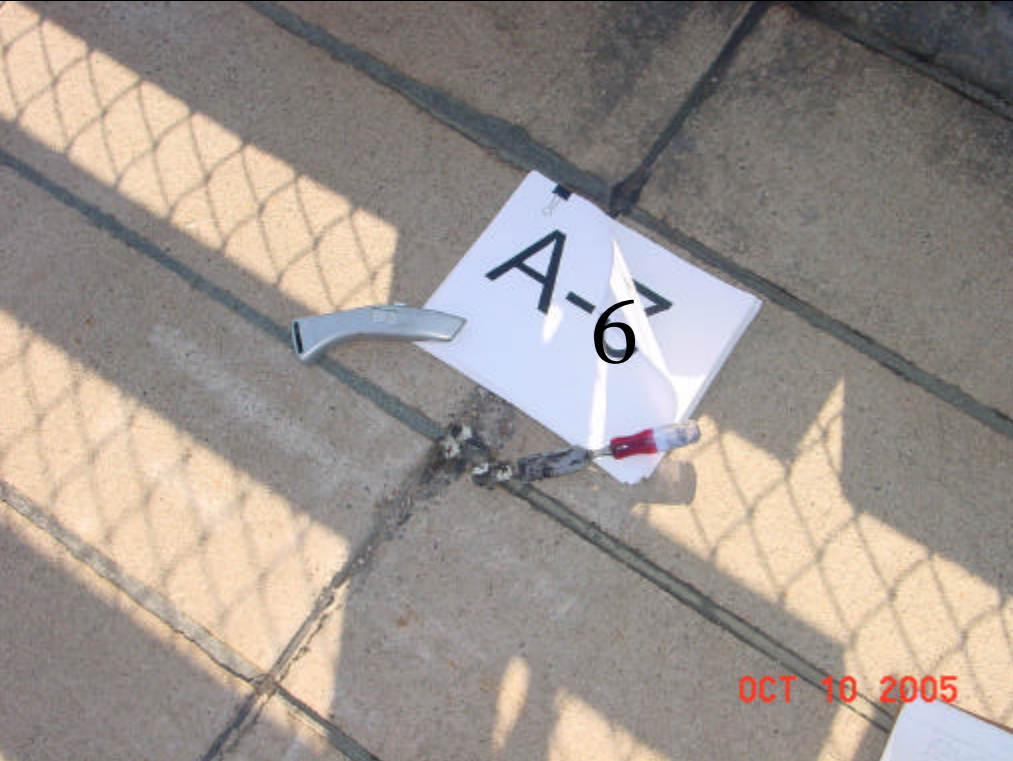
Photo No. 10	Date: 10/10/05

- Joint sealant on bridge sidewalk contained 5% asbestos = 2,150 linear feet (see Photograph #10).
- Caulk in electric junction boxes on bridge contained 5% asbestos = 20 inches³ (located in 16 electrical boxes on the north side of the bridge) (see Photograph #12).
- Transite utility piping under bridge contained 15% asbestos = 12 transite pipes (4-1/2" O.D.) approximately 200 linear feet per pipe (see Photograph #16).

Direction Photo Taken: Looking down at bridge sidewalk on the south side of the central portion of the bridge			
Description: Asbestos sample A-6 Bridge sidewalk sealant mid-span Three separate sealant layers were identified: 1) White layer 2) Black hard layer and 3) Rubber layer

The ACMs, identified in the Asbestos Summary (above), are required to be removed and properly disposed of in accordance with MnDOT Specifications, prior to demolition (see documents in Section 3 for the detailed sample locations, amounts, conditions and summary inventory of suspect materials).

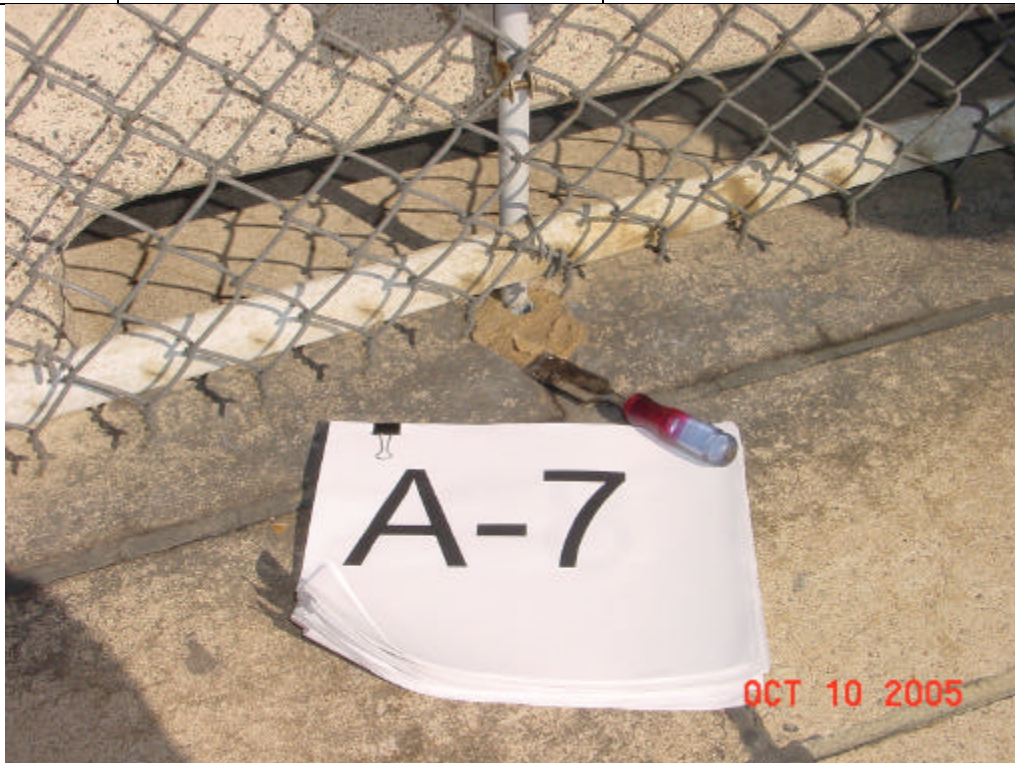
Photo No.: 11	Date: 10/10/05
-------------------------	--------------------------

Description:
Asbestos sample A-7
Brown material below electric box

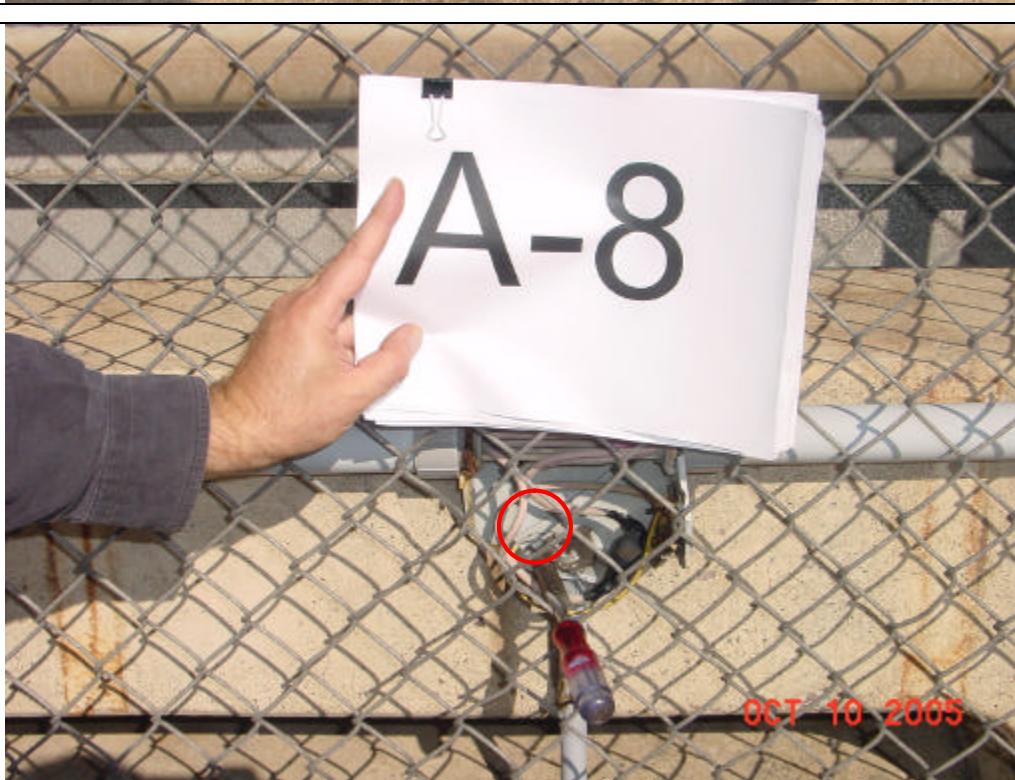
Photo No.: 12	Date: 10/10/05
-------------------------	--------------------------

Description:
Asbestos sample A-8
White layer and black layer - electric caulk on junction box

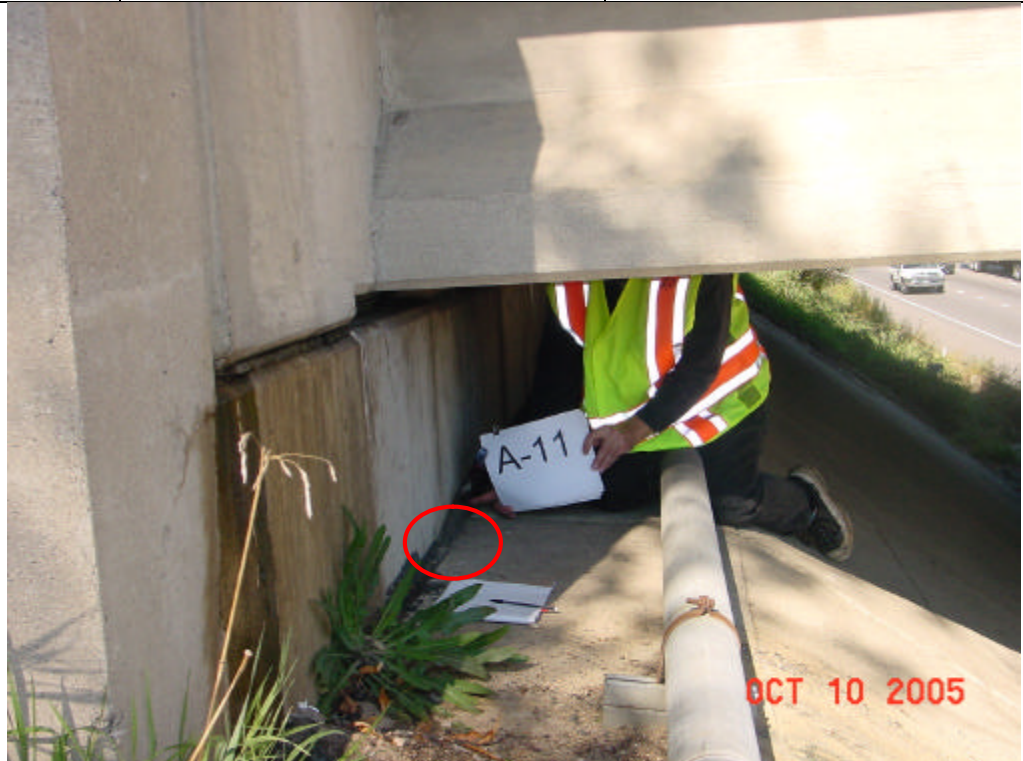
Photo No.: 15	Date: 10/10/05
-------------------------	--------------------------

Description:
Asbestos sample A-11
Joint compound btw footing & slope concrete

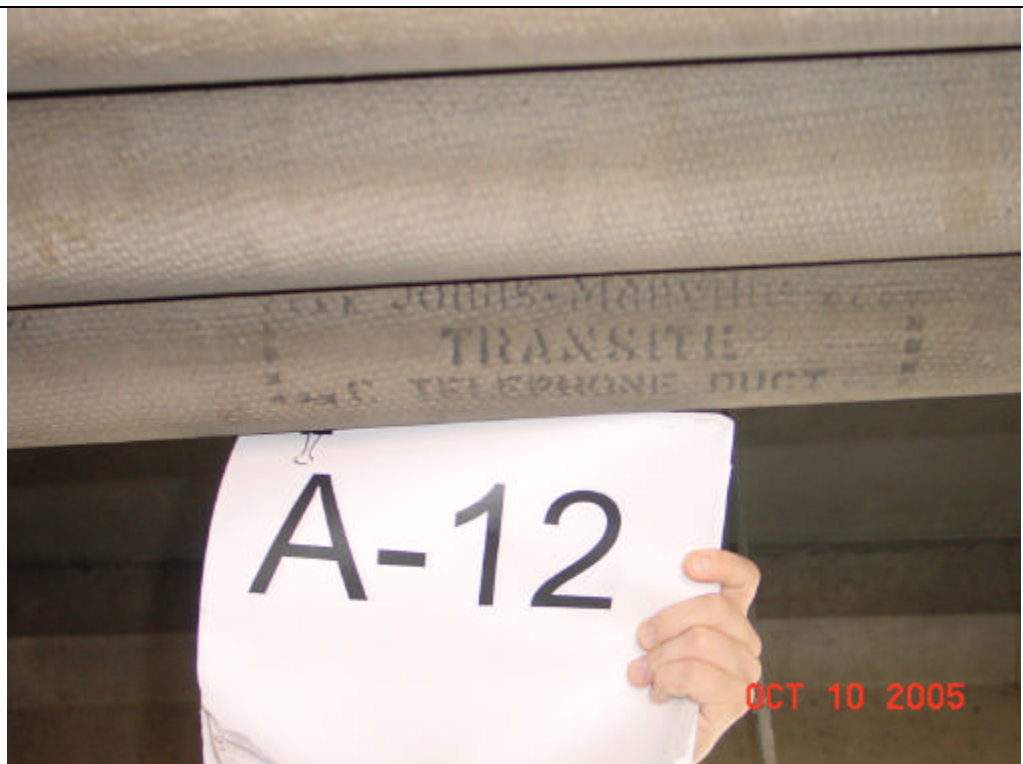
Photo No.: 16	Date: 10/10/05
-------------------------	--------------------------

Description:
Asbestos sample A-12
Transite piping under bridge
12 transite pipes x 4-1/2" O.D. were identified spanning the length of the bridge.

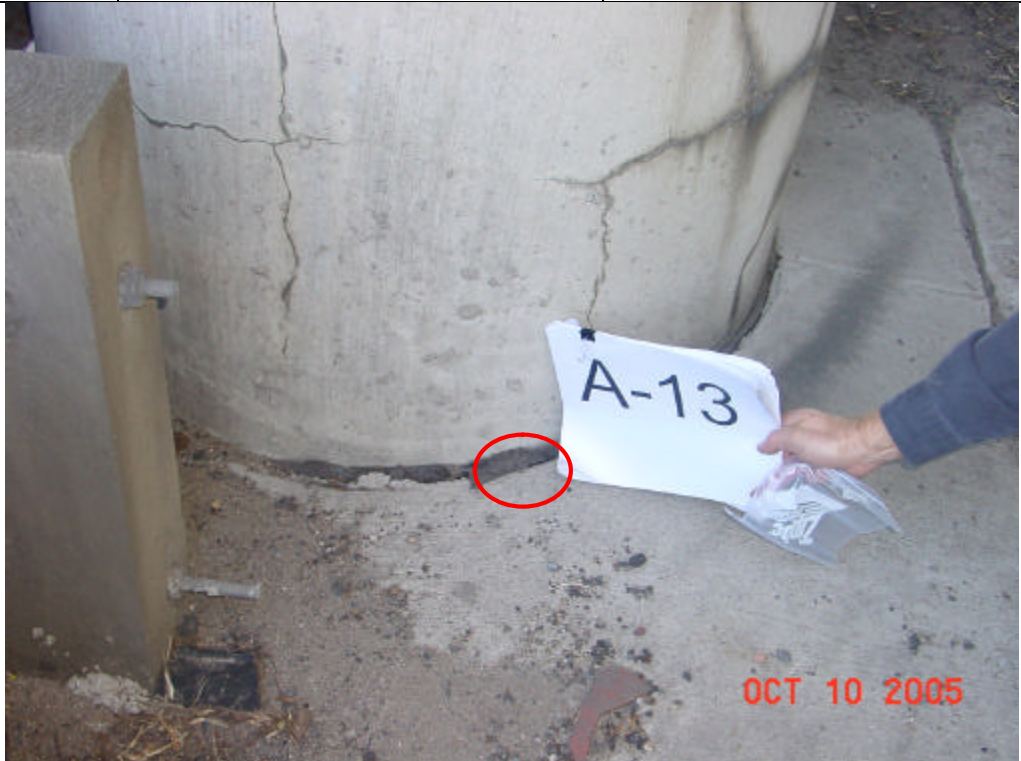
Photo No.: 17	Date: 10/10/05
-------------------------	--------------------------

Description:
Asbestos sample A-13
Joint at base of pier

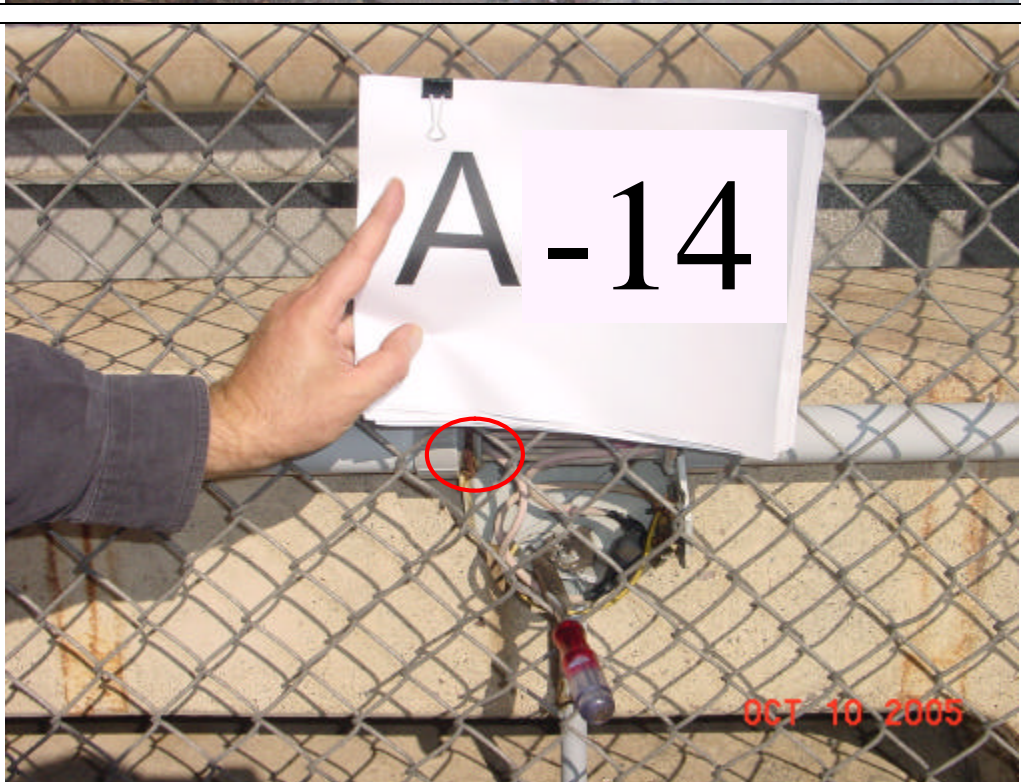
Photo No.: 18	Date: 10/10/05
-------------------------	--------------------------

Description:
Asbestos sample A-14
Electric box gasket

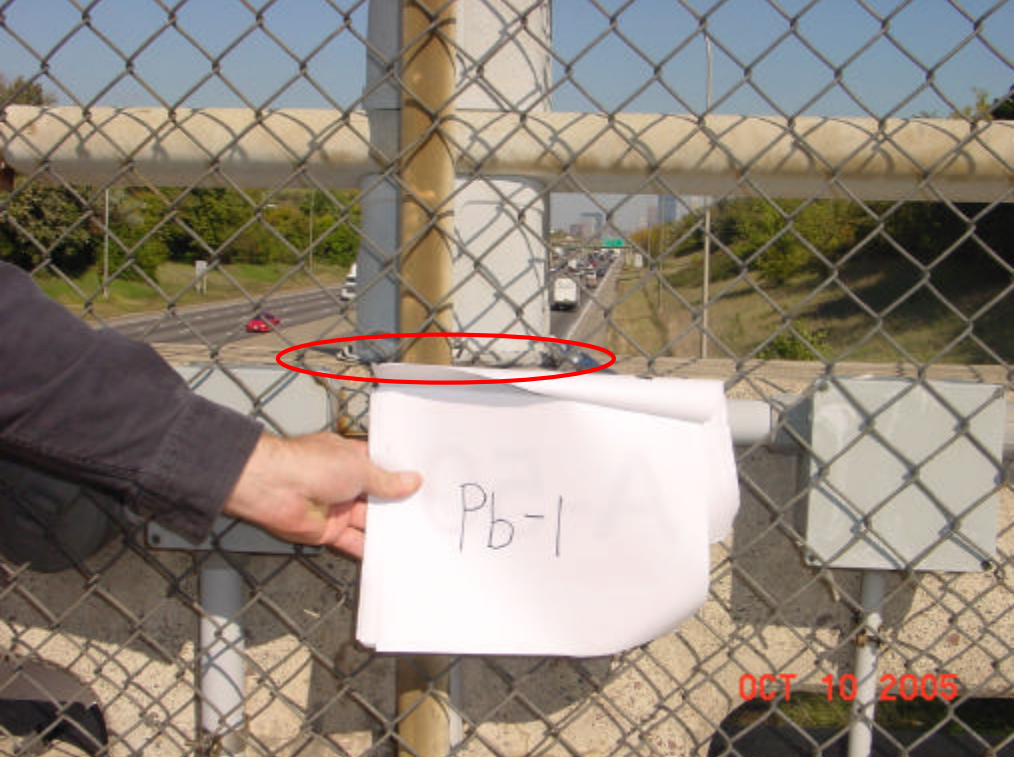
Client Name: Mn/DOT		Site Location: Bridge #9616	Project No. 30070-XA
Photo No. 19	Date: 10/10/05

Lead: Lead gaskets (48% lead concentration) were identified under the bridge guard railings during the inspection (see Photograph #19). Approximately 52 lead containing gaskets (size 8" x 8" x 1/4") were identified between the concrete guard railing and the steel railings on the bridge.

Direction Photo Taken: Facing railing gasket on north side of bridge			
Description: Lead sample Pb-1 Railing gasket

The lead gaskets are required to be removed/disposed prior to demolition. The portion of creosote treated timber piles and green treated crash barrier posts required to be removed for bridge demolition shall be managed and disposed in accordance with Mn/DOT specifications.

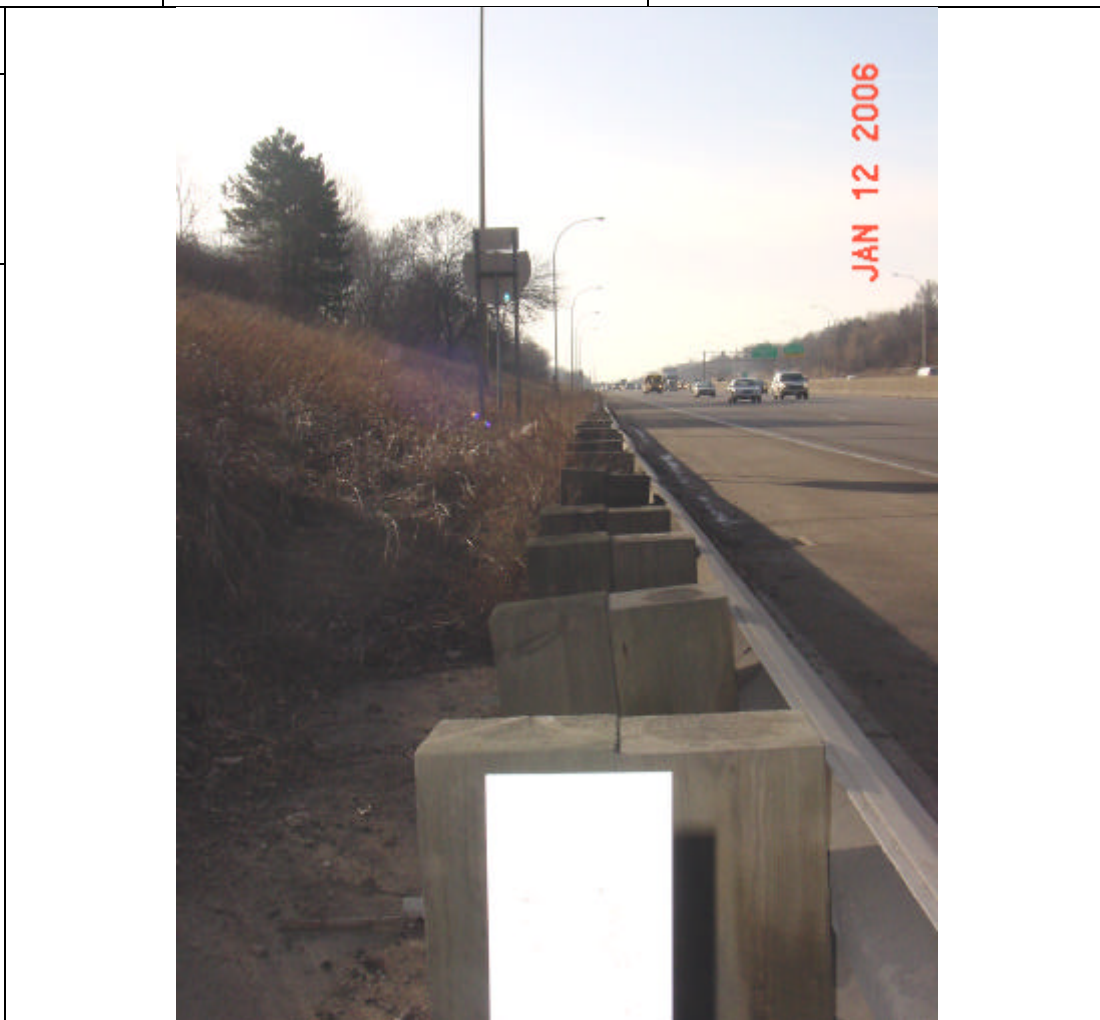
Photo No. 21	Date: 1/12/06
------------------------	-------------------------

Description:
Green treated wood guard rail support posts were observed under the bridge.
