Re: Request for extension of time to comply with railroad yard lighting statute

***Engineering Study
Lighting Status Report
UP Western Avenue Railroad Yard
St. Paul, Minnesota***

***Engineering Study
Lighting Status Report
CN Proctor Railroad Yard
Proctor, Minnesota***

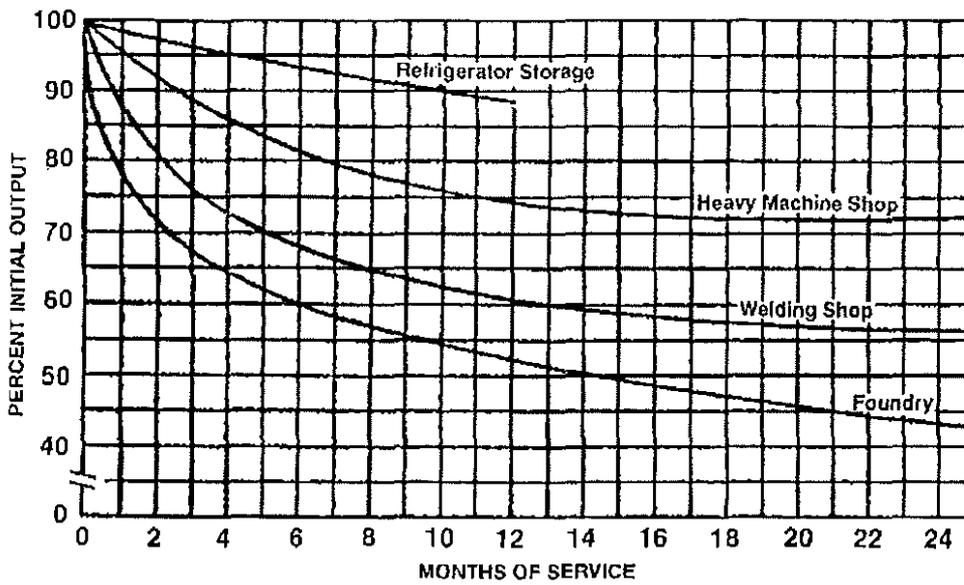
Figure 33-10-2. Decline in Light Output Due to Dirt, High-bay Areas

- d. In many installations it will be found the light output is only 50% as high as it should be. Light output can be increased by repainting, cleaning fixtures, and by correcting the voltage to designed levels.

- e. Figure 33-10-2 and Figure 33-10-3 show how much light output decreases over a two-year period in various types of high-bay and low-bay areas.

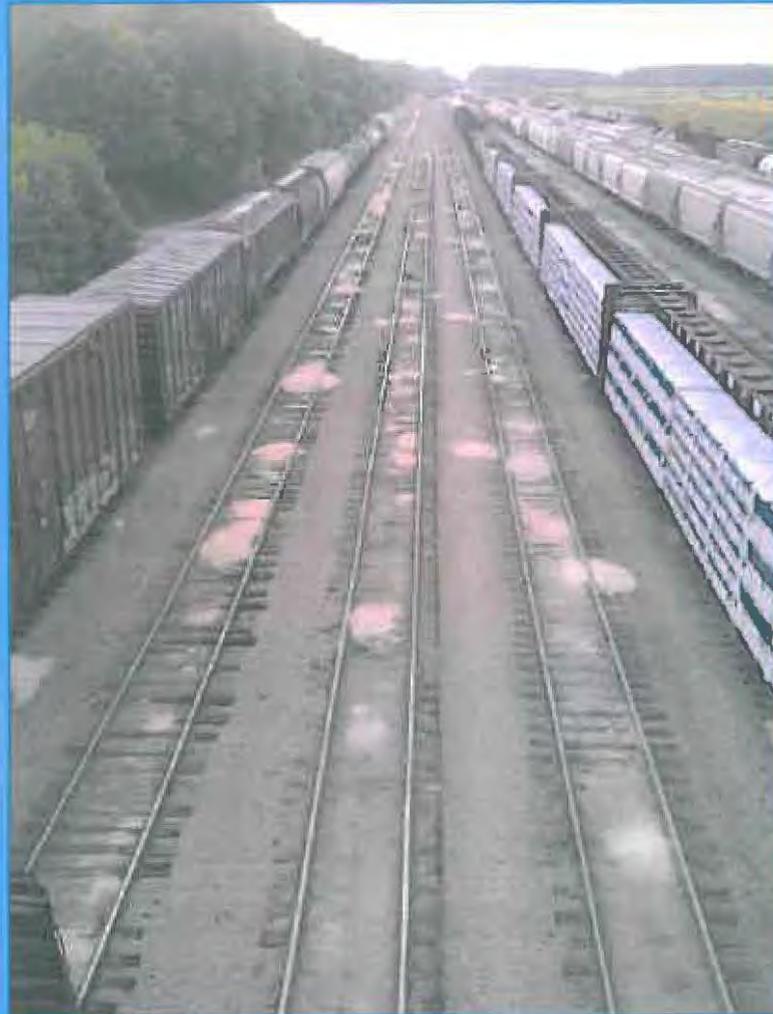
Railroad Yard – Fouled Walkway
