FINAL MIDTOWN CORRIDOR INDIVIDUAL BRIDGE SUMMARY AND MANAGEMENT PLAN

Prepared By: Olson & Nesvold Engineers, P.S.C.
SRF Consulting Group, Inc.
Gemini Research
Braun Intertec
MacDonald & Mack Architects

Bridge 90437
Cedar Ave S

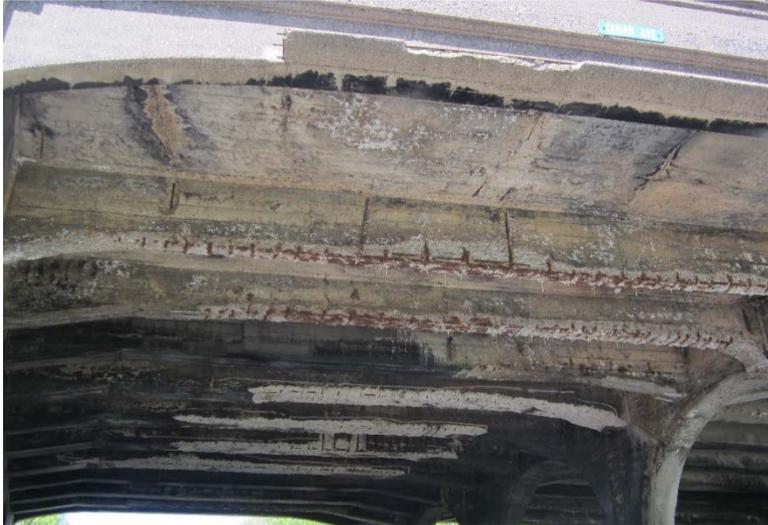
7 of the 10 interior beams in the center span are deteriorated.

A few of the bays have minor deck spalls, but the entire deck is undergoing significant freeze/thaw damage.

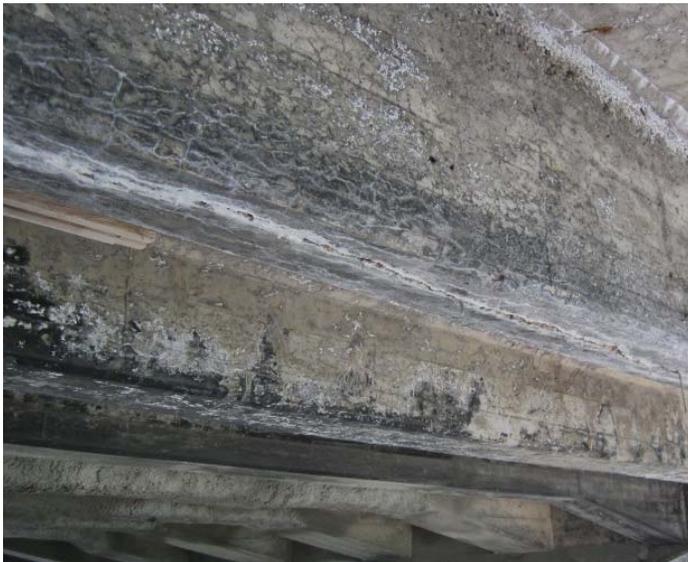
7 of the 10 interior beams in the south span are deteriorated; additional beams are covered in shotcrete.

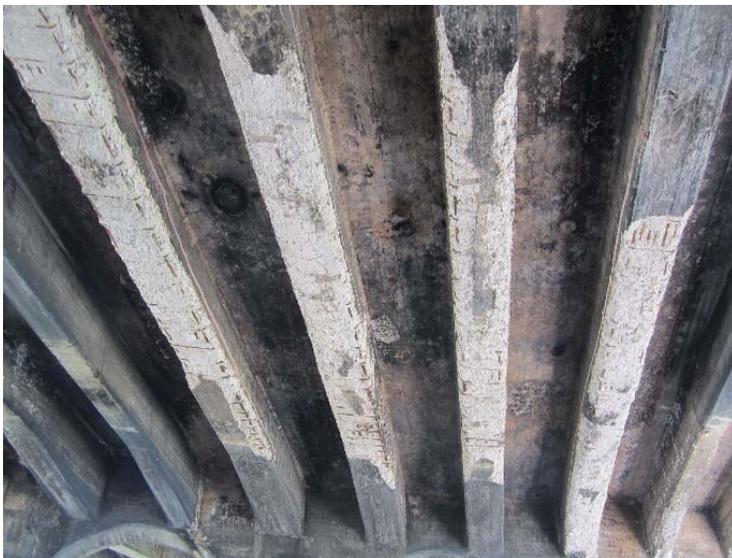
6 of the 10 interior beams in the north span are deteriorated

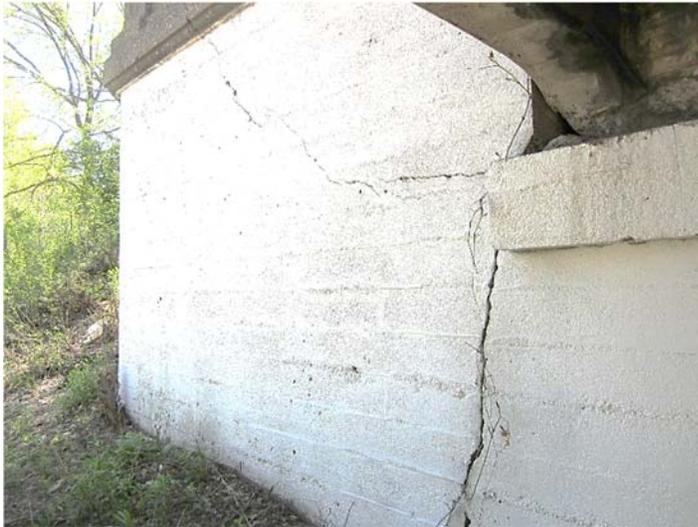
Cracks are present in the abutments indicating movement of the center portion of the abutment relative to the adjoining wing walls. This movement appears to be both vertical and horizontal. Shear blocks are not present. About 15 linear feet of cracks are less than ½ inches in width; about 25 linear feet of cracks are more than ½ inches in width on the south abutment.

There are deep and shallow spalls on the south abutment. There are about 100 square feet of spalls where the unsound concrete is likely more than 4 inches deep and about 50 square feet of more shallow spalls.

The south abutment and remaining pier columns would require spall repairs, both major (where approximately 4 inches of concrete is estimated to be replaced) and minor (where approximately 2 inches of concrete is estimated to be replaced). With the major repairs, the existing reinforcement should be cleaned and assessed for corrosion. Additional reinforcement may need to be added depending on the extent of the corrosion. All new concrete should be finished with a board form treatment to line up with the original board form lines and should match the texture and color of the adjacent historic concrete.

A few narrow cracks on the south abutment need to be filled with epoxy which is compatible with the adjacent historic concrete.

A few major cracks on the south abutment would need repair. The repair would likely consist of new reinforcement bars which are stitched into the existing concrete and span over the large crack. All replacement concrete would be finished similar to the spall repairs.

Helical anchors are suggested to prevent further settlement of the south abutment and wing walls. Helical anchors would be installed by drilling through the abutment and wing wall footings and vertical faces. The new concrete which will replace the concrete removed to install the anchors would be finished similar to the spall repairs.

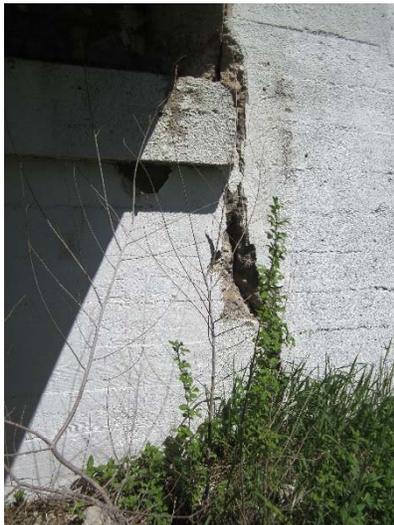
Cracks located on the north abutment appear to be much deeper and are believed to protrude through the abutment stem.

The north abutment has severe cracks which are believed to protrude through the entire concrete section, thereby causing the abutment to act as pieces instead of one entity as intended. The far northeast pier column also has major freeze/thaw damage; the damage is believed to be deep into the concrete and therefore, precludes repair. The deck has significant freeze/thaw damage and most of the beams are in poor condition. For these reasons, the following items are suggested to be replaced: north abutment, far east pier column in the north bent, beams, deck, sidewalk, and railing. A typical section showing removal limits is provided on the following page.

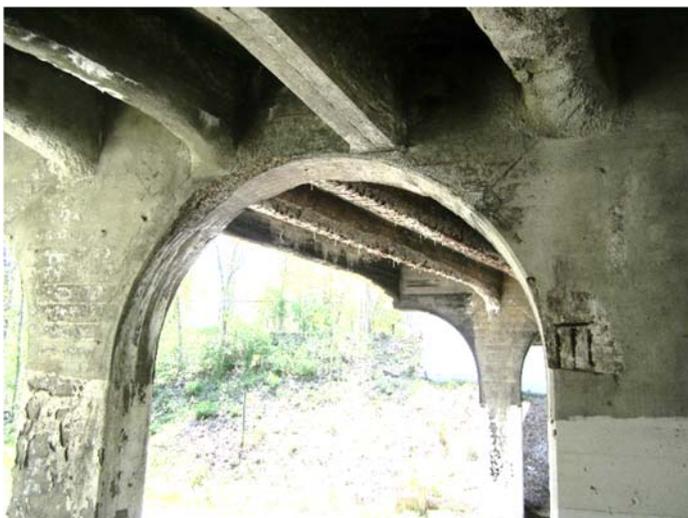
The pier columns and caps appear to be in fair condition. The far northeast column has major freeze/thaw damage while the other columns have some spalls. There are about 20 square feet of spalls where the unsound concrete is likely more than 4 inches deep and about 50 square feet of more shallow spalls.

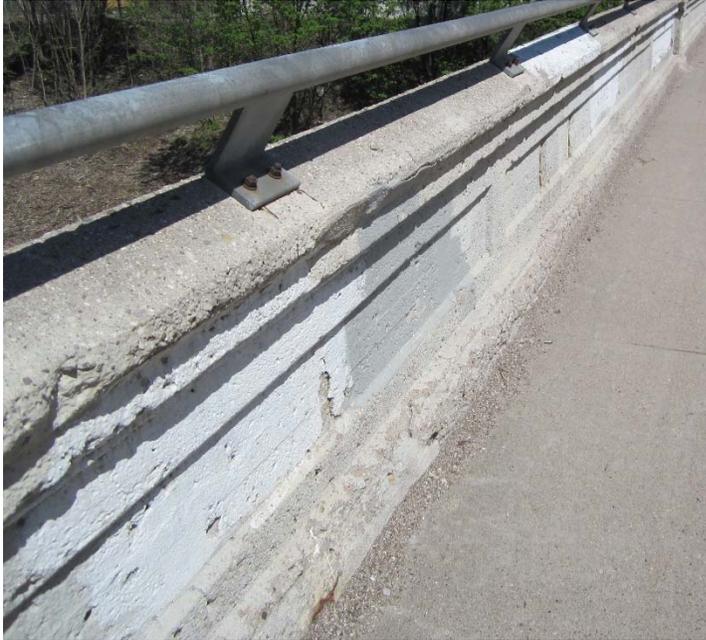
The railings are in poor condition. The railing is badly pitted throughout; the toe concrete is flaking apart. Vertical rebar is also visible in one panel.

The sidewalk appears to be in fair condition.

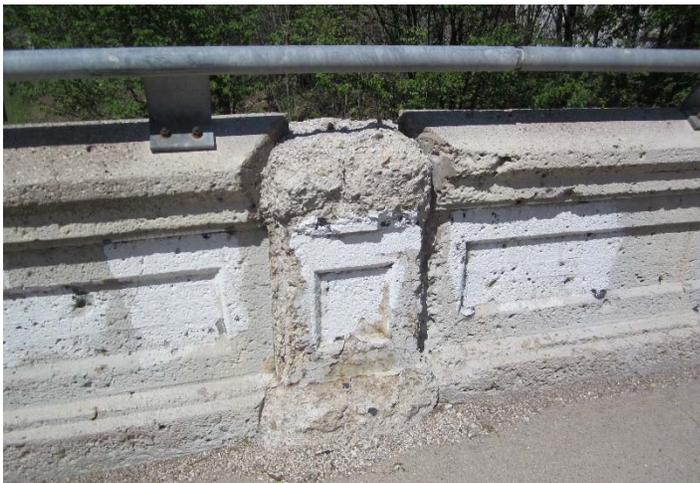
This is a typical condition of original posts. (One post was reconstructed in-kind).

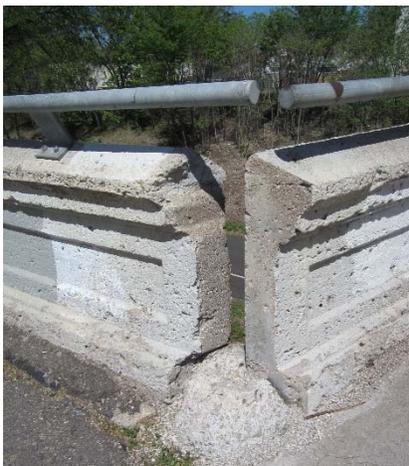
The southwest post is missing.

The entire length of the railing is in poor condition (290 linear feet).

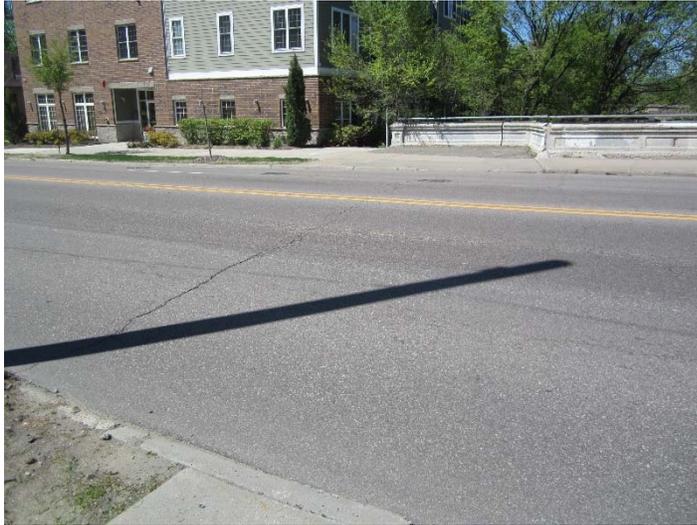
Bituminous pavement approaches are at each end of the bridge. Utilities are present in the approaches with two manhole covers present.

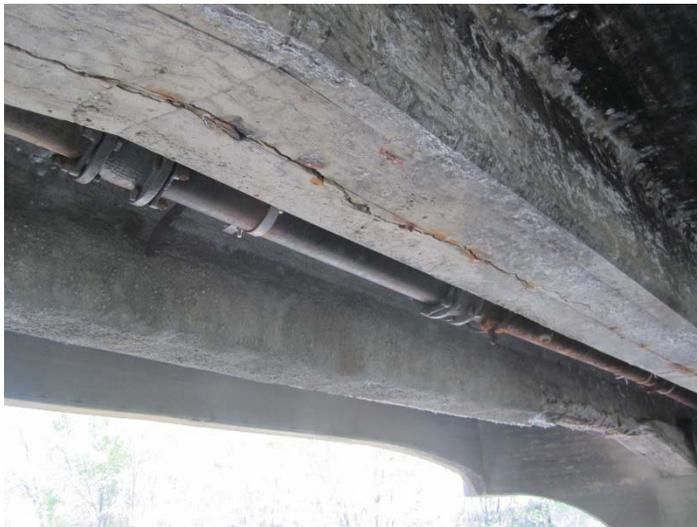
A watermain is supported on the bridge between the first two interior beams on the west side of the bridge.
