Bridge Number: 90494
Portland Ave. S

FINAL MIDTOWN CORRIDOR INDIVIDUAL BRIDGE SUMMARY AND MANAGEMENT PLAN

Prepared By: Olson & Nesvold Engineers, P.S.C.
SRF Consulting Group, Inc.
Gemini Research
Braun Intertec
MacDonald & Mack Architects

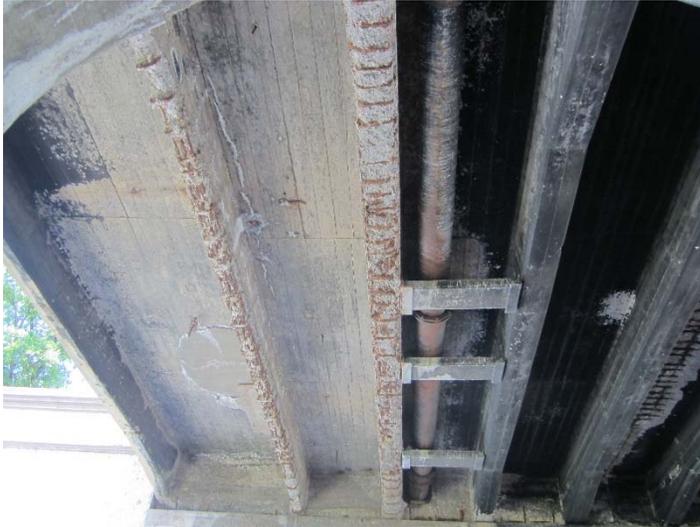
The first two to three interior girders on either side of the bridge are in poor condition. A typical state of the beams next to the watermain is shown to the left. There are major spalls and reinforcement section loss on these beams.

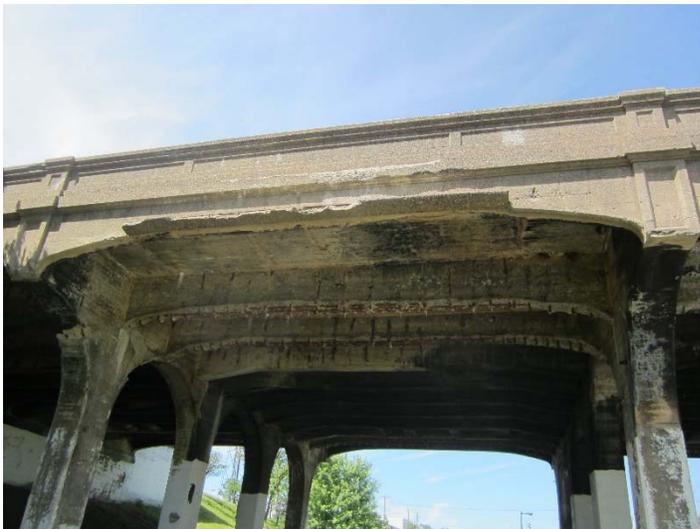
Deteriorated beams can be seen in the center span of the bridge.

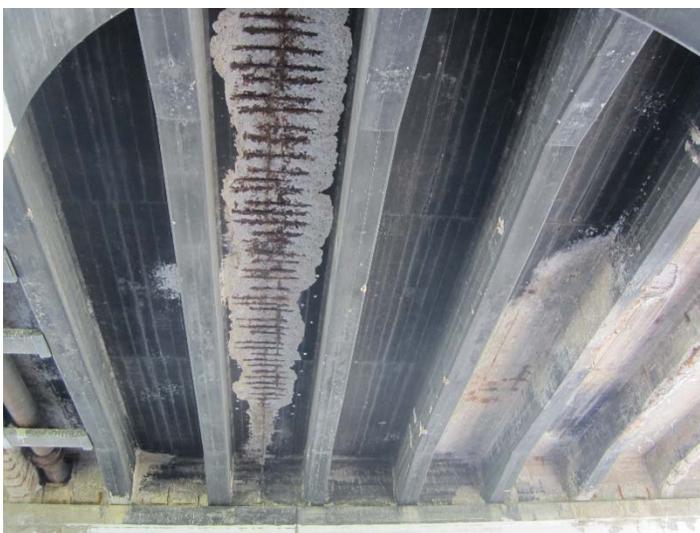
There are major deck spalls in the center of the bridge along the longitudinal joint.

The center beams have approximately 30 square feet of minor spalls.

A few of the center beams which are suggested to remain would require minor spall repairs, where approximately 2 inches of concrete is estimated to be replaced. All new concrete should be finished with a board form treatment to line up with the original board form lines and should match the texture and color of the adjacent historic concrete. Limit excess removals and excess new concrete to preserve the black residue that remains on the beams.

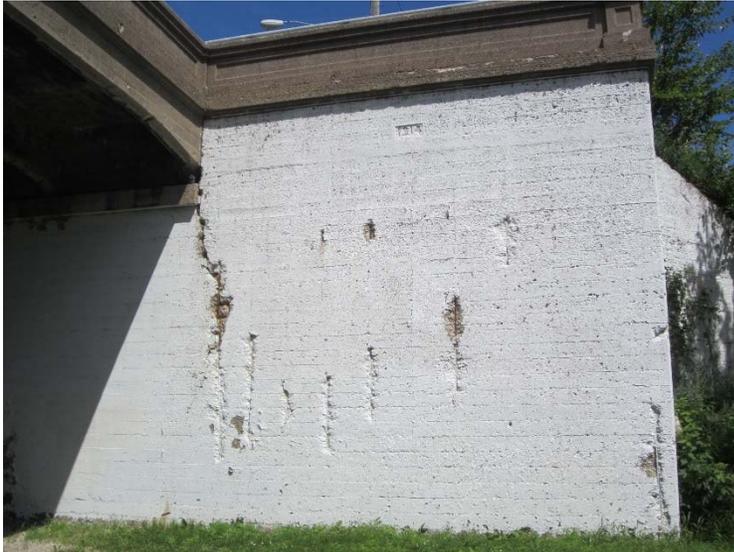
Spalls and cracks are on both abutments. This is more defined on the outer pier columns as seen in the pictures below. There are slight signs of settlement on the south abutment. The two north wing walls are tilting outwards about 3 to 4 inches.

About 25 linear feet of cracks are less than ½ inches in width; about 25 linear feet of cracks are more than ½ inches in width on both abutments.

A few narrow cracks on the abutments need to be filled with epoxy which is compatible with the adjacent historic concrete.

A few major cracks on the abutments would need repair. The repair would likely consist of new reinforcement bars which are stitched into the existing concrete and span over the large crack. All replacement concrete would be finished similar to the spall repairs.

Helical anchors are suggested to prevent further settlement of the south abutment and north wing walls. Helical anchors would be installed by drilling through the abutment and wing wall footings and vertical faces. The new concrete which will replace the concrete removed to install the anchors would be finished similar to the spall repairs.

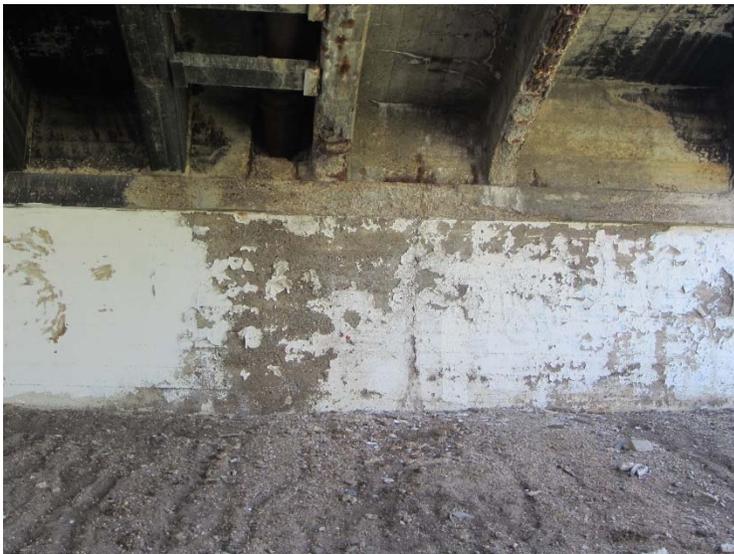
There are deep and shallow spalls on both abutments. There are a total of about 250 square feet of spalls where the unsound concrete is likely more than 4 inches deep and about 50 square feet of more shallow spalls.

The abutments and remaining pier columns would require spall repairs, both major (where approximately 4 inches of concrete is estimated to be replaced) and minor (where approximately 2 inches of concrete is estimated to be replaced). With the major repairs, the existing reinforcement should be cleaned and assessed for corrosion. Additional reinforcement may need to be added depending on the extent of the corrosion. All new concrete should be finished with a board form treatment to line up with the original board form lines and should match the texture and color of the adjacent historic concrete.

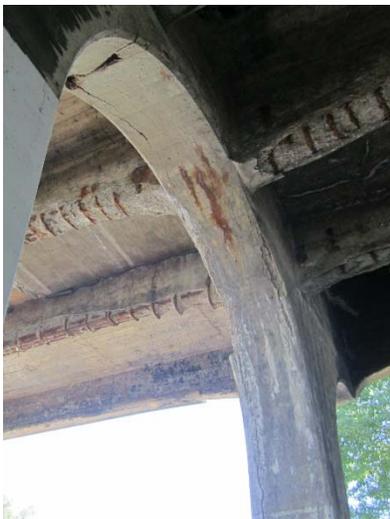
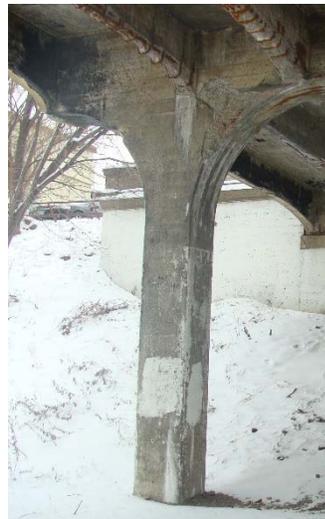
The pier columns and caps appear to be in poor condition. The outer columns have the most damage while the other columns have some spalls. The outer columns have numerous small cracks.

There are about 10 square feet of spalls where the unsound concrete is likely more than 4 inches deep and about 20 square feet of more shallow spalls on the interior columns.

The outer pier columns have numerous small cracks; the damage is believed to be deep into the concrete and therefore, precludes repair. The deck has spalls and half of the beams are in poor condition. For these reasons, the following items are suggested to be replaced: two outer pier columns in each bent, eight beams, deck, sidewalk, and railing. A typical section showing removal limits is provided on the following page.

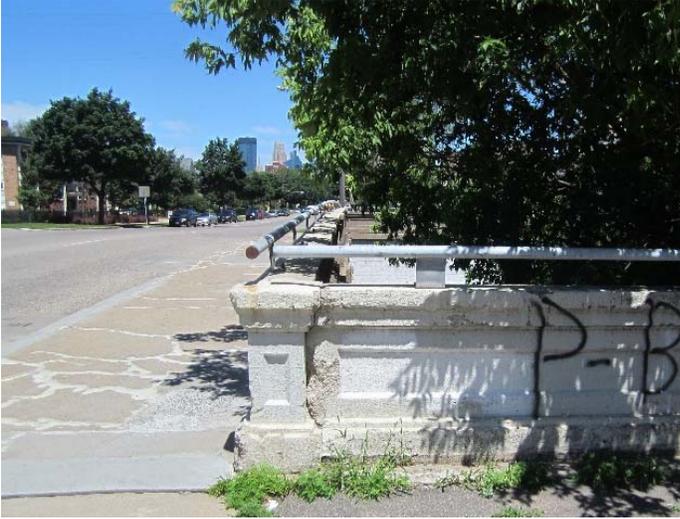
The railings are in poor condition. This shows a typical wingwall condition. The panel adjacent to the corner post has poor concrete. The rest of the railing on the wingwall has a few spalls and delaminations.

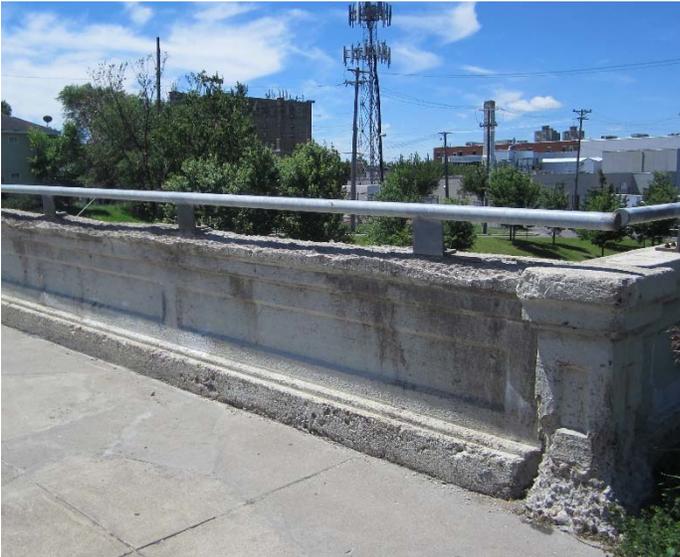
The railings are in poor condition. The bottom of most posts is deteriorated. The top cap is also deteriorated.

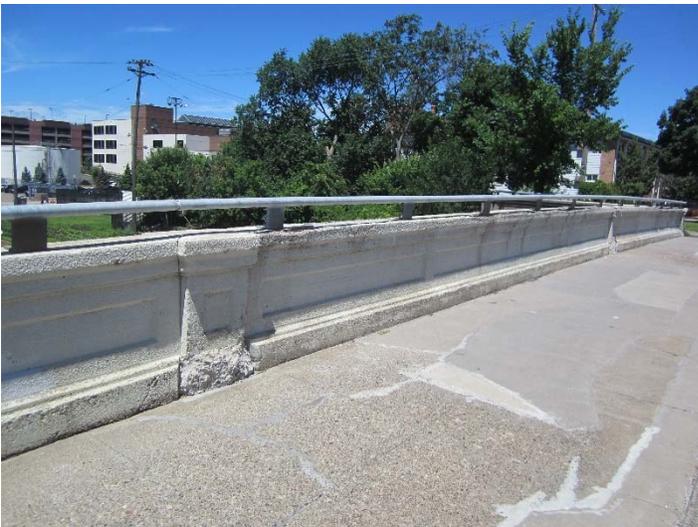
Many patches and sealed cracks were noticed in the sidewalks during the site visits.

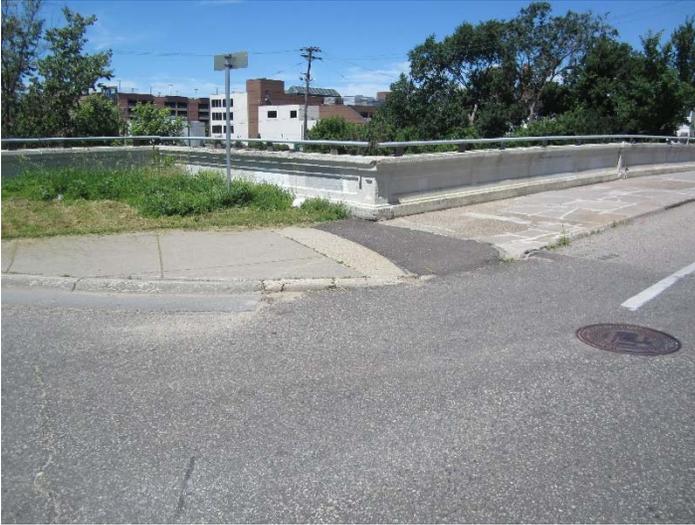
The approaches are bituminous. The south approach show signs of significant settlement.

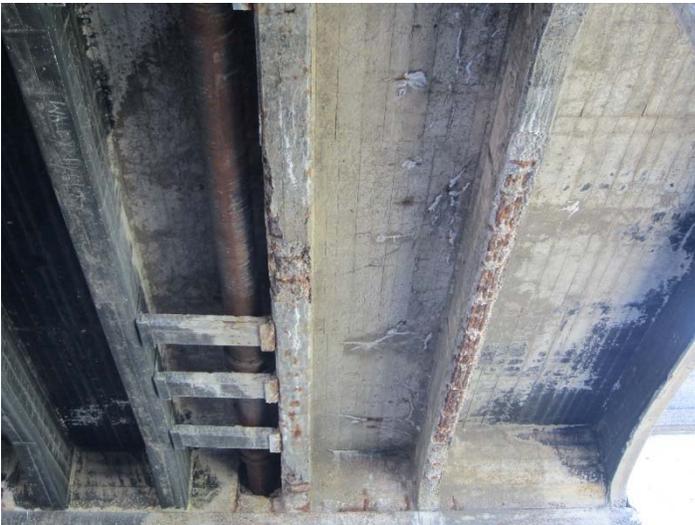
A watermain is supported between the second and third interior beams on the west side of the bridge.
