## FINAL MIDTOWN CORRIDOR INDIVIDUAL BRIDGE SUMMARY AND MANAGEMENT PLAN

The Fremont Avenue Bridge (Bridge L8901) carries vehicular and pedestrian traffic over the Midtown Greenway in the city of Minneapolis. The bridge was constructed in 1912-1913 and is a contributing element in the Chicago, Milwaukee, and St. Paul Railroad Grade Separation Historic District.

**Bridge L8901  
Fremont Ave S**

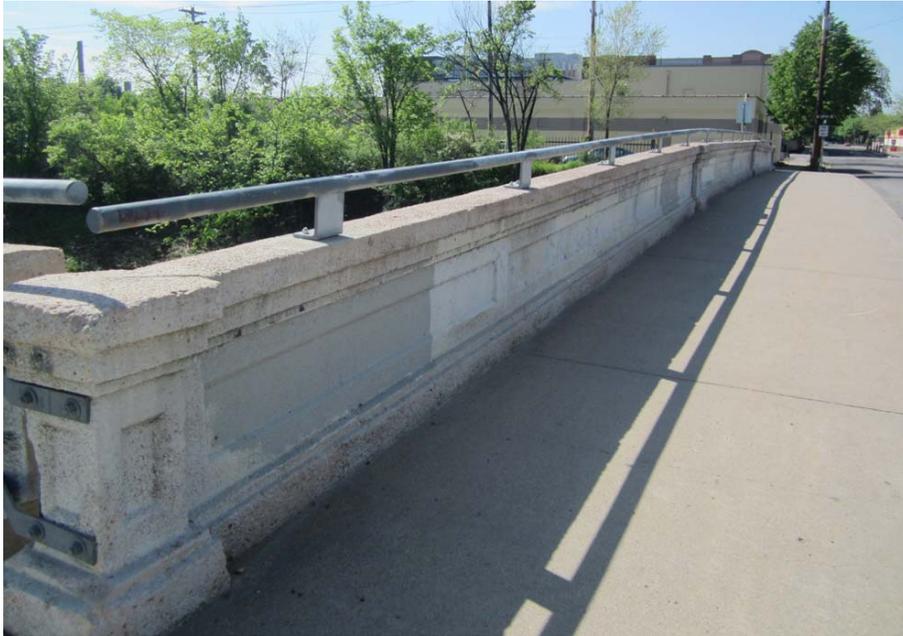
**Feature 2: Abutments with classical coping on bridge seats. Piers comprised of four square columns joined by rounded arches that extend to the fascia to support cantilevered sidewalks. Multiple beams integrated with the deck; beams are angled to follow the curve of the fascia beams. Fascias are haunched with recessed panel detailing over the piers. (Two characteristics of the corridor's bridges are currently missing: date block imprints are covered with shotcrete and both smoke shields have been removed.)**

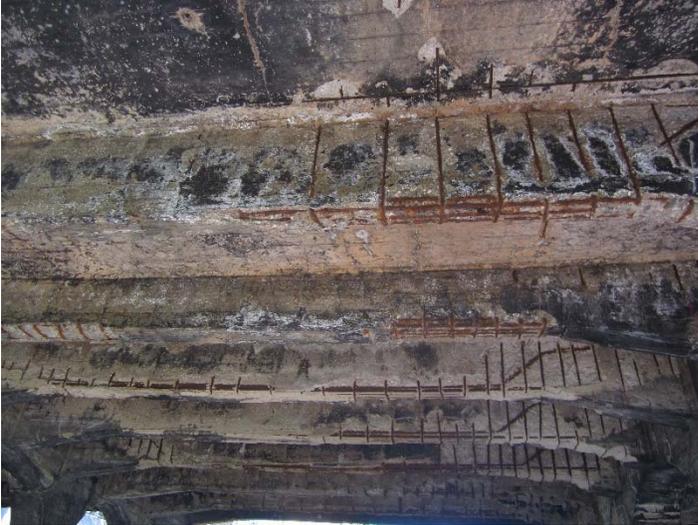
This is the condition of the center span. All beams have some spalling or scaling present and all bays have at least minor deck spalls with reinforcement exposed.

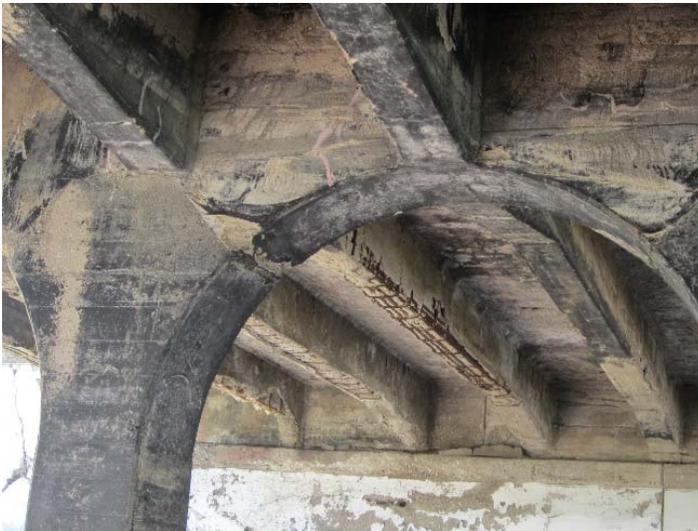
This is the condition of the south span. Some beams only have scaling present, but the majority of the beams have spalling with exposed, corroded reinforcement. All bays have at least minor deck spalls with reinforcement exposed.

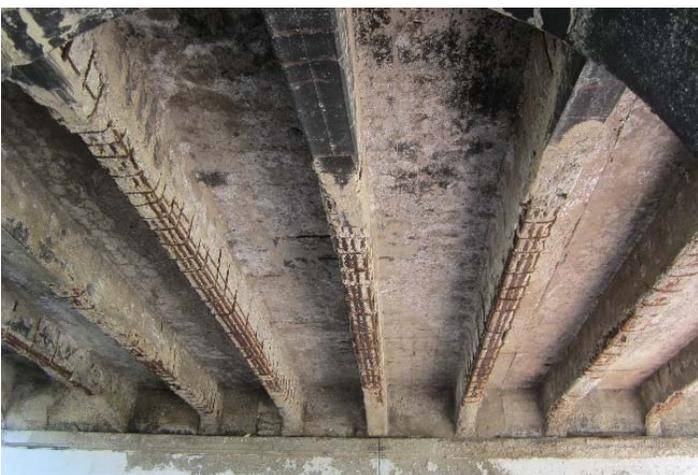
This is the condition of the north span. Similar to the center span, all beams have some spalling or scaling present and all bays have at least minor deck spalls with reinforcement exposed.

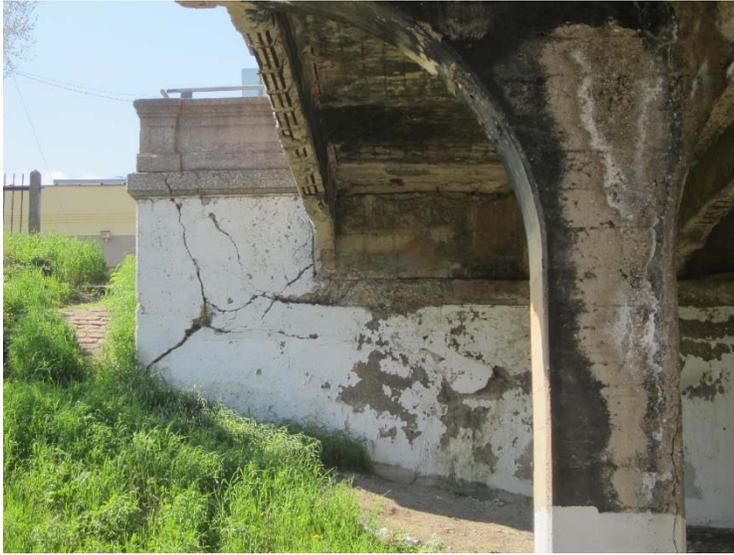
The south wing walls are cracked; the southeast corner is shown to the left. There are also numerous spalls and scaling on the face of the abutment.

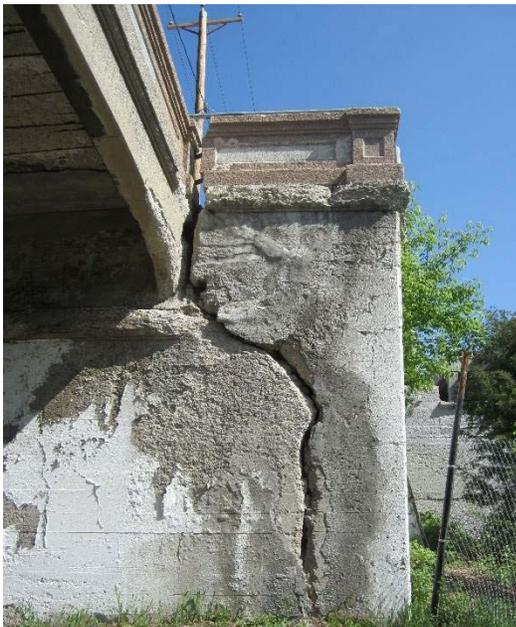
The north wing wall cracks were repaired with shotcrete; the northeast wing wall crack reappeared. It is believed that this crack protrudes through the abutment.

There are also spalls and scaling on the face of the north abutment.

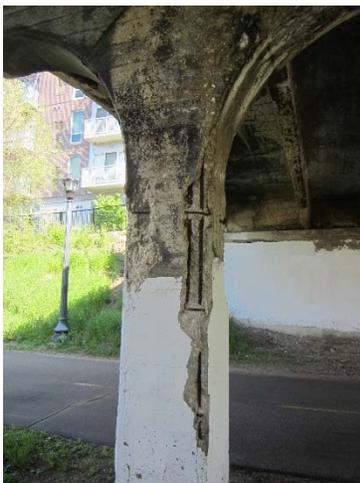
There are spalls located on all of the pier columns and arches between the columns. Structural cracks are also visible in the arches.

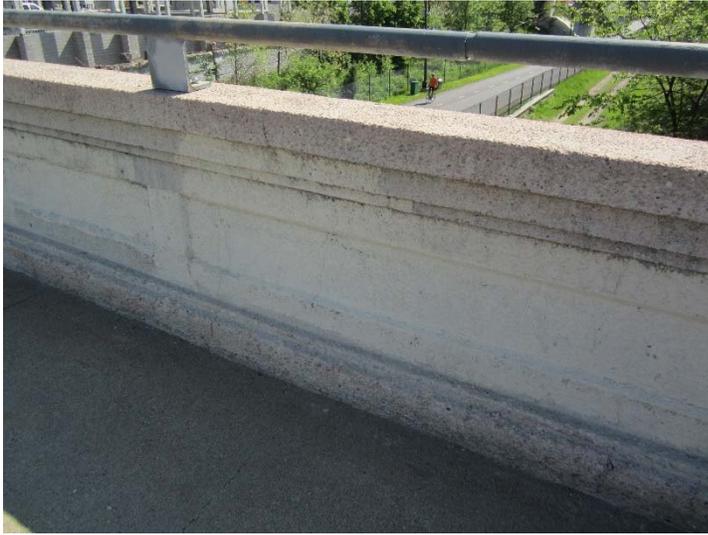
The railings are in satisfactory condition except for the large separation at the posts at the end of the bridge. Typical hairline cracks are found along the railing.

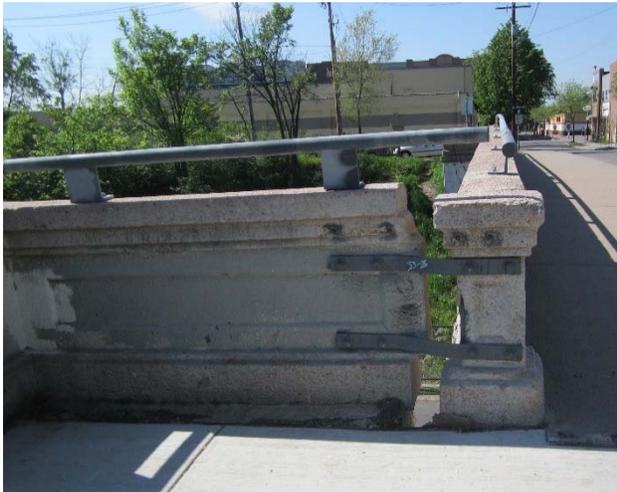
This is the northeast corner. Metal straps are being used to try to prevent the wing walls from settling further. The connection between the railing and wing walls were likely not designed with this purpose in mind.

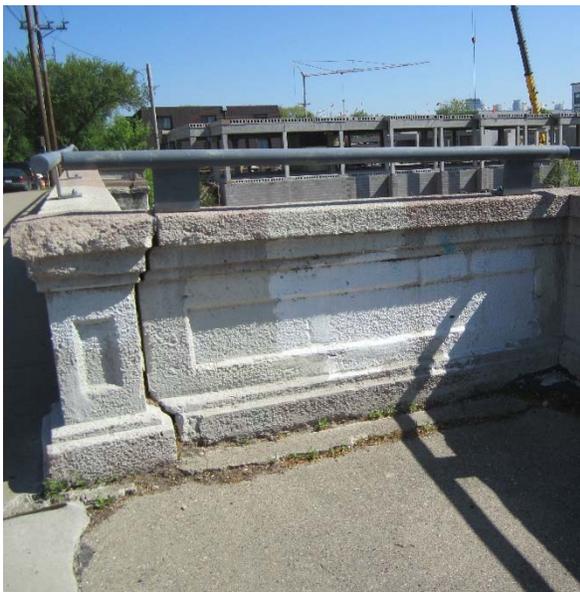
The southeast corner is the only corner without the metal straps.

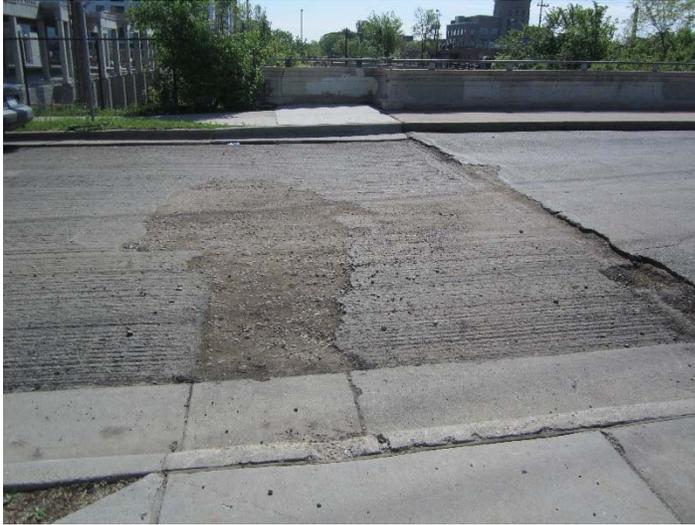
The approaches were milled at the time of this picture. Some additional spalls can be seen beneath the bituminous overlay.
