Collapse of I-35W Highway Bridge
Minneapolis, Minnesota
August 1, 2007

ACCIDENT REPORT

NTSB/HAR-08/03
PB2008-916203

Highway Accident Report

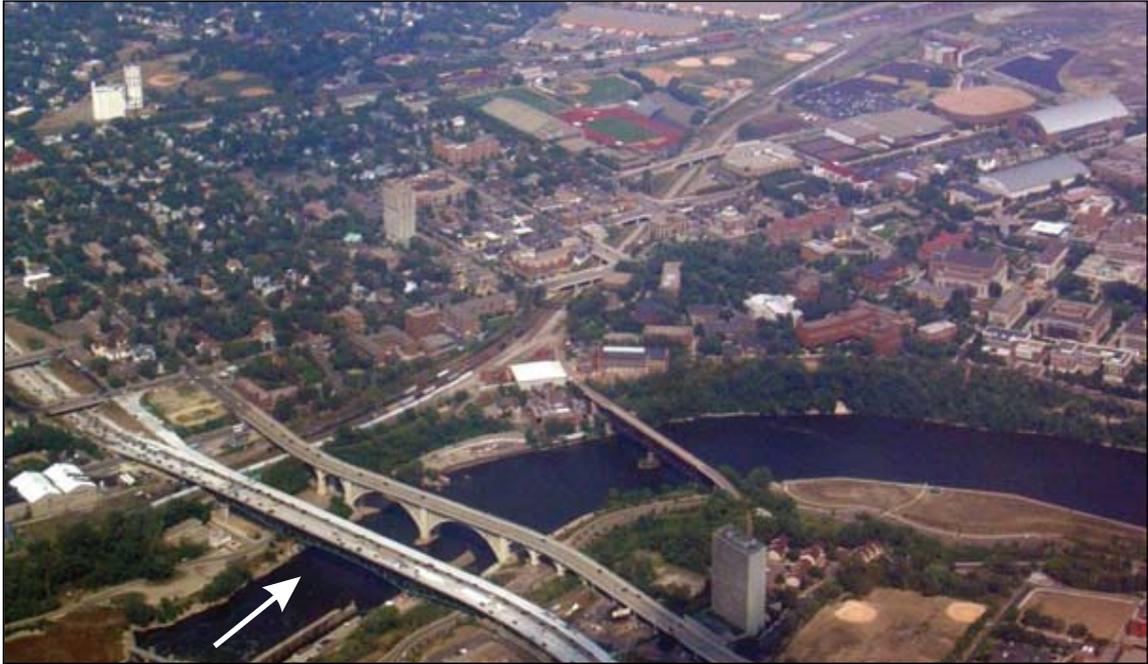
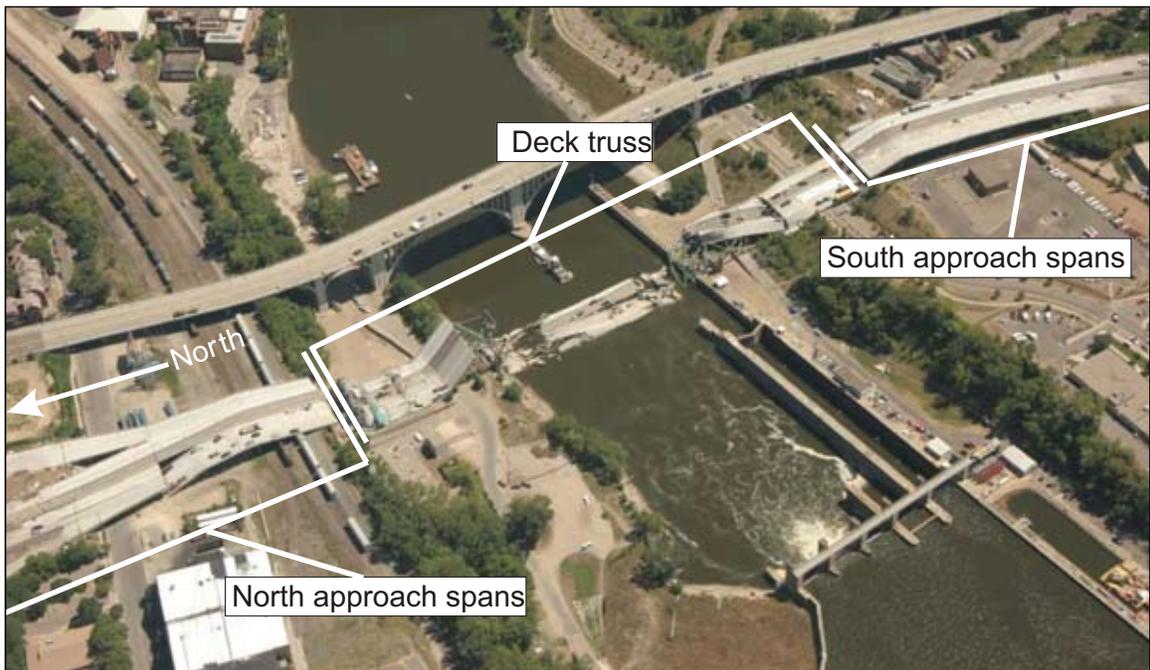
Figure 1. (Top) Aerial view (looking northeast) of I-35W bridge (arrow) about 2 hours 15 minutes before collapse. This photograph was taken by a passenger in a commercial airliner departing Minneapolis/St. Paul International Airport. (Bottom) I-35W bridge after collapse.

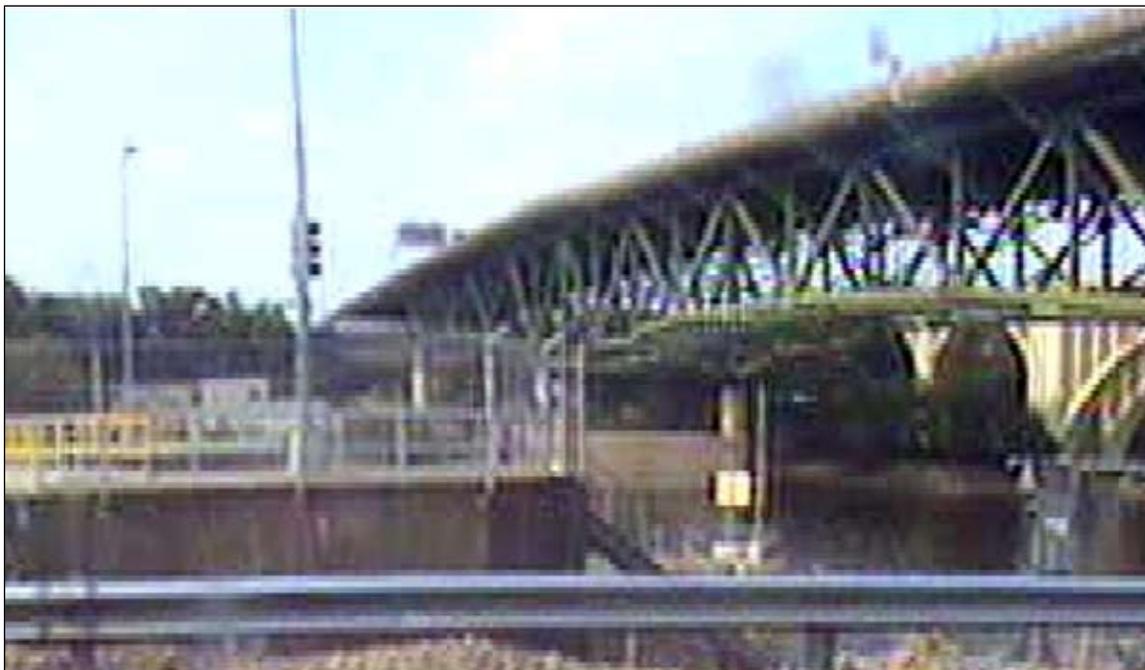
The video system activated at 18:04:57 central daylight time,¹⁰ just after initiation of the collapse. The first video image of the collapse (see figure 10) shows that the southern end of the visible structure of span 7 has dropped downward as compared to its position in precollapse recorded images. In the north portion of the span, a bend appears in lower chord members L9'/L10'W and L10'/L11'W.¹¹ In the south portion, deck stringer 14, the westernmost stringer, has begun to separate from the deck at the U11W node. Over the next 3 seconds, the entire center span separates from the rest of the bridge structure and falls into the river. The video shows that during the collapse of this span, the bridge deck remained generally level east to west, but the north end of the span remained higher than the south end as the bridge section fell.

Figure 10. Close-up of first image of collapse sequence, captured by surveillance camera at 18:04:57. The south (near) end of the center span can be seen to have dropped from its position as shown in precollapse images (compare with figure 9).

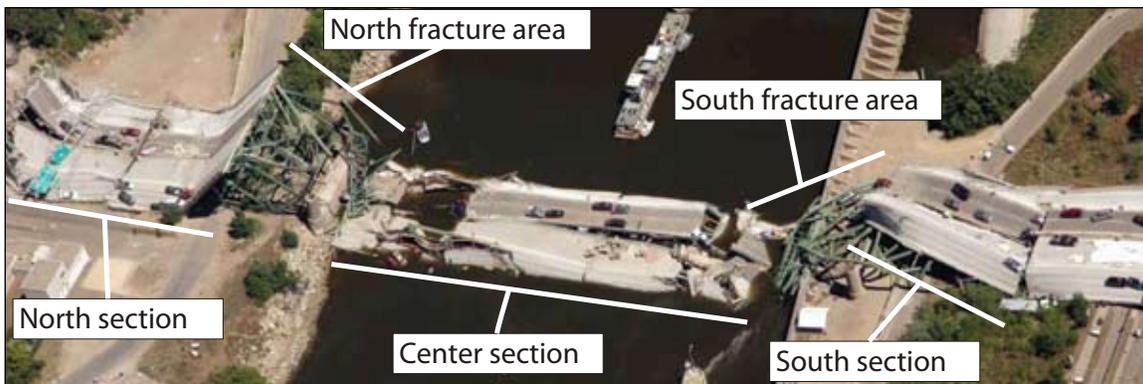
During the collapse sequence, the deck truss portion of the bridge separated into three large sections. Most of the center span, between piers 6 and 7 (referred to here as the “center section”), separated from the remainder of the truss and fell into the river. The section south of pier 6 (the “south section”) fell onto land on the south side of the river, and the section north of pier 7 (the “north section”) fell onto land on the north side of the river. (See figure 11.) General damage to each of these sections is detailed below. The fractures in the members between these sections are discussed later in this report in the “Examination of Deck Truss Fracture Areas.”

Figure 11. Collapsed deck truss sections of I-35W bridge.

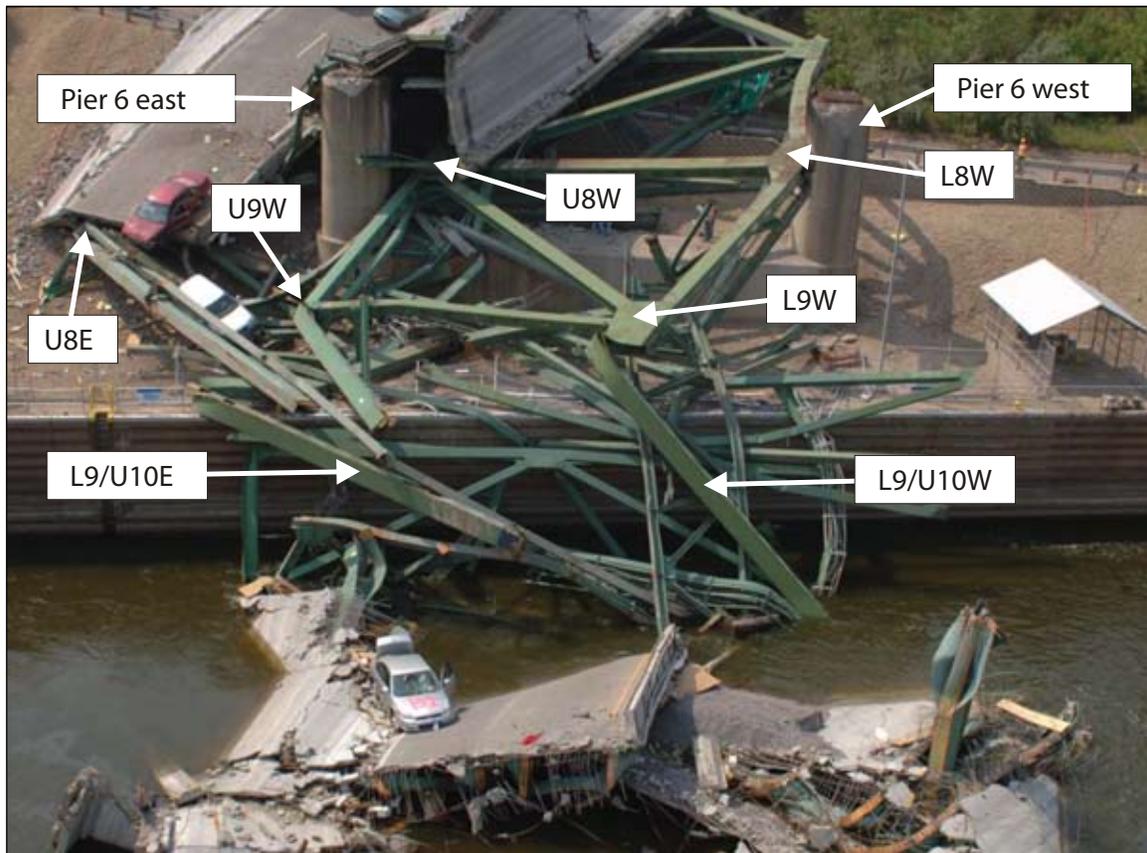
South Section. Figure 12 shows the collapsed south section of the deck truss. The deck and floor stringers north of the U8 node (directly over pier 6) separated at this node and remained attached to the center section of the structure, which fell into the river. The deck and stringers south of the U8 node remained approximately in their original positions relative to the upper chords of the truss. The U8 and L8 nodes, east and west (at pier 6), remained with the collapsed south section of the truss.

Figure 12. Looking south at south fracture area and a portion of collapsed south section.

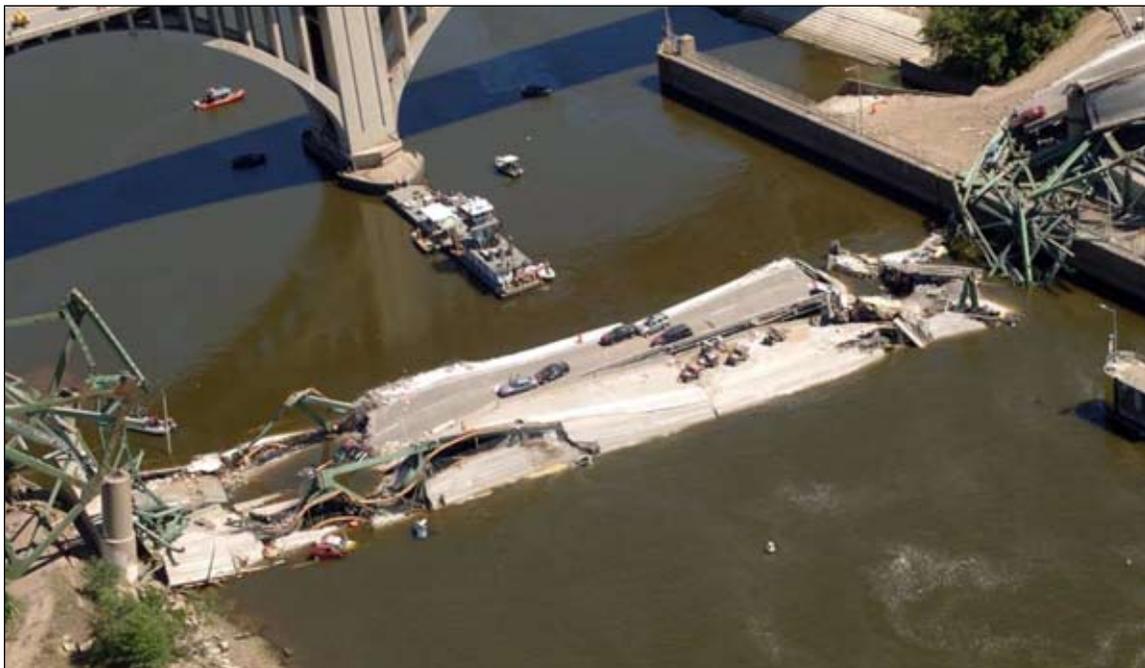
Figure 14. Collapsed bridge center section, looking southeast.

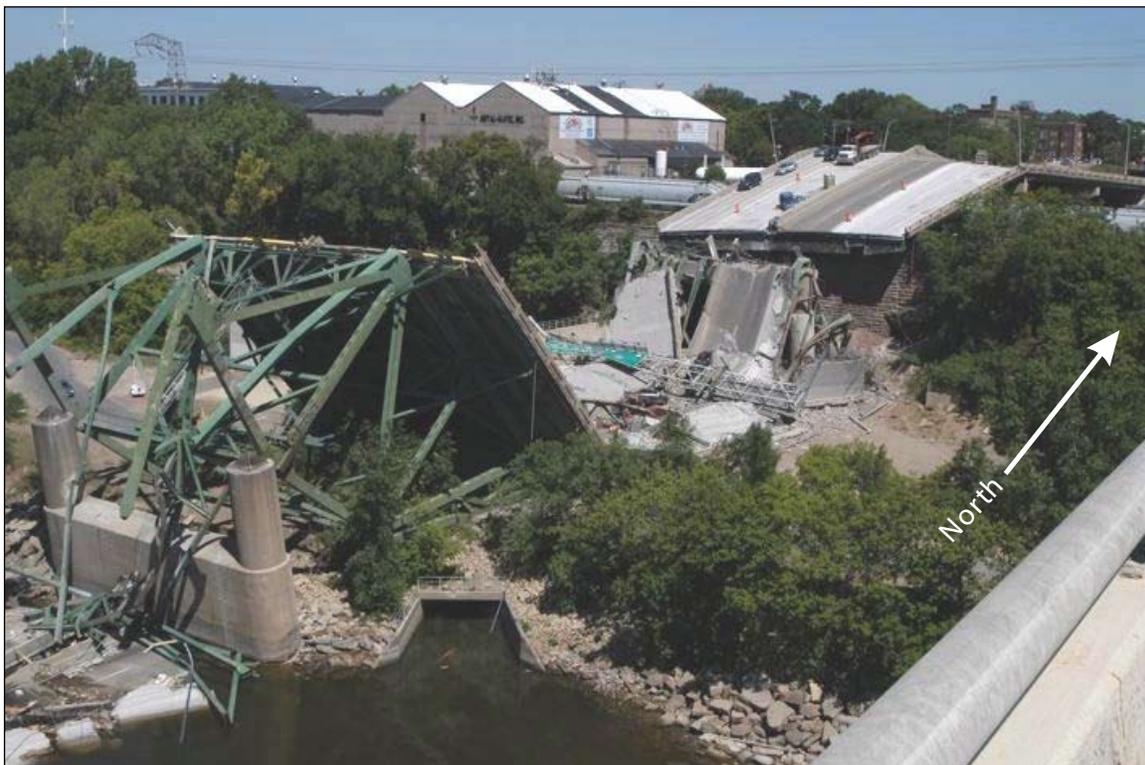
North Section. An overall view of the north portion of the deck truss postcollapse is shown in figure 15. A large portion of the deck truss above and north of pier 7 had rotated to the north as a rigid unit. This portion included the deck and upper chords from the U8' to U6' nodes, the lower chords from the L9' to L7' nodes, and the diagonals and verticals between these nodes. In the postcollapse position, lower chord members L7'/L8' east and west were contacting the north side of the upper end of the pier 7 columns. The video shows that the rigid portion of the deck truss initially remained in position and did not rotate as the center span dropped into the river. Later in the recording, after the water splash clears and the debris settles, this portion of the structure can be seen to have rotated to the north.

Figure 15. Collapsed north section of bridge.

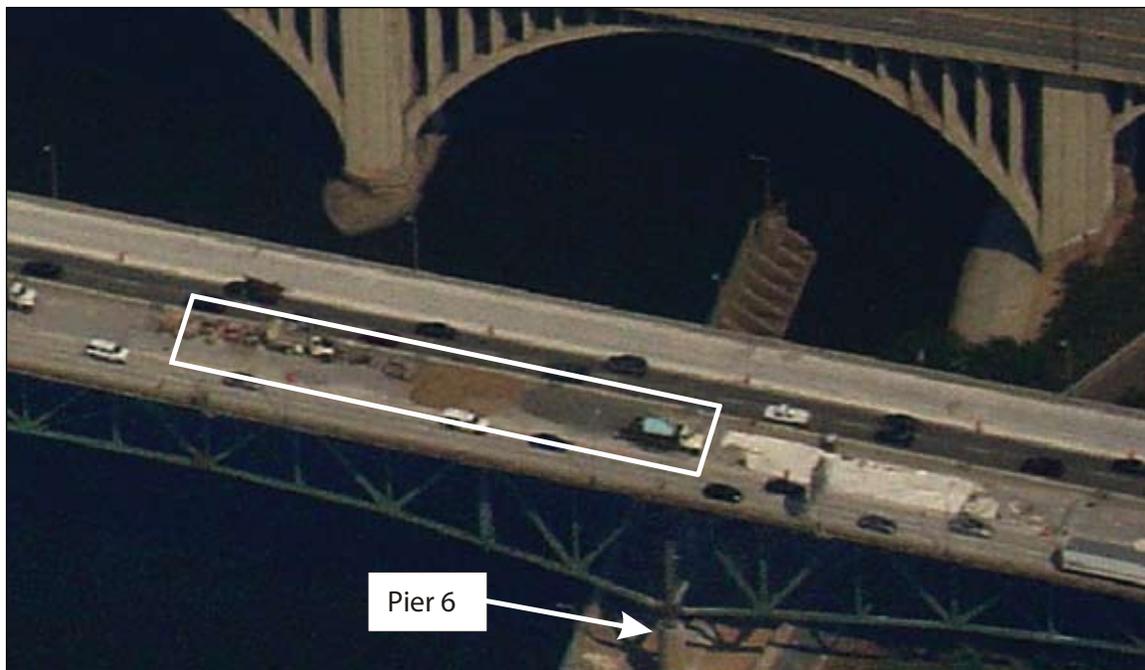
The aggregates and associated construction vehicles would come to occupy an estimated 228-foot-long section of the two closed southbound lanes over the main river span (span 7). The area where the equipment and materials were stored was established by interviewing witnesses, by examining the limits of the work area, and by examining photographs, including one (figure 1 top) taken about 3:45 p.m. by a passenger aboard a commercial airliner. After this photograph was taken (see figure 16), PCI workers moved the materials closer to the median barrier to allow more room for the movement of construction vehicles and traffic.

Figure 16. Construction equipment and aggregates (indicated by white box) stockpiled on southbound lanes of bridge about 2 hours 15 minutes before collapse. (This figure is an enlargement of a section of a photograph taken by a passenger in a commercial airliner departing Minneapolis/St. Paul International Airport.)

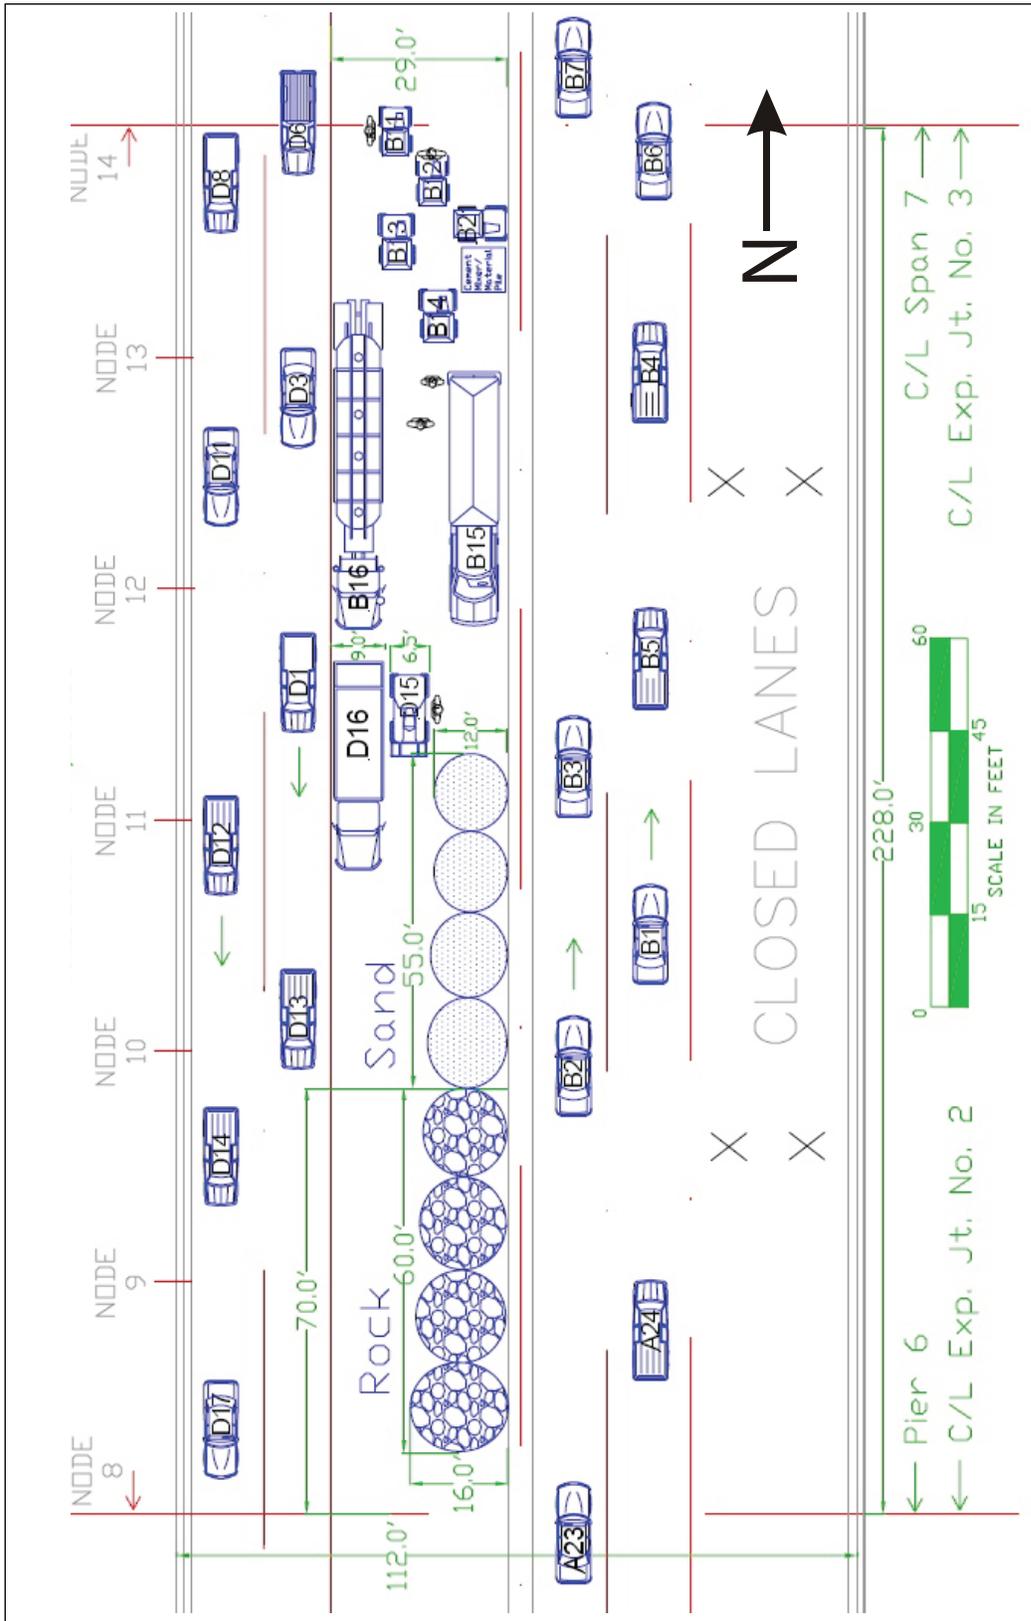
The construction aggregates were distributed in eight adjacent piles (four sand and four gravel) placed along the median in the leftmost southbound lane just north of pier 6. The combined aggregates occupied a space about 115 feet long and 12–16 feet wide, with its southern boundary about 10 feet north of pier 6. (See figure 17.) This staging placed the aggregate piles generally centered longitudinally over the deck truss U10 nodes. Along with the aggregates in this area were a water tanker truck with 3,000 gallons of water, a cement tanker, a concrete mixer, one small loader/excavator, and four self-propelled walk-behind or ride-along buggies for moving smaller amounts of materials.

Figure 17. Reconstruction of estimated positions of construction aggregates and equipment along the two inner southbound lanes of I-35W bridge at time of collapse.

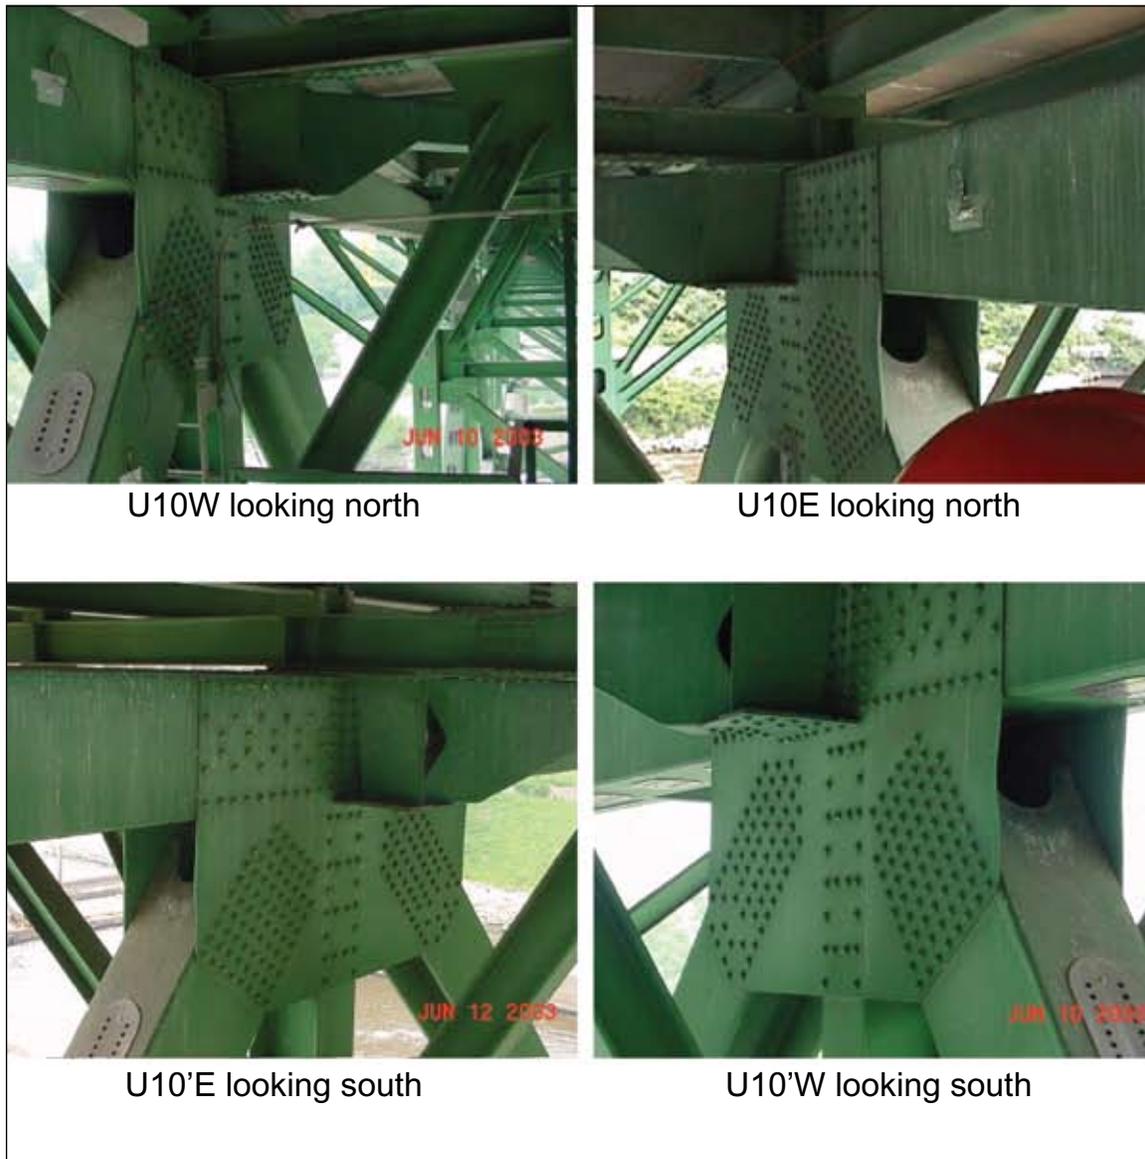
Figure 19. Bowed gusset plates at nodes 10 and 10'. (Source: University of Minnesota, top right photo; URS Corporation, other three photos)

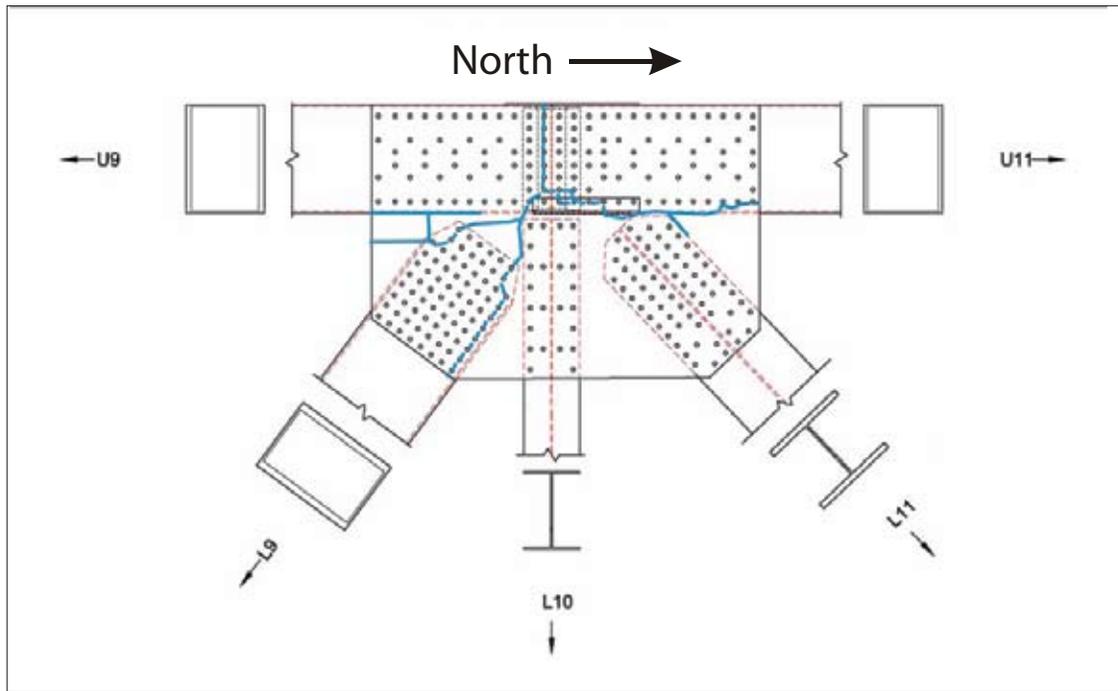
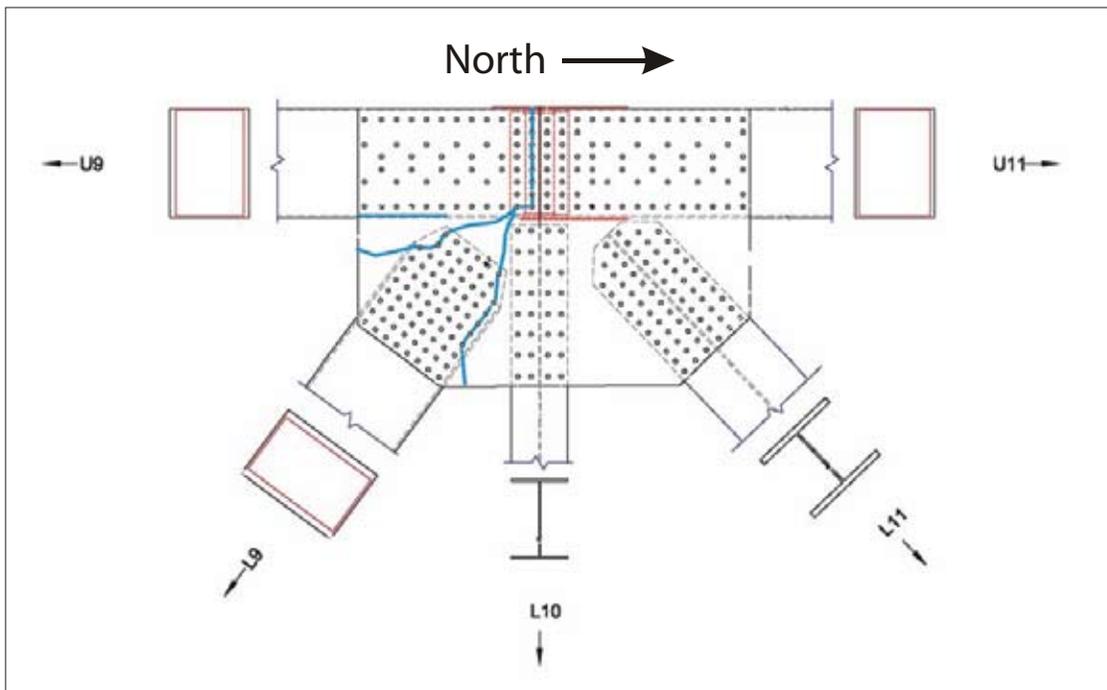
The fractures on all four U10 gusset plates left a portion of the plates attached to the upper ends of the separated diagonals L9/U10, with a V-shaped piece of the plates extending beyond the ends of the diagonals. On both the east and west diagonals, these V-shaped pieces were bent toward the east, indicating that the upper ends of the diagonals shifted laterally to the west as the gusset plates deformed and fractured. As these shifts occurred and the remainder of the node dropped, the east side plates of the diagonals penetrated through the interior structure of the nodes. Pieces associated with the remainder of the nodes and floor truss 10 contained multiple impact marks from contact with the upper ends of the diagonals. Deformation patterns associated with a fracture in the upper chord of floor truss 10, just west of the U10E node, were consistent with this fracture having resulted from the impact of the west side plate of diagonal L9/U10E with the lower side of the upper chord of the floor truss.

Figure 20A. Inside (east) gusset plate at U10W (top) and outside (east) gusset plate at U10E (bottom), showing similar fracture patterns in blue.

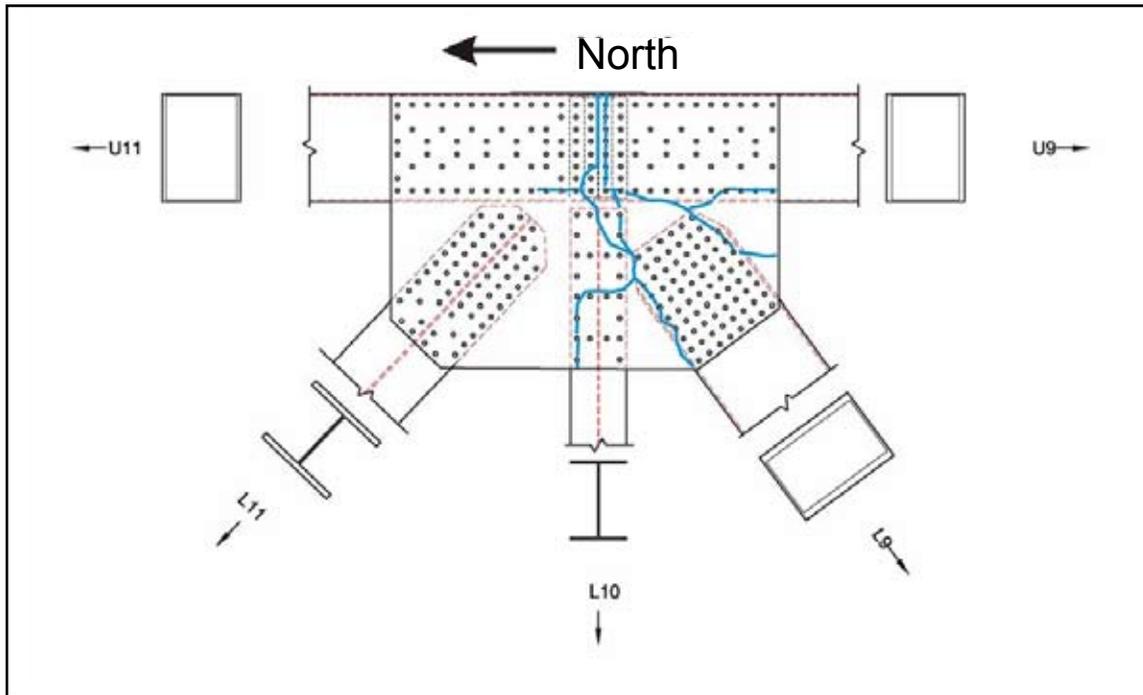
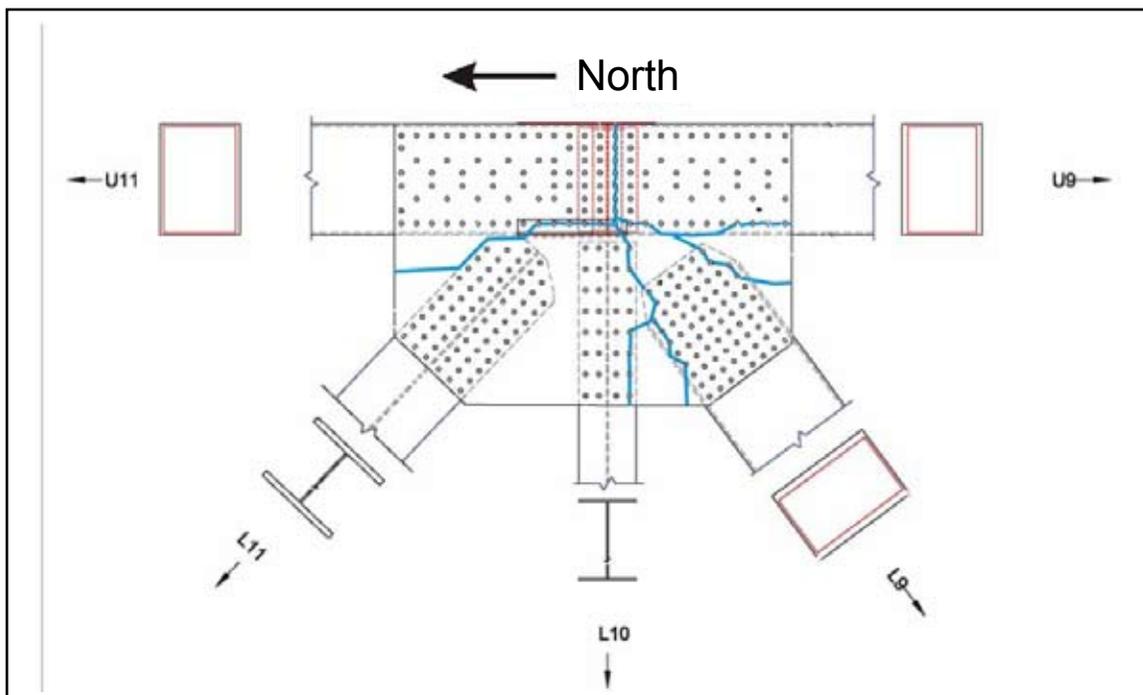
Figure 20B. Outside (west) gusset plate at U10W (top) and inside (west) gusset plate at U10E (bottom), showing similar fracture patterns in blue.

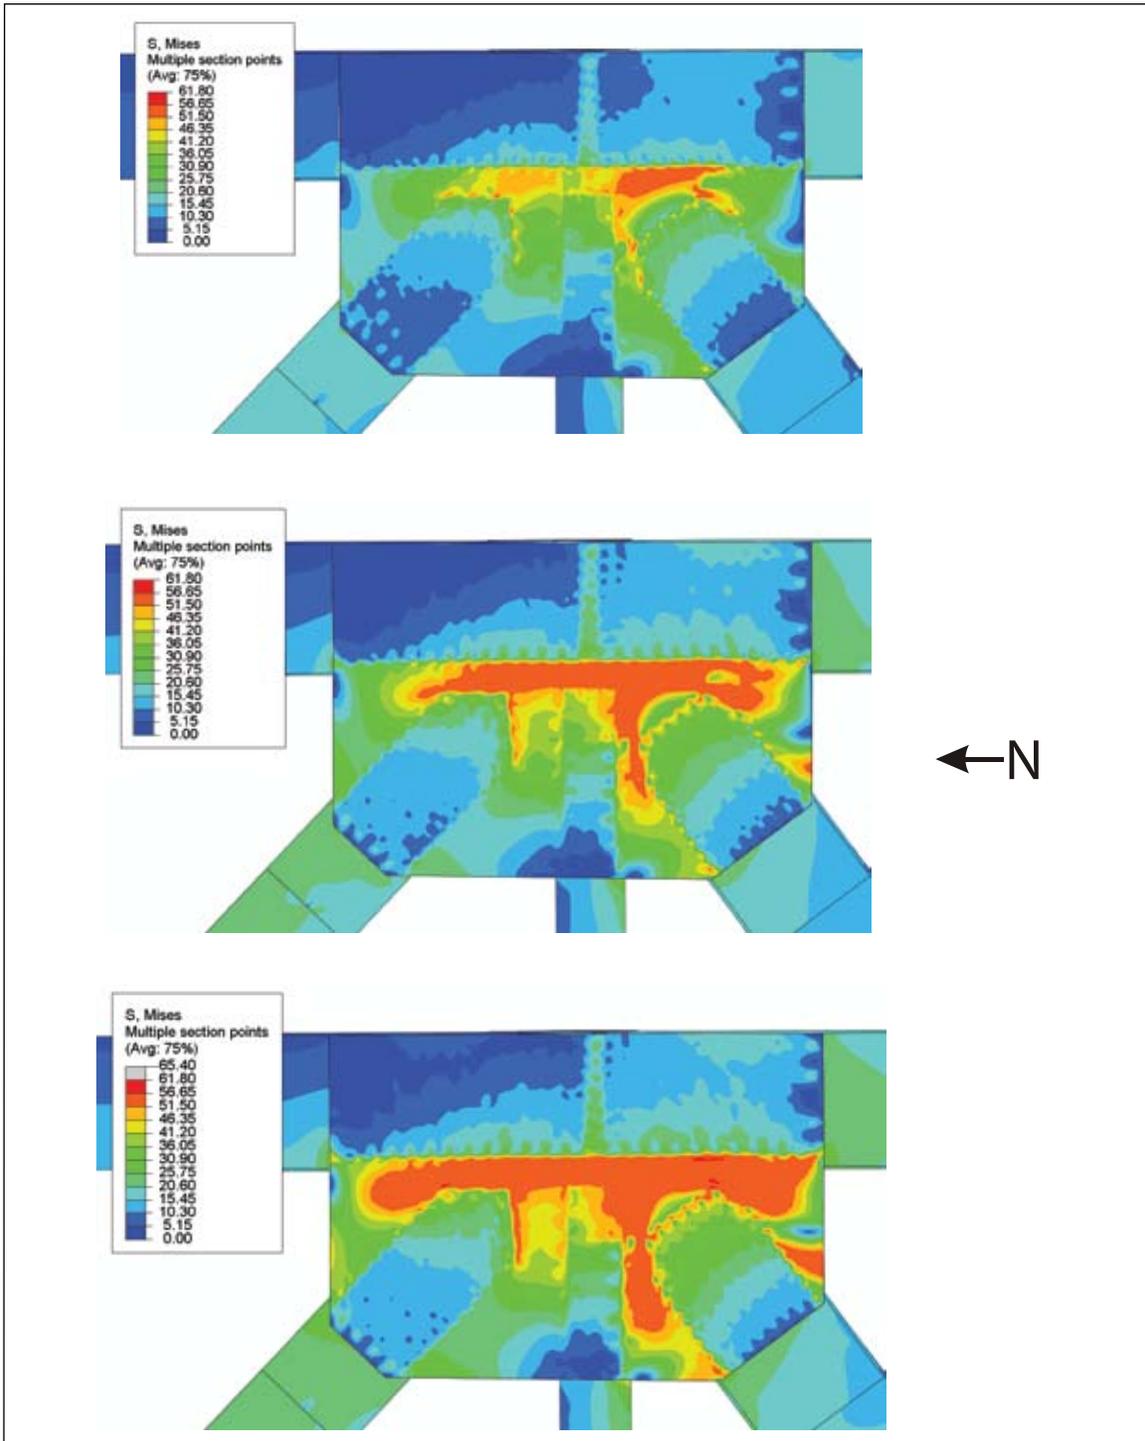
³⁸ An instability is evident in the model when it cannot balance increasing applied loads. The model showed that, at the point of instability, the highly stressed gusset plates at the U10W node are unable to resist the lateral shifting of the upper end of diagonal L9/U10. At that point, the lateral shift of the upper end of the diagonal will proceed even with no added load.

Figure 21. Finite element model stress contours for outside (west) gusset plate at U10W at time of bridge opening in 1967 (top); after 1977 and 1998 renovation projects, which increased deck thickness and modified barriers (middle); and on August 1, 2007 (bottom). Note areas that are yielding (dark orange and red contours above yield stress of 51.5 ksi) around ends of diagonals, beginning with original bridge and becoming larger as loads were increased.

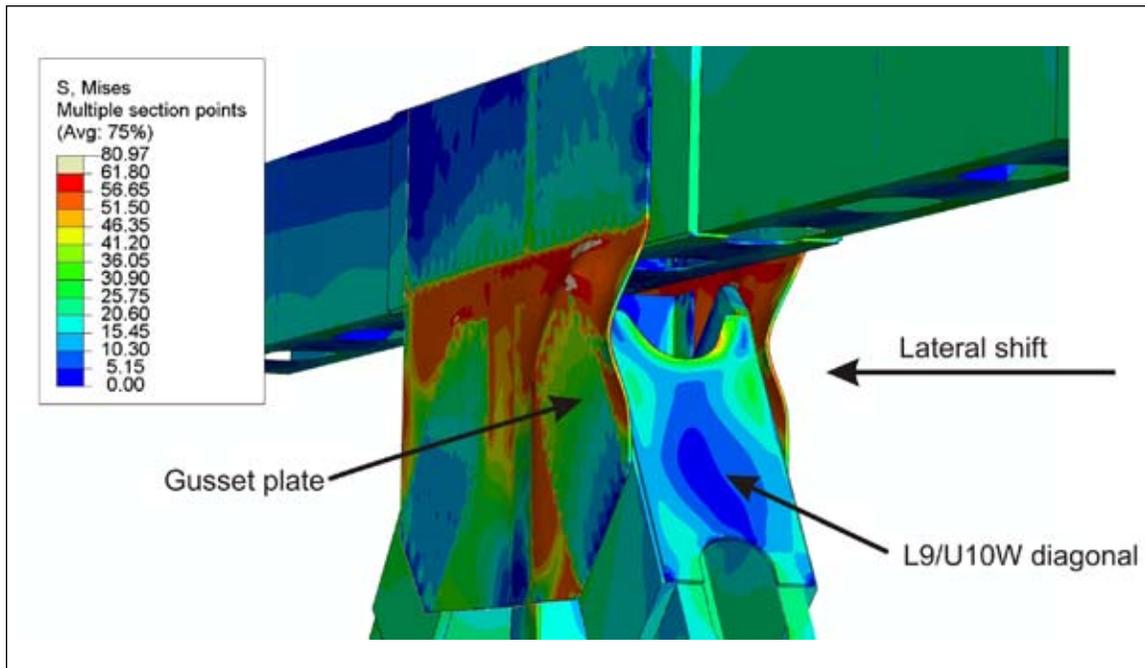
Figure 22. View of node U10W looking north, indicating lateral shift west of upper end of L9/U10W diagonal member at point of instability. (For purpose of illustration, the amount of lateral displacement, including bowing of gusset plates, is exaggerated by a multiple of 5.)

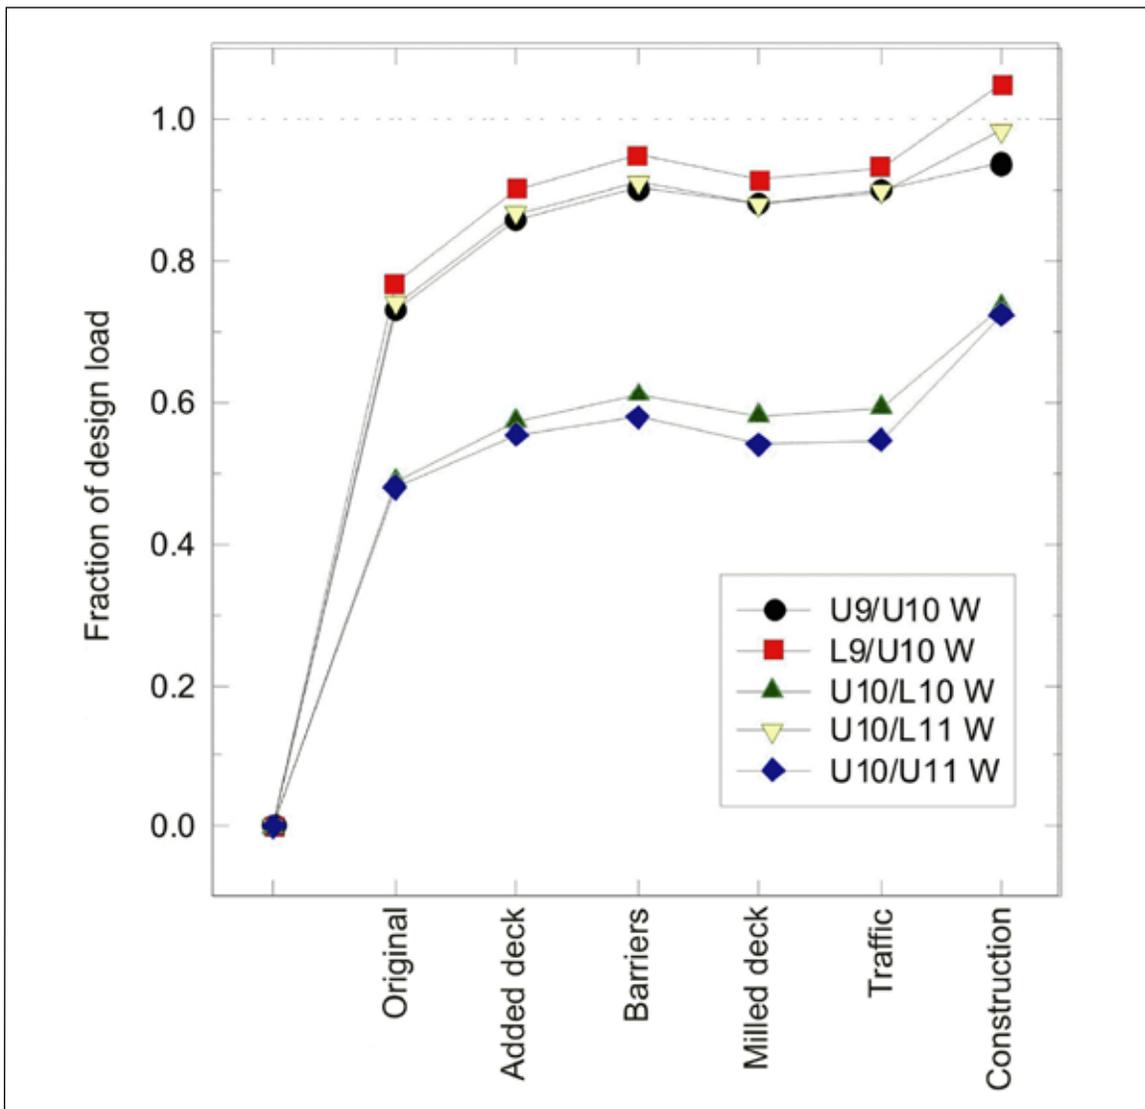
Figure 23. Loads (as fraction of design load) in five main truss members that connect at U10W node, as calculated using FHWA global model. Steps include dead load of original design, added deck thickness in 1977, and modification to barriers in 1998. The final three steps include conditions on the day of the accident: milled-off deck thickness in southbound lanes, traffic at collapse, and construction materials and vehicles.
