*Transportation Pooled Fund Project 5(165)*

**DEVELOPMENT OF DESIGN GUIDE FOR THIN AND ULTRA-THIN CONCRETE  
OVERLAYS OF EXISTING ASPHALT PAVEMENTS**

*TASK 1 REPORT:*

**COMPILATION AND REVIEW OF EXISTING  
PERFORMANCE DATA AND INFORMATION**

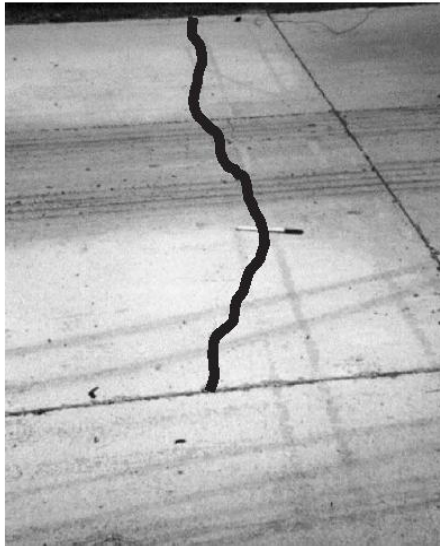
Figure 4 and Figure 5 show typical transverse and corner cracks observed in the ALF experimental study. The most significant faulting was observed along the longitudinal joint probably due to the channelized nature of the loading. Faulting was also observed in a few transverse joints but this was less severe compared to the longitudinal faulting. Figure 6 shows faulting that developed. Most of the observed spalling was of low severity.

Figure 4: Typical UTW transverse cracking at the FHWA ALF.  
(Rasmussen et al., 2002)

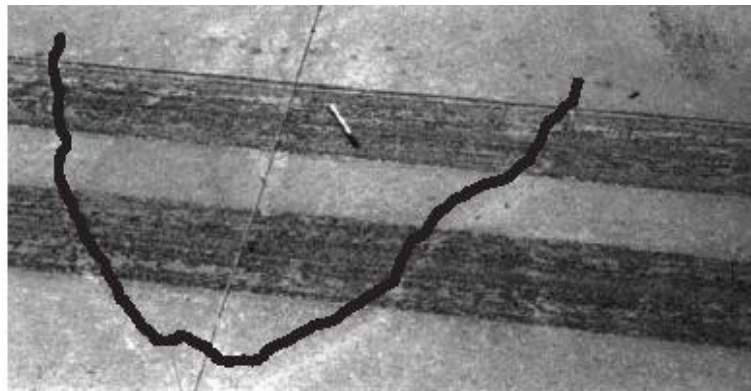
Figure 5: Typical UTW corner cracking at the FHWA ALF.  
(Rasmussen et al., 2002)

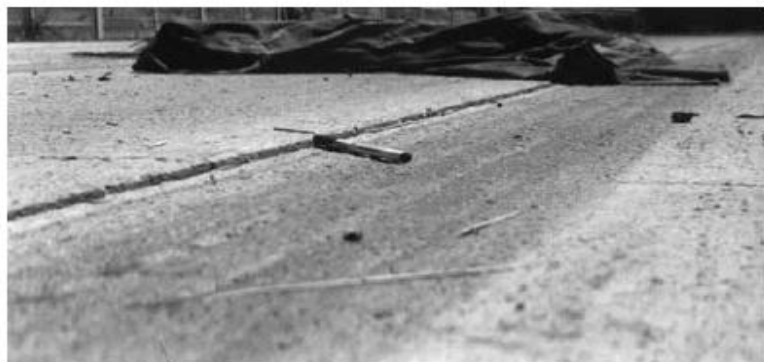
Figure 6: Typical UTW longitudinal faulting at the FHWA ALF.  
(Rasmussen et al., 2002)

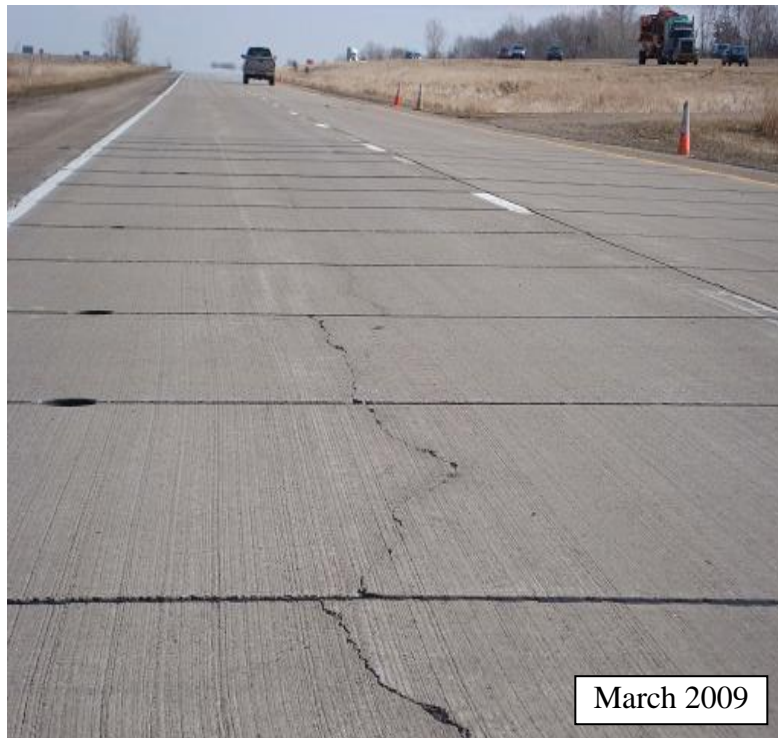
Figure 20: Longitudinal cracks in Cell 97.

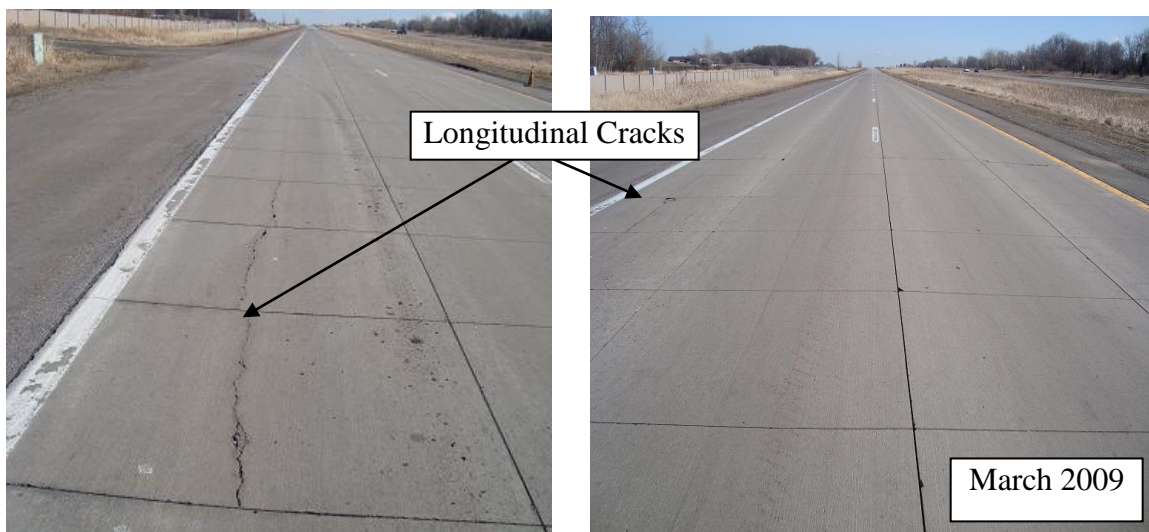
Cells 60 and 62, which were constructed in 2004 and have a 6-ft x 5-ft joint spacing and are 5- and 4-in thick, respectively, developed a relatively small amount of longitudinal cracks after 3.8 million ESALs. Both cells are undoweled and unsealed. It can be seen in Figure 21 that the longitudinal cracks in these cells also went through multiple panels similar to those in Cell 97. The severity of the cracks is still low; however, some spalling has occurred in Cell 60 (Figure 21). It is interesting to note that the longitudinal cracking that developed in Cells 61 and 63 are comparable, indicating that the longitudinal cracking is associated with the panel size for these TWT sections (Figure 22).

Figure 21: Longitudinal cracks in Cells 60 and 62.

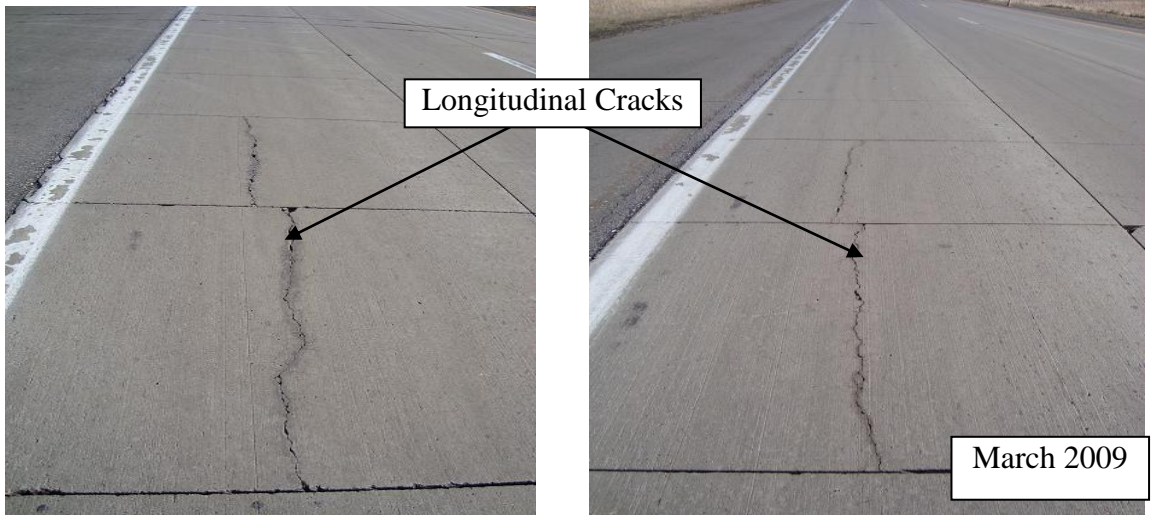
(a) Cell 61 (b) Cell 63  
 Figure 22: Longitudinal cracks in Cells 61 and 63.

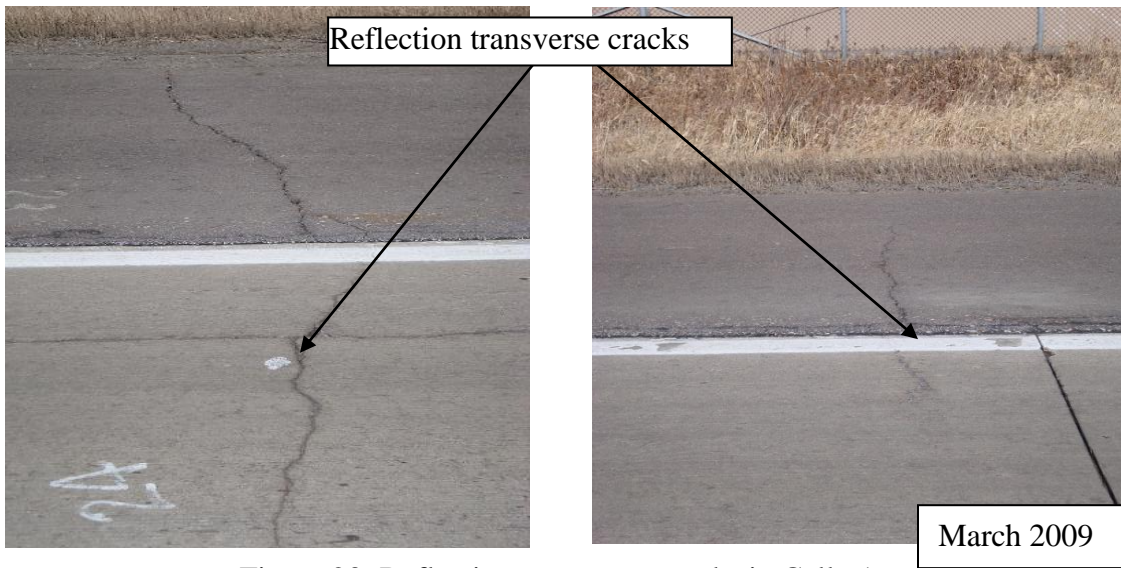
Figure 23: Reflection transverse cracks in Cell 61.

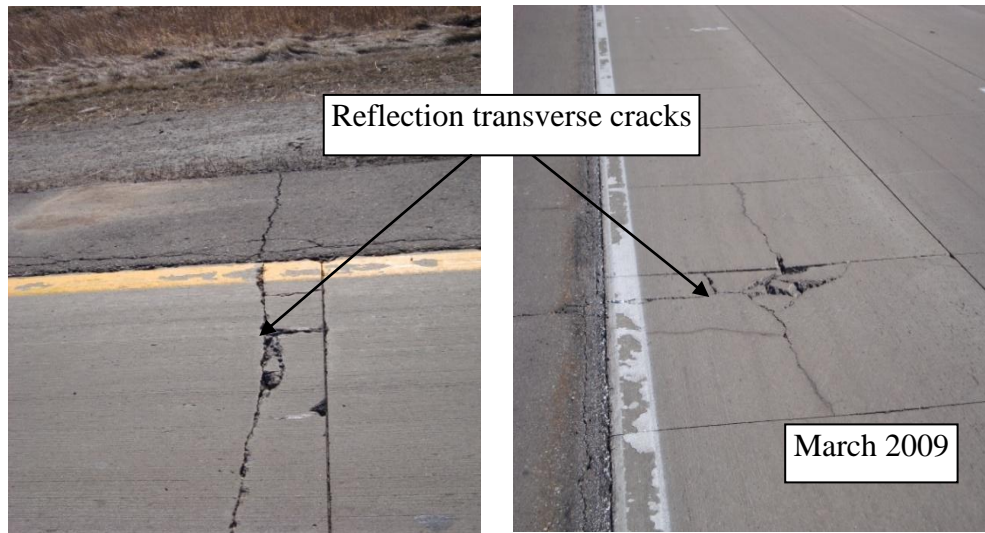
Figure 24: Reflection transverse cracks in Cell 63 at two locations.

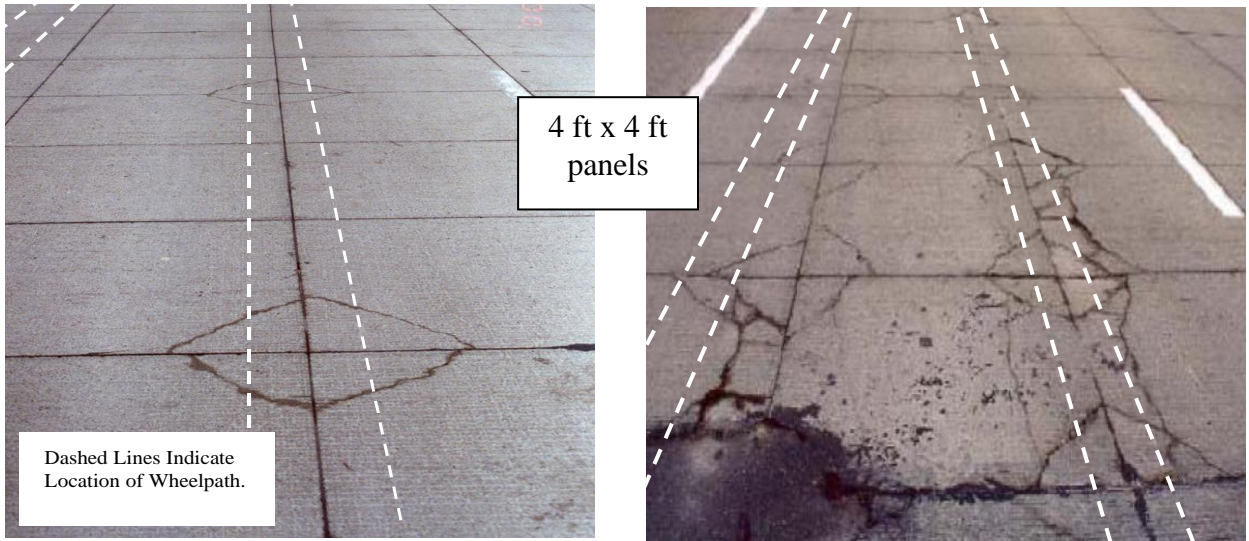
(a) Cell 94 during 2001

Figure 27: Corner cracks along the inside wheelpath on Cell 94.  
(Vandenbossche, 2001 and Burnham, 2005)

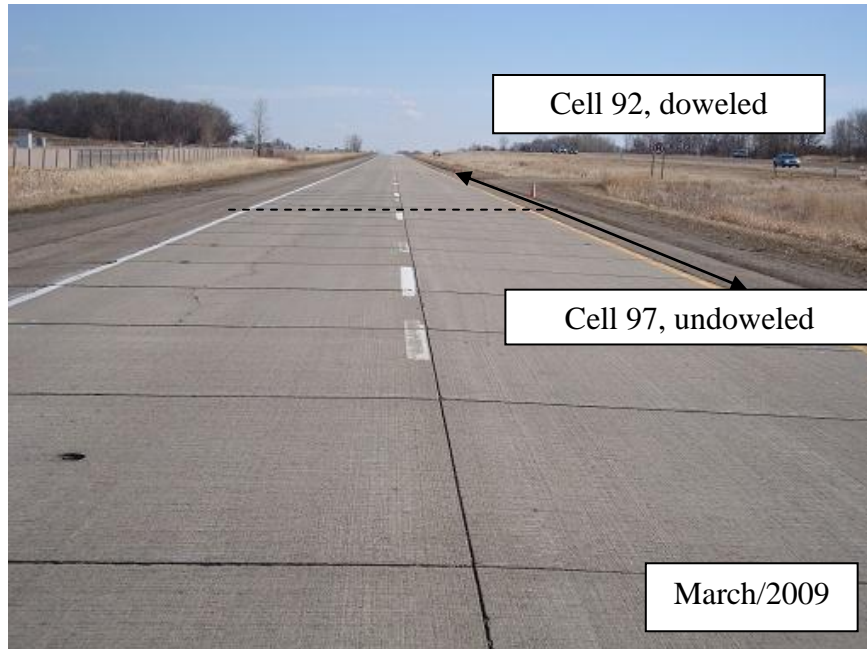
Among all of the MnROAD whitetopping sections, only Cell 92 has doweled joints. The faulting history of the cells, as mentioned in Section 4.1.2, shows that the presence of dowel bars helps to reduce the joint faulting in Cell 92. Cell 92 and Cell 97 have a similar configuration except that Cell 92 contains 1-in dowel bars. Figure 29 clearly shows the presence of faulting in Cell 97, whereas no faulting is visible in the adjacent Cell 92. Dowels are not typically used for TWT or UTW since these overlays are commonly constructed on lower volume roads. The results show that there is potential to extend the range of applications for these overlays since they have the potential to perform for extended periods of time (11.5 years), even on the interstate. This increase in performance was observed with only a 1-in diameter dowel bar. It is interesting to see that the performance of the joints in Cell 92 (doweled, 10 ft x 12 ft) and Cell 96 (undoweled, 5 ft x 6 ft) are comparable. Decreasing the joint spacing exhibited a similar improvement in joint performance as the addition of 1-in dowels.

Figure 29: Faulting of panels in Cell 97(undoweled) but no faulting in Cell 92 (1-in dowels).

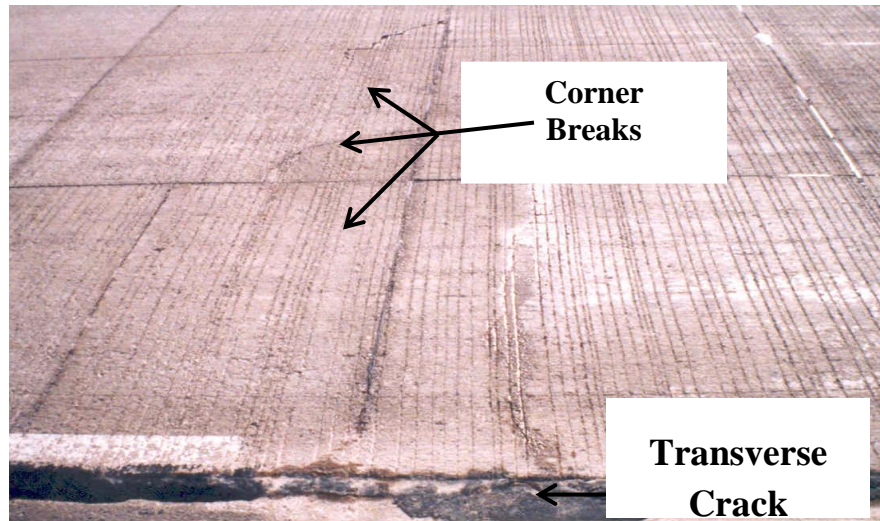
Cracks observed in the ultra-thin whitetopping test sections with a 4-ft x 4-ft joint pattern included corner breaks and transverse cracks. The corner breaks occurred primarily along the inside longitudinal joint and the lane/shoulder (L/S) longitudinal joint. Many of the corner breaks that developed along the inside longitudinal joint did not appear until 1999. The inside longitudinal joint lies directly in the inside wheelpath resulting in high edge and corner stresses. Transverse cracks developed in the panels adjacent to the shoulder. The transverse cracks typically developed 1.3 ft away from the transverse joint, which is approximately one third of the length of the panel. The cracking patterns along the wheelpath are shown in Figure 35 and Figure 36. The Main Street test section was constructed using a 6-ft x 6-ft joint pattern. Corner breaks were the primary distress that developed in this test section, although very little cracking was exhibited compared to the sections with a 4-ft x 4-ft joint layout. The corner breaks were typically located in the outside panel adjacent to the lane/shoulder joint intersecting the transverse joint at the wheelpath. A few corner breaks also developed in the inside panels. Again, the corner break typically intersected the transverse joint at the wheelpath and then intersected the longitudinal joint separating the two panels. Both of the corner breaks exhibited in the inside and outside panels intersected the longitudinal joint at the nearest wheelpath. Figure 37 shows the typical pattern of the corner cracks in the Main Street test section. The pattern of the corner cracks of Cell 98 (4ft x 4ft) is comparable to the performance of Cell 93 to 95 in the MnROAD test sections. The distress pattern in the US-169 test sections validated the fact that joint layout optimization is important to avoid corner cracks.

Figure 35: Transverse crack and corner breaks in the Jackson Street test section (03.30.98).  
(Vandenbossche, 2003)

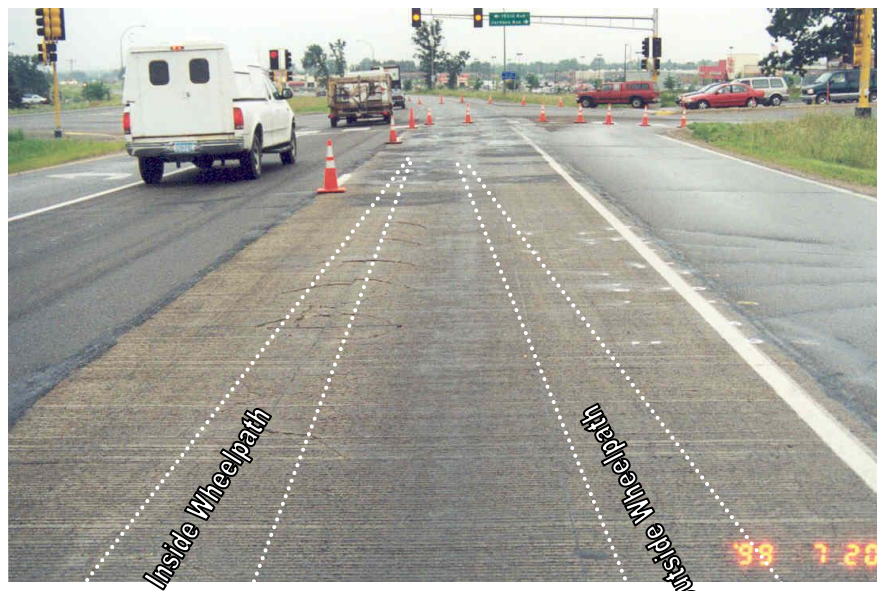
Figure 36: Corner breaks in the inside wheelpath at the Jackson Street test section.  
(07.20.99) (Vandenbossche, 2003)

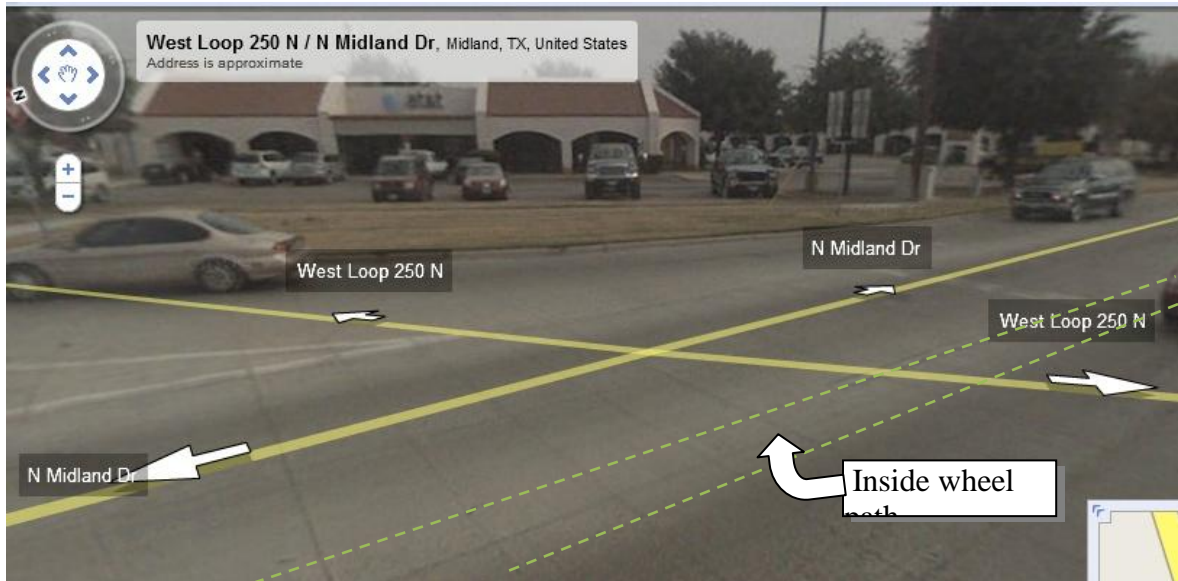
Figure 40 and Figure 41 are two pictures of the intersections at Midland Drive and Wadley Avenue obtained from Google Street View in February of 2009. The figures clearly show that the inside wheel path is along the longitudinal joints.

Figure 40: UTW at the intersection of LP-250 and Midland Drive at Odessa District. (Google Street view (February/2009))

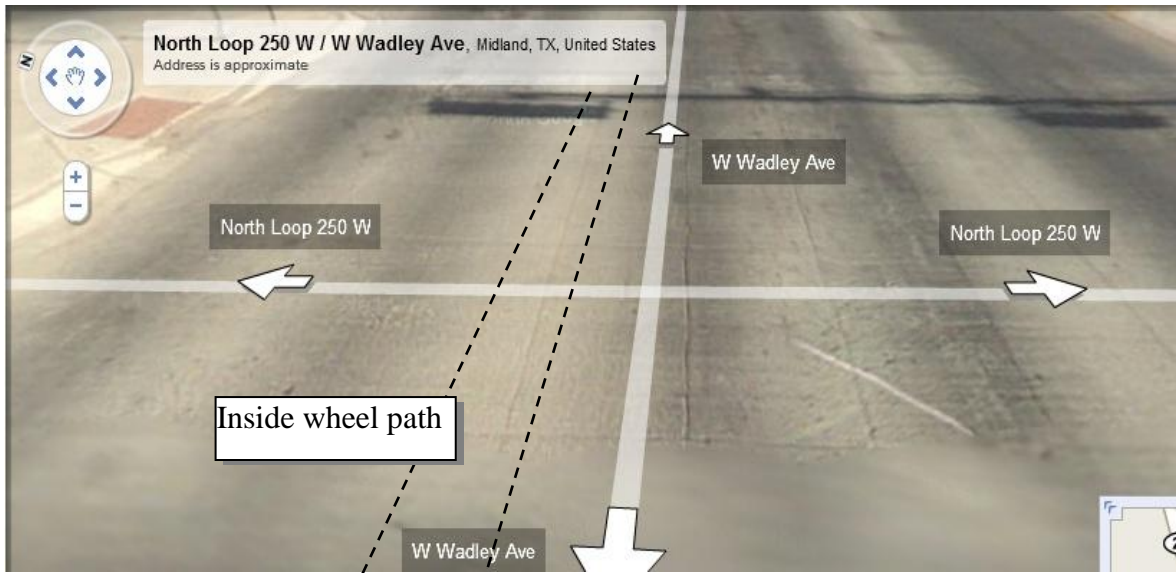
Figure 41: UTW at the intersection of LP-250 and Wadley Avenue at Odessa District.  
(Google Street view (February/2009))

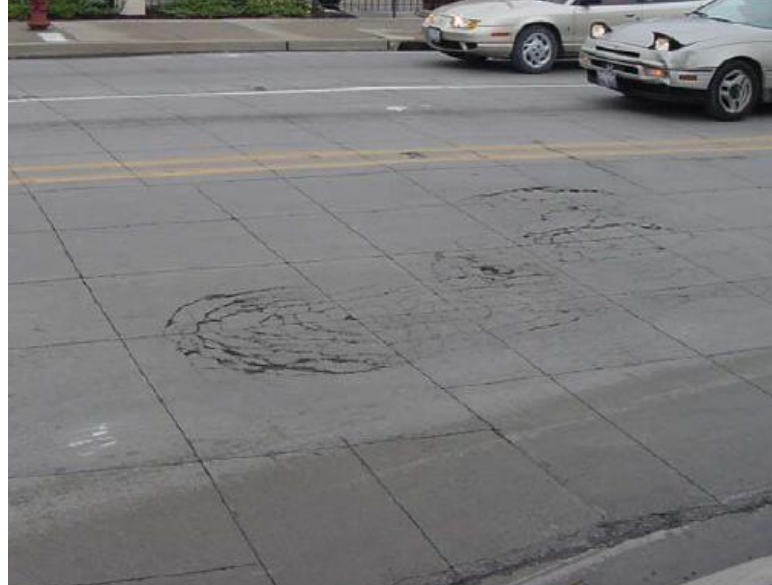
Figure 44 shows some of the distressed panels with high severity. It seems that the cracks developed in the shape of a spider web. A little bit of depression is observed as well. The distress initiation at this location is unknown; but, it was reported that the underlying layers did not show any considerable defects. The severe distresses indicate that non-uniform support conditions may have been the trigger. Additionally, the progression of the debonding between the layers might have caused the distresses to spread across multiple slabs.

Figure 44: Distressed panels at the intersection. (Winkelman, 2005)

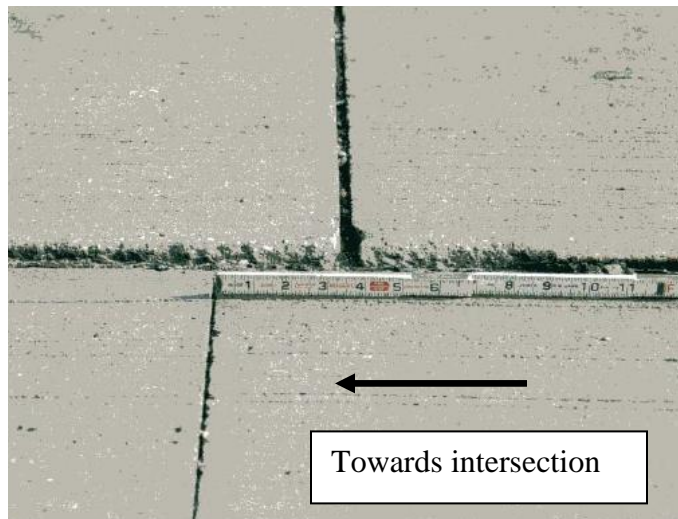
Figure 45: Movement of the panels toward the intersection (Winkelman, 2005).

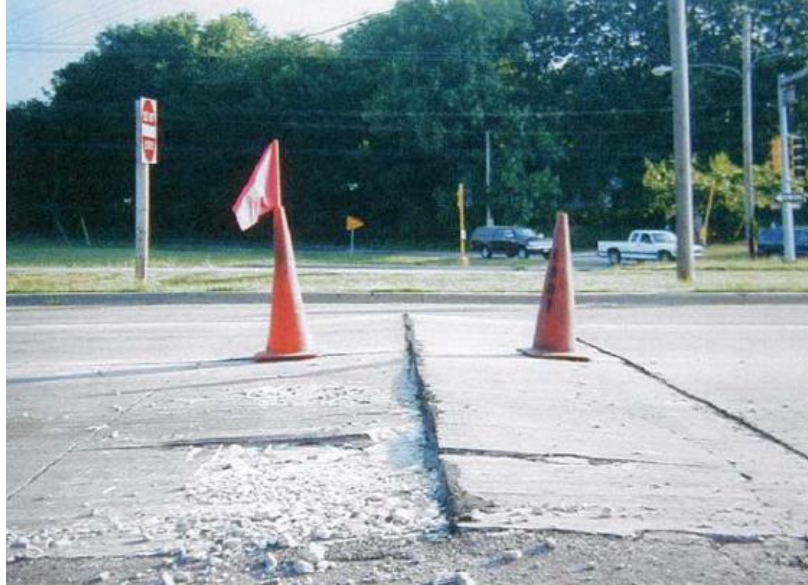
Figure 46: Blow up of the UTW slabs (Winkelman, 2005).

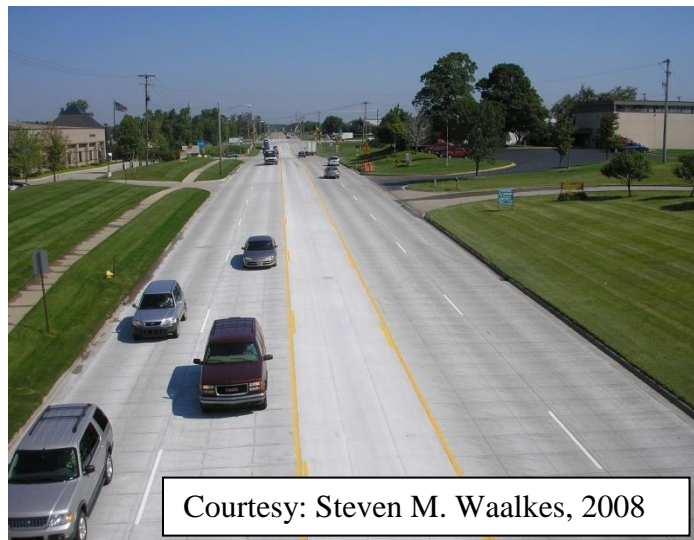
***Distress data:*** There are two distressed areas: the intersection at Patterson Avenue and 36th Street and the southbound lanes of Patterson Avenue at Danvers Drive. The intersection at Patterson Avenue and 36th Street was widened in 2006 along with the application of whitetopping. The underlying asphalt edge did not line up properly with the joint between the whitetopping and the full-depth widening. The southbound lanes of Patterson Avenue at Danvers Drive were gapped halfway when the whitetopping was placed. This area coincides with a manhole. There is some distress around the manhole that is indicative of poor support/poor compaction of the base/subbase/asphalt around the structure, as well as debonding of the PCC from the asphalt. However, the overall condition of the project is good. A photograph taken in 2008 as shown in Figure 48 presents the condition of the road.

Figure 48: Condition of the UTW after two years (2008).
