UNDERWATER BRIDGE INSPECTION REPORT

STRUCTURE NO. 4654

TRUNK HIGHWAY NO. 36

ST. CROIX RIVER

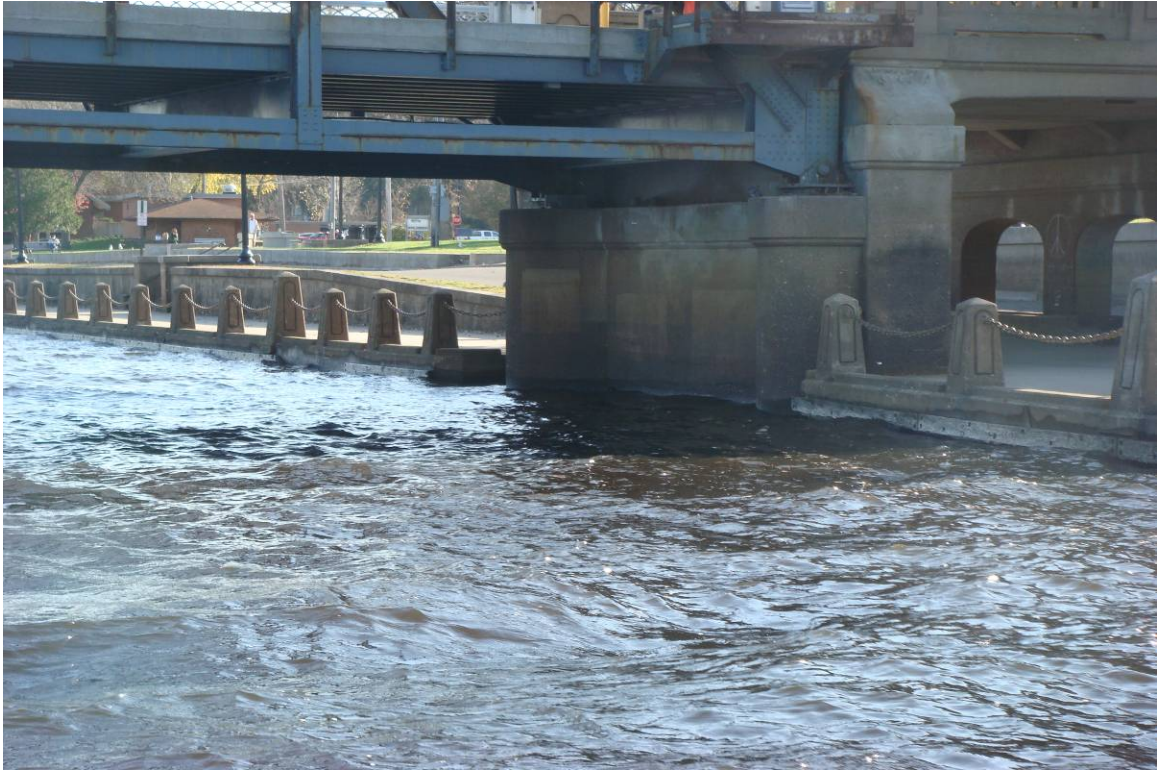
Photograph 1. View of Pier 2, Looking Southwest.

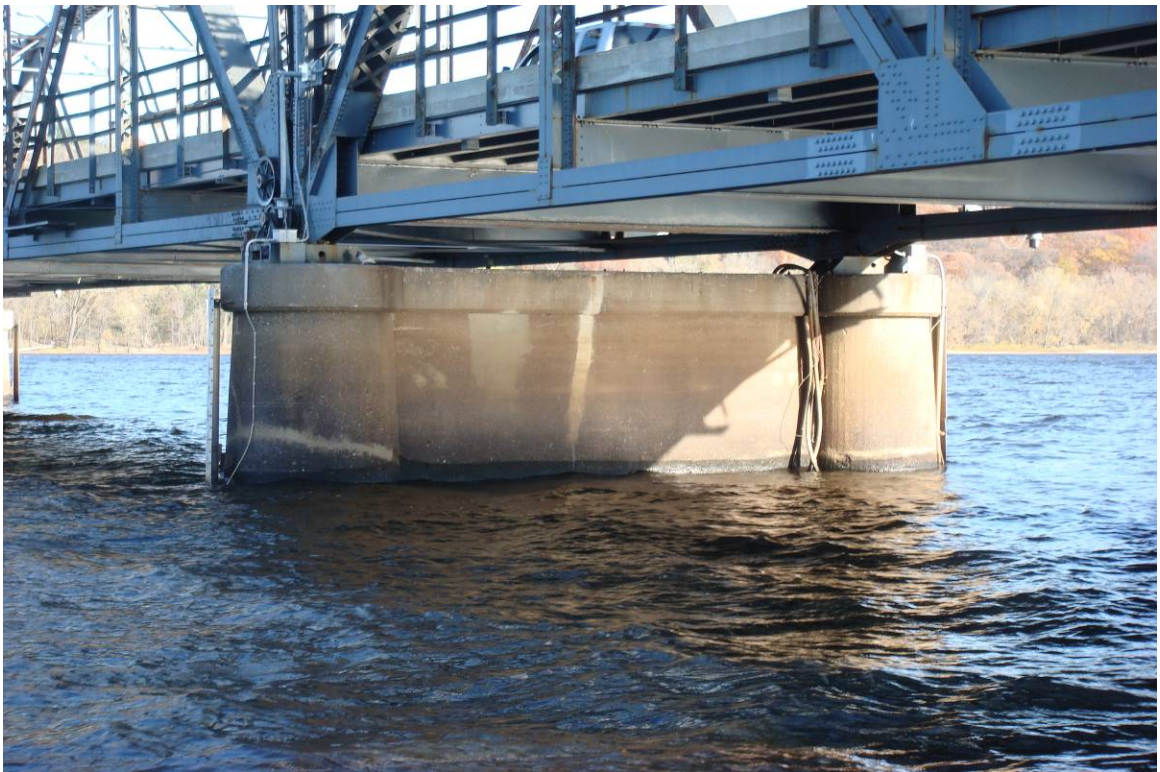
- (C) Scour depressions, up 3 feet deep with 15 foot radius, were noted at the upstream end of Piers 3 through 5.
- (D) There was a small area of top of footing exposure at the upstream nose of Pier 3 with no vertical exposure noted.

Photograph 2. View of Pier 3, Looking Southeast.

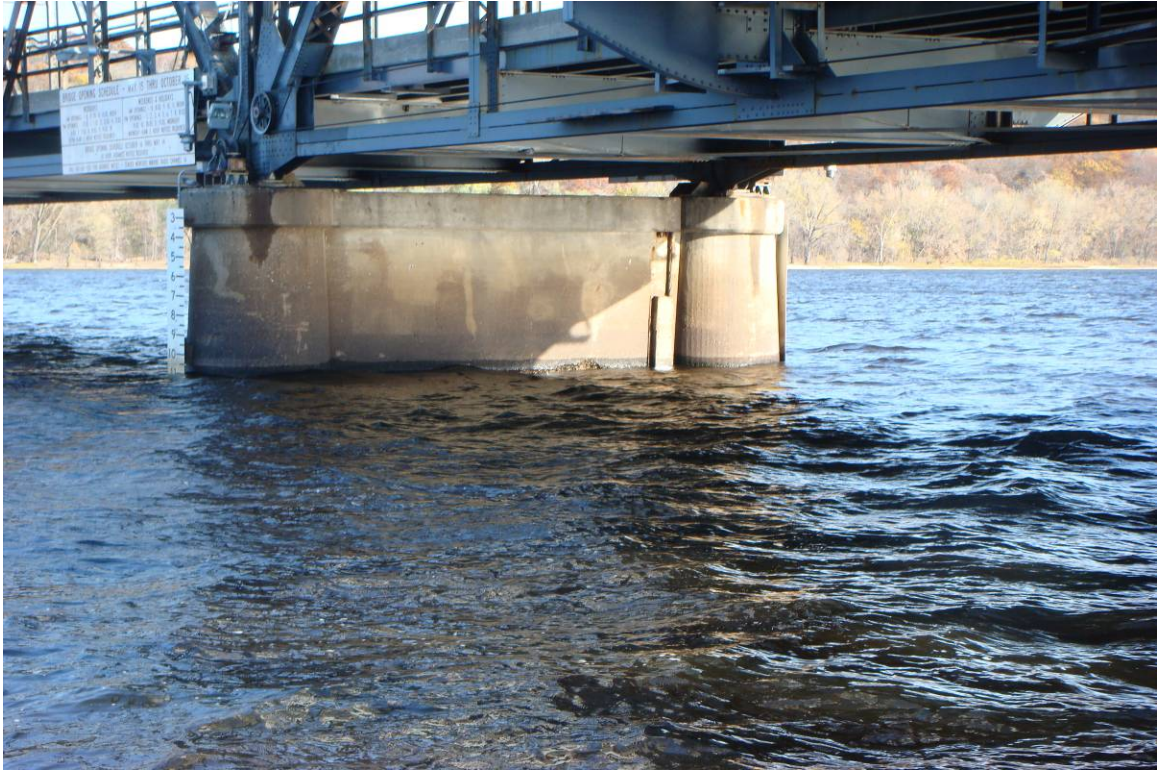
- (E) A 3 foot wide area of heavy scaling with up to 5 inches of penetration was noted at the downstream quarter point on the west face of Pier 4, from 1 to 5 feet below the waterline.

- (F) An 1/8 wide vertical crack was observed at the upstream quarter point on the west face of Pier 4 extending from 10 feet below the waterline to the channel bottom.

- (G) Moderate timber debris accumulation, consisting of three 1 foot diameter logs, was located at the upstream nose of Pier 4.
- (H) The footing at Pier 5 was fully exposed around the entire perimeter of the pier with 4 feet (full footing height) of vertical exposure. In addition, the seal was exposed around nearly the entire pier perimeter with a maximum of 2 feet of vertical exposure.

Photograph 3. View of Pier 4, Looking Southeast.

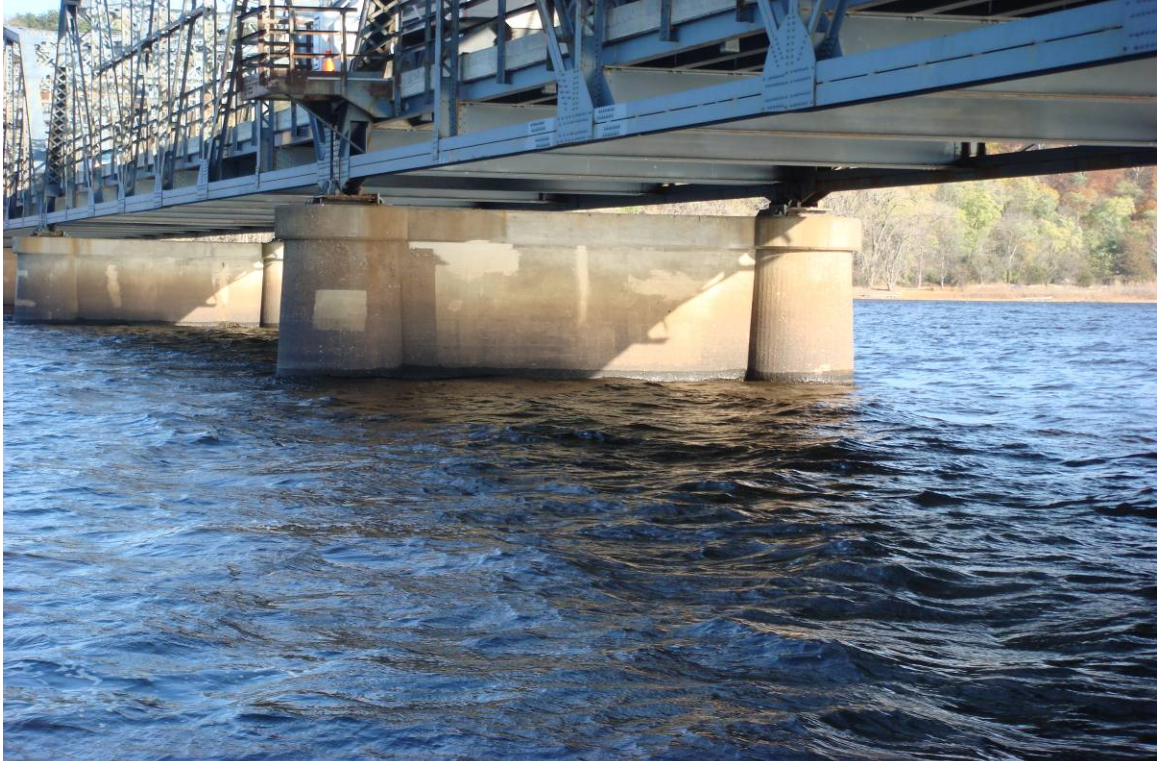
Photograph 4. View of Pier 5, Looking Southeast.

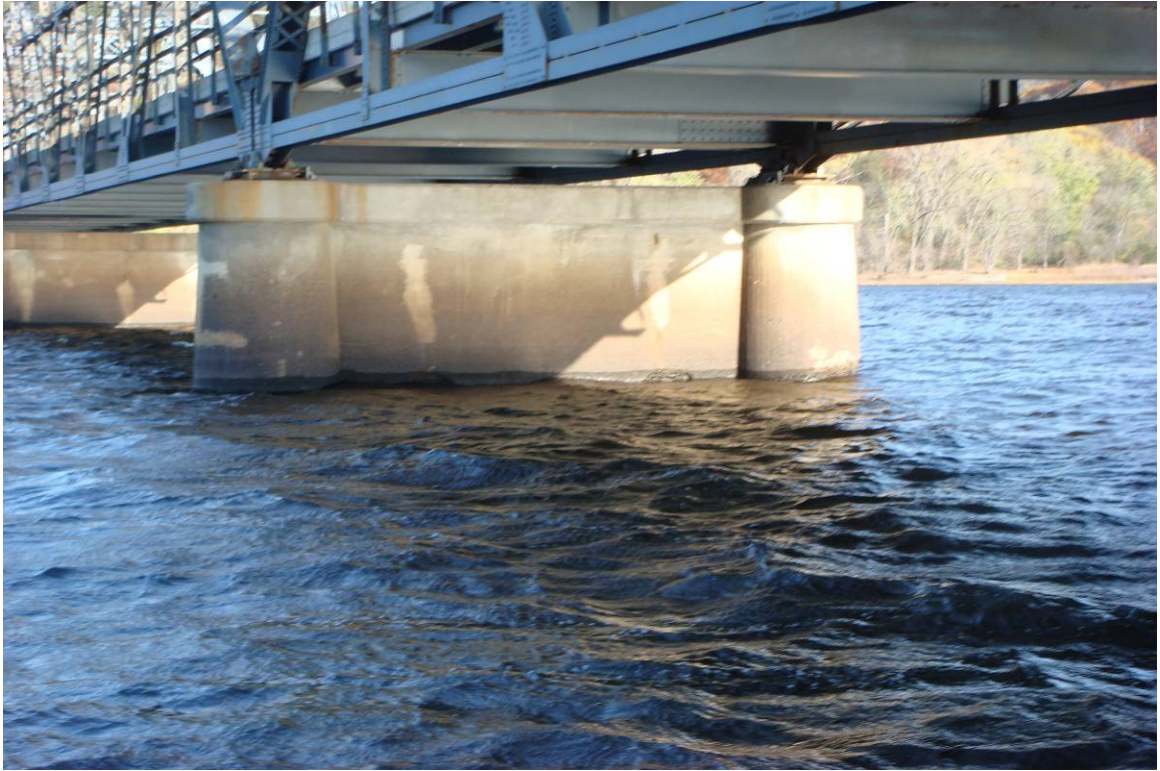
- (I) The footing at Pier 6 was fully exposed around the entire perimeter of the pier with 4 feet (full footing height) of vertical exposure. The seal was exposed at the upstream most end of the pier with a maximum of 2 feet of vertical exposure.

Photograph 5. View of Pier 6, Looking Southeast.

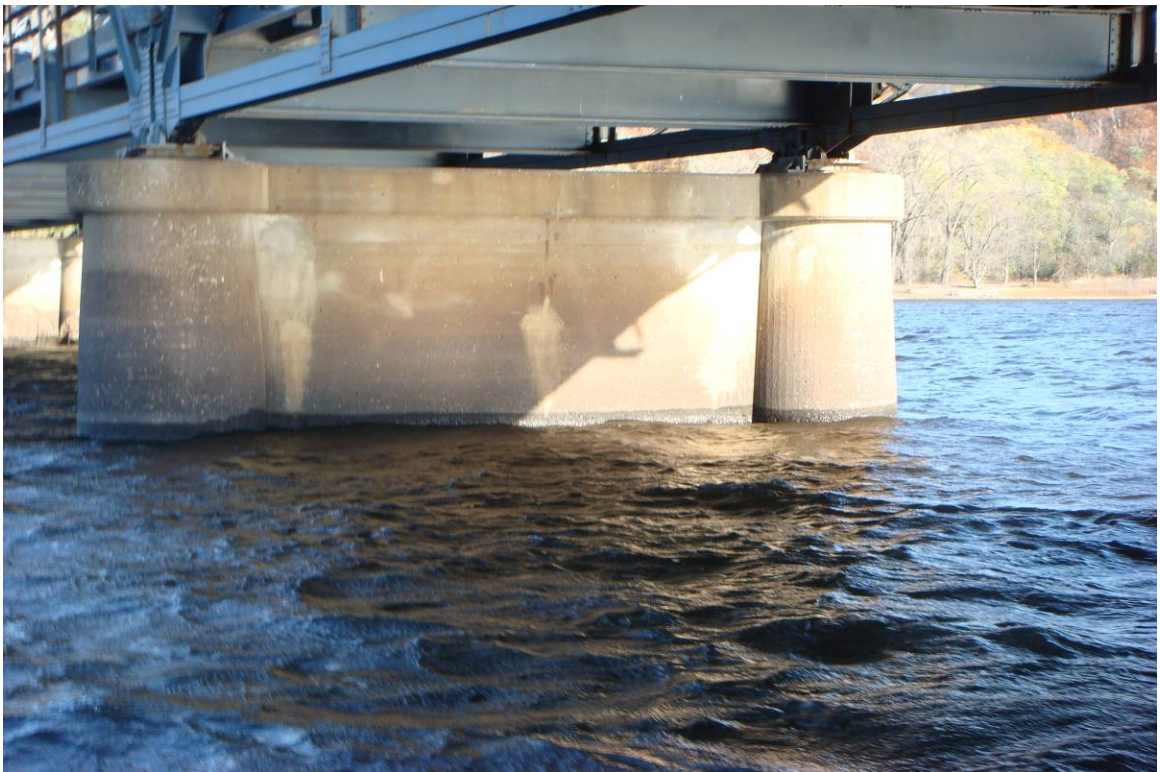
- (J) A 4 foot by 4 foot area of poor concrete consolidation with 1/2 inch of penetration was observed at the midpoint on the west face of Pier 7.
- (K) The footing at Pier 7 was fully exposed around the entire perimeter of the pier with 4 feet (full footing height) of vertical exposure. The seal was exposed across the entire upstream face and the upstream half of the east face with a maximum of 1 foot of vertical exposure.

Photograph 6. View of Pier 7, Looking Southeast.

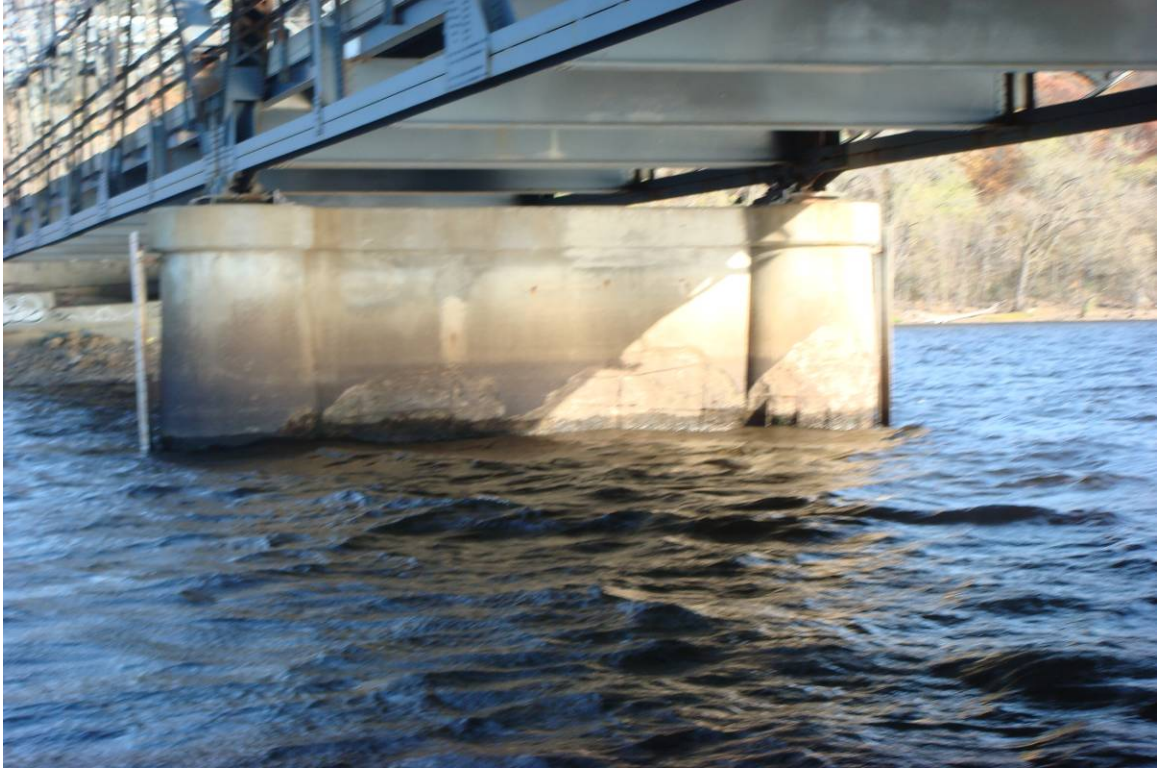
- (L) Areas of scaling with related heavy concrete section loss and with up to 6 inches of penetration and exposed reinforcing steel were observed around the entire perimeter of Pier 8, from 4 feet above to 2 feet below the waterline.
- (M) The footing at Pier 8 was fully exposed around the entire perimeter of the pier with 4 feet (full footing height) of vertical exposure. The seal was exposed and undermined across the upstream most end of the pier. The undermined area exhibited a 6 inch high cavity with minimal horizontal penetration and no piles exposed.

Photograph 7. View of Pier 8, Looking Southeast.

- (B) The moderate to heavy scaling at all of the inspected substructure units, as well as the heavier related concrete section loss, especially at Pier 8 are not structural concerns at this time given their size compared to the overall pier size; however, consideration should be given to repairing these areas to prevent corrosion of the exposed steel reinforcement from accelerating the rate of deterioration of the surrounding concrete, and consequently, leading to more detrimental condition. Repairs would include removal of all unsound concrete, cleaning and replacing reinforcing steel as required, and placing concrete designed to provide high durability with low permeability.

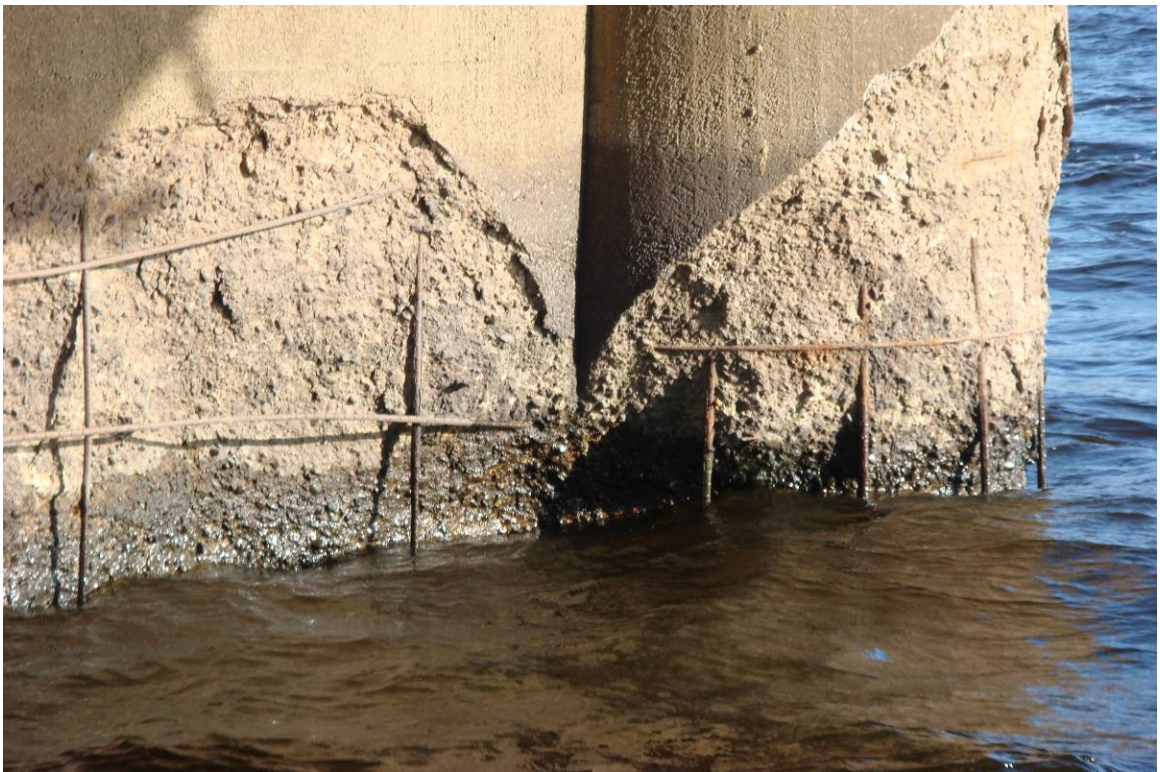
Photograph 8. View of the Concrete Section Loss on the West Face of Pier 8, Looking Southeast.

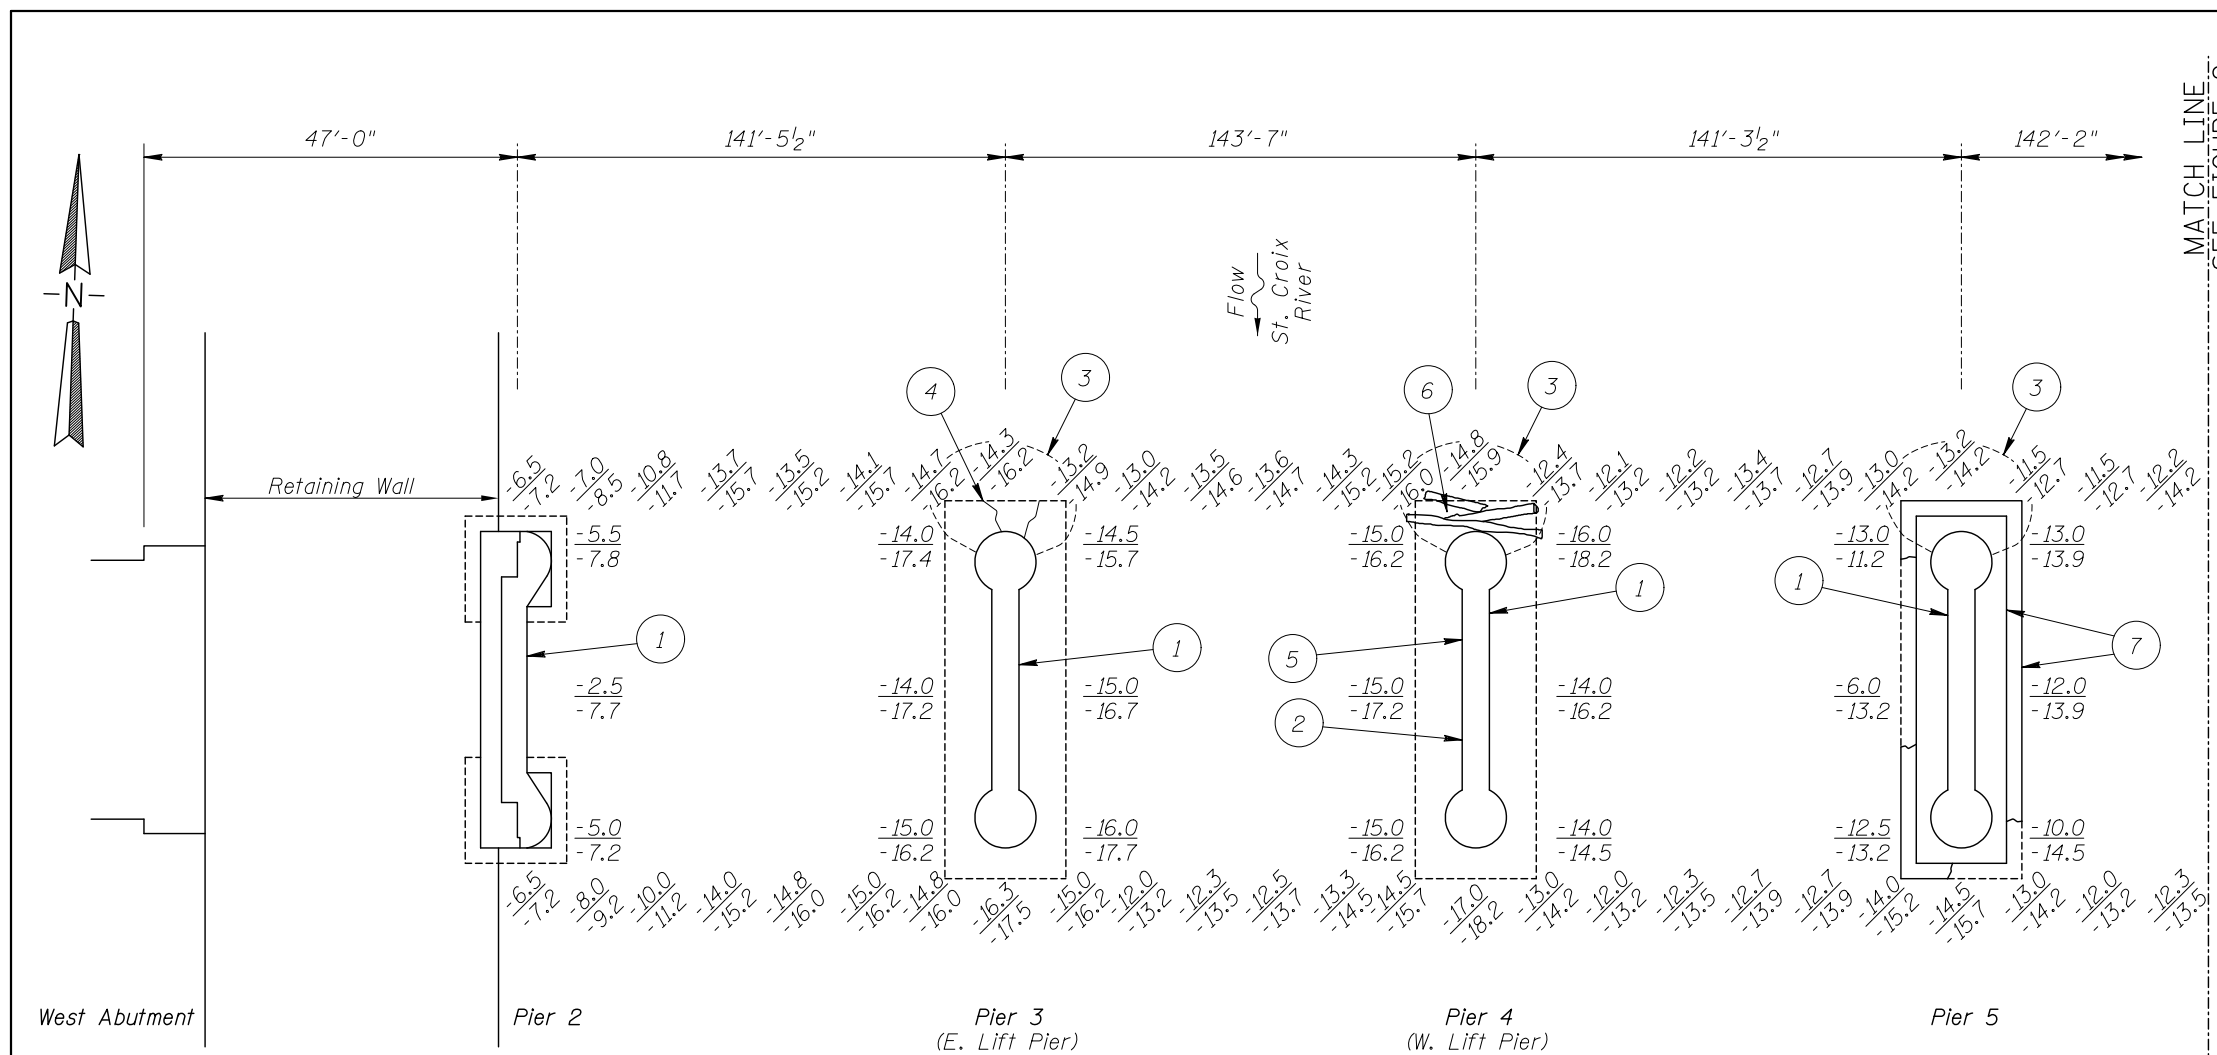
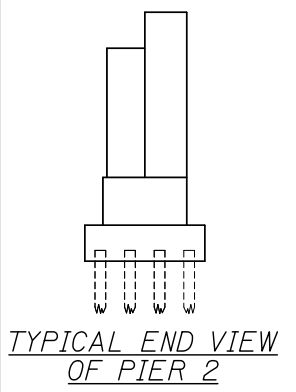
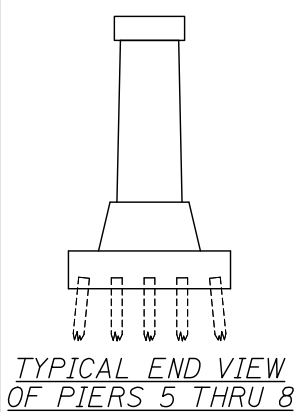
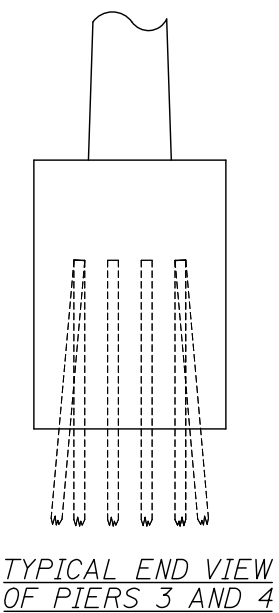
- 1 Moderate to heavy scaling with exposed reinforcing around the perimeter of Piers 2 through 5 from 1 to 3 feet below the waterline with penetration of 1 to 4 inches.

- 2 A 3 foot wide area of heavy scaling from 1 to 5 feet below the waterline with 4 to 5 inches of penetration at Pier 4 at the downstream 1/4 point on the west side.

- 3 A scour depression, with a radius of 15 feet and a depth of 1 to 3 feet, at the upstream nose of Piers 3, 4, and 5.
- 4 There was a small area of footing exposure at the upstream nose of Pier 3 with no vertical exposure.

- 5 An 1/8 inch wide crack from 10 feet below the waterline to the channel bottom at the upstream 1/4 point on the west side of Pier 4.
- 6 Moderate timber debris accumulation, consisting of three 1 foot diameter logs, was located at the upstream nose of Pier 4.

- 7 The footing at Pier 5 was fully exposed around the entire perimeter of the pier. The seal at Pier 5 was partially exposed for 3 feet downstream from the northwest corner, across the upstream face down to the centerline of the downstream column along the east face. In addition, the seal was exposed for 12 feet north and 5 feet east from the southwest corner. The exposures were 1.5 foot at the southwest corner and 1 and 2 feet at the northwest and northeast corners, respectively.

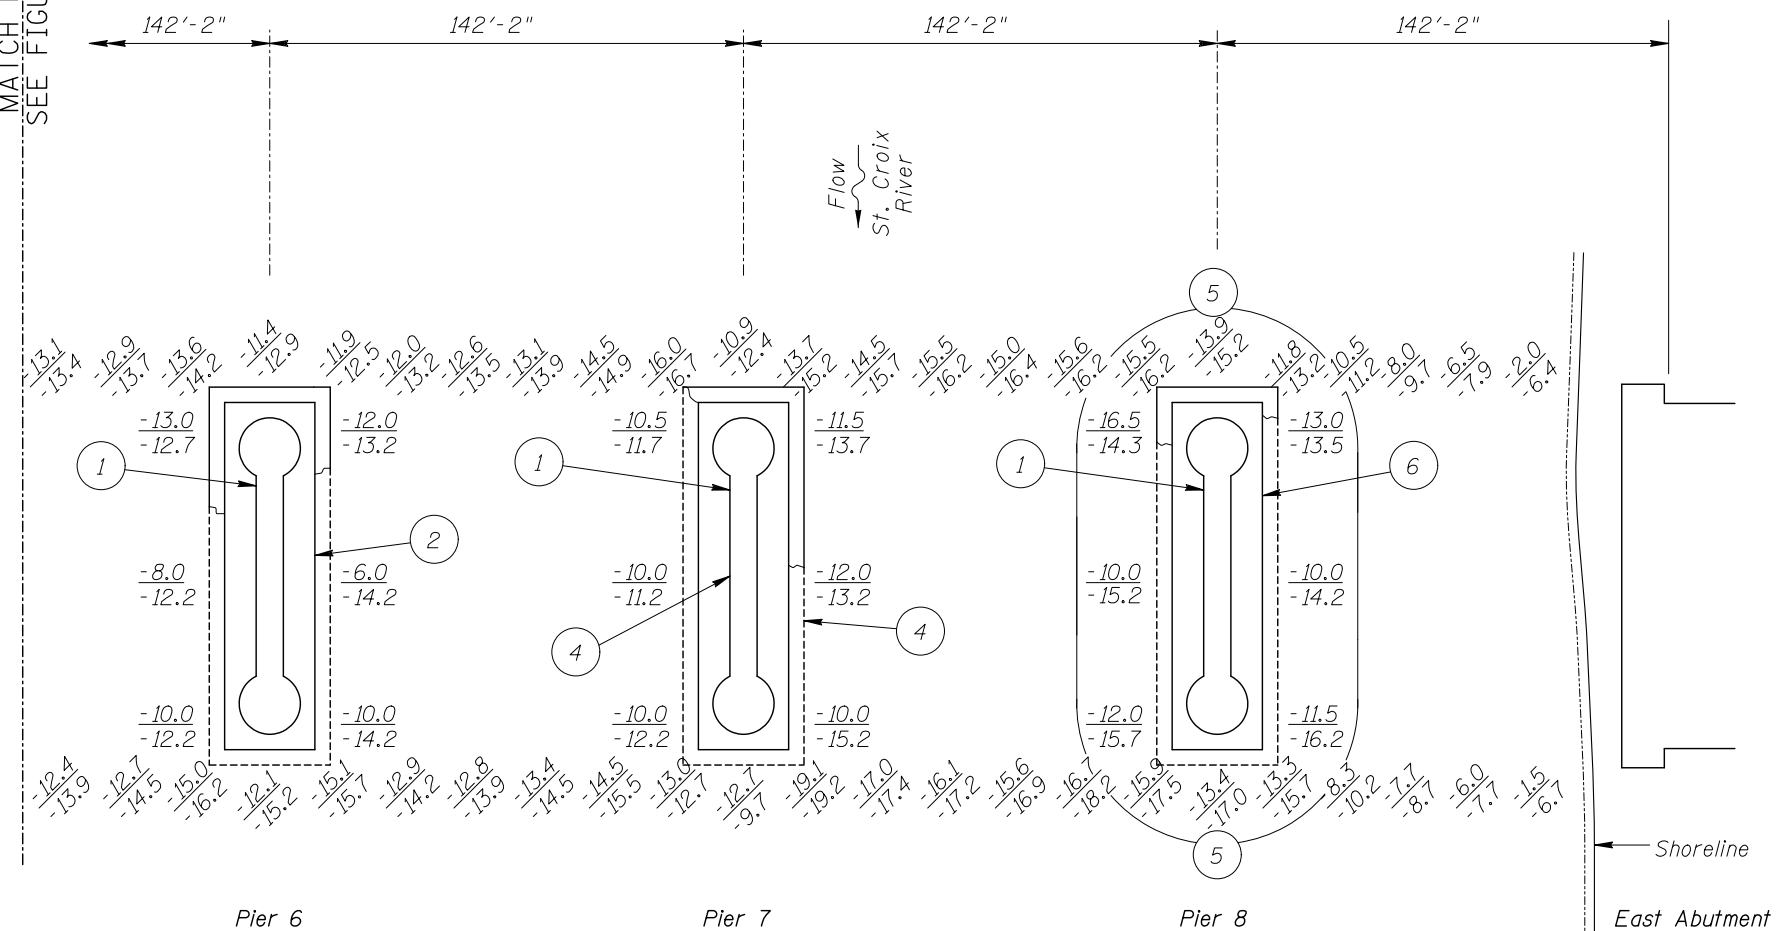
- ① Moderate to heavy scaling with exposed reinforcing around the perimeter of Piers 6 through 8 from 1 to 3 feet below the waterline with penetration of 1 to 4 inches.

- ② The footing at Pier 6 was fully exposed around the entire perimeter of the pier. The seal was exposed at the upstream most end of the pier, for 10 feet along the west face and 5 feet along the east face from the upstream end of the pier. The exposure ranged from 1 foot at the northeast corner to 2 feet at the northwest corner.

- ③ The footing at Pier 7 was fully exposed around the entire perimeter of the pier. The seal was exposed along the entire upstream face with 6 inches of vertical exposure and along the east face to the midpoint with 1 foot of maximum vertical exposure.

- ④ A 4 foot by 4 foot area of poor consolidation with 1/2 inch penetration at the midpoint on the west side of Pier 7.
- ⑤ Areas of scaling related heavy section loss from 4 feet above to 2 feet below the waterline with 2 to 6 inches of penetration and exposed reinforcing steel around the entire perimeter of Pier 8.

- ⑥ The footing at Pier 8 was fully exposed around the entire perimeter of the pier with 4 feet (full footing height) of vertical exposure. The seal at Pier 8 was exposed for 12 feet and undermined for 10 feet across the upstream nose from the northeast corner as well as exposed for 5 feet and undermined for 4 feet along the west side. The undermining exhibited 6 inch high cavity with minimal penetration and no piles exposed.
