Pedestrian Railing Repair Study

REPORT OF FINDINGS

STILLWATER LIFT BRIDGE

(Mn/DOT Br. No. 4654 – Wis/DOT Br. No. M-61)
over St. Croix River

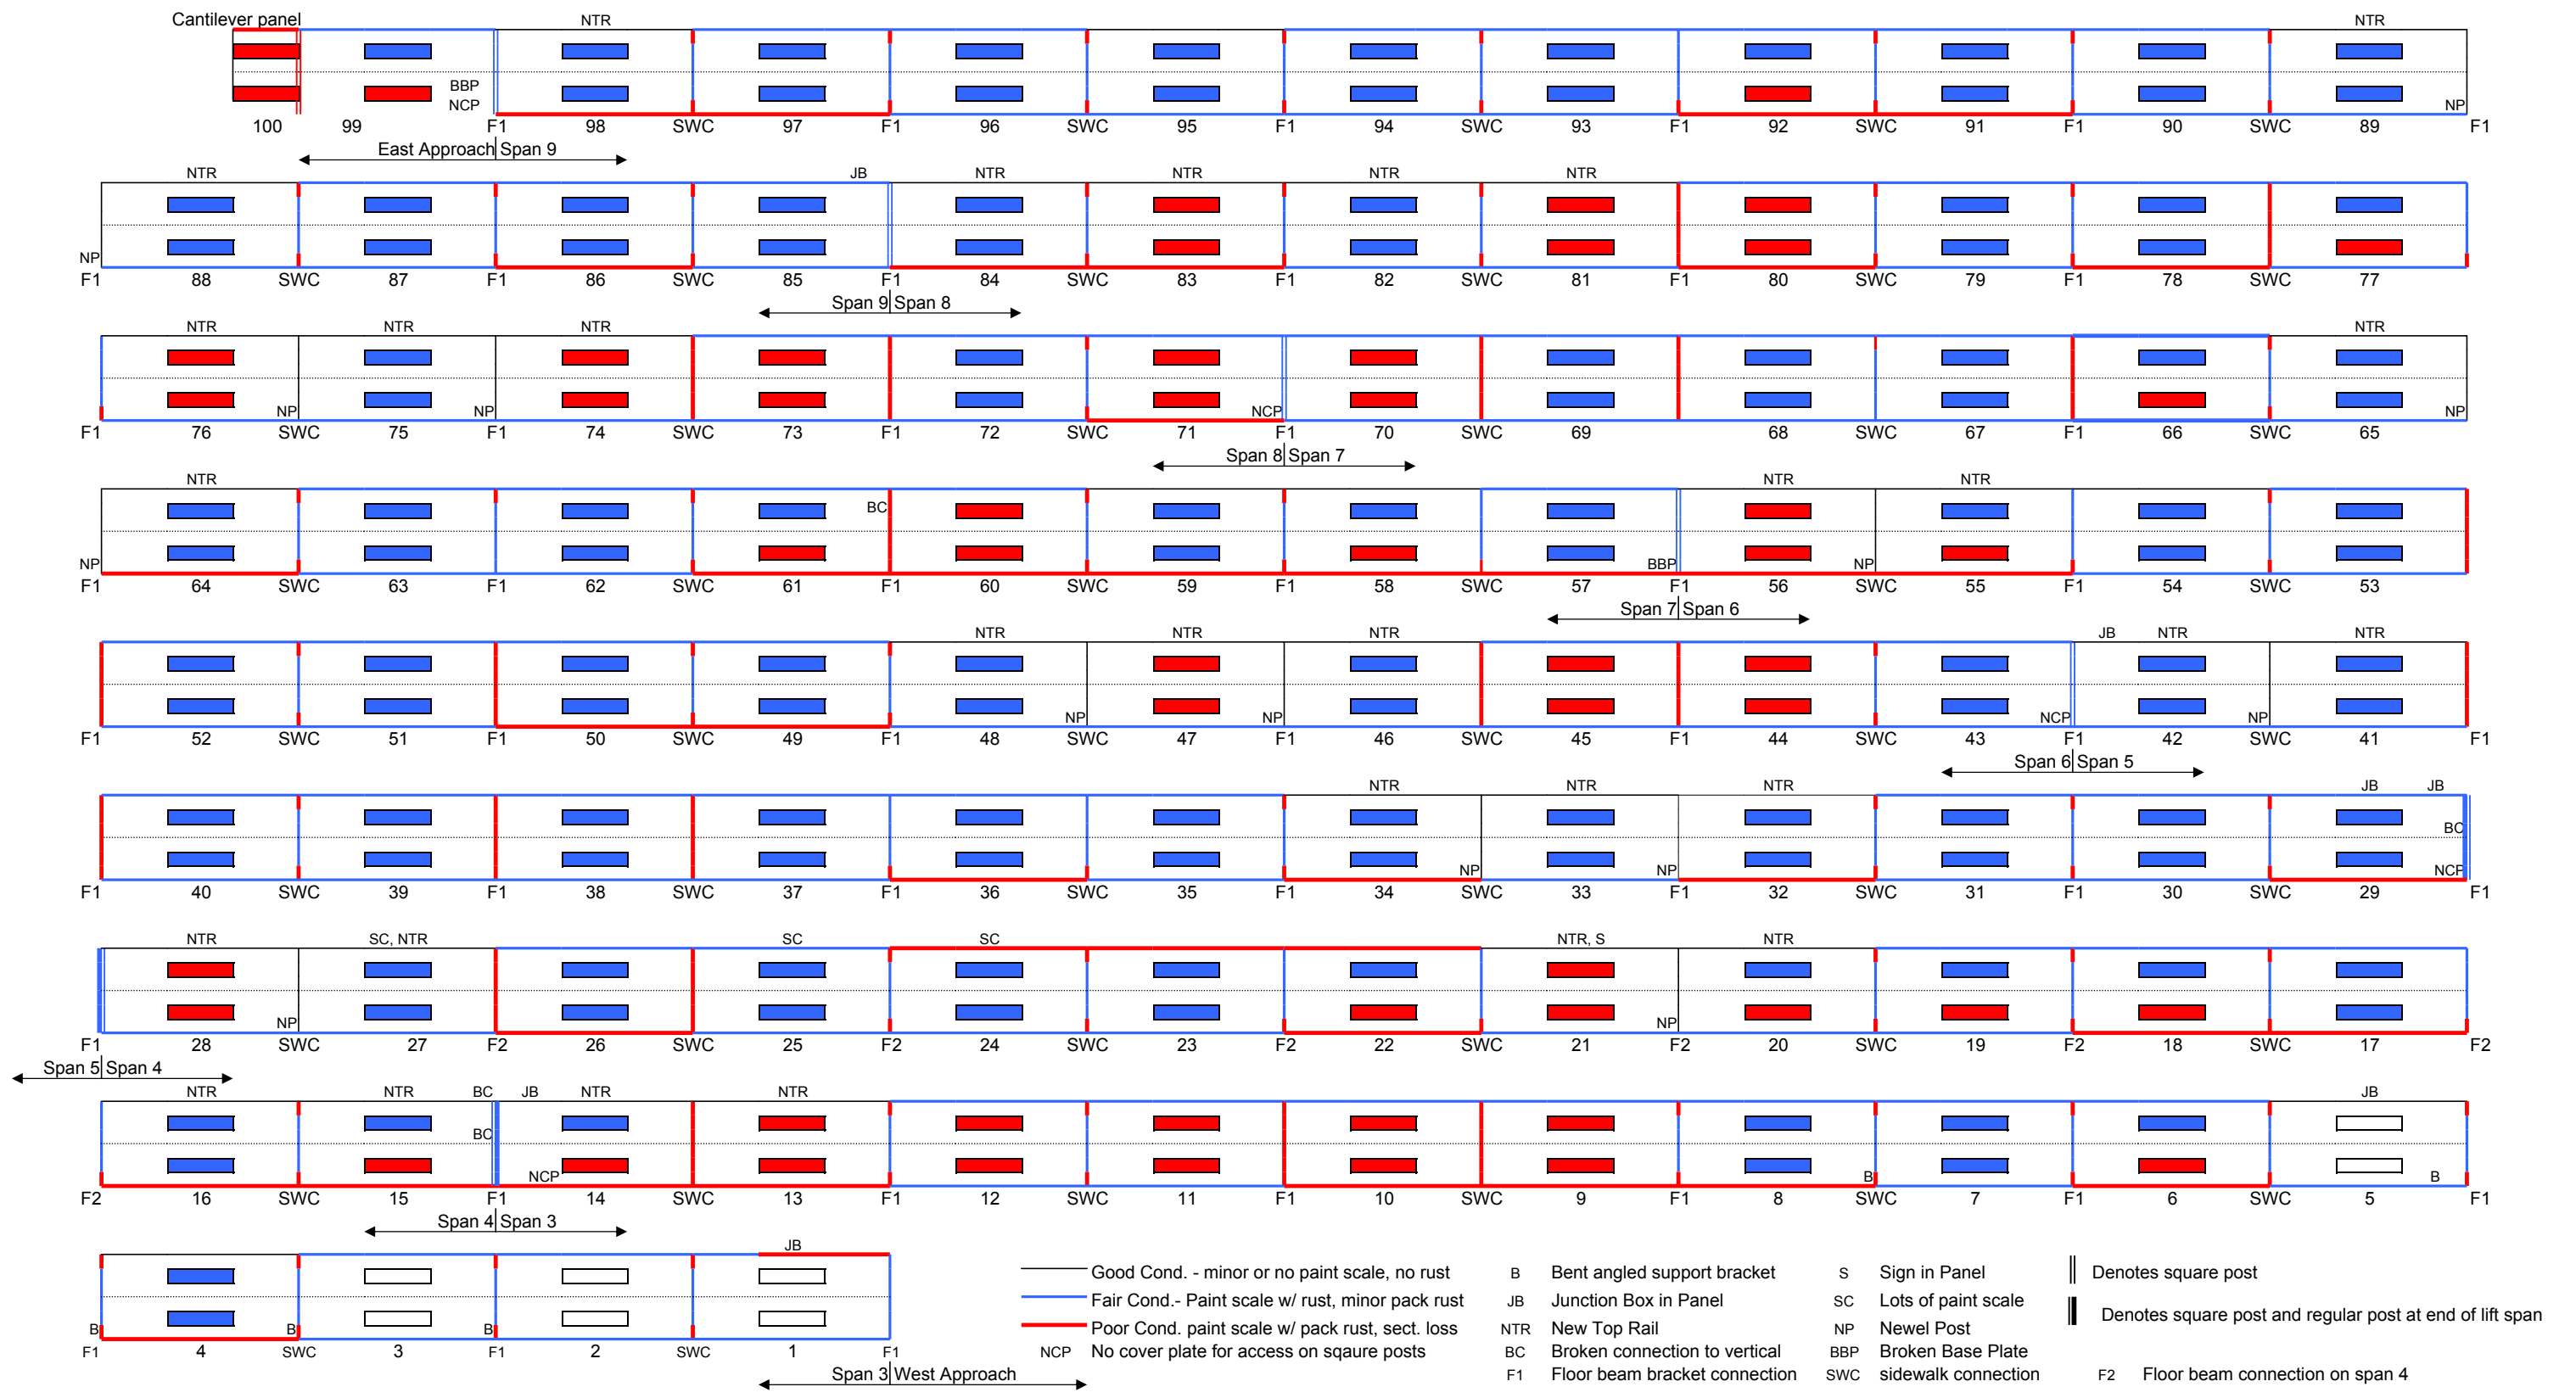
South Railing Elevation Looking South

- The elements depicted in red indicate significant paint scale, pack rust and/or section loss due to corrosion – poor condition.
- The elements depicted in blue indicate limited paint scale, pack rust and corrosion – fair condition.
- The elements depicted in black indicate good condition.

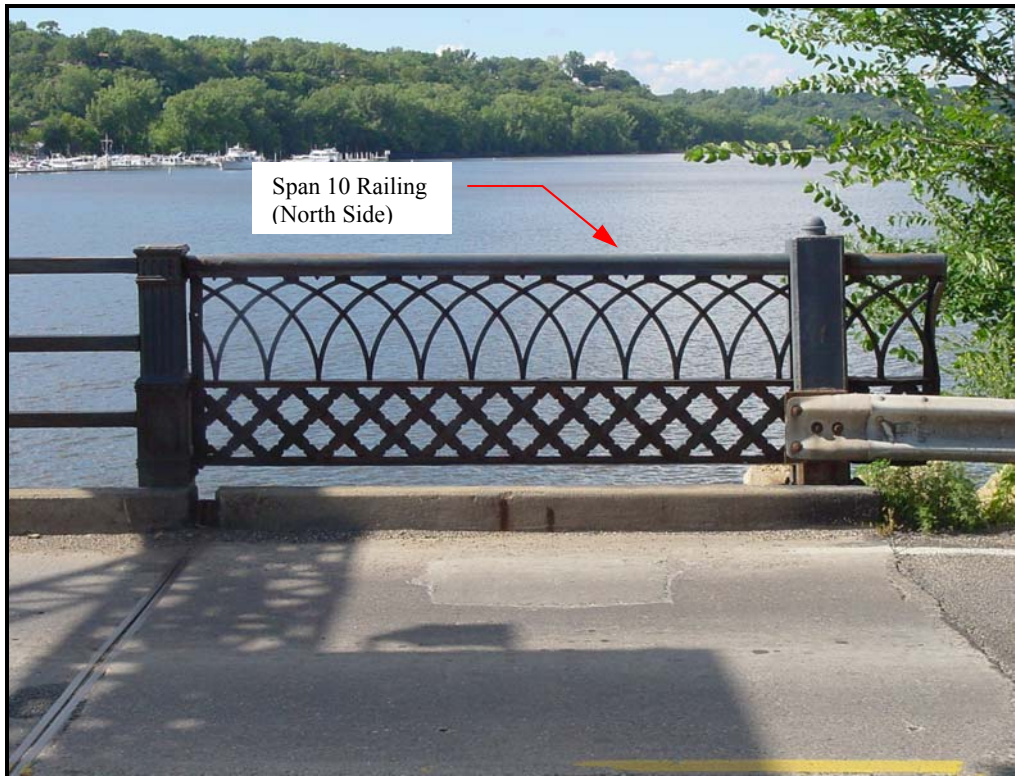
Presently the pedestrian railing is used on north side of Span 10 without benefit of a traffic guard rail or traffic barrier to restrain errant vehicles. It is recommended that a traffic guard rail or traffic barrier be constructed on north side of Span 10. The traffic barrier could be design to be architecturally consistent with original design should that be deemed desirable.

Photo 6: North Side Span 10 Railing

Additionally, the pedestrian railing presently fixed to the north side of Span 10 is recommended to be replaced with traffic barriers capable of restraining vehicles, or a suitable guard rail installed. The replacement traffic barrier could be constructed of concrete and detailed to be visually consistent with the other elements of the bridge, should that be deemed to be consistent with historic preservation.

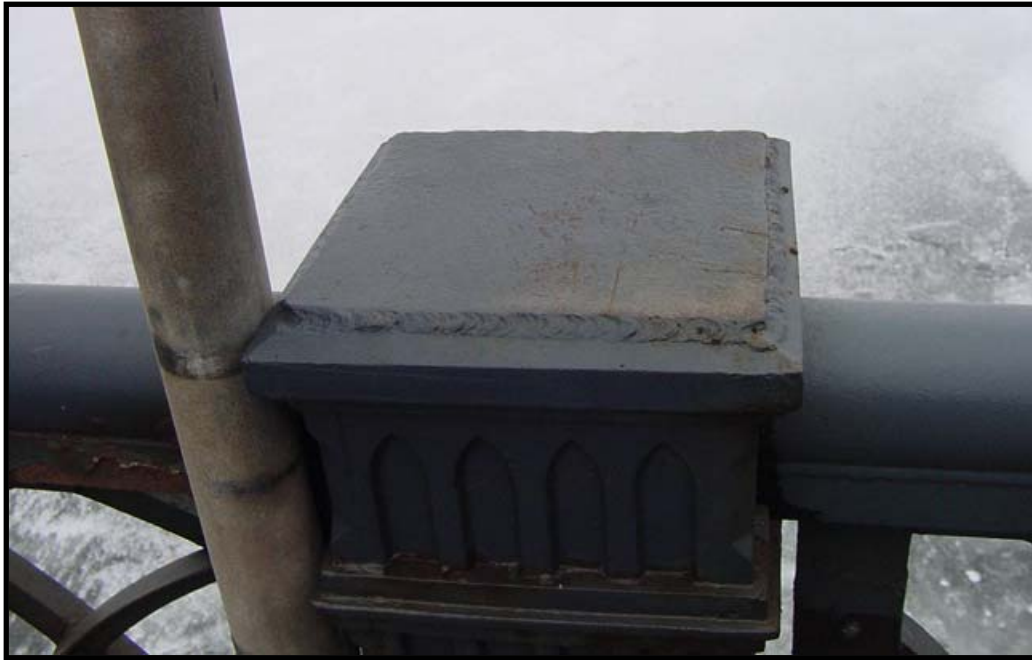
Photo 7: Typical Retrofit of Newel Post Light Anchorage

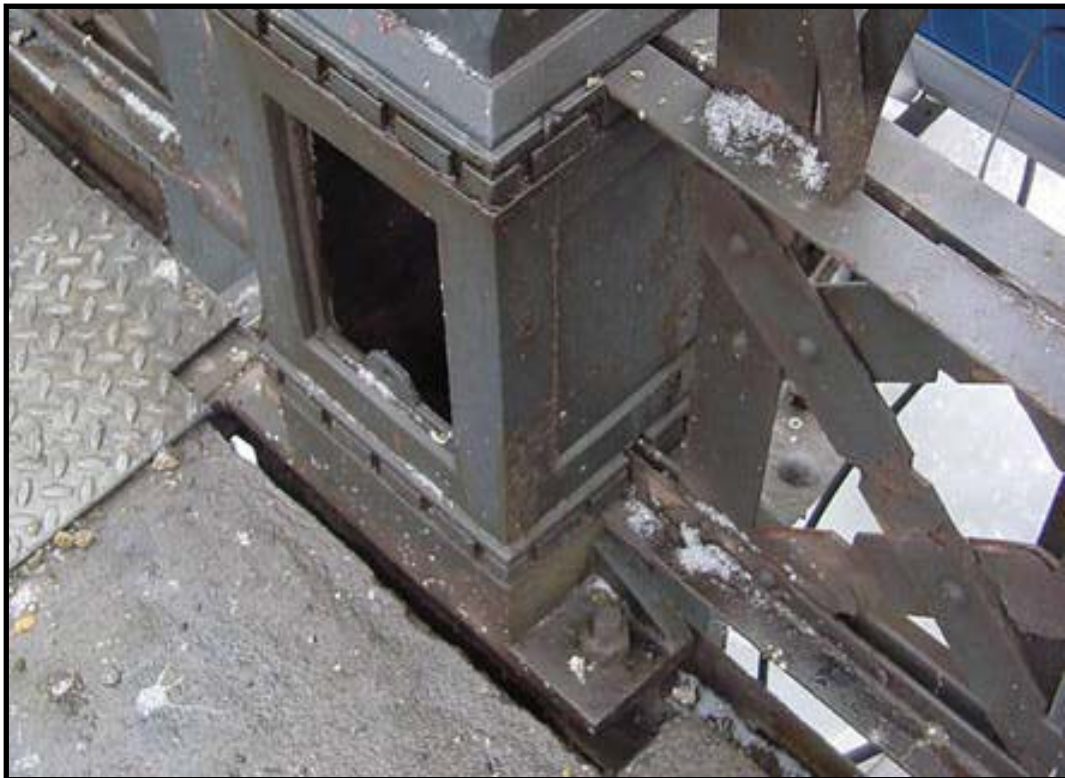
Photo 8: Newel Post Hand-hole – Missing Cover Plate

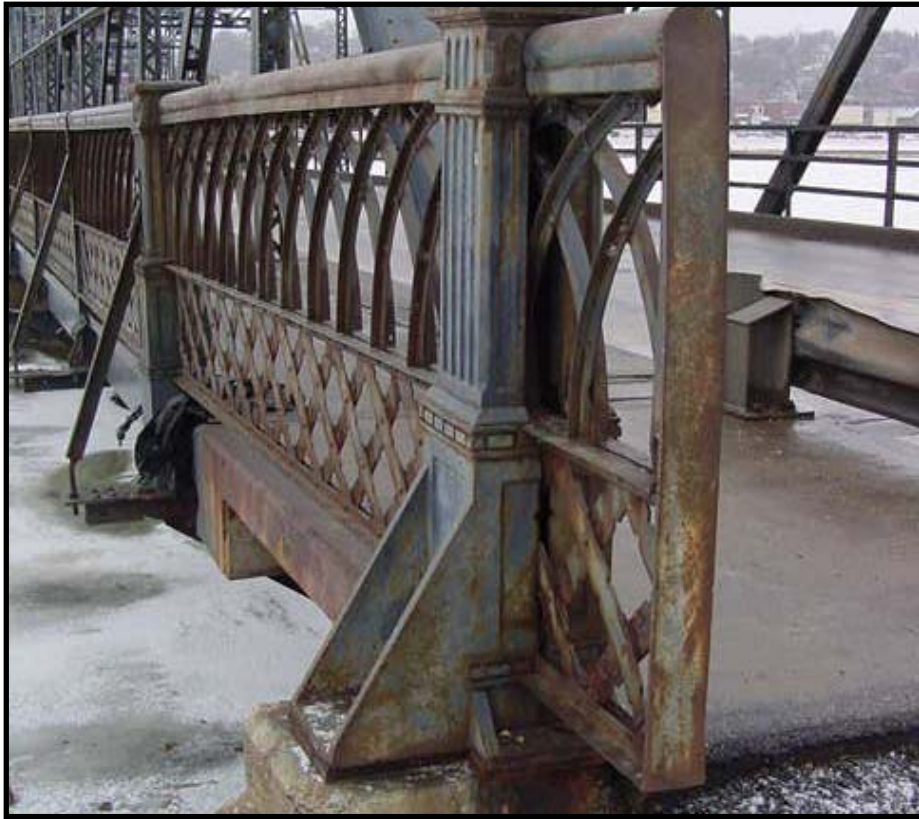
Photo 9: Span 10 Modified Newel Post

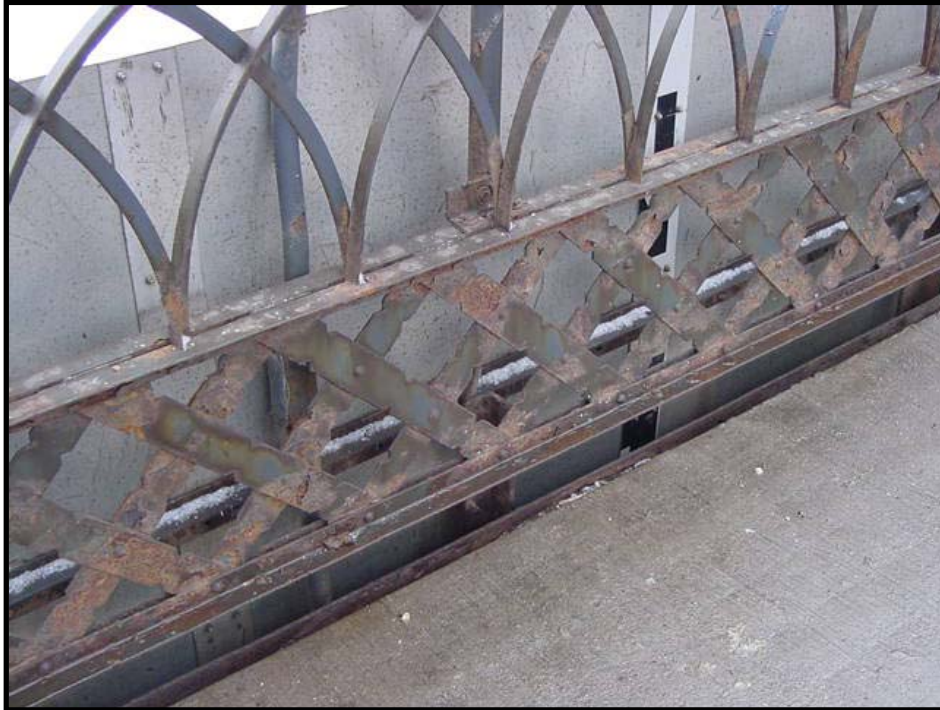
Photo 10: General Corrosion of Original Railing Cross-bar Pane

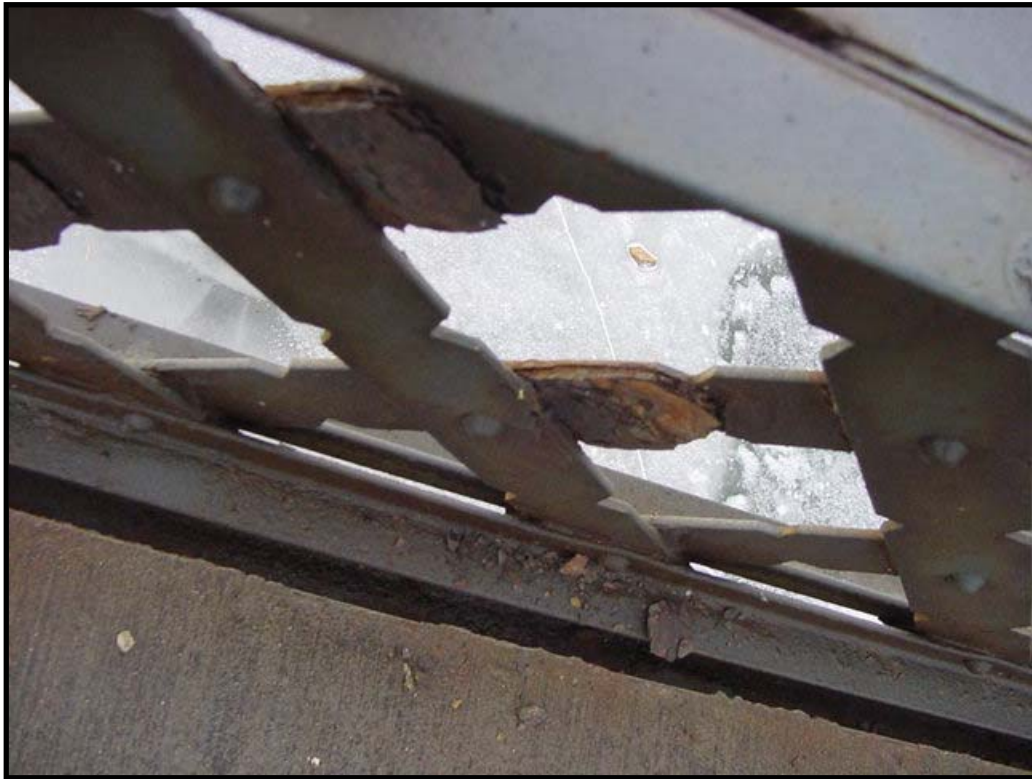
Photo 11: Corrosion of Original Railing Cross-Bars

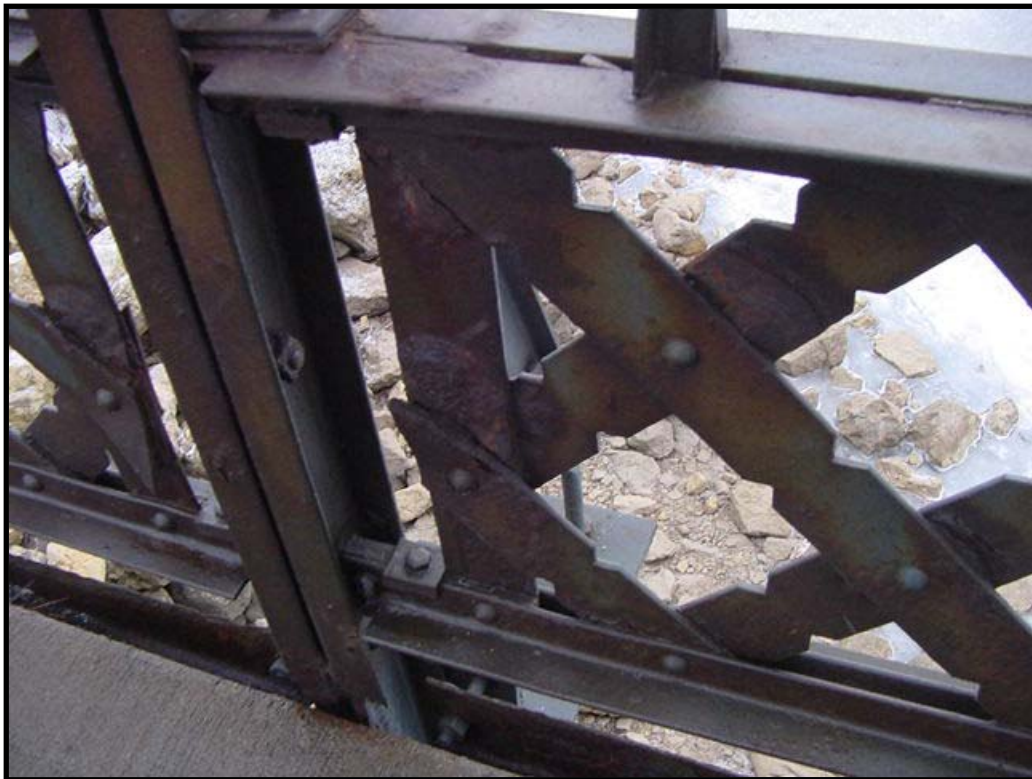
Photo 12: Corrosion of Original Railing Cross-Bars

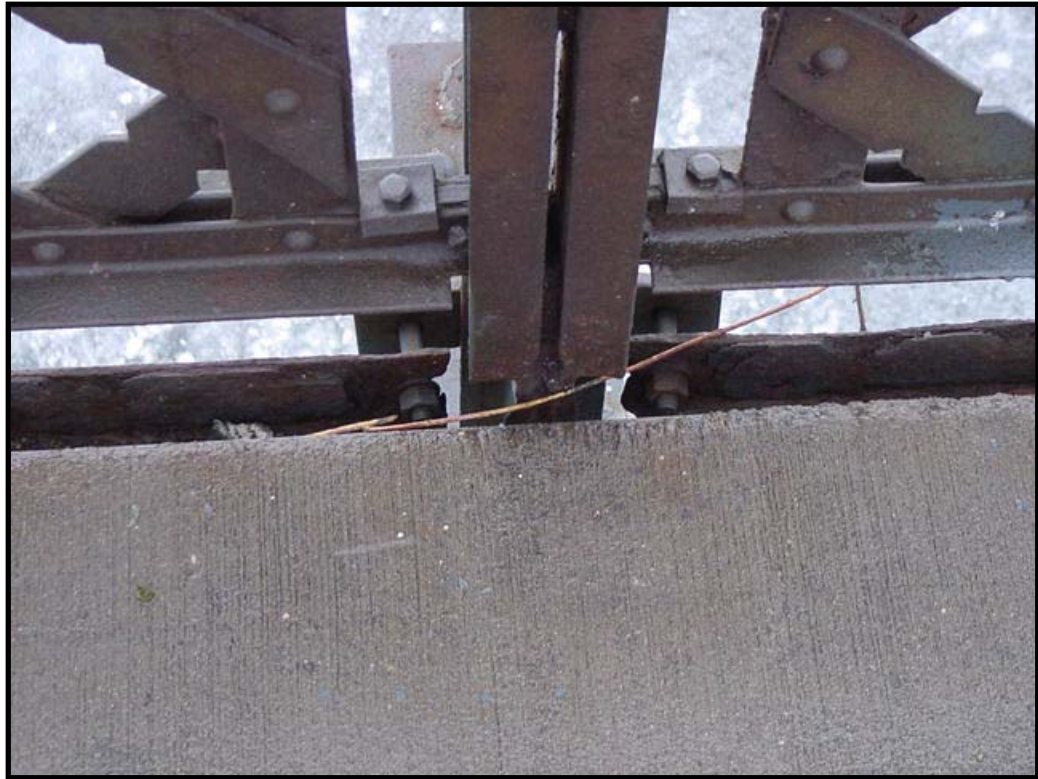
Photo 13: Substantial Section Loss to Rail Post Flanges Due to Corrosion

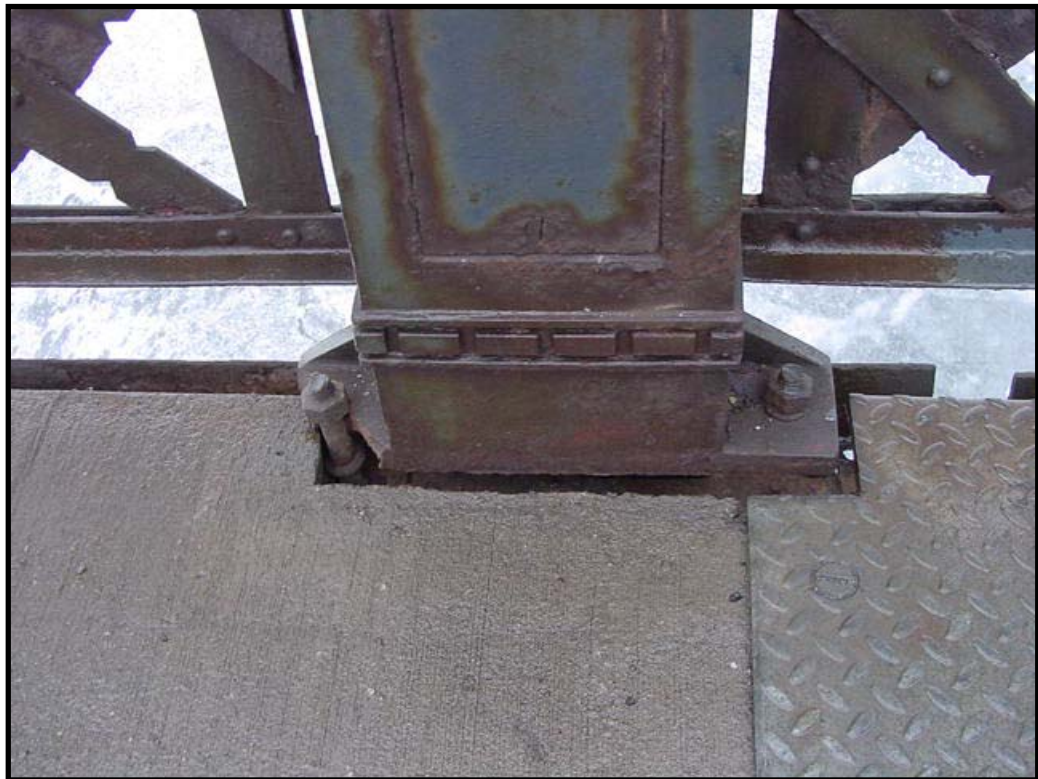
The newel posts are ornate and of original construction and consist of hollow cast-iron elements. The newel posts originally incorporated an anchorage assembly for ornamental lights on top of each post. The ornamental lights have been removed. A metal plate has been welded to the top of the newel posts to cover the remnants of the lighting anchorage assembly (Ref. Photo 7). The newel posts are fastened to supporting structural members with bolted connections and supported laterally (transverse to the centerline of the bridge) with knee braces. The supporting elements of several newel posts are damaged in the form of broken mounting flanges and missing or broken anchorage bolts. (Ref. Photo 14).

Photo 14: Broken Newel Post Anchorage Flange
