Relocation Feasibility Report  
Bergstein Shoddy Mill and Warehouse  
6041 Stagecoach Trail North  
Oak Park Heights, Minnesota

## SITE VISIT REPORT

**Bergstein Shoddy Mill and Warehouse**

**6041 Stagecoach Trail North**

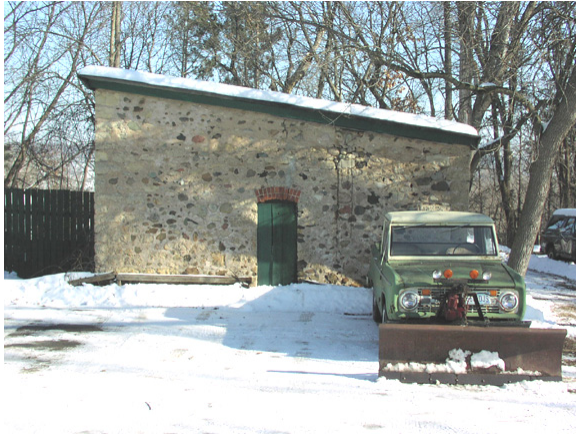
*Shoddy Mill-West Elevation*

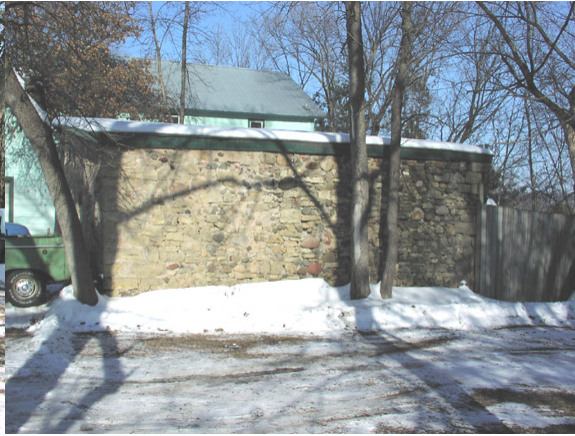
*Shoddy Mill-South Elevation*

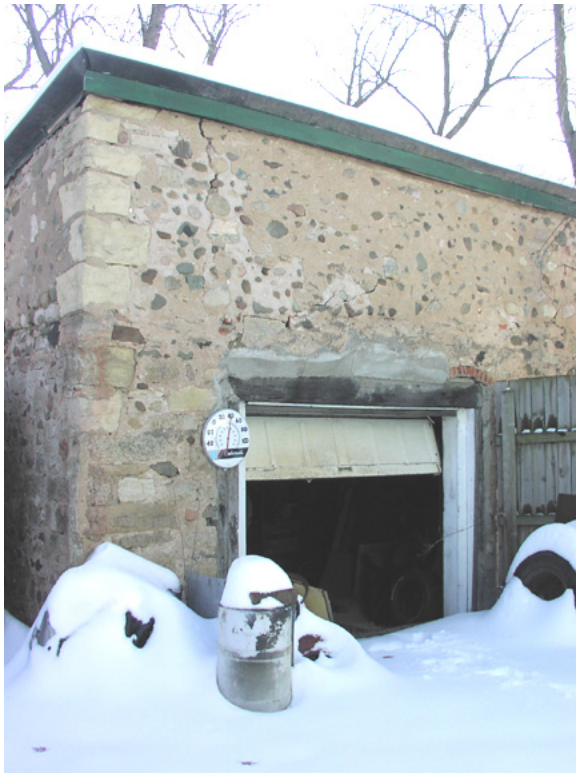
- A. The apparent settlement at the southeast corner of the building and other signs of movement would indicate that the building is on fairly shallow foundations. The 18" thick walls and small footprint of the building would account for its fairly sound condition. The corners of the building were laid with dressed stone quoins that lend stability to the structure. Three corners of the building are plumb and square. The southeast corner has settled and the east portion leans out at the top. This corner also has the most mortar joint deterioration.

*Shoddy Mill-Northeast Elevation*

- A. The southeast corner of the masonry may have to be rebuilt due to the amount of settlement and shift that has occurred. The remainder of the wall cracks can be repaired without reconstruction. Rebuilding of a deteriorated portion of a building with original and in-kind materials must meet the requirements of a Restoration under the Secretary of the Interior's Standards for the Treatment of Historic Properties.

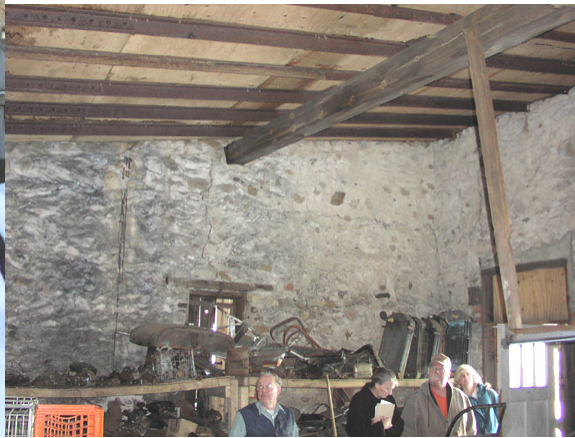
*Shoddy Mill-Northwest Interior*

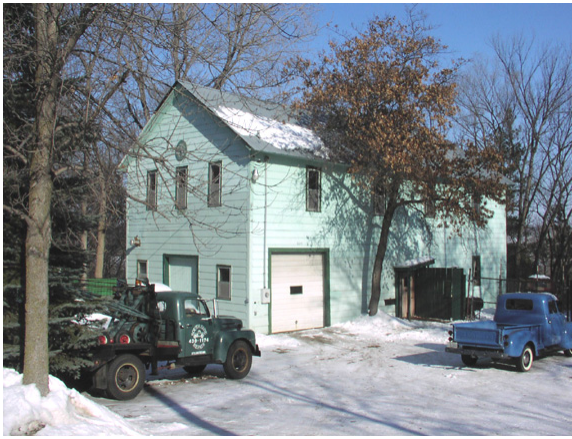
*Warehouse-Southwest Elevation*

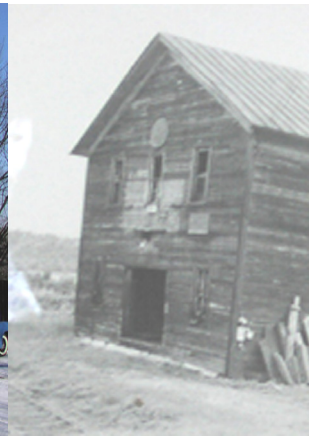
*Warehouse-Southwest 1950s*

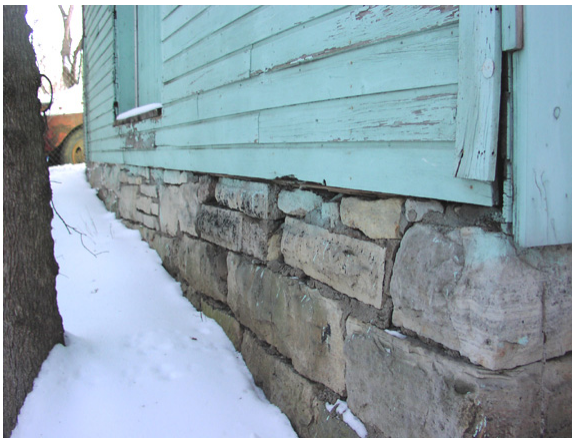
- A. The building is set on a dressed stone foundation that appears to be in good condition with no signs of settlement or movement.
- B. The original wood ground floor construction has been removed and a concrete slab installed. It is our understanding that the wood structure still rests on its original wood perimeter sill beam.

*Warehouse-East Foundation*

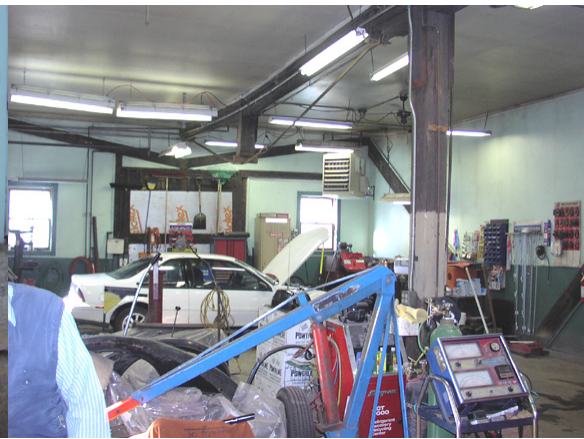
*Warehouse-Northwest Interior*

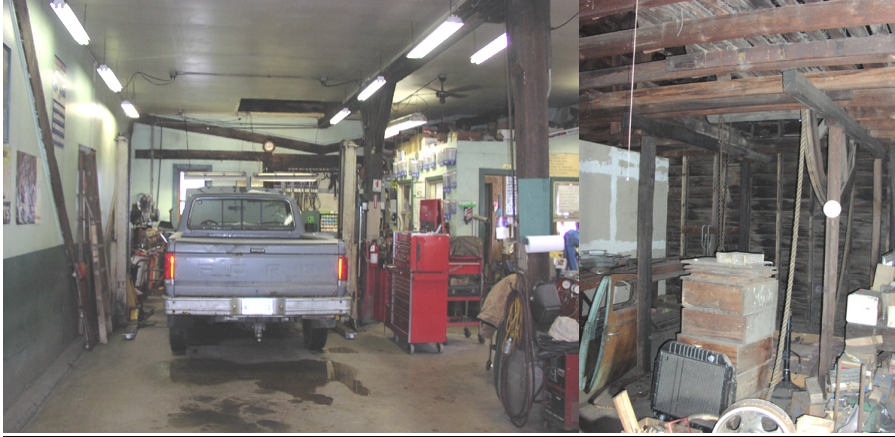
*Warehouse-East Interior*

*Warehouse-Attic Lift*
