Early Performance of Concrete Pavement Overlays in Minnesota

15th Annual TERRA Pavement Conference
February 10, 2011

Tom Burnham, P.E.
Minnesota Department of Transportation

Early PCC Overlay Performance in Minnesota

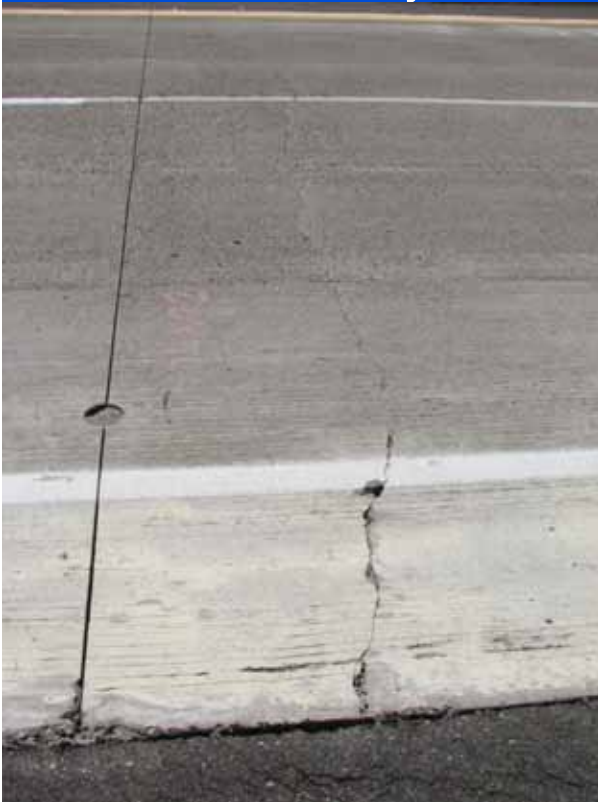
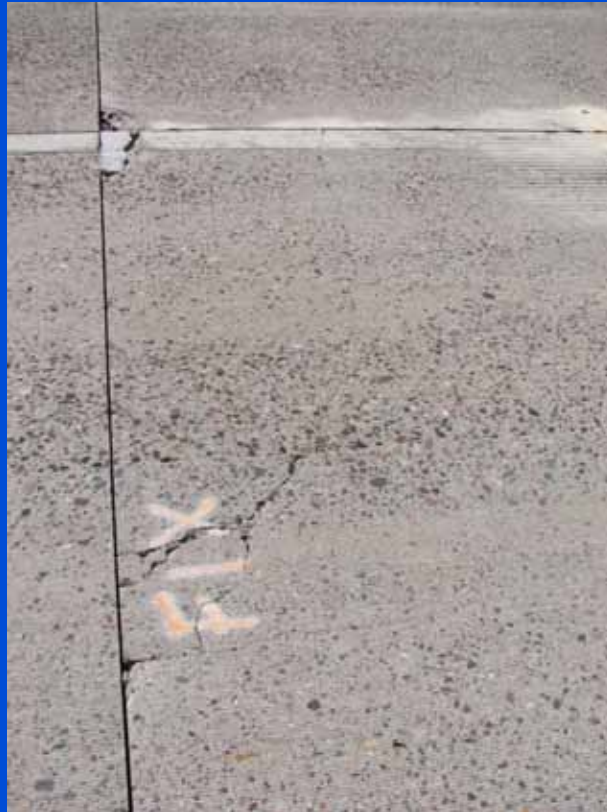
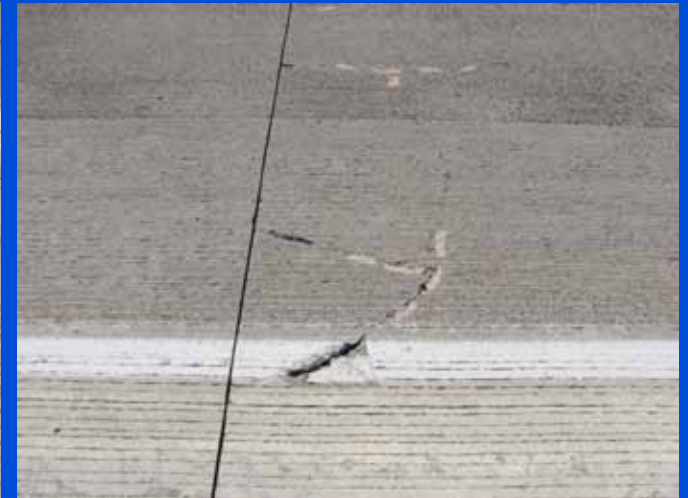
MnROAD Cells 105-205, Thin UBOL

- Early Performance = poor
 - More than 80% of 4" thick panels cracked within 2 years
 - Cause: Excessive curling of thin slabs
 - Distress from impact loads
 - To be replaced in 2011 with 5", 6'L x 6'/7.5'W panels over fabric interlayer

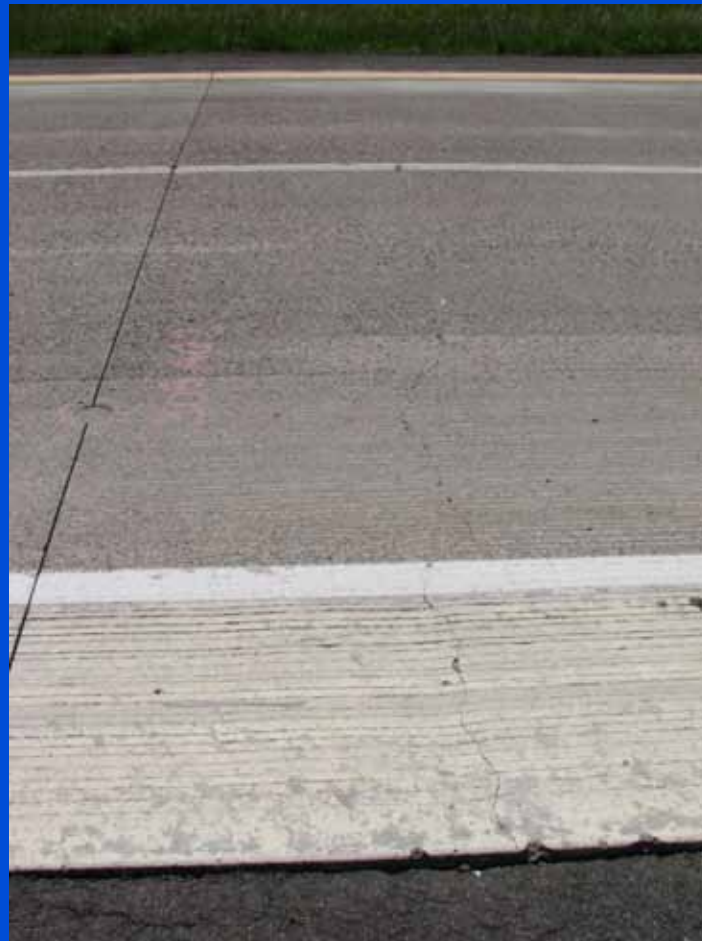
MnROAD Cells 305-405, Thin UBOL

- Early Performance = fair
 - 40% of 5" thick panels cracked within 2 years
 - Less cracked panels over non-broken joints

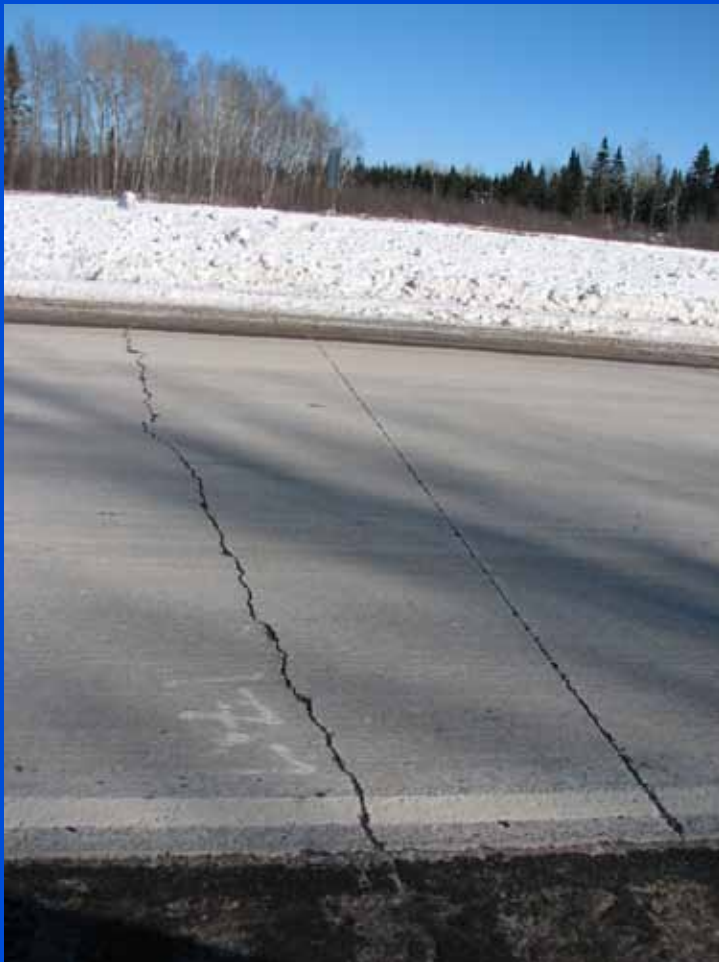
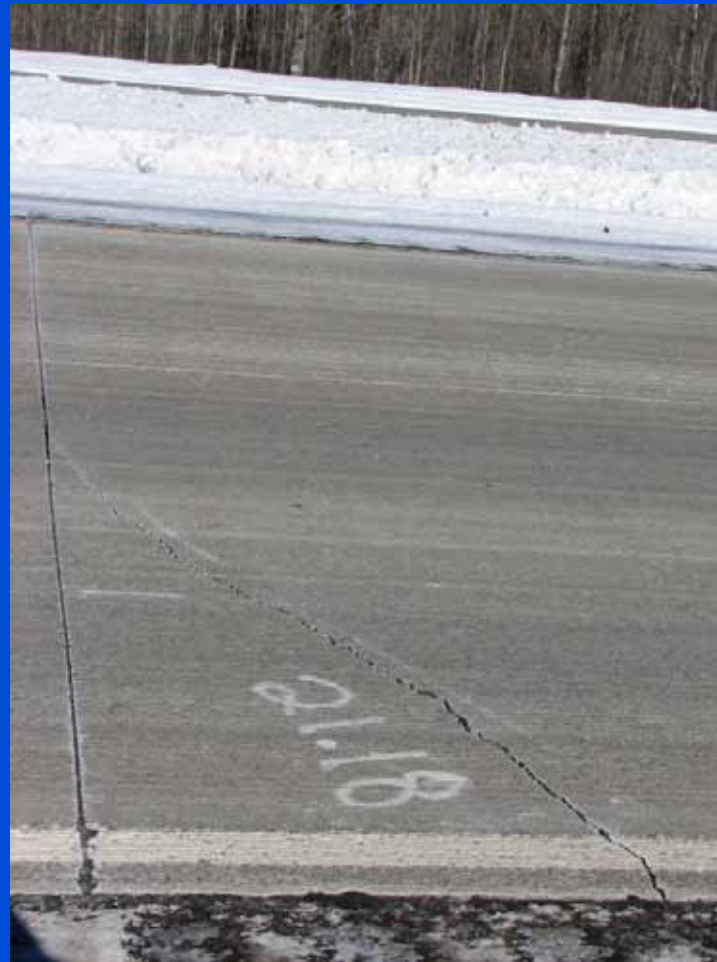
TH 53 Twig Southbound, Thin UBOL

- Early Performance = fair
 - Numerous transverse cracks within 6 months
 - Corner and longitudinal cracks now progressing

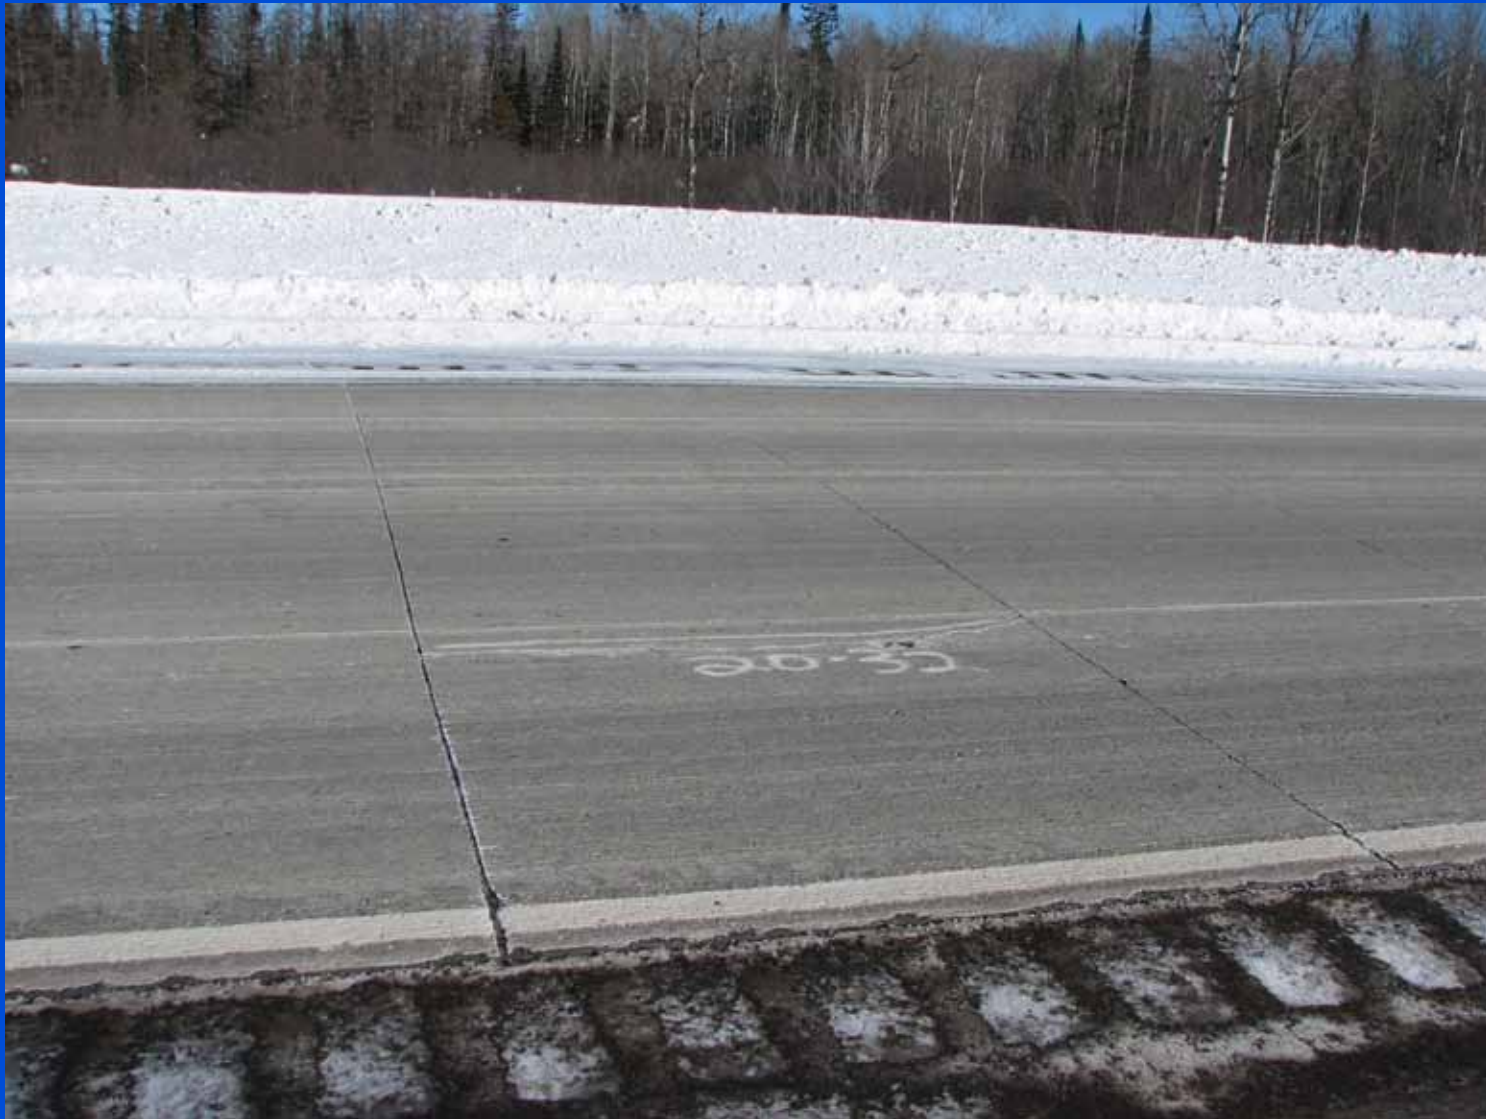
TH 53 Twig Southbound, Thin UBOL

Crack in 6' x 6' panel

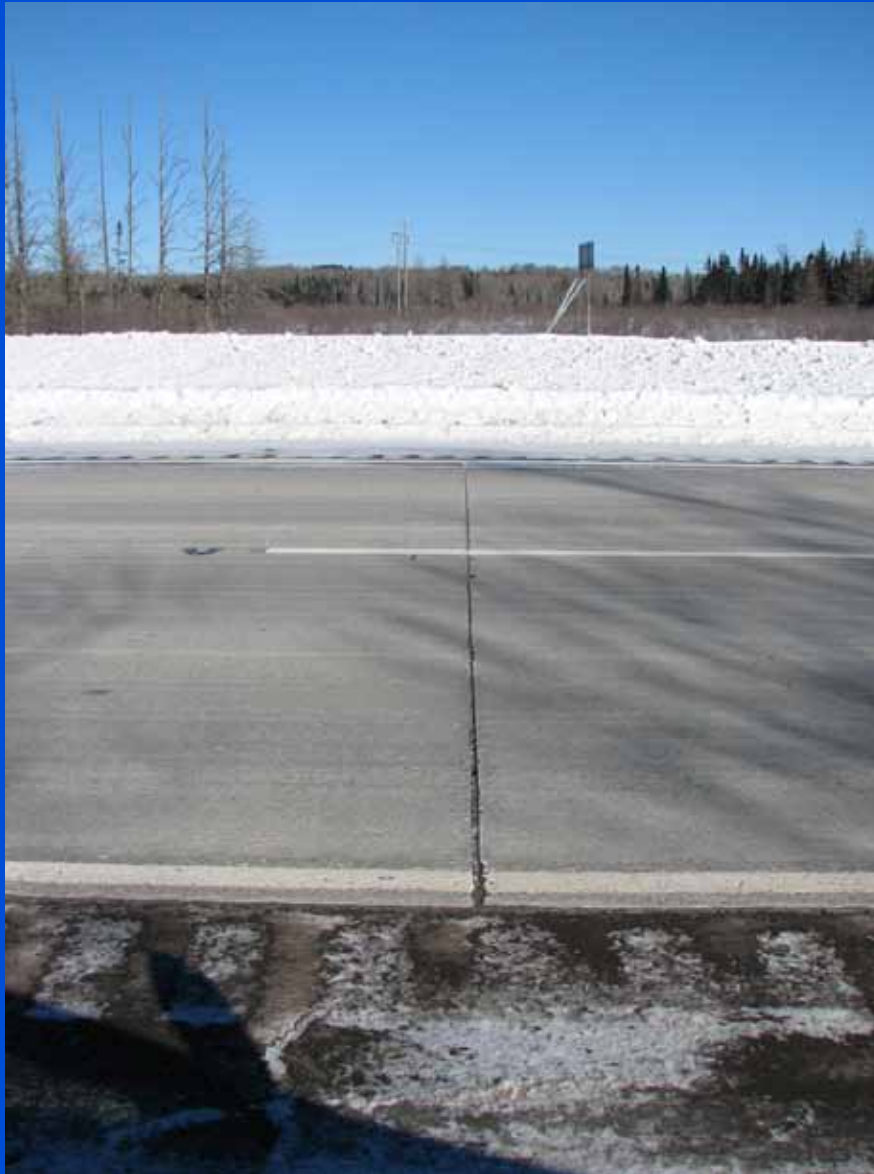
TH 53 Twig Southbound, Thin UBOL

Wide joints – Would hot-pour sealant be effective?

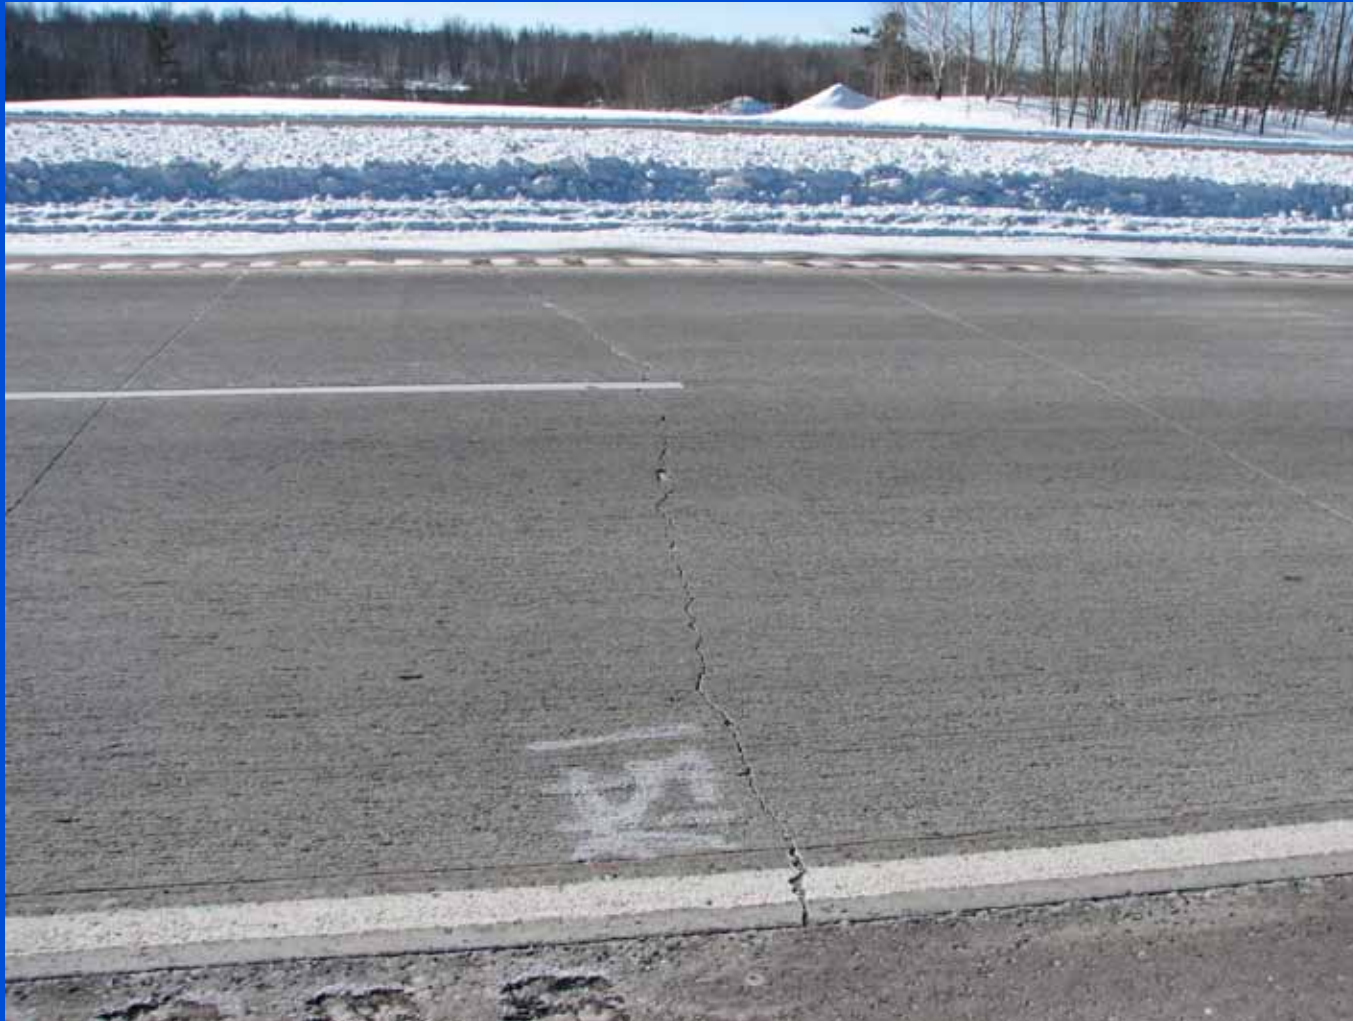
TH 53 Twig Northbound, Thin UBOL

- Early Performance = good
 - Some transverse cracks

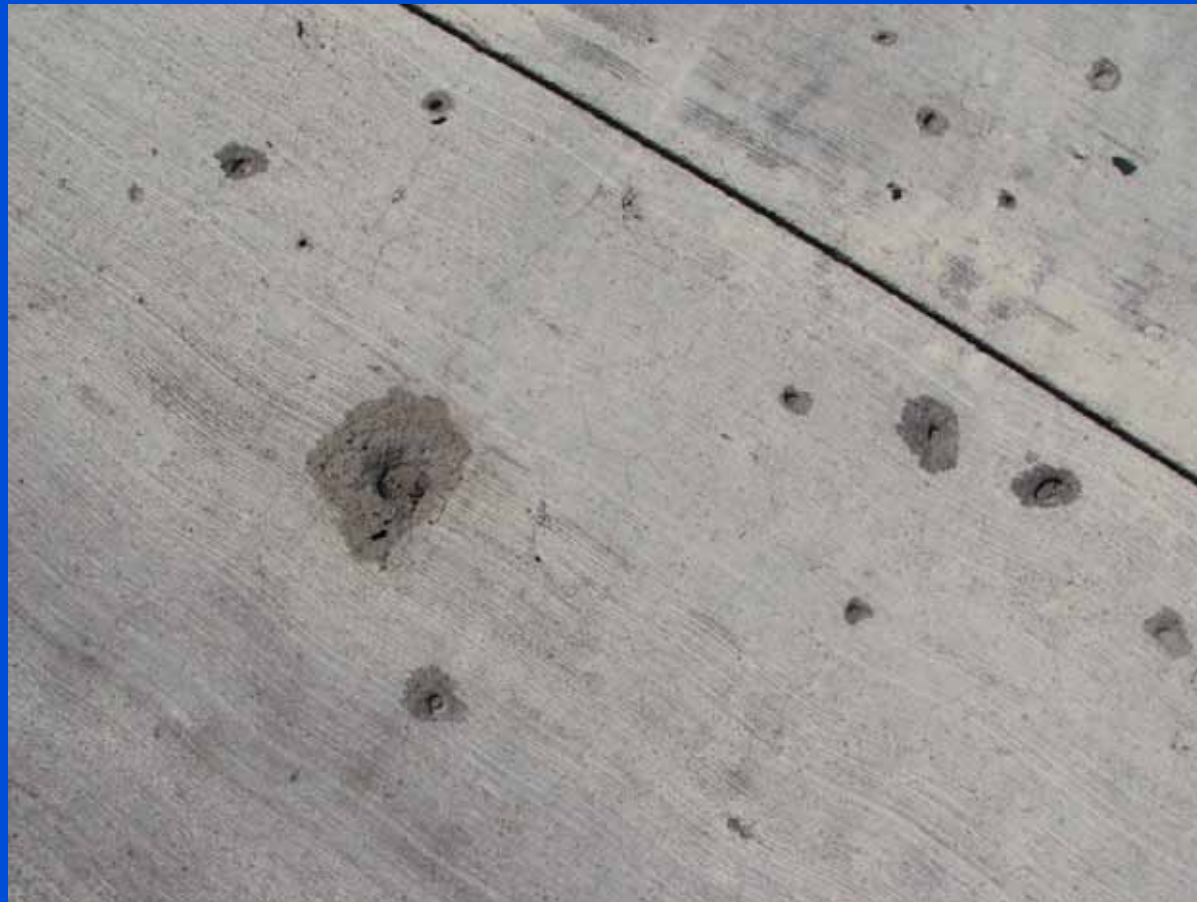
MnROAD Cells 114-514, Thin Whitetopping

- Early Performance = Good
 - A few panels cracked, Cells 114 and 314
 - Insufficient remaining HMA thickness (5") or bad material?

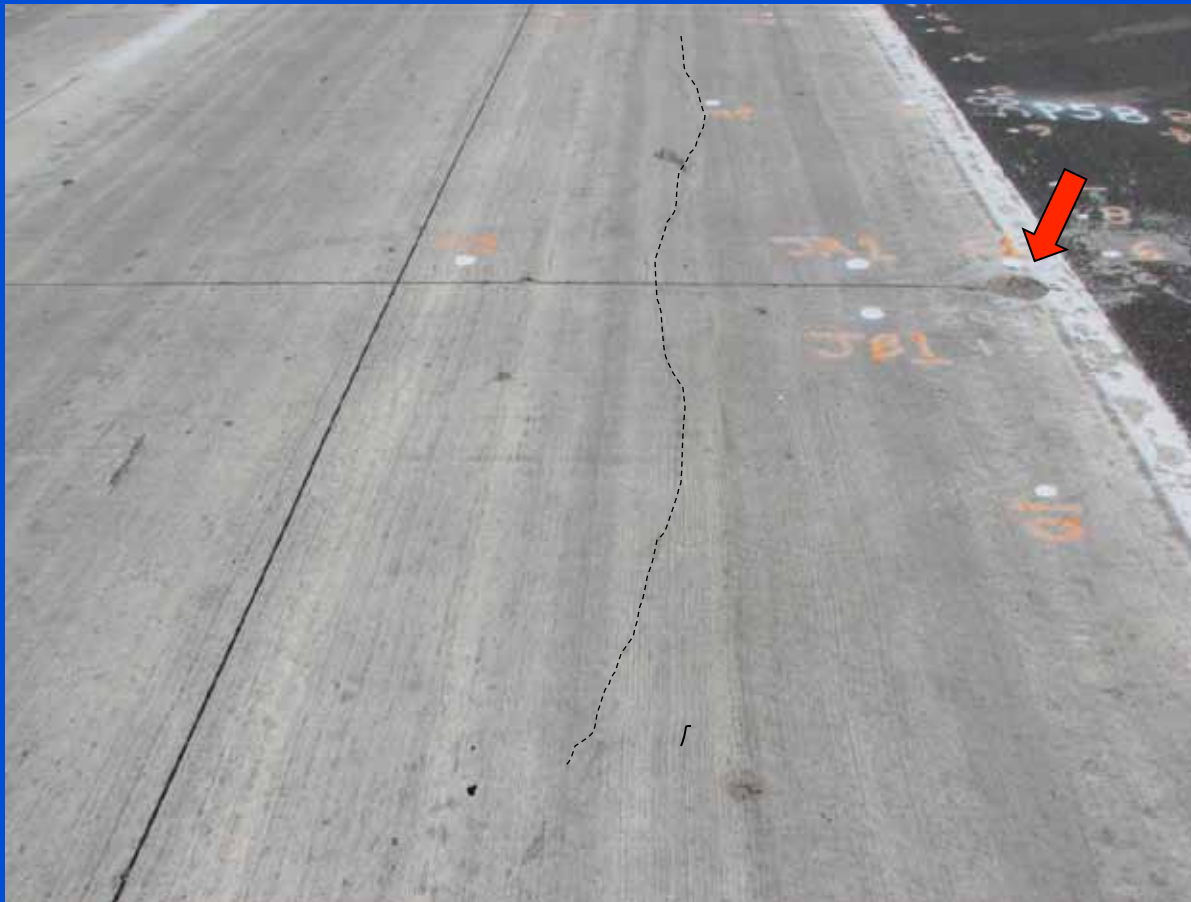
MnROAD Cell 614, Thin Whitetopping

- Early Performance = Good
 - One longitudinal crack
 - Cause: Refill of core hole?

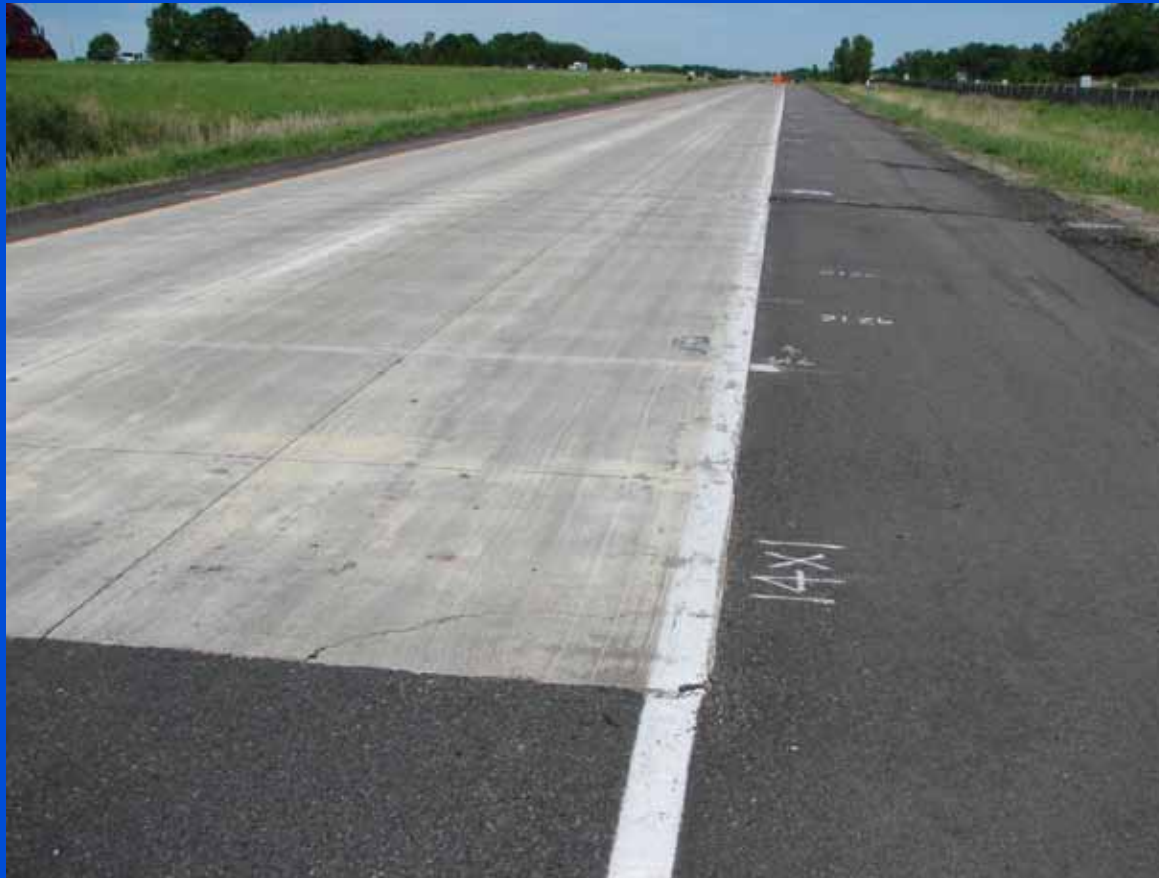
MnROAD Cells 714-914, Thin Whitetopping

- Early Performance = Very Good
 - No distresses (other than popouts)
 - Sufficient remaining HMA thickness = 8"?

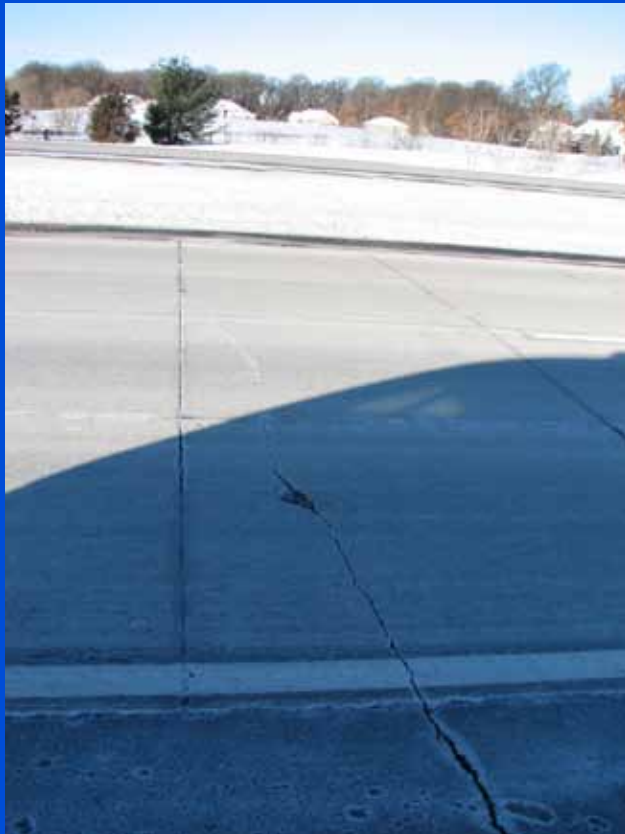
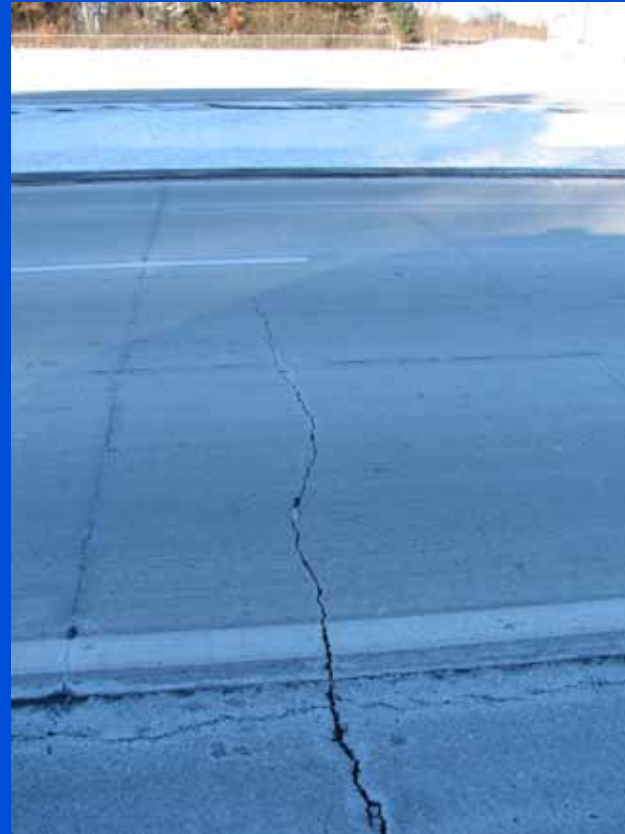
I-35 North Branch, Thin Whitetopping

- Early Performance: Good
 - Multiple transverse cracks with first 6 months
 - Cause: Reflective cracking from underlying bonded HMA
 - Feb 2011: Little change in distresses

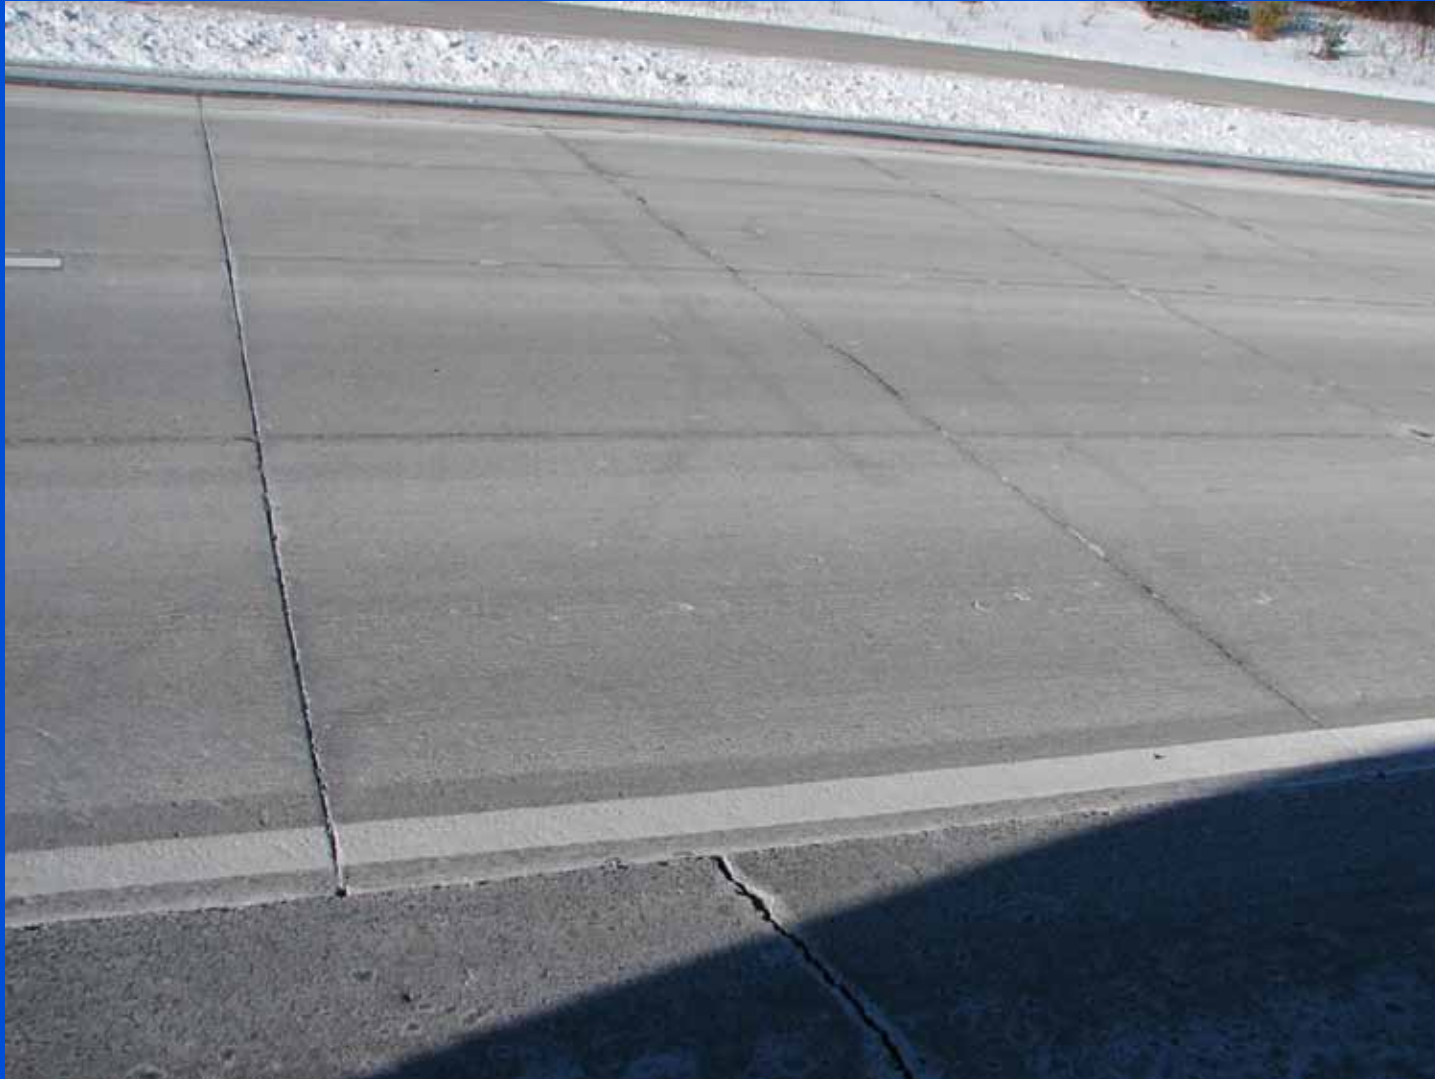
I-35 North Branch, Thin Whitetopping

Cracks in shoulder do not always reflect

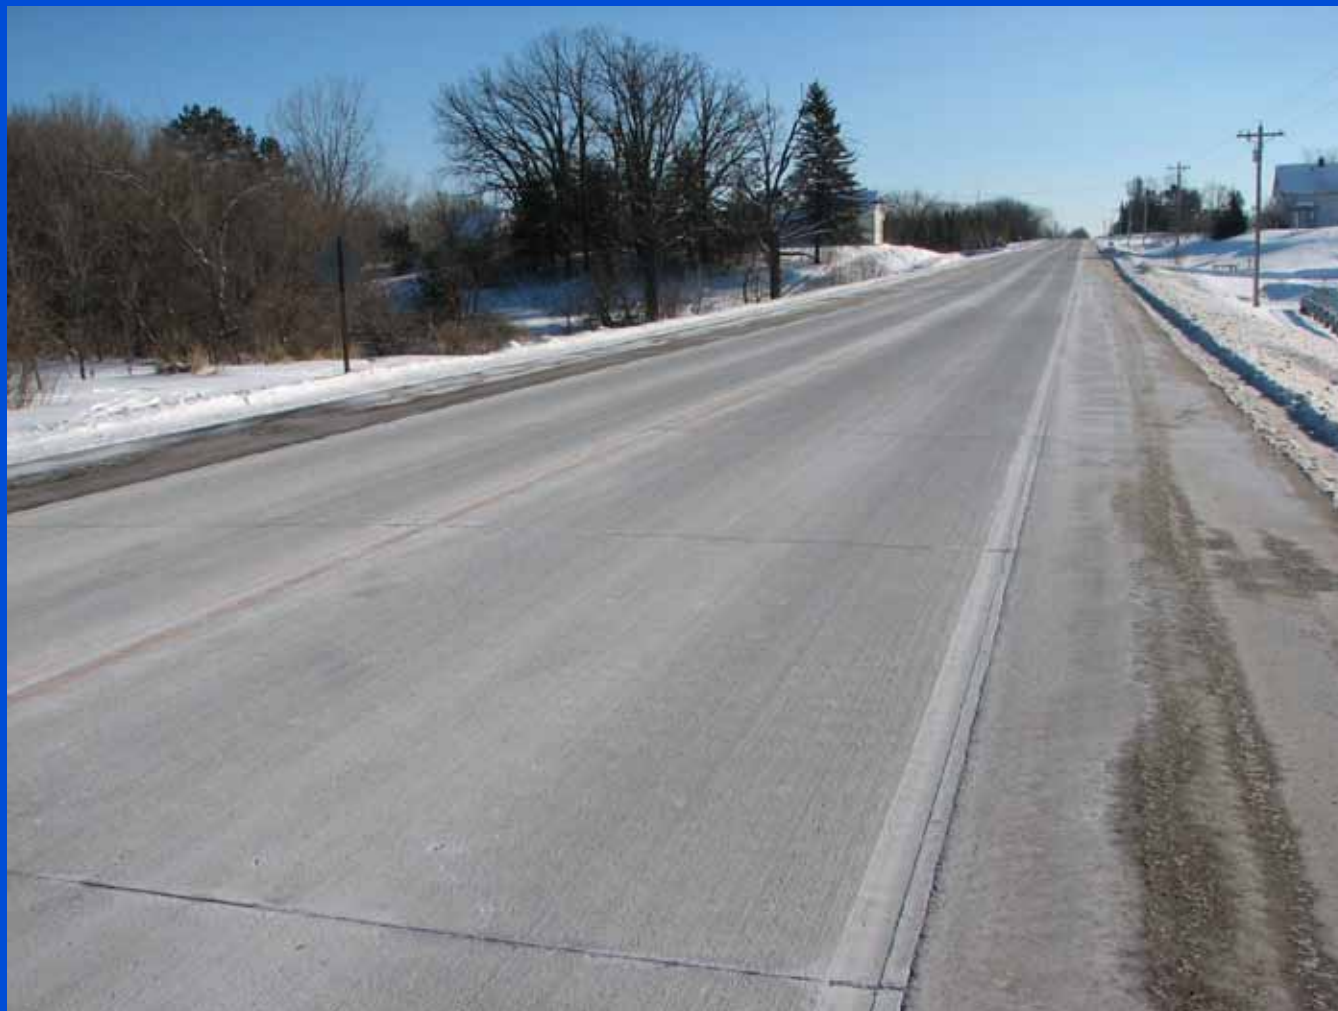
CSAH 9 Harris, Whitetopping

- Early Performance = Very good
 - No visible cracks

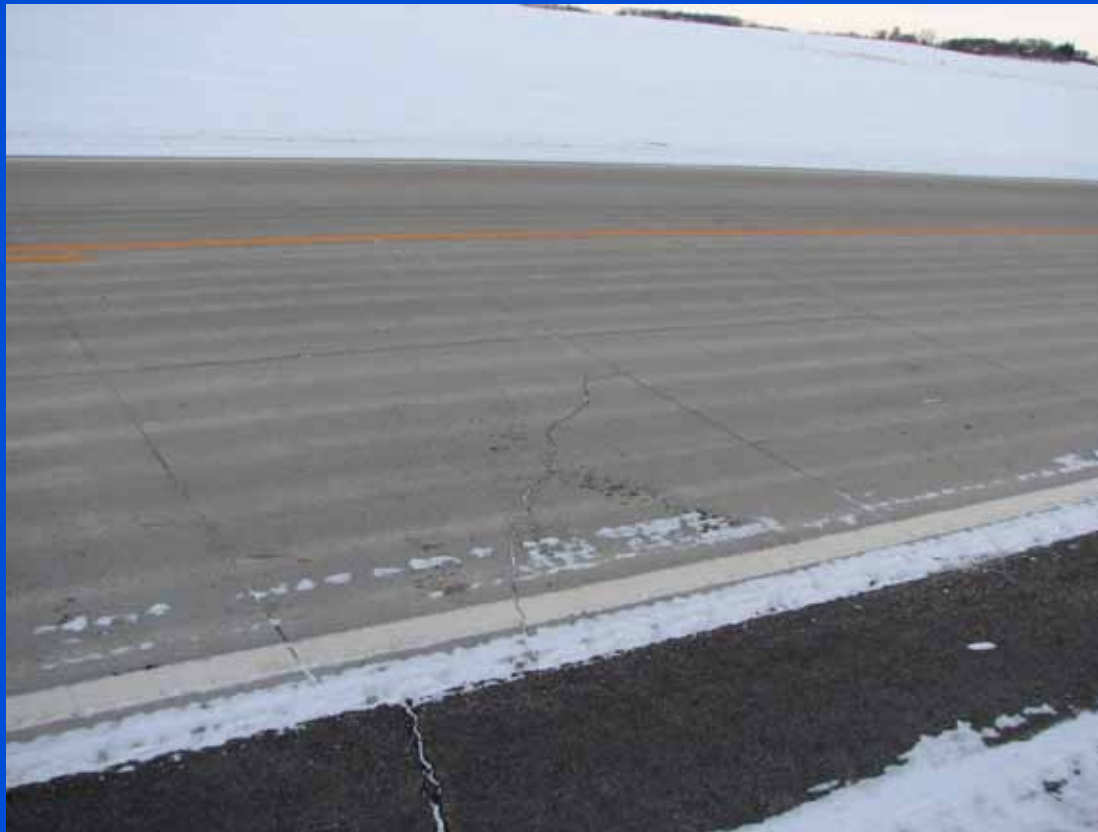
- Early Performance: Good
 - One reflective crack near driveway

No reflective cracking into inlay

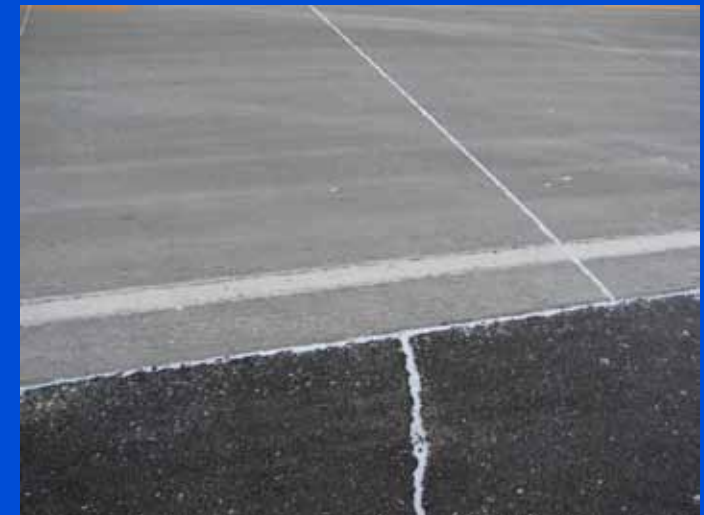
Reflective cracking into PCC from HMA driveway entrance?

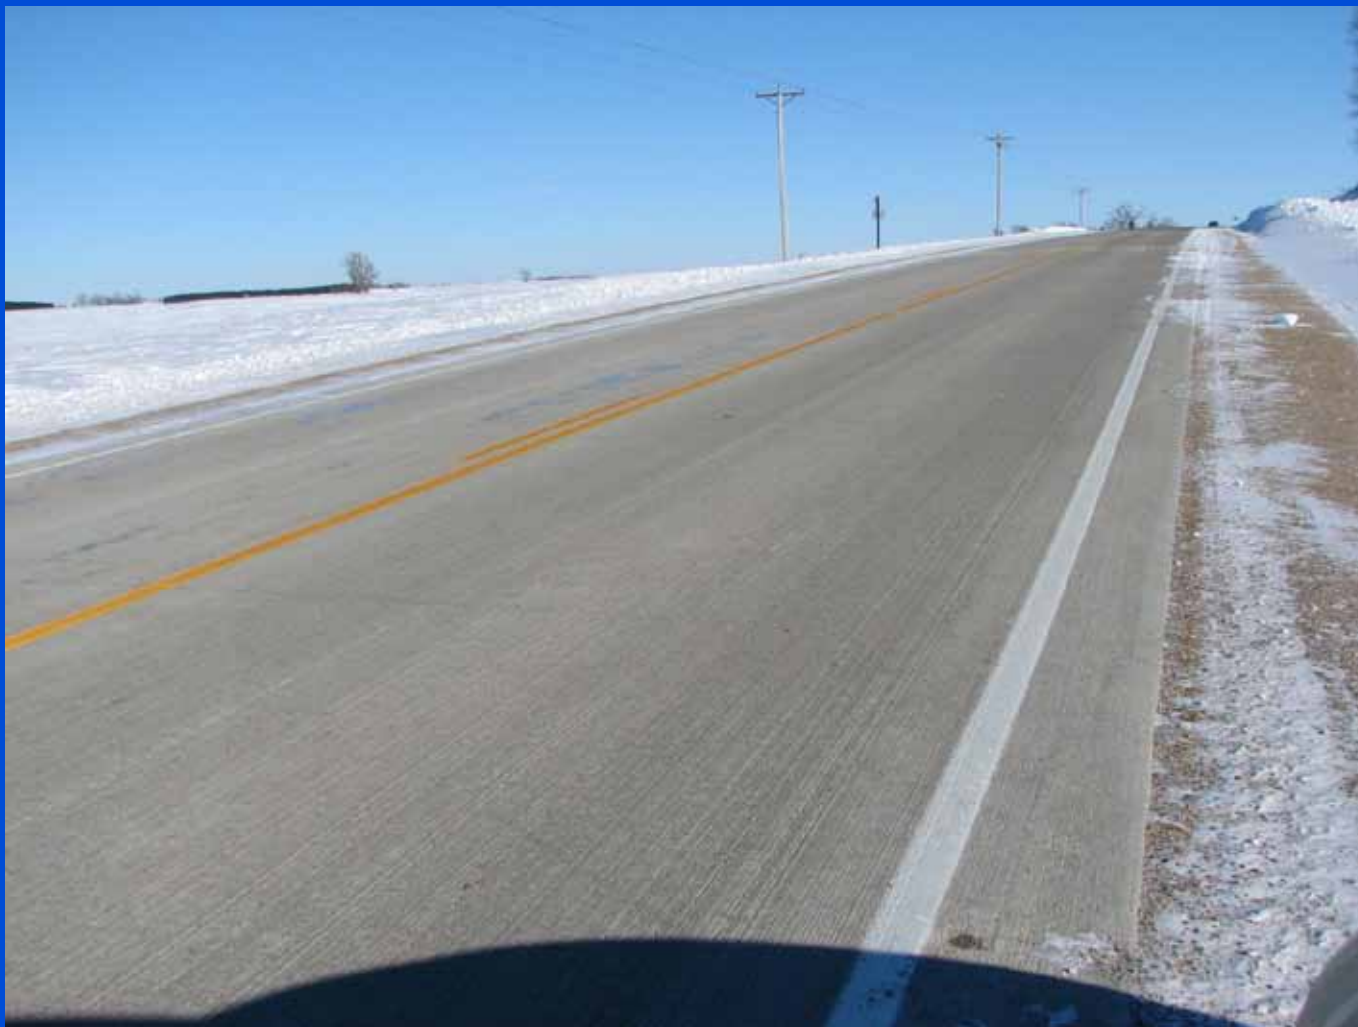
CSAH 46 Albert Lea, Thin Whitetopping

- Early Performance: Very Good
 - No visible distresses

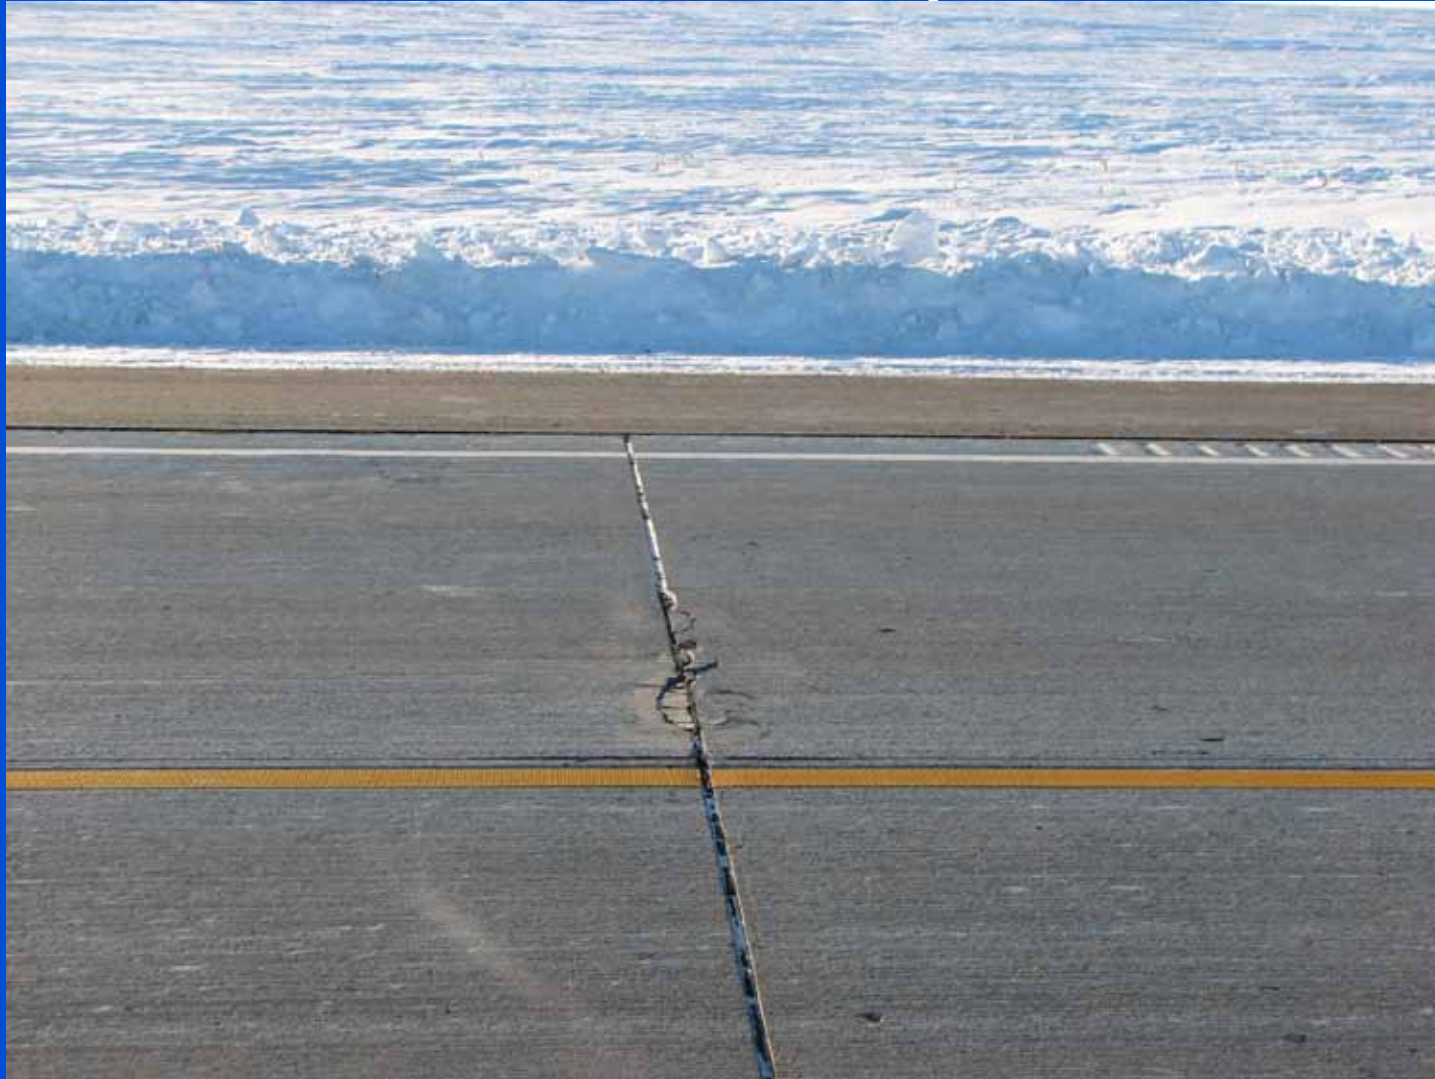
TH 56 West Concord, Thin Whitetopping

- Early Performance: Very Good
 - Some construction issues at joints
