1. Report No. MN/RC 2017-XX	2.	3. Recipients Accession No.	
4. Title and Subtitle Effective Long Lasting Partial Depth Joint Repairs for Challenging Conditions – Installation Summary		5. Report Date May 2018

Report for Effective Long-Lasting PCC Partial Depth Joint Repairs for Challenging Conditions

Installation through 1st Year Performance

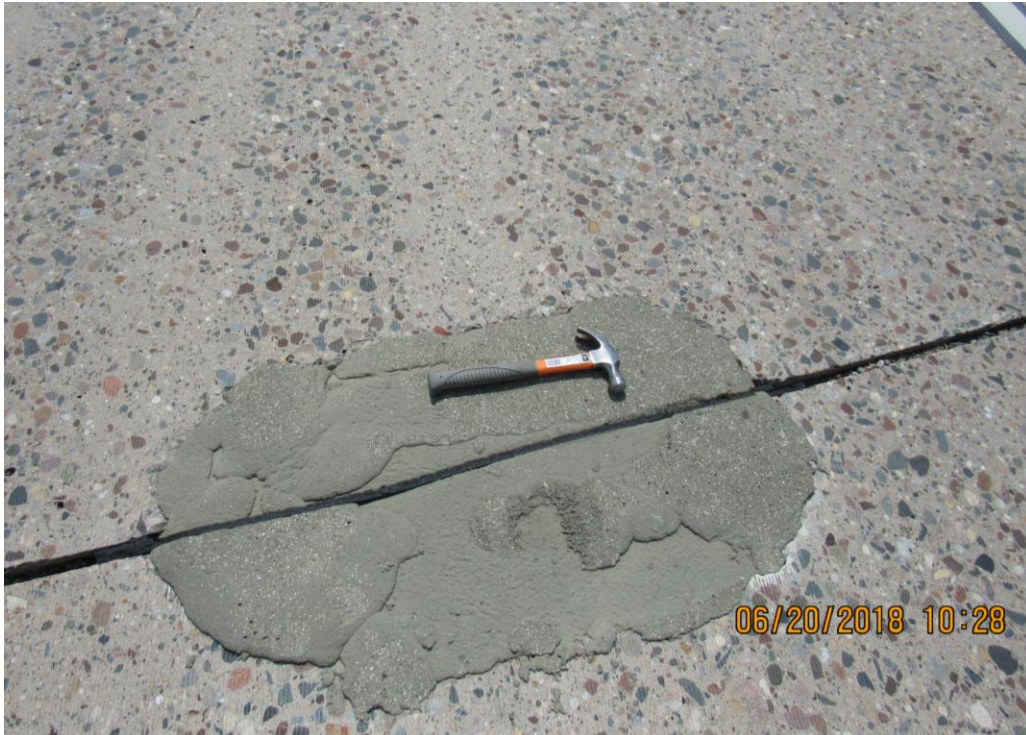
The driving lane WP and ML patches had about 50 percent of the patch material missing during the first-year review and were repaired with the Crafc HP Concrete Cold Patch material. These patches were given a rating of 1. The other patches were in generally good condition, with some shrinkage cracks present. However, it was clear to see that the material had set before finishing could be completed. Figure 5.12 shows the general condition of the patches in Cell 94006 (A), which were given a rating of 4.

Figure 5.12 Cell 94006 (A) – General patch condition (Rating – 4)

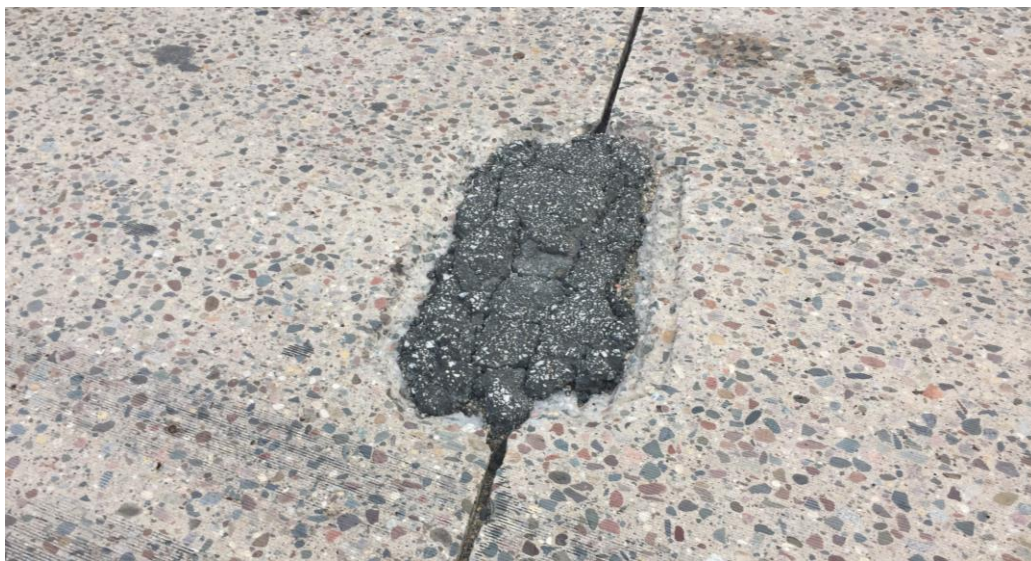
The driving and passing lane MLJ along with the driving lane CP have failed and have been repaired. These patches were rated as 0. The majority of the patches are exhibiting significant cracks and missing material along the edges and were rated as 2. Aqua Patch is a material designed for patching HMA pavements. It is not recommended for patching jointed areas or where pavement is designed to move.

Figure 5.18 Cell 94008 (A) – General condition, cracks and missing material (Rating – 2)

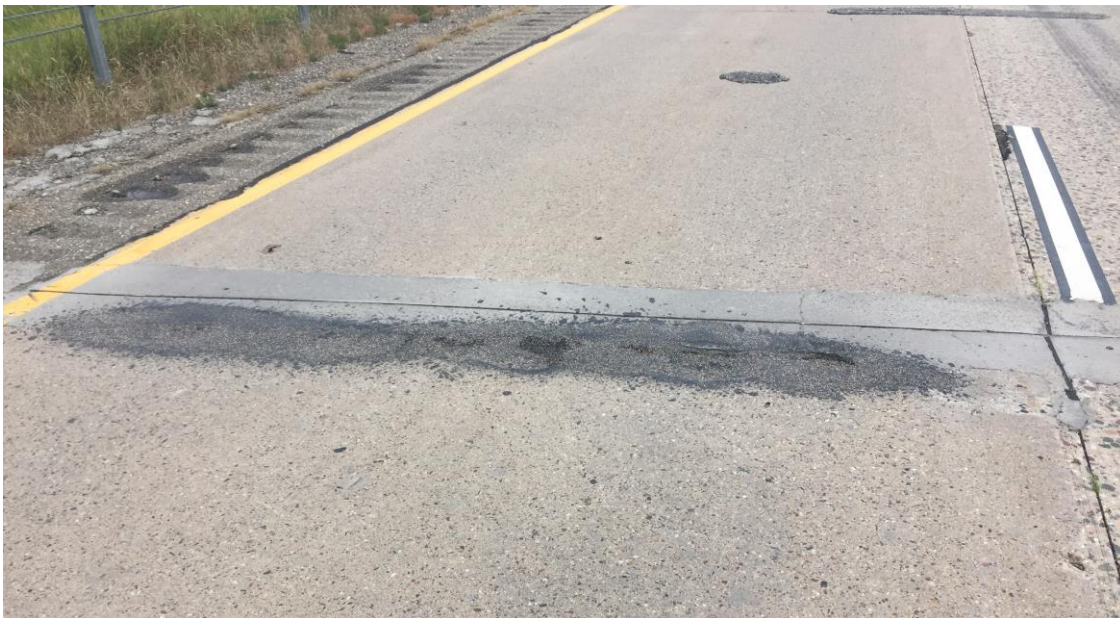
The passing lane FL patch lost material. Less than 50 percent of the original material was lost, so the patch was rated as 2. The driving lane FL was in generally good condition and given a rating of 4.

Figure 5.20 Cell 94008 (B) – General condition, cracks and missing material (Rating – 2)

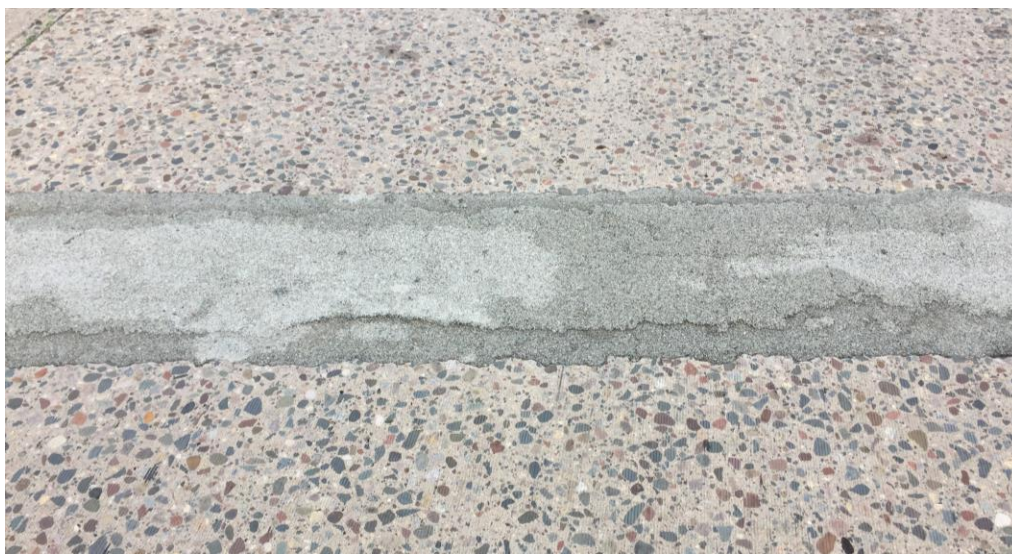
During the first-year review, the patches were exhibiting no signs of distress, although most of the patches had settled to some degree. An additional layer was added to the driving lane FL patch due to settling. All of the patches in Cell 94009 were rated as 4.

Figure 5.22 Cell 94009 – General patch condition (Rating – 4)

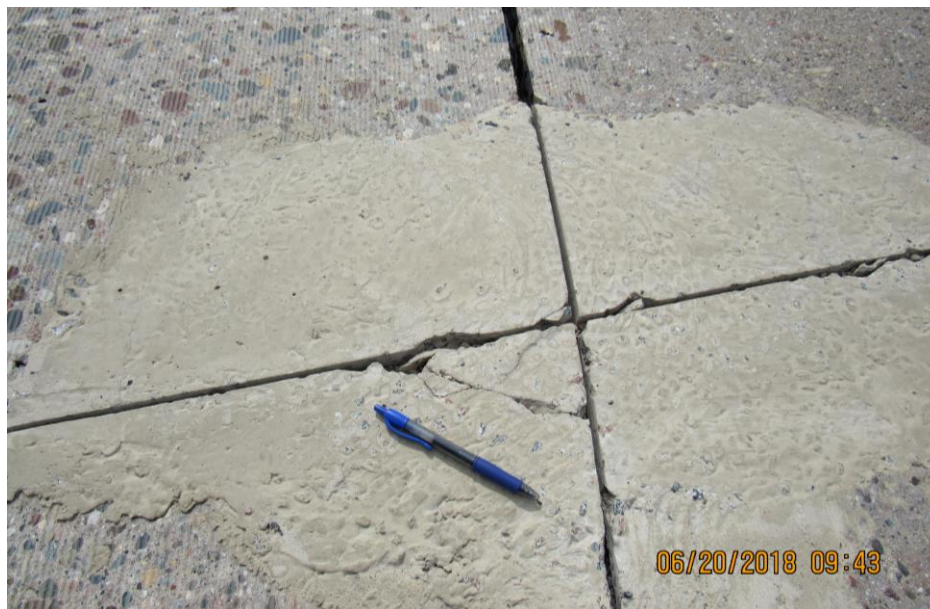
Most of the patches were showing no signs of distress and were rated as 4. However, the CLJ patch developed a corner break and additional cracking and was rated 3.

Figure 5.28 Cell 94012 – CLJ patch, corner break and cracking (Rating – 3)

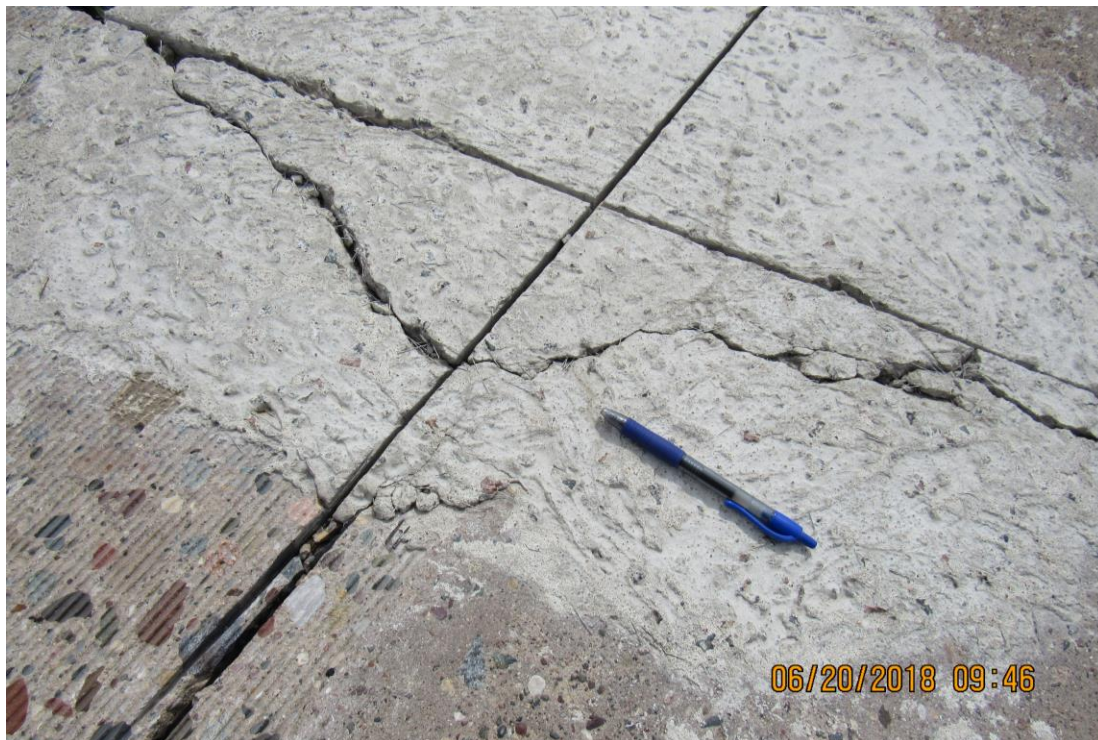
The patch conditions were generally similar to Cell 94013 (A) as well, with some patches having shrinkage cracks. Most of the patches were rated 4. The CLJ patch developed a crack near the edge of the original distress and was rated as 3.

Figure 5.32 Cell 94013 (B) – CLJ patch, cracking near edge (Rating – 3)

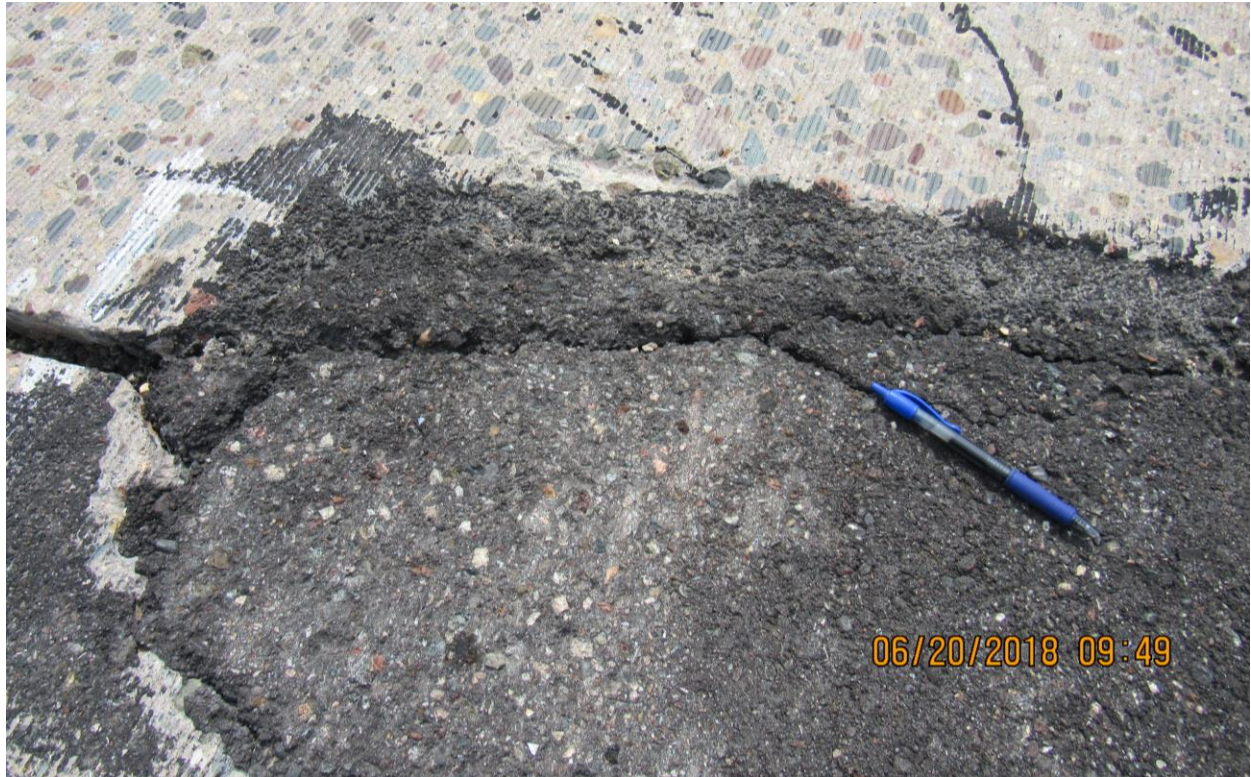
During the first-year review, the HMA patches had developed minor cracks along the edges of the patches and were in generally good condition. Figure 5.35 shows the general condition of the HMA patches in cells 94014 and 94015.

Figure 5.35 Cell 94015 – General Patch Condition for Cells 94014 and 94015

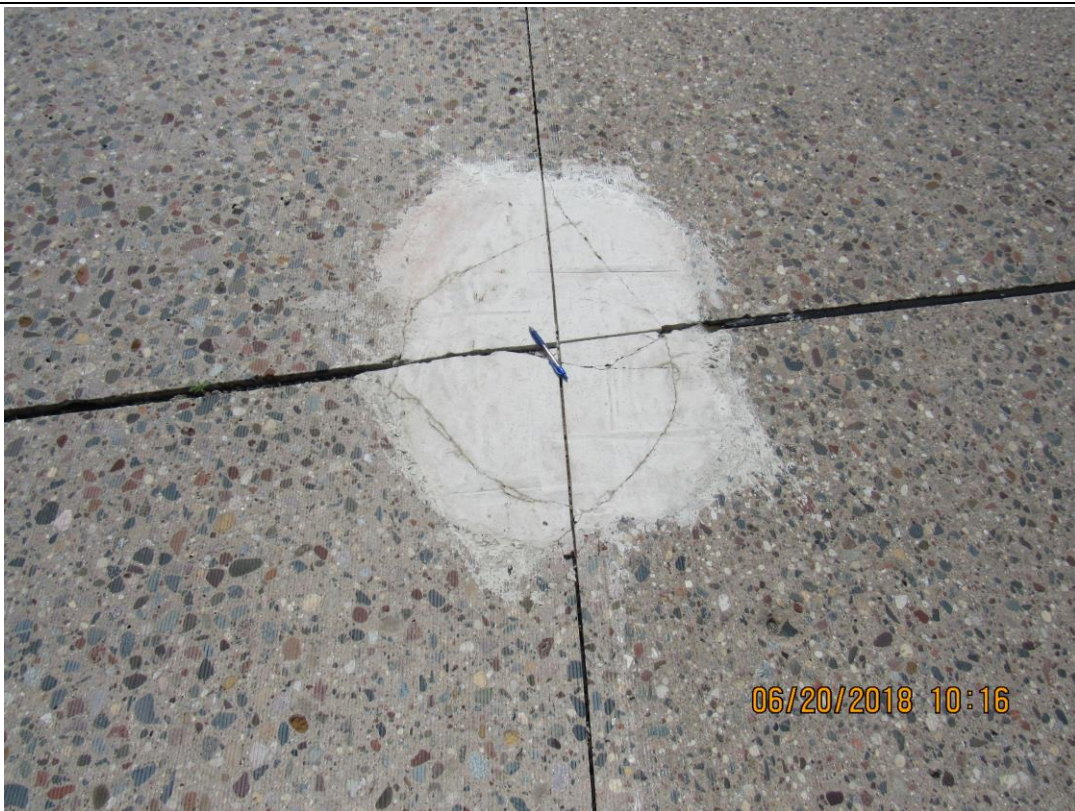
Cell/Patch: 94001/CLJ
 Date: 6/20/2018
 Condition: Linear Cracks
 Rating: 3

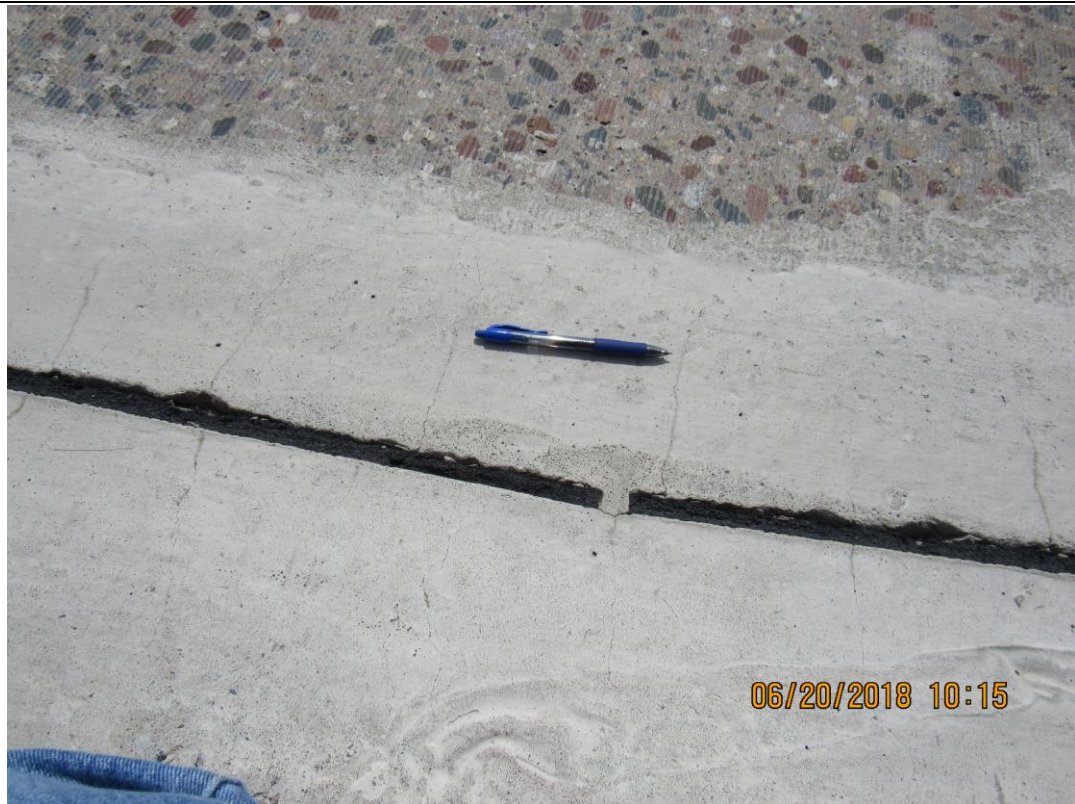
Cell/Patch: 94001/FL
 Date: 6/20/2018
 Condition: Shrinkage Cracks
 Rating: 4

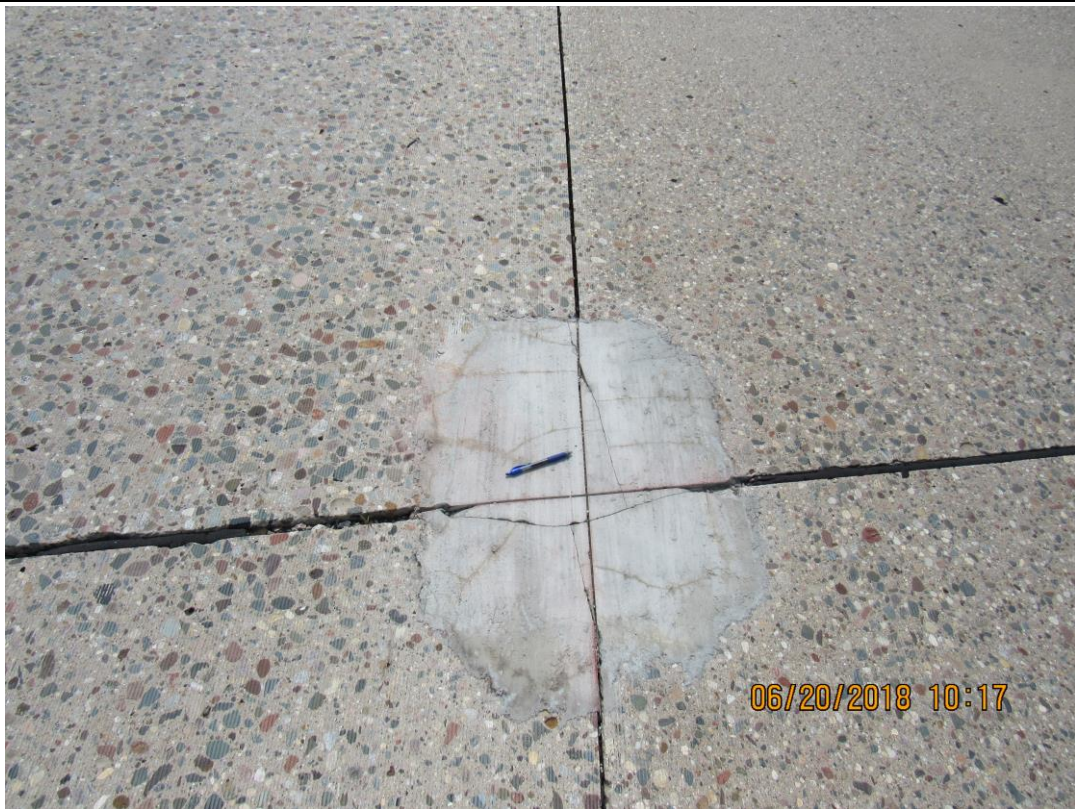
Cell/Patch:	94002 (A)/CLJ	Material: SpecChem, RepCon 928
Date:	6/20/2018	
Condition:	Linear Cracks	
Rating:	3

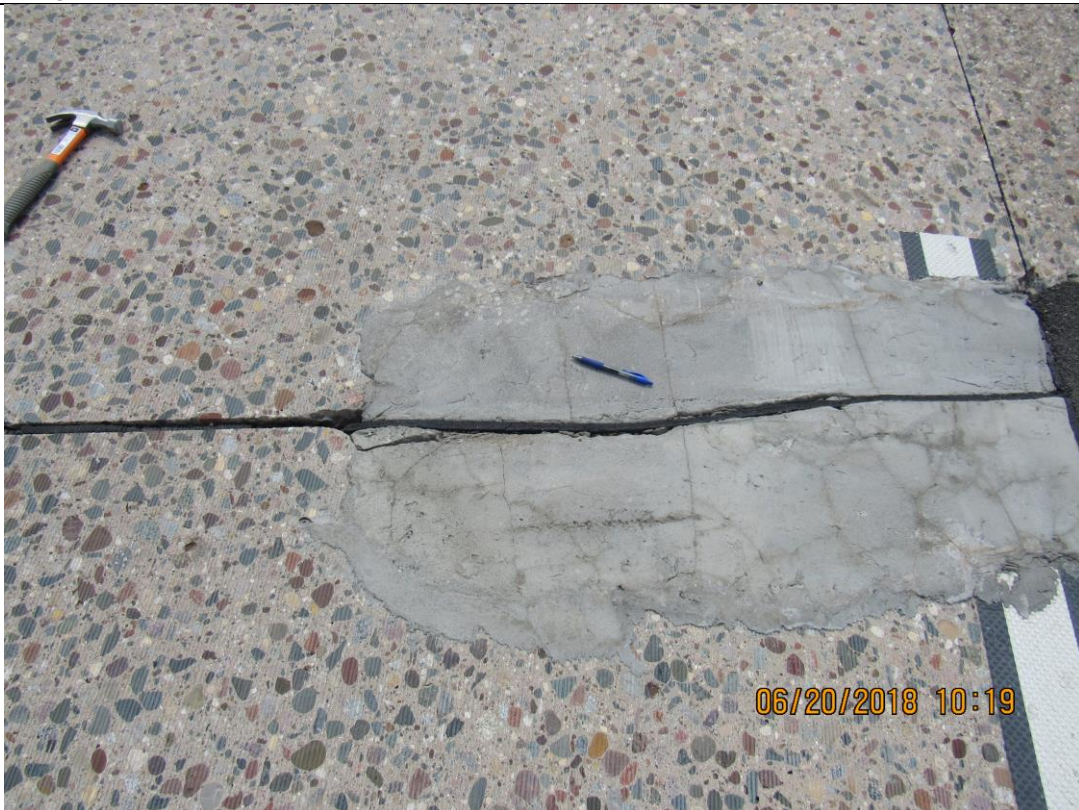
Cell/Patch:	94002 (A)/WP – driving lane	Material: SpecChem, RepCon 928
Date:	6/20/2018	
Condition:	Linear Cracks	
Rating:	3

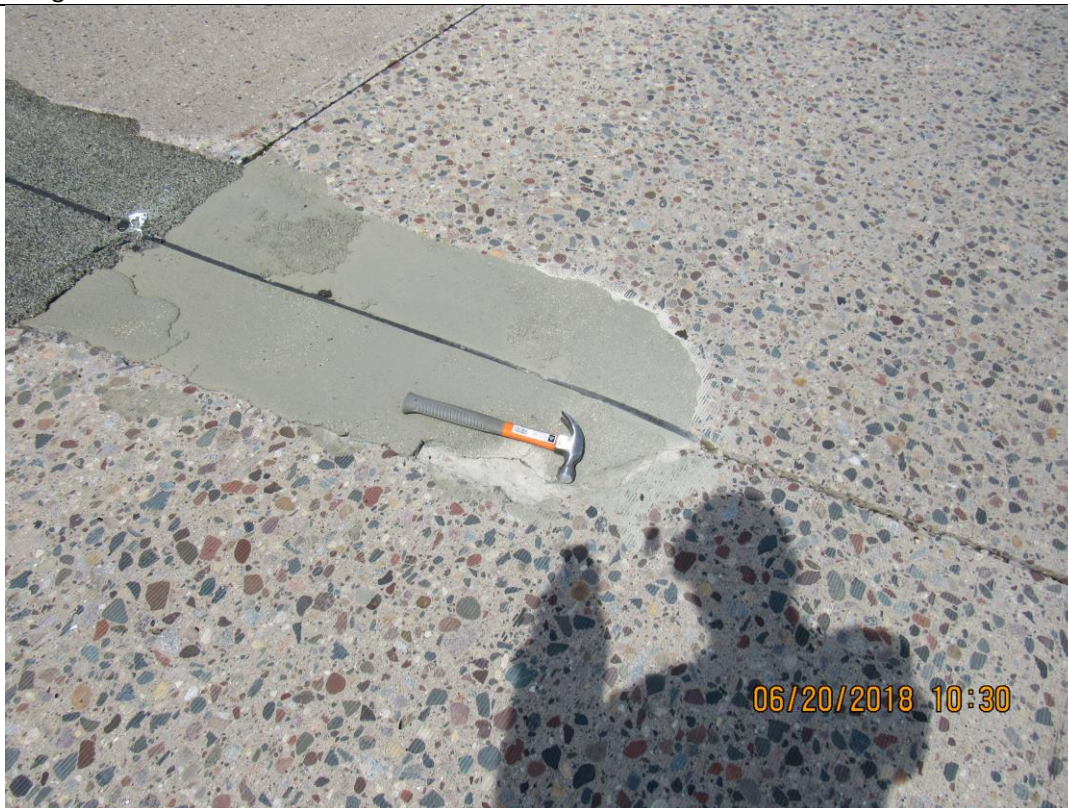
Cell/Patch:	94006 (A)/WP – driving lane	Material: Rapid Surface Repair Easy Mix
Date:	6/20/2018	
Condition:	Missing material along edge, less than 50%	
Rating:	2

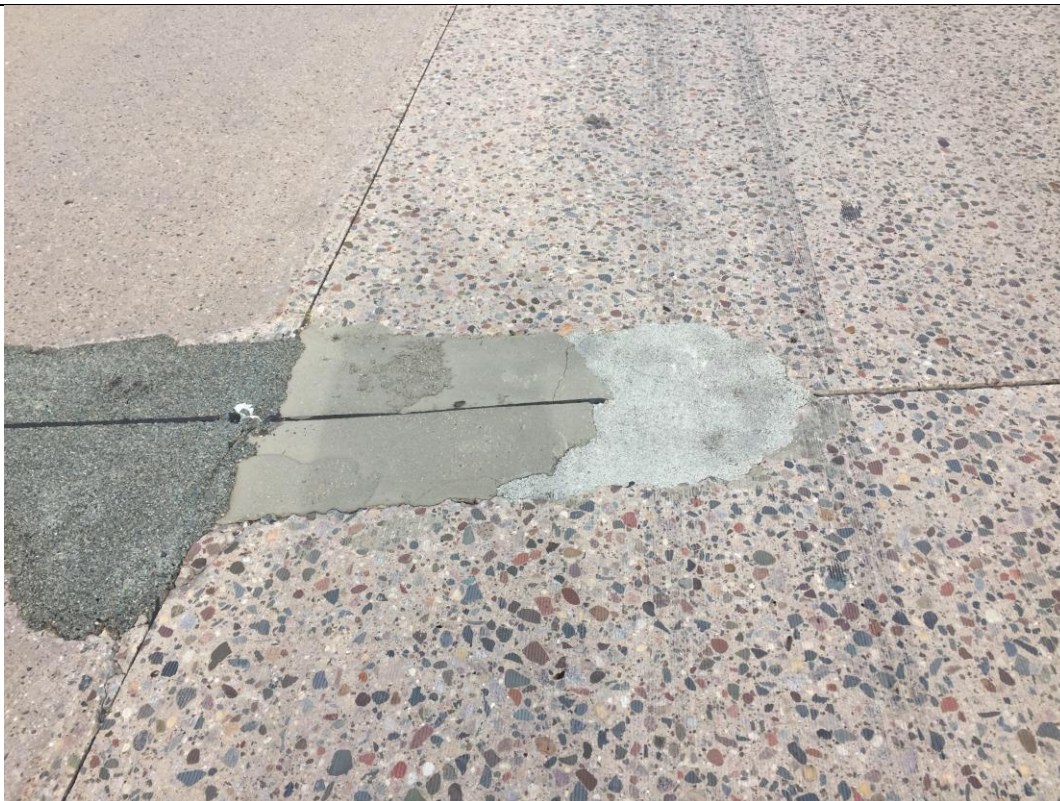
Cell/Patch:	94006 (A)/ WP – driving lane	Material: Rapid Surface Repair Easy Mix
Date:	9/15/2018	
Condition:	About 50% of patch was repaired.	
Rating:	1

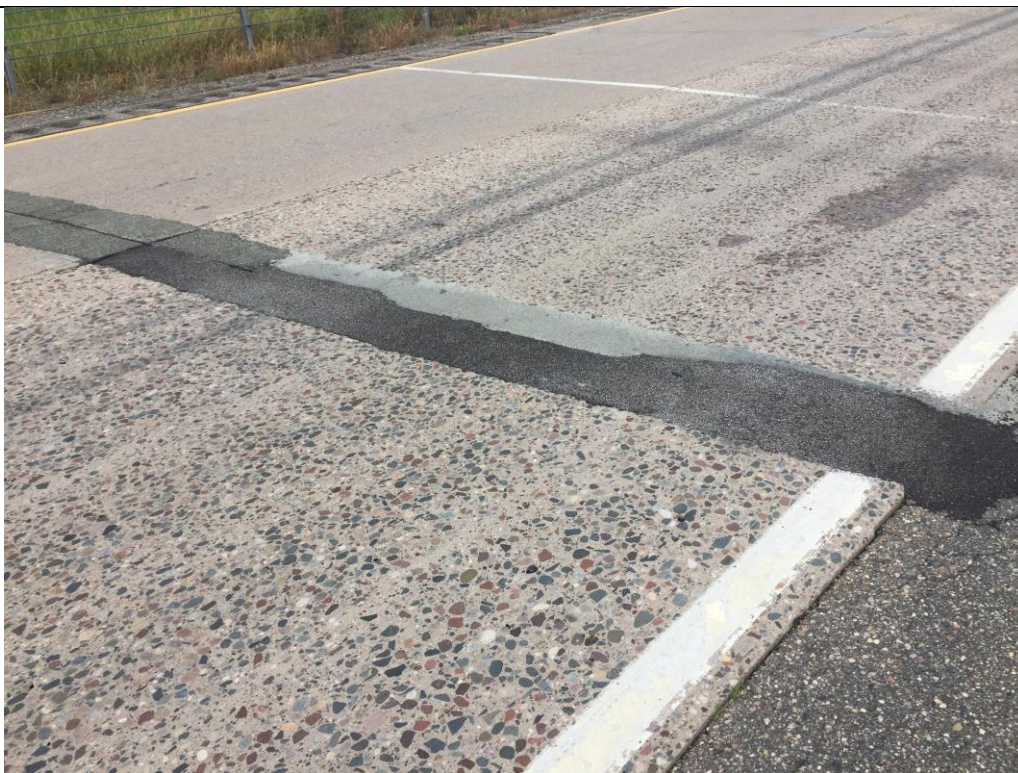
Cell/Patch:	94006 (B)/FL – driving lane	Material: Rapid Surface Repair Epoxy Fix
Date:	9/15/2018	
Condition:	Most of patch has been repaired.	
Rating:	1

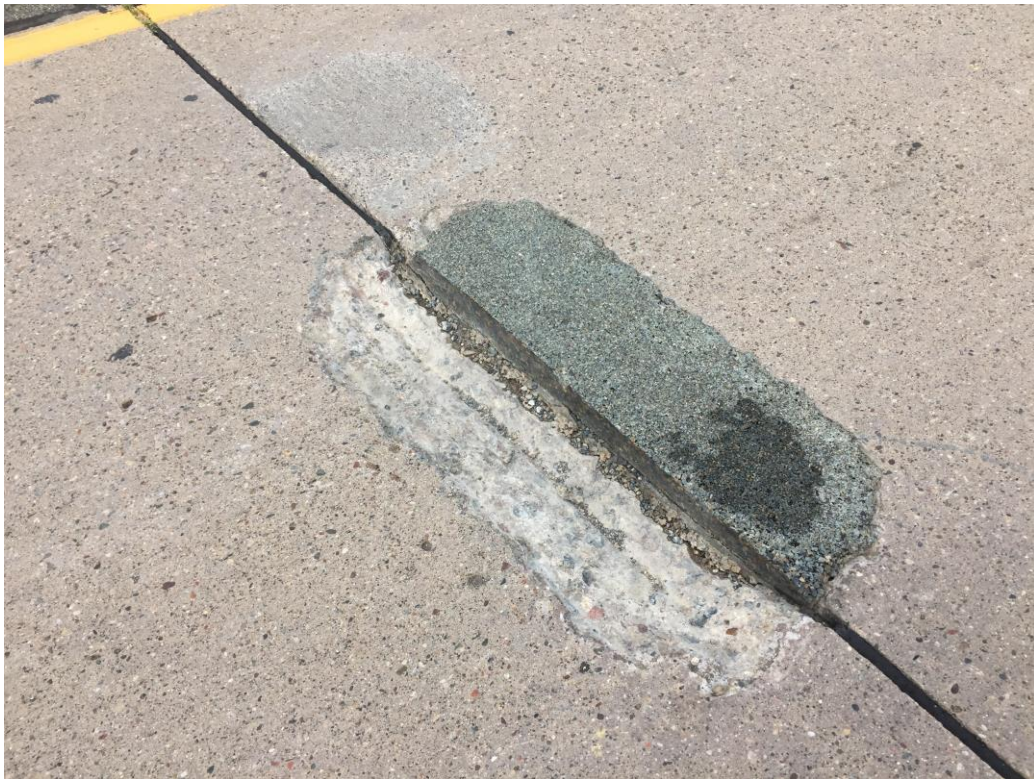
Cell/Patch:	94006 (B)/MLJ – passing lane	Material: Rapid Surface Repair Epoxy Fix
Date:	9/15/2018	
Condition:	50% of the patch is gone, needs repair	
Rating:	1

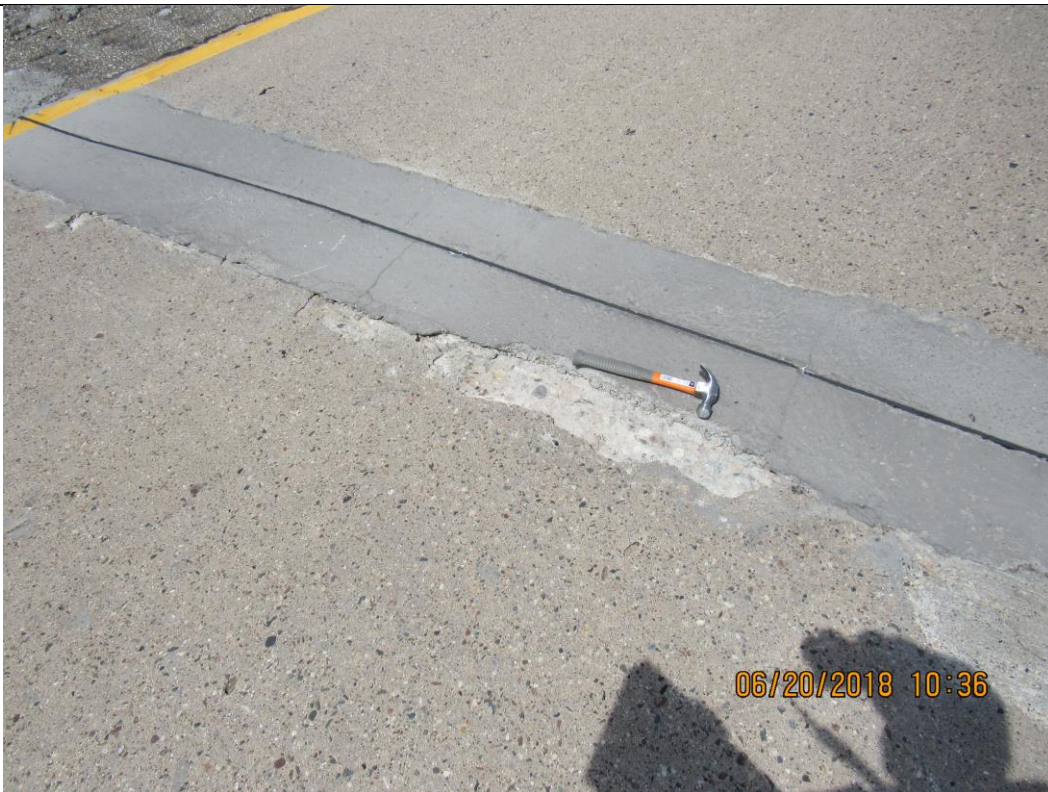
Cell/Patch:	94007/FL – passing lane	Material: TCC Materials, ProSpec
Date:	6/20/2018	Concrete Patching Mix
Condition:	Less than 50% of material missing, needs repair	
Rating:	2

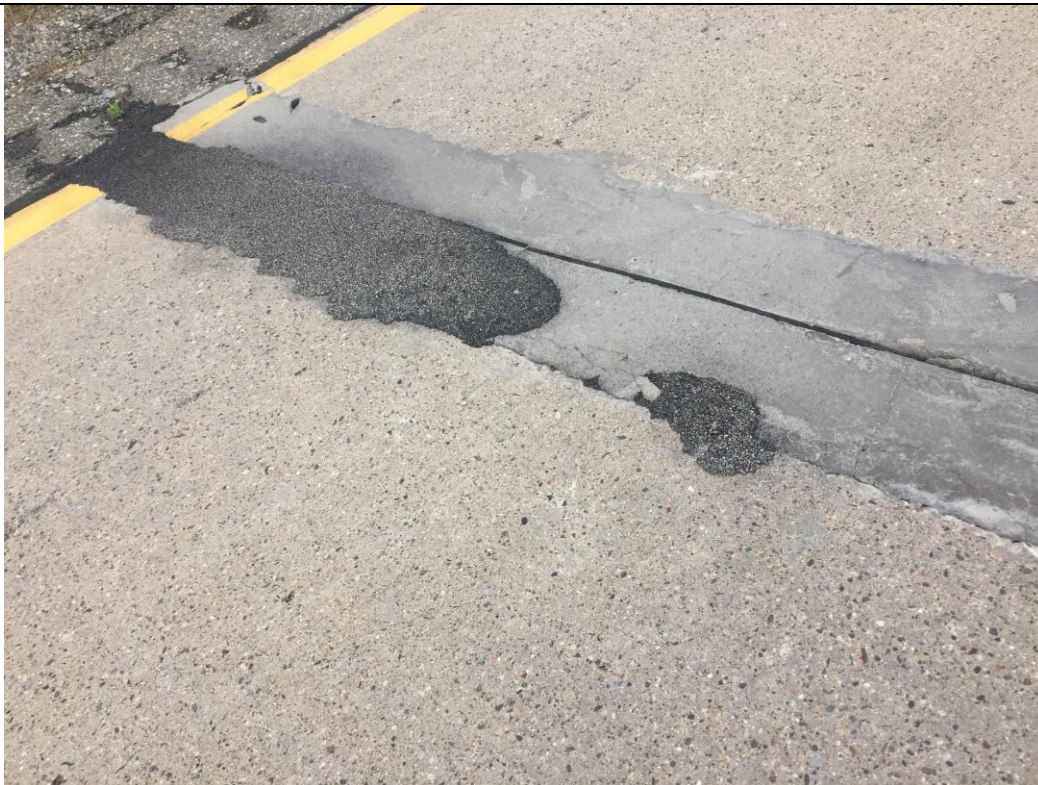
Cell/Patch:	94007/FL – passing lane	Material: TCC Materials, ProSpec
Date:	9/15/2018	Concrete Patching Mix
Condition:	Less than 50% of patch repaired	
Rating:	2

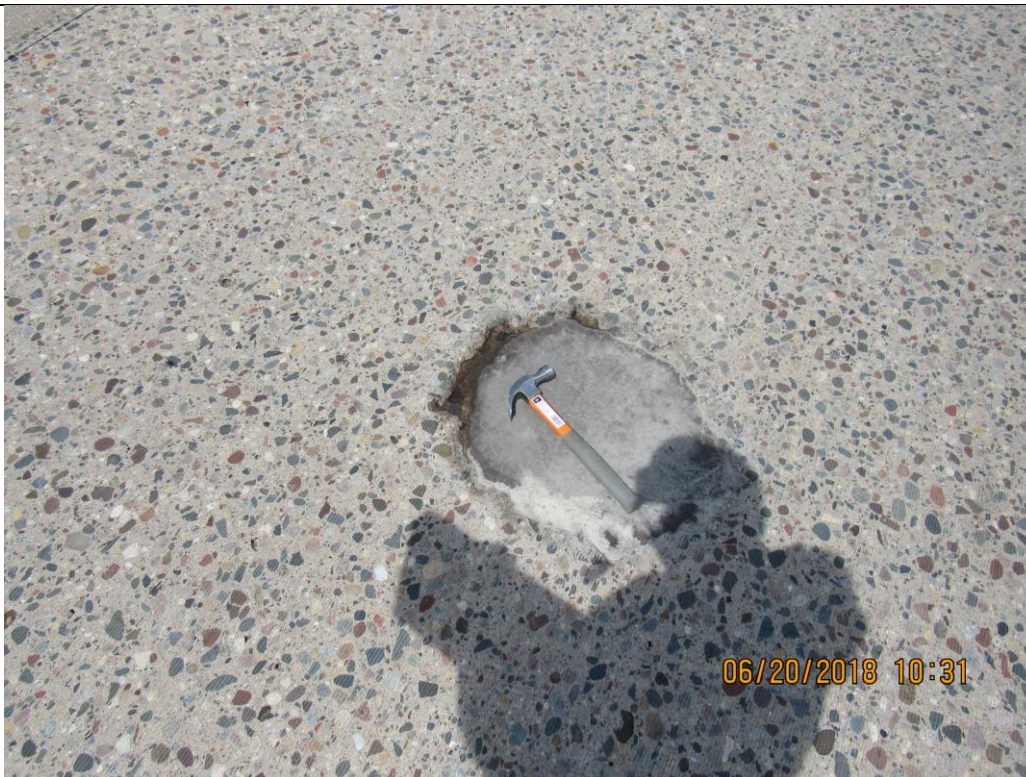
Cell/Patch:	94007/ML	Material: TCC Materials, ProSpec
Date:	6/20/2019	Concrete Patching Mix
Condition:	Less than 50% of material missing, needs repair	
Rating:	2

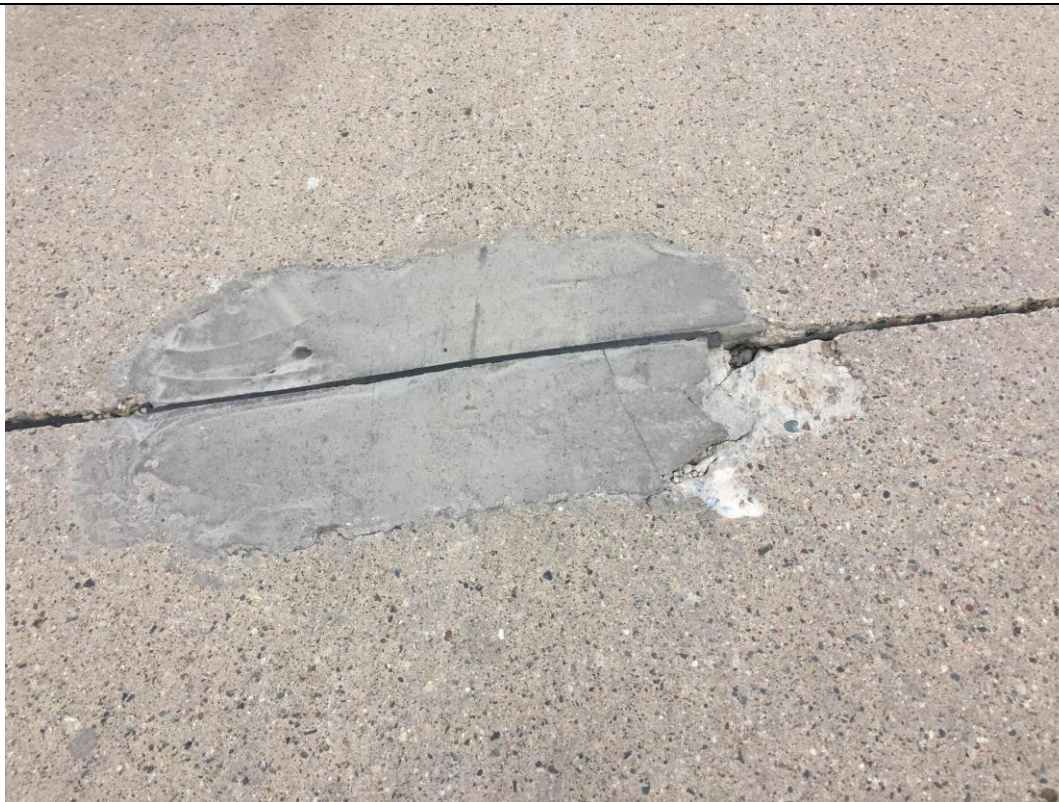
Cell/Patch:	94007/MLJ	Material: TCC Materials, ProSpec
Date:	9/15/2018	Concrete Patching Mix
Condition:	Less than 50% of material missing, needs repair	
Rating:	2

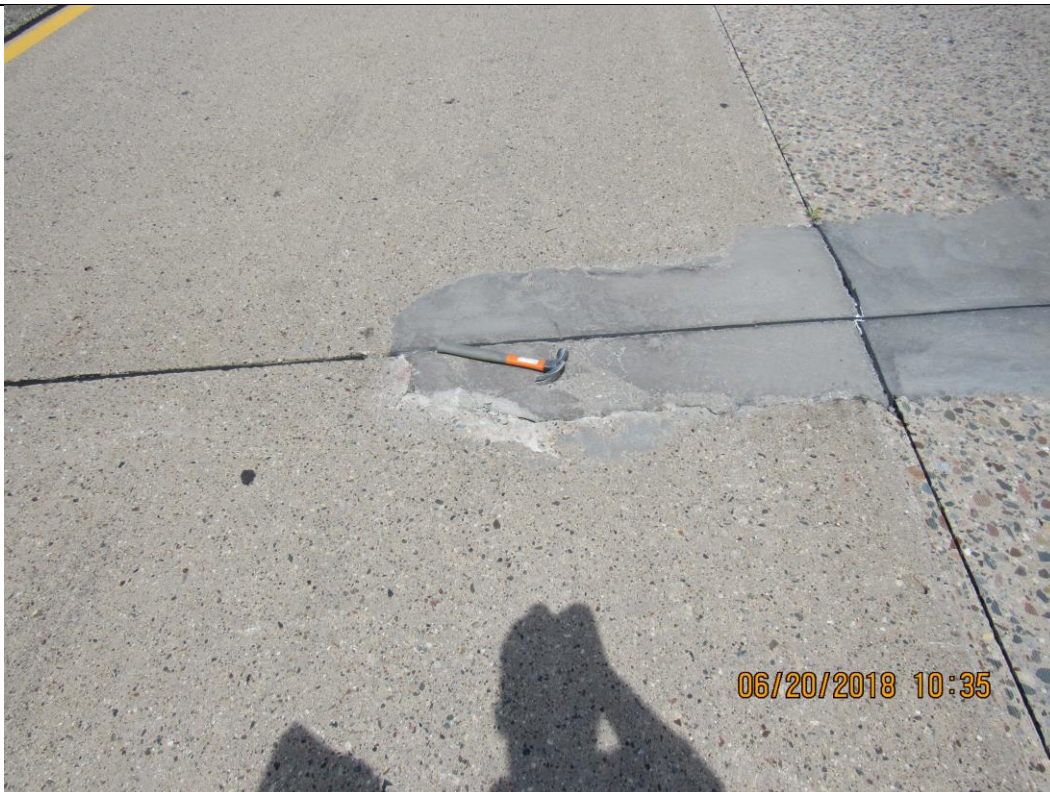
Cell/Patch:	94007/WP	Material: TCC Materials, ProSpec
Date:	6/20/2018	Concrete Patching Mix
Condition:	Less than 50% of material missing, needs repair	
Rating:	2

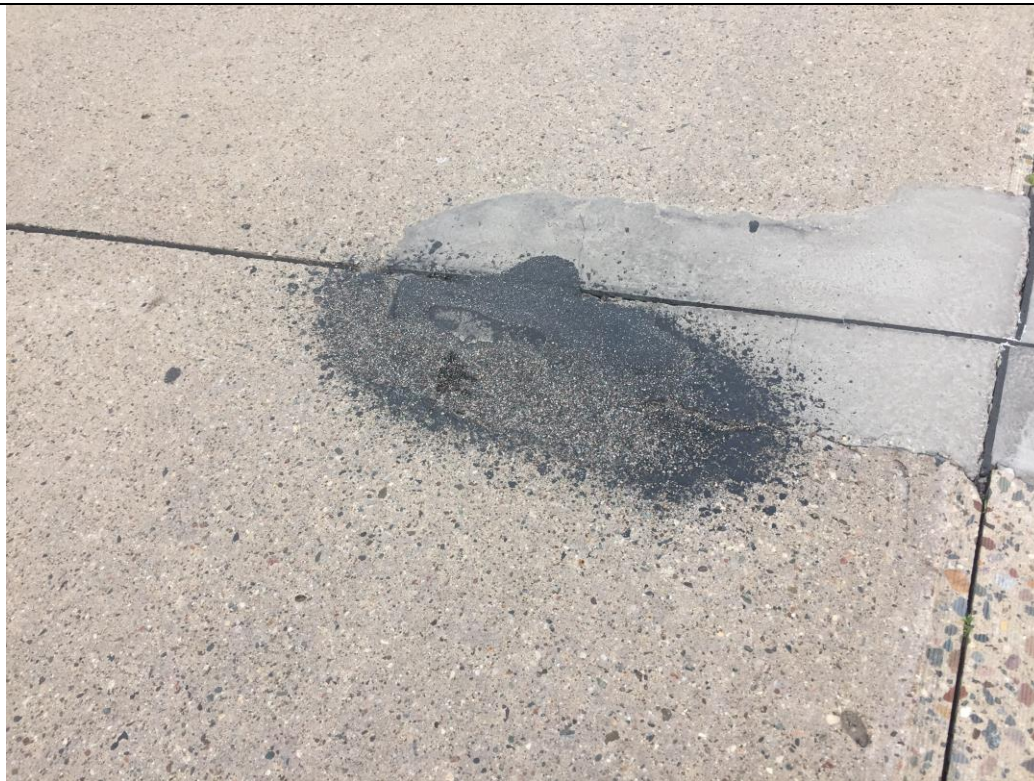
Cell/Patch:	94007/WP	Material: TCC Materials, ProSpec
Date:	9/15/2018	Concrete Patching Mix
Condition:	Less than 50% of patch repaired	
Rating:	2

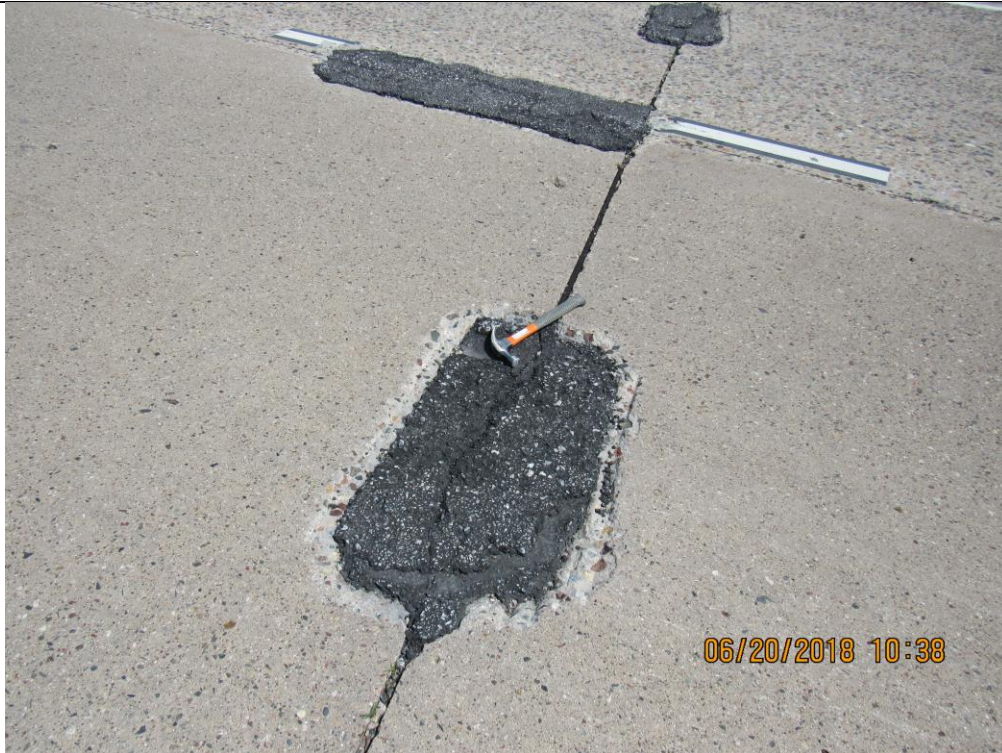
Cell/Patch:	94008 (A)/MLJ – passing lane, CL, and MLJ – driving lane	Material: Aqua Patch Road Materials,
Date:	6/20/2018	Aqua Patch
Condition:	Linear cracks along joints, some edge material missing (less than 50%)	
Rating:	2

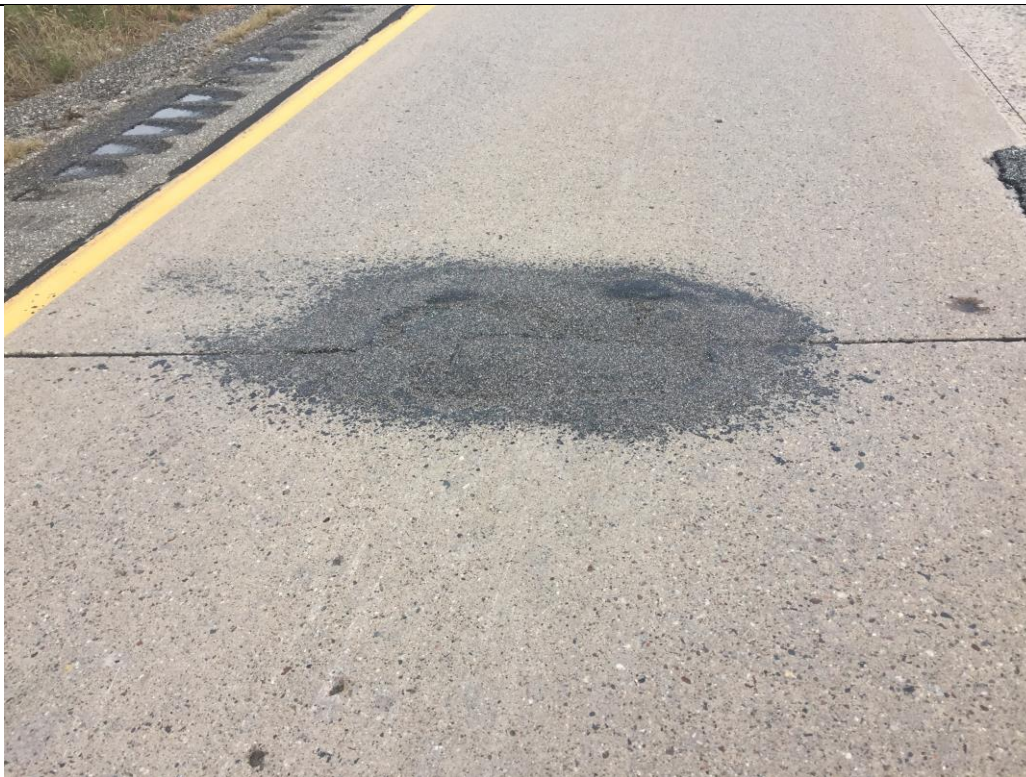
Cell/Patch:	94008 (A)/MLJ – passing lane	Material: Aqua Patch Road Materials,
Date:	9/15/2018	Aqua Patch
Condition:	100% of patch repaired, patch failed	
Rating:	0

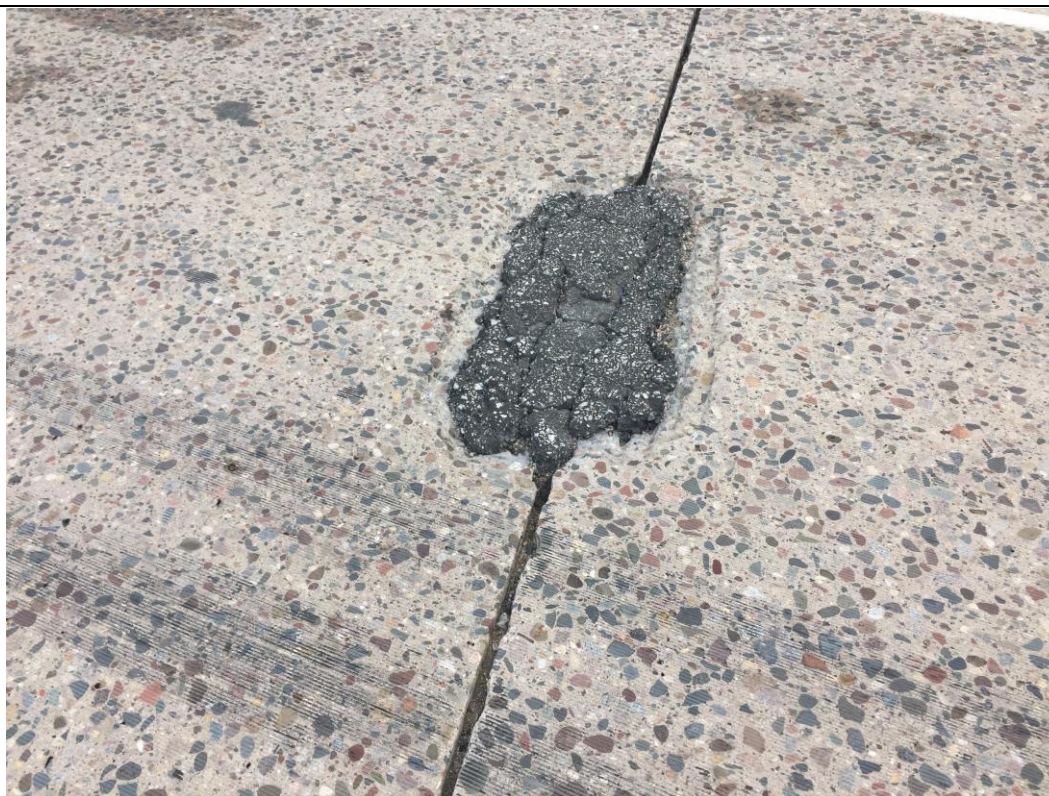
Cell/Patch:	94008 (A)/MLJ – driving lane	Material: Aqua Patch Road Materials,
Date:	9/15/2018	Aqua Patch
Condition:	Linear cracks and missing material (less than 50%)	
Rating:	2

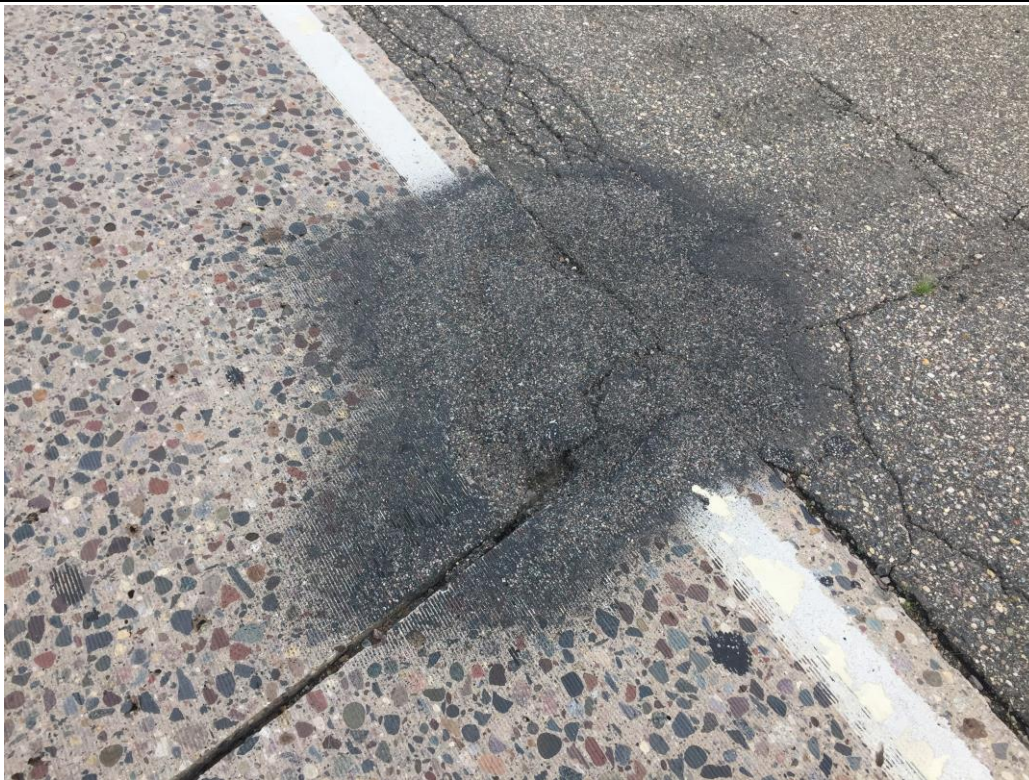
Cell/Patch:	94008 (A)/CP – driving lane	Material: Aqua Patch Road Materials,
Date:	9/15/2018	Aqua Patch
Condition:	100% of patch repaired, patch failed	
Rating:	0

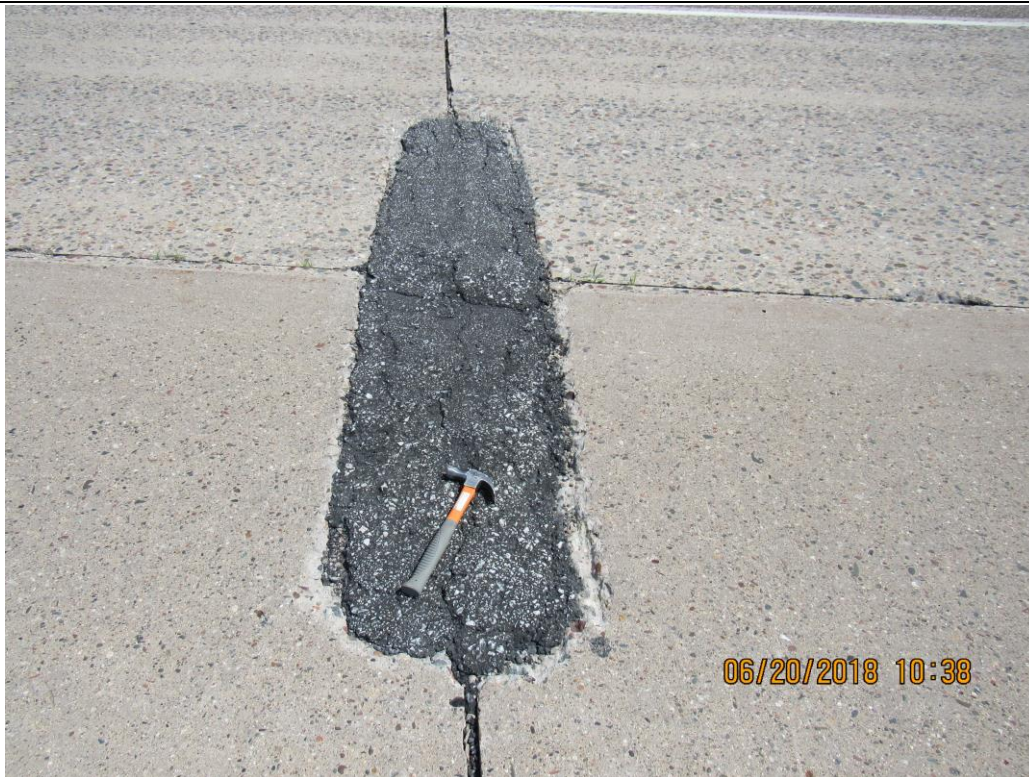
Cell/Patch:	94008 (A)/WP	Material: Aqua Patch Road Materials,
Date:	6/20/2018	Aqua Patch
Condition:	Linear cracks and missing material along edges (less than 50%)	
Rating:	2

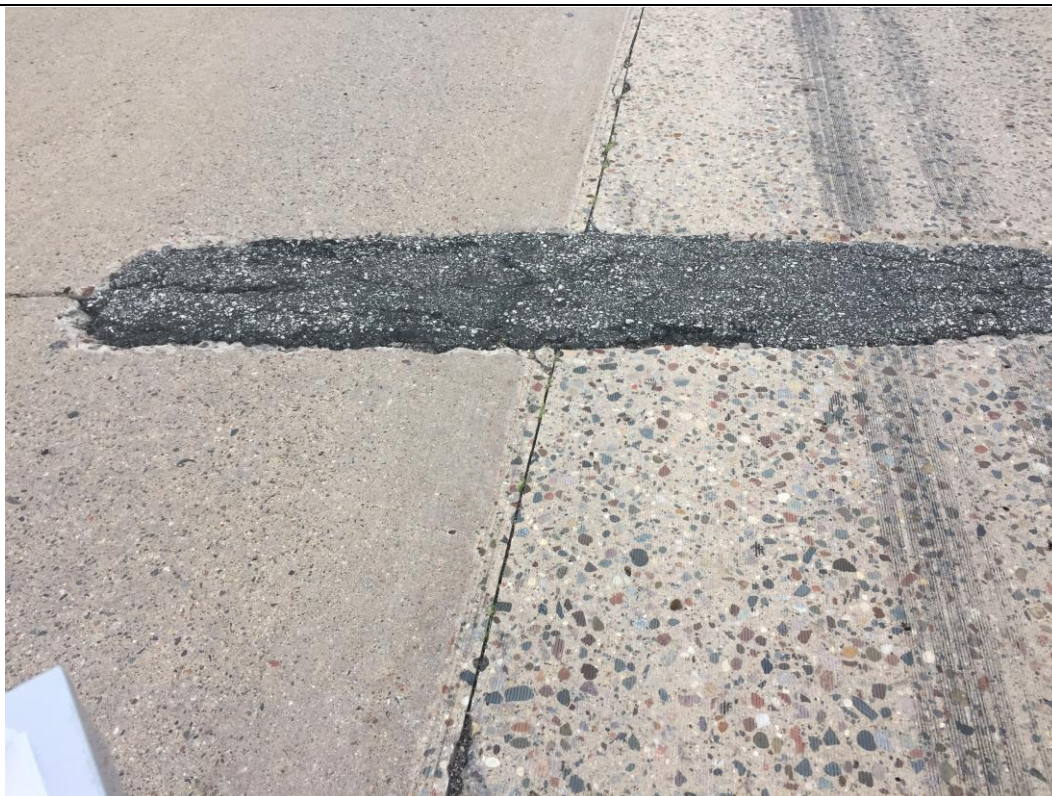
Cell/Patch:	94008 (A)/WP	Material: Aqua Patch Road Materials,
Date:	9/15/2018	Aqua Patch
Condition:	Linear cracks and missing material along edges (less than 50%)	
Rating:	2
