1. Report No. MN/RC 2017-XX	2.	3. Recipients Accession No.	
4. Title and Subtitle Effective Long Lasting Partial Depth Joint Repairs for Challenging Conditions – Installation Summary		5. Report Date May 2018

Report for Effective Long-Lasting PCC Partial Depth Joint Repairs for Challenging Conditions

Installation through 1st Year Performance

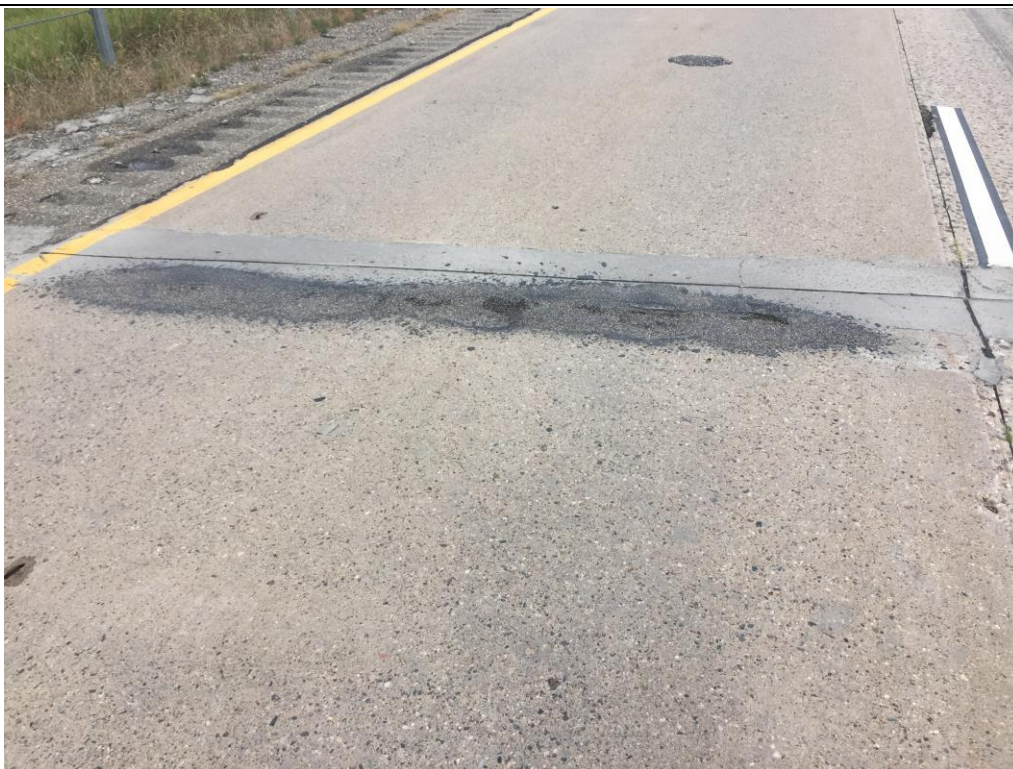
Cell/Patch:	94008 (B)/FL – passing lane	Material: TCC Materials, ProSpec
Date:	9/15/2018	Concrete Patching Mix
Condition:	Less than 50% of patch repaired	
Rating:	2

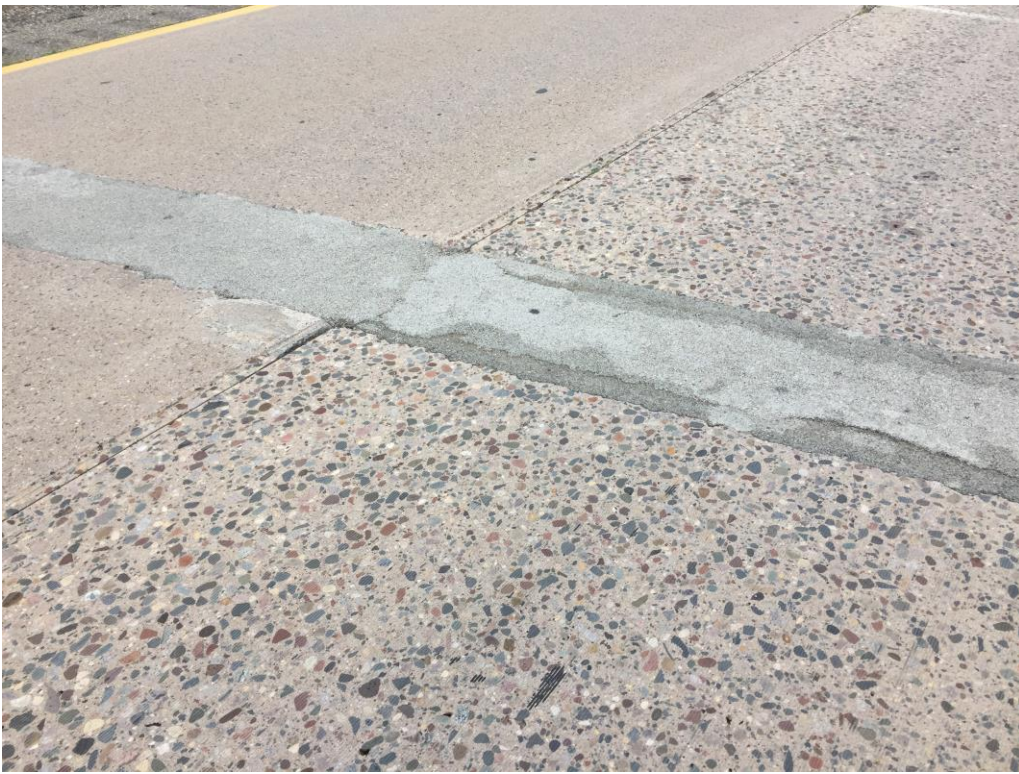
Cell/Patch:	94009/FL – both lanes	Material: Crafc0, HP Concrete Cold Patch
Date:	9/15/2018	
Condition:	No distress, layer of material added to driving lane FL due to depression	
Rating:	4

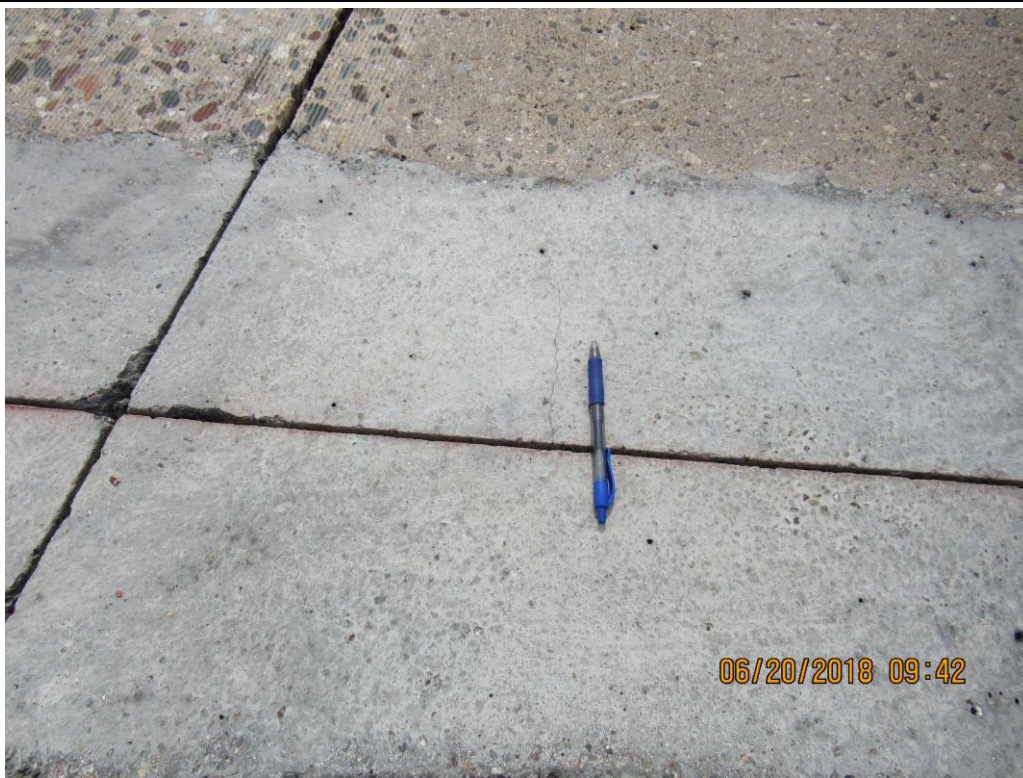
Cell/Patch:	94011/WP	Material: TCC Materials, 3U18 Modified
Date:	6/20/2018	
Condition:	No distress, shrinkage cracks developing	
Rating:	4

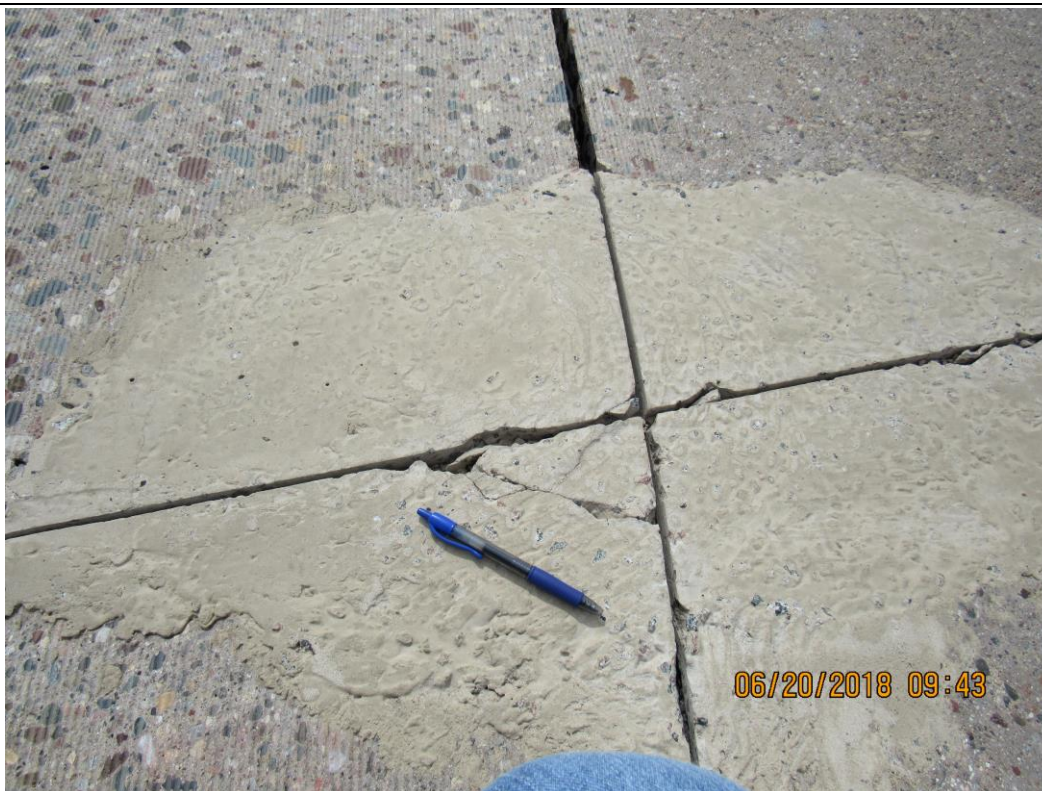
Cell/Patch:	94012/CLJ	Material: USG Ecofix
Date:	6/20/2018	
Condition:	Corner break and cracks	
Rating:	3

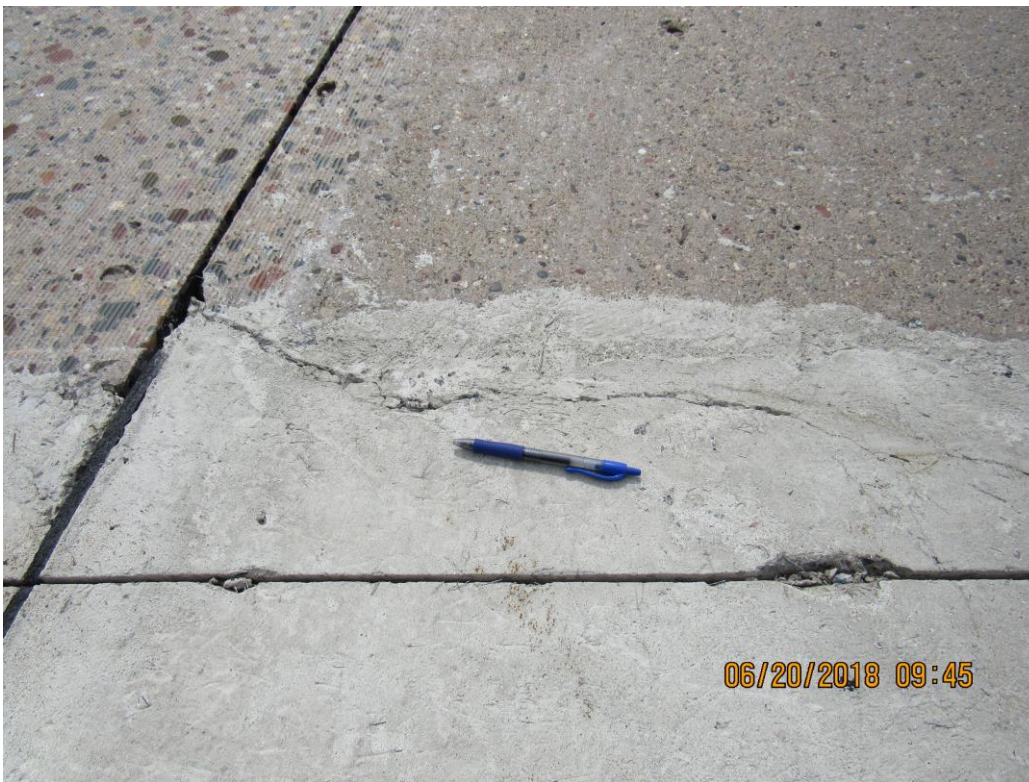
Cell/Patch:	94013 (A)/WP	Material: CTS, Rapid Set DOT Repair Mix
Date:	6/20/2018	and Helix 5-25-Standard BA (Zinc Coated)
Condition:	Crack along edge of patch	Fibers
Rating:	3

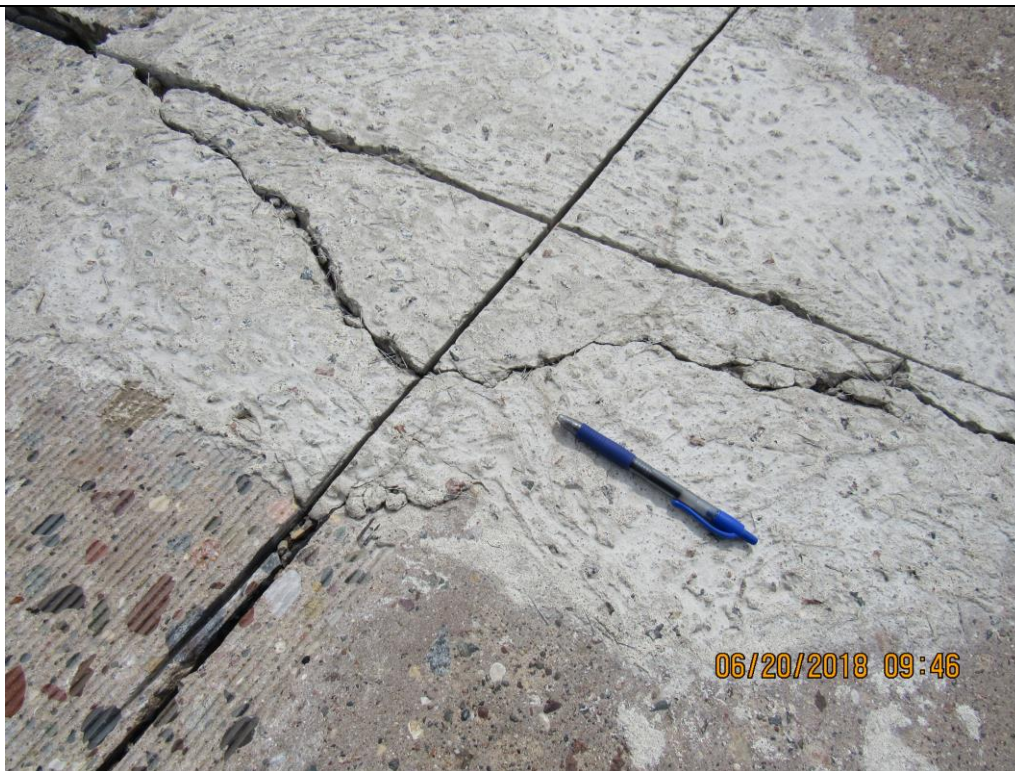
Cell/Patch:	94013 (B)/CLJ	Material: CTS, Rapid Set DOT Repair Mix
Date:	6/20/2018	and Helix 5-25-SS BA (Stainless Steel)
Condition:	Crack near edge of patch	Fibers
Rating:	3

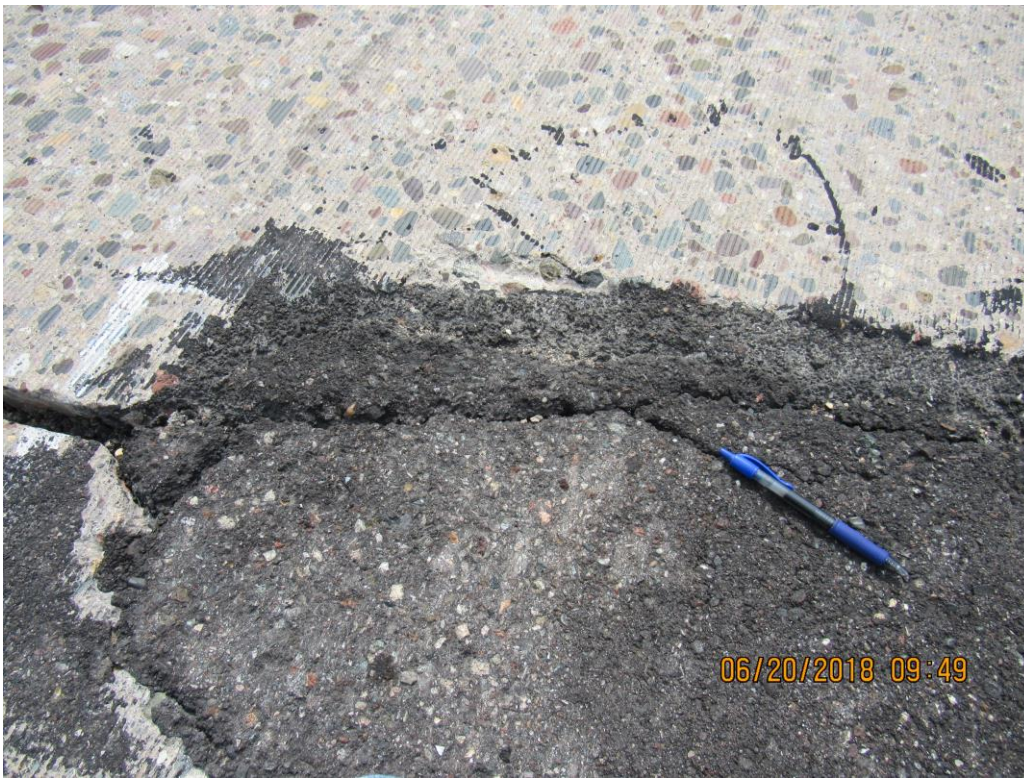
Cell/Patch: 94015/MLJ
Date: 6/20/2018
Condition: Linear cracks
Rating: NA/Not failed
