MnDOT Contract, No. 1003325, Work Order No. 56

NRRA Long-term Research Project

**Performance Benefits of Fiber-reinforced Thin Concrete
Pavement and Overlays**

**Task-2: Third Year Annual Cell Performance Report
(2019-2020)**

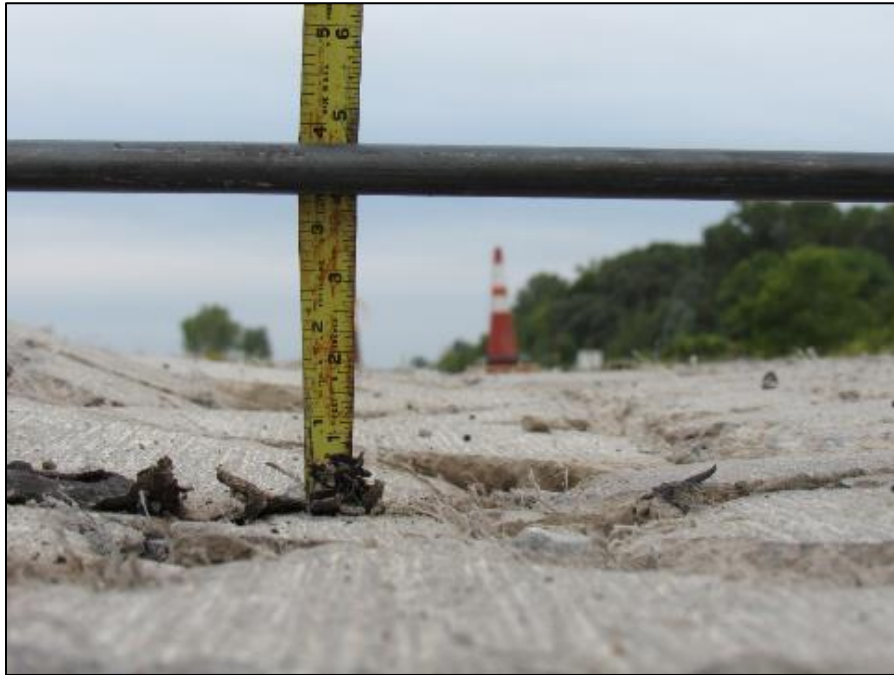
Figure 2-4. Depression along the wheel path in Cell 139 .

Because of the occurrence of the high severity of the distresses (slab shattering and depression along the wheel path), as many as 14 of the 44 slabs of the inside lane were replaced on September 27, 2018. Figure 2-5 shows a few photos collected during the removal of broken slabs and the construction of the replacement slabs. The replacement slabs were 4-inch thick, with eight of them containing fiber reinforced concrete and the other six with plain concrete. The fibers used in the replacement slabs were different and laterally stiffer than those used in 2017, as shown in [Figure 2-6](#)~~Figure 2-6a~~. The dosage of the fiber was 5.5 lb/cy, which corresponds to a 30% residual strength ratio. [Figure 2-6](#)~~Figure 2-6b~~ shows the ASTM C1609 test results for the two numbers of beam samples prepared at the site during the construction of replacement slabs in Cell 139. The replacement slabs have performed well; the distress survey conducted in the spring of 2020 showed only one crack in one of the fiber-reinforced replacement slabs. The location of this crack was at the transition joint of the new 4 inch thick replacement slabs and old 3 inch thick slabs. The reason behind this crack is more due to the repetitive impact of the wheel load than fatigue stresses.

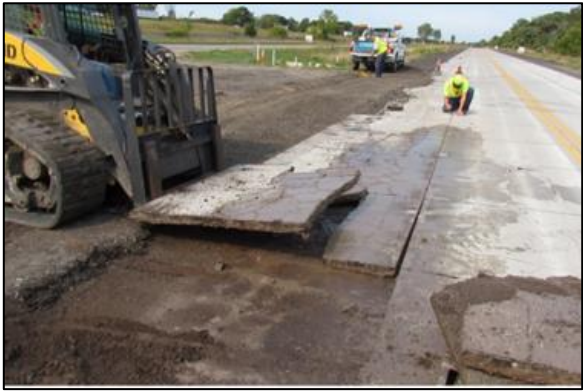
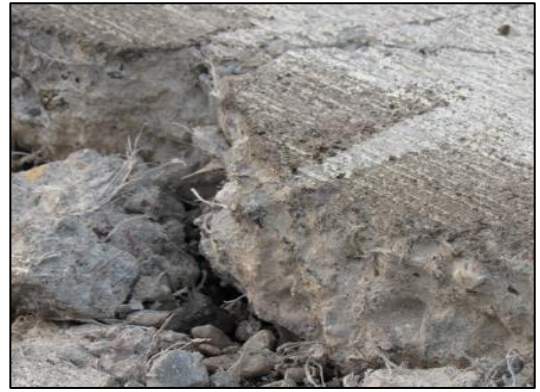
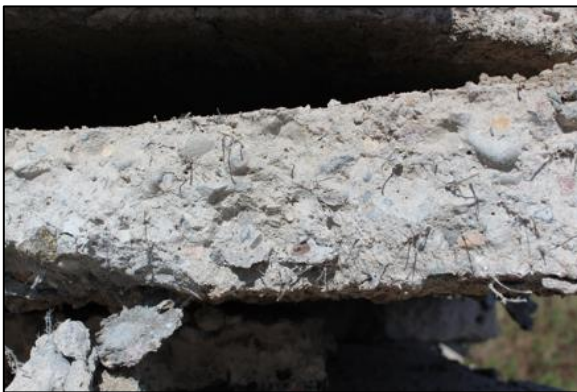
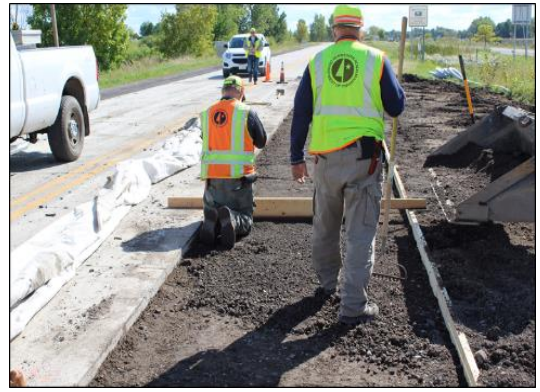
(2.5 a) Removal of broken slabs for Cell 139

(2.5b) Close shot of the broken concrete pieces

(2.5c) Fibers on the fractured face of a concrete piece.

(2.5d) Preparation of the base layer for reconstruction of the broken slabs.

Figure 2-5. Photographs of the replacement and reconstruction on Cell 139
(outer slabs, inside lane).

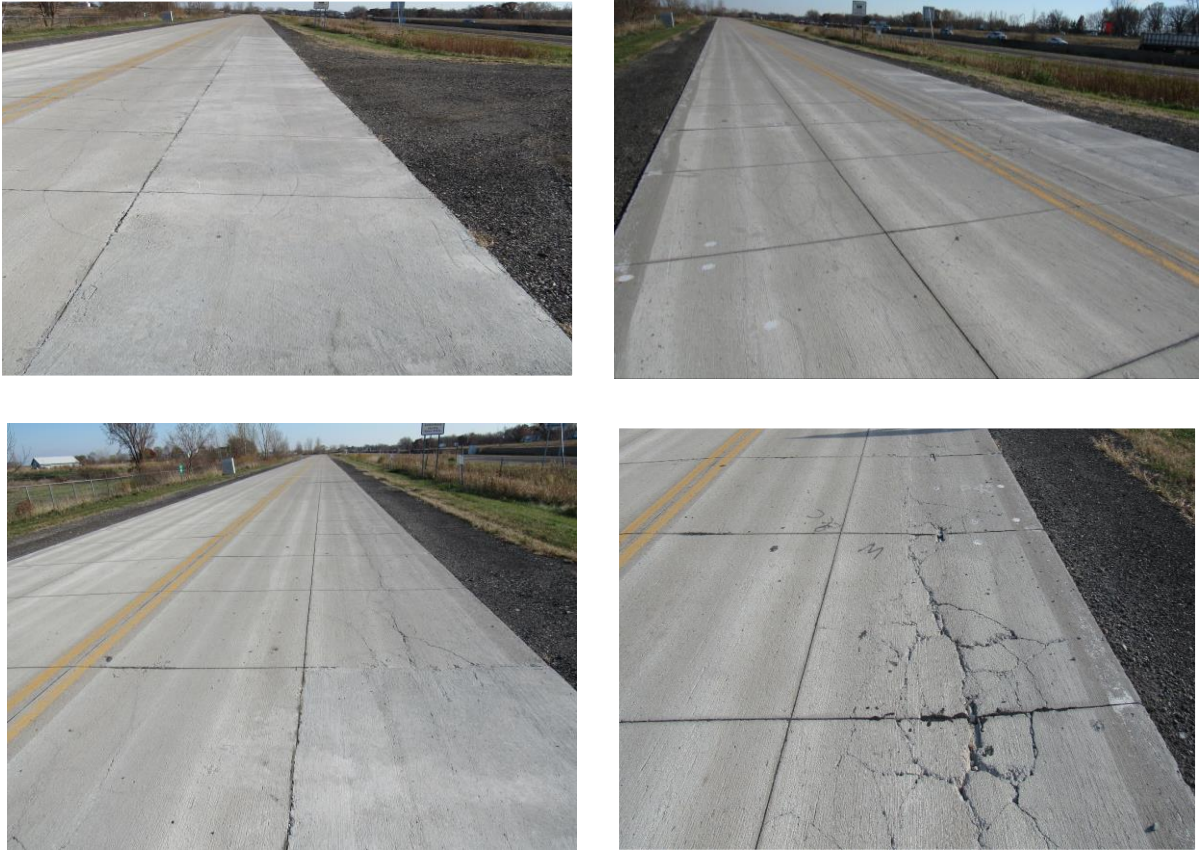
On the other hand, unrepaired (original) slabs continued to be distressed with traffic load and age, with primary longitudinal and secondary transverse and diagonal cracks. Based on the December 2019 distress survey data, it was found that as much as 75% of the slabs have cracked in Cell 139 after 114,000 ESALs applied to them. Figure 2-7 shows four photographs of Cell 139 taken in October 2019. The unrepaired slabs eventually failed and became undrivable in the middle of the third year of service (2020).

Figure 2-7. A few photographs of Cell 139 during October 2019.

While the slab thickness limitation (only 3-inch thick) of this cell and early-age loading were the main reasons for the initiation of the distresses of Cell 139, a relatively weak base layer and some drainage issues were believed to have aggravated the distress of this cell.

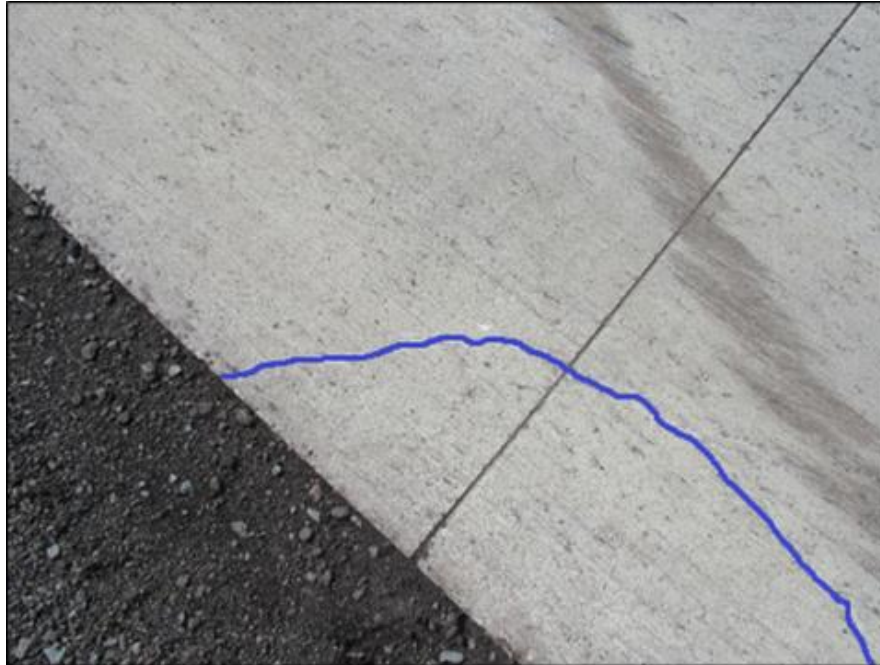
Figure 2-8. Corner cracks in Cell 239 (2018)

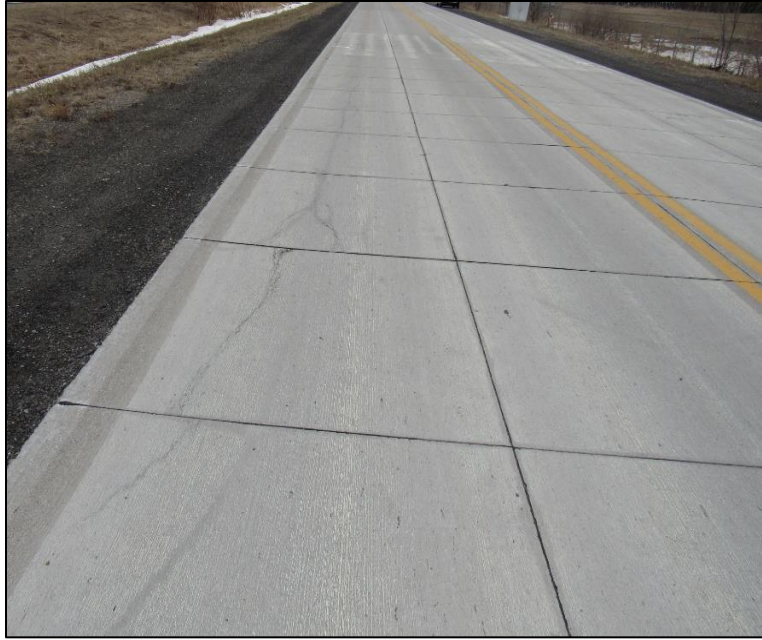
Cell 239 performed way better than Cell 139 throughout the last three years. Based on the distress survey data until March 2020, a total of 35 panels have cracked in this cell, with 27 in the inside lane. A total of 20% of slabs have cracked after 145,000 ESALs in this cell compared to more than 75% cracked slabs in Cell 139 with a similar traffic load. The severity of the cracks in Cell 239 was also much less than those in Cell 139. It should be noted that this cell also had much less early construction traffic loadings than Cell 139.

Figure 2-9. Longitudinal cracks in Cell 239 (April 2019)

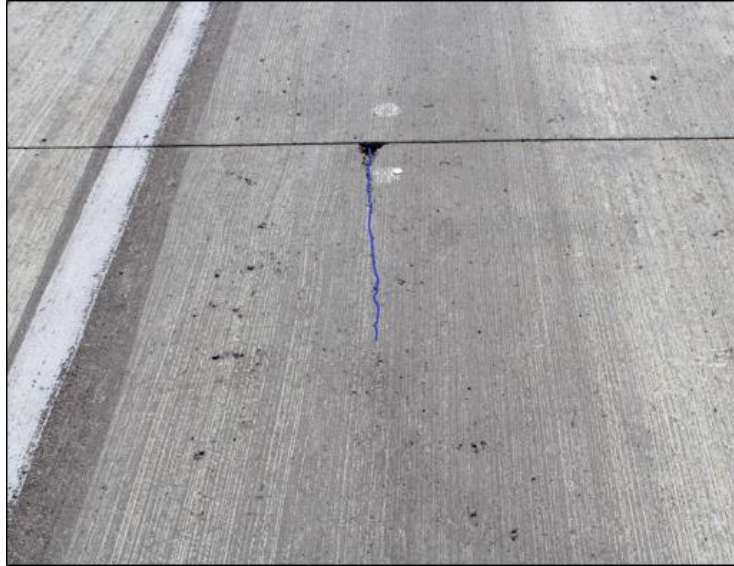
Figure 2-10. Longitudinal crack in Cell 705 (2018)

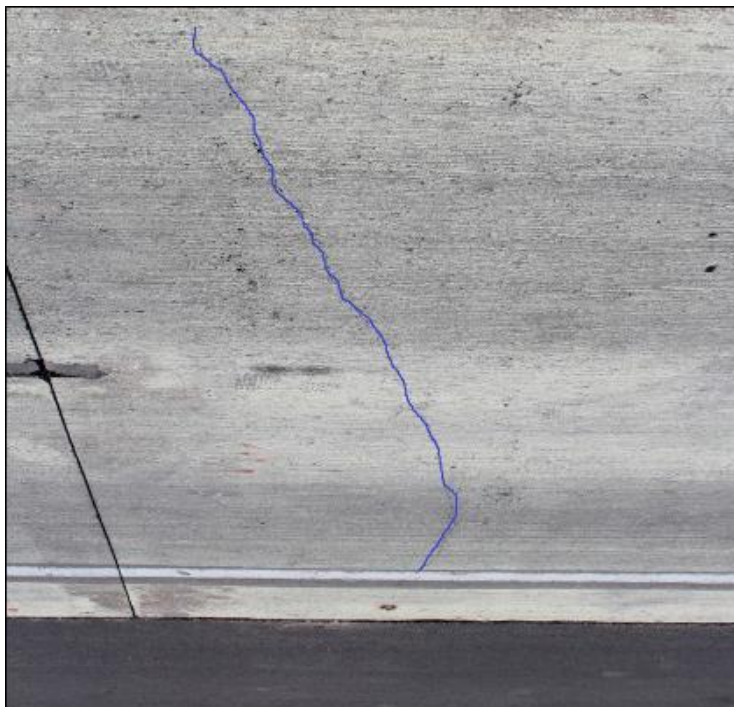
Figure 2-11. Transverse crack in Cell 705 (2018)

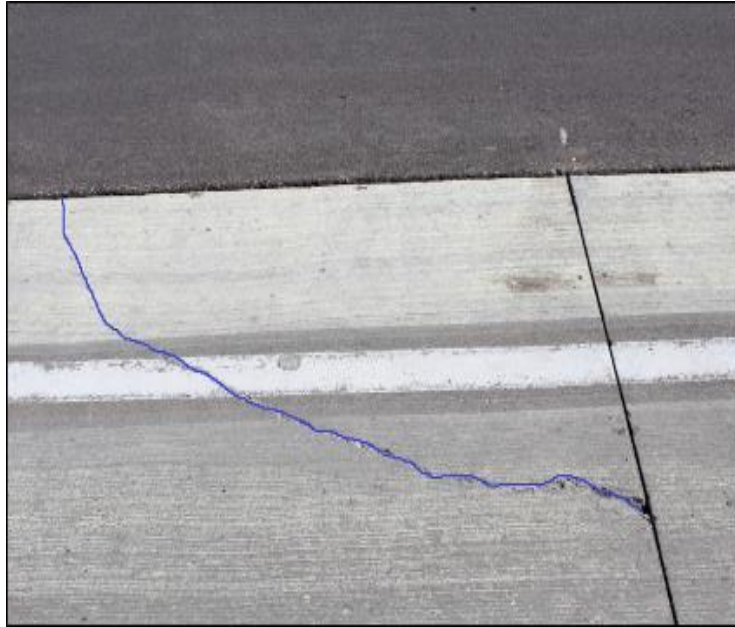
Figure 2-12. Corner crack in Cell 705 (2018)

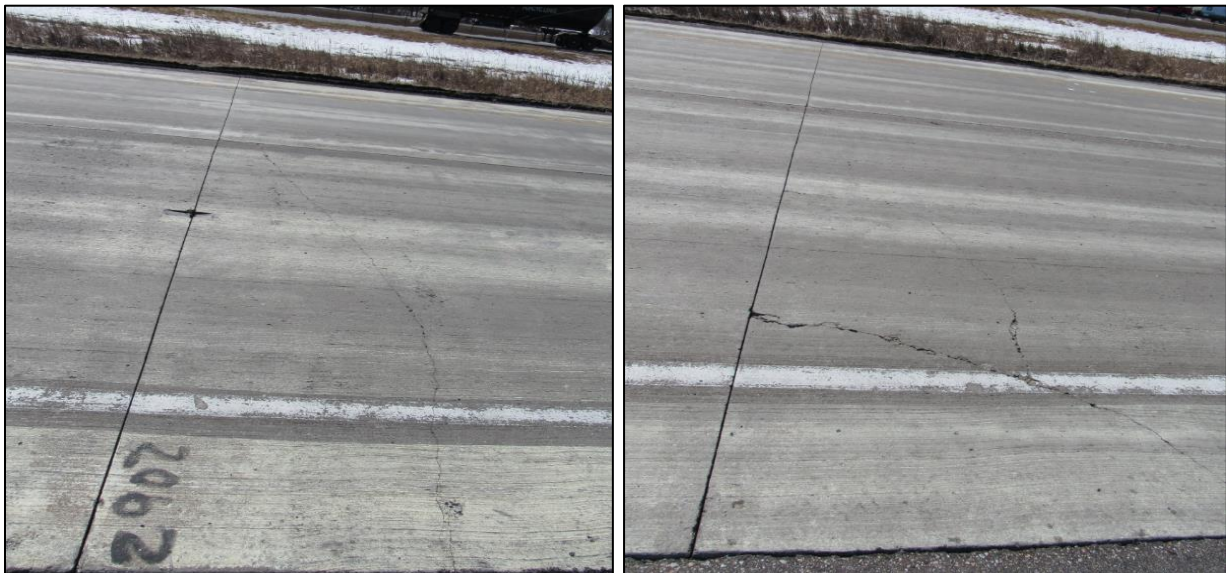
Figure 2-13. Photographs of transverse and corner cracks in Cell 705 as observed during April 2019

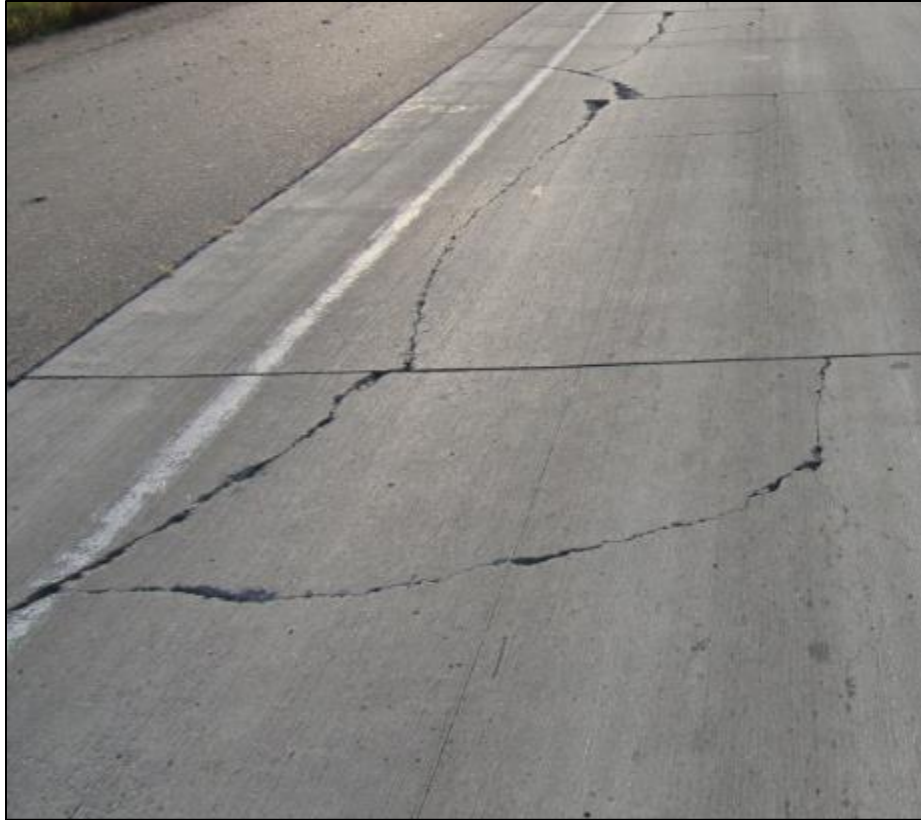
Figure 2-14. Photograph of Cell 705 before replacement on September 2020

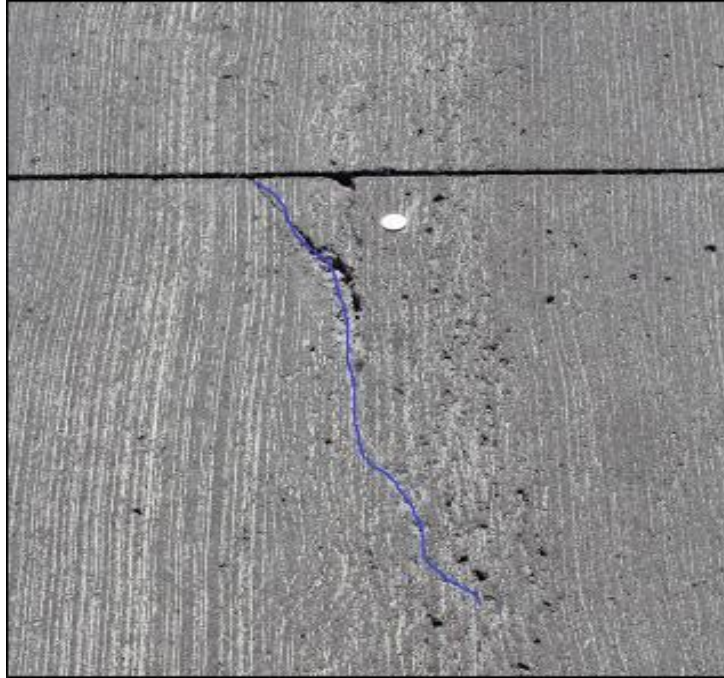
Figure 2-15. Longitudinal crack in Cell 805 (2018)

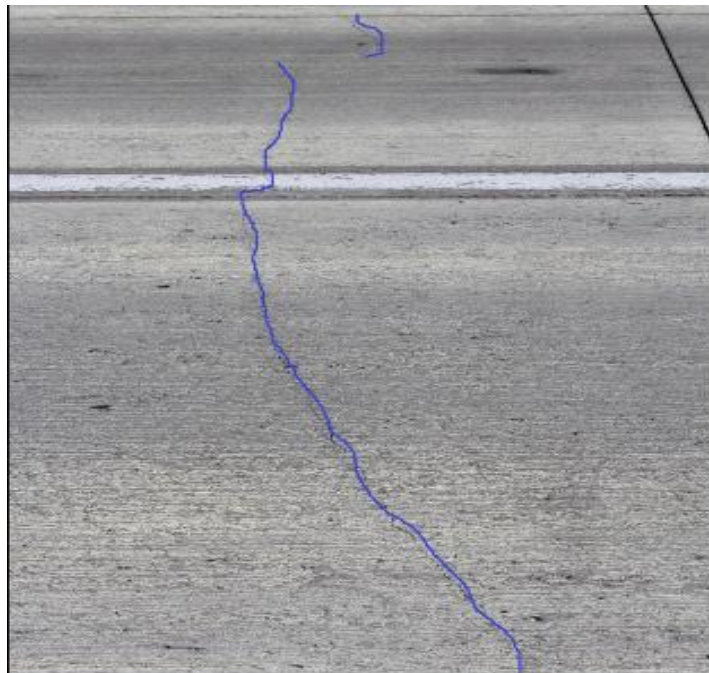
Figure 2-16. Transverse crack in Cell 805 (2018)

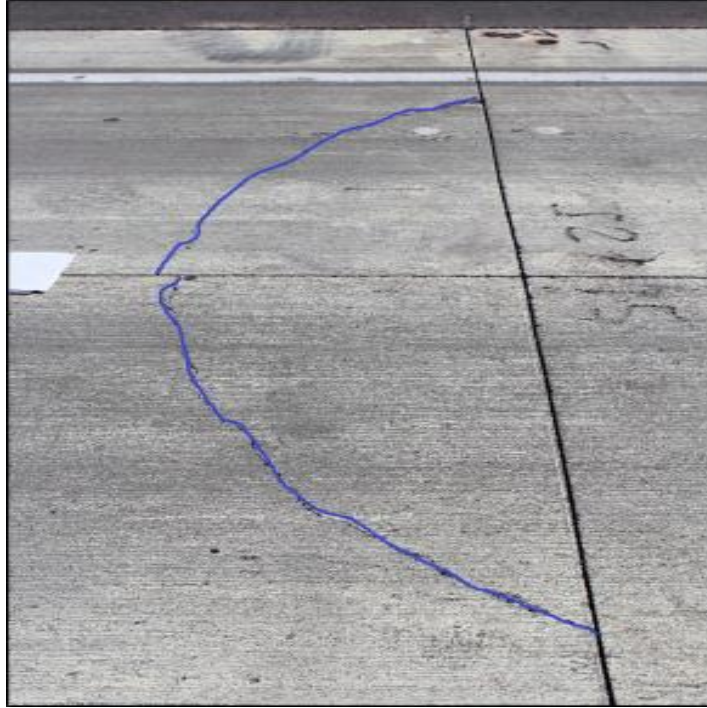
Figure 2-17. Corner crack in Cell 805 (2018)

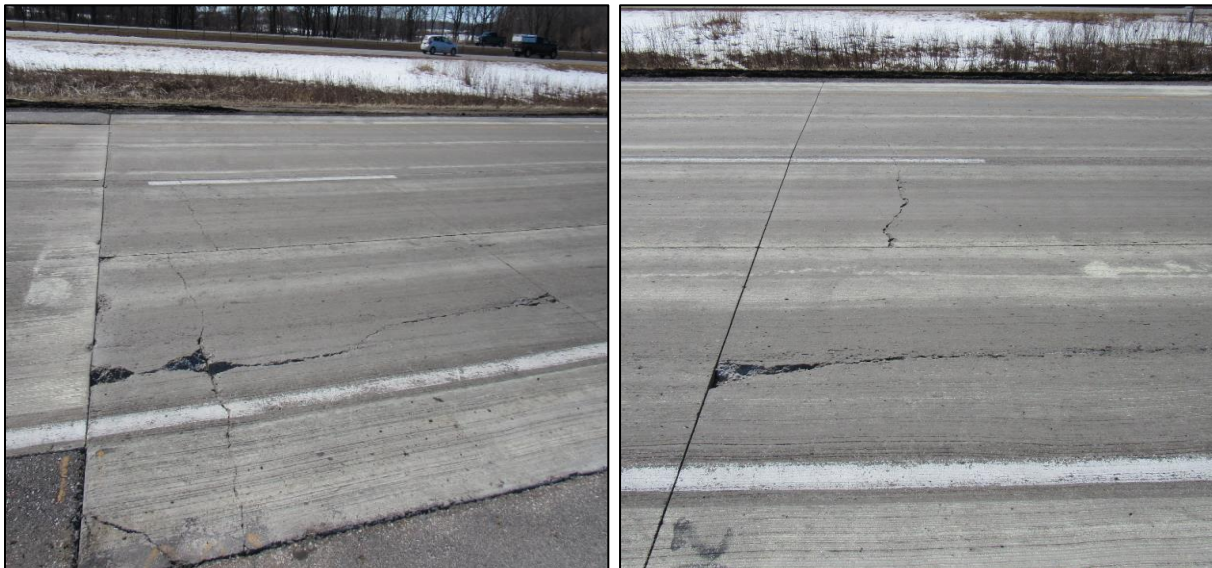
Figure 2-18. Photographs of observed cracks in Cell 805 during April 2019.

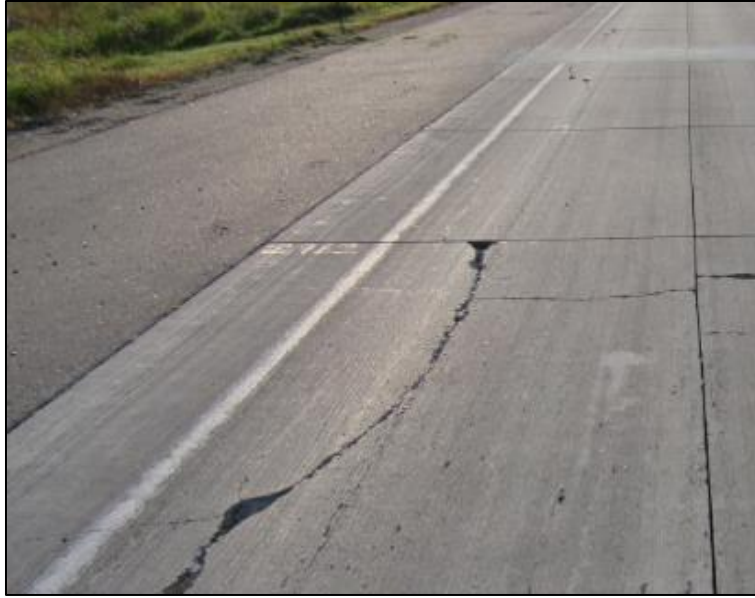
Figure 2-19. Photograph of Cell 805 before removal on September 2020

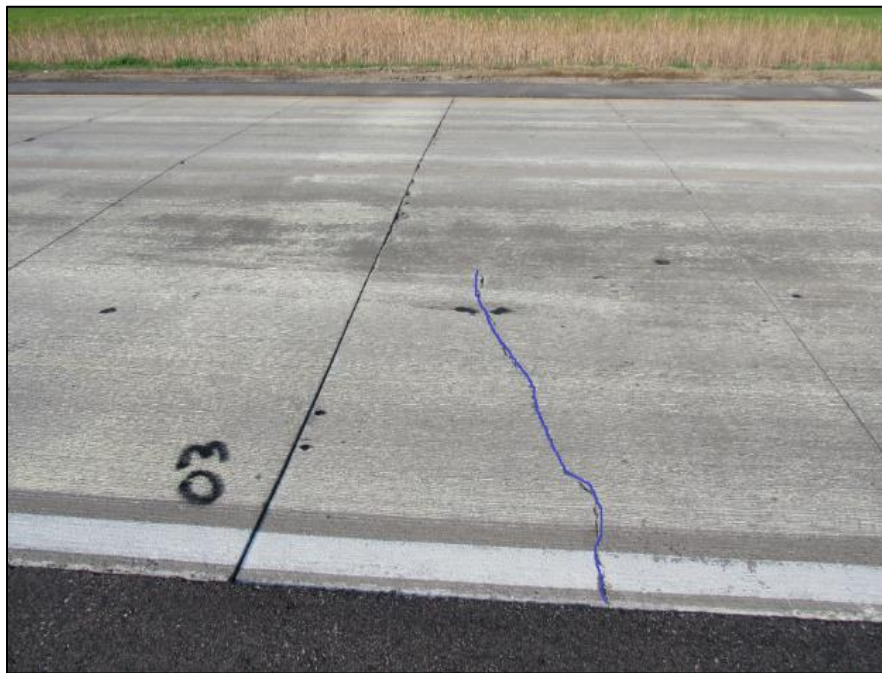
Cell 506, which is the control cell constructed without any fibers, experienced one transverse crack, and spalling on 15 numbers of transverse joints before April 2018. The October 2019 distress survey reveals that Cell 506 experienced one diagonal crack and two more transverse cracks in addition to the cracks observed in 2018. Figure 2-20 and [Figure 2-21](#) show photographs of the transverse crack and joint spalling documented in April 2018. Figure 2-22 shows the photograph of the cracks in 2019. All three cracks developed in three adjacent slabs which is a probable indication that the underlying base layer or subgrade support was weaker in this location. These cracks have deteriorated with the traffic severely and had to be replaced in the summer of 2020. [Figure 2-23](#) shows a photograph of distressed slabs of Cell 506 before they were replaced in June 2020.

Figure 2-20. Transverse crack in Cell 506 (control, non-FRC) observed in the year 2018.

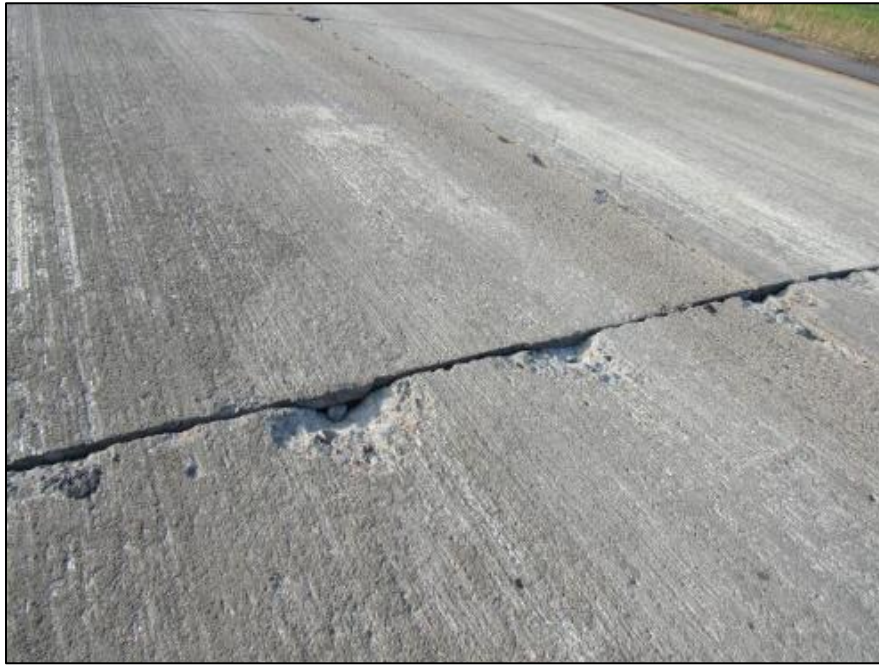
Regarding the spalling in Cell 506, upon looking closer at multiple spalling locations, it was found that joint areas were filled with hardened saw-cut residue. The residue was not cleaned out of the joints after sawing. There was a clear correlation between the spalling and the presence of the residue. It was up to ¼" deep and completely spanned the saw cut. Thus, when the joints closed in the summer, the spalls formed in these locations. Figure 2-24 shows two photographs of hardened saw-cut residue found at the spalled joints of Cell 506. No visible saw-cut residue was noticed at the joints of other cells. As the occurrence of the spalling in Cell 506 was not primarily because of the weaker concrete, the spalling statistics are not included in the distress summary in [Figure 2-1](#)~~Figure 2-1~~.

Figure 2-21. Spalling in Cell 506 (control, non-FRC) observed in the year 2018.

- Cell 506 experienced joint spalling in many locations. An investigation conducted in summer 2020 confirmed that the absence of fibers in this cell was not responsible for the spalling; instead, some hardened saw-cut residue stuck within the saw-cuts of the transverse joints was responsible.

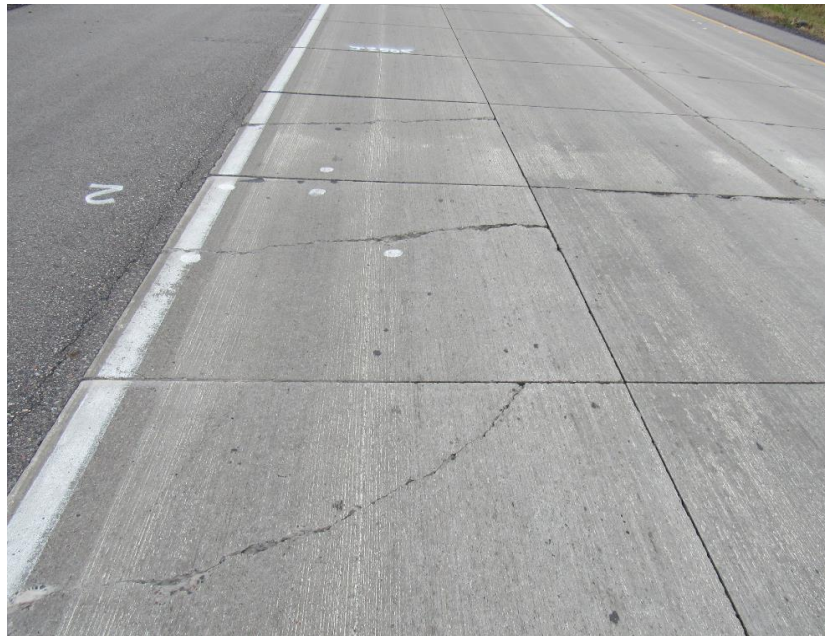
Figure 2-22. Photographs of transverse and diagonal cracks in Cell 506 (October 2019)

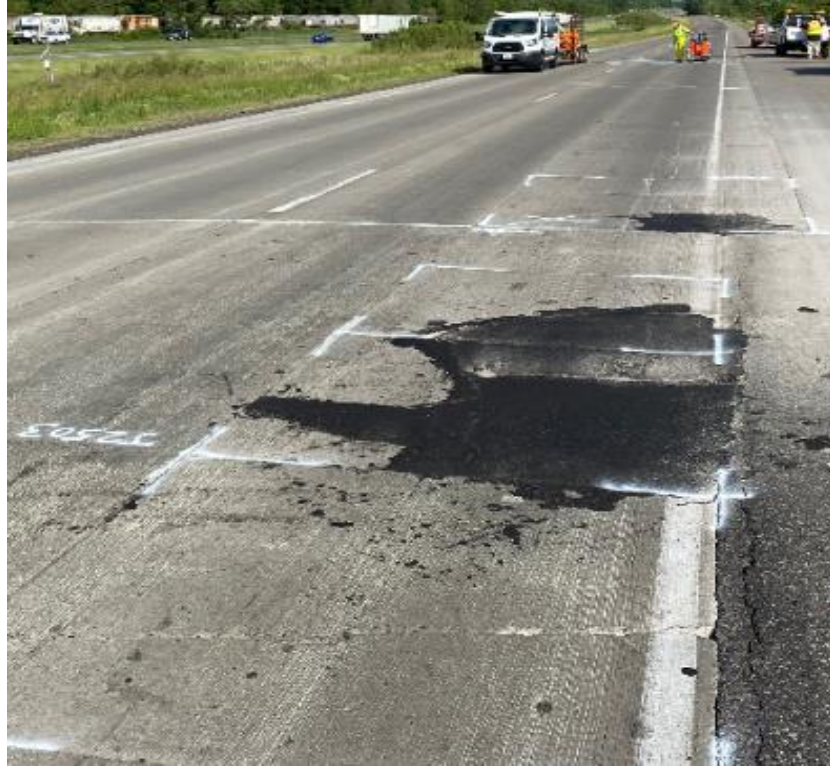
Figure 2-23. Cell 506 before replacement in June 2020

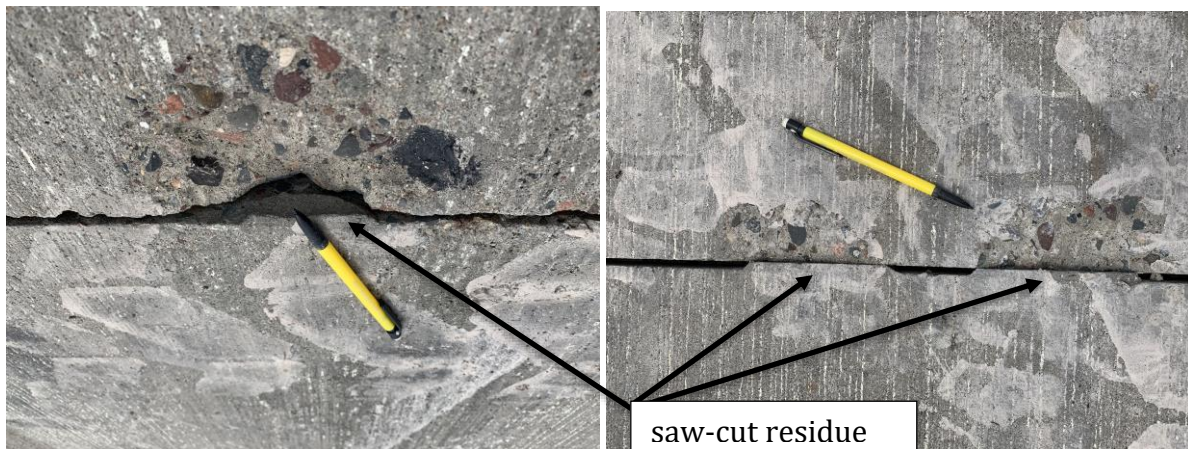
Figure 2-24. Hardened saw-cut residue found within the spalled joints of Cell 506.

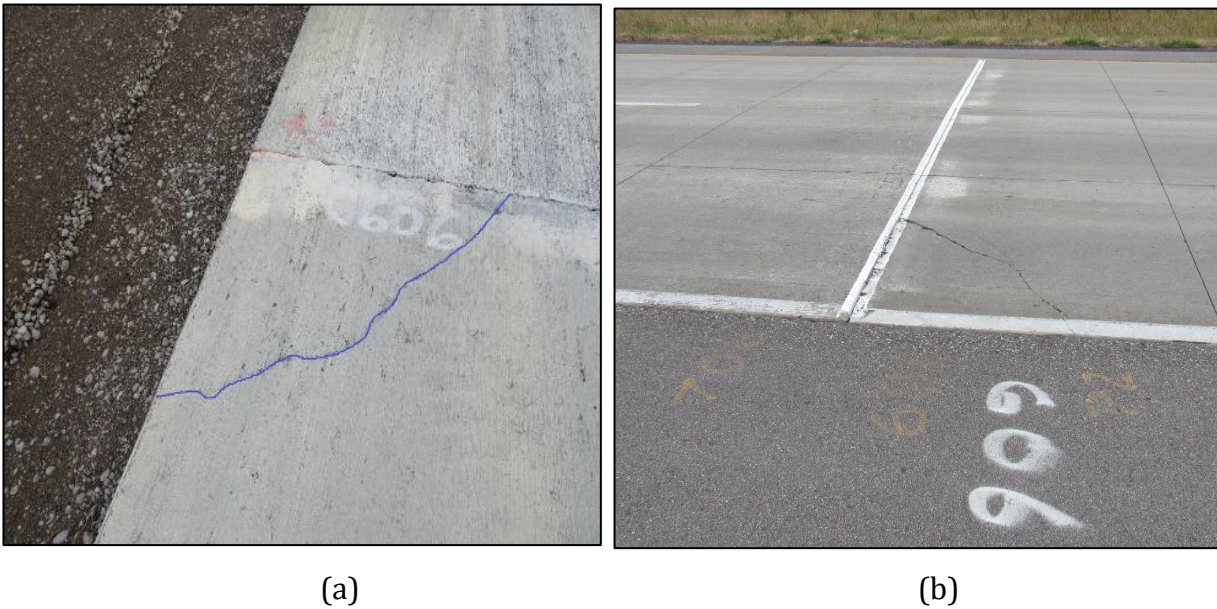
Cell 606, which was constructed with 5 lbs./cy (20% residual strength) of structural fibers, experienced one corner crack prior to April 2018. This corner crack was the only crack as observed during the 2019 distress survey as well. [Figure 2-25](#) shows

photographs of the crack in April 2018 and October 2019. It can be seen that the severity of this crack did not change much as compared to what has happened for the cracks in Cell 506 (Figure 2-20 vs. Figure 2-22). As this crack is in the last panel next to a cell transition joint, it can be assumed that this crack is not a typical fatigue-related crack; it occurred because of a construction issue. The distress survey conducted on March 2020 found one joint spalling and two additional low severity corner cracks.

Figure 2-25. Corner crack (construction issue) in the last panel of Cell 606 observed (a) in the year 2018 and (b) 2019

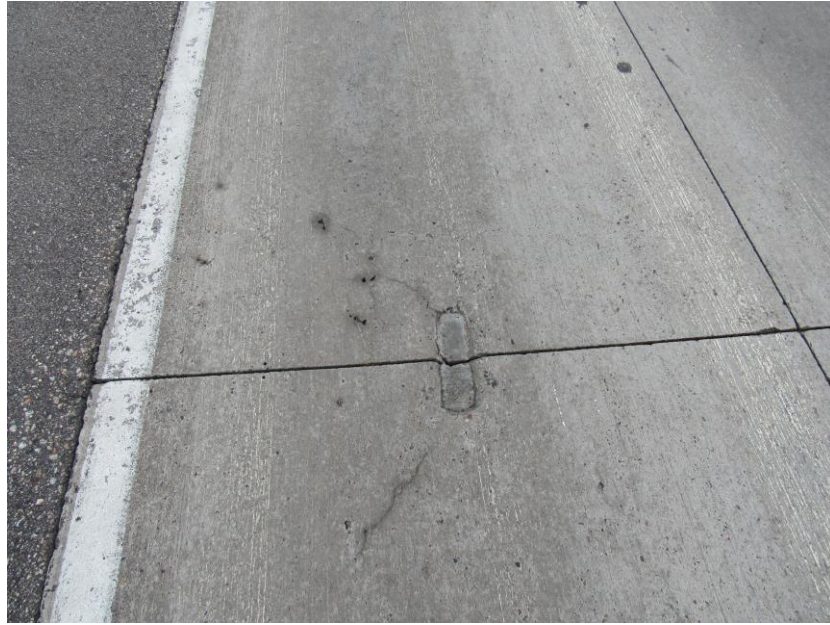
Cells 706 and 806, which were constructed with fiber dosages of 8 and 11.7 lbs/cy, respectively, did not experience any cracks or spalling prior to October 2019 except for a couple of narrow cracks in Cell 806 originated at the location of a joint opening sensor (~~Figure 2-26~~~~Figure 2-26~~). March 2020 distress survey did not report any additional cracks for these two cells.

Figure 2-26. Narrow cracks in Cell 806, originated at the location of the joint opening sensor

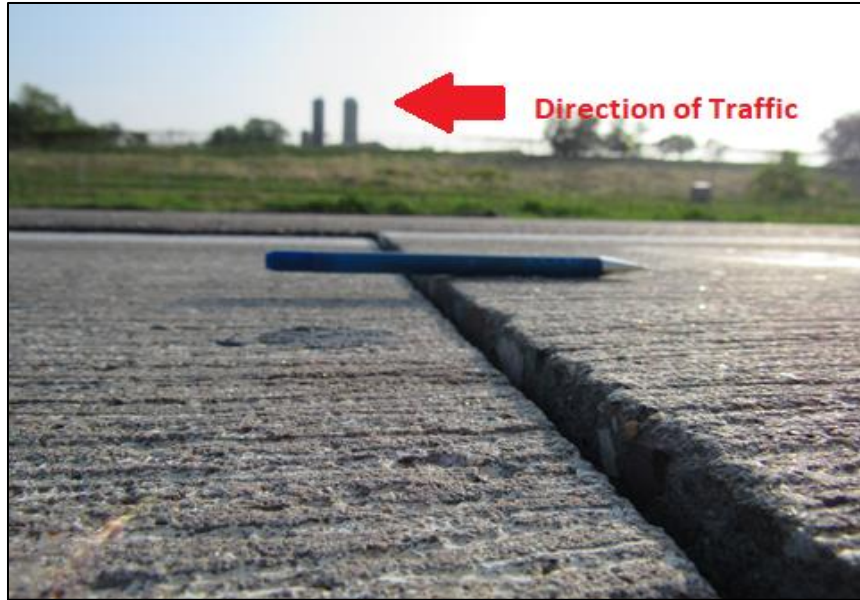
Figure 2-30. Photograph of faulting of Cell 506 (non-FRC). Note that faulting is exaggerated due to the broken corner in leave slab.
