# Minnesota Department of Transportation (Mn/DOT)

## Historic Bridge Management Plan

Bridge Number: 3355

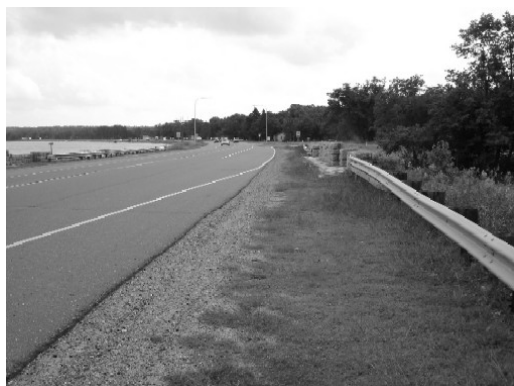
Figure 1. A view looking south from the west shoulder. A turn lane to access Mille Lacs County Road 25 is provided on the bridge.

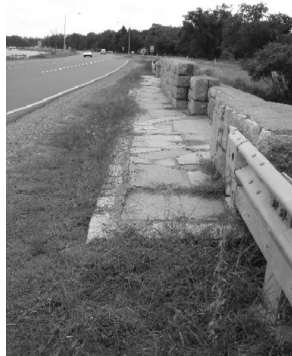
Figure 2. Looking south along the west sidewalk and railing. A considerable amount of vegetation is growing on the shoulder and in the masonry joints. Concrete has been placed on top of the railing to function as a capstone. 1939 railing contains significant snag points and blunt impact surfaces.

1. Remove debris and vegetation from the masonry sidewalks, railings, and wingwalls on both sides of the bridge.
2. Remove silt and vegetation that is partially blocking the hydraulic channel on the upstream side of the bridge.
3. Seal the joints between the sidewalks and the railings and wingwalls.
4. Seal the transverse cracks in the roadway pavement.
5. Restore the embankment at the southeast corner of the bridge to its original elevation.

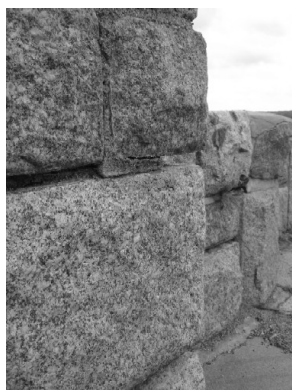
Figure 3. Typical mortar joint condition on the inside face of the east railing. (Missing mortar, deep cavities, and vegetation growing in joints).

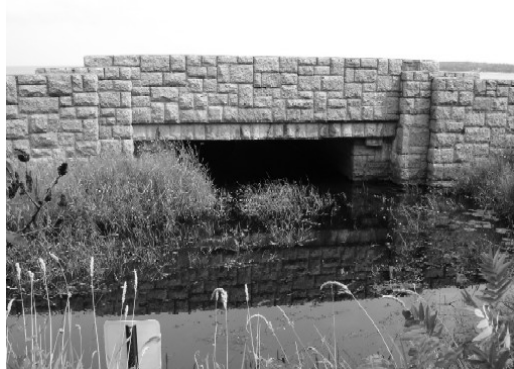
Figure 4. Vegetation and silt deposits are partially blocking the hydraulic opening on the upstream side of the bridge.

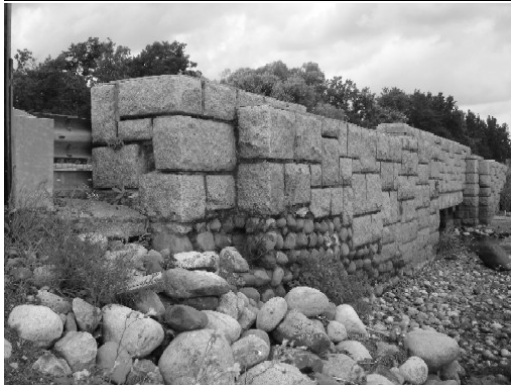
Figure 5. Cut granite and rock masonry evident at the SE corner of the bridge. Missing mortar and vegetation growing in the joints.

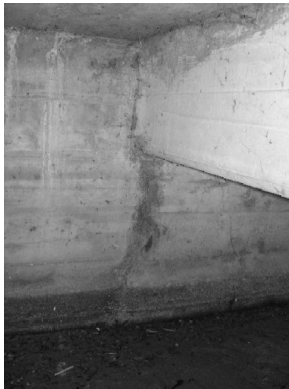
Figure 6. Cracks in the abutment breastwall on the north abutment near the west construction joint.

8. Seal cracks in the existing abutments.
9. Install a drainage system behind the new abutments
10. Restore the masonry sidewalks. Photograph, label, carefully remove, and temporarily store the existing stone from the sidewalks. Construct a new reinforced concrete sleeper slab on each side of the bridge to support the reconstructed sidewalks. Rebuild the masonry sidewalks on the sleeper slabs. Utilize a mortar consistent with that recommended in the mortar analysis.

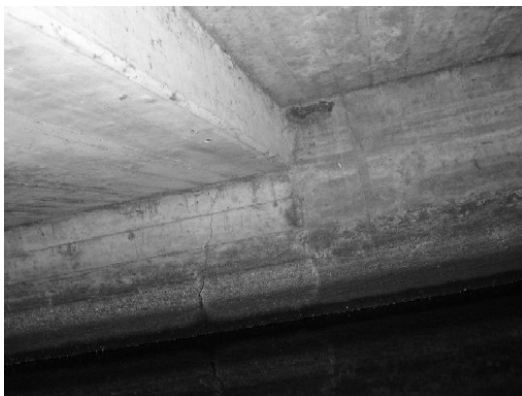
Figure 7. Cracks in the south abutment breastwall near the west construction joint. The upstream side of the wall is to the right in this photo. The lower original slab functions as a hydraulic constraint inside the bridge.

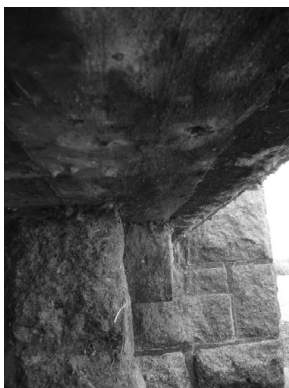
Figure 8. Soffit deterioration at the south end of the west lintel.

6. Contingent upon the findings of the masonry and concrete inspections, repair the masonry railings and wingwalls. Reconstruct the lintel elements at both edges of the existing slab. While performing masonry repairs and reconstruction tasks, utilize a mortar with the properties recommended in the mortar analysis.

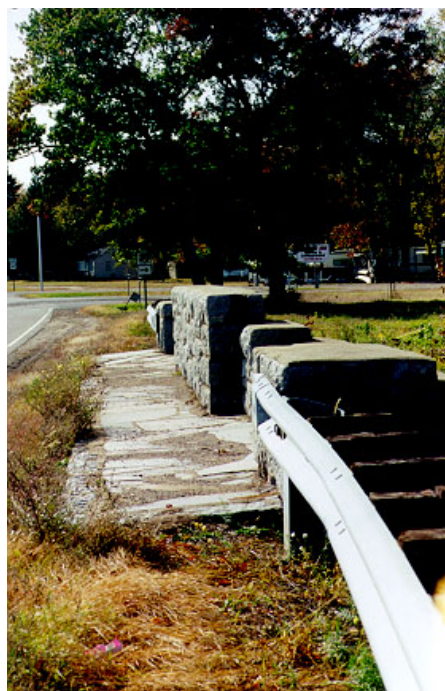
6. West Wall looking South (*overgrown turf*)

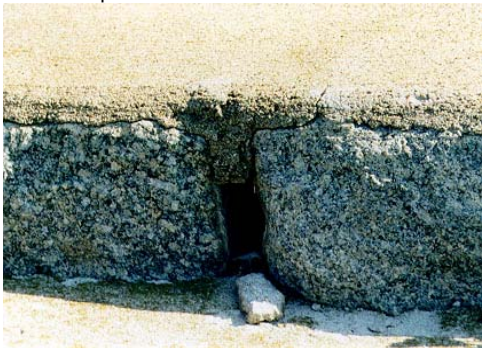
9. Close-up of Mortar Joint Condition.

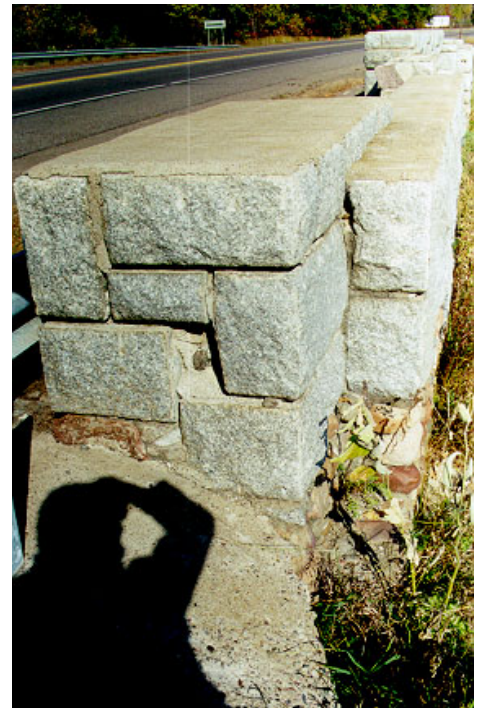
10. Missing Stone and Poor Mortar

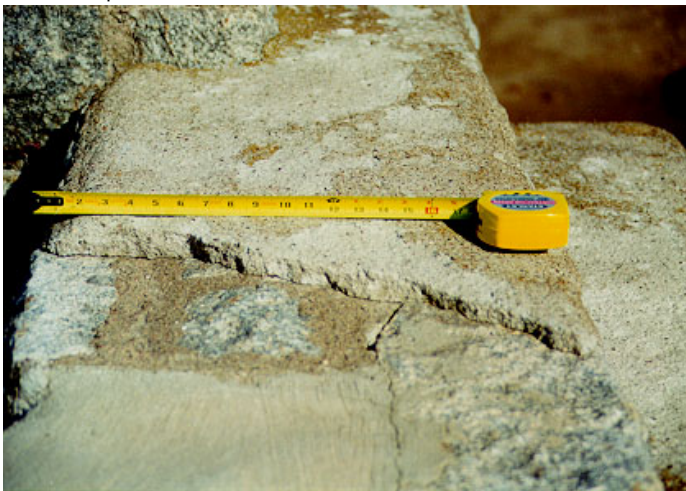
11. Mortar Topping at Walls (*broken and spalling*)

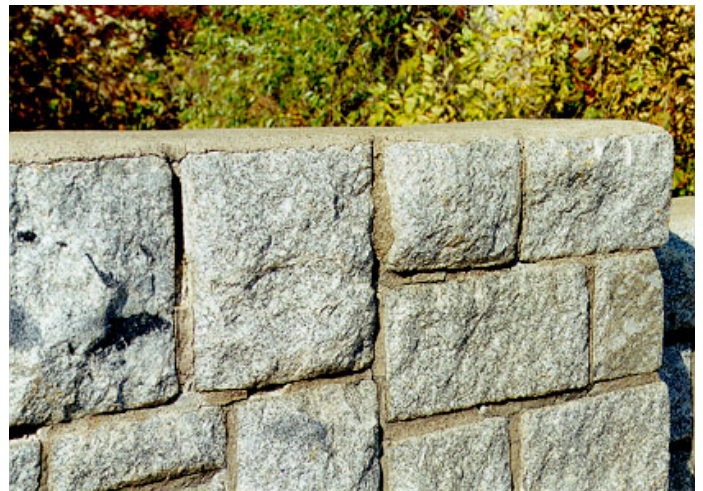
12. Mortar Joint Conditions

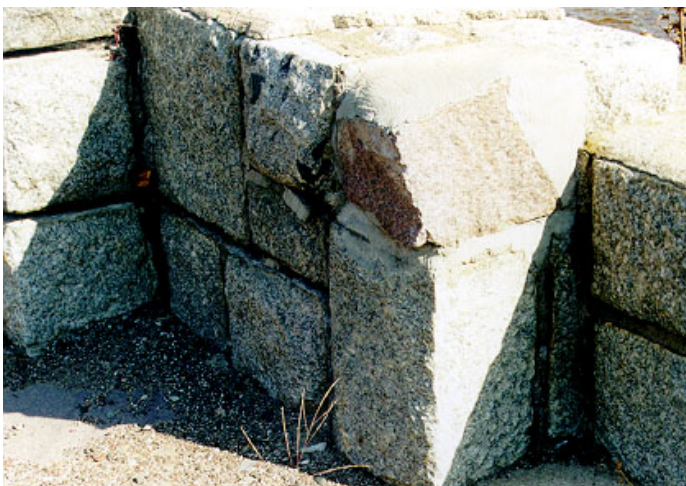
13. Patched End Caps (*spalled mortar topping above sloped stone patch and loose mortar behind*)

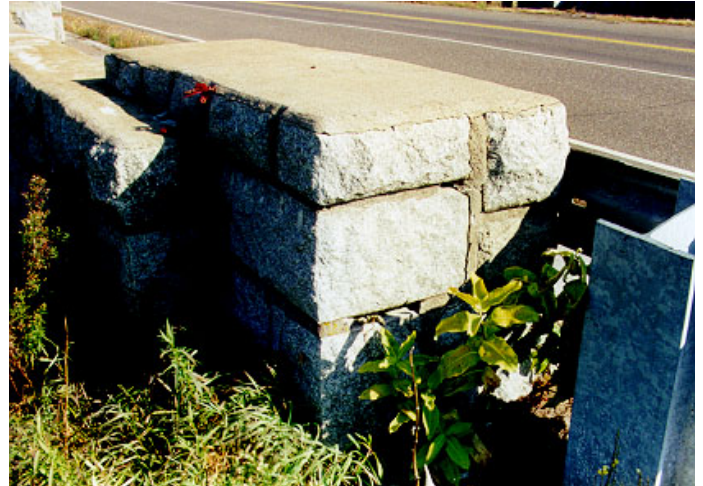
14. Wall End showing Poor Mortar Conditions and Overgrown Vegetation

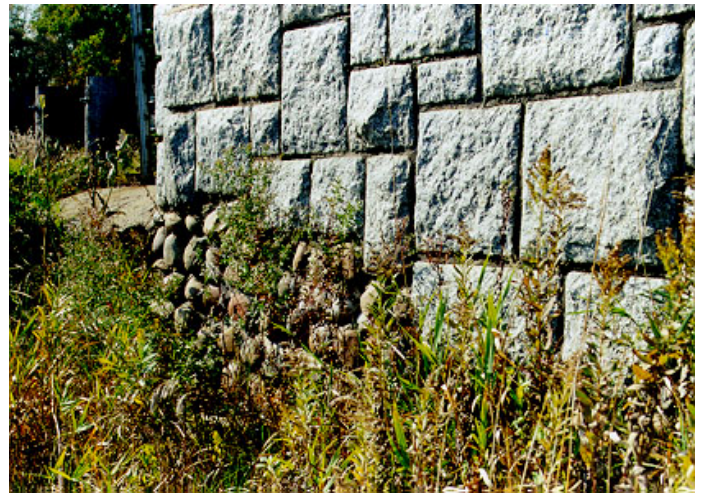
16. Granite/Fieldstone Foundation (Note: fill settling)

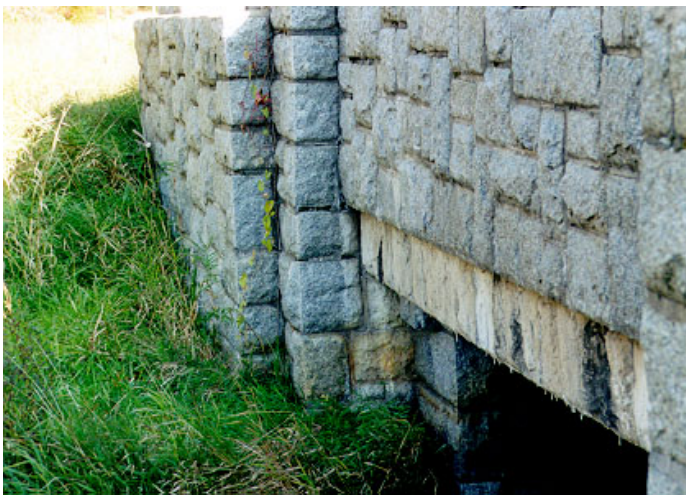
17. Culvert Opening (Note: Condition of granite header and surrounding mortar joints)

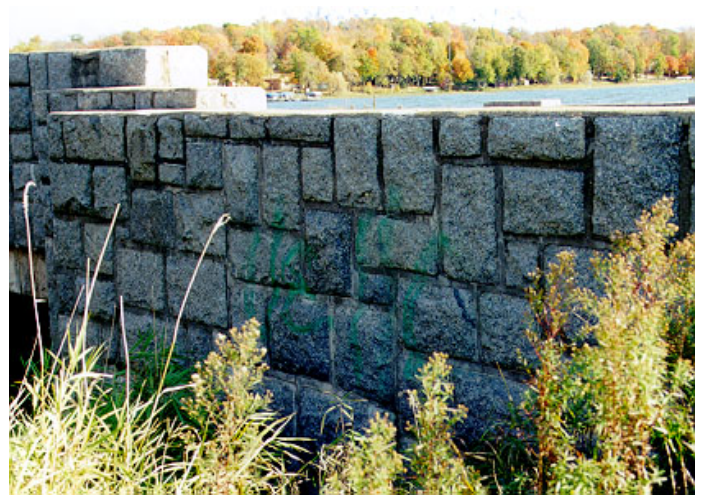
18. Graffiti on West Wall

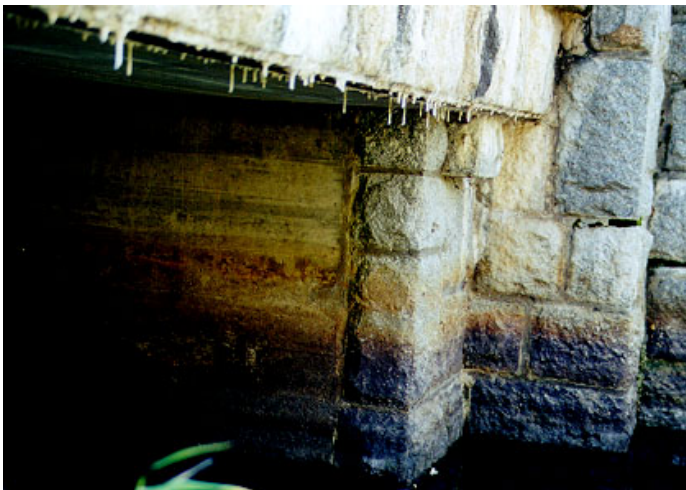
19. Culvert Condition Showing Granite, Concrete and Water Level Variations
