Historic Bridge Management Plan

Bridge Number: 5265

Executive Summary

Bridge 5265 (Garrison Pedestrian Underpass) was built in 1938 by the Civilian Conservation Corps (CCC) to carry vehicular traffic on US Highway 169 over a small creek along Lake Mille Lacs at the south edge of Garrison, Crow Wing County. It also was designed to facilitate pedestrian traffic beneath the highway. Including wingwalls, it has an overall structure length of 80 feet, an out-to-out headwall width of 44.5 feet, and a roadway width of 39.5 feet. The superstructure is a corrugated-metal, multi-plate, arch culvert with a 14-foot span and a 44-foot barrel. The substructure consists of stone masonry headwalls, wingwalls, sidewalls, and railing, with a two-cell masonry culvert beneath the concrete-slab floor of the pedestrian underpass. The stone masonry is random-coursed, rock-faced, ashlar granite.

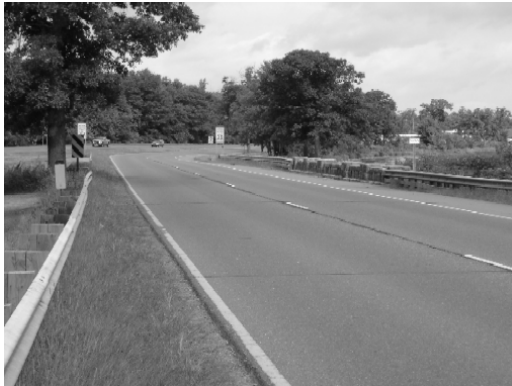
A large tree will damage the southwest wingwall if it is not removed.

Figure 1. Looking north at the bridge from the west shoulder. Note the large tree growing near the southwest corner of the bridge. Note the signs at the end of the guardrail regarding the 35 mph speed zone ¼ mile away.

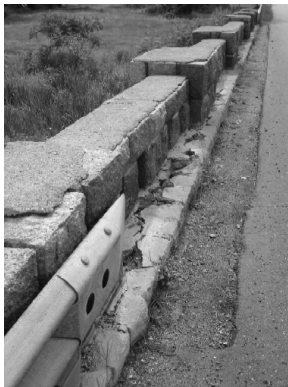
Concrete has been placed on top of the railings and the east curb stonework to function as a capstone. The concrete is in poor condition on the railings and extremely poor condition on the east curb.

Figure 2. Concrete has been placed on top of the railing to function as a capstone. Deteriorated concrete or mortar placed on the “curb” stone is also evident.

3. Based on the findings of the mortar-joint inspection and the mortar analysis, tuck point and/or reconstruct the wingwalls, headwalls, and railings. Details should be developed and implemented to remove the concrete topping placed on the railings and curbs. As recommended in National Park Service briefs, appropriate flashing, capstone details, and sealing should be utilized in reconstructed elements to minimize the intrusion of water into the masonry elements.

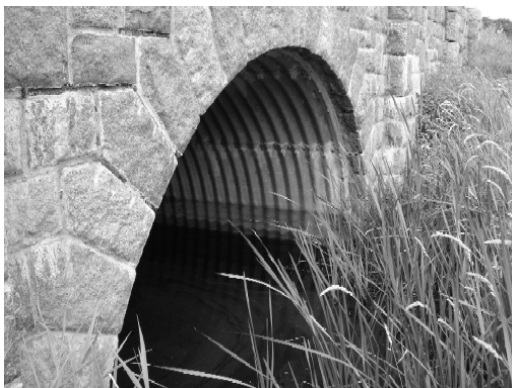
Based on USGS records, the surface of Lake Mille Lacs has risen over 7 feet from 1936 to 2002. Portions of the bridge that were dry and readily accessible, including parts of the multi-plate arch, are now submerged and deteriorating. The description of the featured crossed should be changed from "dry stream" to "Mille Lacs backwater."

Figure 3. Looking north at the east end of the multi-plate arch. Significant corrosion is evident near the water line.

1. Temporarily dewater the barrel. Prep and paint corroded portions of the multi-plate arch with a zinc-rich primer to stop active corrosion until preservation activities can be conducted. Protect substructure masonry and concrete elements from damage when dewatering. Before commencing work on submerged parts of the bridge, obtain any required permits from, and coordinate activities with, the Department of Natural Resources (DNR), the relevant Watershed District, and other agencies.
2. After prep work, and prior to painting, the remaining thickness of the arch plates shall be measured non-destructively and mapped. The thicknesses will be used in the load rating analysis.

5. Rehabilitate the multi-plate arch. When the structural condition warrants, remove the arch elements utilizing balanced excavation procedures and avoiding damage to the masonry footings. Steel connections between individual multi-plate arch components shall be disassembled to facilitate the rehabilitation of all metal elements. Components with negligible section loss shall be regalvanized. If necessary, steel elements with significant section loss may be replaced. All elements shall be galvanized with a zinc thickness suitable for submerged, splash-zone, or atmospheric conditions. Reassemble and install the rehabilitated arch. Backfill the arch with balanced procedures to minimize unbalanced earth loads. Install a geotextile membrane below the pavement and above the backfill to minimize the amount of roadway water reaching the multi-plate arch.

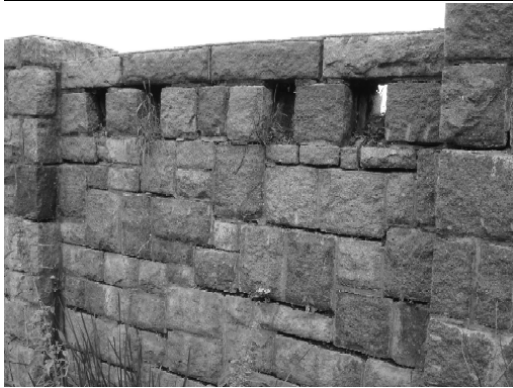
The mortar joints are generally in poor condition, with missing mortar, mortar that can be removed by hand, and vegetation growing in the joints.

Figure 5. Deteriorated mortar joints and vegetation growing in the joints on the southwest wingwall.

5. Repoint, or remove and re-set, stone masonry identified as deteriorated in the arm's length inspection on a five-year cycle.

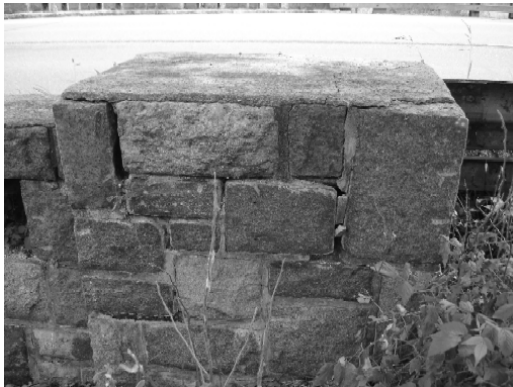
Figure 6. Missing mortar in the southwest corner post.

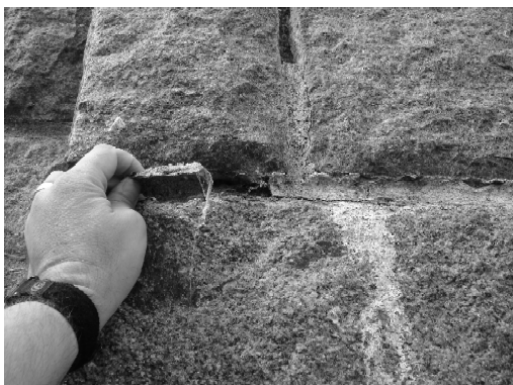
Figure 8. Deteriorated mortar removed by hand from one of the mortar joints in the southeast wingwall.

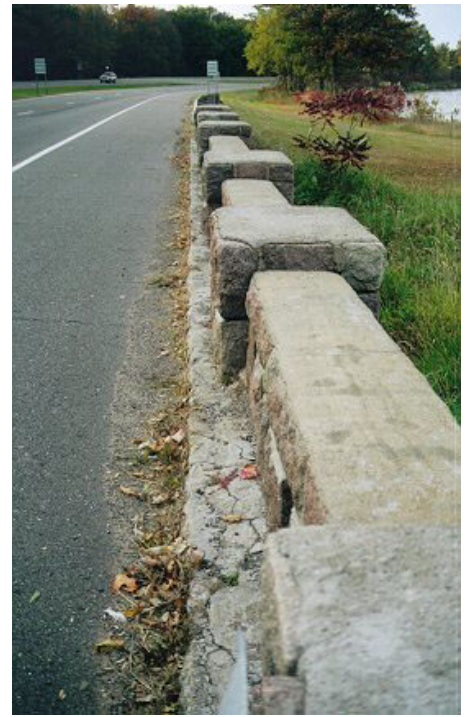
7. North end of West side Wall (*Note: condition of curb and mortar*)

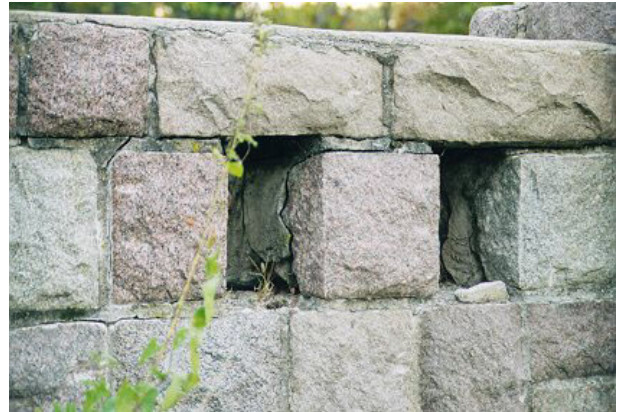
13. Close-up of Joints and Openings in Wall

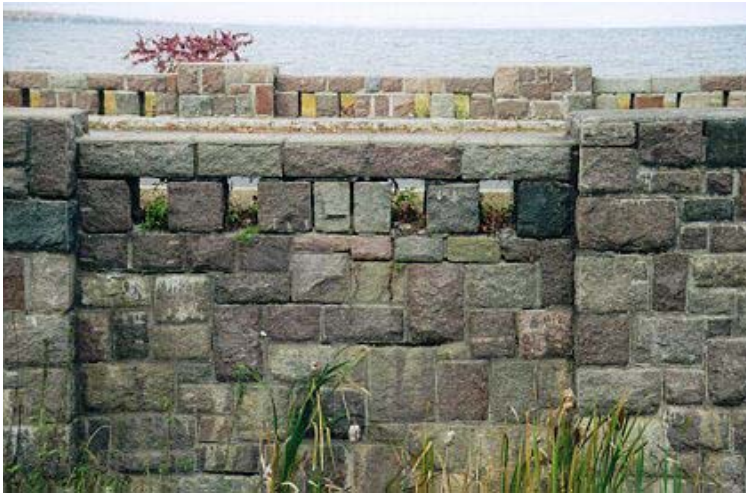
14. Midsection of West Wall looking East (Note Vegetation)

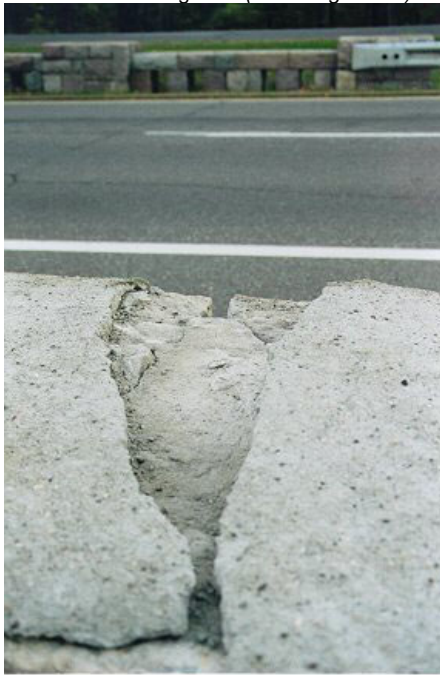
16. Missing Mortar Topping

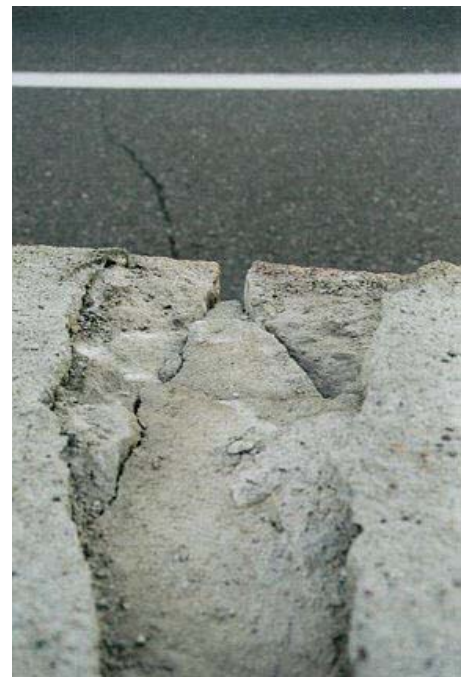
17. Close-up View of Missing Mortar and Condition of Underlying Stone Joint
