Unmanned Aerial Vehicle Bridge Inspection Demonstration Project

Minnesota
Department of
Transportation

Barritt Lovelace, Principal Investigator
Collins Engineers, Inc.

Research Project
Final Report 2015-40

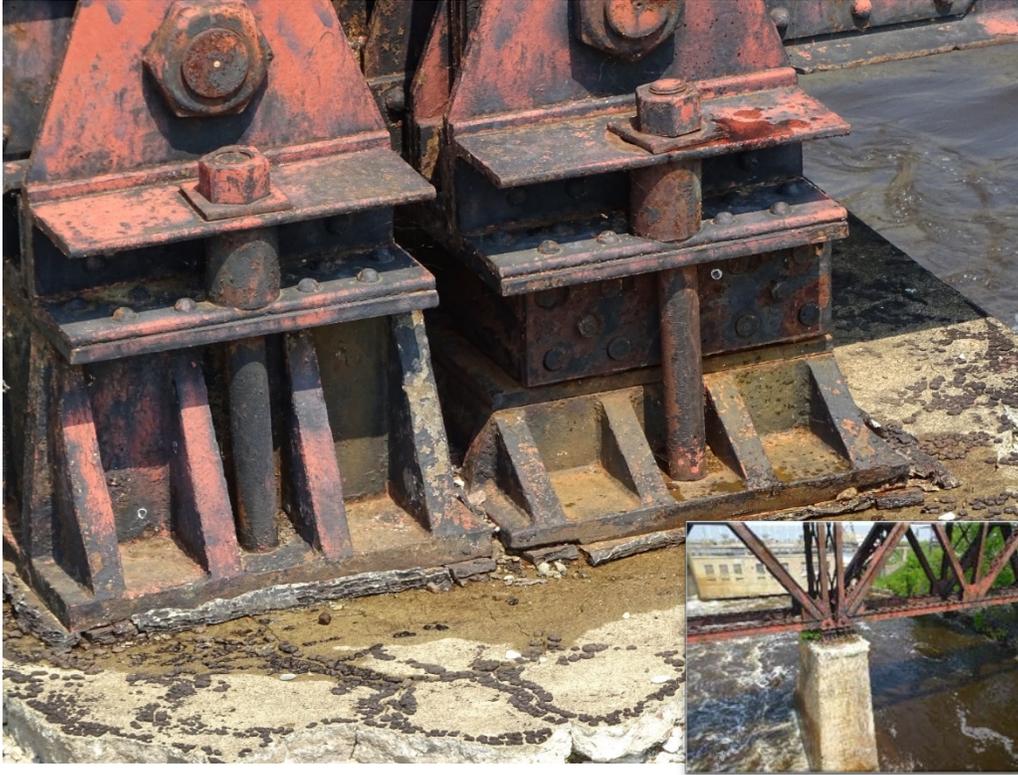
Figure 3-3 Example of the Detail Obtained at a Difficult to Access Bearing Location.

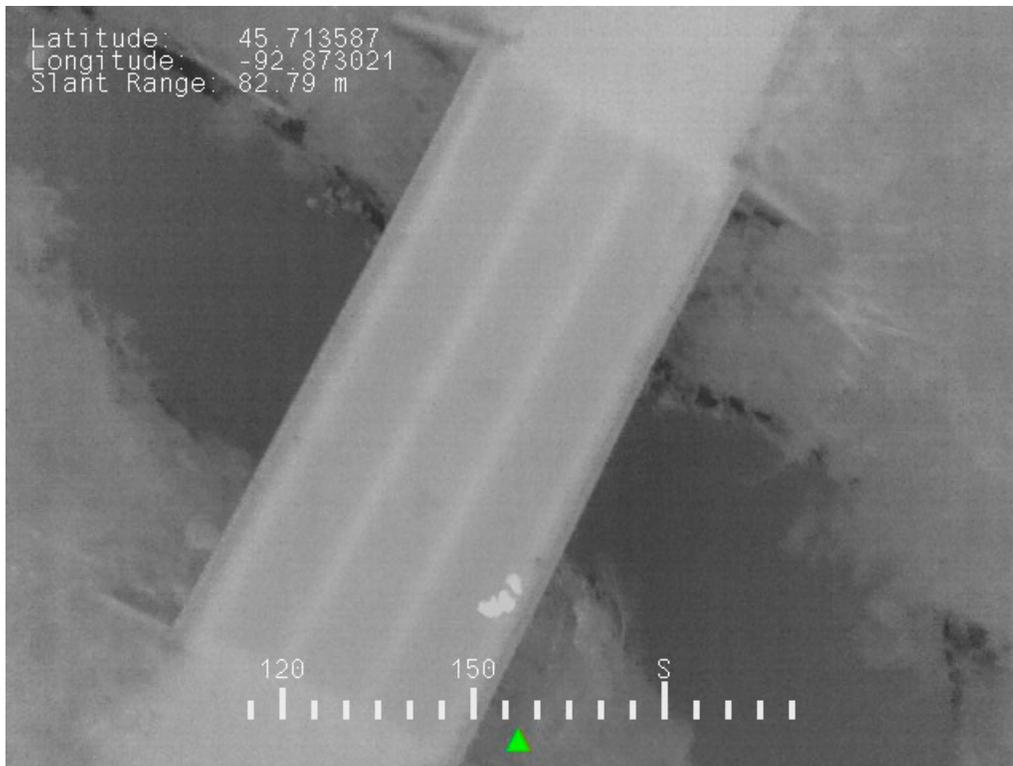
One of the highlights of this investigation was the infrared camera function. The image below shows a still IR image of the deck clearly showing the thermal gradient at the beam locations. While this deck did not have any delamination's that were observed it can be assumed that delamination's could be seen with the IR camera if they were present. The beams are clearly visible in Figure 4.1.3 showing the temperature variations present at the time of inspection. The images could also be dimensionally calibrated to provide repair quantity estimates. Significant research has been performed on the use of IR for evaluating concrete defects, and IR use is an accepted practice in non-destructive evaluation.

Figure 5-3 Bridge 13509 IR Image of Bridge Deck.

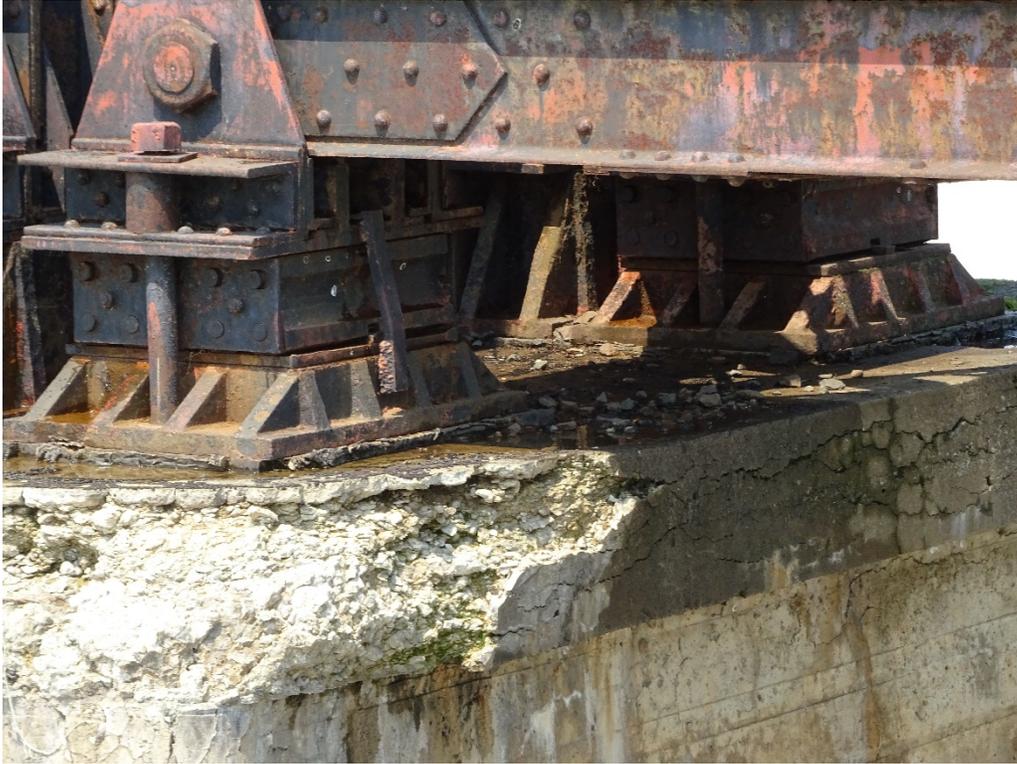
Figure 5-15 Photograph of Bridge 49553 Pier Cap Concrete Deterioration.

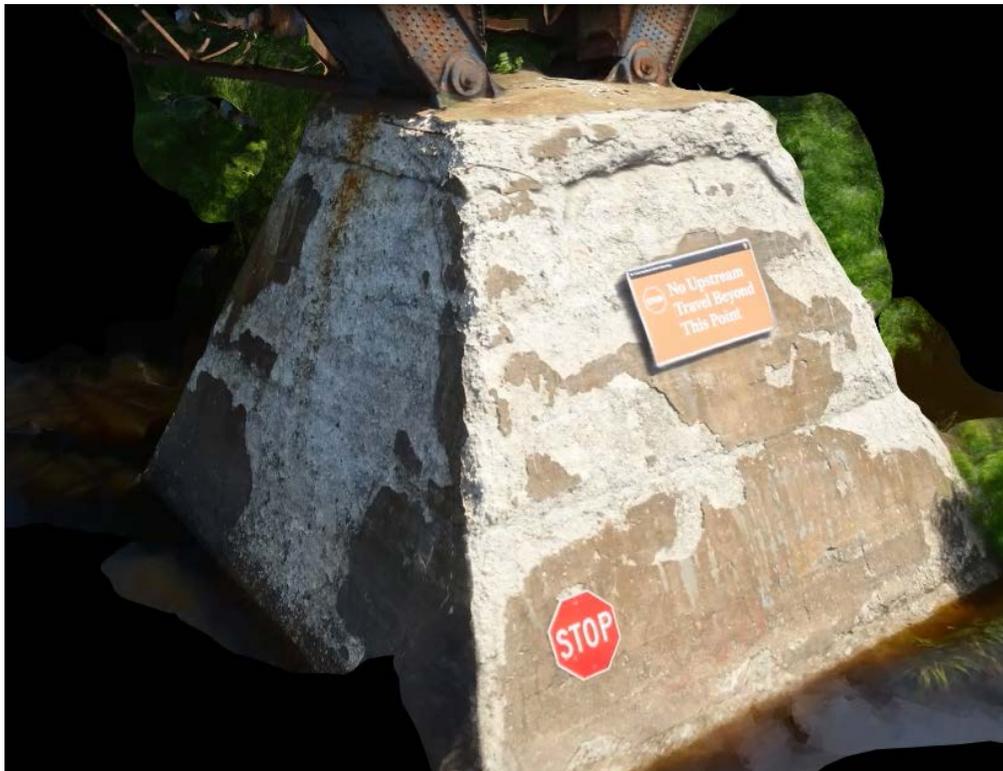
Figure 5-23 3D Orthographic Model of Bridge Foundation.

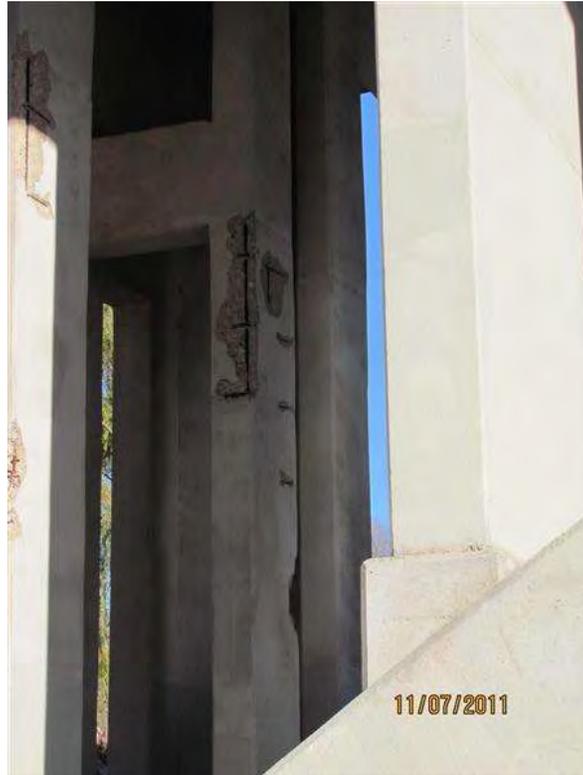
Photo 3 - North Columns spalls

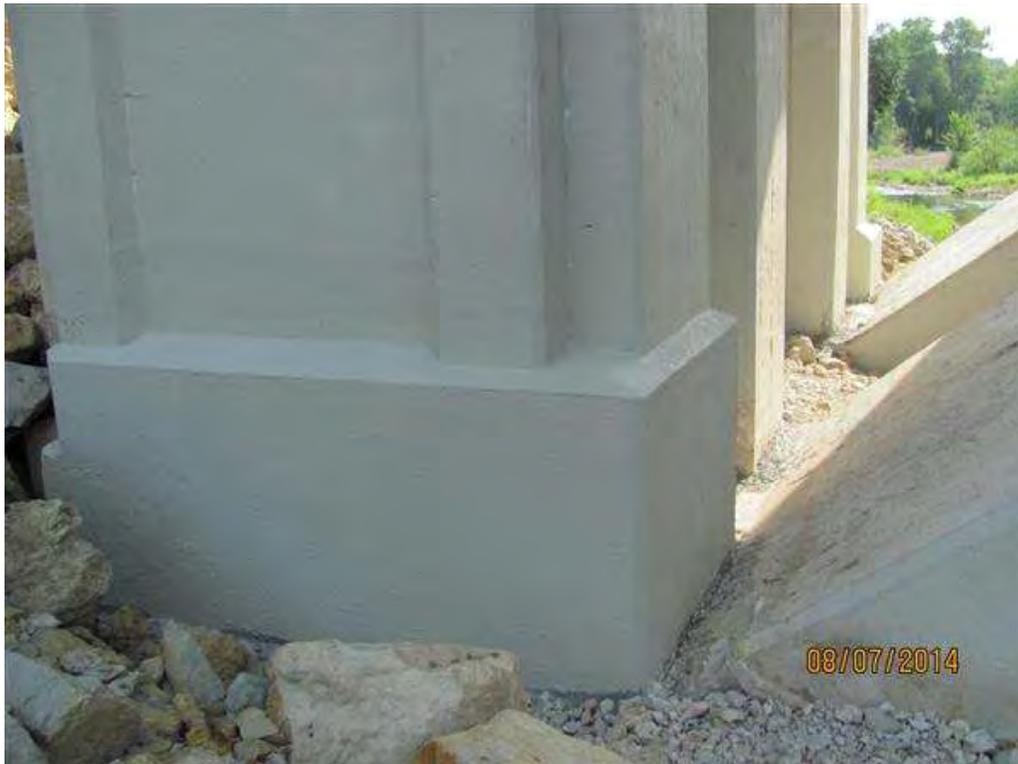
Photo 12 - Repaired Northwest side of Arch ftg.

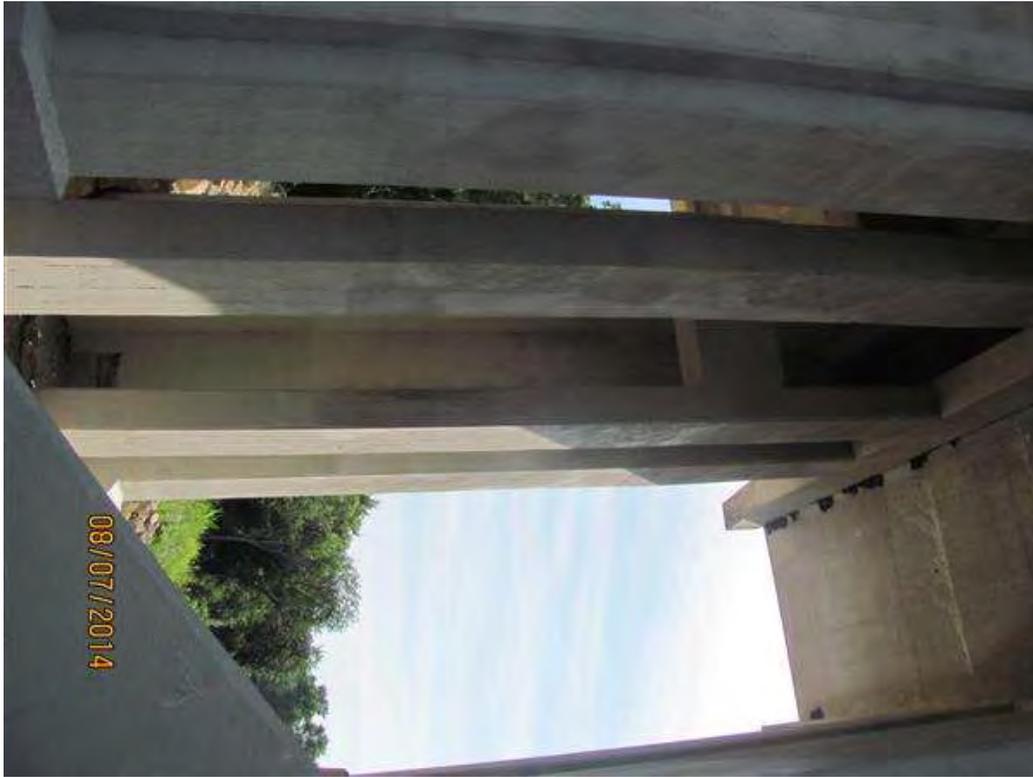
Photo 13 - Repaired columns at NW corner.

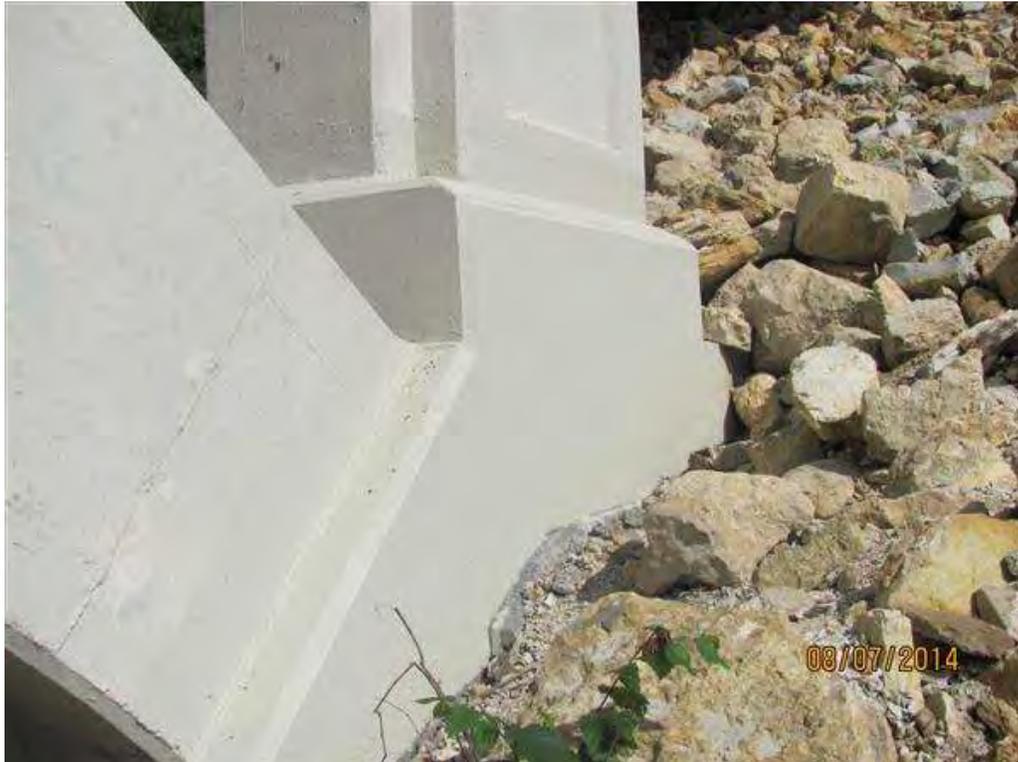
Photo 14 - Repaired Northeast side of the arch.

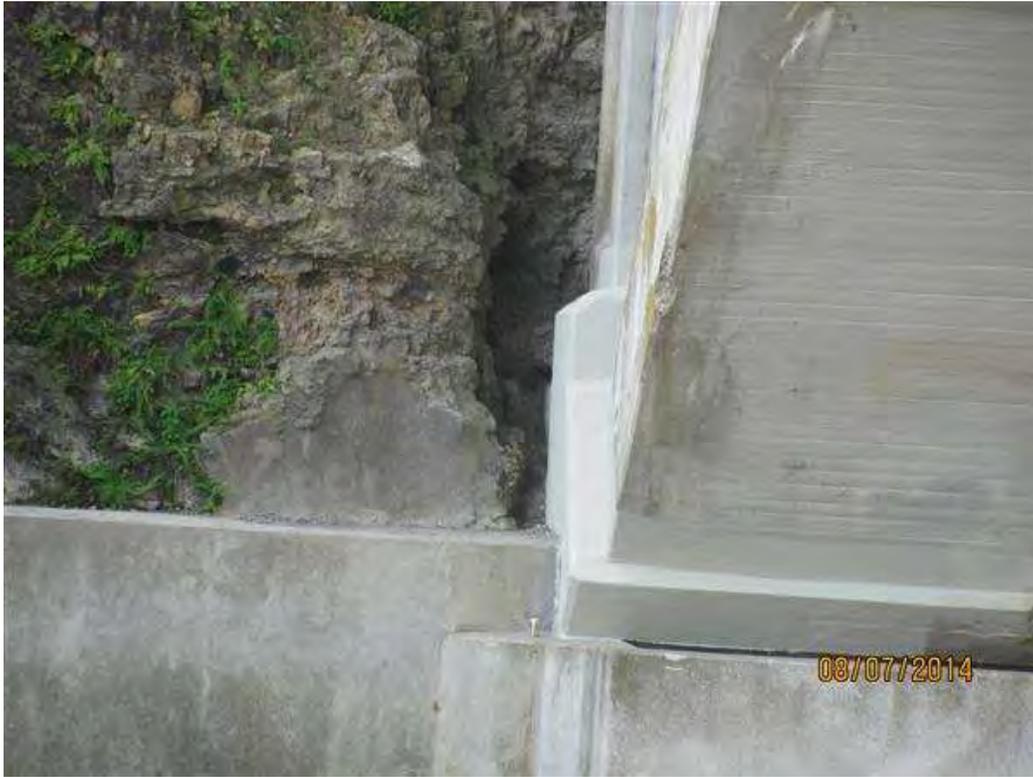
Photo 15 - SE corner of the arch repaired

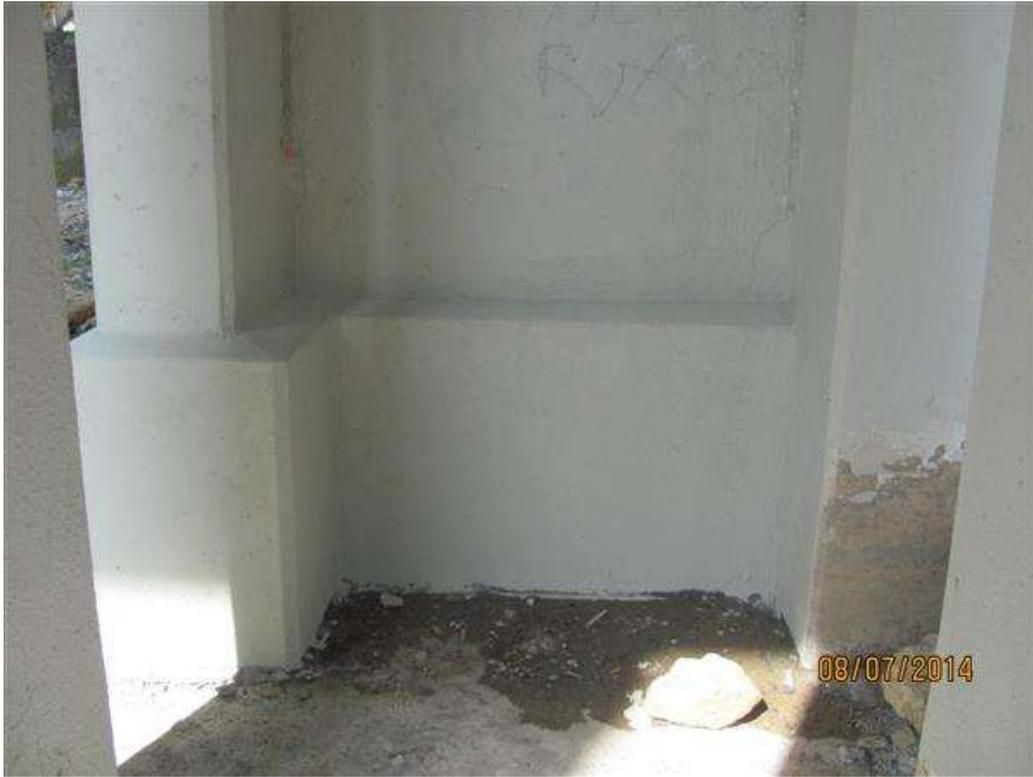
Photo 17 - Column repairs at north base of arch.
