REPORT DOCUMENTATION PAGE	1. Report No. MN/RD - 92/02	2.	3. Recipient's Accession No.
4. Title and Subtitle CULVERT RENEWAL		5. Report Date April, 1992

CULVERT RENEWAL

Final Report
March 1992

Physical Research Section
Office of Materials and Research
Minnesota Department of Transportation

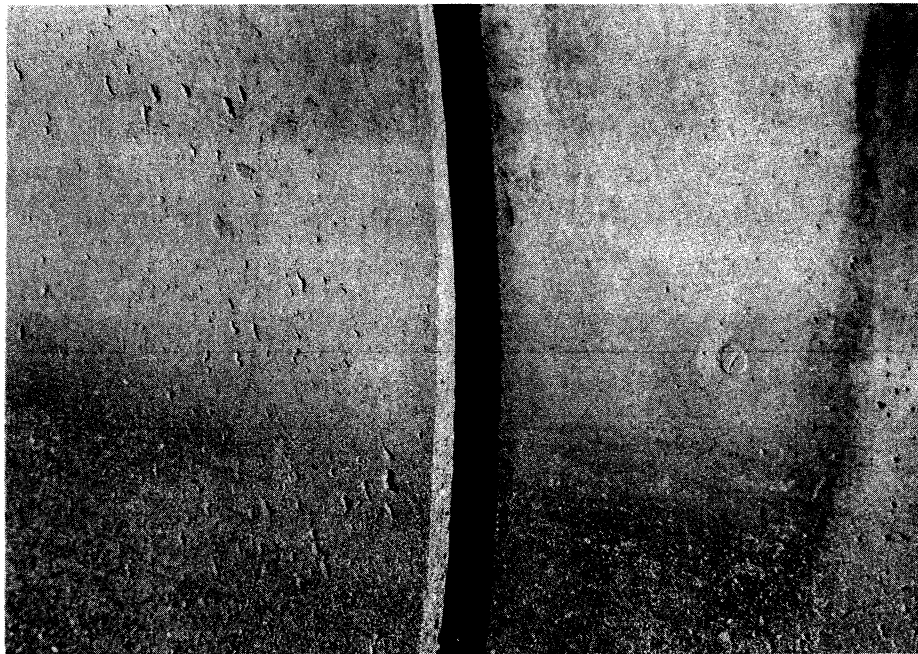
Joint separation in a concrete culvert.
