Historic Roadside Property and Safety Rest Area

Preservation and Restoration Report

Spruce Creek Culvert

CS 1602 (Bridge 8292)

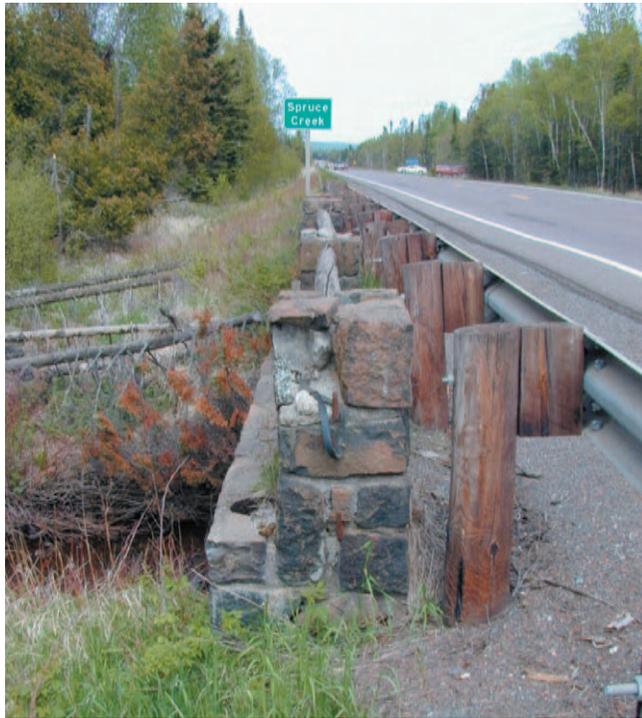
A Looking east along north rail
Note missing stonework and proximity to guardrail.

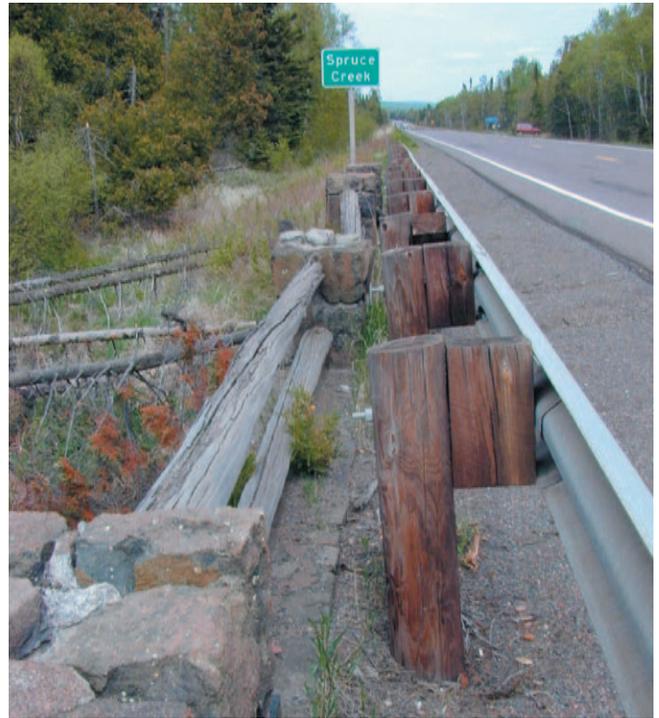
C Looking east on road side of north rail
Note condition of wood rails & space taken by guardrail

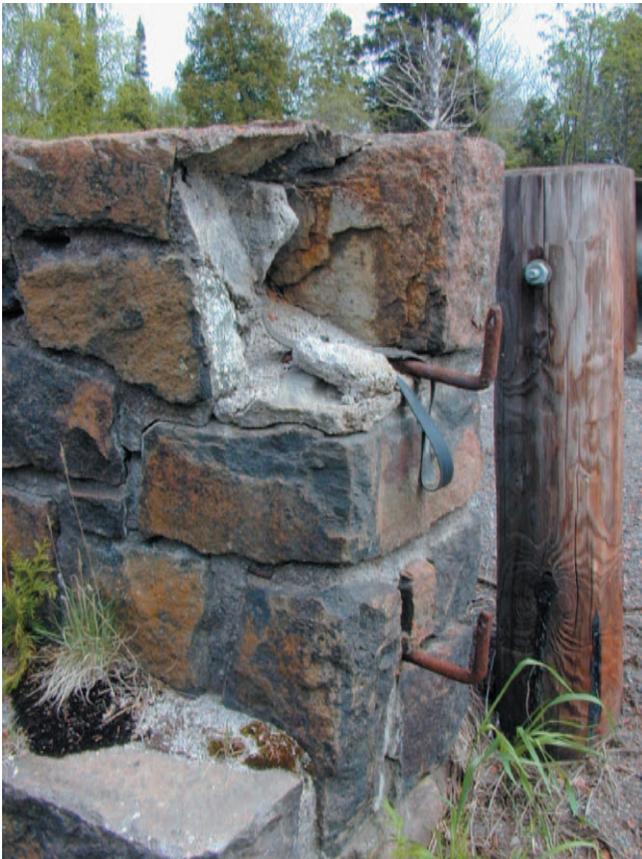
B North pier #2 from NW
Note metal brackets at #2 and #5 piers.

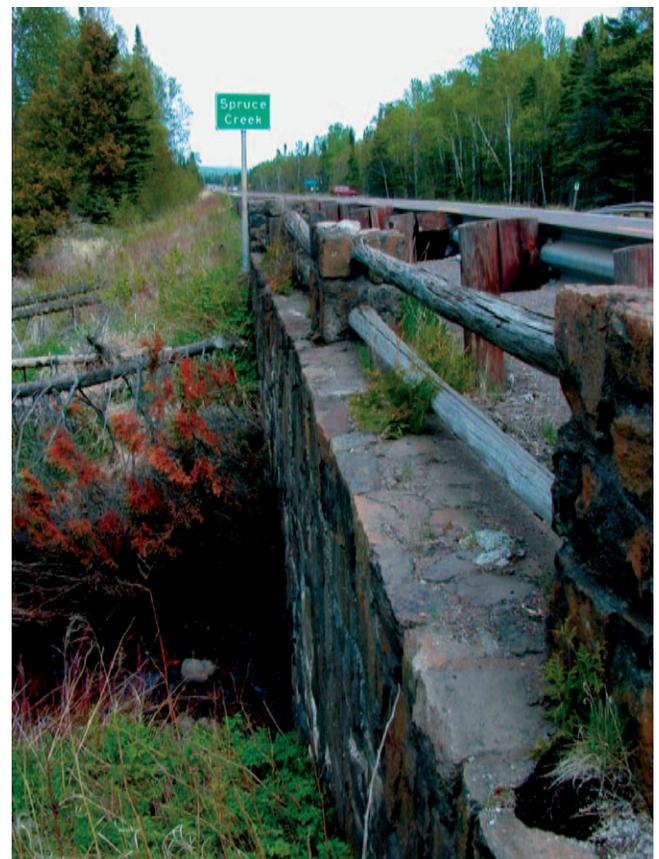
D Looking east along north wall of rail
Note vegetation adjacent to masonry walls.

Summer 2002: Remove vegetation growing immediately adjacent to walls. Remove and store existing wood rails.

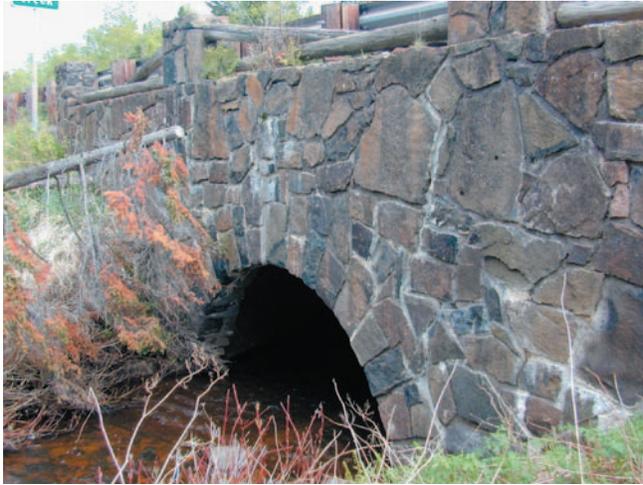
E North of upstream wall, looking from NW
Note random coursing of masonry.

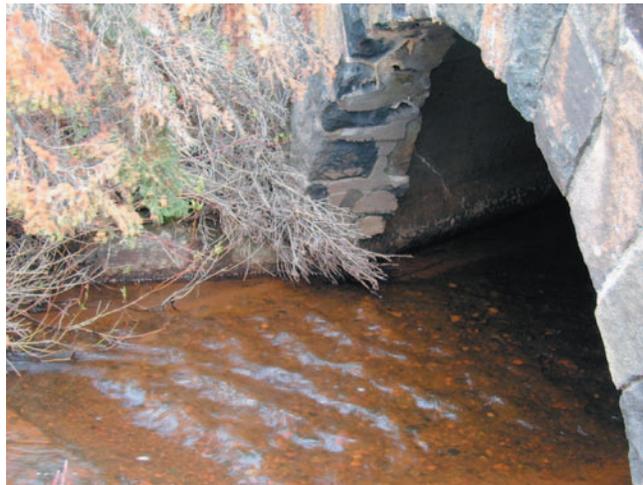
F Upstream entrance to culvert
Note re-pointing work under culvert arch.

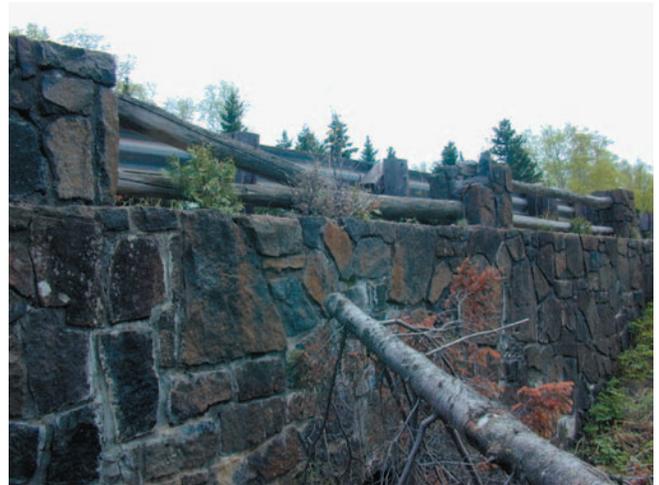
I North wall railing
Note missing masonry & deteriorated rails.

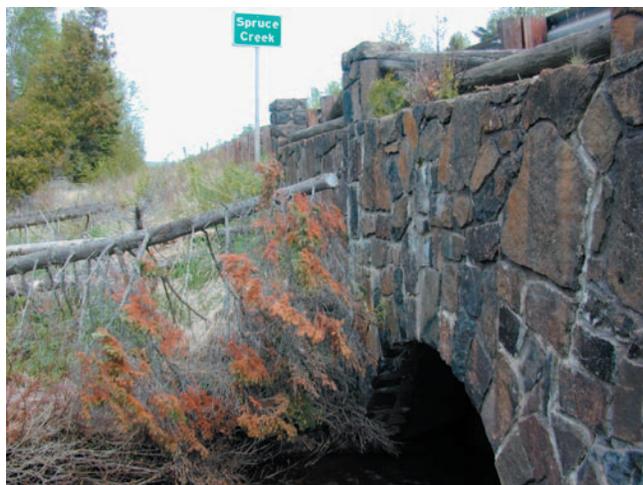
G North wall face
Note stone masonry coursing.

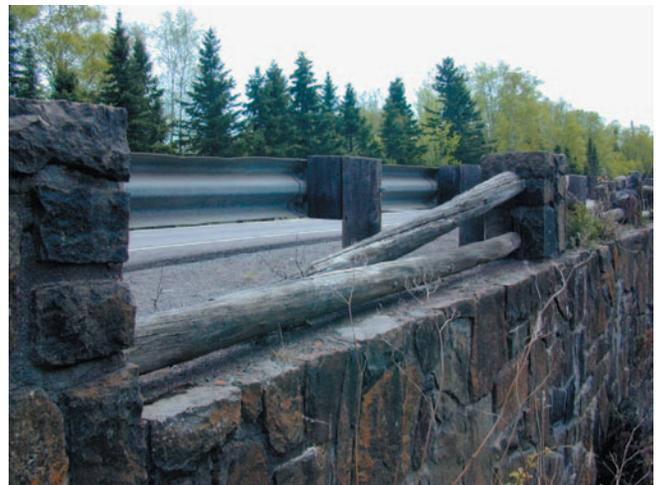
J North wall looking SW
Note missing cap stones and repair efforts with light mortar.

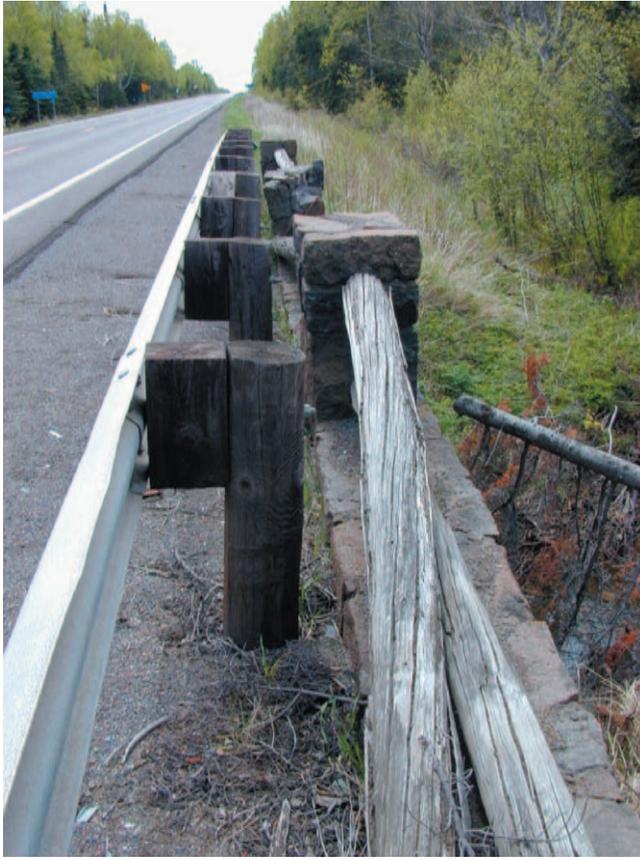
Assessment--Vehicle Circulation: Trunk Highway 61 at the Spruce Creek Culvert site is relatively narrow, with two undivided traffic lanes and a paved road edge that constricts still more at the culvert bridge (see photograph K), where the shoulder / road edge is only a few feet wide. Galvanized metal guardrails with timber posts are placed near the edge of the roadway, immediately in front of the historic culvert rail. The roadway shoulder is not wide enough for vehicles to stop at the culvert, although it widens on either end (even stopping at this point seems unsafe with sloping narrow shoulders and significant traffic volume).

K North railings looking west
Note minimal distance between guard rail, culvert rail, and roadway.

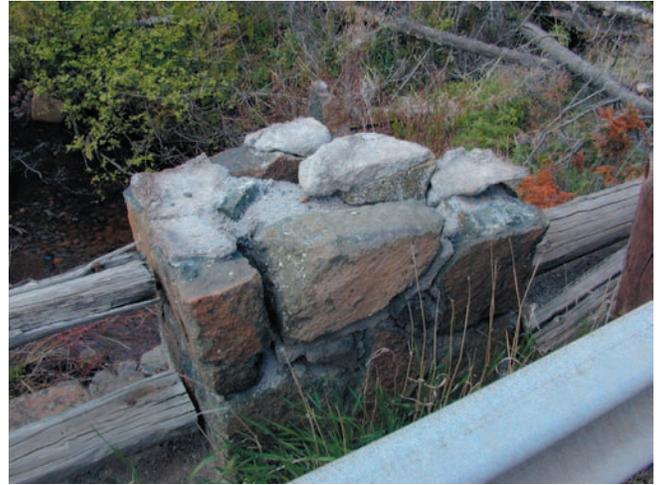
M North pier # 3
Note deteriorated top of masonry pier.

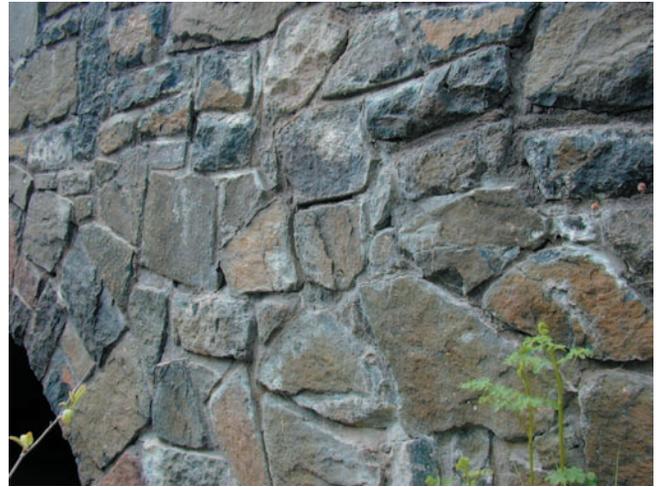
R Masonry of south face
Note random pattern of stone masonry.

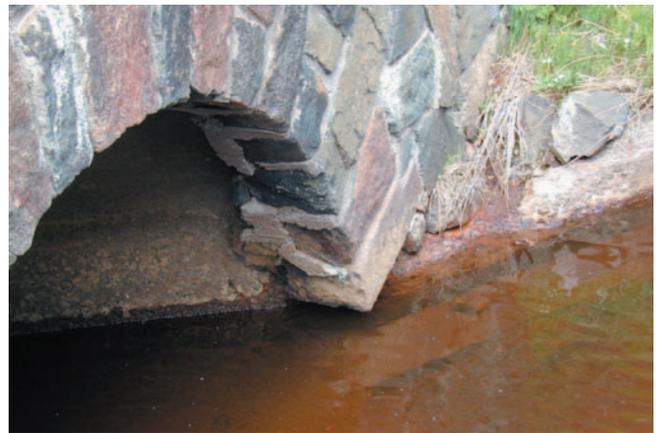
S Erosion under south wall arch
Note masonry mortar joints.

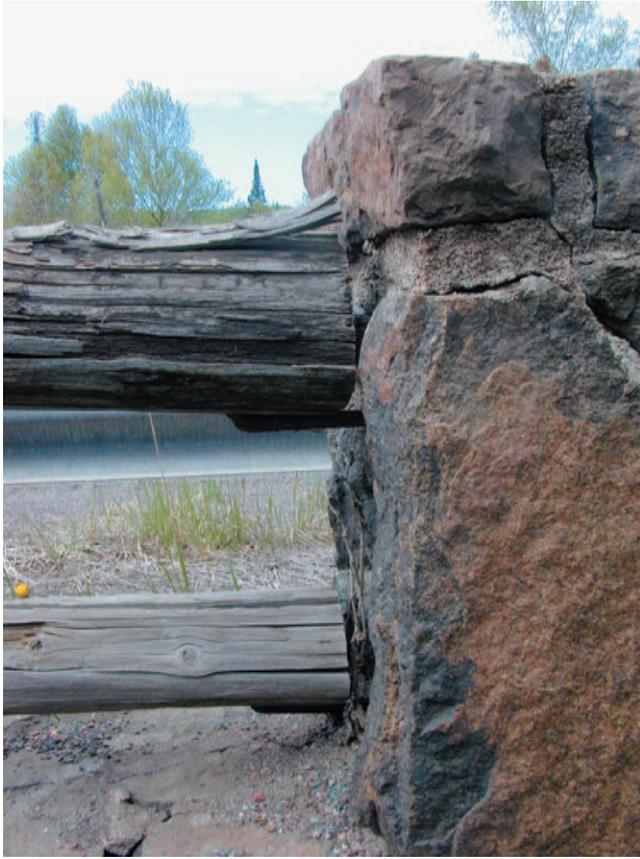
T South wall pier # 5
Note condition of mortar joints and railing ends.

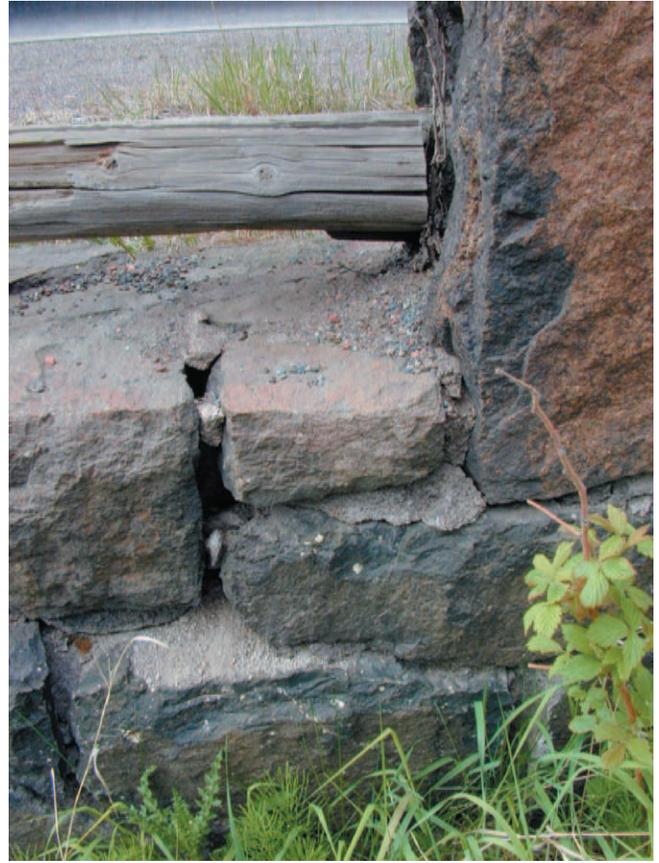
U Stone masonry pier
Note missing mortar.

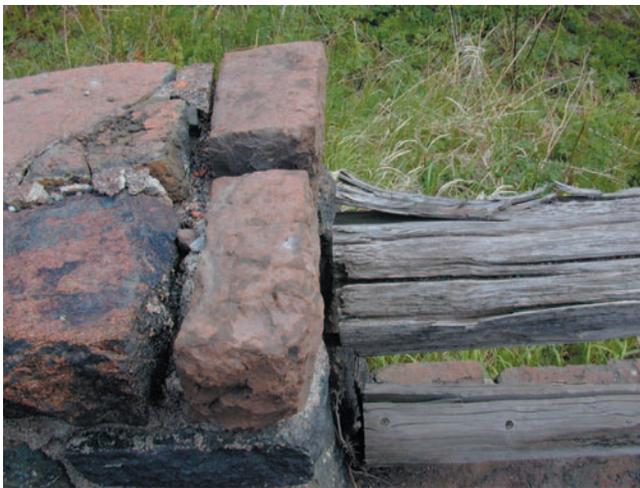
V South pier # 5
Note masonry pier and timber railing condition and detail.

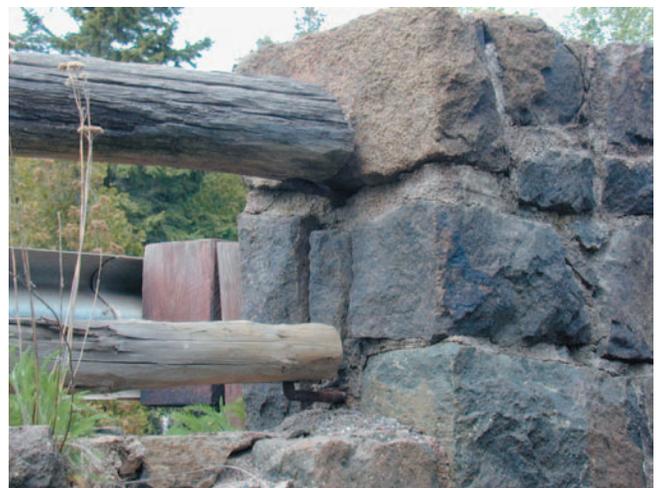
W South pier # 2
Note metal brackets designed to carry timber rails.

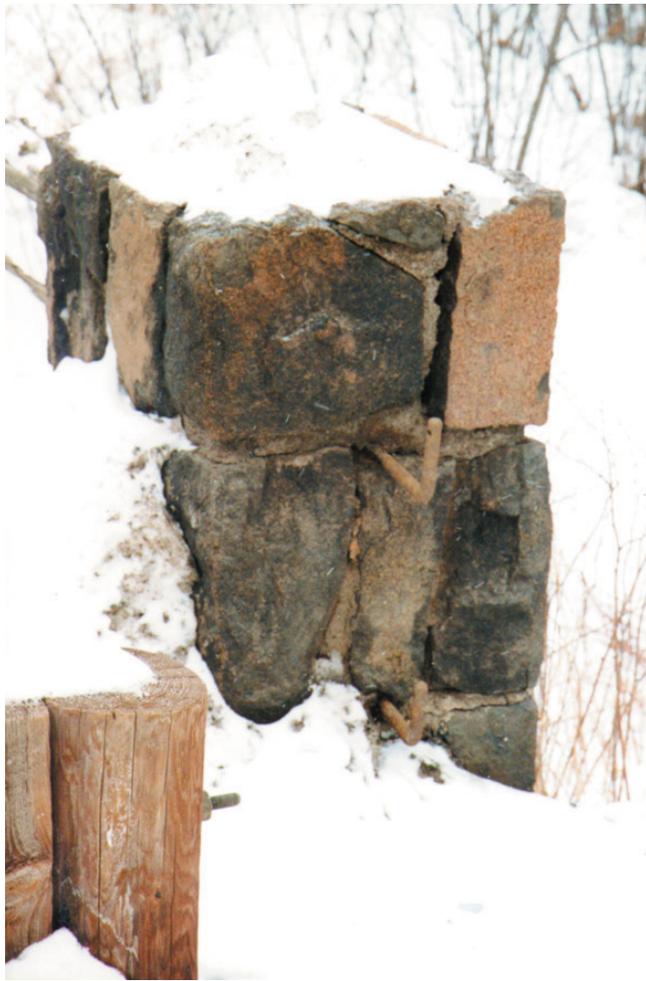
South wall pier # 2

Note metal brackets typical at end piers #2 and #5 at both west and east ends without existing rails. It is assumed that the wood rail once extended beyond each end of the stone pier for an unknown distance.
