UNDERWATER BRIDGE INSPECTION REPORT

STRUCTURE NO. 36516

UT NO. 79

BEAVER BROOK

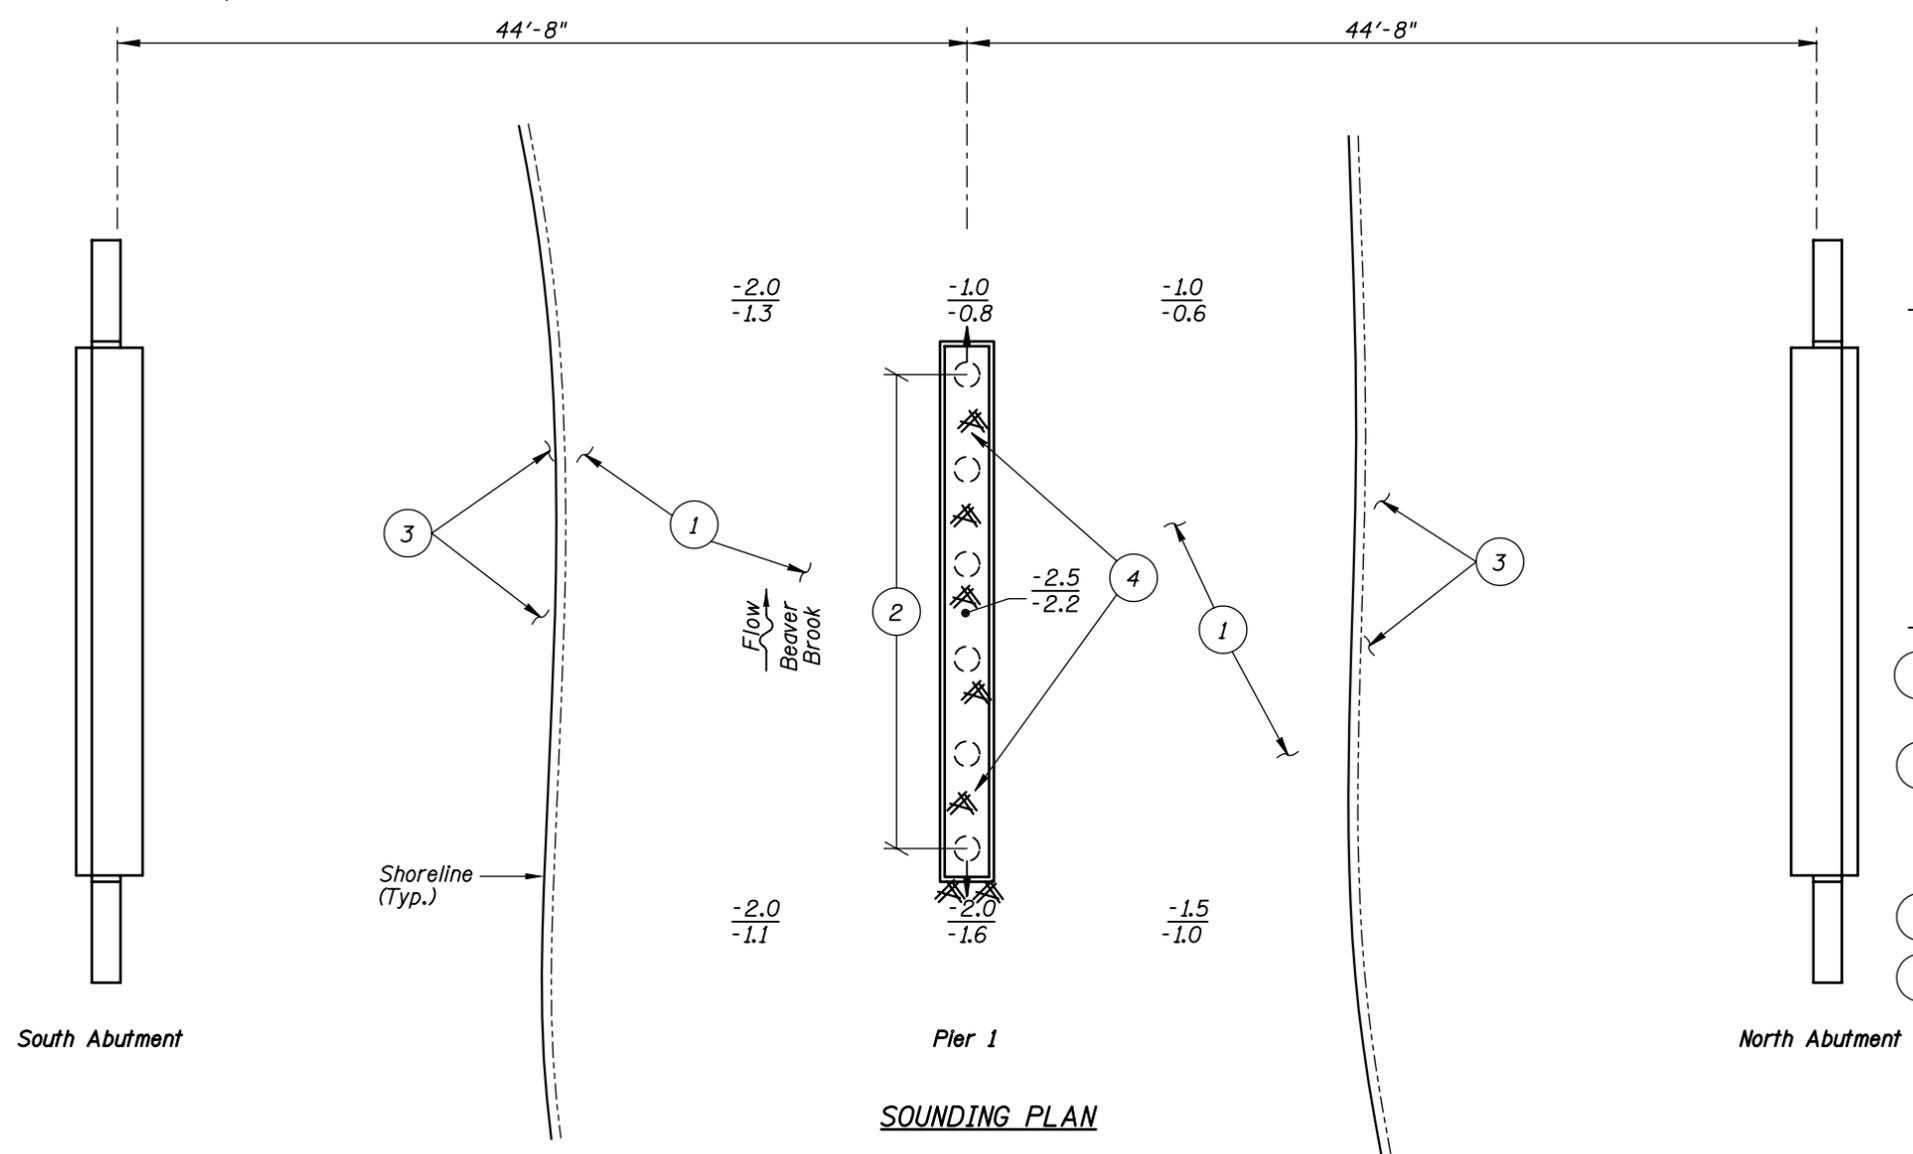
- 1 The channel material consisted of silty sand and random scattered riprap with a maximum probe rod penetration of 6 inches.
- 2 Up to 50 percent coating failure and up to 25 percent nodular corrosion ranging in size from 1/4 inch to 1 inch in diameter was observed from 1-1/2 feet above the waterline to the mudline on all of the steel pipe piles. Typical pitting under the nodules was 1/32 inch with some pitting up to 1/16 inch.
- 3 The banks consisted of 6 inch to 3 feet diameter riprap.
- 4 Light timber debris consisting of logs ranging from 6 inches to 1 foot in diameter were observed among the piles.

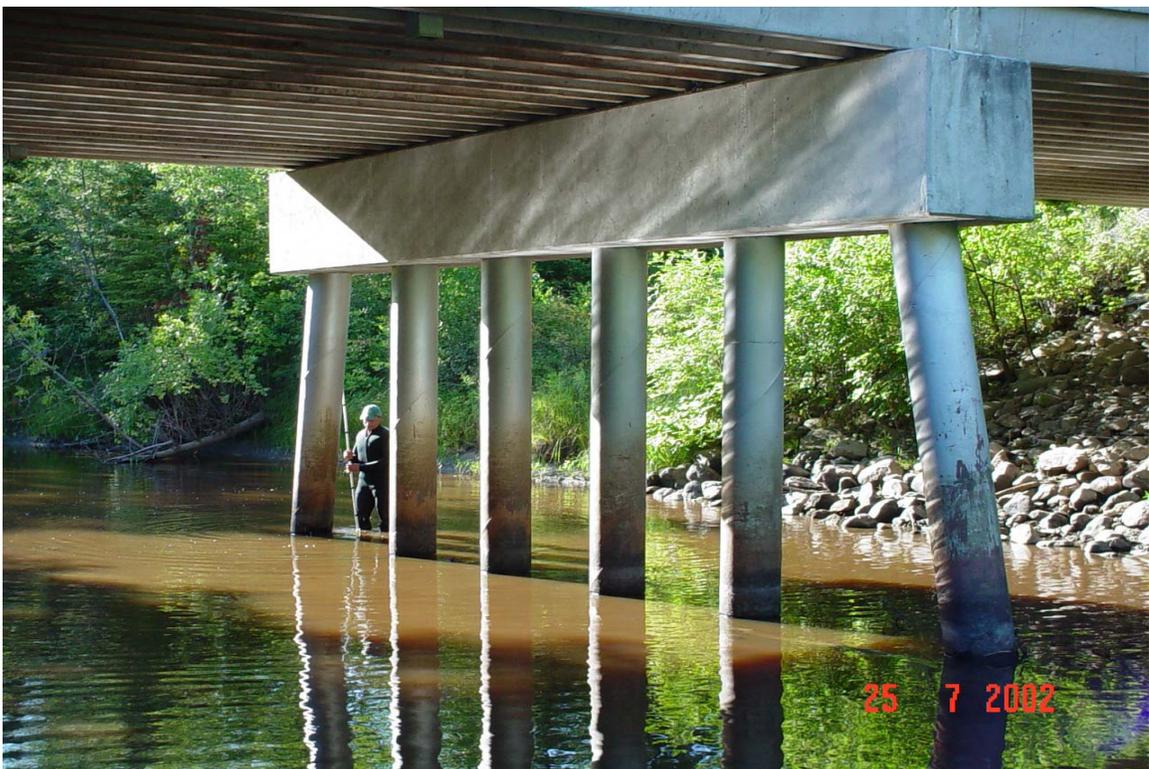
The substructure unit inspected below water at Bridge No. 36516, Pier 1, was found to be in good condition with no defects of structural significance observed. The channel bottom appeared stable with no significant scour and no significant changes since the last inspection.

Photograph 2. View of Pier 1, Looking Northwest.

- (A) Reinspect the submerged substructure units at the normal maximum recommended (NBIS) interval of five (5) years.

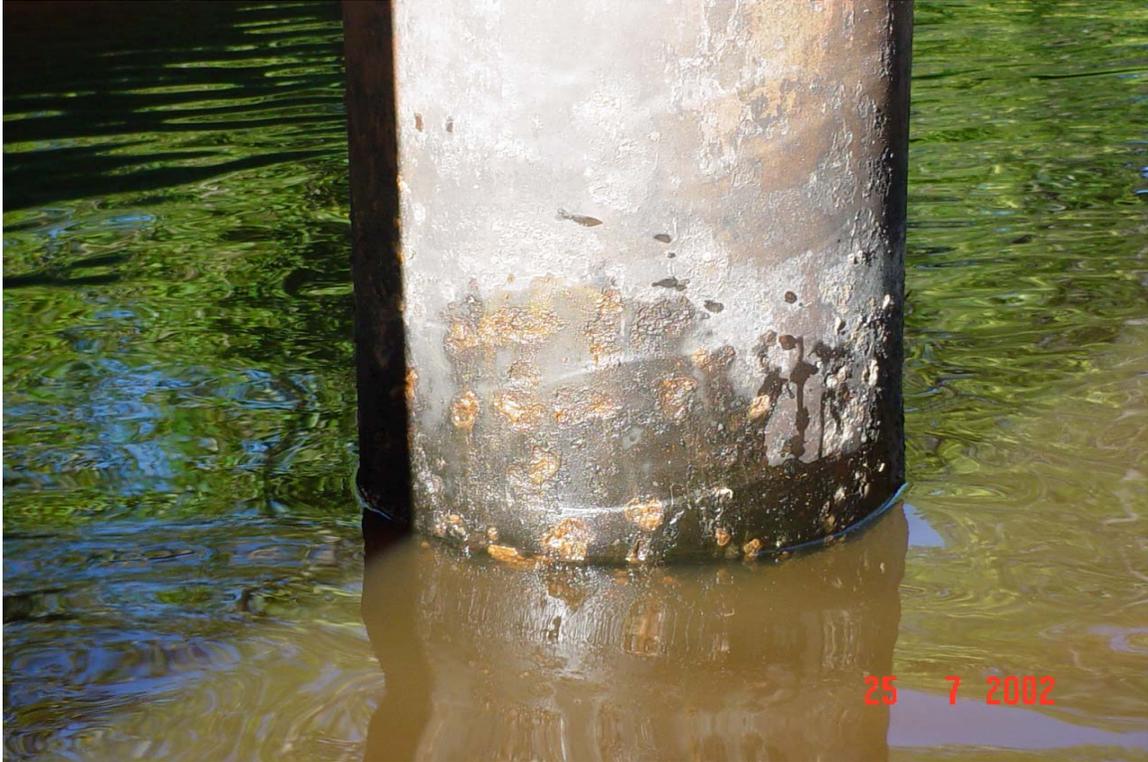
- (A) Random areas of coating failure and light surface corrosion were observed on all piles with some minor pitting, but with no significant section loss or other defects observed.
- (B) There was some light timber drift on the channel bottom scattered amongst the pier piles.

Photograph 3. View of Typical Pitting and Rust Nodules at the 2<sup>nd</sup> Pile in from the Upstream Fascia of Pier 1, Looking Northeast.

REMARKS: The steel shell piles were in good, sound condition, with 50% coating failure, and up to 25% nodular corrosion, with nodules ranging in size from 1/4 inch diameter to a maximum of 1 inch diameter. When removed, nodules revealed typical pitting ranging from 1/32 inch penetration to 1/16 inch of penetration.
