UNDERWATER BRIDGE INSPECTION REPORT

STRUCTURE NO. 58506  
CSAH NO. 7  
OVER THE  
SNAKE RIVER  
DISTRICT 1 - PINE COUNTY

PREPARED FOR THE  
MINNESOTA DEPARTMENT OF TRANSPORTATION  
BY  
COLLINS ENGINEERS, INC.  
JOB NO. 3512 (CEI 73)

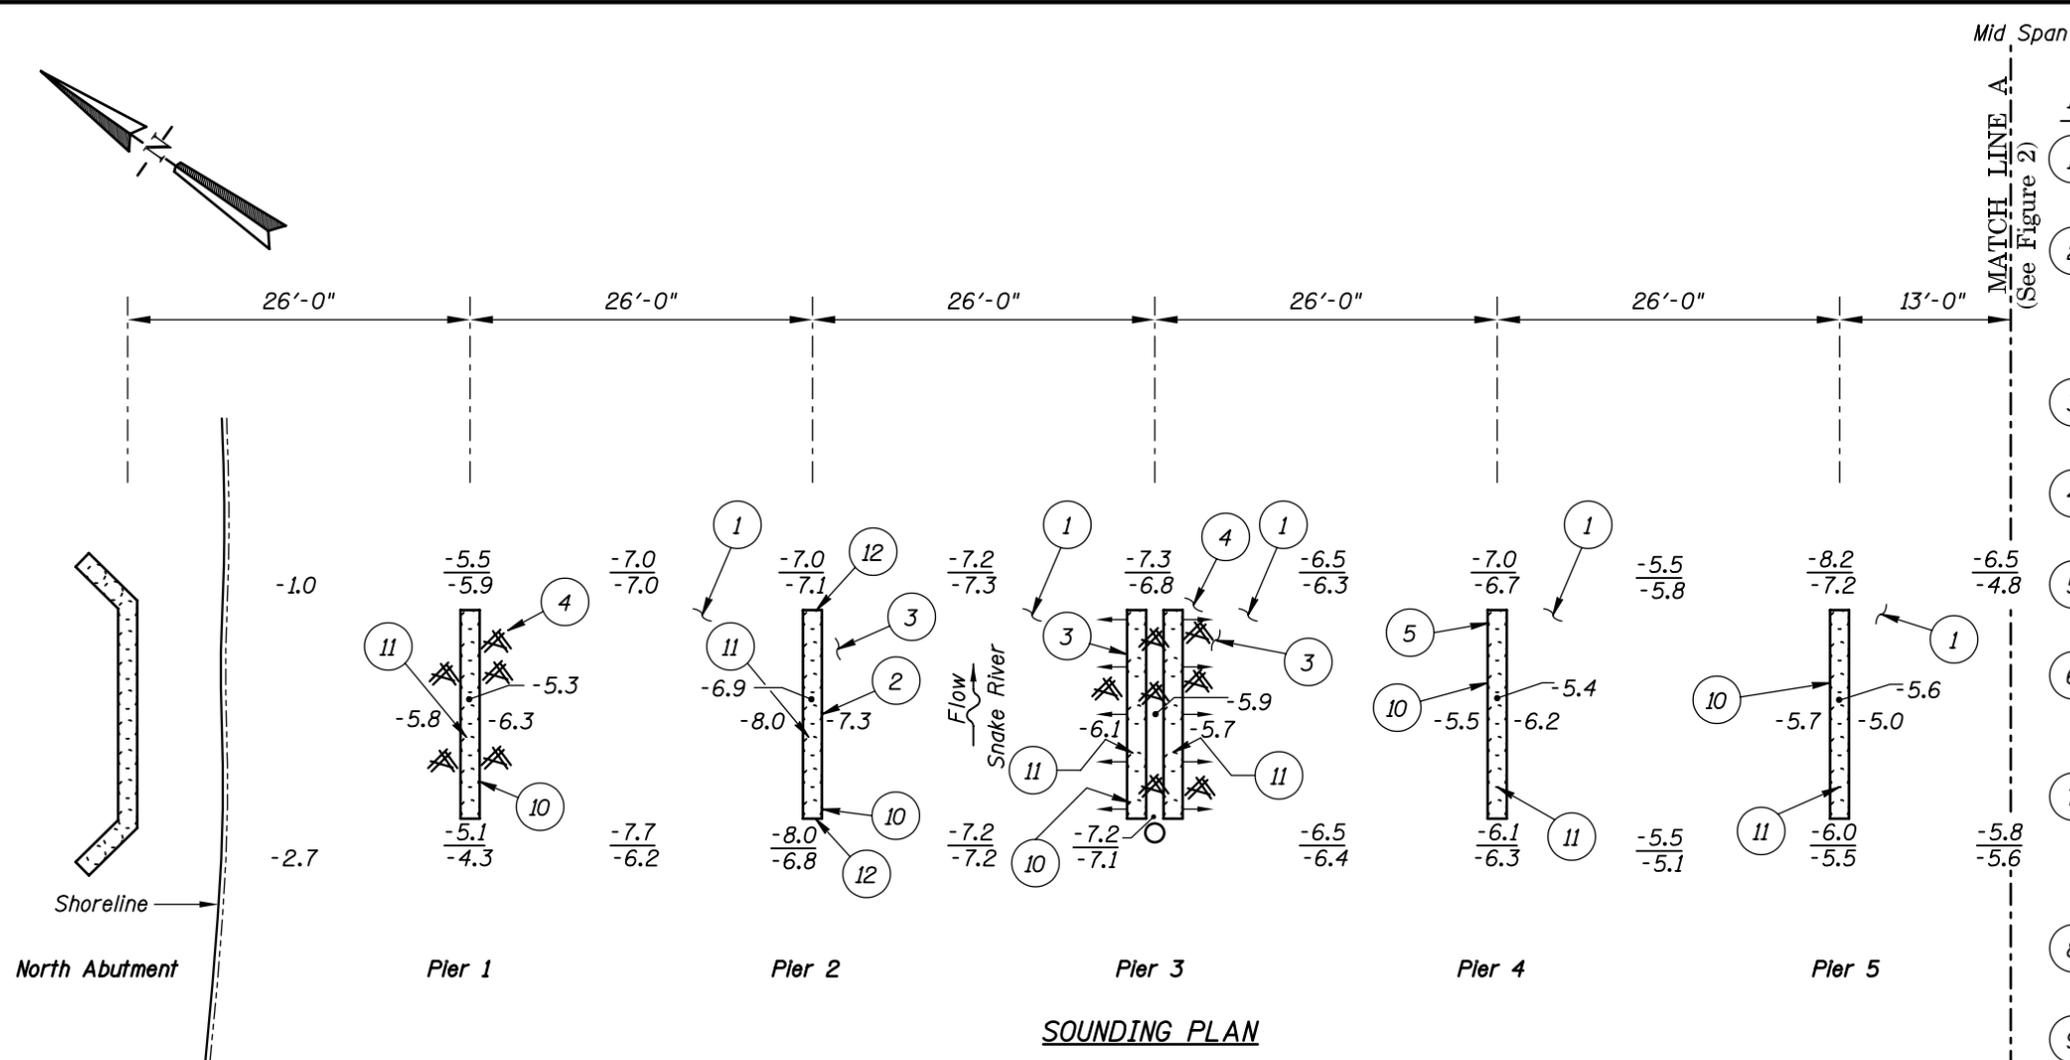
- 1 The channel bottom consisted of silty sand with random scattered riprap and up to 6 inches of probe rode penetration.
- 2 The outer 1/2 inch shell of the fourth pile from the west end of pier was cracked, splintered, soft, and delaminated. This condition was present from the channel bottom to 1 foot above the waterline. Probing revealed the wood beneath this outer shell to be sound.

- 3 The channel bottom at Piers 2 and 3 consisted of sand and riprap up to 6 inches in diameter with no appreciable probe rod penetration.
- 4 A minor accumulation of timber debris was observed around the piles of Piers 1, 3, and 7.

- 5 A 1/2 inch wide by 5 feet long crack was present in the diagonal bracing at the east connection on the north side.
- 6 The diagonal brace was cracked and splintered at the bottom connections. The fourth pile from the west end displayed soft wood to a depth of 1/2 inch at a 3 inch diameter knot hole 1 foot below the waterline.

- 7 A 12 inch high by 6 inch wide by 3/4 inch deep portion of the outer shell of this pile has splintered outward. The wood beneath this area was soft to a depth of 1/4 inch. The estimated loss in cross sectional area was 10 to 20 percent. This condition occurred at 2 feet below the waterline.

- 8 The channel bottom at Piers 7 through 9 consisted of a mixture of gravel and riprap with no appreciable probe rod penetration.
- 9 The east-west retaining wall at this location was leaning and has failed.

- 10 Brace at connection heavily cracked and deteriorated.
- 11 All of the piles exhibited random checking up to 1/4 inch wide, and a softer out pile shell up to 1/4 inch thick with 1/8 inch wide splits.

- 12 The edge braces were broken at the waterline at the upstream pile and the downstream pile of Pier 2.
- 13 A 1/2 inch wide by 8 feet long split in the brace that was broken through the pile connection was observed on the north face of Pier 3.

- 14 A 1/2 inch wide by 5 feet long split in the brace connection was observed on the downstream end of Pier 6.

- (A) The cracked, split, and deteriorated pier cross-bracing should be replaced to restore the lateral stability of the piers.

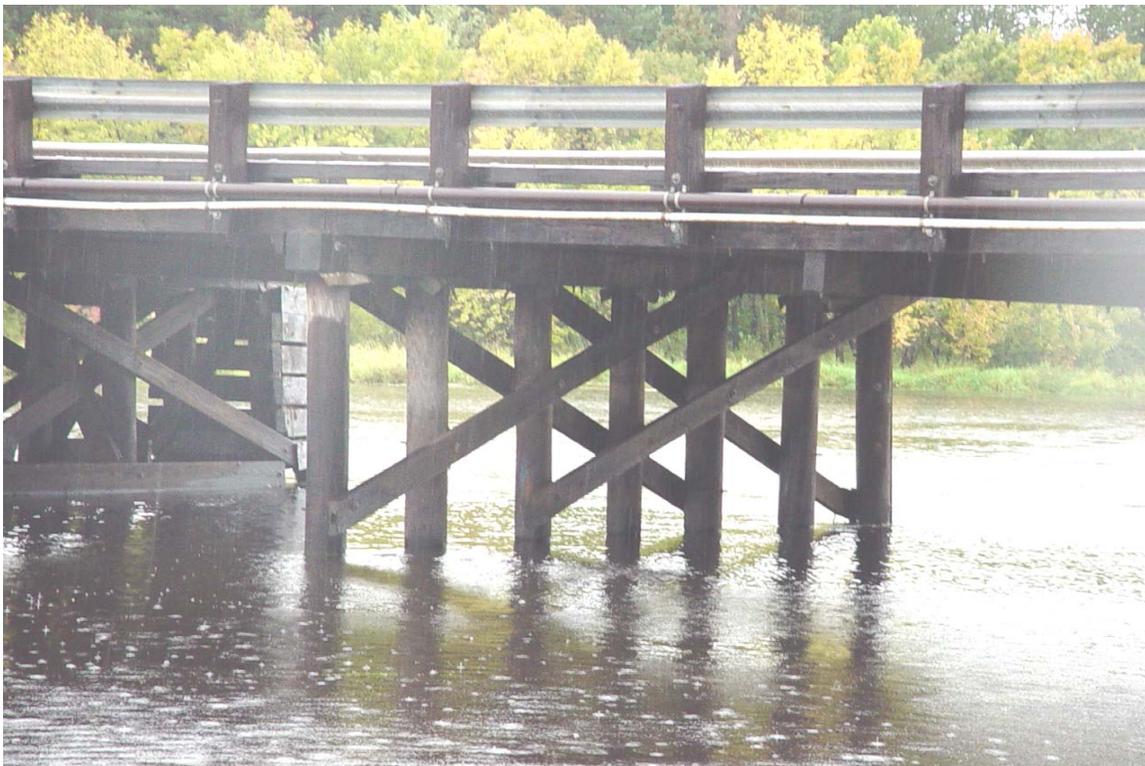
Photograph 4. View of Pier 2, Looking Southwest.

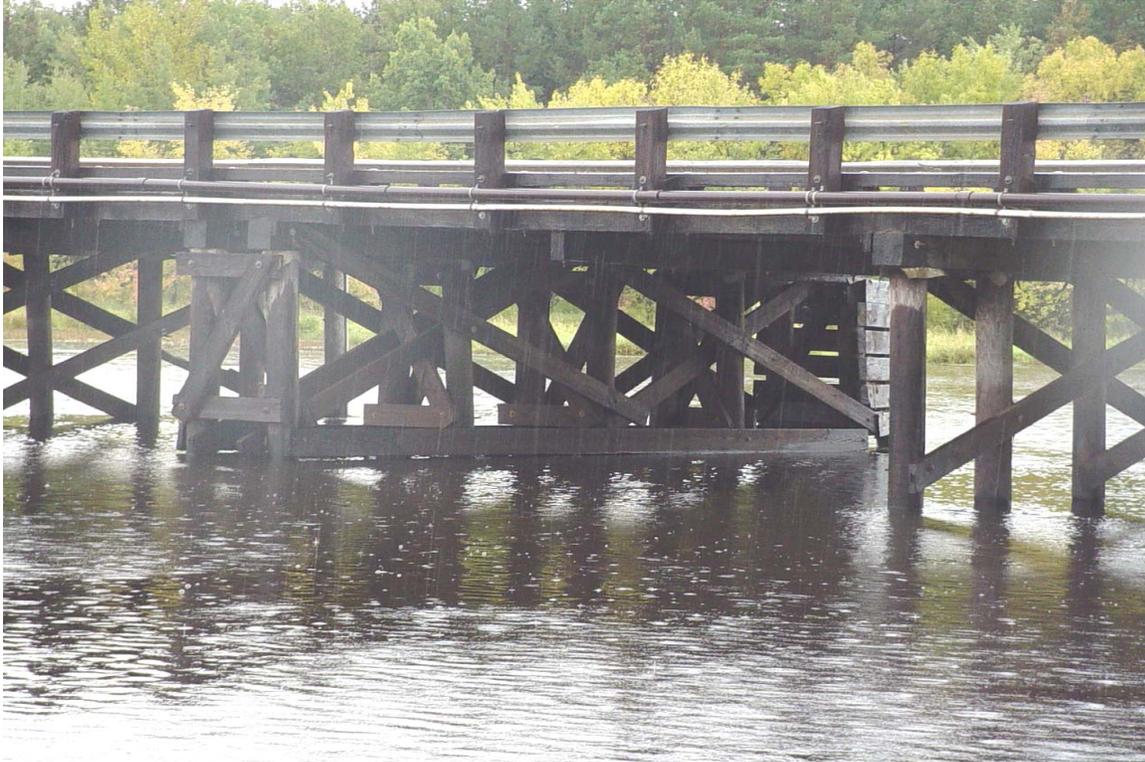
Photograph 5. View of Pier 3, Looking Southwest.

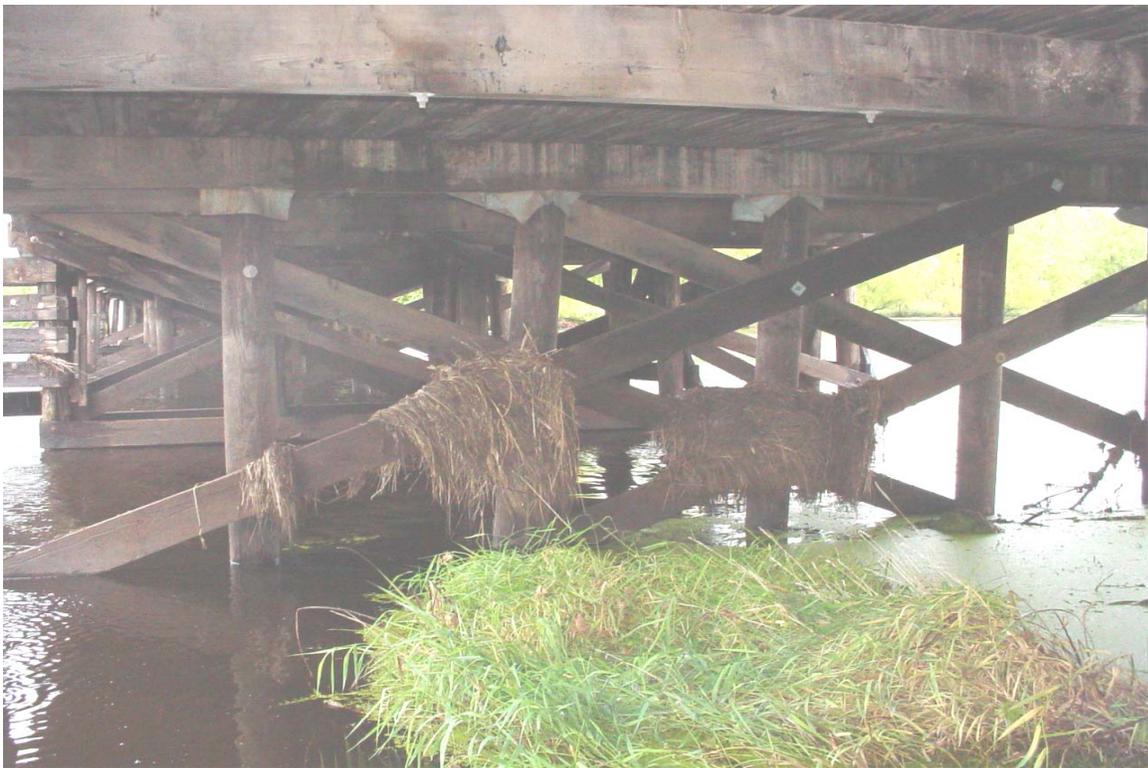
- \* The westernmost pile on the south side of Pier 7 was splintered over a 12 inch high by 6 inch wide by 3/4 inch deep area. This area was located 2 feet below the waterline. The material beneath the splintered material was soft to an estimated depth of 1/4 inch. The total loss of cross-section at this location was estimated to be between 10 and 20 percent.

Photograph 8. View of Pier 7, Looking North.

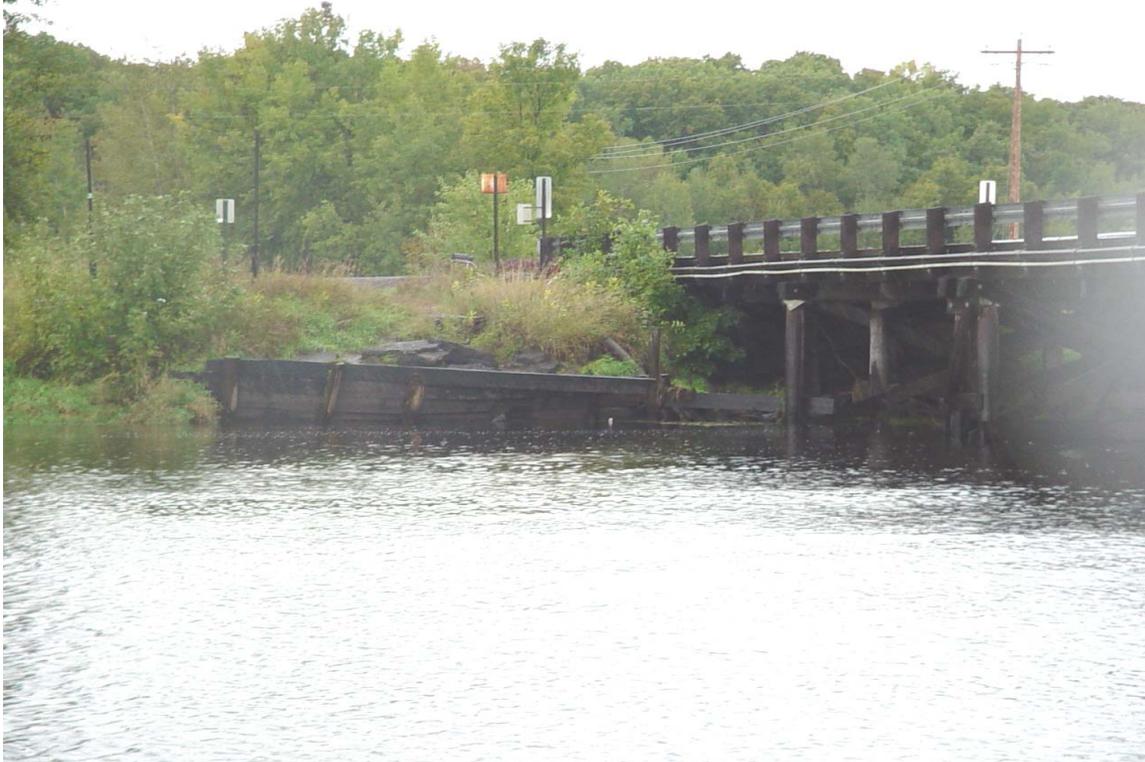
- (A) It was observed that the retaining wall located to the east of Pier 8 was leaning into the channel and has failed.
- (B) In general, the cross-bracing between the piles of each pier was in fair to poor condition with splitting typically at one or more brace connections on each pier. Many of the pier braces also displayed moderate to heavy section loss and related connection failures.
- (C) The majority of the timber piles were in fair condition with weathering and random vertical checking present with widths of up to 1/4 inch. The only significant pile distress found was as follows:
  - \* The pile at the center of Pier 2 was cracked, splintered and soft to a depth of 1/2 inch. This condition existed from 1 foot above the waterline to the channel bottom. Below this 1/2 inch softer outer layer, the wood material was sound and firm.

Photograph 9. View of the Retaining Wall Along the Southeast Embankment at the Bridge, Looking Southeast.
