UNDERWATER BRIDGE INSPECTION REPORT

STRUCTURE NO. 58510
CSAH NO. 61
OVER THE
SNAKE RIVER
DISTRICT 1 - PINE COUNTY

PREPARED FOR THE
MINNESOTA DEPARTMENT OF TRANSPORTATION
BY
COLLINS ENGINEERS, INC.
JOB NO. 3512 (CEI 72)

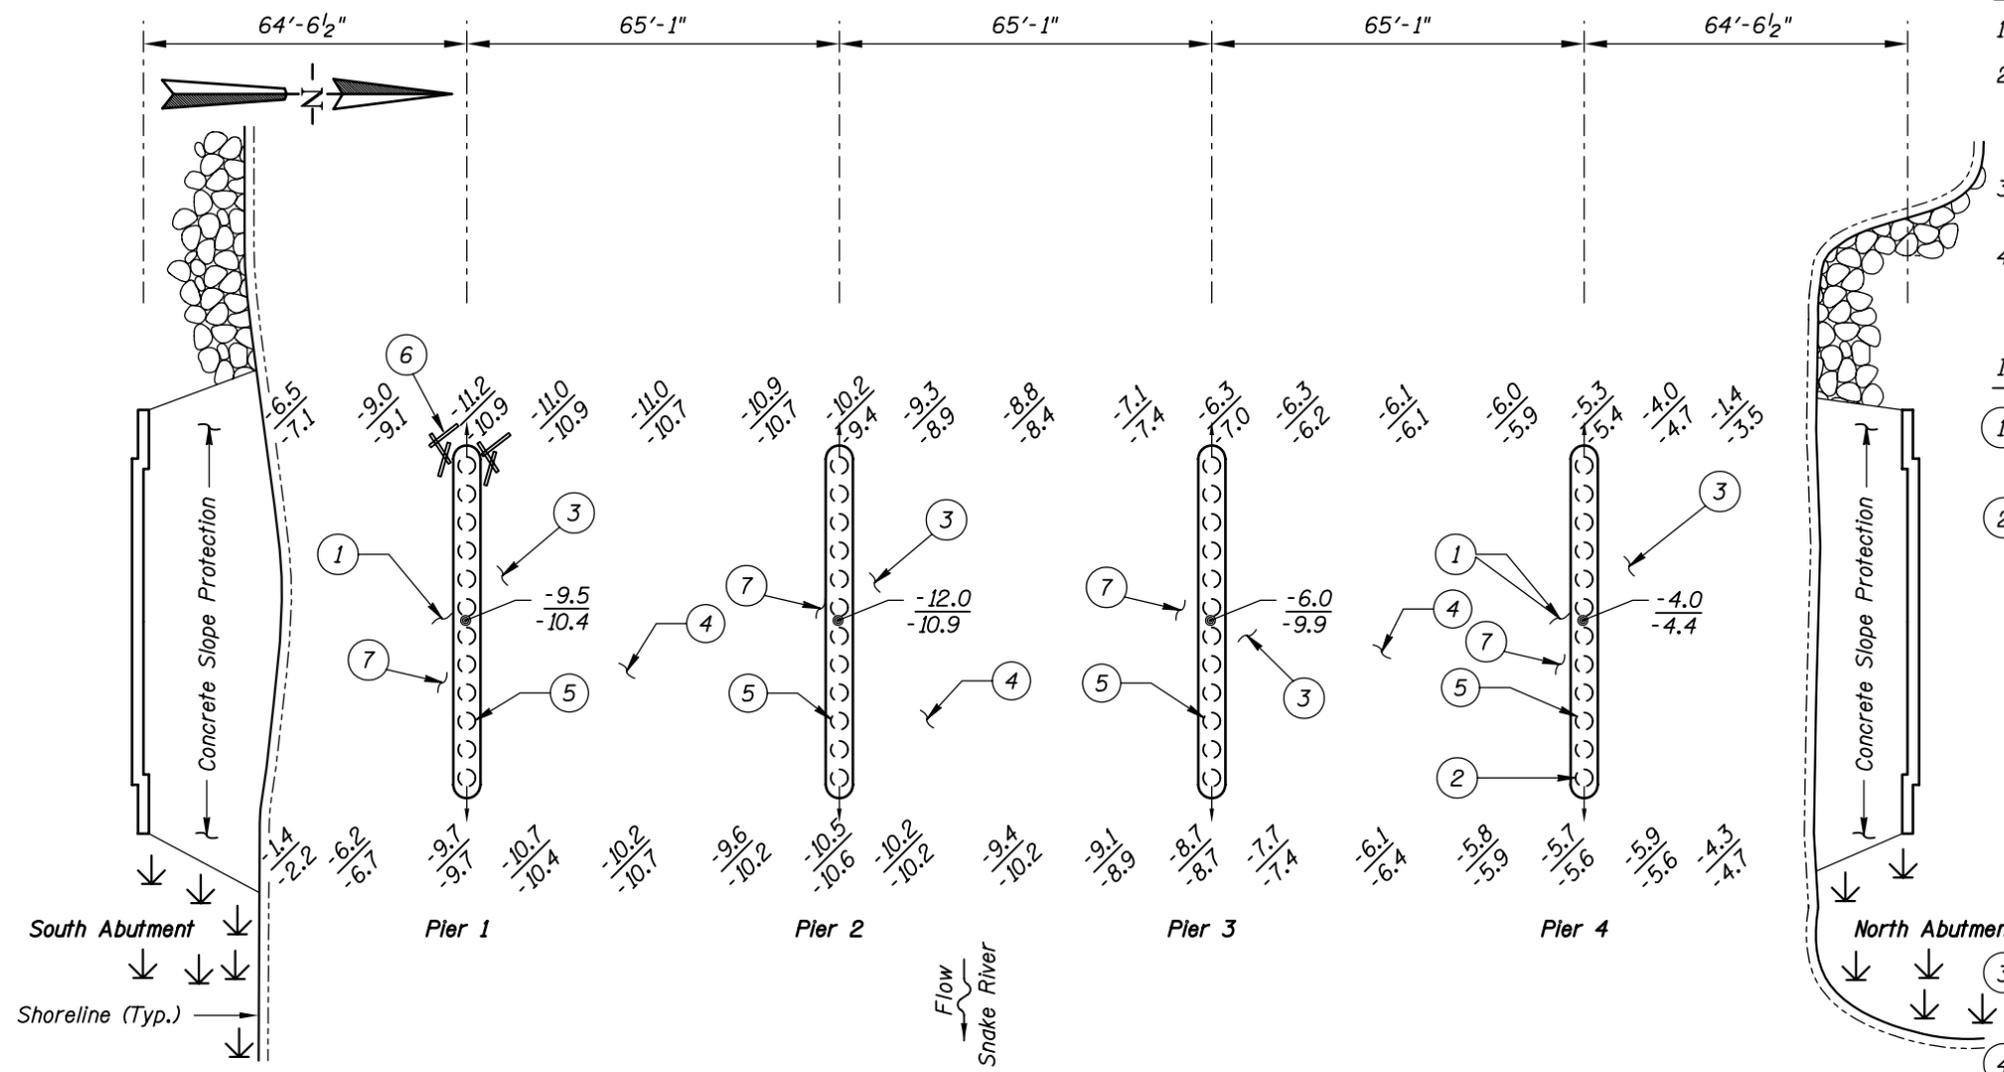
SOUNDING PLAN

- ① A light amount of scattered timber debris was observed on the south side of Piers 1 through 4 along the channel bottom.
- ② Four deformations were present on the east and south side of the easternmost pile:

- A. A 6 inch wide by 3 inch high by 2 inch deep dent was located 4 feet below water on the south face.
 - B. A 6 inch by 3 inch high by 1 inch deep dent located at 3 feet below the waterline.

- C. A 6 inch diameter by 2 inch deep dent located at the waterline. This dent was accompanied by 1/8 inch deep corrosion pitting.
 - D. An 8 inch diameter by 1 inch deep dent located at 1.5 foot below the waterline.

- ③ Timber piles from an earlier structure were located along the north side of each pier. The tops of the piles were located at 2 feet above channel bottom.

- ④ Channel bottom material consisted of gravelly sand with scattered riprap and cobbles, and 2 inch maximum probe rod penetration.
- ⑤ Light to moderate corrosion on all piles from 2 feet above the waterline to the channel bottom with 1/4 inch diameter rust nodules covering approximately 50% of the surface area of the piles, with a maximum of 1/8 inch deep pitting.

- ⑥ Metal dock framing debris was observed around the two upstream piles of Pier 1.
- ⑦ A light accumulation of grassy vegetation was observed around all of the piers.

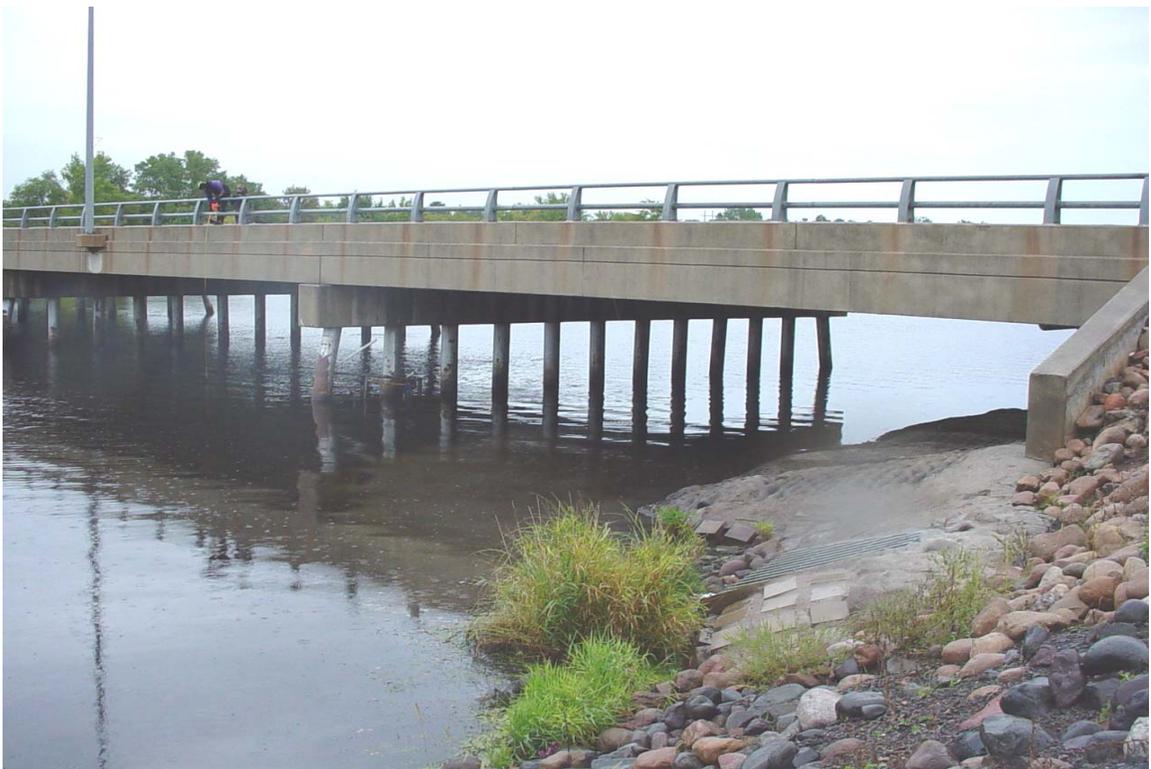
Photograph 2. View of Pier 1, Looking Northeast.

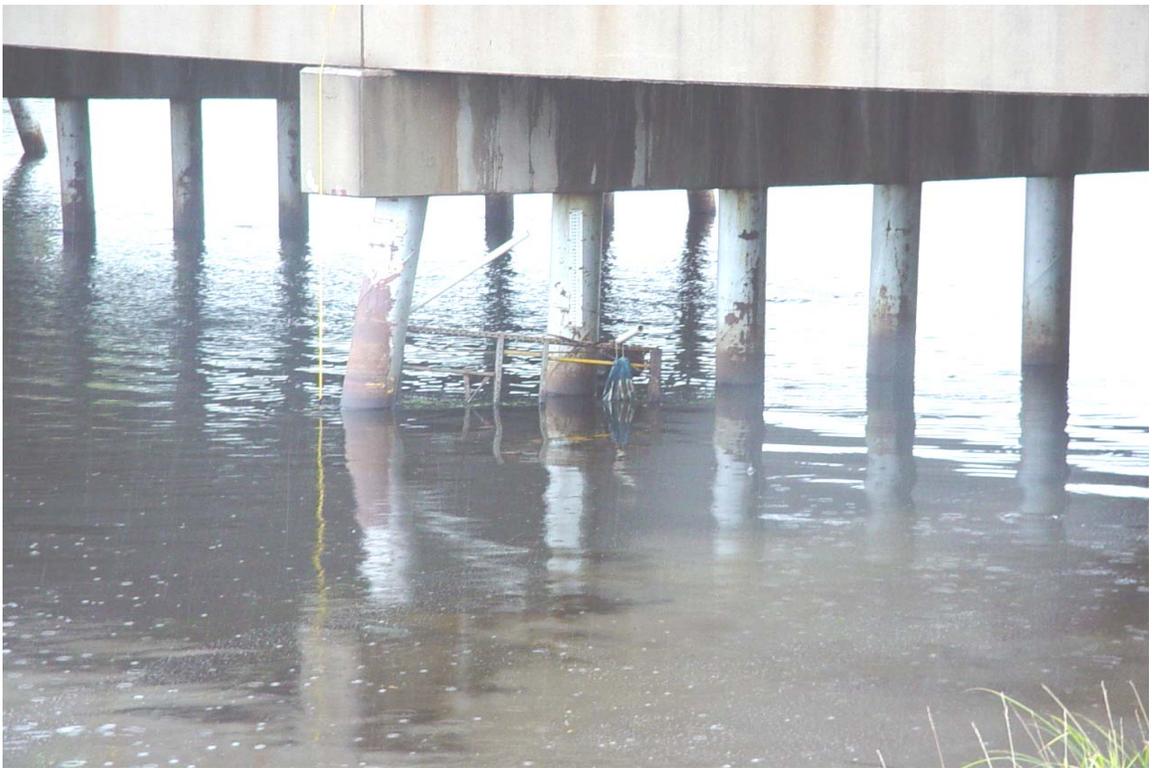
Photograph 6: View of Debris at the Upstream Nose of Pier 1, Looking Northeast.
