# UNDERWATER BRIDGE INSPECTION REPORT

STRUCTURE NO. 7111

CR NO. 229

BIG FORK RIVER

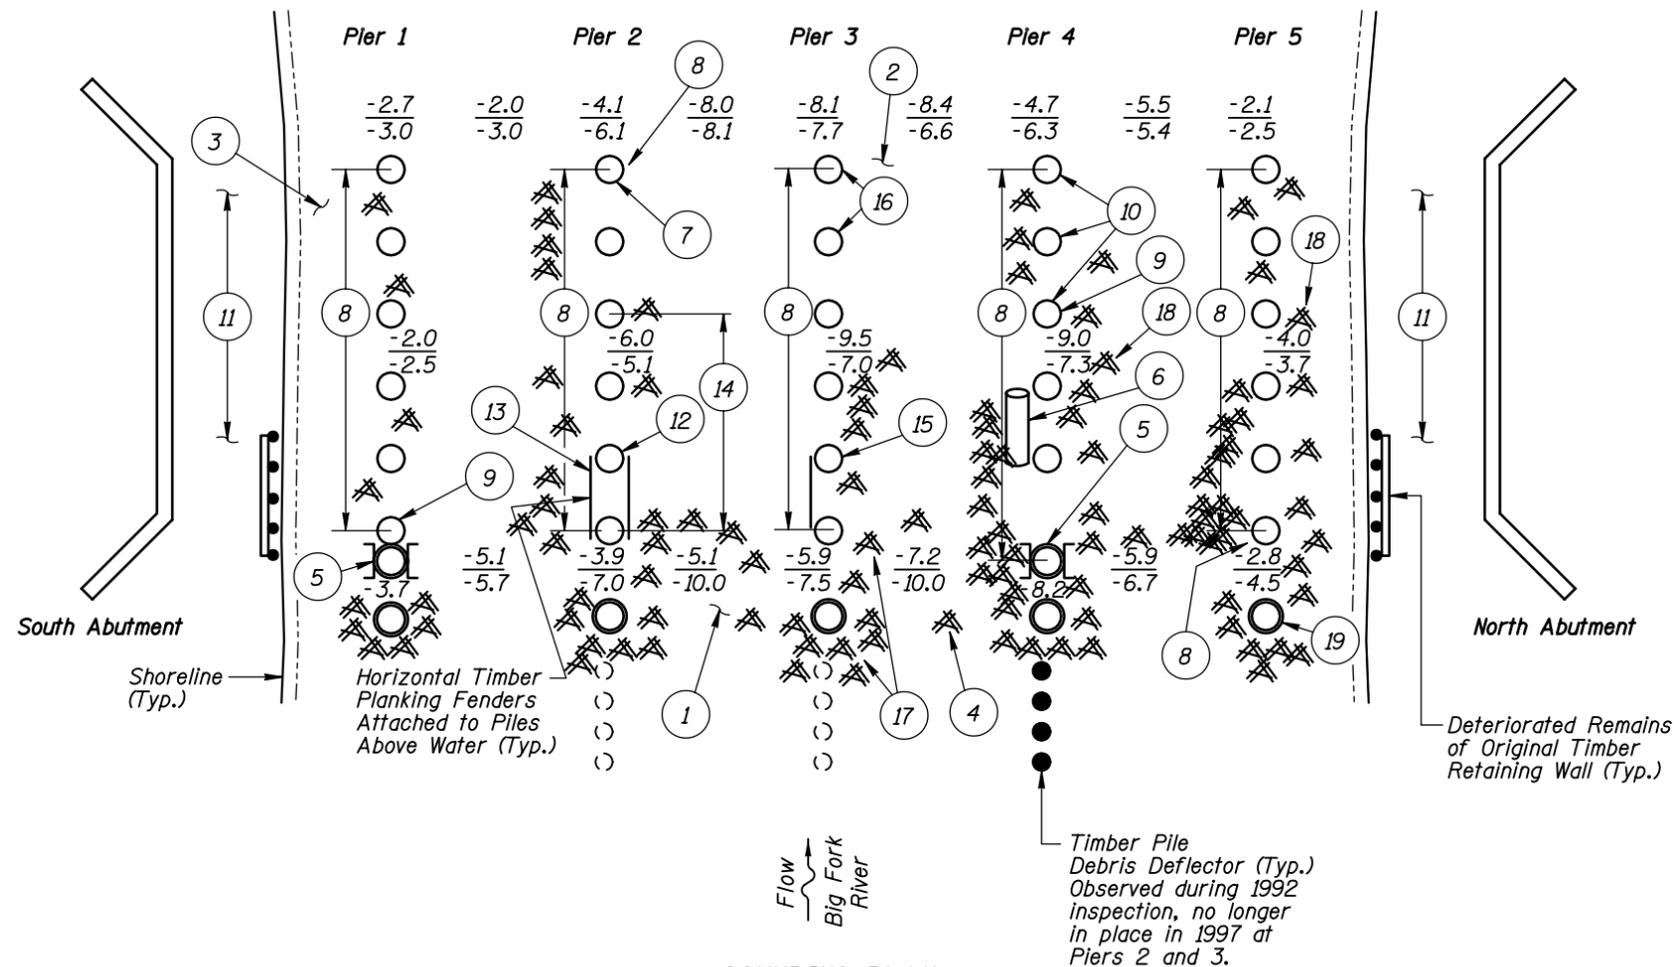
**INSPECTION AND SOUNDING PLAN**

- 1 The upstream channel bottom material consisted of soft silty sand with 6 inches of probe rod penetration.
- 2 The downstream channel bottom material consisted of firm silty sand with 1 to 3 inches of probe rod penetration.

- 3 The channel bottom between the South Abutment and Pier 1 consisted of cobbles and riprap with no probe rod penetration.
- 4 Along the upstream fascia of the bridge between Piers 2 through 5 and along the sides of the piers, heavy timber drift was present typically extending from just above the waterline down to the channel bottom.

- 5 The upstream piles at Piers 1 and 4 have been supplimented with concrete filled steel piles that were connected to the upstream end of the existing timber pier caps with steel braces.

- 6 The upstream timber pile had been displaced and was laying at an incline towards the downstream fascia with the top of the pile about 4 feet above the waterline.

- 7 The upstream pile has been displaced approximately 1.5 inches westward under the cap with some related damage present at the pile top due to timber drift and high water.

- 8 All substructure timber was observed to be in sound and firm condition with minor 1/8 inch wide checking below the water. All piles exhibited frequent 1/8 inch to 1/2 inch wide cracking, splintering, and abrasion damage, with typical loss of section between 5 and 15 percent, due to drift or ice impact and rubbing above water.

- 9 Pile exhibited a 1/2 to 1 inch wide crack above the waterline.
- 10 The timber cross bracing had a split extending from the downstream pile to the 3rd pile in from the downstream fascia of Pier 4. The split extended through the connection at the downstream pile and approximately 3 feet of the timber bracing under the split was broken away.

- 11 Both shorelines under the bridge exhibited signs of erosion.
- 12 A 3 inch wide split through the entire pile diameter was observed from 3 feet above the waterline to 6 inches below the waterline, with moderate decay exhibited inside the split.

- 13 Heavy drift and ice related damage to the horizontal timber planking.
- 14 The bottom horizontal timber planking on the north face of Pier 2 was missing from the 1st upstream pile to the 4th pile in from the upstream fascia. The rest of the timber planking on the north face of Pier 2 exhibited heavy damage due to drift and ice flows.

- 15 The timber cross bracing was broken off on the north face of Pier 3, at the 2nd pile in from the downstream fascia. The timber cross bracing was no longer connected to the 2nd pile in from the downstream fascia.

- 16 The top horizontal timber planking on the south face of Pier 3 was missing from the 1st upstream pile to the 2nd pile in from the upstream fascia.

- 17 Moderate timber debris was observed along the north face and at the upstream pile of Pier 3. The debris extended from the channel bottom to the 3 feet above the channel bottom along the north face, and extended from the channel bottom to 6 feet above the channel bottom at the upstream pile.

- 18 Moderate to heavy timber debris consisting of up to 1-1/2 inch diameter branches was observed from the upstream piles of Piers 4 and 5 through the rest of the piers, extending from the waterline to the channel bottom.

- 19 All of the piers had new concrete filled steel pipe piles located approximately 15 feet upstream of the pier. All of the concrete filled steel pipe piles had heavy accumulations of drift extending from the channel bottom to the waterline.

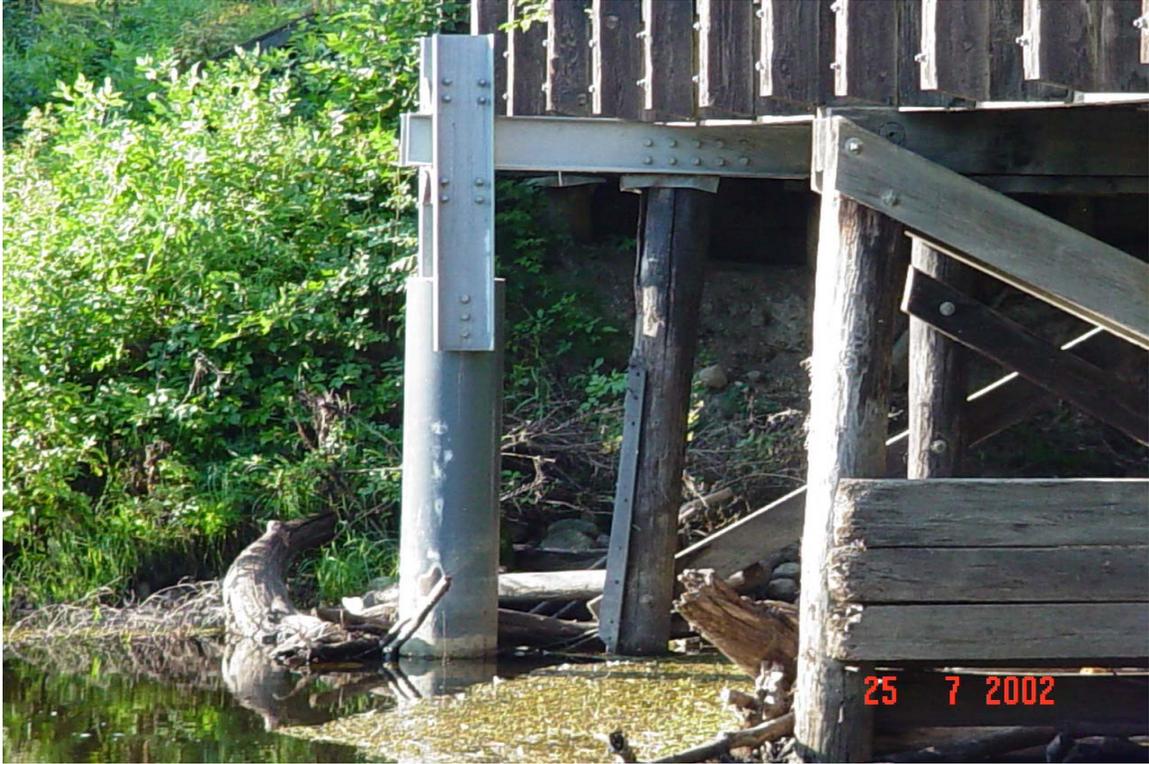
- (B) At Pier 4, the upstream pile that had been displaced out from under the pile cap is now laying parallel to Pier 4 and has been supplemented with a concrete filled steel pipe pile. At Pier 1, the upstream pile that had been displaced approximately 1.5 inches downstream under the cap with some related damage present at the pile top has also been supplemented by a concrete filled steel pipe pile. Both of these repairs appear to be functioning adequately.

Photograph 7. View of Repair Pile at the Upstream Fascia of Pier 1, Looking South.

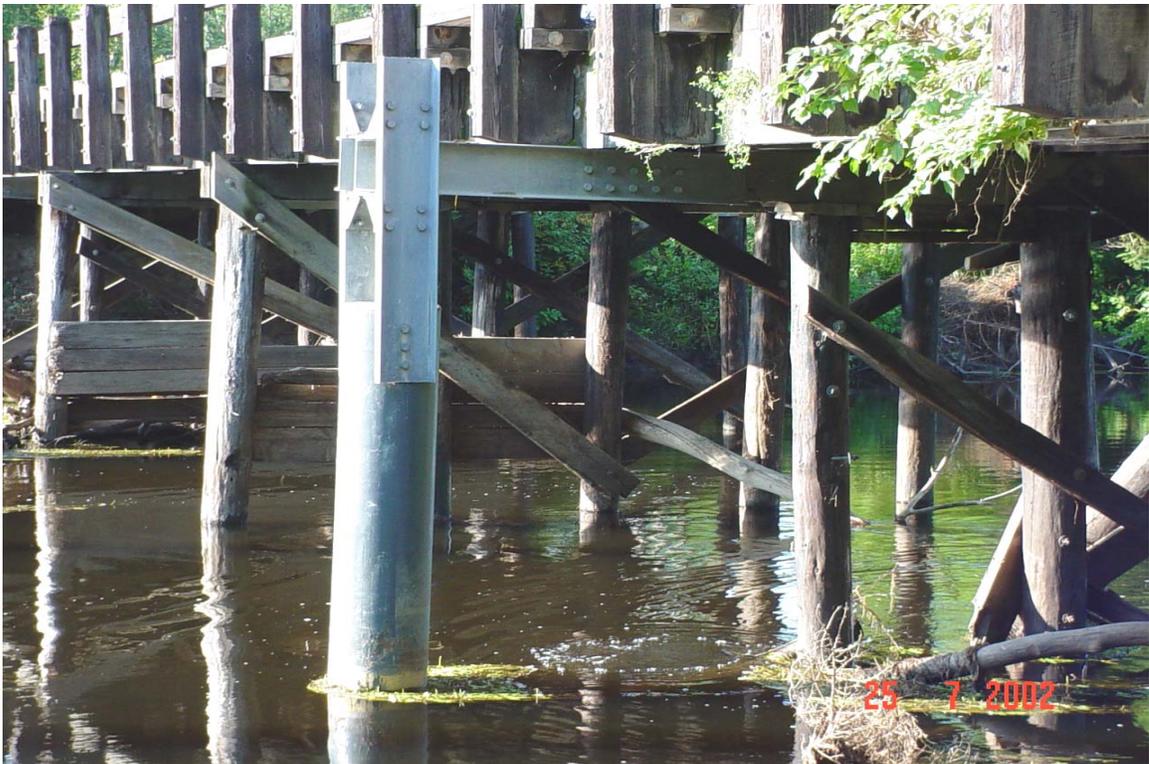
Photograph 8. View of Repair Pile at the Upstream Fascia of Pier 4, Looking Southwest.

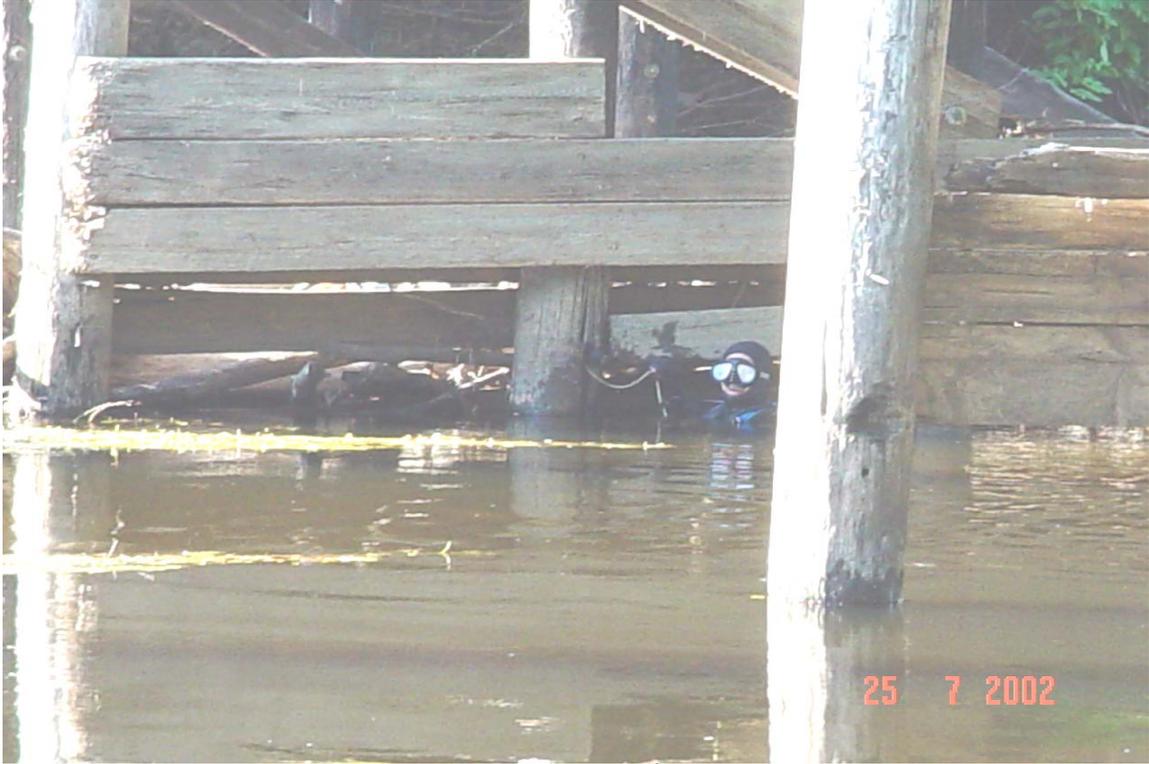
- (D) The 2<sup>nd</sup> pile in from the upstream fascia of Pier 2 exhibited significant damage, consisting of a 3 inch wide split through the entire pile diameter with some related internal decay.

Photograph 9. View of Split Timber Pile at the 2<sup>nd</sup> Pile in From the Upstream Fascia of Pier 2, Looking Southwest.

- (D) The stability and load carrying capacity of Pier 2 should be examined based on the damaged pile, and if found to be insufficient, it may be necessary to supplement the pile with some means of carrying load for the pier. If Pier 2 still has sufficient capacity/stability, given the significantly cracked pile, then future inspections should particularly monitor that pile and pier for any further distress.

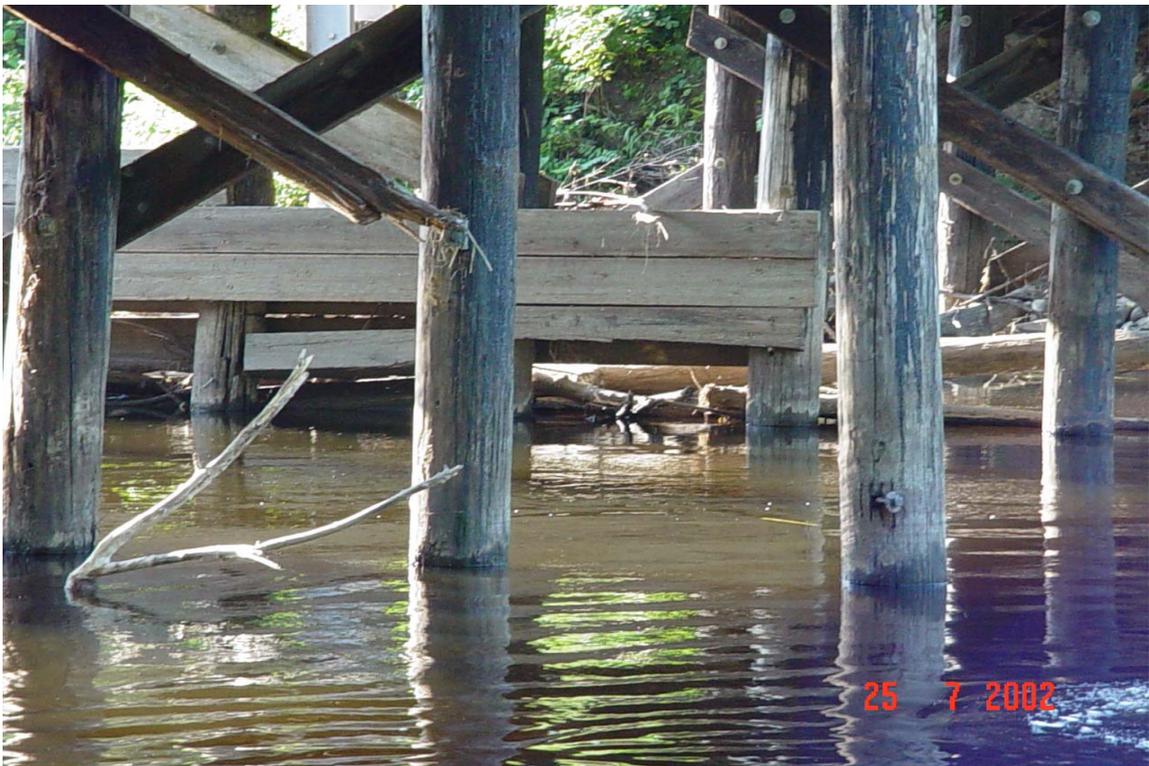
Photograph 10. View of Broken Cross Bracing at the Downstream Pile of Pier 3, Looking Southeast.

- (A) All deficient cross bracing should be renewed at the piers to restore the original overall lateral stability of bridge.
- (B) Remove timber drift at the bridge to prevent additional build-up and to eliminate potential for abrasion or scour damage and excessive lateral loads on the piers. Until drift can be removed, closely monitor the accumulations at the bridge especially during any high water events.

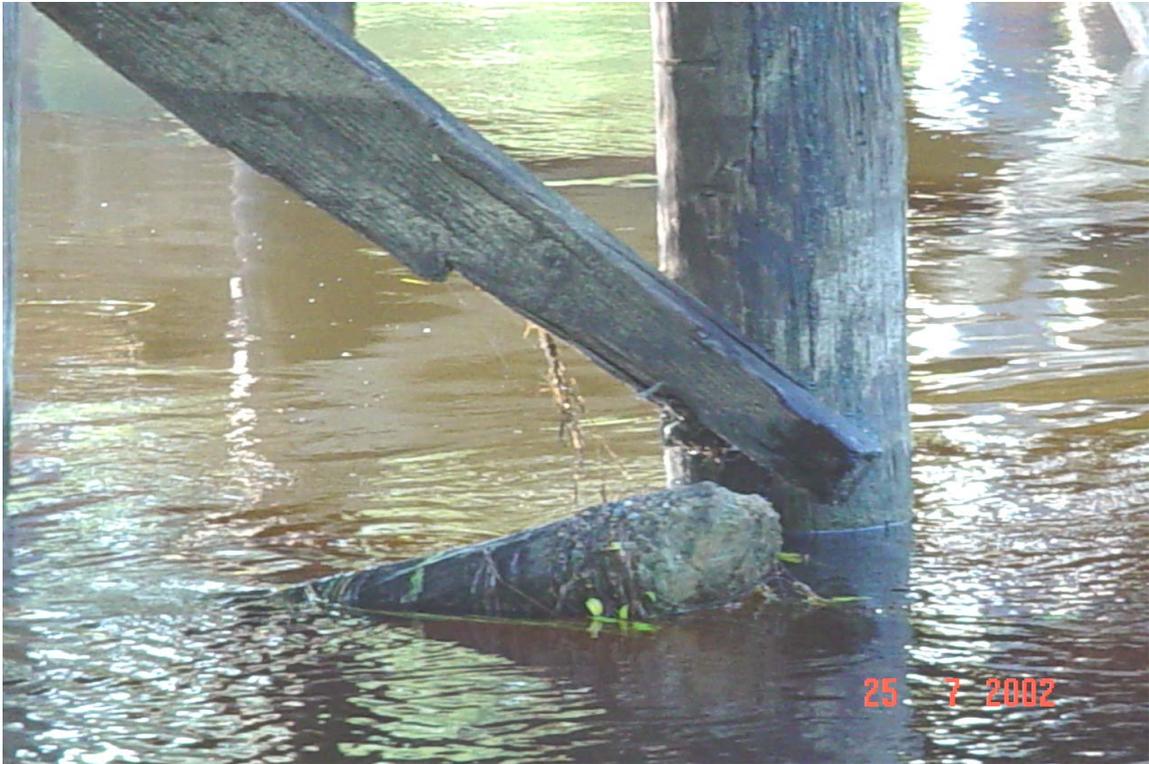
Photograph 11. View of Broken Cross Bracing at the Downstream Pile of Pier 4, Looking Southeast.

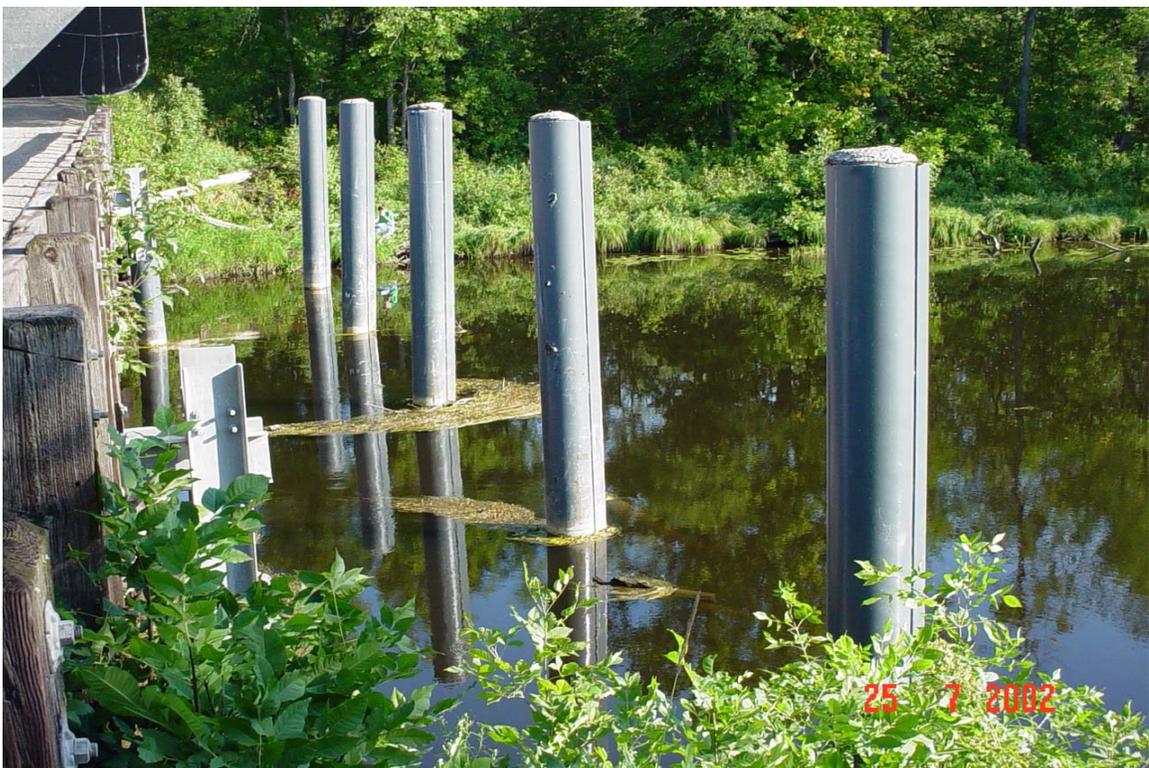
Photograph 12. View of New Debris/Timber Protection System, Looking Northeast.

The additional piles installed upstream of the piers is a good measure towards restricting drift from impacting/accumulating at the bridge. Currently, however, there is still excessive drift at the bridge which can exert excessive loads on the bridge and/or influence scour/restrict flow. Therefore, the present drift accumulations should be removed before they can worsen and adversely affect the bridge. At the time the drift is removed from around the bridge piers, it should also be removed from the additional upstream piles.
