UNDERWATER BRIDGE INSPECTION REPORT

STRUCTURE NO. 7183

CSAH 100

ST. LOUIS RIVER

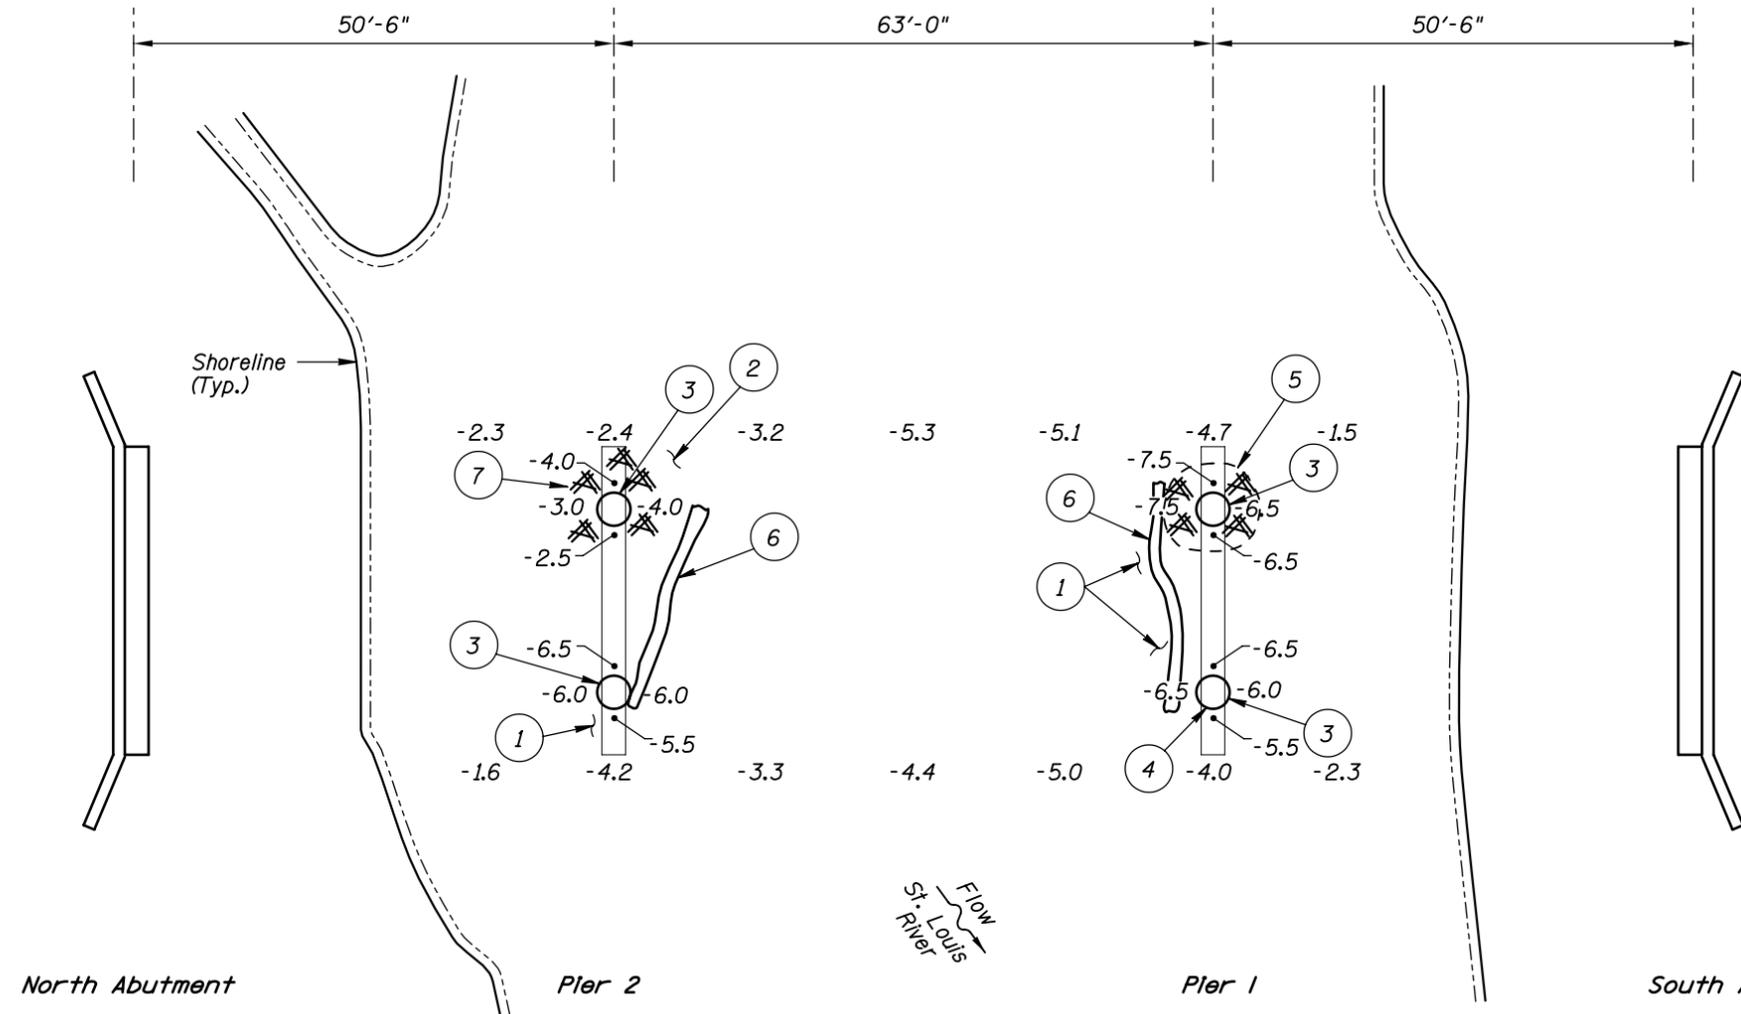
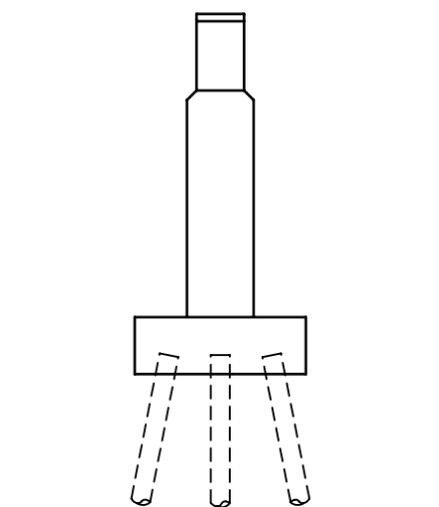
**SOUNDING PLAN**

- 1 The channel bottom consisted of sand and gravel with 6-inch-diameter and smaller cobbles and random 1-foot-diameter riprap and a maximum probe rod penetration of 1 inch.

- 2 The channel bottom consisted of soft silt and organic material with 1.5 feet of probe rod penetration at the upstream column of Pier 2.
- 3 Light to moderate scaling with some aggregate exposure from 1.5 feet above the waterline to 3 feet below the waterline with typical penetrations of 1/8 inch and up to 1/4 inch maximum at the upstream columns. Heavier scaling was observed at the downstream columns with a maximum penetration of 1/2 inch at Pier 2.

- 4 An area of heavy scaling/section loss, 1-foot-high by 2.5-feet-wide, with a maximum penetration of 1 inch.
- 5 A scour depression, 2 to 3 feet in radius with a depth of 1 to 2 feet, was observed at the upstream column. A light accumulation of timber debris was observed in the depression.

- 6 6-to 12-inch-diameter log was observed on the channel bottom along the pier.
- 7 A moderate accumulation of 6-inch-diameter and smaller timber debris was observed on the channel bottom and extending up to the waterline.

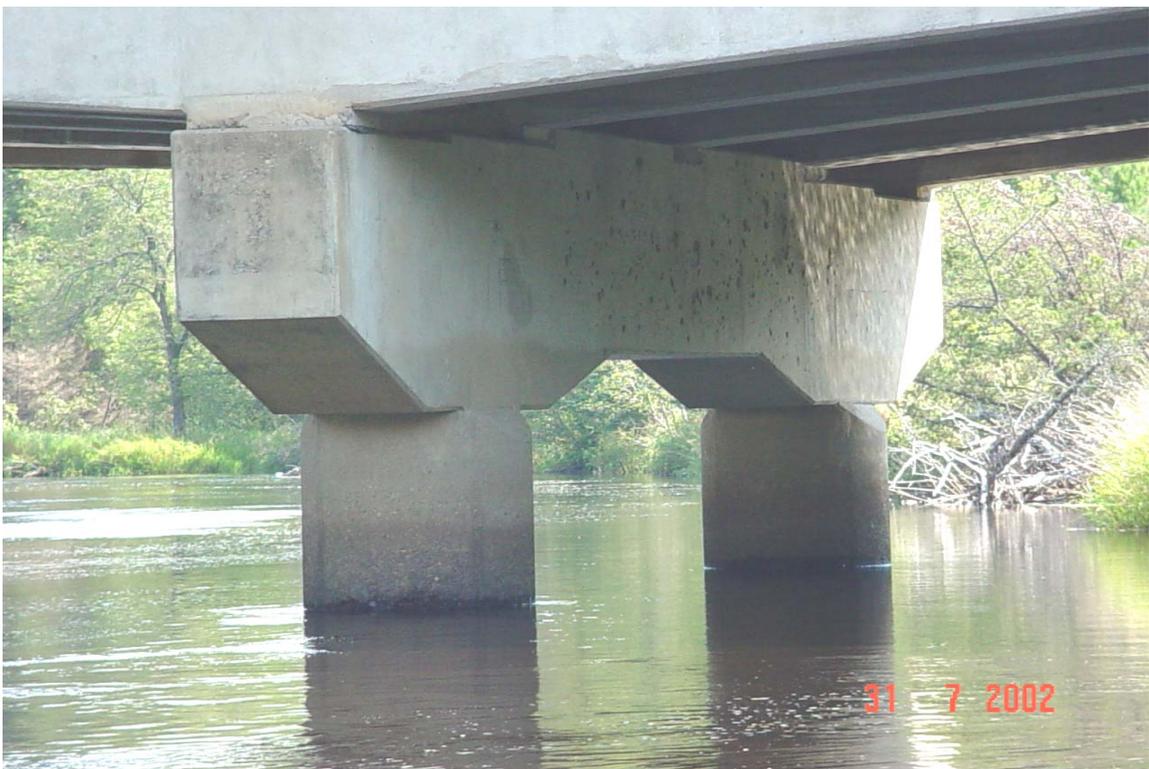
- (B) An area of section loss, 1-foot-high by 2.5-feet-wide, was observed at the waterline with a maximum penetration of 1 inch on the downstream column of Pier 1.

- (C) A scour depression measuring 2 to 3 feet in radius with a depth of 1 to 2 feet was observed at the upstream column of Pier 1. A light accumulation of 6-inch-diameter and smaller timber debris was observed in the depression.

Photograph 2. View of Pier 1, Looking Northeast.

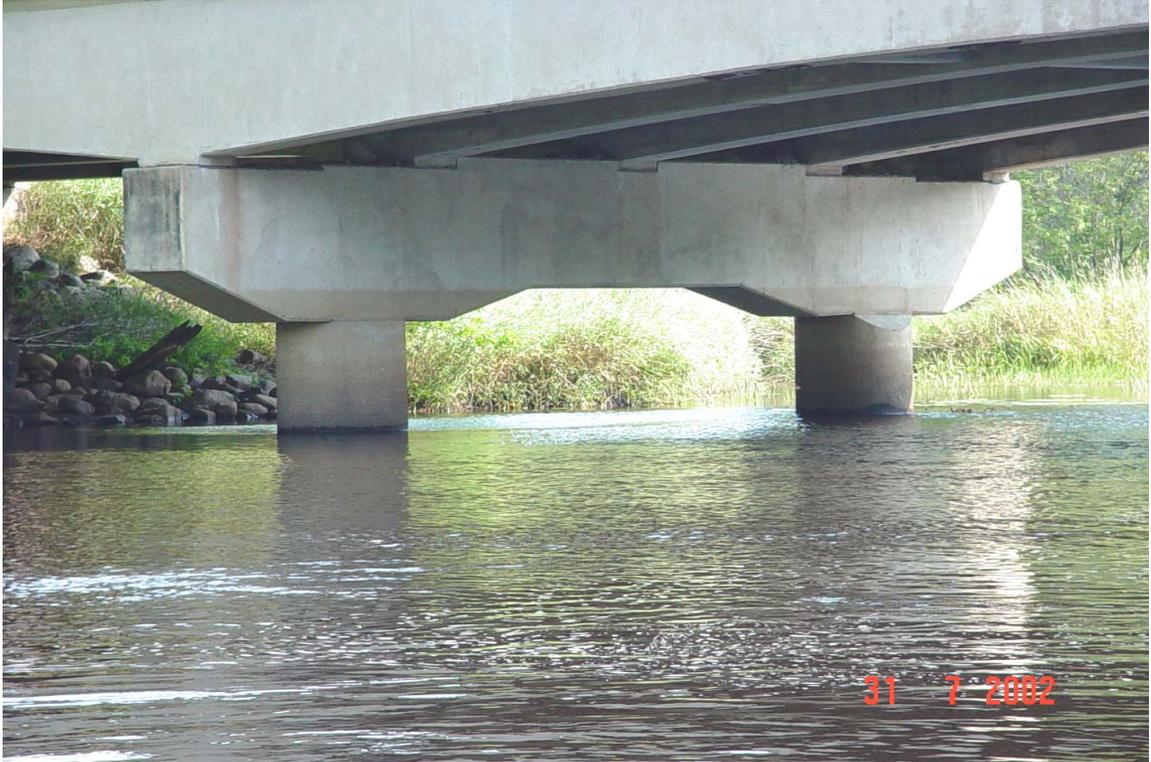
- (D) A moderate accumulation of 6 inch diameter and smaller timber debris was observed on the channel bottom and extending up to the waterline at the upstream end of Pier 2. Two 6-inch-diameter logs were observed along the channel side of both Piers 1 and 2.

Photograph 3. View of Pier 2, Looking Northeast.

- (A) Monitor the drift accumulations at both piers during future inspections, and if found to be increasing in size, removal of the timber debris during normal maintenance of the bridge may be warranted.

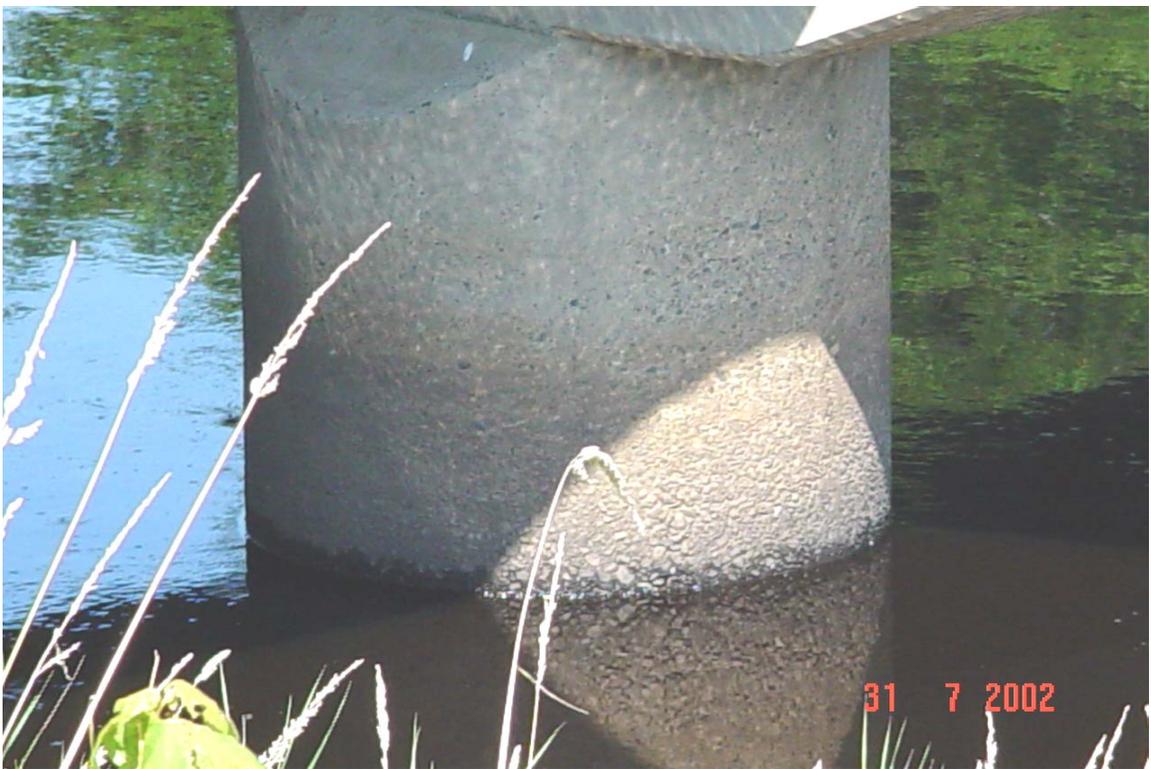
- (A) Light to moderate scaling with some aggregate exposure from 1.5 feet above the waterline to 3 feet below the waterline with typical penetrations of 1/8 inch and up to 1/4 inch maximum penetration was present at the upstream columns. Heavier scaling was observed at the downstream columns with a maximum penetration of 1/2 inch at Pier 2.

Photograph 4. View of Typical Scaling at the Upstream Column of Pier 2, Looking Northwest.
