UNDERWATER BRIDGE INSPECTION REPORT

STRUCTURE NO. 7771

CSAH NO. 110

CHANNEL AT WHITEWATER AND COLBY LAKES

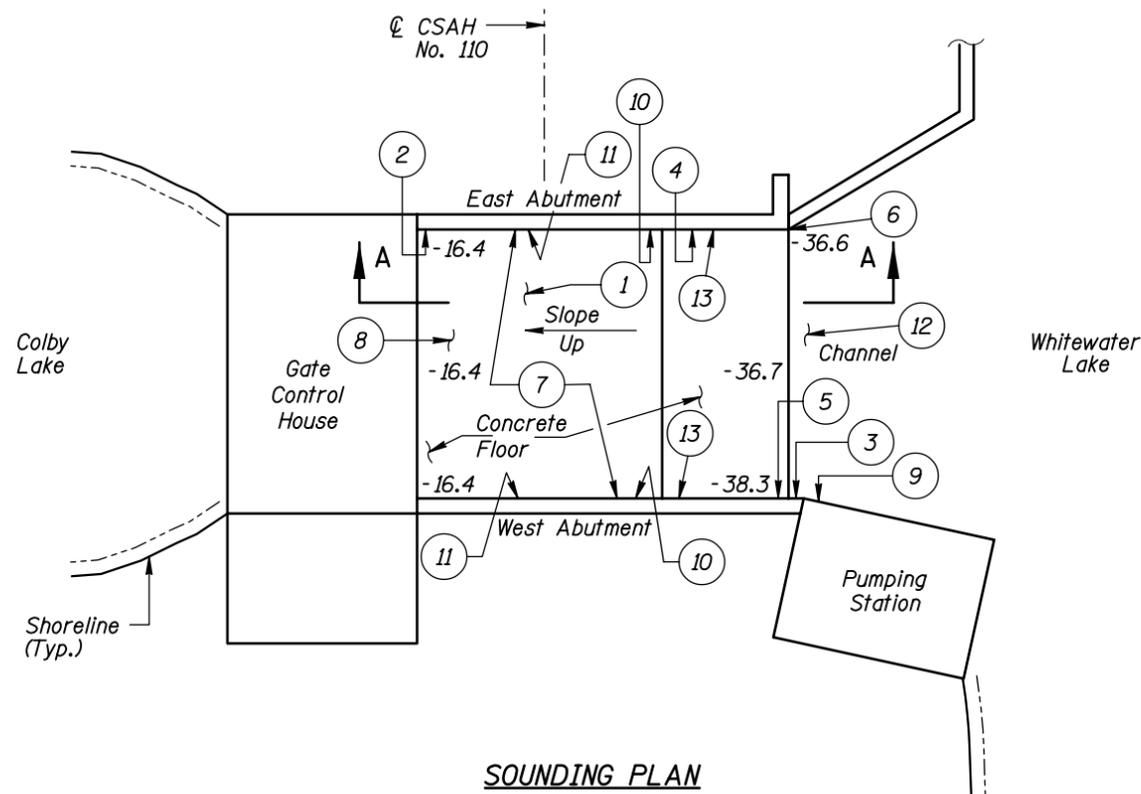
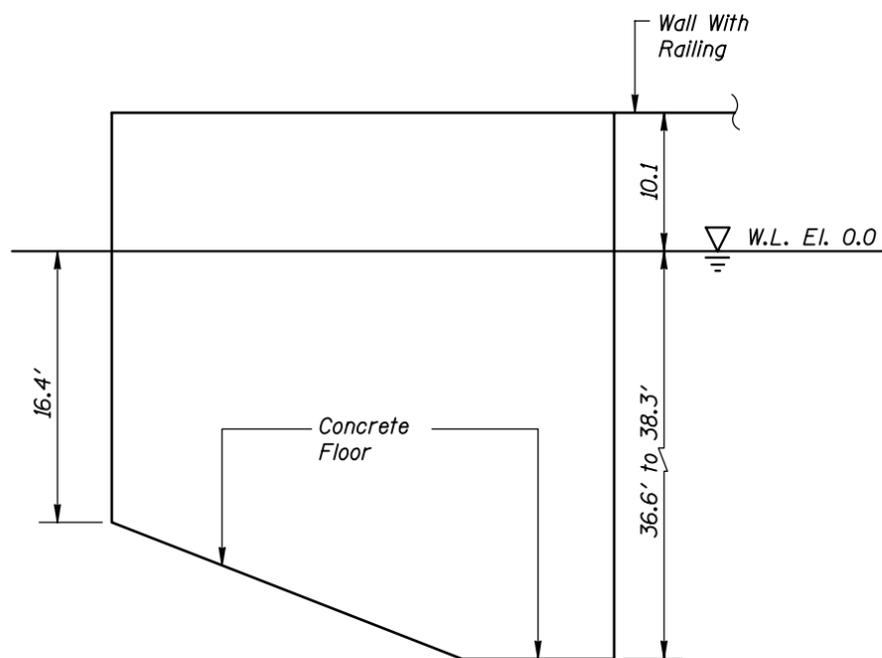
- 1 The channel bottom consisted of a formed concrete slab with a light layer of silt.
- 2 At 9 feet below the water level, the bottom of the vertical joint exhibited a 6-inch-high by 3-inch-wide area of section loss with a penetration of 1 inch.

- 3 Vertical crack, extending from under the fascia beam to 1 foot below the waterline with a maximum width of 1/8 inch and minor loss of section with surface openings of up to 1 inch wide along crack.

- 4 Vertical hairline crack with efflorescence from 7 feet below the waterline to 16 feet below the waterline.
- 5 Area of horizontal section loss at 3 foot below the waterline, measuring 2.5 feet long by 3 inches high with a maximum penetration of 1.5 inches.

- 6 Section loss on corner at 2 feet above the waterline, measuring 9 inches wide by 2 feet high with 2 inches of penetration.
- 7 The concrete on all faces was generally in good condition with random small pockets of poorly consolidated concrete. On walls, up to 1/2 inch section loss along various horizontal cold construction joints below water.

- 8 Three discarded bicycles were observed on the concrete floor slab.
- 9 An area of horizontal section loss, 3 feet long by 2 inches high, with 3 inches of penetration, was observed on the pump station wall.

- 10 Random hairline map cracking with light efflorescence was observed from the waterline to 3 feet above the waterline.
- 11 A 1/16 inch wide vertical crack with light efflorescence was observed on both abutment walls beginning at the bottom of the bridge deck, between the center and next to the north beams, and extended to 1 foot below the waterline.

- 12 Scattered riprap was observed along the south fascia.
- 13 Light scaling with from 1/8 inch to 1/4 inch penetration was observed from 1.5 feet above the waterline to 10 feet below the waterline on both abutment walls.

- (A) Monitor the cracks in both abutment walls for any progression, which could result due to freeze and thaw action, and if found to be worsening, repairs could be warranted at a later date.

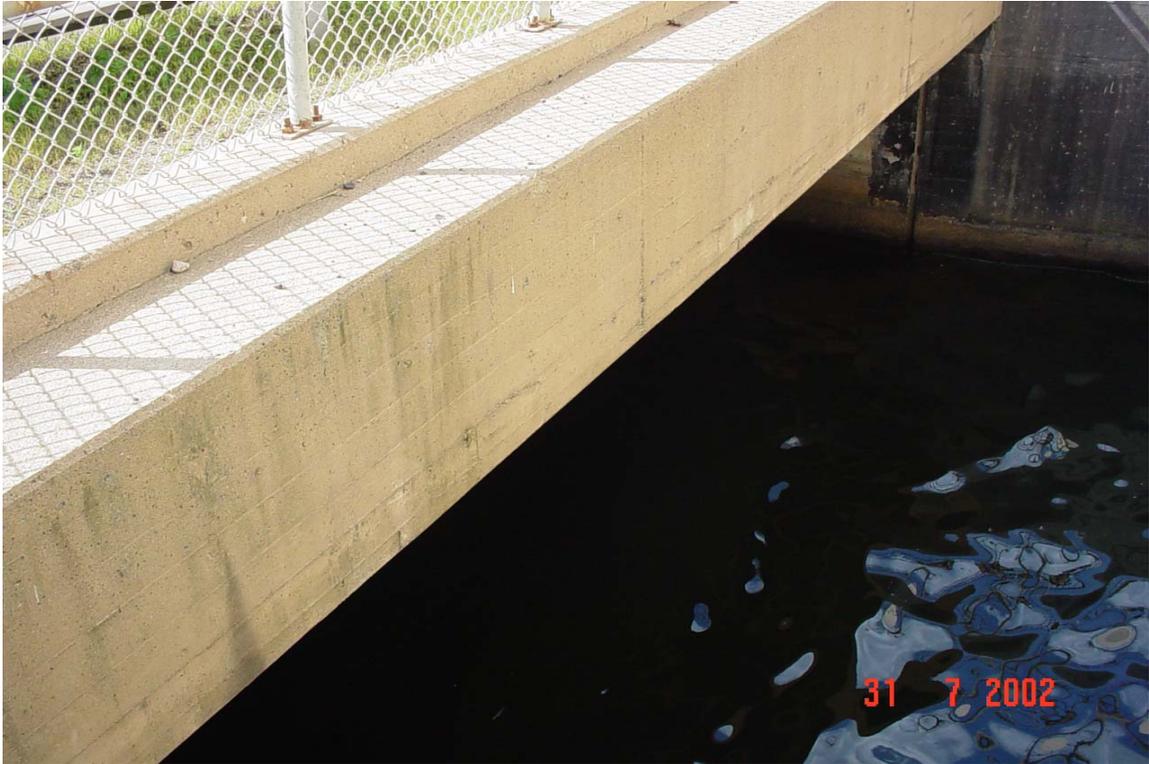
Photograph 1. View of the West Abutment, Looking Southwest.

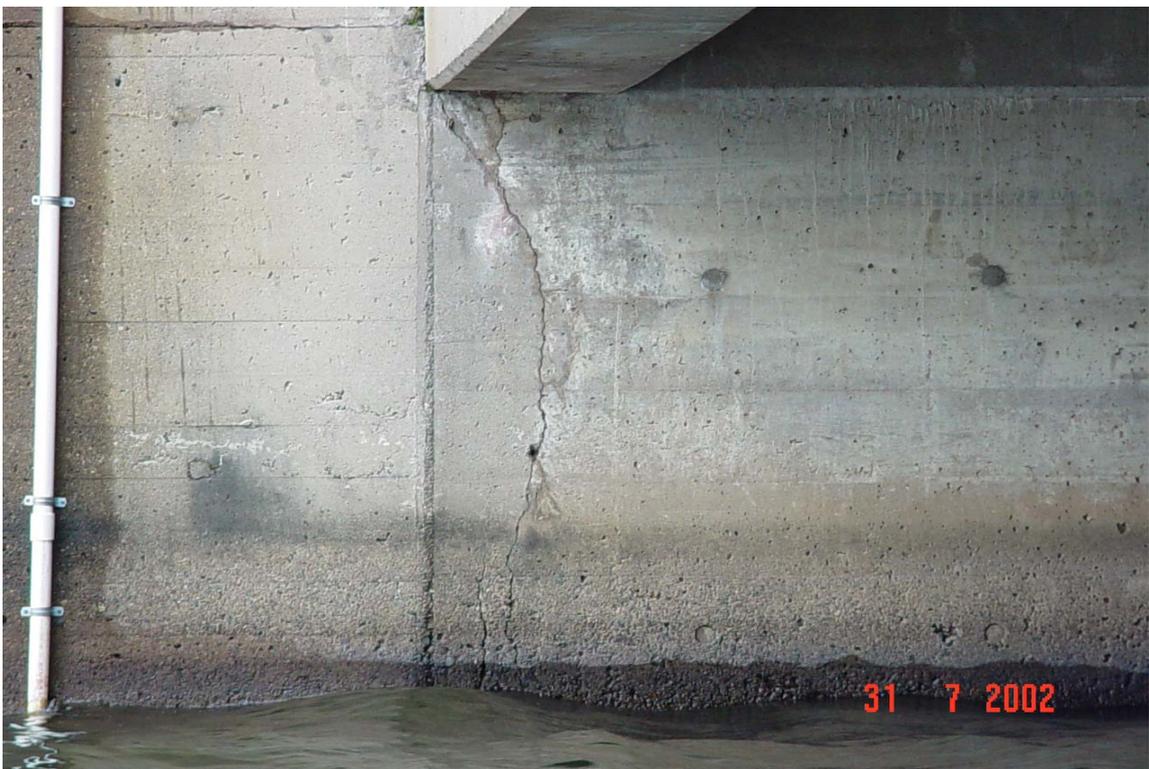
- (A) There was a vertical crack at the south end of the West Abutment, extending from under the fascia beam to 1 foot below the waterline with a maximum width of 1/8 inch. Minor section losses, up to 1 inch wide, were observed at various locations along the crack. At the bottom of the crack, a larger area of section loss with up to 1.5 inches of penetration was present.

Photograph 2. View of Crack in the West Abutment, Looking West.

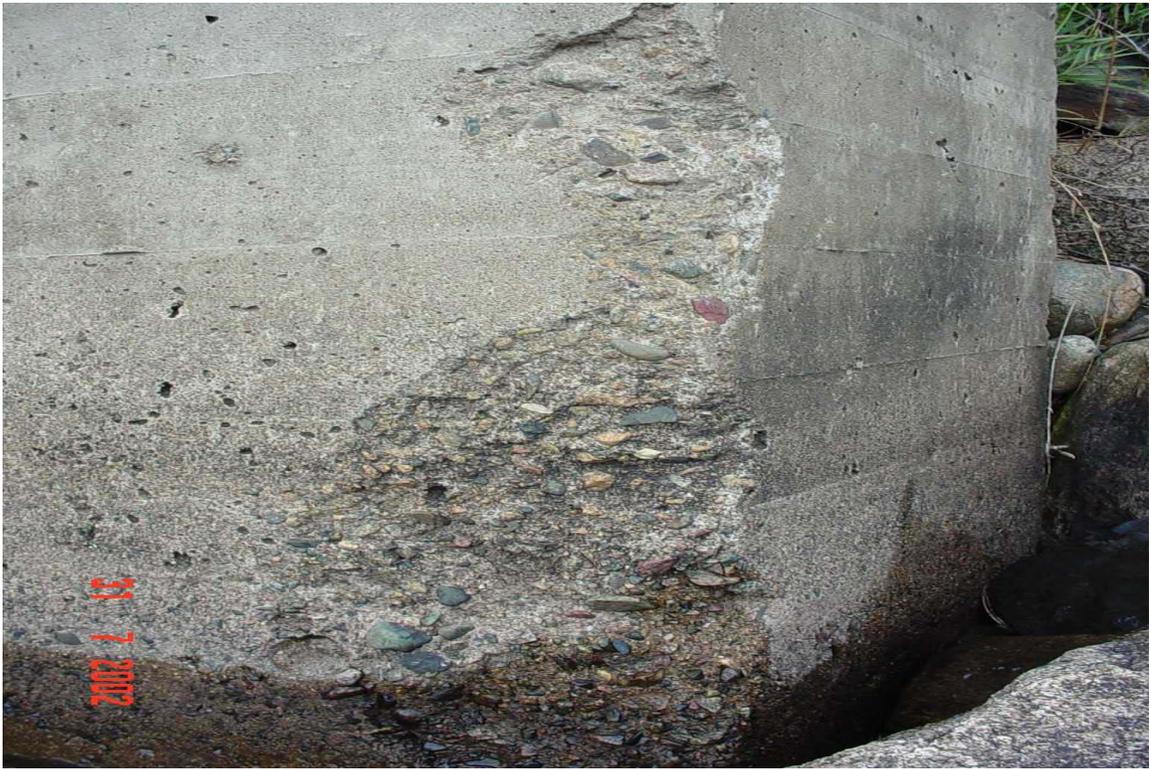
Photograph 3. View of the Section Loss on South Corner of the East Abutment, Looking North.
