UNDERWATER BRIDGE INSPECTION REPORT

STRUCTURE NO. 58520

KETTLE RIVER

PREPARED FOR THE
MINNESOTA DEPARTMENT OF TRANSPORTATION

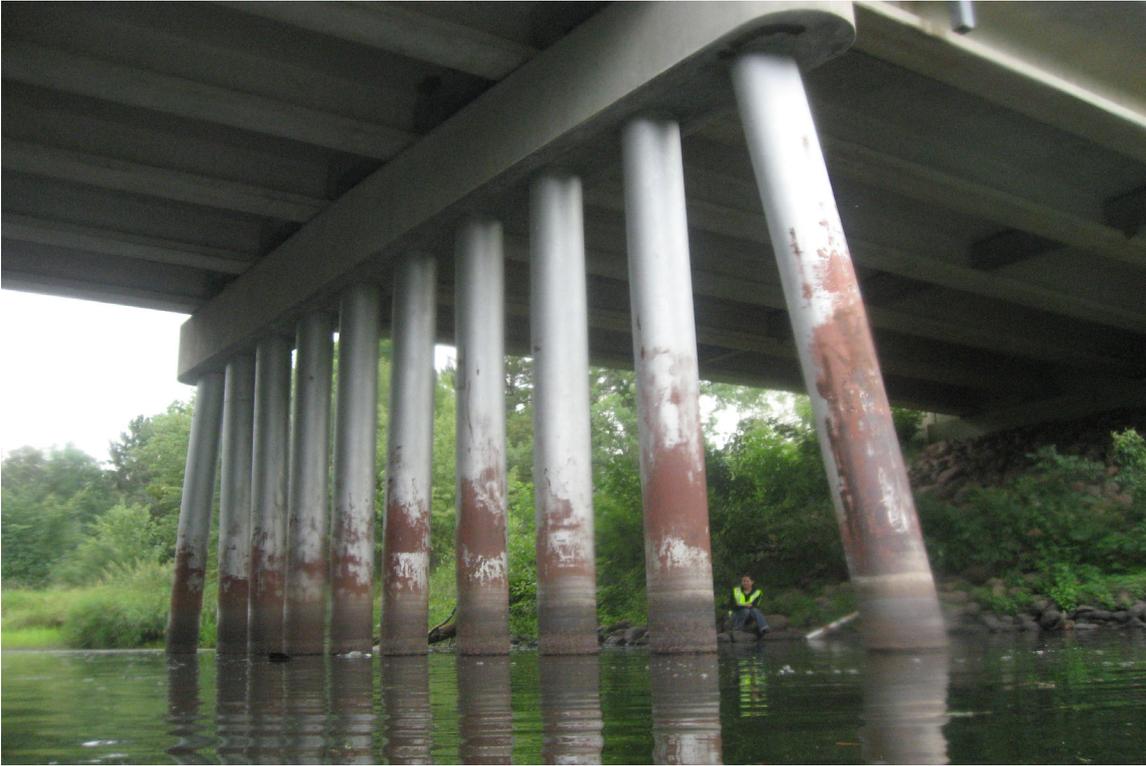
Photograph 2. View of Pier 1, Looking Southeast.

- (A) The steel piles exhibited coating failure on 80 to 100 percent of the surface area, and light surface corrosion with rust nodules and up to 3/16 inch deep pitting on 50 percent of the surface area, from 3 feet above the waterline to the channel bottom. Deterioration was heaviest from 1 foot above the waterline to 1 foot below the waterline.
- (B) A moderate accumulation of timber debris consisting of 1 foot diameter and smaller logs and branches, including a 12-inch-diameter tree, was observed at the downstream end of Pier 1, and an 18-inch-diameter tree was observed extending along the south side of Pier 2.

- (A) Reinspect the submerged substructure units at the normal maximum recommended (NBIS) interval of five (5) years. Monitor the drift accumulations at the piers during future inspections.

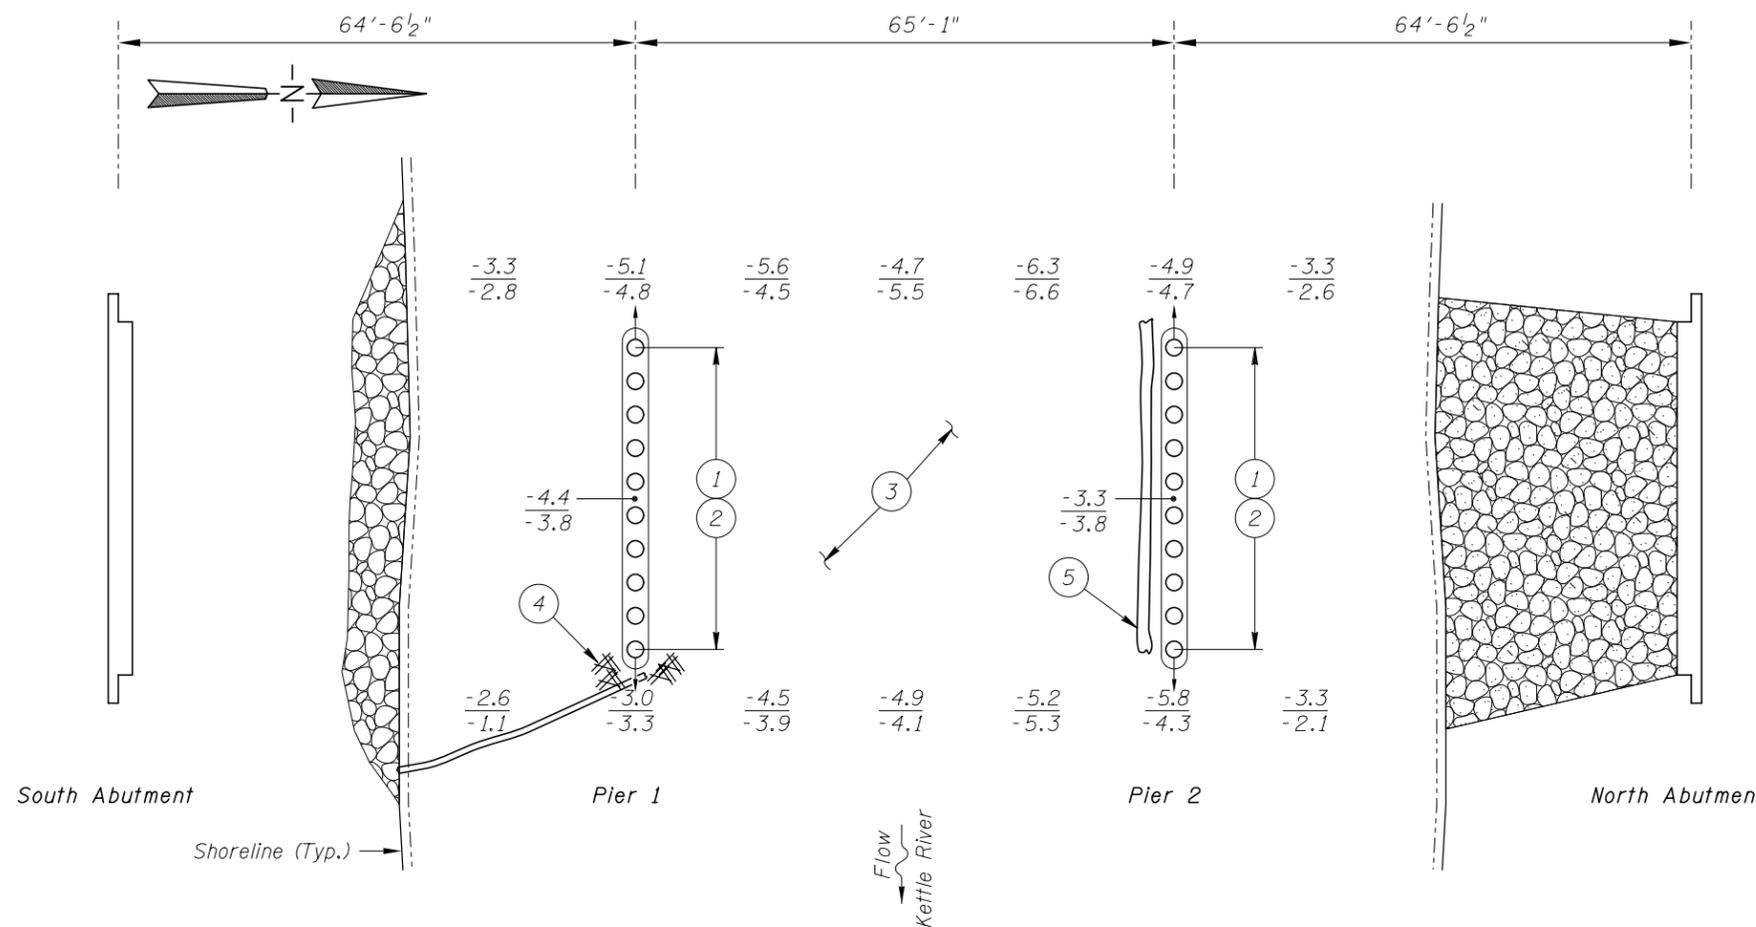
SOUNDING PLAN

- ① The steel piles exhibited coating failure on 80 to 100 percent of the surface area from 4 feet above the waterline to the channel bottom.
- ② The steel piles exhibited light surface corrosion with rust nodules and up to 3/16 inch of pitting on up to 50 percent of the surface area from 3 feet above the waterline to the channel bottom. Deterioration was heaviest from 1 foot above waterline to 1 foot below waterline.
- ③ The channel bottom material consisted of sandy gravel and approximately 4-inch-diameter cobbles with random larger rocks on banks with up to 2 inches of probe rod penetration.
- ④ A moderate accumulation of timber debris consisting of 1 foot diameter and smaller logs and branches, including a 12-inch-diameter tree, was observed at the downstream end of Pier 1.
- ⑤ An 18-inch-diameter tree was observed along the south side of Pier 2.
