UNDERWATER BRIDGE INSPECTION REPORT

STRUCTURE NO. 69536
TWP NO. 415
OVER THE
CHANNEL AT LAKE VERMILLION
DISTRICT 1 - ST. LOUIS COUNTY

PREPARED FOR THE
MINNESOTA DEPARTMENT OF TRANSPORTATION
BY
COLLINS ENGINEERS, INC.
JOB NO. 5221 (CEI 12)

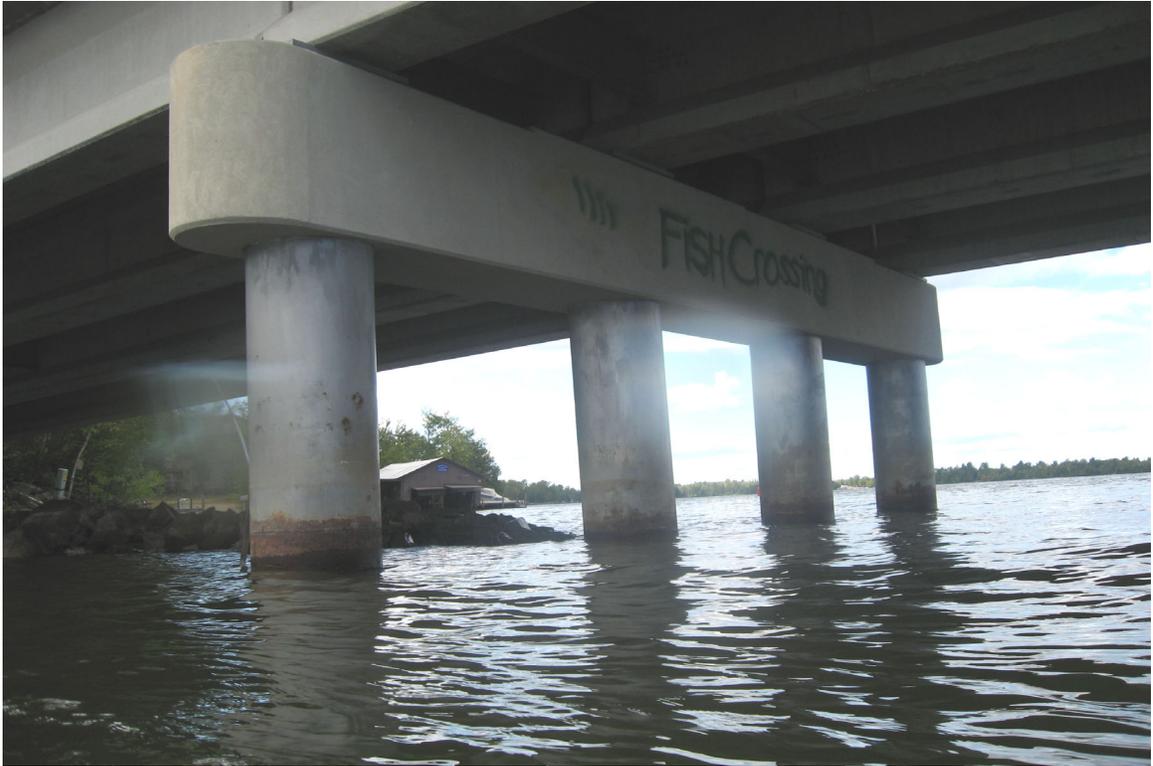
Photograph 1. View of Pier 1, Looking Northwest.

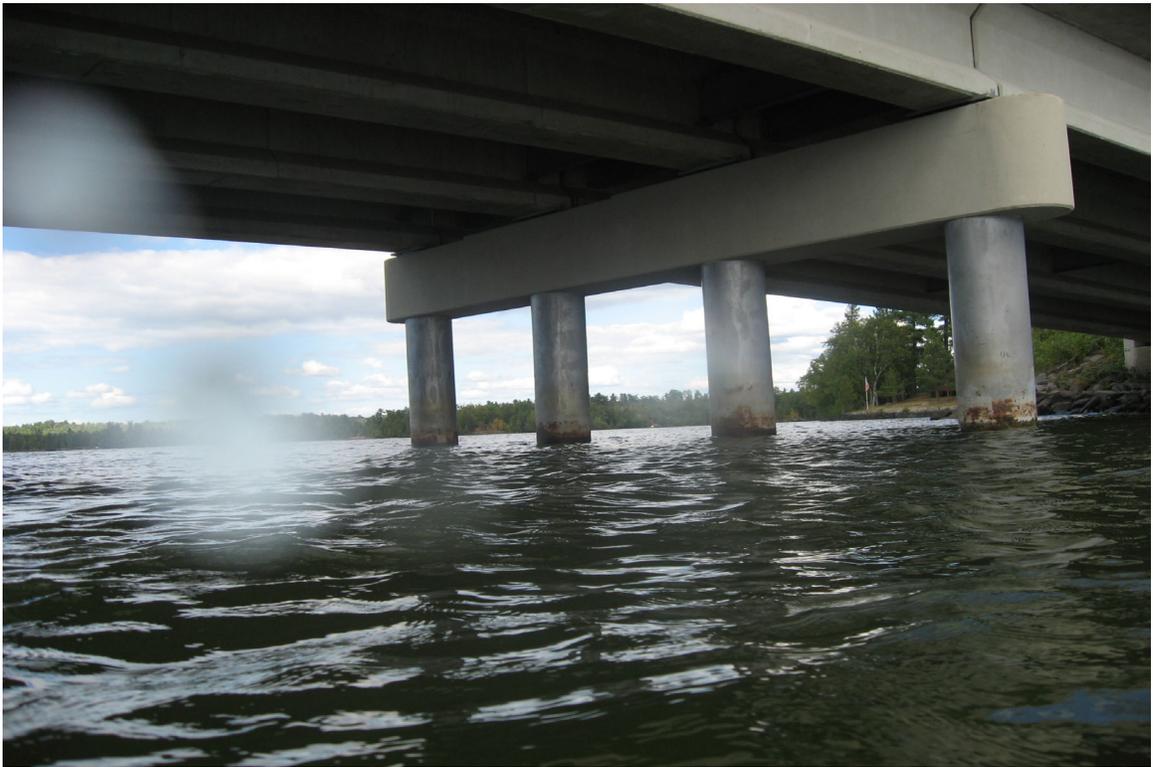
Photograph 2. View of Pier 2, Looking Northeast.

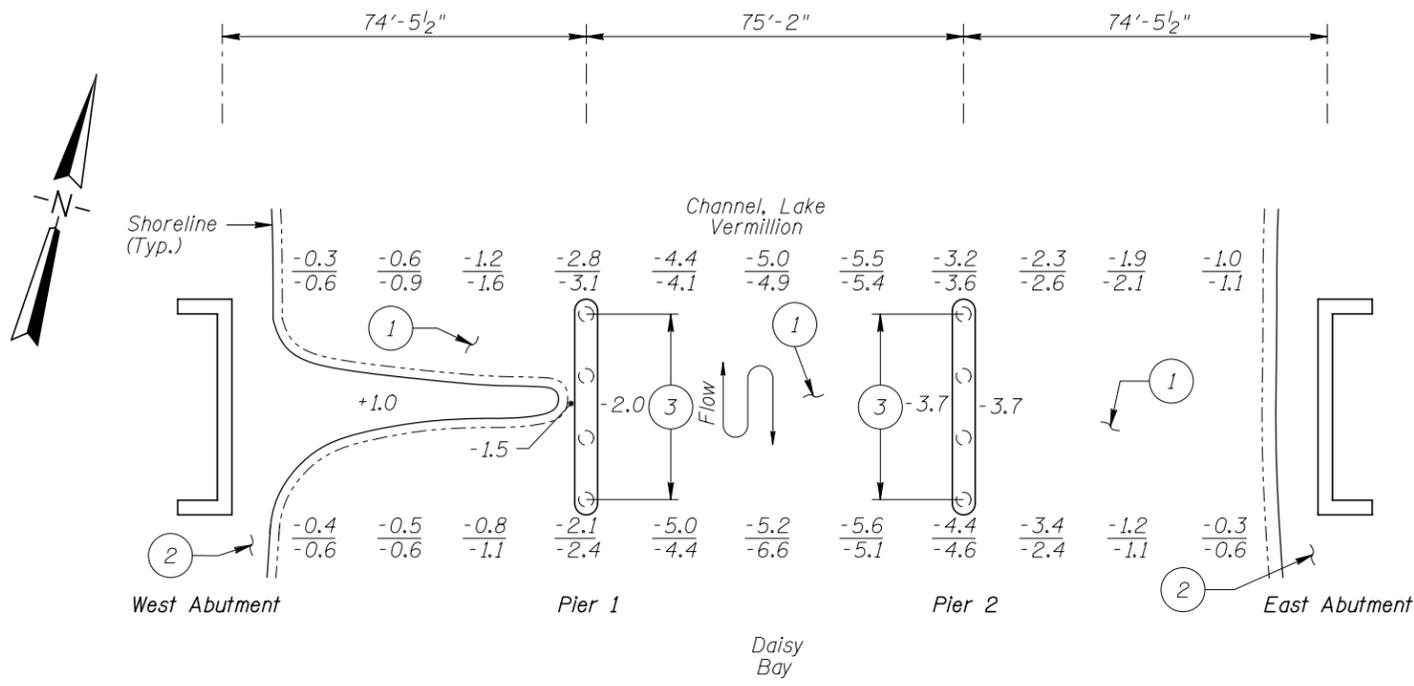
SOUNDING PLAN

- ① The channel bottom material typically consisted of firm sand with scattered riprap up to 18 inches in diameter allowing a maximum probe rod penetration of 1 to 3 inches.
- ② Both shorelines were well protected with 12 inch to 3 foot diameter riprap material along the banks.
- ③ The steel pipe piles exhibited 50 to 75 percent coating failure from 1 foot below the waterline to the channel bottom with heavy nodular corrosion (25-50% coverage), ranging in size from 1 to 1.5 inches in diameter. Rust nodules exhibited typical pitting of 1/32 inches in depth and up to 1/16 inches deep.
