UNDERWATER BRIDGE INSPECTION REPORT

STRUCTURE NO. 09513

CSAH NO. 61

THE ST. LOUIS RIVER

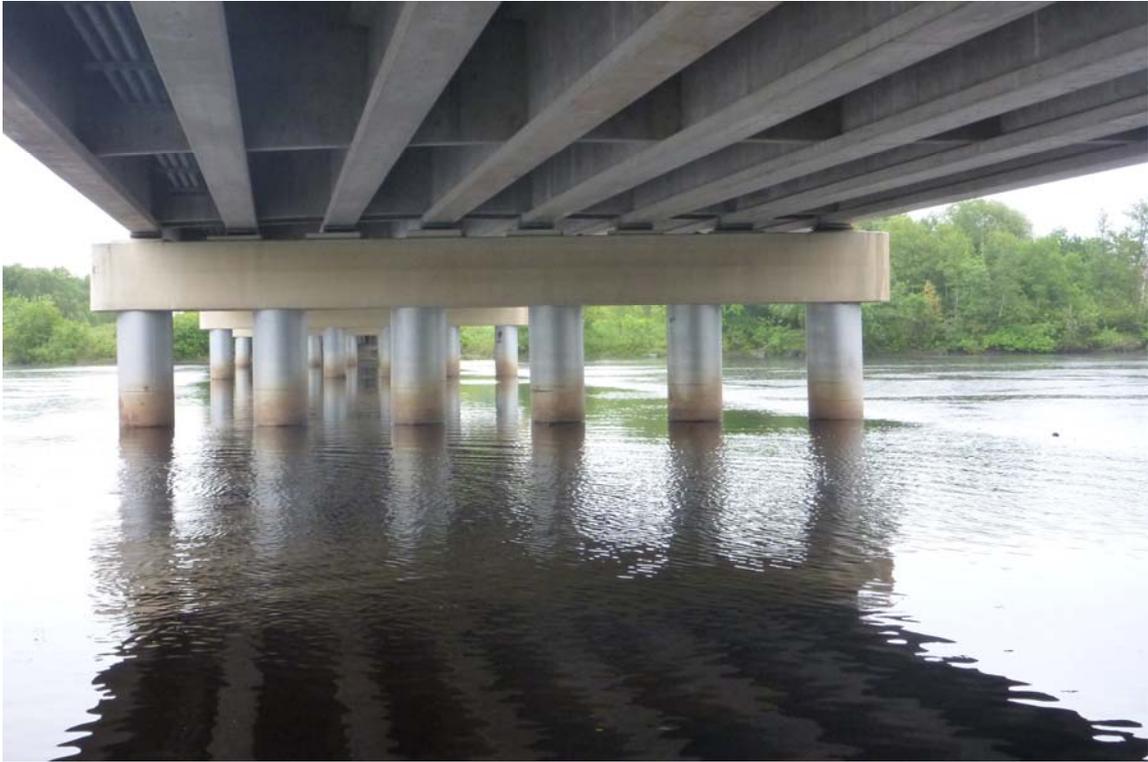
Photograph 1. View of Pier 1, Looking East.

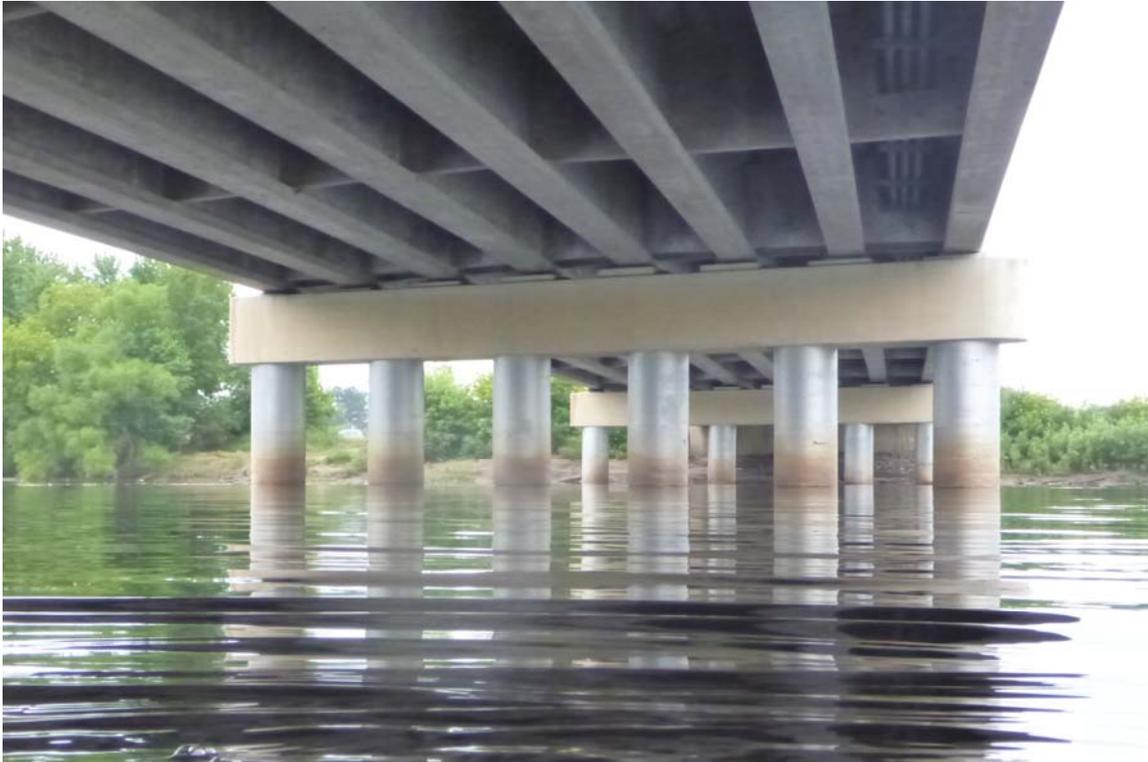
Photograph 2. View of Pier 2, Looking West.

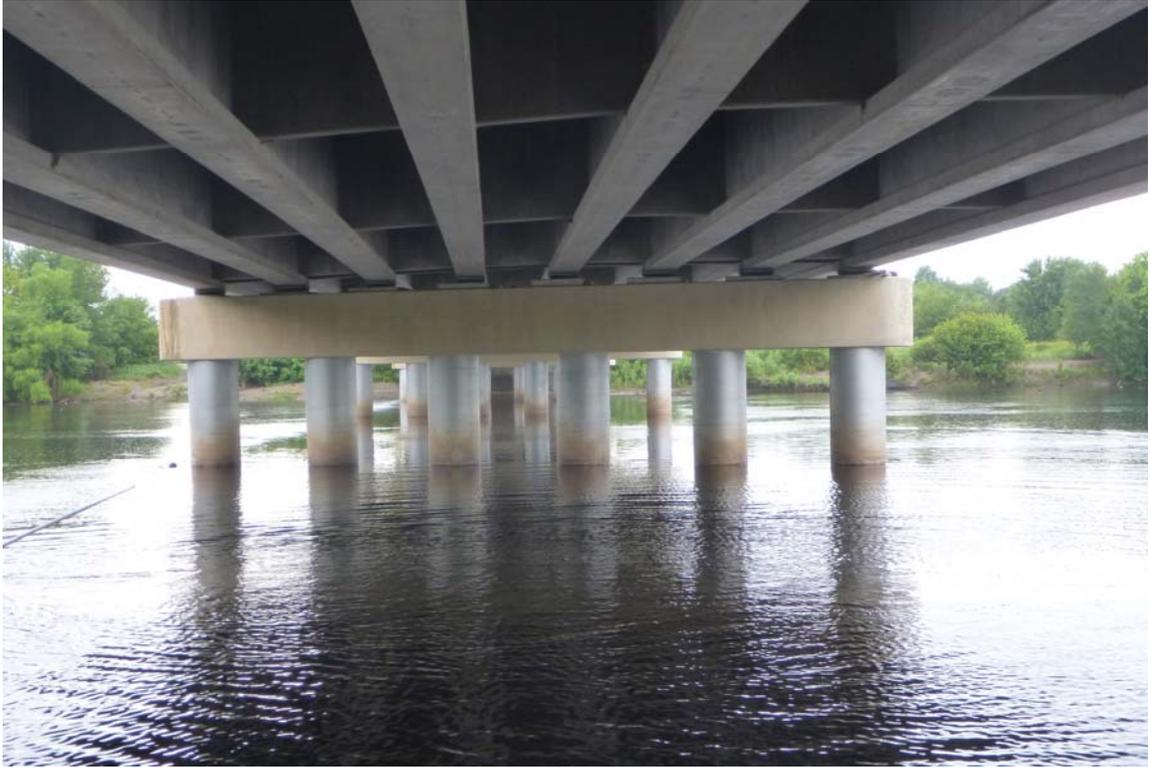
- (A) The steel pipe piles exhibited coating loss affecting 10 to 25 percent of the surface area with up to ½ -inch-diameter nodular corrosion on the upper portion of the pipe piles, and 50 to 100 percent coating loss with up to 1/2-inch-diameter nodular corrosion on the lower portion of the pipe piles. The piles exhibited 1/32 inch deep pitting associated with the nodular corrosion.
- (B) An outer steel casing was observed around the second upstream pile at Pier 3 extending from the channel bottom to 8 feet below the waterline, and it exhibited 100 percent nodular corrosion with up to 1/16 inch section loss.
- (C) A moderate accumulation of 1-foot-diameter and smaller timber debris, was observed at Pier 3, extending up to 3 feet off the channel bottom.

Photograph 3. View of Pier 3, Looking West.

- (A) Monitor accumulation of timber debris, and if found to be progressing, removal operations may become warranted.

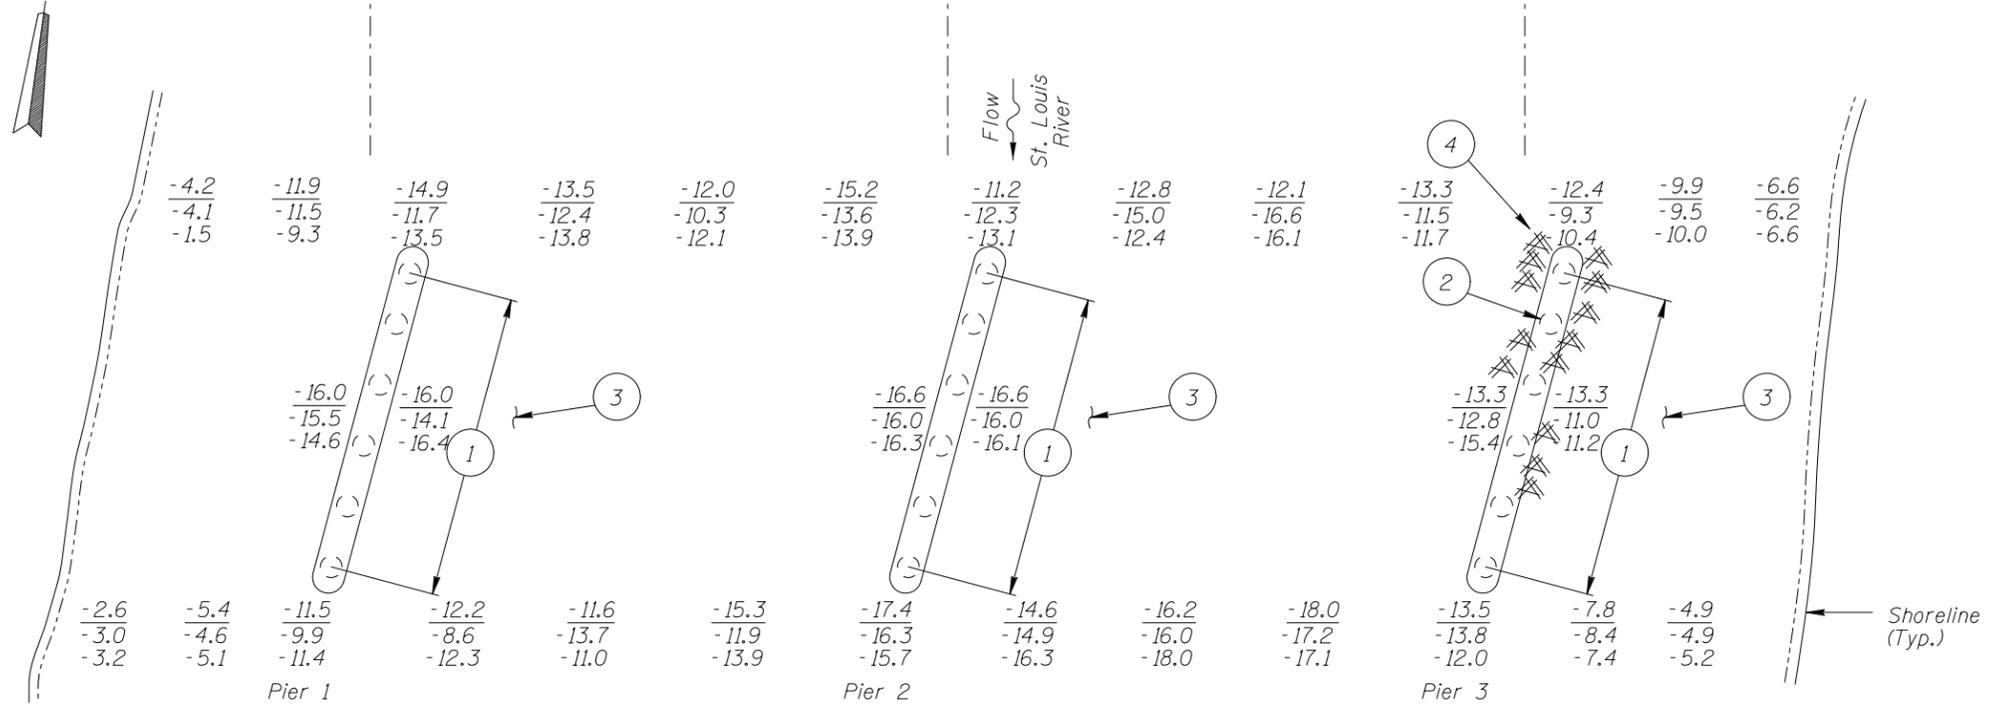
INSPECTION AND SOUNDING PLAN

- The steel pipe piles exhibited coating loss with up to 1/2-inch-diameter nodular corrosion and up to 1/32-inch-deep section loss (pitting) over 10 to 25 percent of the surface area from the waterline to 4 feet below and on 100 percent of the surface area from 4 feet below the waterline to the channel bottom.
- An outer steel casing was observed around the second upstream pile at Pier 3. The outer casing extended from the channel bottom to 8 feet below the waterline.
- The channel bottom consisted of sand and gravel with 8 inches of probe rod penetration and occasional cobbles and riprap.
- A moderate accumulation of 1-foot-diameter and smaller timber debris, ranging from 3 feet high off the channel bottom at the upstream end of the pier to 1 foot high throughout the pier, was observed on the channel bottom.
